PRE-721 EVALUATION - PHASE 1

1234 Main Street
Imperial Beach, CA 91932-1412

Buyer Name
05/02/2024 9:00AM

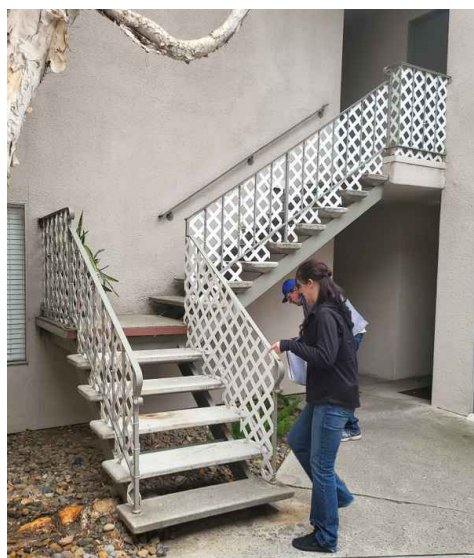
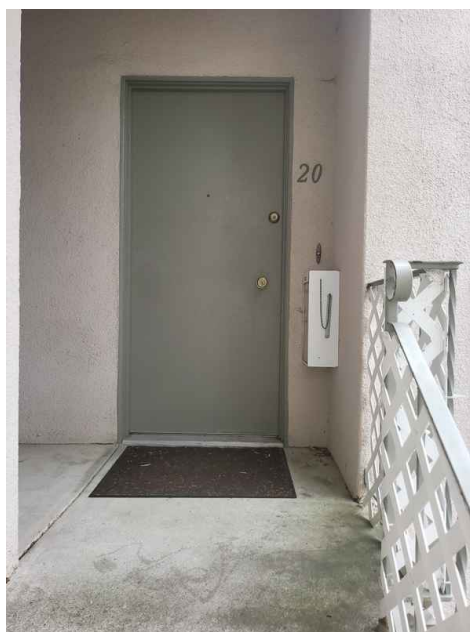
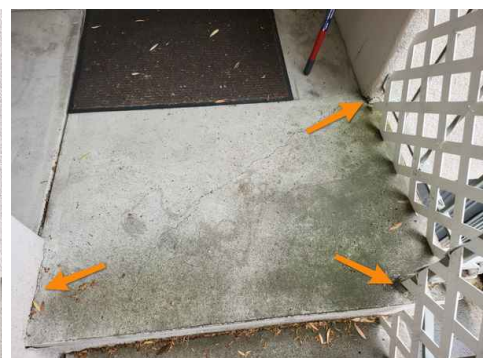
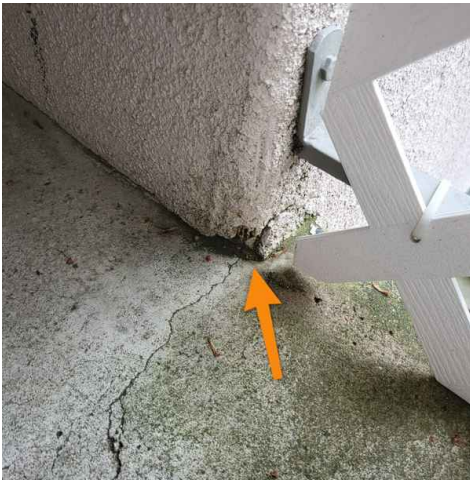
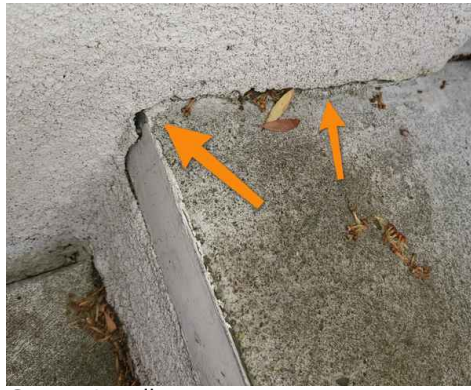
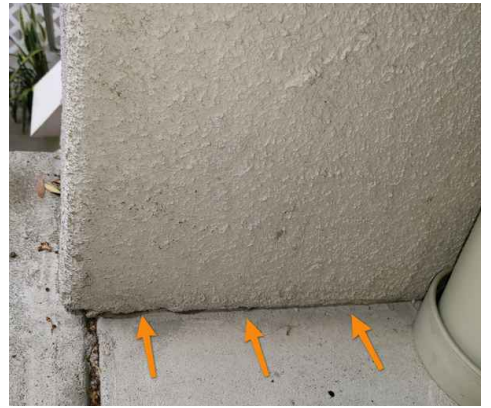
WALKWAY - SEALANT REQUIRED

UNIT #20 WALKWAY

Concrete walkway is showing signs of weathering and/or water intrusion. There are cracks in the concrete deck and gaps where the deck meets the stucco. New water sealant/weatherproofing is recommended.

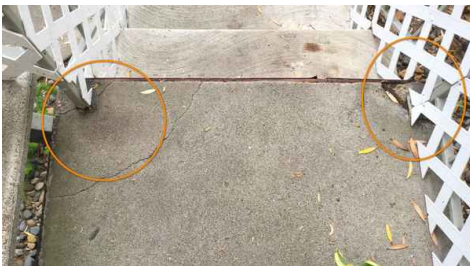
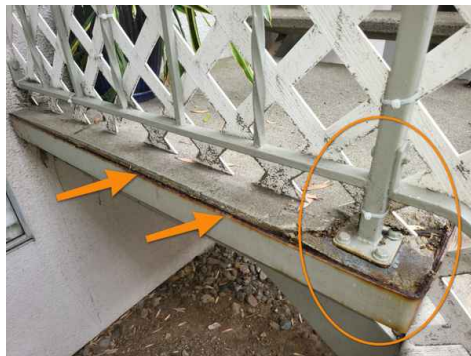
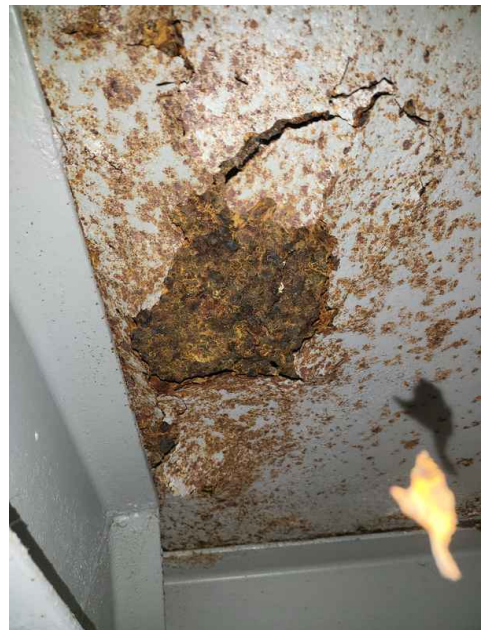
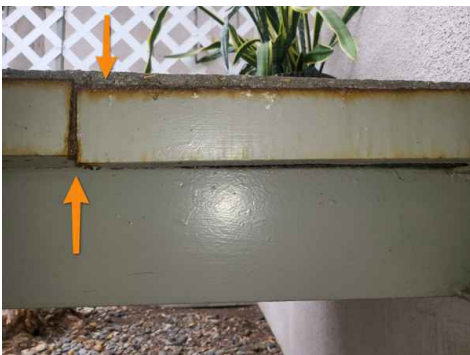
LANDING

UNIT #20 LANDING

The concrete landing has significant deterioration. Edge metal and metal baseplate have extensive corrosion. New edge metal and baseplate are recommended. The concrete deck needs replacement. These deficiencies must be addressed before SB-721 Inspection.

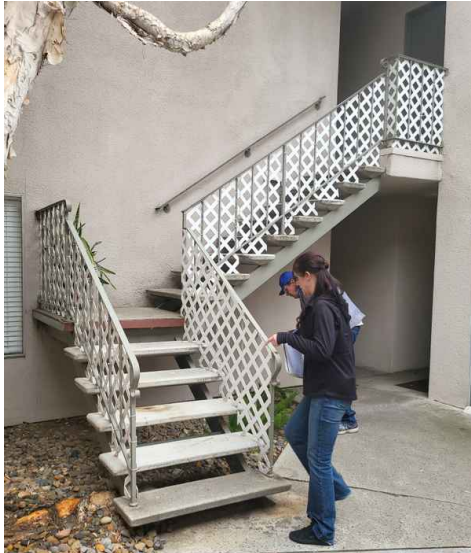
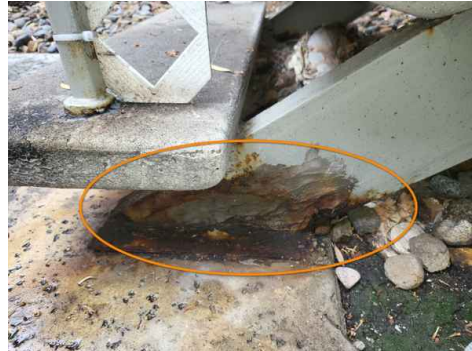
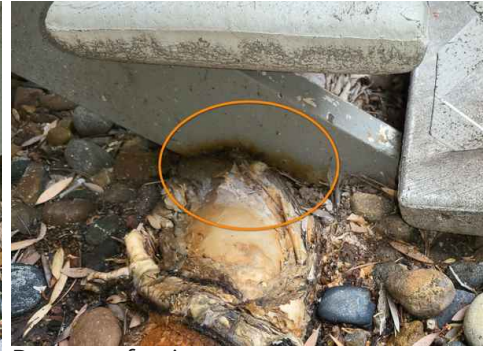
STAIRS - DETERIORATED

STAIRS TO UNIT #20

One or more sections of the exterior stairs are deteriorated. Right bottom stringer rusted through. The left bottom stringer is uplifted by a large tree root. These areas need attention.

Several of the concrete stair treads are cracked or crumbling and must be replaced.

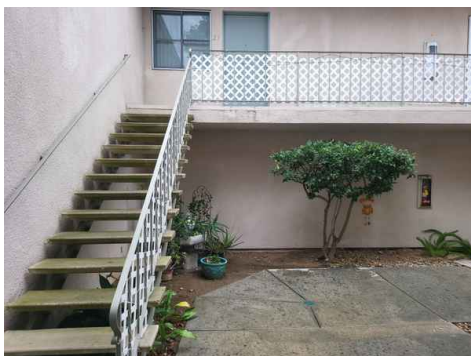
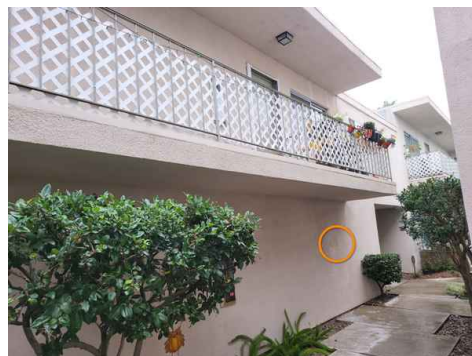
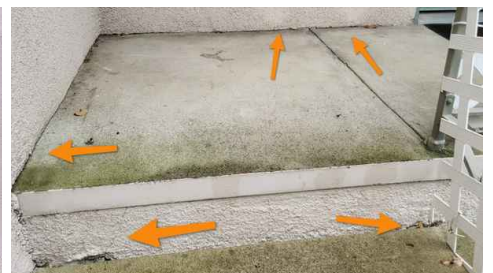
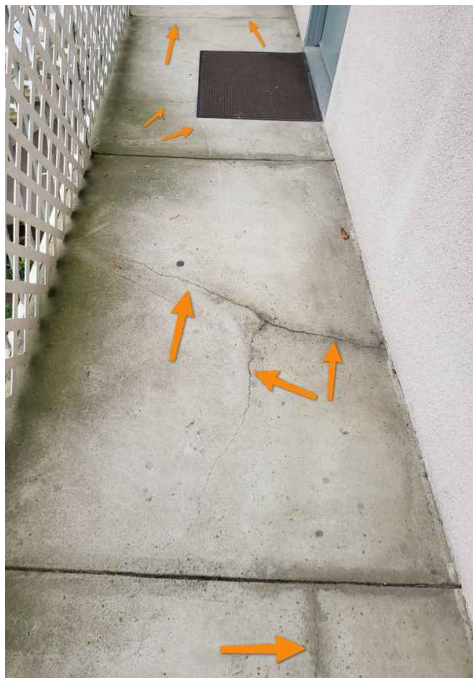
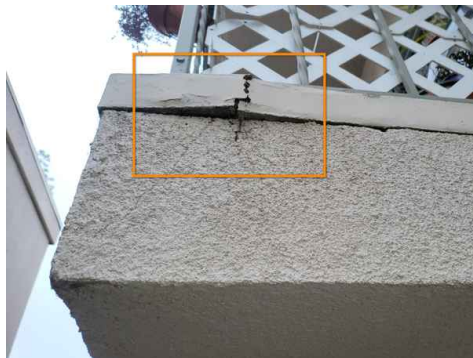
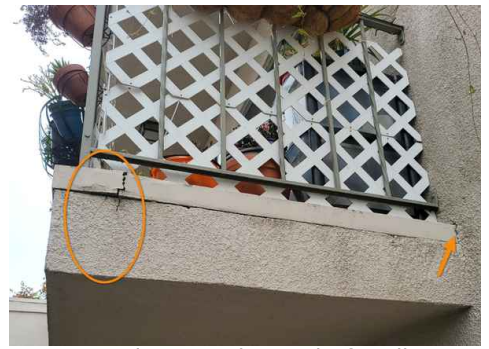
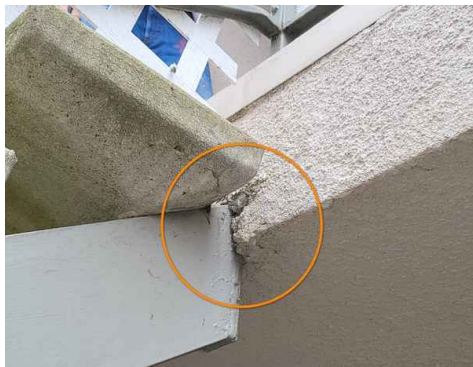
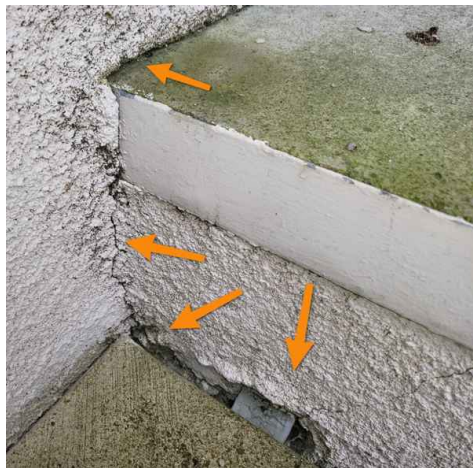
WALKWAY WATER SEALANT REQUIRED

UNIT #21 AND 22

The concrete walkway is showing signs of weathering and water intrusion. There are cracks in the concrete deck and gaps where the deck meets the stucco and around where the stringers attach. New water sealant/weatherproofing is recommended. Further investigation into what caused the cracks in the walkway is recommended. The plywood and support framing may have termite damage.

A borescope inspection is recommended under the stair stringer, the cracks in concrete, and along the edge metal.

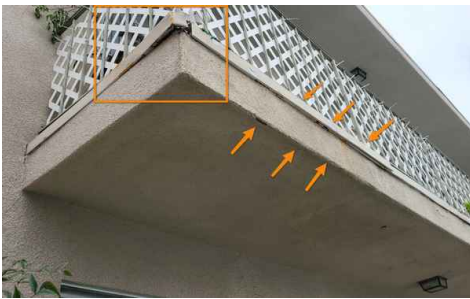
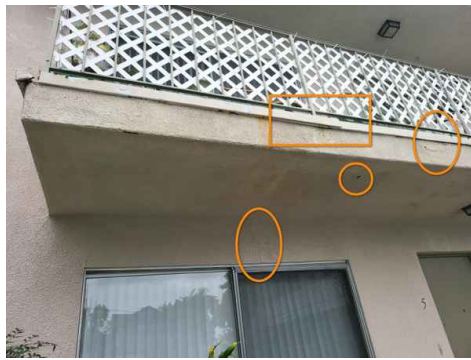
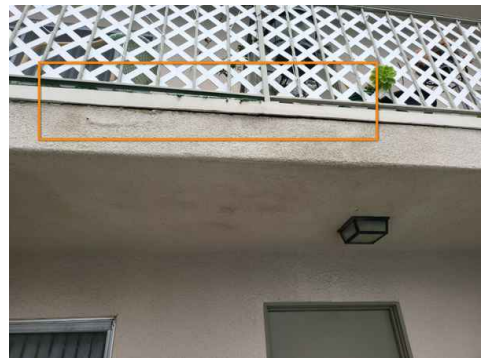
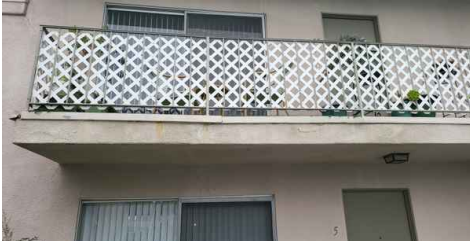
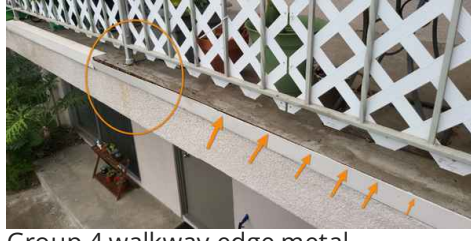
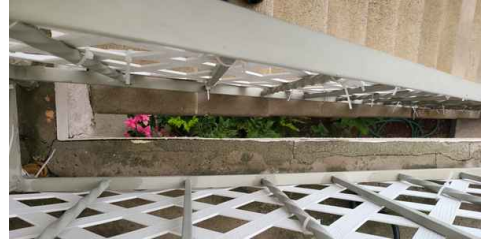
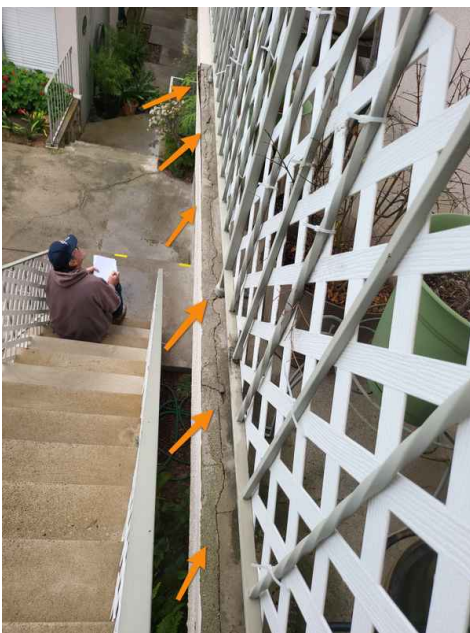
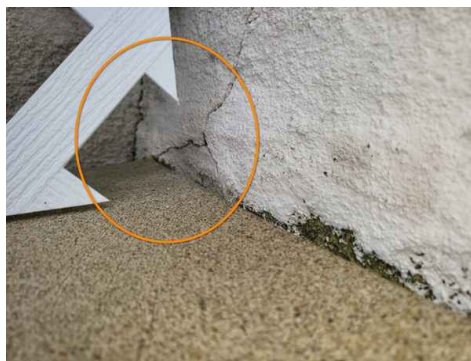
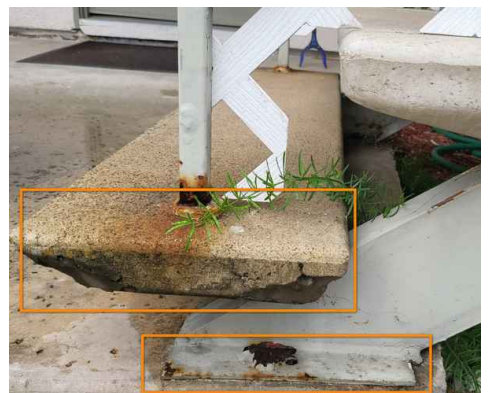
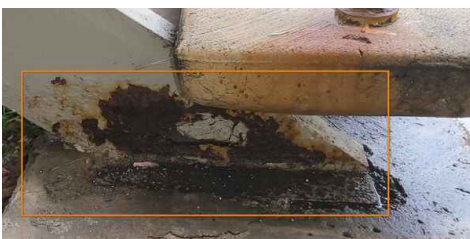
The concrete walkway is showing signs of weathering and water intrusion.

The deck edge metal has been repaired in the last few years. This repair has failed. Demo and replacement of 40ft section of edge metal is recommended.

Bottom of stair stringers severely rusted and need to be stripped and evaluated.

A Borescope inspection is needed under the stair stringer and along the rim board. Larger investigative openings may be necessary near one or more of these areas.

New sealant where stucco meets the concrete walkway is recommended.

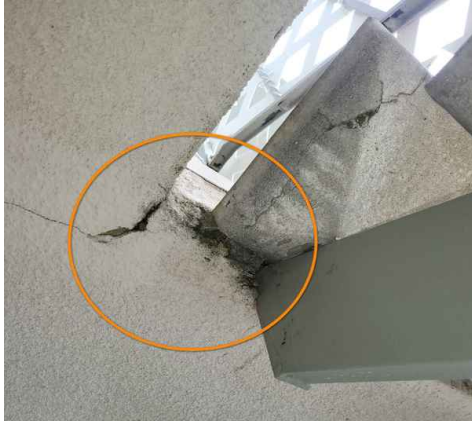
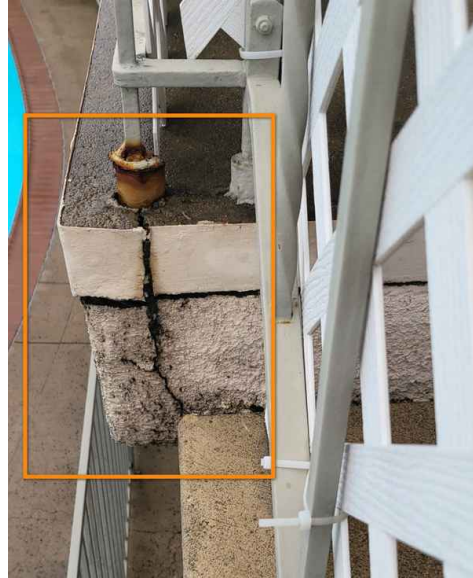
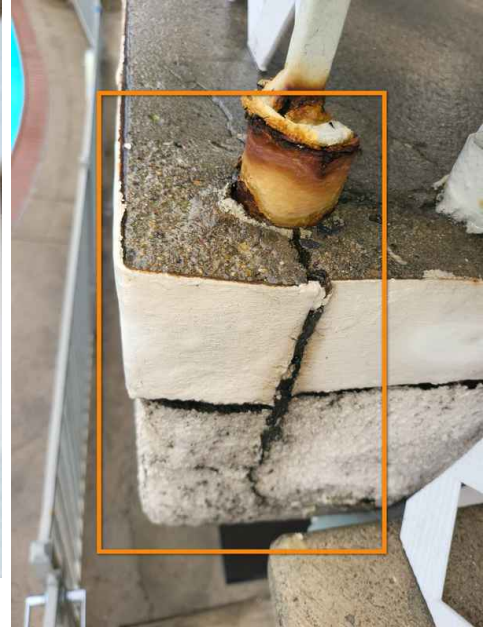
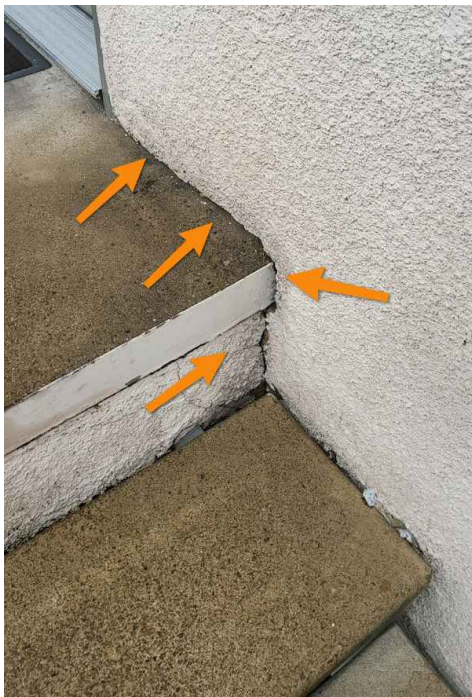
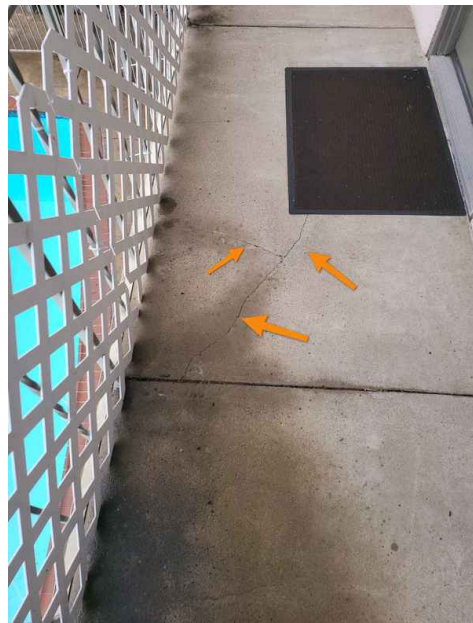
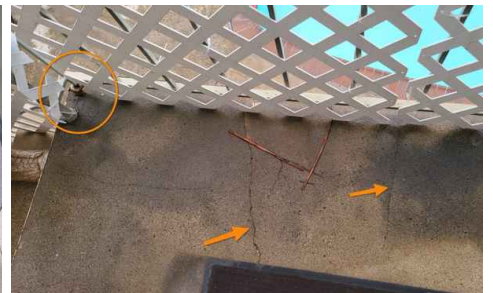
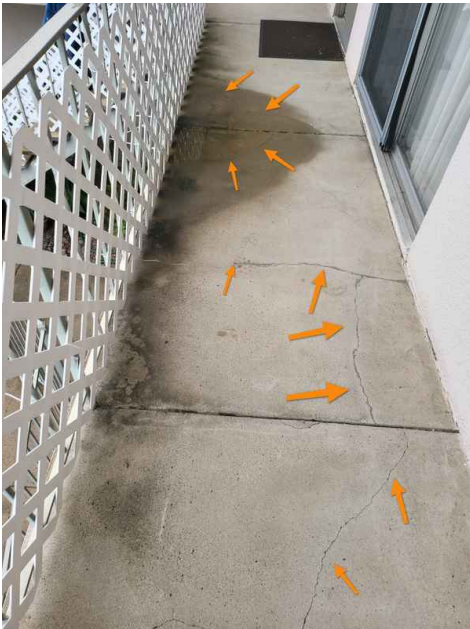
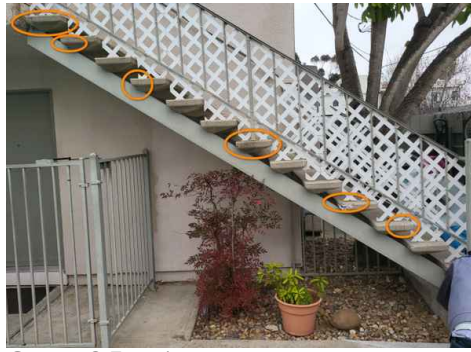
STAIRS AND WALKWAY CONTINUED

UNIT 11, 12 AND 13

The concrete walkway is showing signs of weathering and water intrusion. New Caulking around the 30 ft perimeter of the walkway deck is recommended. Cracks along 52ft length of walkway must be resealed with flexible sealant. Borescope Inspections are recommended underneath both stair stringers on the East and West ends. Deck edge metal needs new sealant along the entire 52ft length. The edge metal is corroded and needs to be replaced.

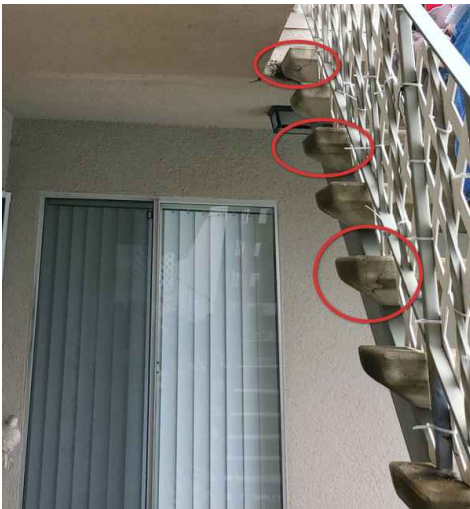
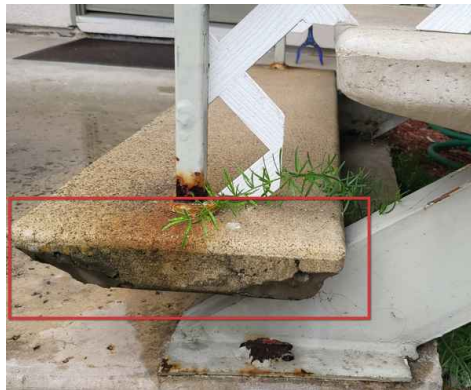
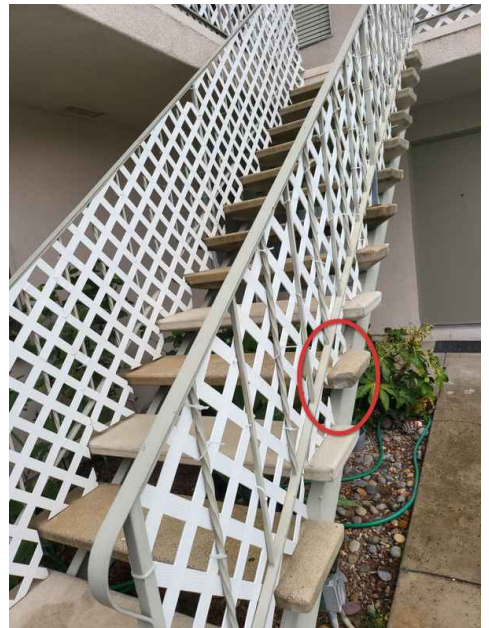
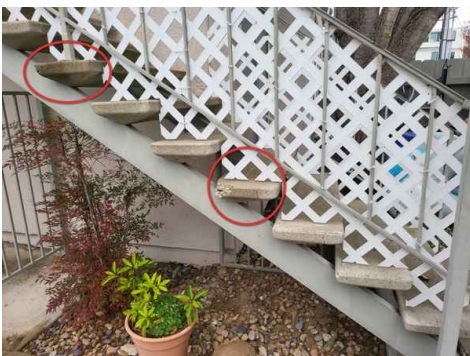
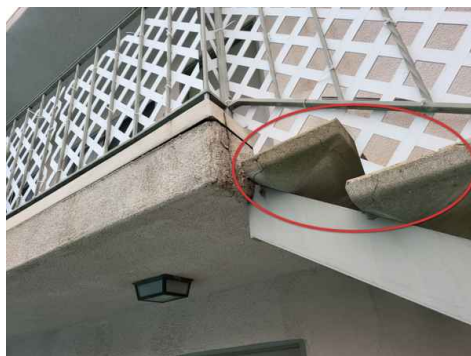
STAIRS - DETERIORATED

Several of the concrete stair treads are cracked or crumbling and must be replaced.

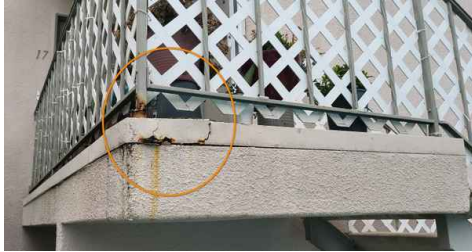
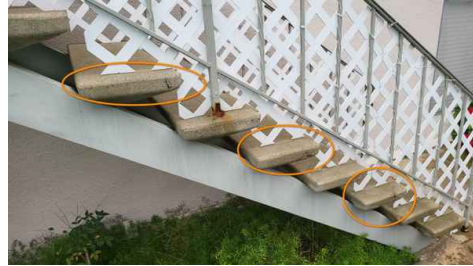
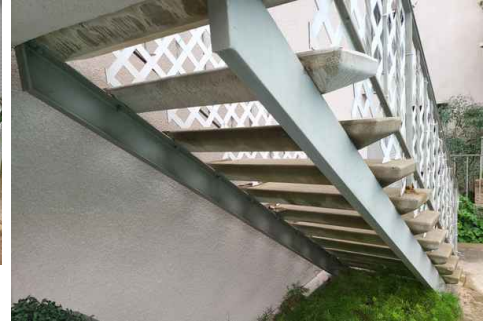
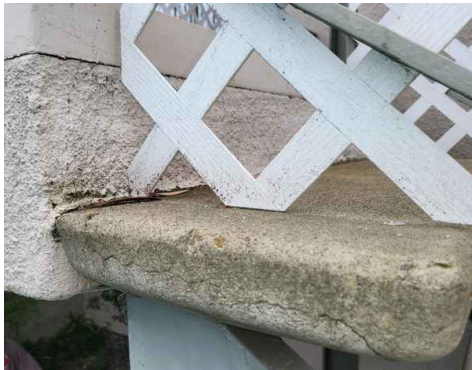
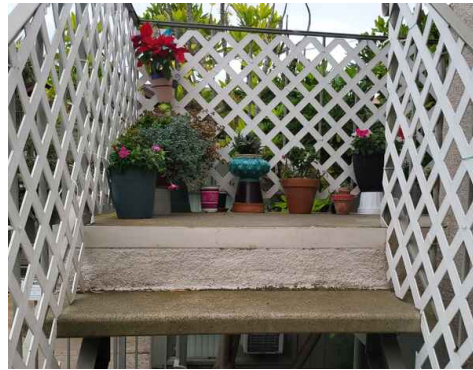
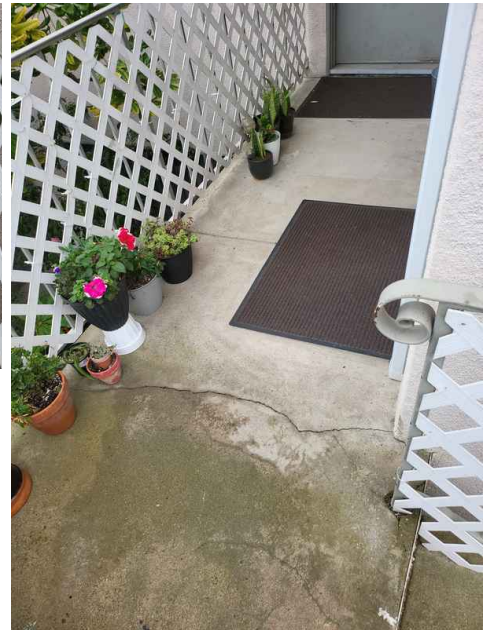
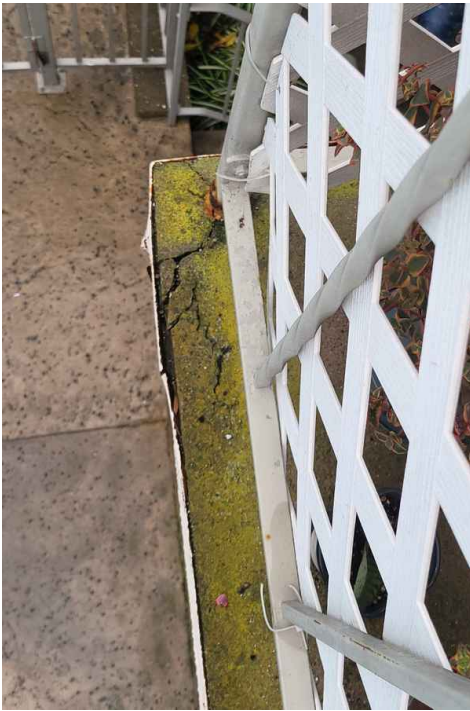
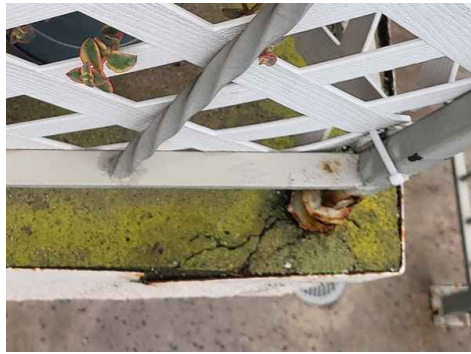
STAIRS AND WALKWAY

Walkway is showing signs of weathering and water intrusion. Outside corner of the edge metal is rusted apart. Metal railing needs repair.

A Borescope Inspection is needed underneath the stair stringer, the corner railing attachment where outside metal is rusted, and where walkway is cracked.

Larger investigative openings may be necessary near one or more of these areas.

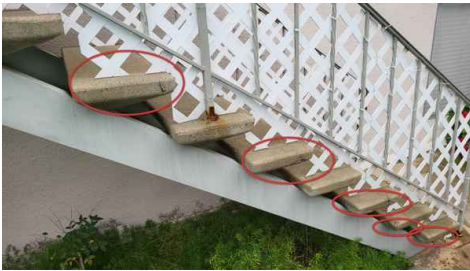
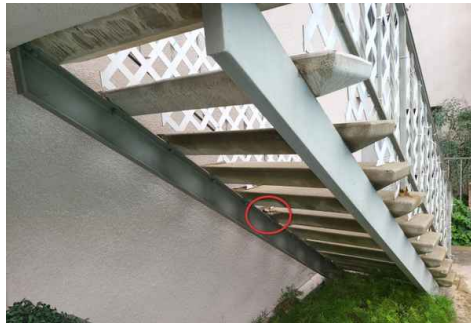
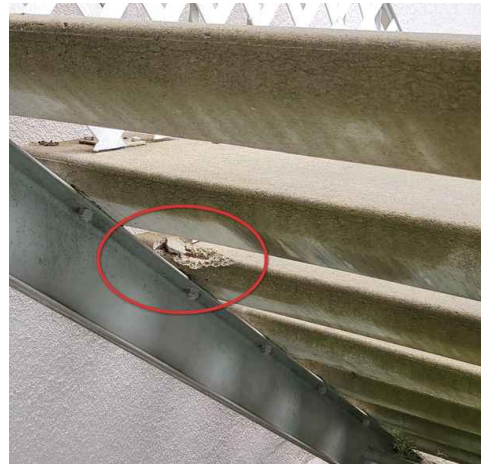
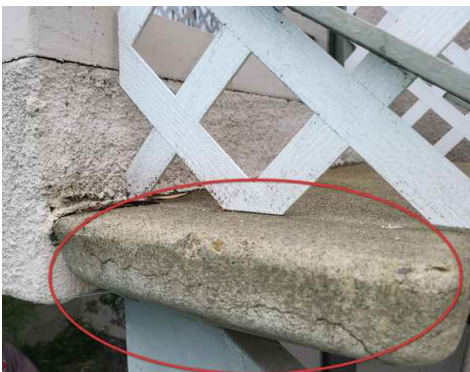
STAIRS - DETERIORATED

Several of the concrete stair treads are cracked or crumbling and must be replaced.
