PHASE 1 SB-721 EVALUATION

1234 Main Street
Imperial Beach, CA 91932-1412

Buyer Name
05/02/2024 9:00AM

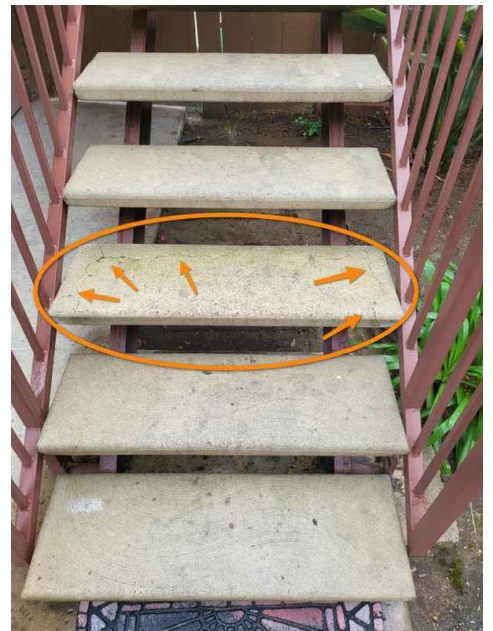
Damaged Stair Tread

DAMAGED STAIR TREADS (MINORITY)

1 of 14 treads are cracked or broken. It is advised that only the affected treads be replaced.

Contact a qualified professional.

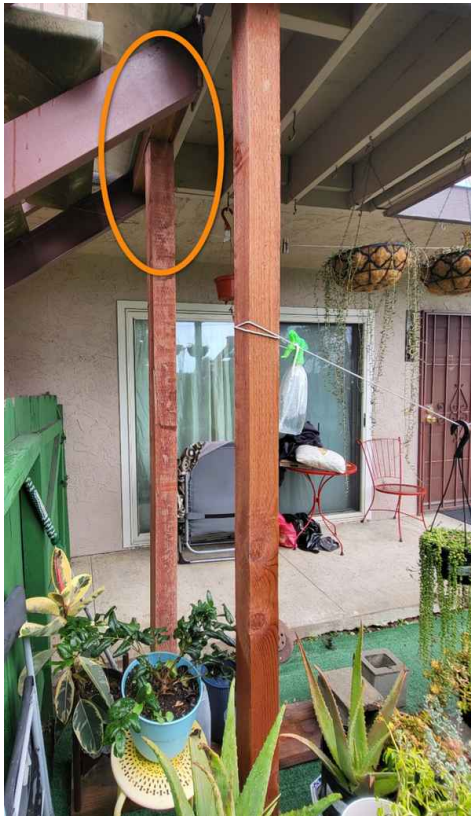
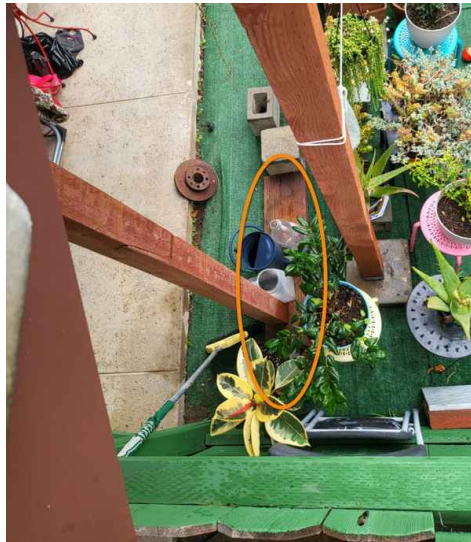
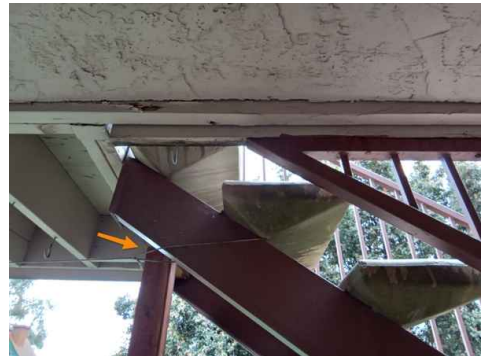
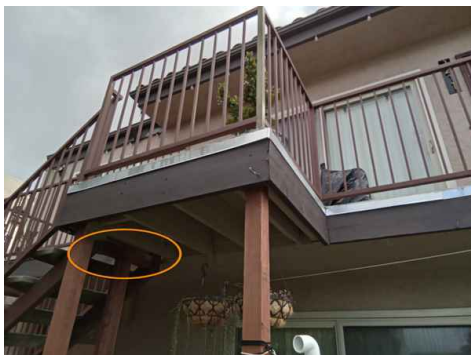
IMPROPER SUPPORT CONSTRUCTION (STABLE)

The inspection revealed evidence of minor to moderate instability in the support structure, possibly due to inadequate or improper construction methods. While currently stable, this condition suggests that the support may not have been built by a licensed contractor and building codes not utilized, potentially leading to long-term issues. Consultation with a licensed contractor is recommended to assess the need for reinforcement or corrective measures.

Contact a qualified professional.

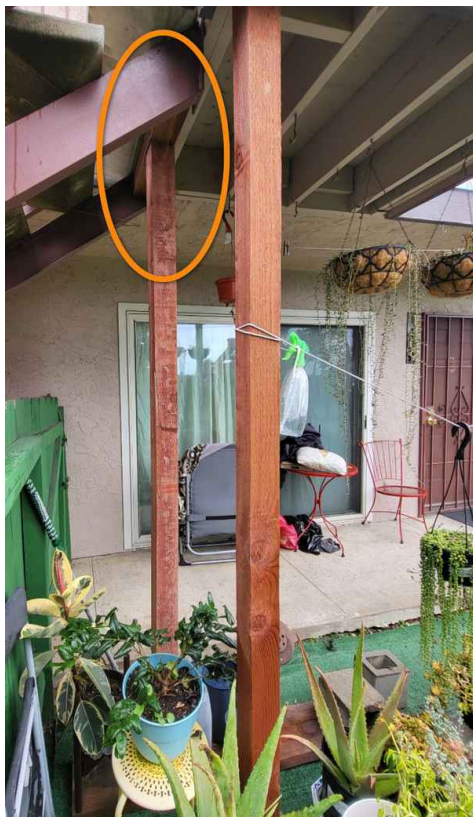
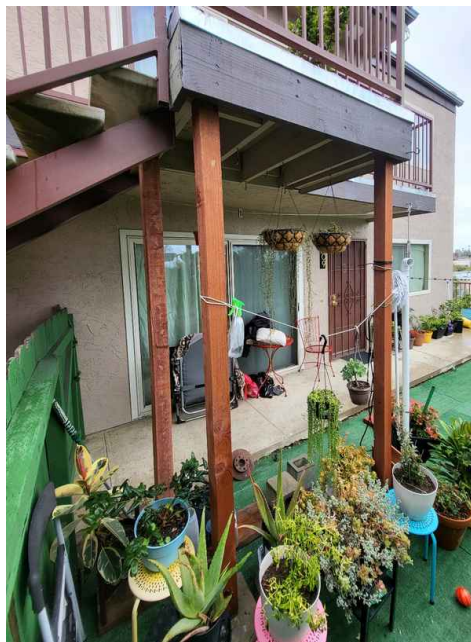
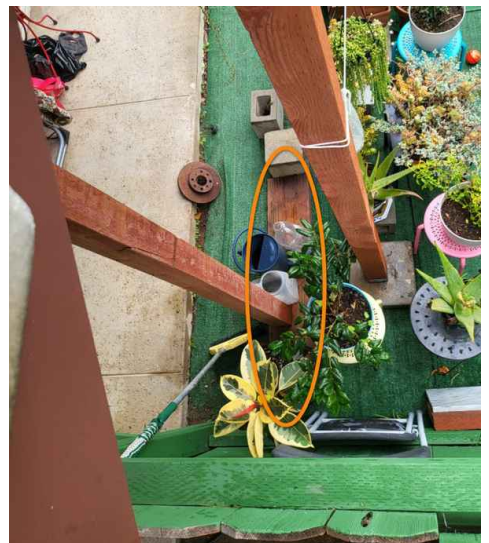
Support Beam on Temp Base

IMPROPER SUPPORT CONSTRUCTION (STABLE)

At the time of the inspection, it was found that the walkway was not properly supported. While currently stable, this condition suggests that the support was not built to code by a licensed contractor, potentially leading to long-term issues. Consultation with a licensed contractor is recommended to assess the need for adequate support and corrective measures.

Contact a qualified professional.

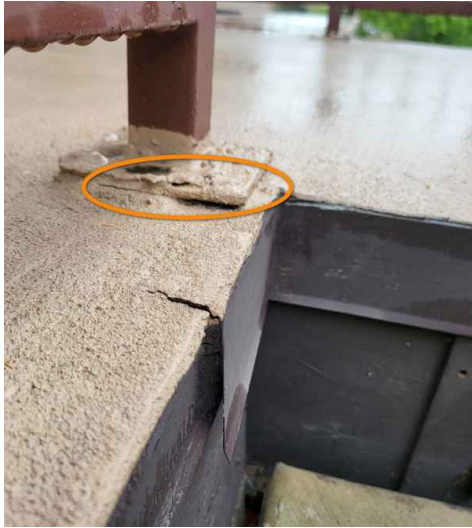
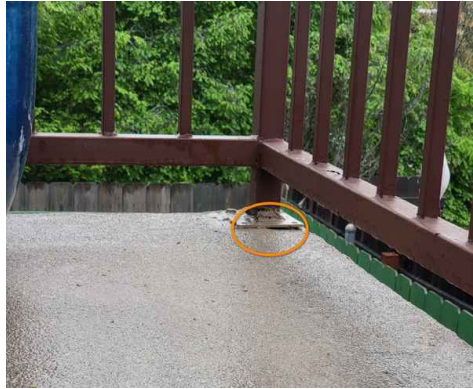
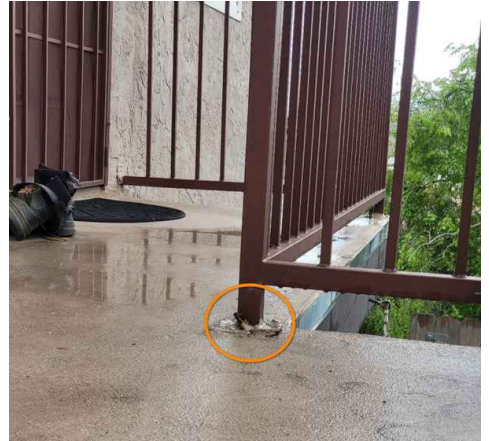
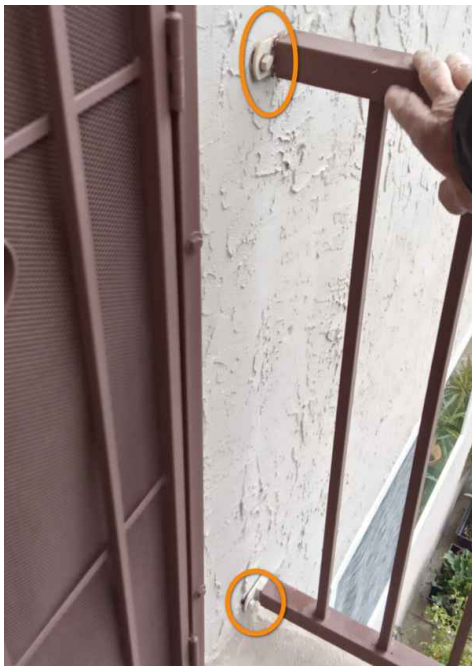
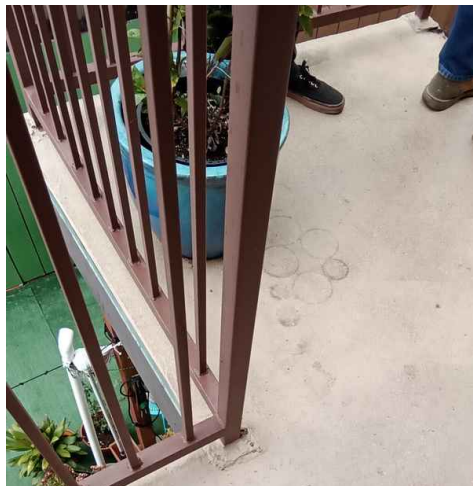
At the time of the inspection, there were one or more areas of the guard railing that were not properly sealed at the attachment points. These areas can allow moisture to seep through, potentially leading to wood rot, structural weakness, and mold growth. Immediate steps should include a professional assessment, repair and sealing of the attachment points, and regular maintenance to prevent further damage and ensure the deck's longevity and safety.

Contact a qualified professional.

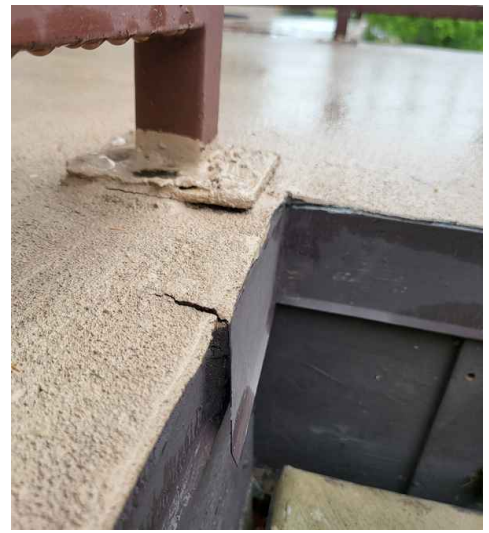
FLASHING/TRIM IMPROPERLY INSTALLED

At the time of the inspection, there were one or more areas where the edge metal was not properly installed or sealed. These areas may allow water intrusion, potentially leading to wood rot, structural weakness, and mold growth. Immediate steps should include a professional assessment, repair and sealing of the openings, and regular maintenance to prevent further damage and ensure the deck's longevity and safety.

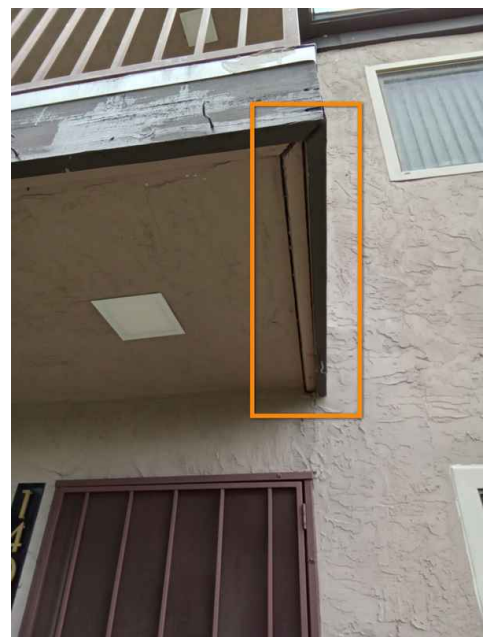
RIM BOARD - LOOSE

One or more sections of the rim board and/or fascia have separated from the soffit. The resulting gaps are potential entry points for water intrusion, insect swarms including termites and bees.

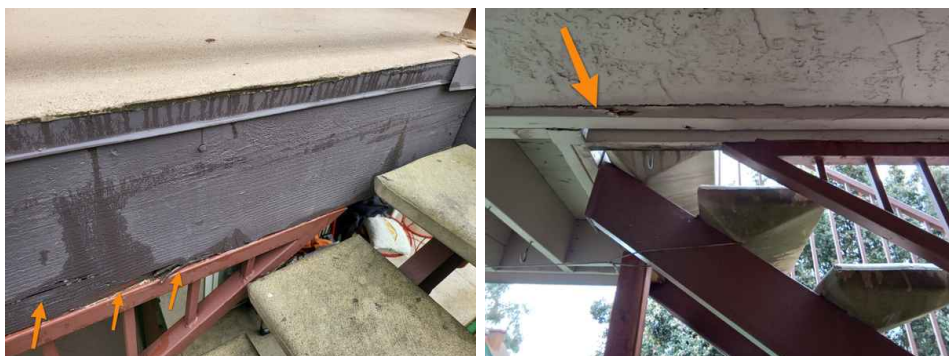
TERMITE/WOOD ROT DAMAGE

One or more sections of the rim joist and/or fascia have termite and/or dry rot damage. It is recommended that these sections be, treated or replaced.

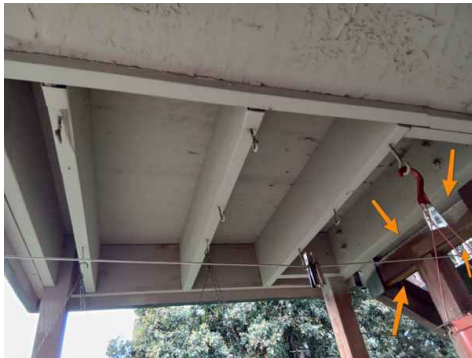
Temporary Support Beam

IMPROPER SUPPORT CONSTRUCTION (STABLE)

The evaluation revealed minor to moderate instability in the support structure, possibly due to inadequate or improper construction methods. Although the structure is stable, the evaluation indicates that it may not have been repaired according to the local building code, which could result in long-term issues. We recommend regular monitoring and consultation with a licensed contractor to assess the need for reinforcement or corrective measures.

Contact a qualified professional.

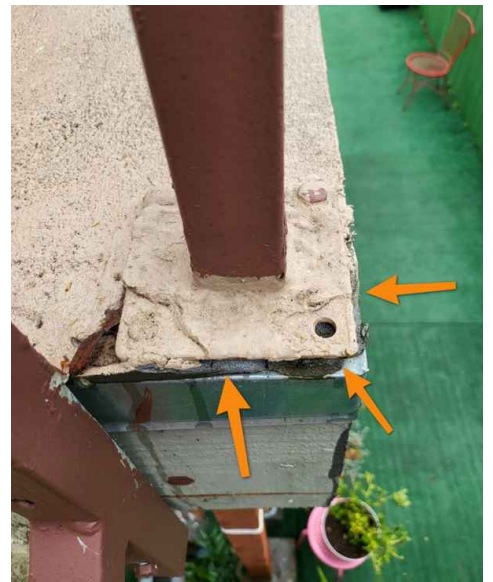
Rail Attachment

At the time of the inspection, there were one or more areas of the guard railing that were not properly sealed at the attachment points. These openings can allow moisture to seep through, potentially leading to wood rot, structural weakness, and mold growth. Immediate steps should include a professional assessment, repair and sealing of the attachment points, and regular maintenance to prevent further damage and ensure the deck's longevity and safety.

Contact a qualified professional.

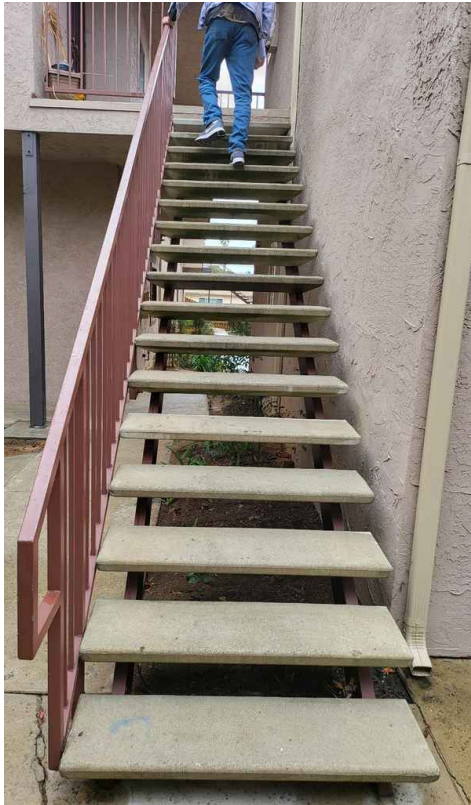
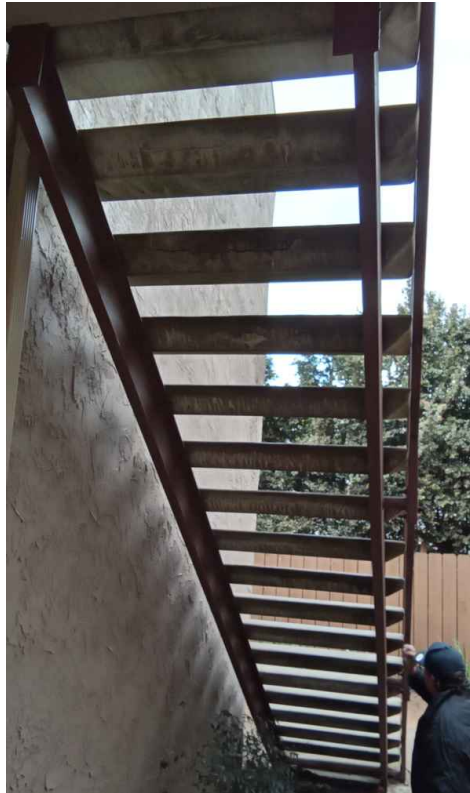
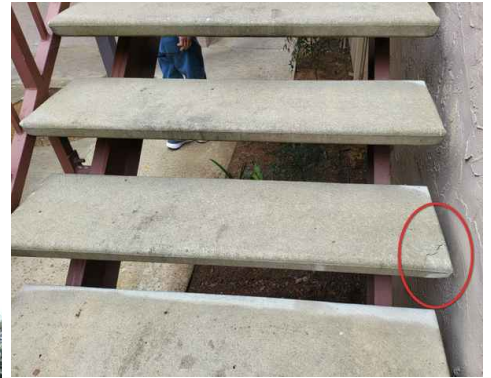
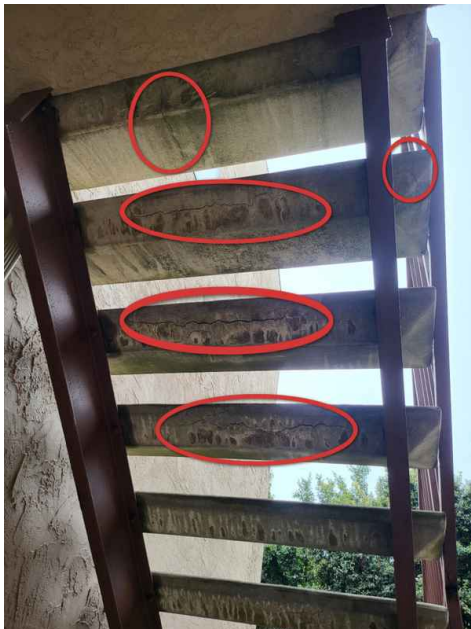
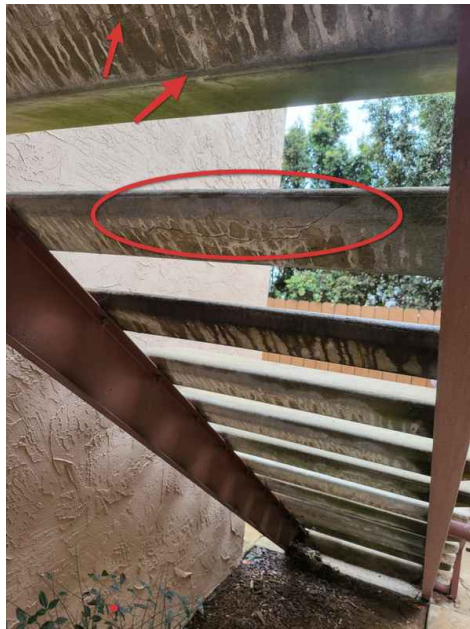
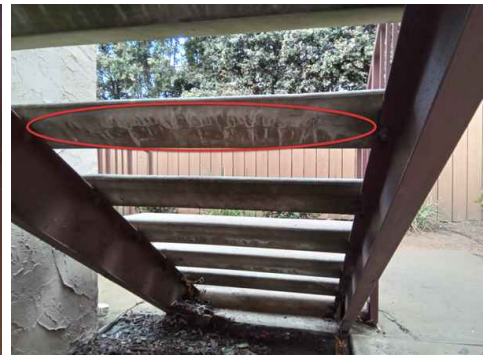
DAMAGED STAIR TREADS (MAJORITY)

More than half the treads are cracked or broken. It is advised that all damaged treads on this stairway be replaced, as this degree of cracking indicates that the treads have reached their end-of-life.

Contact a qualified professional.

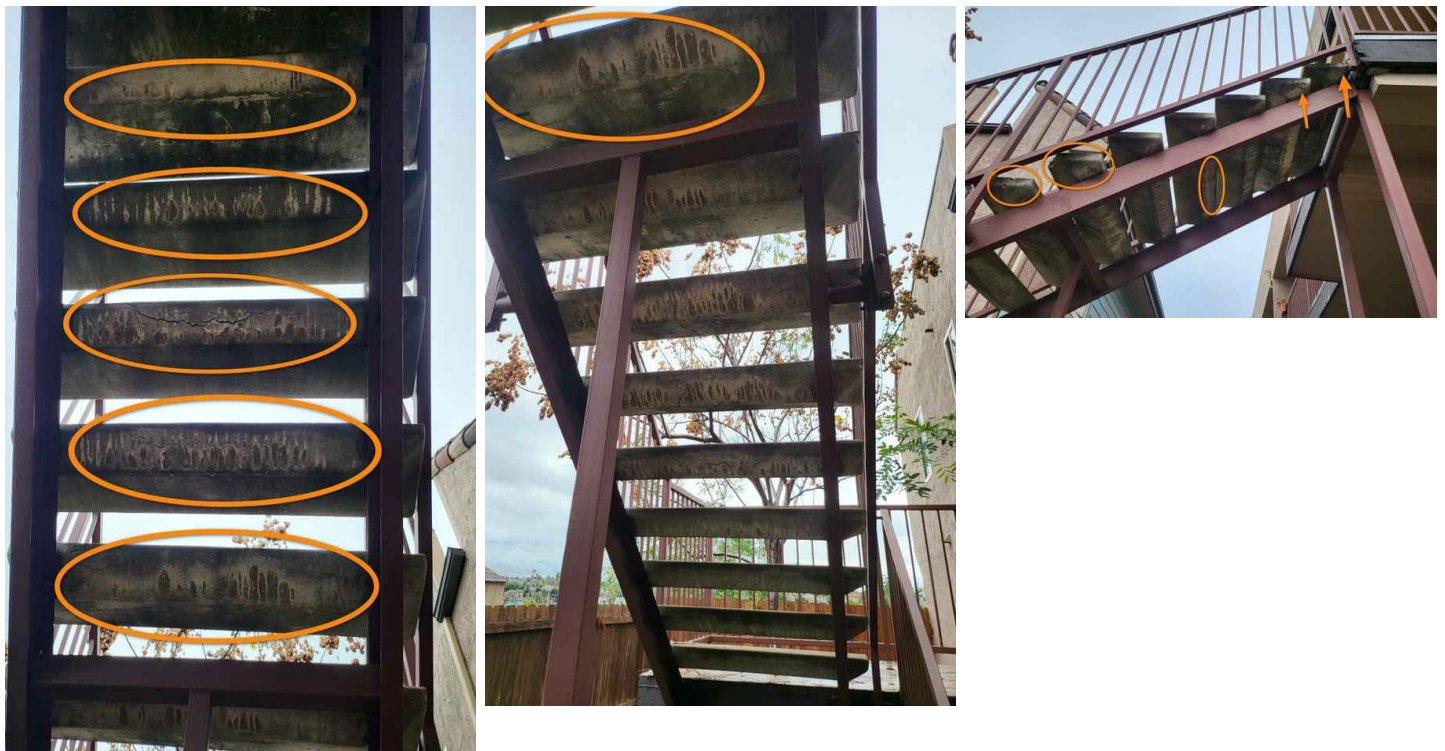
DAMAGED STAIR TREADS

6 or more treads contain cracks or breakages. These damaged stair treads must be replaced prior to SB-271 inspection.

Contact a qualified professional.

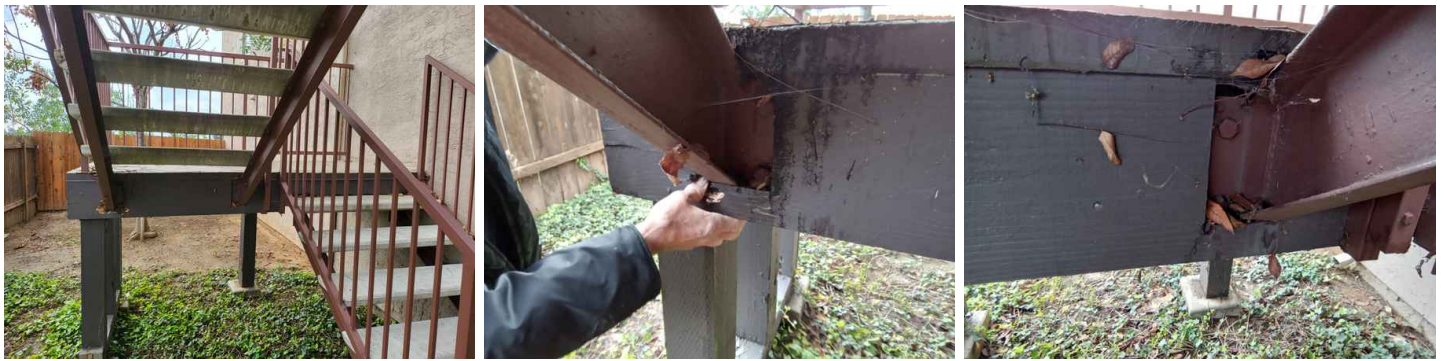
IMPROPER SUPPORT CONSTRUCTION (STABLE)

The inspection revealed evidence of minor to moderate instability in the support structure, possibly due to inadequate or improper construction methods. While currently stable, this condition suggests that the support may not have been built to optimal standards, potentially leading to long-term issues. Regular monitoring and consultation with a construction expert are recommended to assess the need for reinforcement or corrective measures.

Inspector Notes: The load from the upper and low stair stringers is supported by a doubler that has extensive termite damage.

Contact a qualified professional.

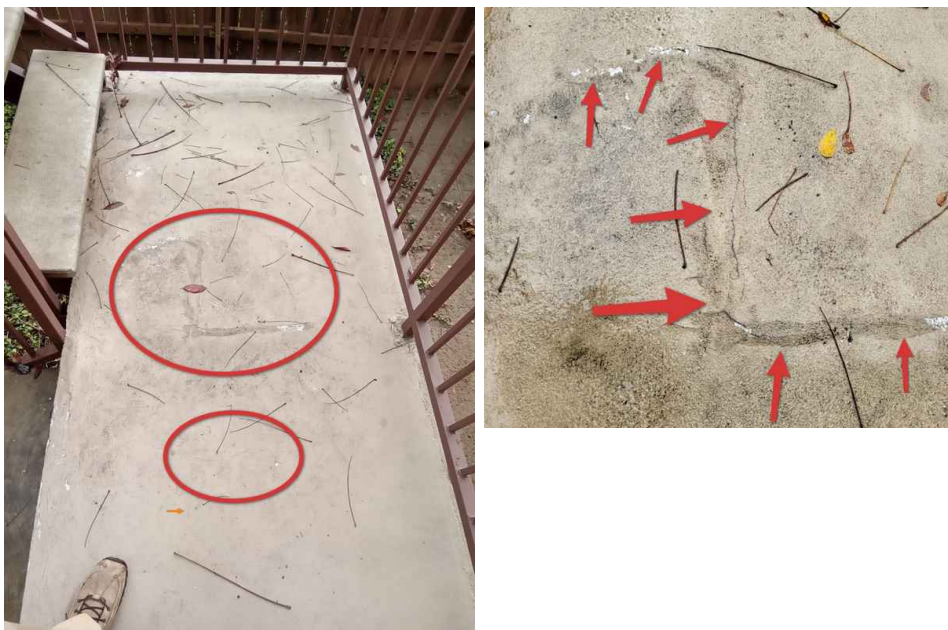
DETERIORATING WATERPROOFING

There are visible cracks in the decking surface and evidence of water intrusion. The decking material is lifted off the plywood in some areas. The plywood under the decking is likely damaged. The decking surface on the landing must be repaired or replaced prior to SB-721 Inspection.

Contact a qualified professional.

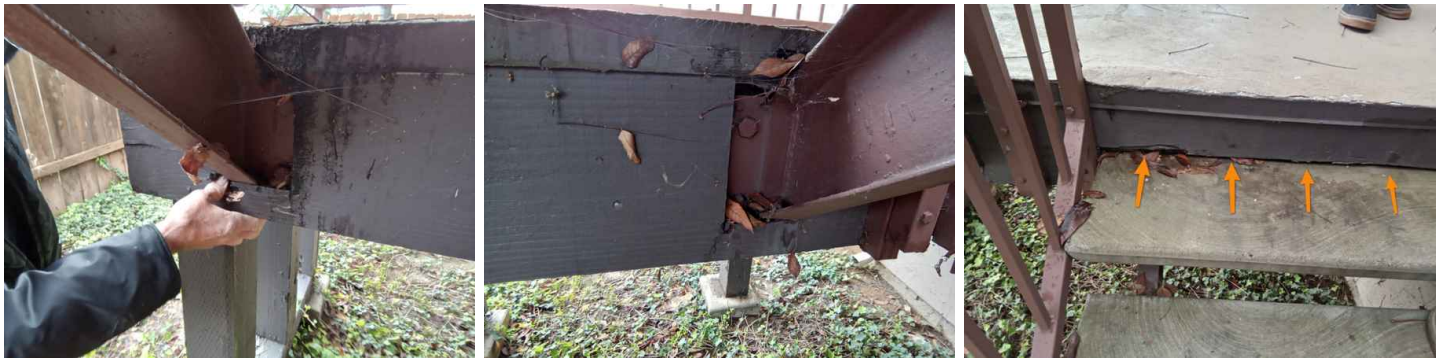
Inspection has revealed that previous repair efforts on the structure are failing, indicating either inadequate repair methods were used or the underlying issues have not been fully addressed. This ranges from moderate to major concern, as the deteriorating condition of these repairs could lead to further damage or safety risks. It is essential to re-evaluate these areas with a qualified professional to determine the cause of failure and to implement more effective and lasting repair solutions. Immediate attention to these areas is advised to prevent the escalation of the defects.

Inspector notes: In previous repairs, a rim board that attaches to the doubler was notched out at the stringer connection. This area is not properly sealed. Water drains down the stringer and pools in these areas and has rotted the surrounding wood. There is a large gap above the top tread of the lower stairway that allows water to enter and get behind the stair tread. There is wood rot at this gap which may spread to the supporting doubler.

Contact a qualified professional.

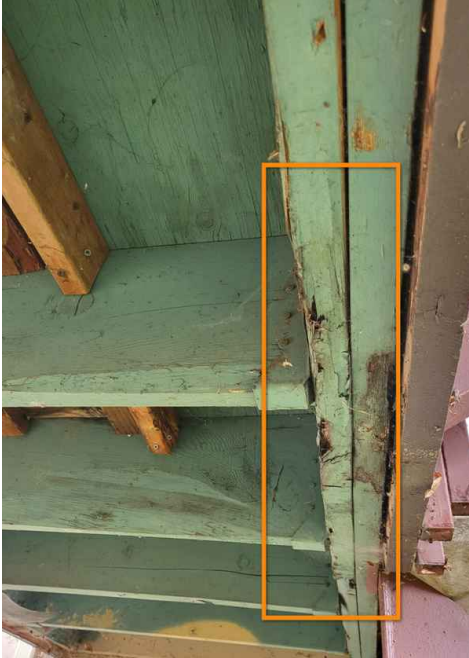
Doubler with Termite Damage

TERMITE/WOOD ROT DAMAGE 2

One or more sections of the support framing have termite and/or dry rot damage. It is recommended that these sections be treated or replaced.

Doubler supporting the stair stringers has moderate to severe termite damage/wood rot. The added 6x6 support beam rests on a 6x6 cross beam that has moderate to severe termite damage/wood rot. See the last photo.

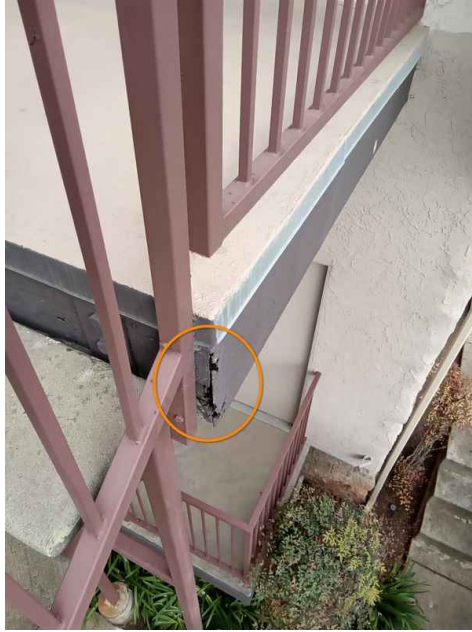
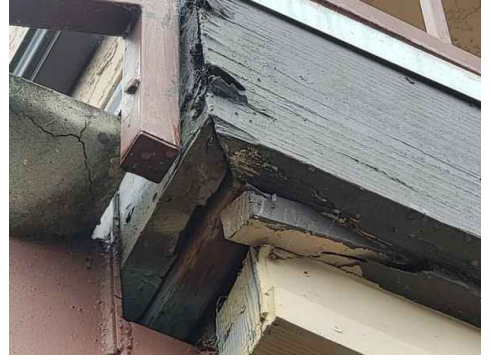
TERMITE/WOOD ROT DAMAGE

One or more sections of the rim joist and/or fascia have termite and/or dry rot damage. It is recommended that these sections be treated and sealed, or replaced.
