PHASE 1 PRE-721 EVALUATION (P1PE)

1234 Main Street
Imperial Beach, CA 91932-1412

The property is a 15 unit apartment complex with two 2-story buildings. This property has one exterior elevated element group with two stairways and a single elevated walkway connecting the two buildings. This group will be referred to as Exterior Elevated Element (E3) Group 1.

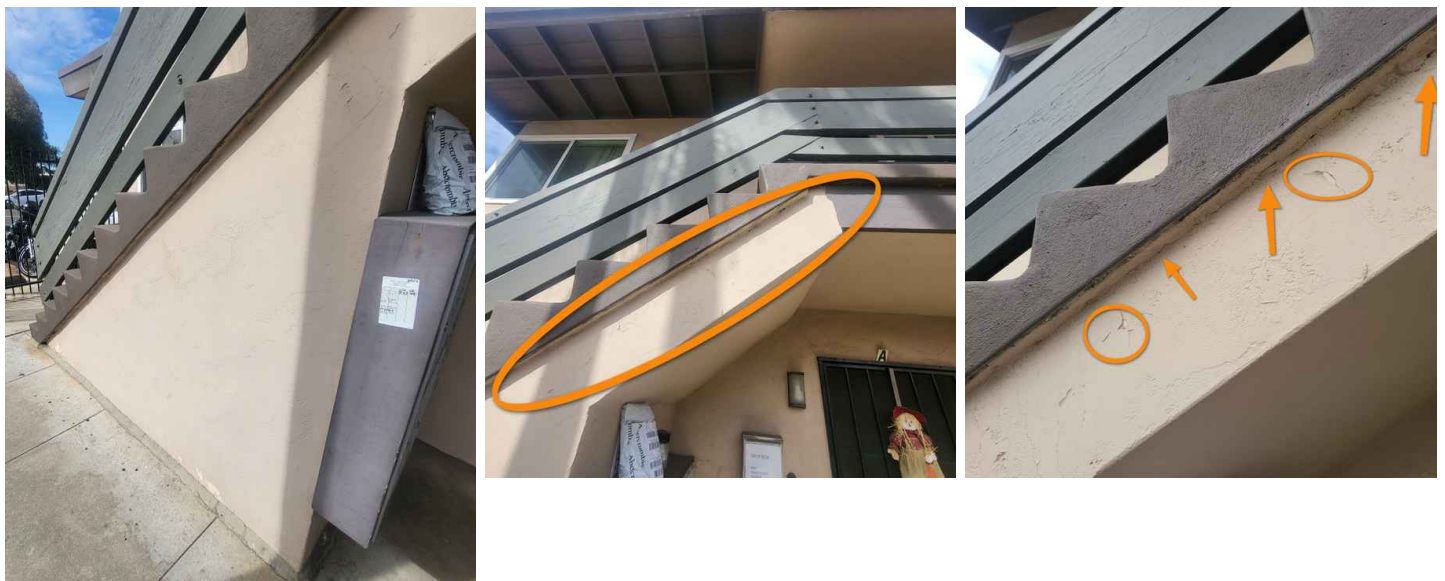
CRACKED STUCCO

There is a crack along the transition where the stucco meets the underside of the concrete stairs. The paint is peeling off the stucco under this crack. These areas should be resealed to prevent further water intrusion. Water intrusion can lead to internal deterioration of materials and possible compromise of structural integrity over time. A Phase 2 Pre-721 Evaluation (P2PE) is recommended to determine the extent of any water damage via borescope inspection, and to formulate a detailed repair plan.

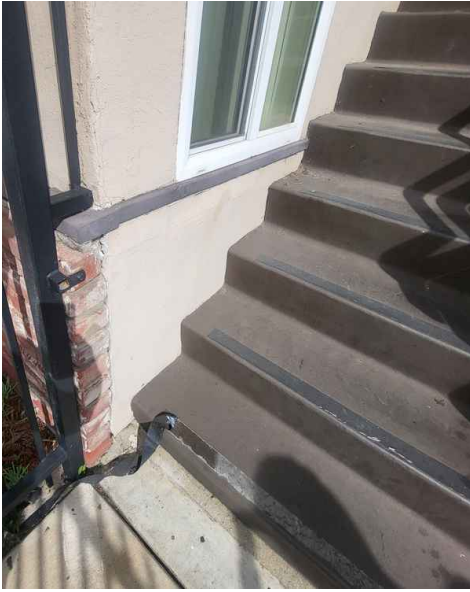
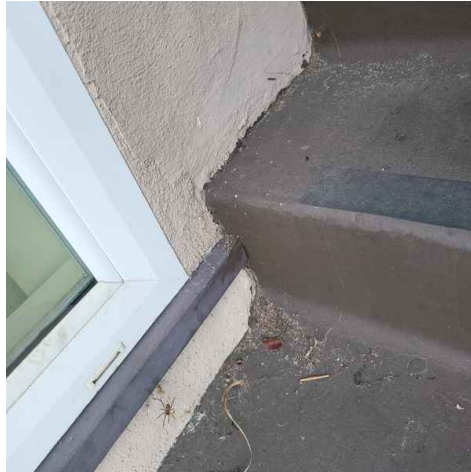
5.2.2 Stairway 1

CRACKS IN WATERPROOFING

There are openings in the waterproofing along the transition where the stairway meets the stucco. Application of sealant is recommended.

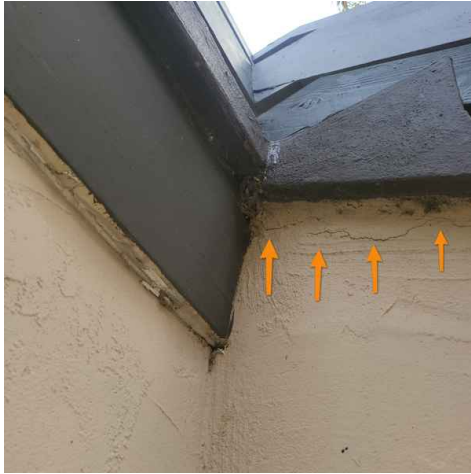
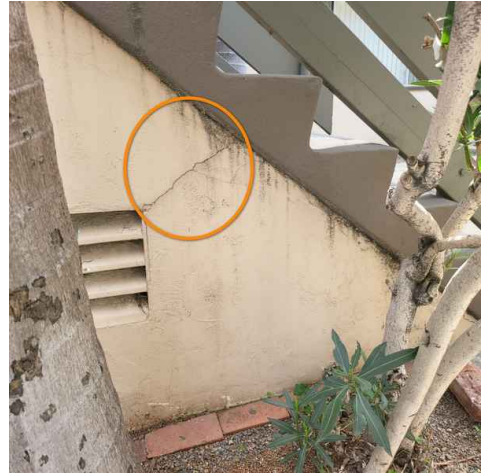
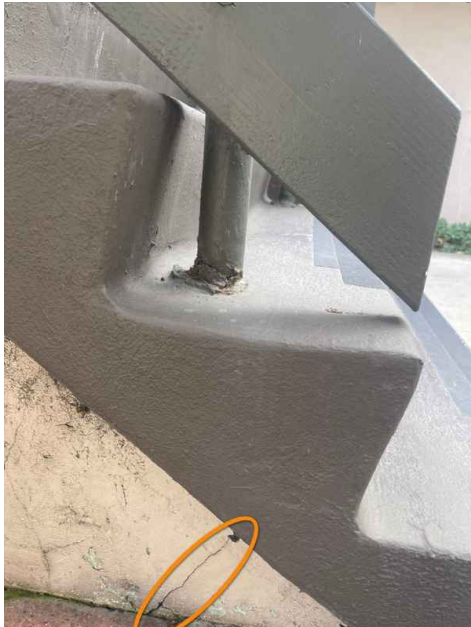
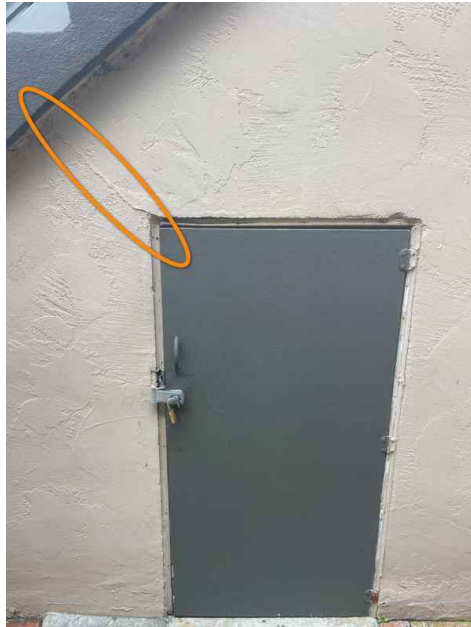
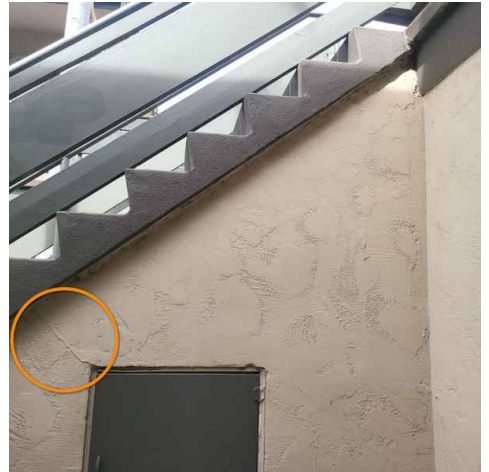
5.3.1 Stairway 2

CRACK(S) IN THE STUCCO

There are cracks in the stucco under the concrete stairway on both sides. This condition raises concerns regarding the potential for water intrusion and the long-term integrity of the underlying support structure. Such water intrusion can lead to internal deterioration of materials and possible compromise of structural integrity over time. A Phase 2 Pre-721 Evaluation (P2PE) is recommended to determine the extent of any water damage via borescoping, and to formulate a detailed repair plan.

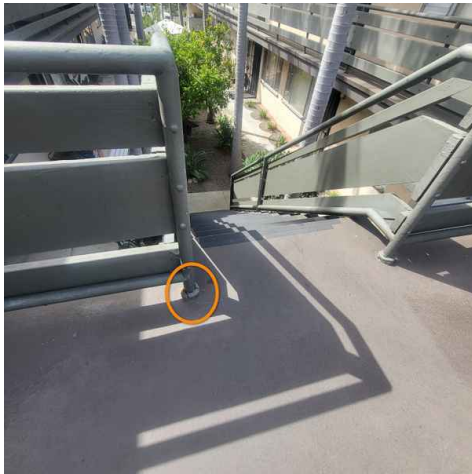
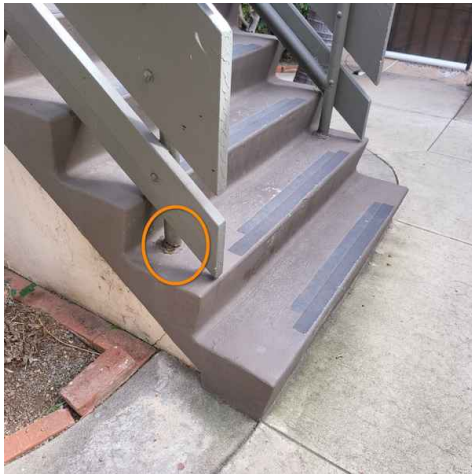
5.3.2 Stairway 2

HANDRAIL CORROSION

The base of the handrail is corroded and cracked allowing water intrusion. Corrosion should be removed, repaired, and resealed.

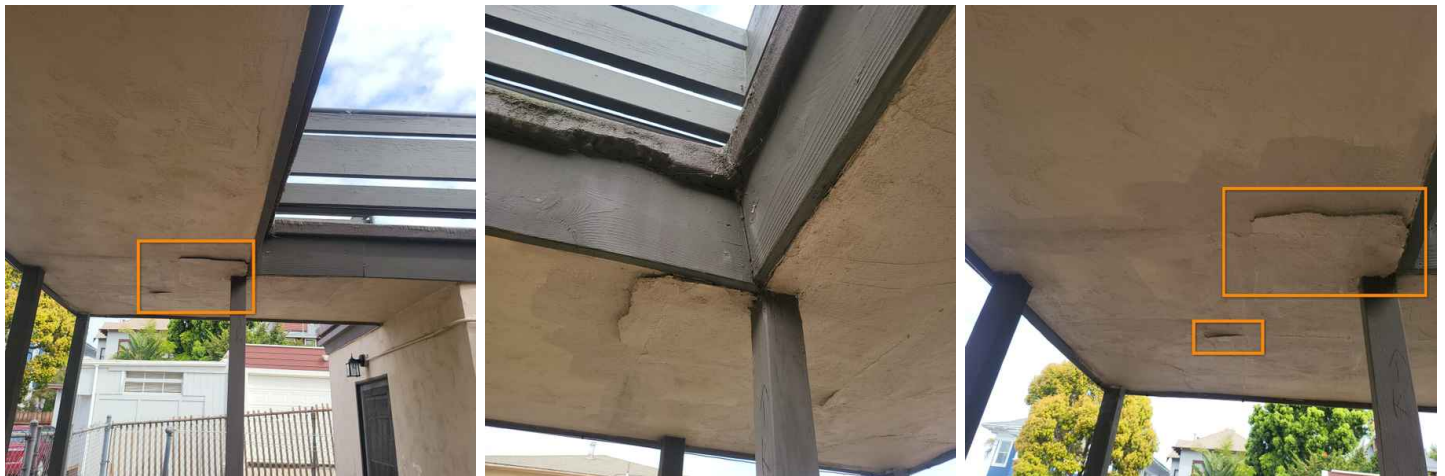
5.4.1 Walkway

Inspector Note: The defects of primary concern are as follows: defect 5.4.1 and 5.4.7.

DAMAGED STUCCO

There is evidence of heavy water flow off the deck for a prolonged period at this location. Algae is growing on the edge of the concrete deck. Sections of stucco are hanging from the soffit at the north end of the elevated walkway. This condition raises concerns regarding advanced deterioration in the underlying support structure. A Phase 2 Pre-721 Evaluation (P2PE) is recommended to determine the extent of any water damage via borescope investigation, and to formulate a detailed repair plan.

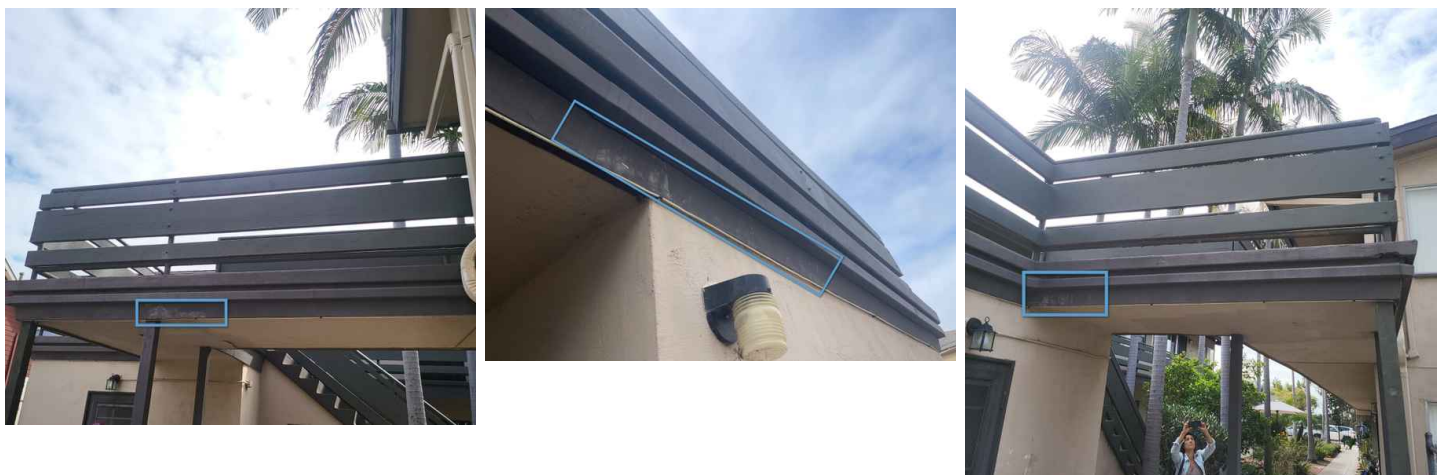
5.4.2 Walkway

FASCIA DISCOLORED

Discoloration of the fascia was observed, indicating potential water intrusion. This water intrusion can lead to internal deterioration of materials and possible compromise of structural integrity over time. Resealing of the fascia is recommended.

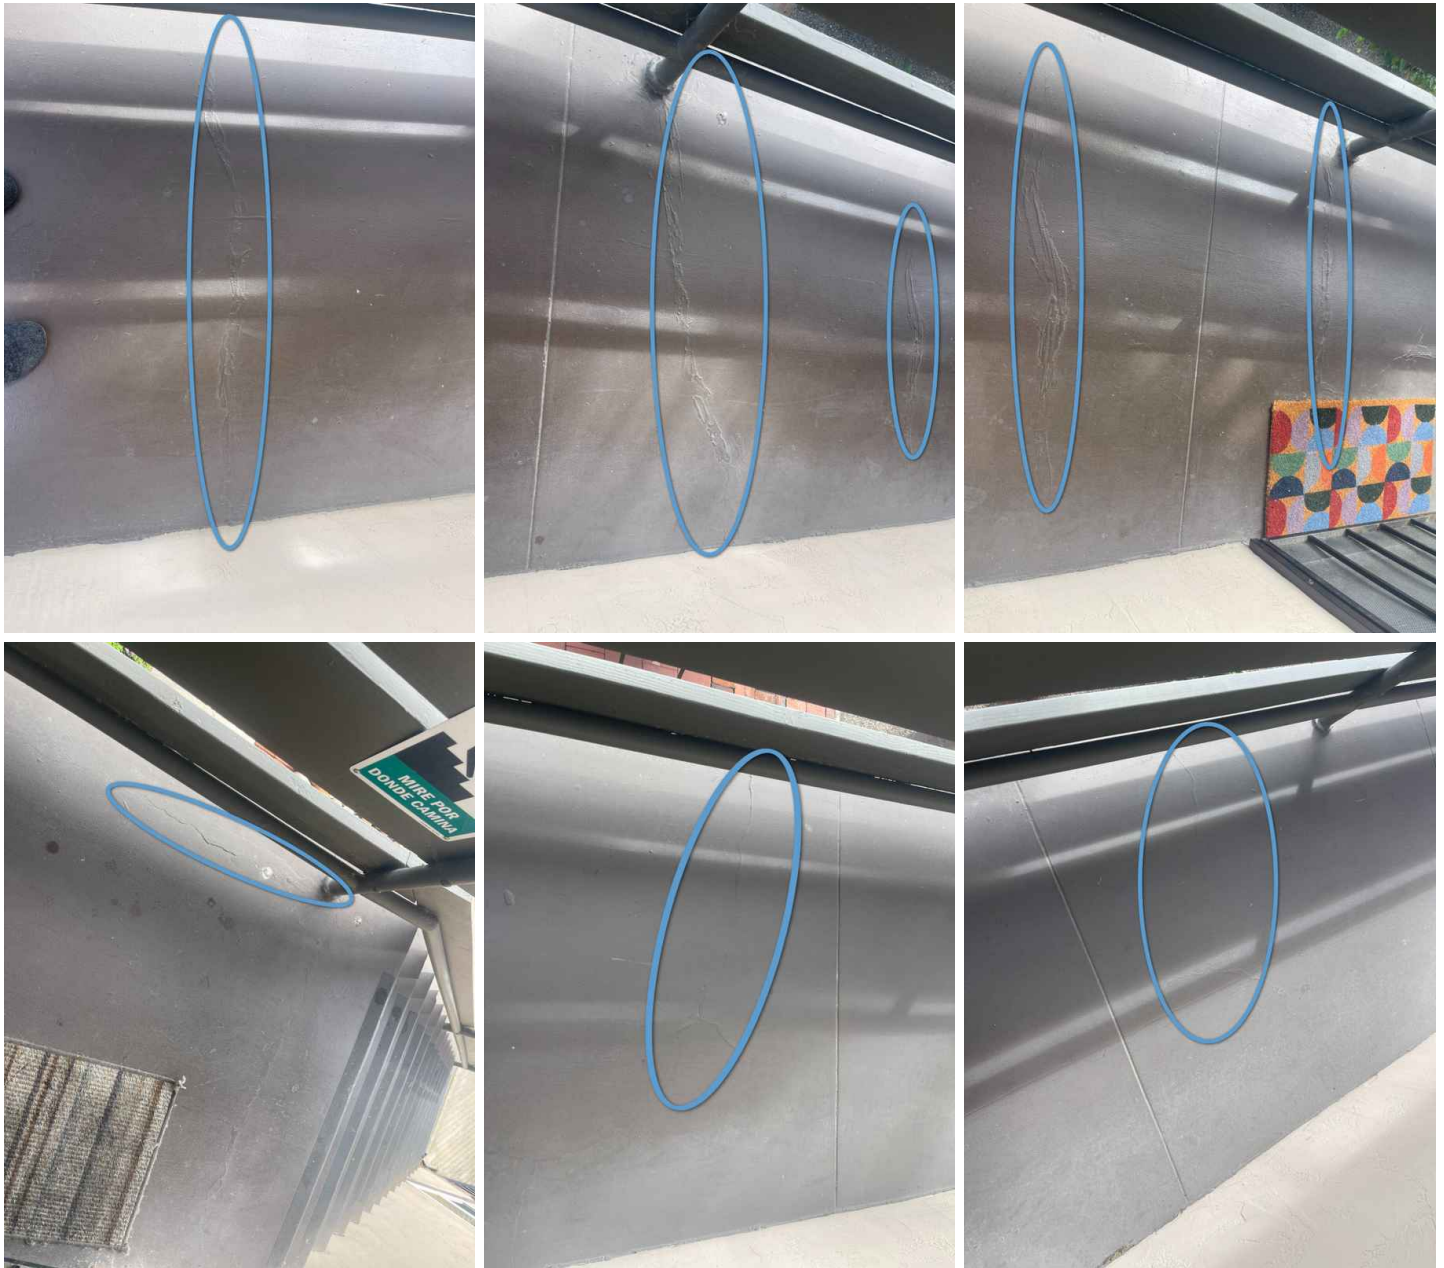
5.4.3 Walkway

WATERPROOFING

The concrete deck waterproofing shows signs of maintenance. Sealant applied to most of the cracks is in good condition. Continued maintenance of the deck waterproofing is recommended.

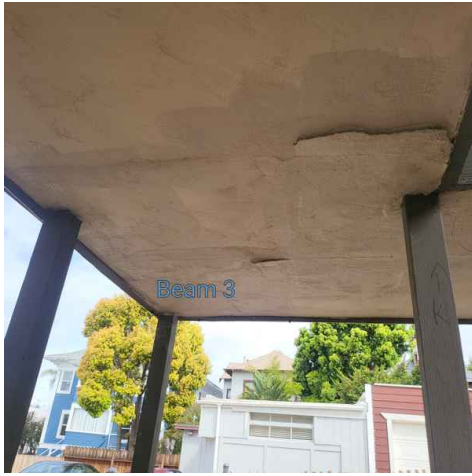
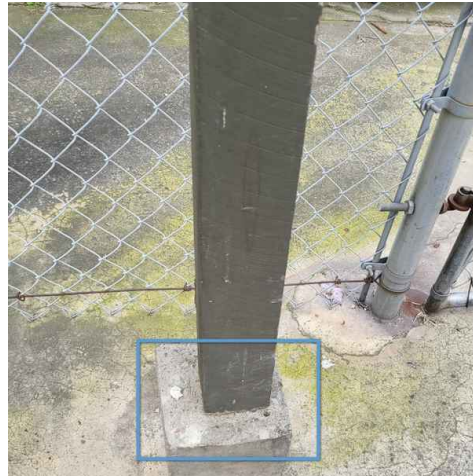
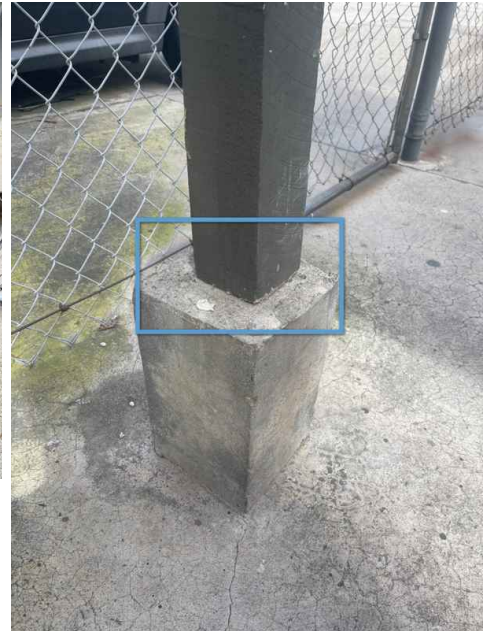
MISSING STAND-OFF(S)

Support Beam 3 is missing a standoff. Standoffs are critical components that separate structural wood elements from concrete foundations or ground contact, preventing direct exposure to moisture. Installation of a standoff is recommended.

Missing Standoff

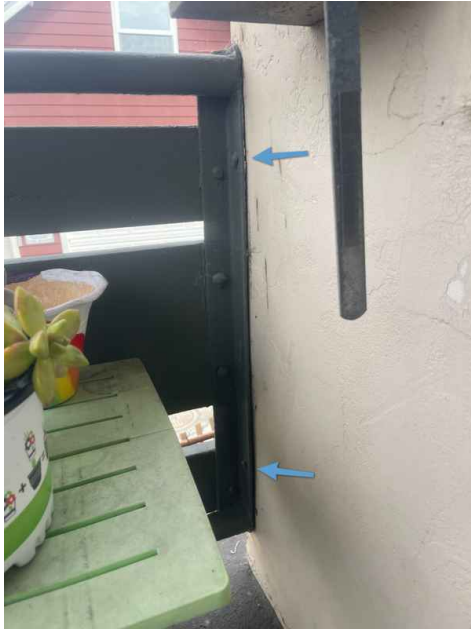
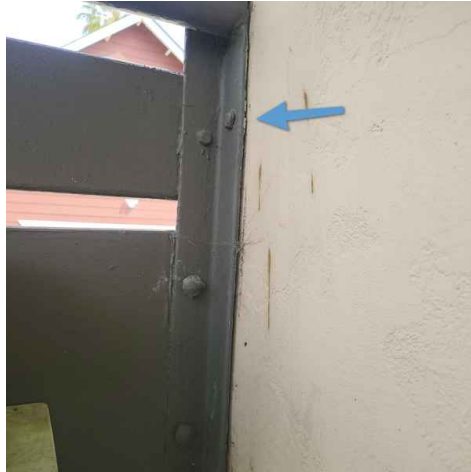
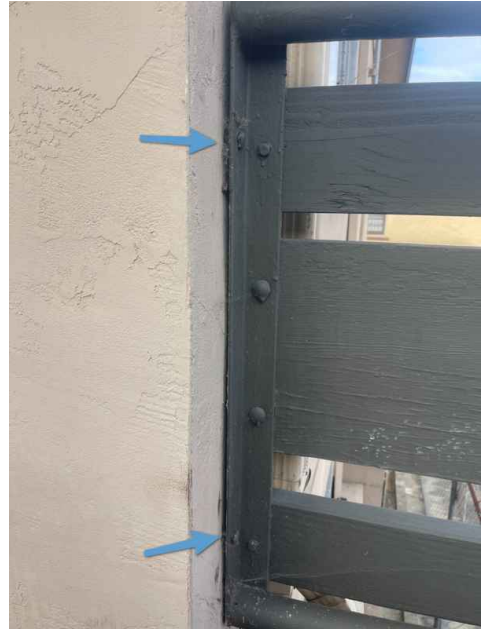
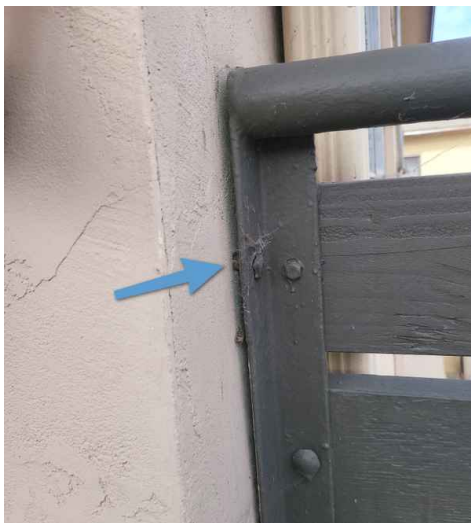
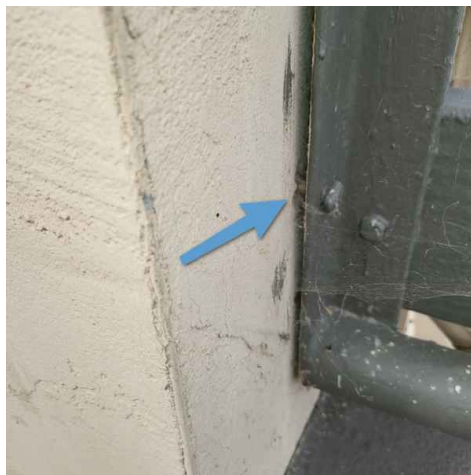
UNSEALED RAILING CONNECTION(S)

Unsealed connections between the railing and the wall were observed. The lack of proper sealing at these junctions raises concerns about potential water intrusion, which can lead to further deterioration of the railing's anchorage and the underlying support structure. This condition may compromise the long-term integrity and stability of the railing system. Sealing these connections with a weather-resistant sealant to prevent water intrusion is recommended.

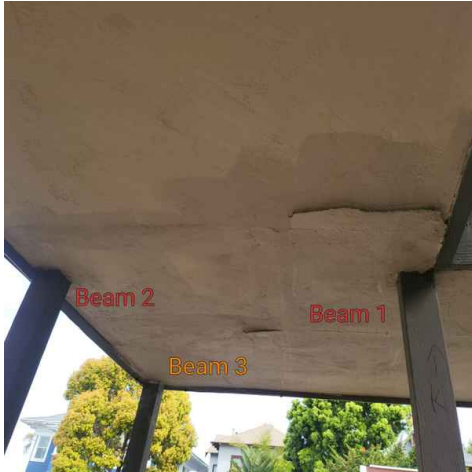
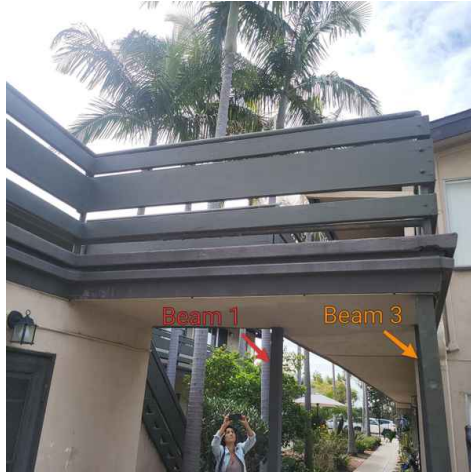
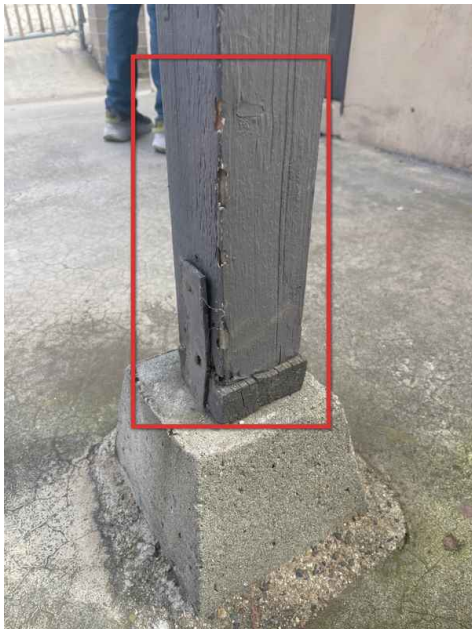
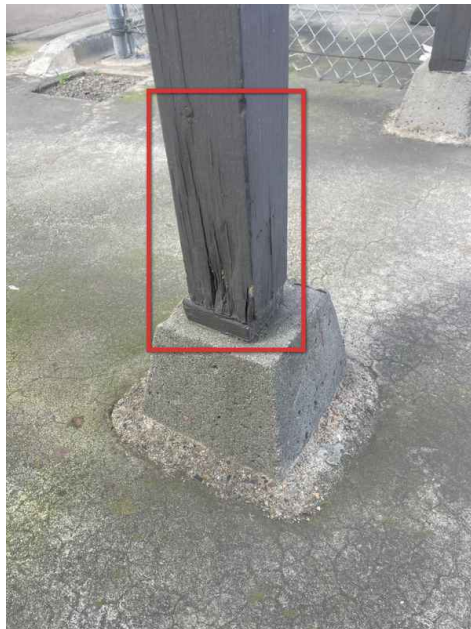
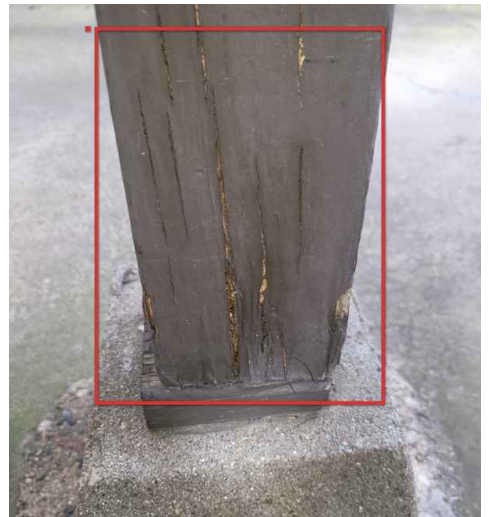
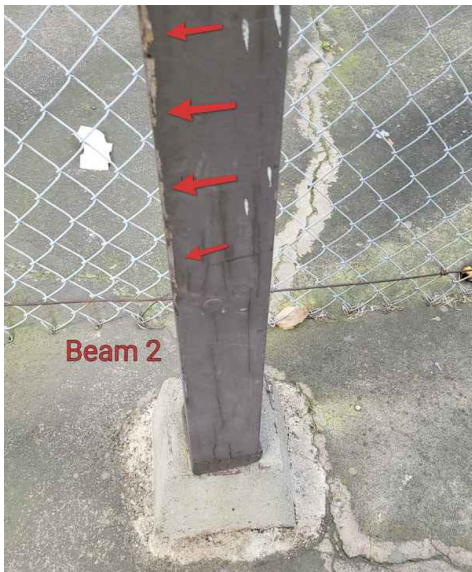
5.4.7 Walkway

TERMITES AND/OR DRY ROT DAMAGE TO SUPPORT BEAMS

Evidence of termites and/or dry rot in support beam 1 and 2 was observed. Termite activity is indicated by visible frass (termite droppings) and hollowed wood. The termite infestation poses a critical concern, as it compromises the load-bearing capacity of the support beam. Support beam 1 and 2 must be replaced prior to SB-721 Inspection.

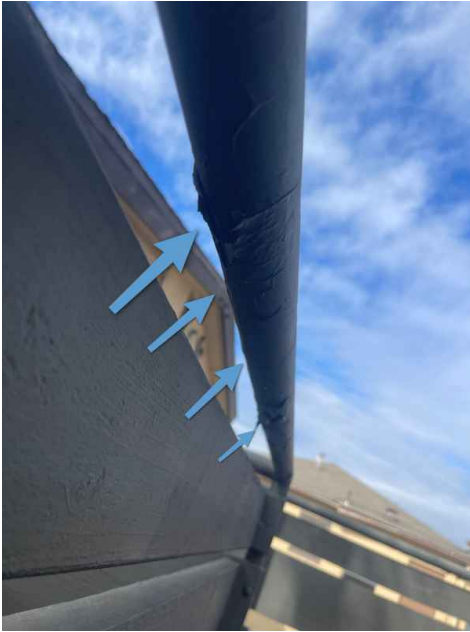
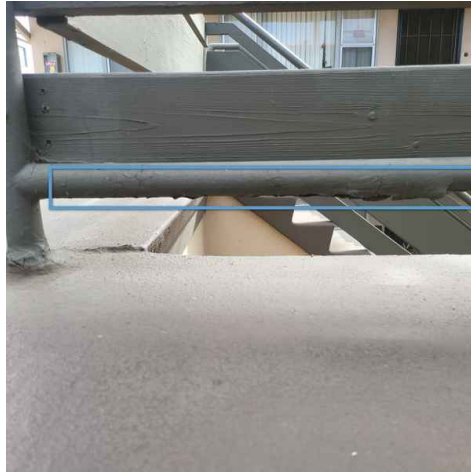
GUARDRAIL CORROSION AND SEALANT DETERIORATION

Corrosion and peeling paint on the underside of the guardrail. Cleaning, followed by the application of a rust-inhibiting primer and resealing is recommended.

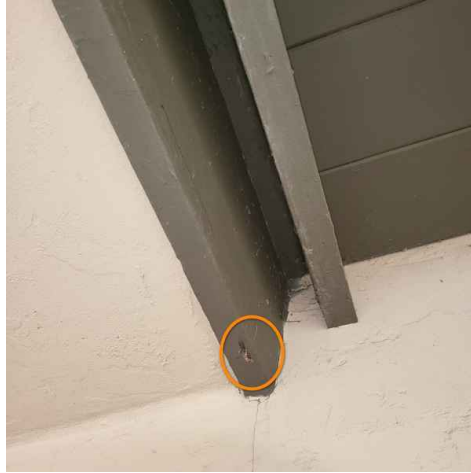
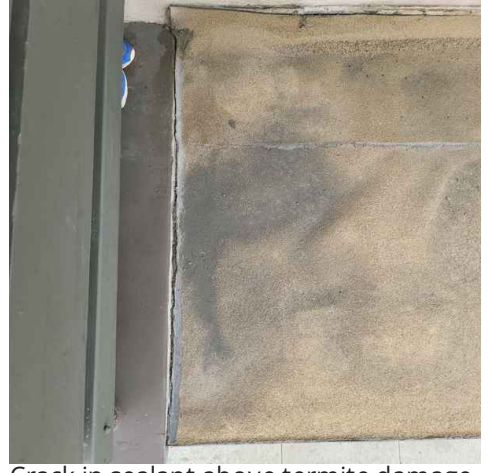
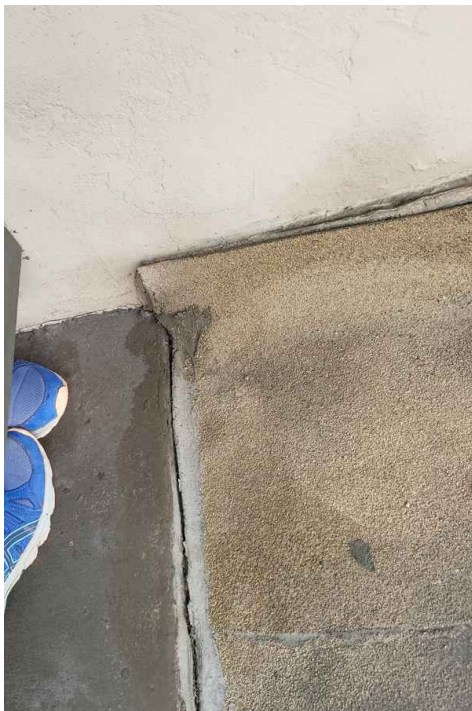
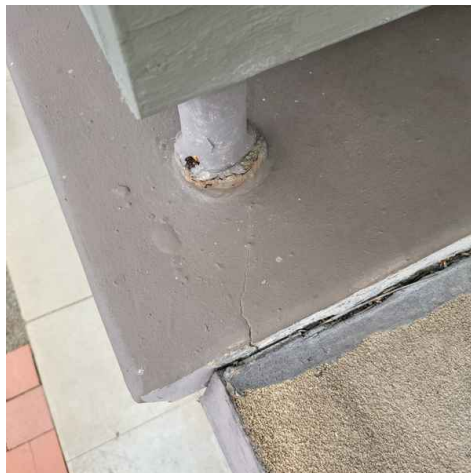
5.4.9 Walkway

TERMITE AND OR DRY ROT DAMAGE

Evidence of termites and/or dry rot in fascia was observed. This condition raises concerns regarding the long-term integrity of the underlying support structure. Termite activity is indicated by visible frass (termite droppings) and hollowed wood. The affected areas should be assessed by a licensed pest control professional to determine the full extent of the termite infestation and to administer a suitable termite treatment plan. A Phase 2 Pre-721 Evaluation (P2PE) is recommended to determine the extent of any termite damage via borescoping, and to formulate a detailed repair plan.

Crack in sealant above termite damage

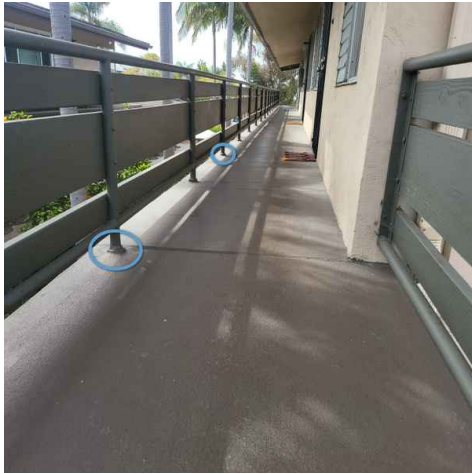
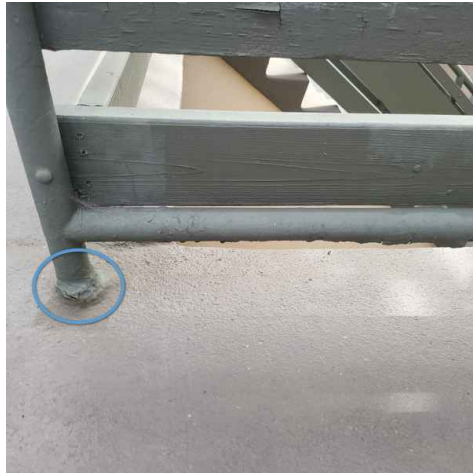
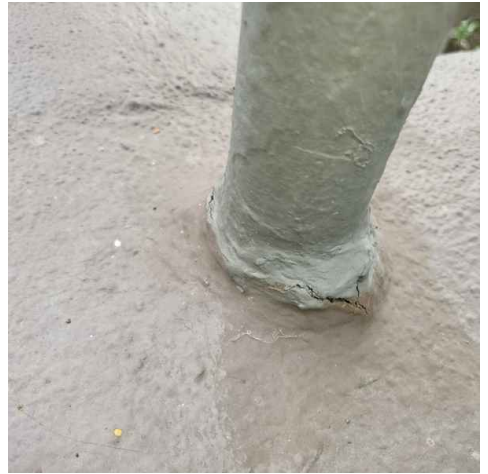
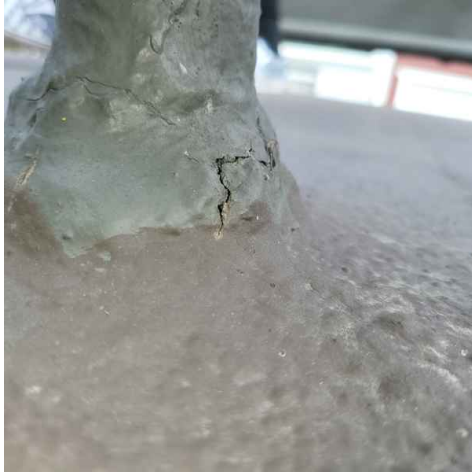
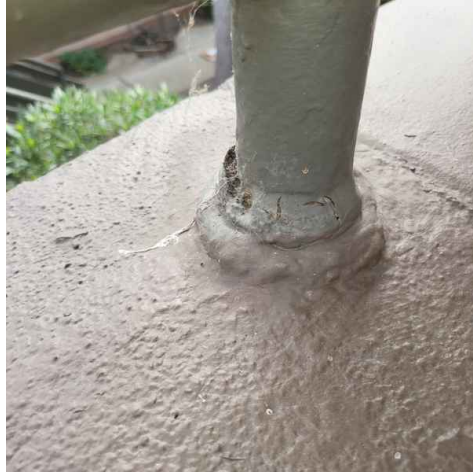
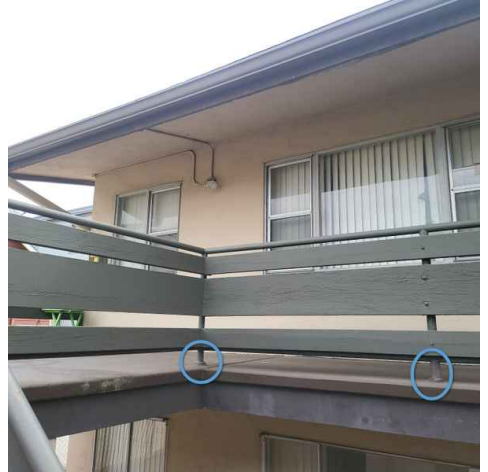
HANDRAIL CORROSION

The base of the stairway handrail is corroded and cracked allowing water intrusion. Some of the handrail connections that need attention are highlighted in the photos below. In general, all handrail connections should be examined, corrosion removed, repaired, and resealed.

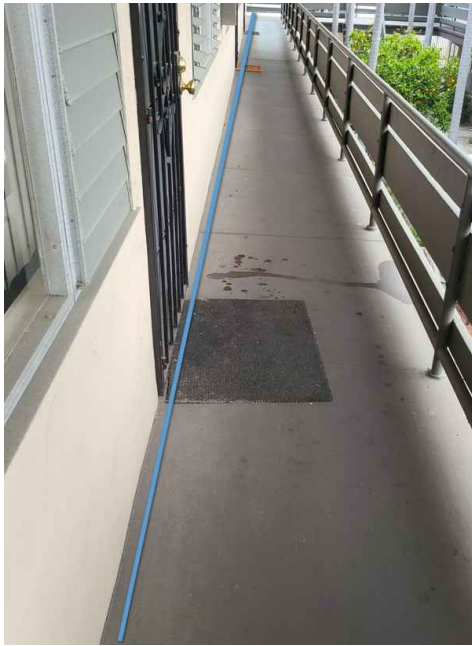
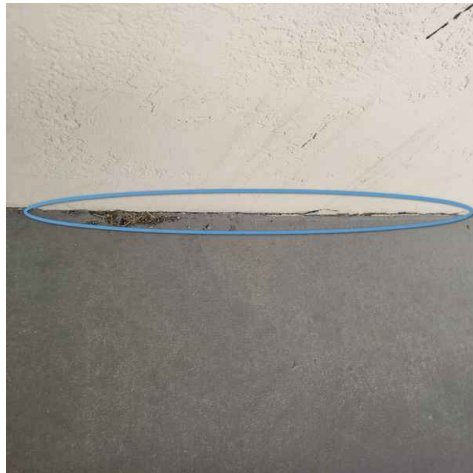
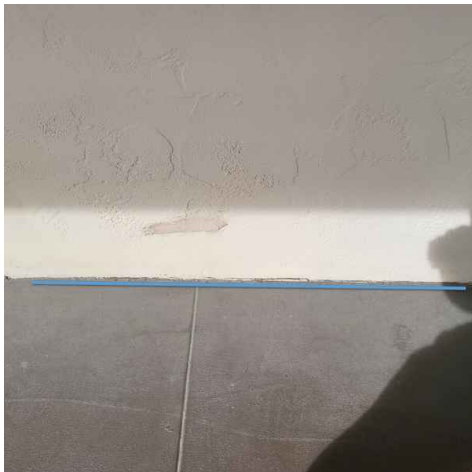
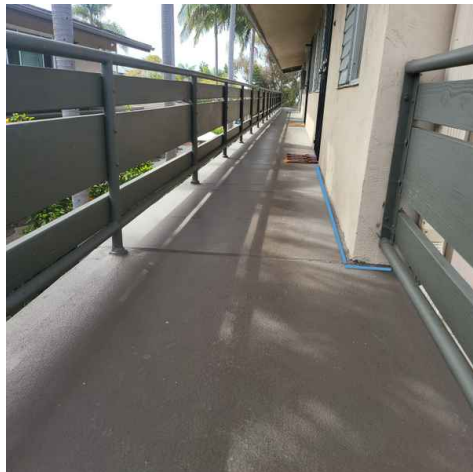
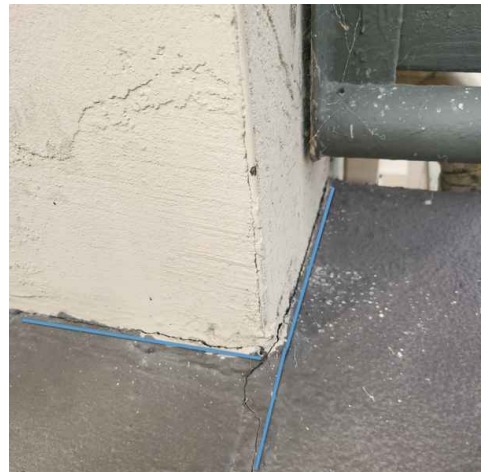
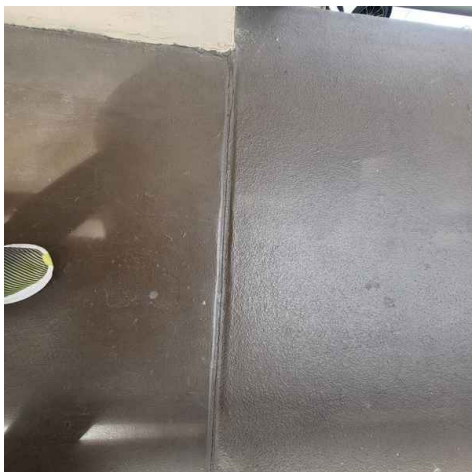
CRACKS IN WATERPROOFING

There are cracks in the waterproofing along the transition where the walkway meets the stucco and at other transitions and joints. Application of sealant is recommended.

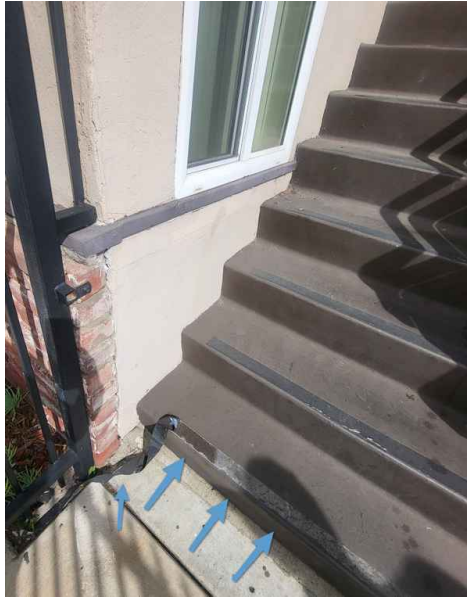
Non-slip Tape on Bottom Stair of Stairway 1

The non-slip tap on the first stair tread has come loose. This old tape should be removed and new tape applied.
