PHASE 1 PRE-SB721 EVALUATION (P1PE)

1234 Main Street  
Imperial Beach, CA 91932-1412

Buyer Name  
05/02/2024 9:00AM

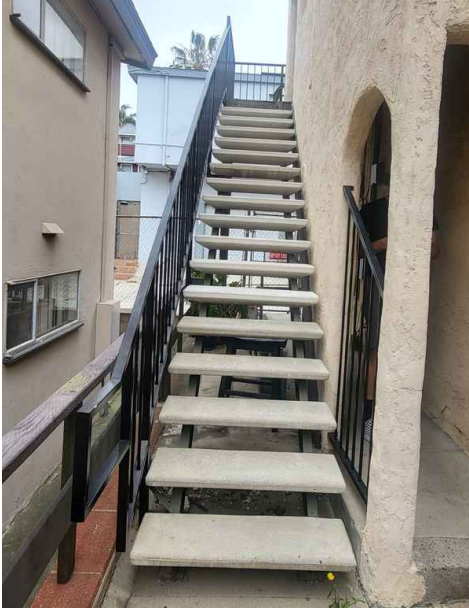
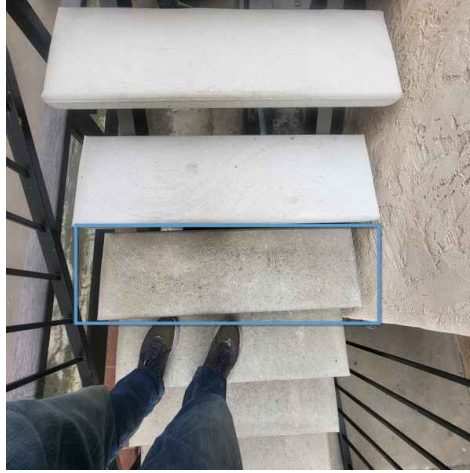
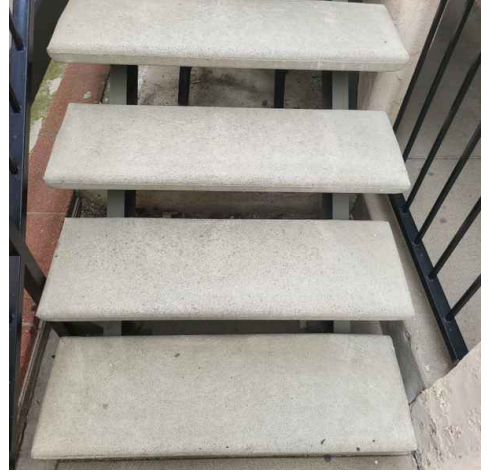
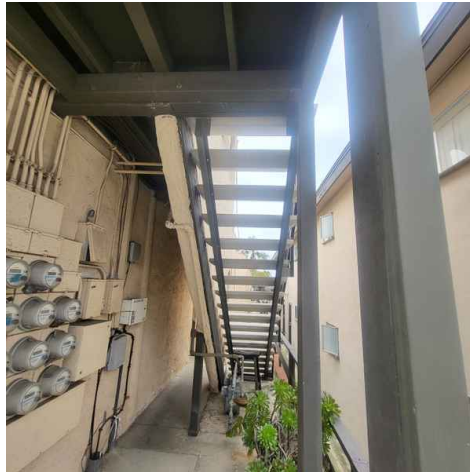
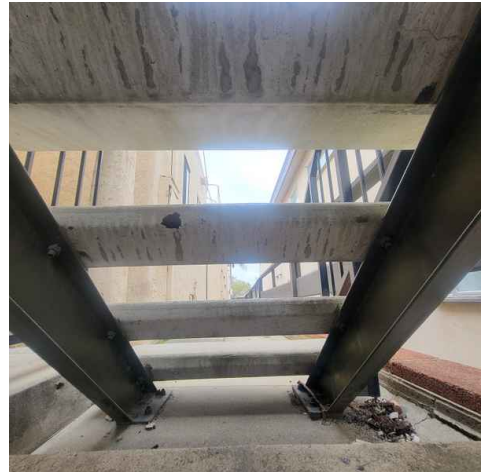
**CRACKING STAIR TREADS (MINORITY)**

11 out of 17 treads have been replaced. The remaining 6 appear to be the same age. 2 treads have cracks.

All cracked stair treads should be replaced.

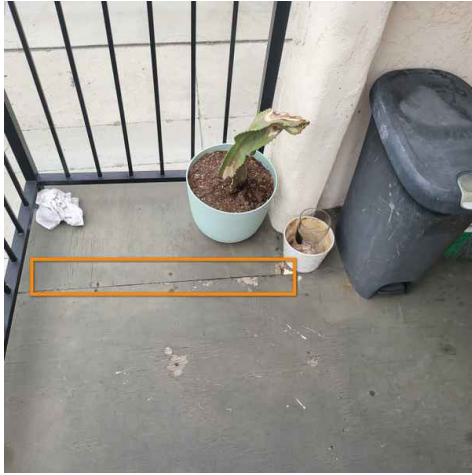
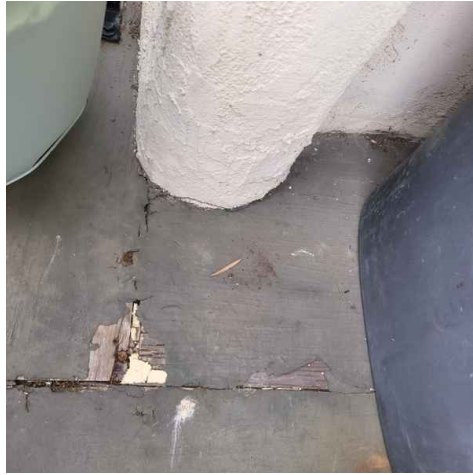
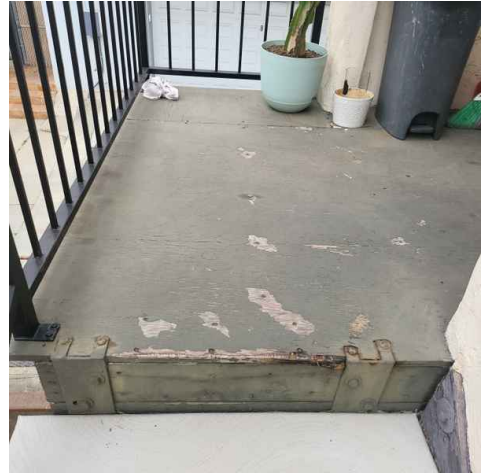
5.3.1 Landing

Deck is showing signs of weathering and/or water damage. There is no waterproof finish on the deck. The deck surface consists of marine plywood with a painted finish. There are openings along plywood joints. The paint is wearing thin and cracking. A waterproof deck coating should be applied.

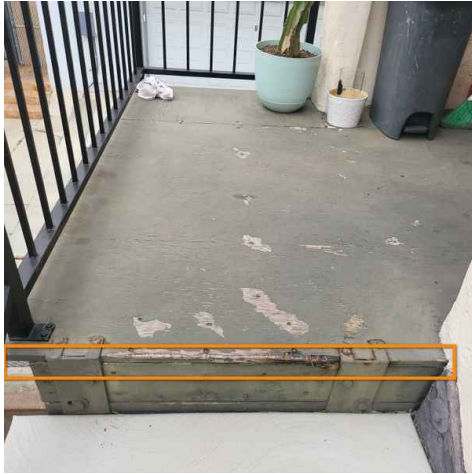
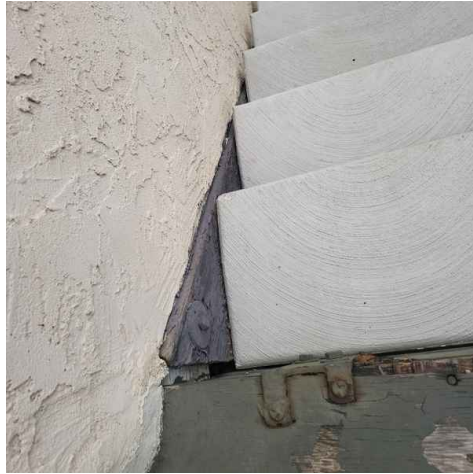
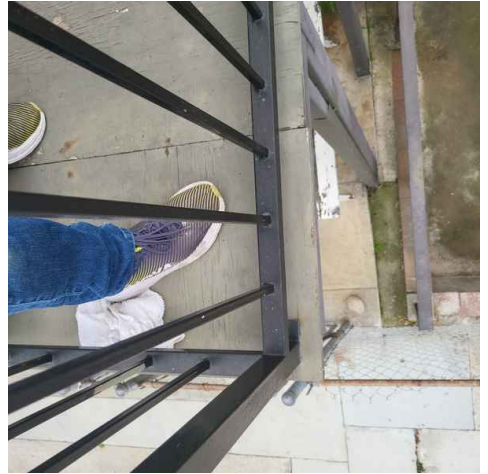
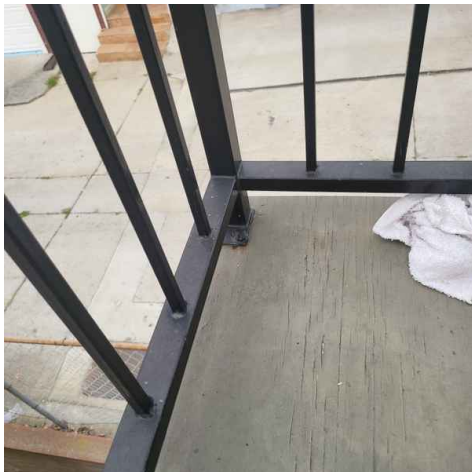
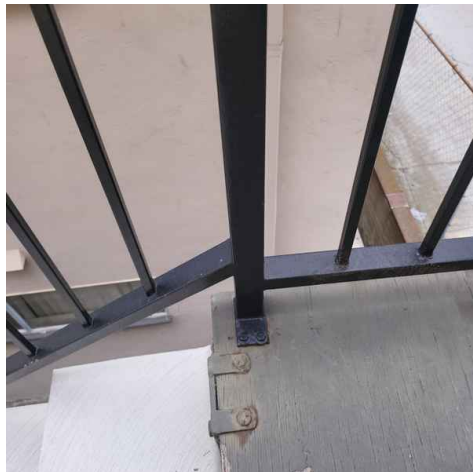
5.3.2 Landing

The edge of the deck was not finished with the appropriate edge metal. There is no drip edge for the water to drain properly off the deck. Without a drip edge, water will roll under the plywood and seep into the fascia, soffit, or deck, causing rotting, mold growth, and structural damage over time. Stair nosing is missing at the top of the stairs and the plywood edge is damaged. There is evidence of water intrusion and dry rot in the doubler. The appropriate flashing and trim pieces should be installed and a waterproof deck coating should be applied.

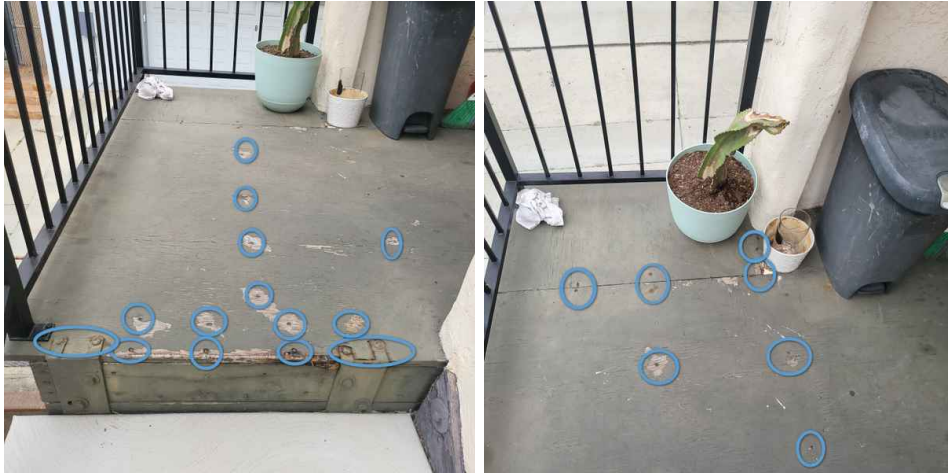
5.3.3 Landing

There are nails penetrating the plywood deck and bolts through the stringer connections that are not sealed. Water intrusion is likely at these penetrations. It is recommended that all deck surface penetrations be sealed.

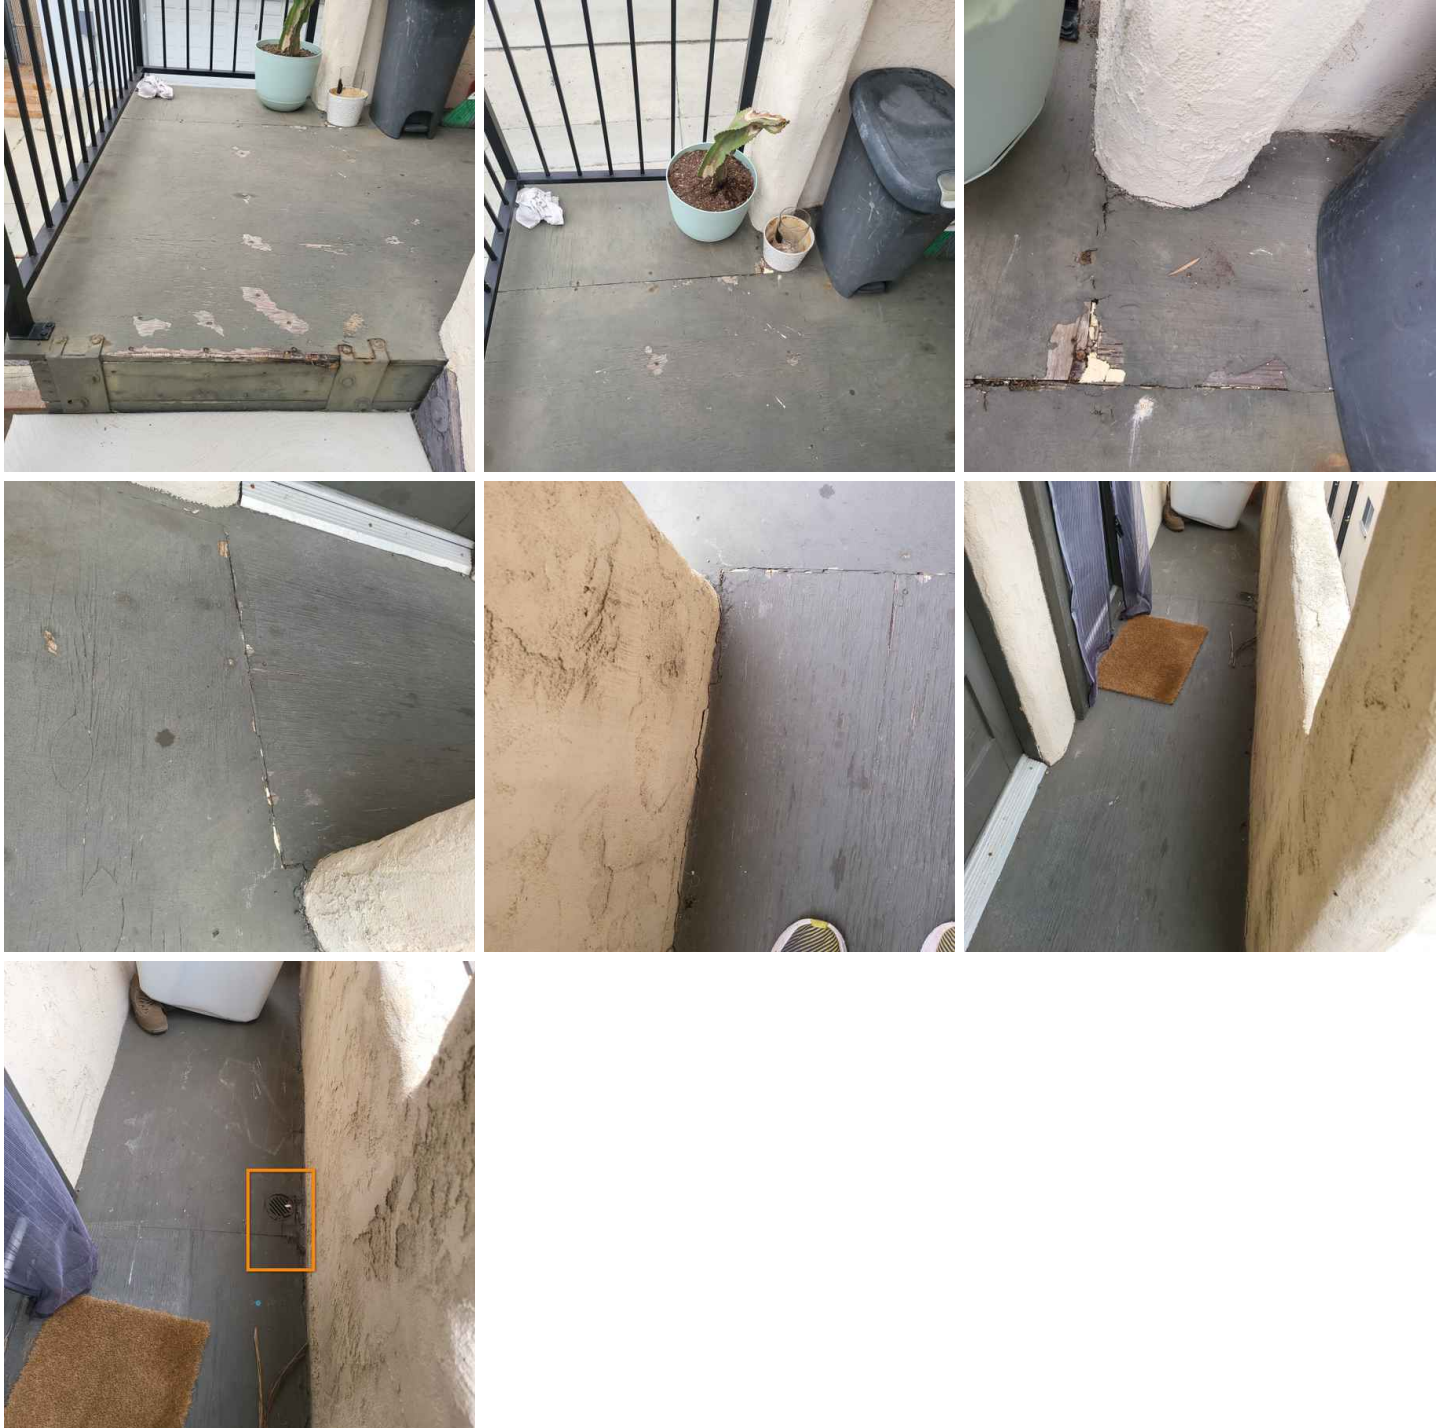
5.4.1 Walkway

**DETERIORATING WATERPROOFING**

Deck is showing signs of weathering and/or water damage. There is no waterproof finish on the deck. The deck surface is painted plywood. There are openings along plywood joint seams. The paint is wearing thin and cracking. The plywood is rotting around the deck drain. It is recommended that the damaged plywood be replaced and a waterproof deck coating applied.

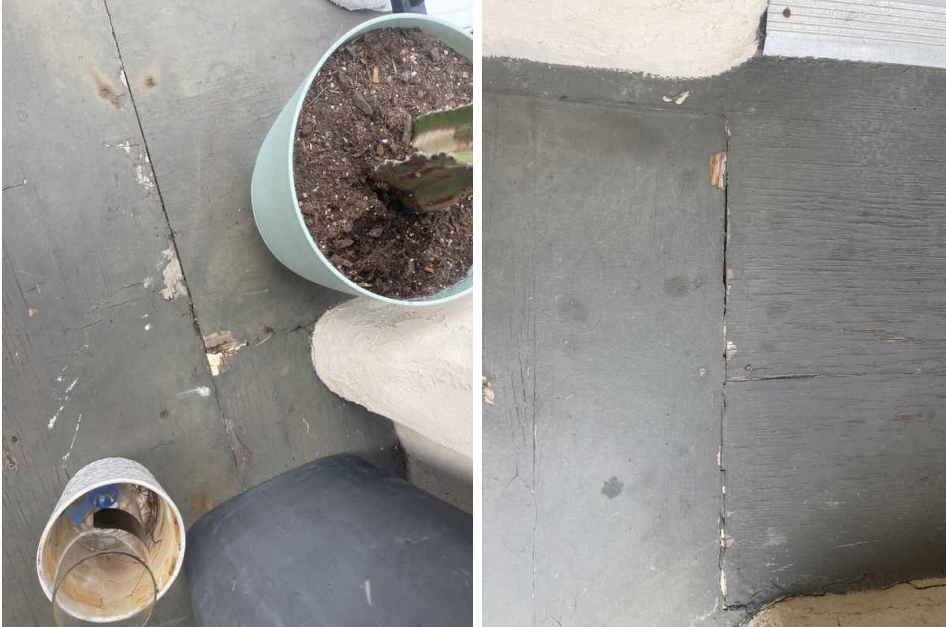
5.4.2 Walkway

**CRACK(S) IN WATERPROOFING**

Multiple visible cracks were observed in the deck surface, raising concerns about water intrusion. These cracks can allow moisture to seep through, potentially leading to wood rot, structural weakness, and mold growth. A waterproof deck coating should be applied.

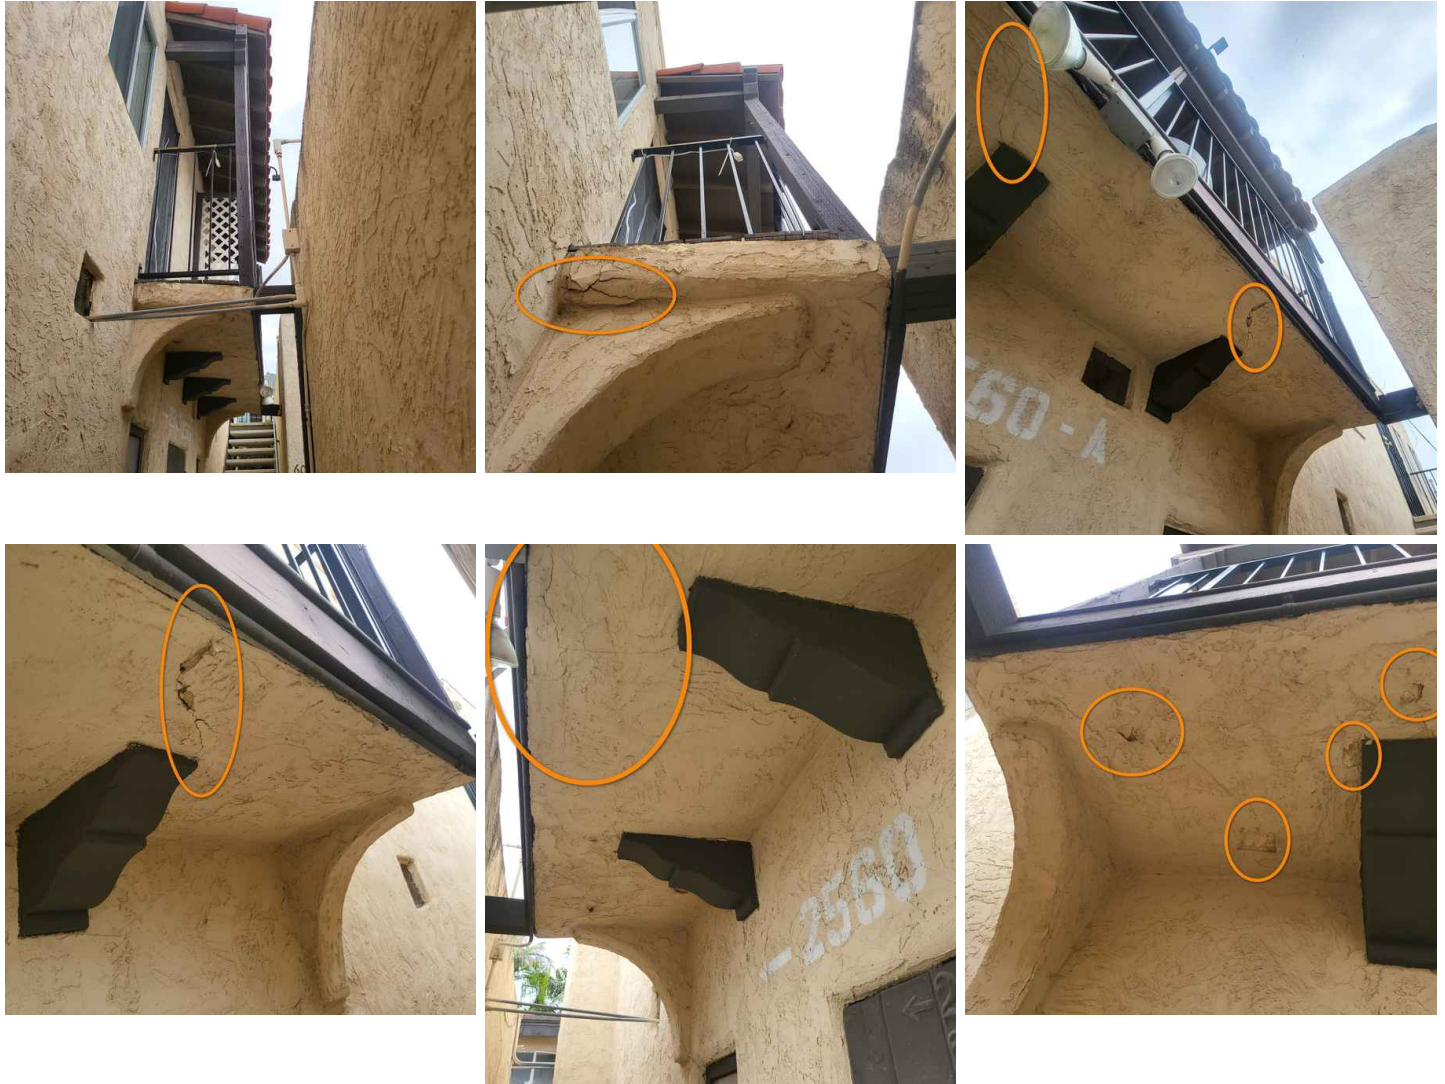
**DAMAGED SOFFIT STUCCO**

There are cracks and opening in the stucco under the soffit. There are locations where water appears to be draining through. This condition raises concerns regarding advanced deterioration in the underlying support structure. A Phase 2 Pre-721 Evaluation (P2PE) is recommended to determine the extent of any water damage via borescope investigation and to formulate a detailed repair plan.

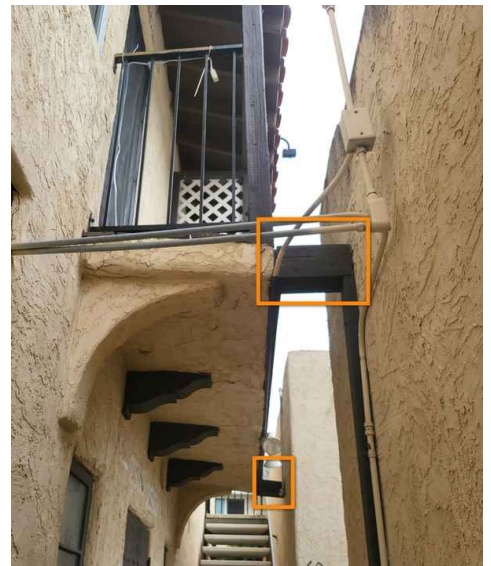
6.2.2 Balcony

**IMPROPER SUPPORT CONSTRUCTION (UNSTABLE)**

A critical inspection finding highlights major instability in the support structure, indicative of improper construction techniques or material use. This presents a significant risk, as the unstable state could lead to structural failure or collapse. Immediate action is required. It is strongly recommended to engage a structural engineer to evaluate the extent of the issue and to undertake urgent remedial work to ensure the safety and integrity of the structure. The balcony is sagging under its weight and is braced against nearby structures. This bracing is inadequate and not to code.

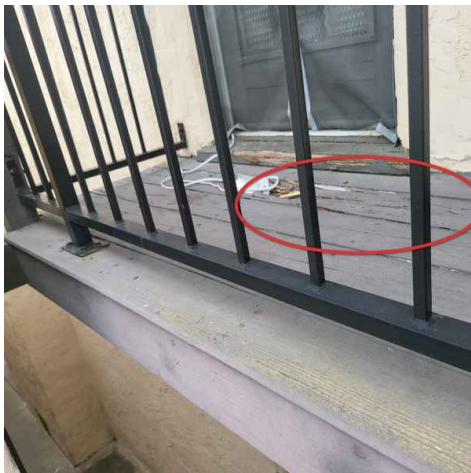
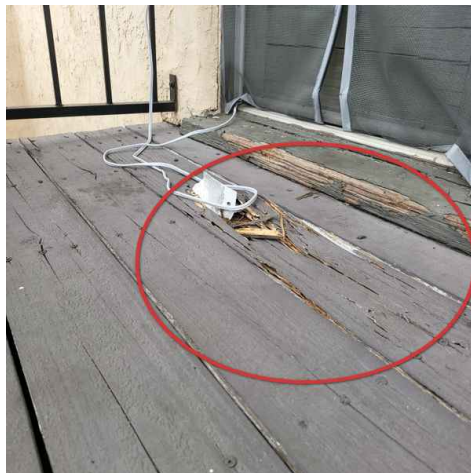
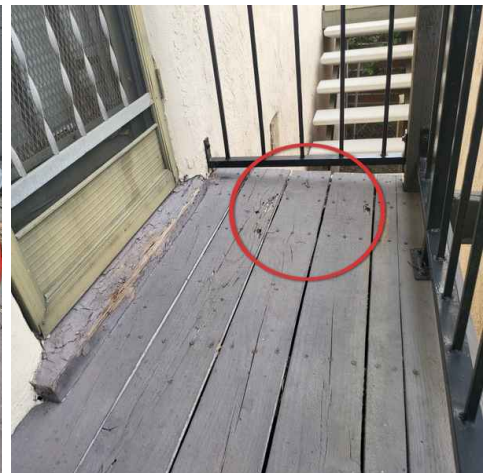
6.2.3 Balcony

**TERMITE DAMAGE**

One or more deck boards have termite damage and/or dry rot. This matter requires immediate attention and the necessary repairs should be carried out prior to the SB-721 Inspection.

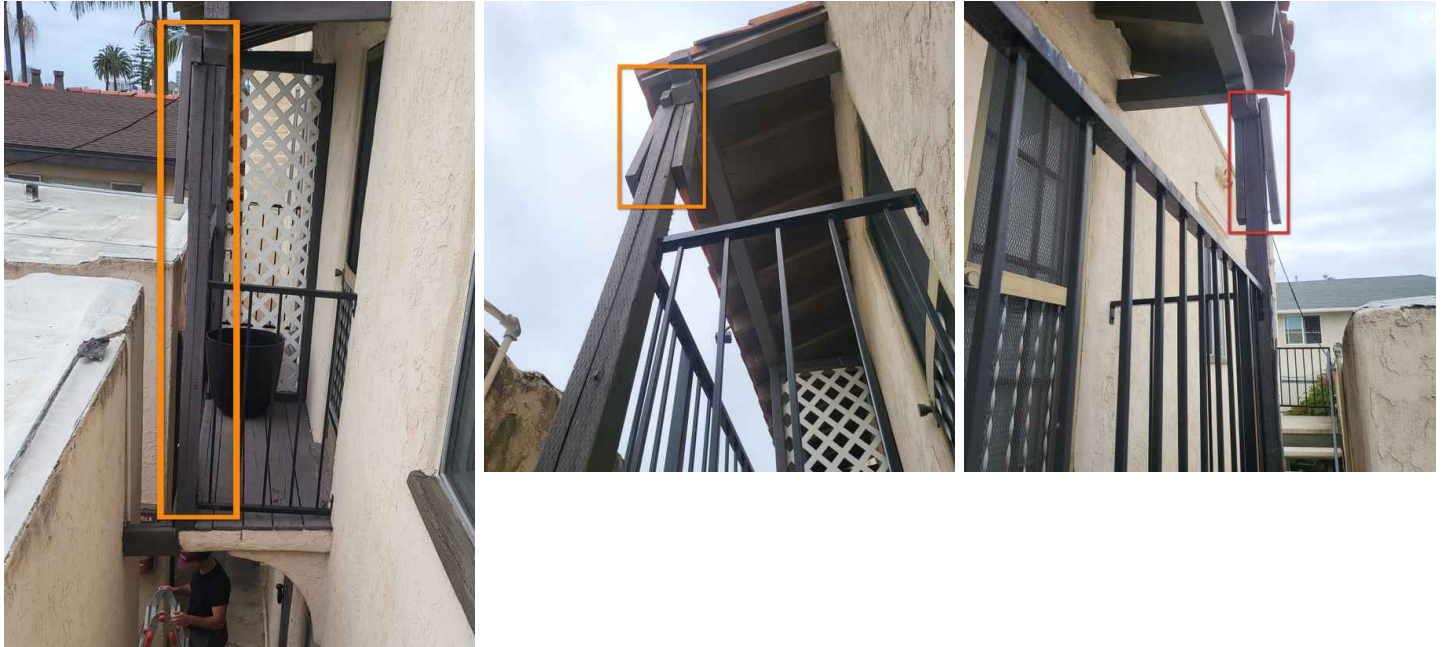
6.2.4 Balcony

The support beam from the deck to the overhang is inadequate and not properly attached. This is a safety hazard. This matter requires immediate attention and the necessary repairs should be carried out prior to the SB-721 Inspection.

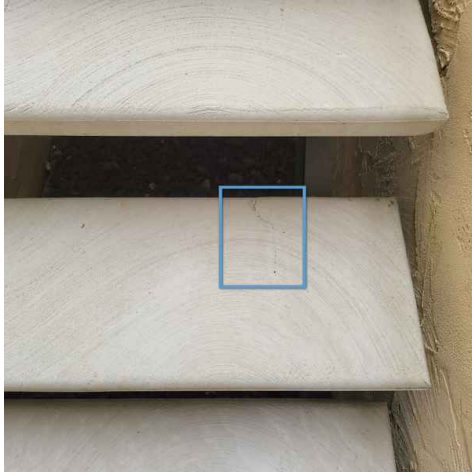
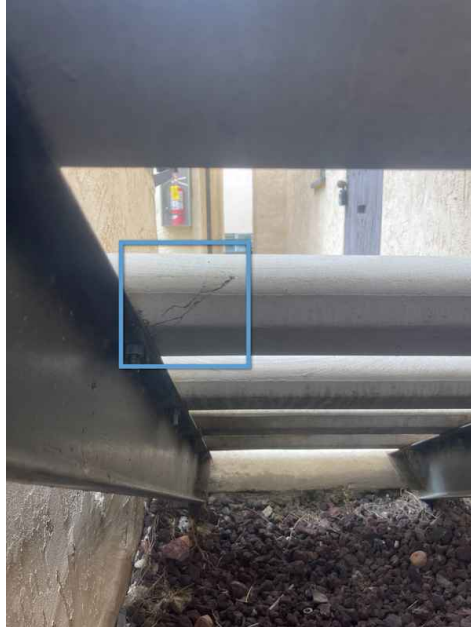
**CRACKING TREADS (MINORITY)**

13 out of 15 treads have been replaced. The remaining 2 appear to be the same age. 1 tread has cracks.

All cracked stair treads should be replaced.

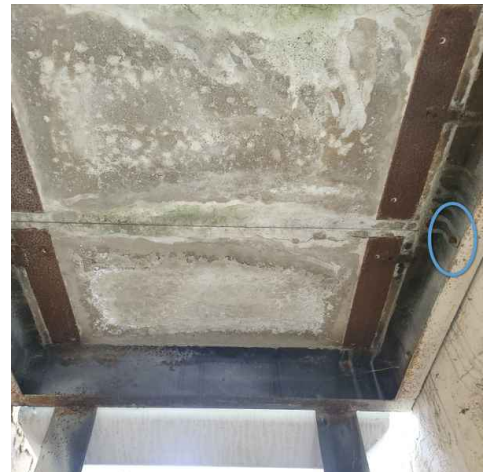
7.3.1 Landing

**DECK - LOOSE ANCHORS**

One or more bolts holding the steel support frame to the wall are loose. This could be due to a compromised underlying support material. It is highly recommended to retighten all anchor bolts to ensure proper stability.

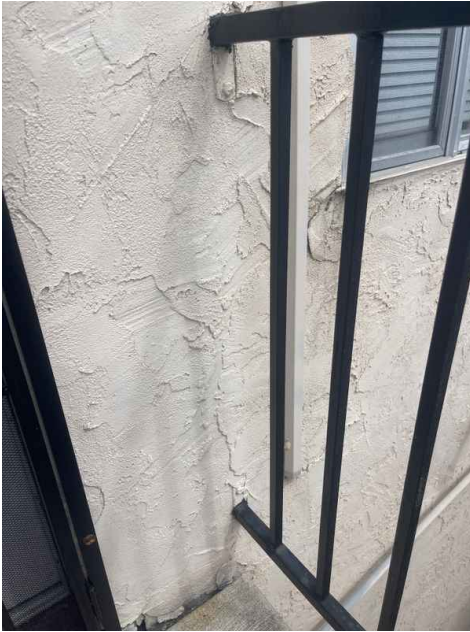
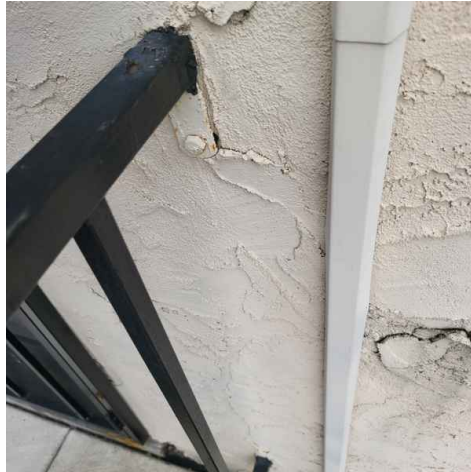
### IMPROPERLY SEALED RAILING CONNECTIONS

There is an opening in the stucco at the top railing connection. Water intrusion is likely at this connection. The opening should be sealed.

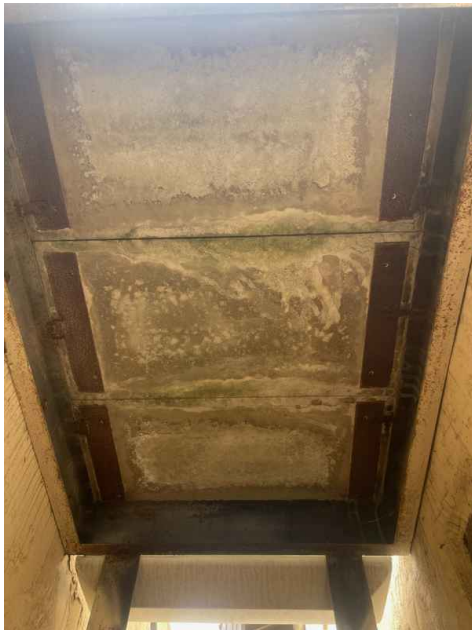
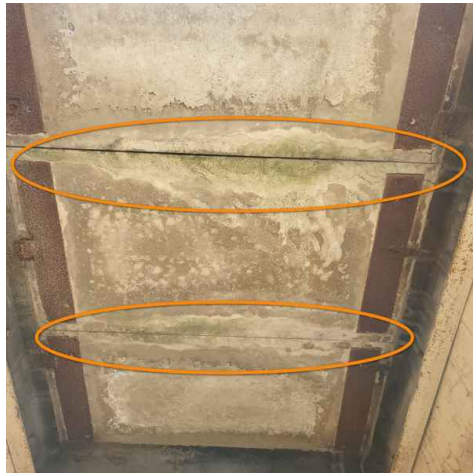
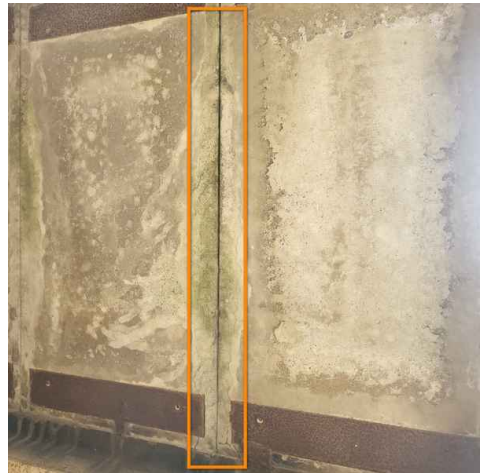
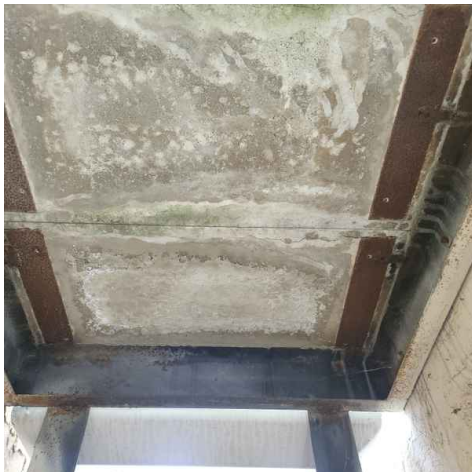
7.3.3 Landing

**CRACKING IN UNDERSIDE OF DECK**

There are cracks on the underside of the concrete slabs that make up the walking surface of the landing. Although this is not an immediate issue, this condition lowers expectations for future performance and projected service life.

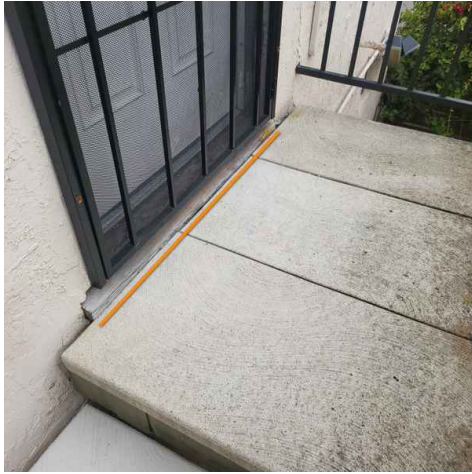
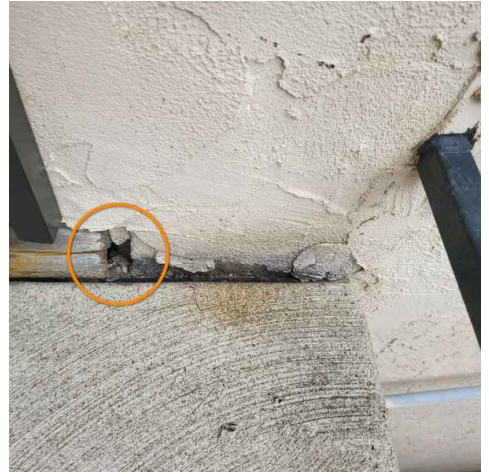
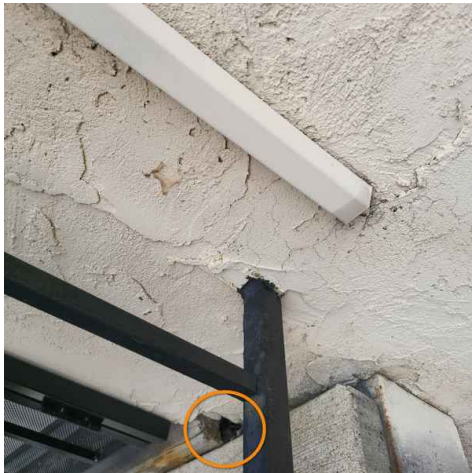
7.3.4 Landing

**TERMITE DAMAGE**

There is termite and/or dry rot damage to the threshold above the support frame for the landing. Part of the threshold on the right side has rotted away leaving a large opening in the stucco where water intrusion is likely. This condition raises concerns regarding advanced deterioration in the underlying support structure. A Phase 2 Pre-721 Evaluation (P2PE) is recommended to determine the extent of any water damage via borescope investigation and to formulate a detailed repair plan.
