PHASE 1 PRE-SB721 EVALUATION

1234 Main Street
Imperial Beach, CA 91932-1412

Buyer Name
05/02/2024 9:00AM

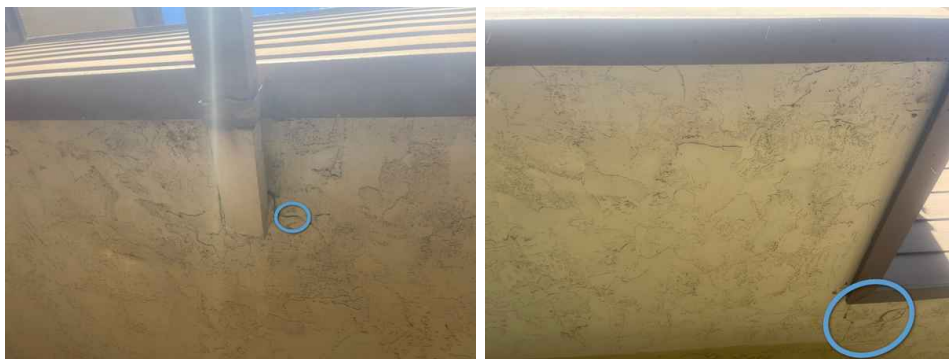
CRACK(S) IN SOFFIT

There are cracks in the soffit on the underside of the balcony. These cracks should be sealed with a waterproof sealant to prevent wood boring insect intrusion.

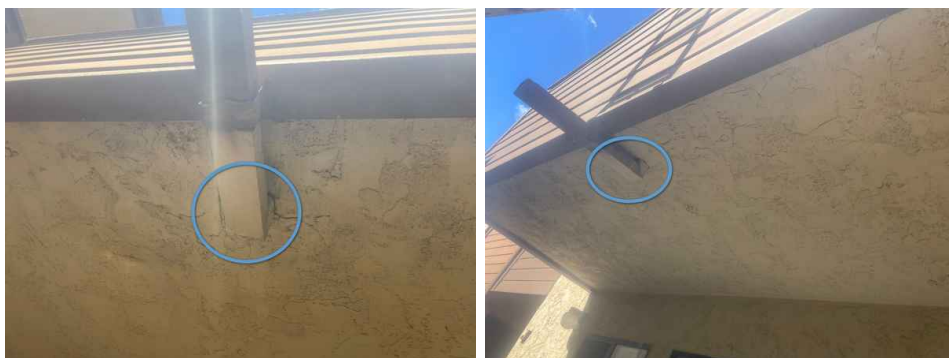
9.2.2 Balcony

UNSEALED DRAINAGE CONNECTION

There is an unsealed drainage pipe on the underside of the balcony. This connection should be sealed with a waterproof sealant to prevent wood boring insect intrusion.

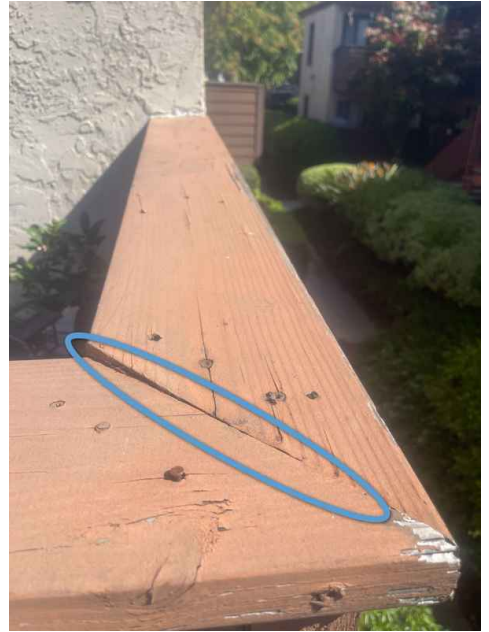
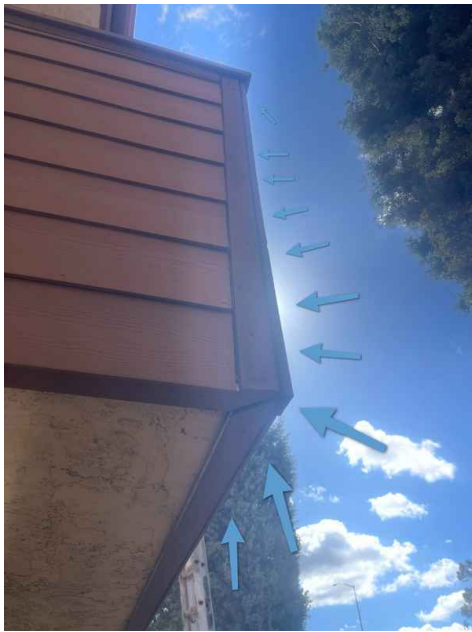
CRACK(S) IN RAILING

There are cracks in the wooden railing. These cracks should be sealed with a waterproof sealant to prevent water and wood boring insect intrusion.

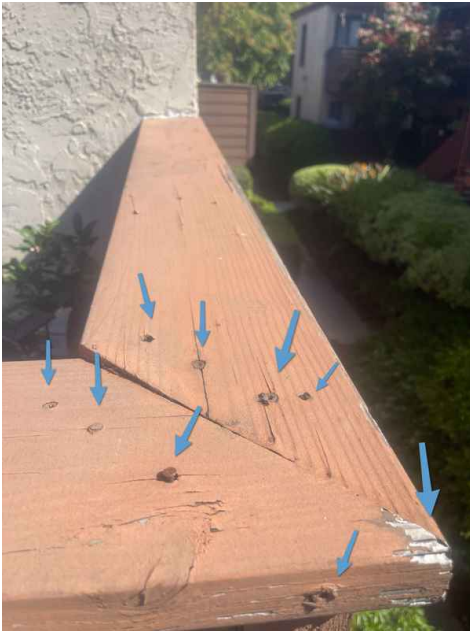
UNSEALED PENETRATION(S) IN RAILING

There are unsealed penetrations in the wooden railing. These penetrations should be sealed with a waterproof sealant to prevent water and wood boring insect intrusion.

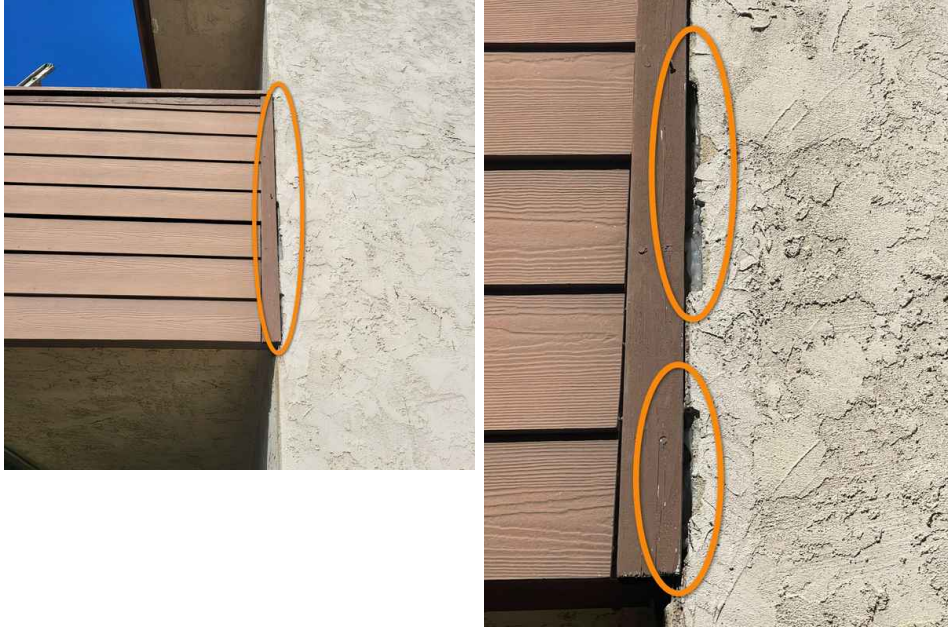
10.2.4 Balcony

There are openings at the connection between the railing and the supporting wall. These openings may indicate potentially severe water intrusion. Water intrusion can lead to internal deterioration of materials and possible compromise of structural integrity over time. A Phase 2 Pre-721 Evaluation (P2PE) is recommended to determine the extent of any water damage via borescope inspection or larger investigative openings, and to formulate a detailed repair plan.

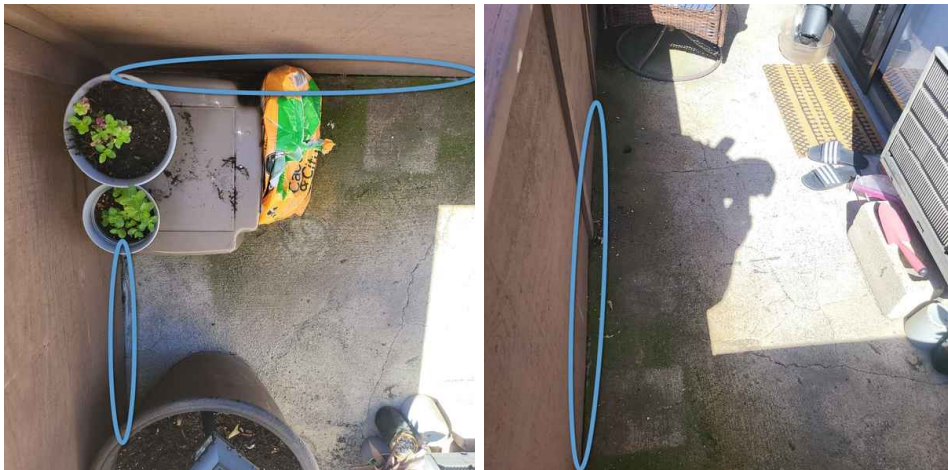
10.2.5 Balcony

There is a gap between the railing and decking. This gap should be sealed with a waterproof sealant to prevent water and wood boring insect intrusion.

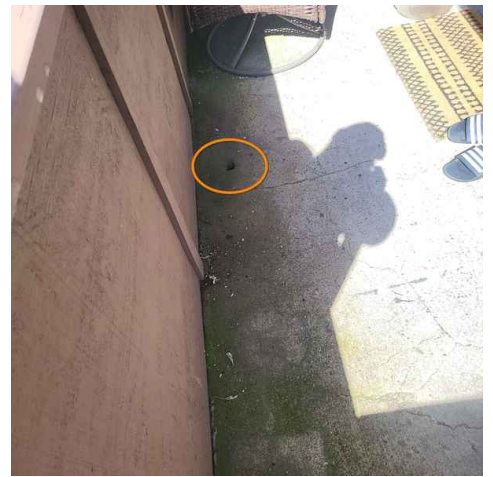
10.2.6 Balcony

The deck is missing a drain assembly. Without a drain assembly the water is free to flow into the soffit rather than down the drain pipe. This water intrusion will lead to internal deterioration of materials and possible compromise of structural integrity over time. A Phase 2 Pre-721 Evaluation (P2PE) is recommended to determine the extent of any water damage via borescope inspection or larger investigative openings, and to formulate a detailed repair plan.

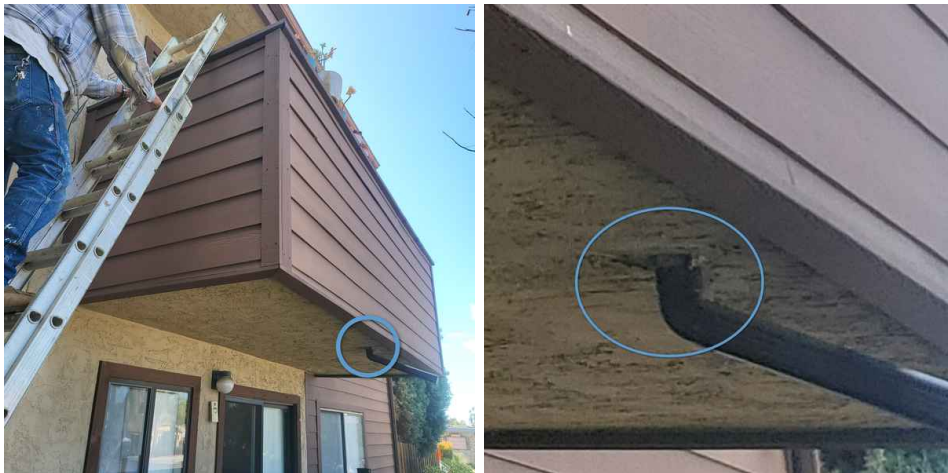
There is an unsealed drainage pipe on the underside of the balcony. This connection should be sealed with a waterproof sealant to prevent wood boring insect intrusion.

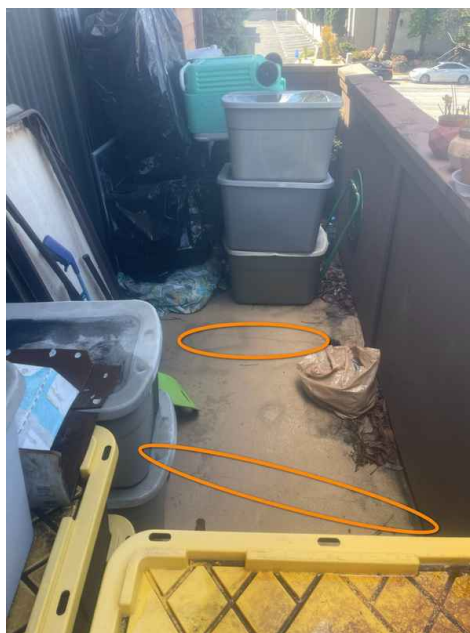
There are cracks in the decking, including a crack that intersects the missing drain assembly. These cracks could indicate potentially severe water intrusion. Water intrusion can lead to internal deterioration of materials and possible compromise of structural integrity over time. A Phase 2 Pre-721 Evaluation (P2PE) is recommended to determine the extent of any water damage via borescope inspection or larger investigative openings, and to formulate a detailed repair plan.

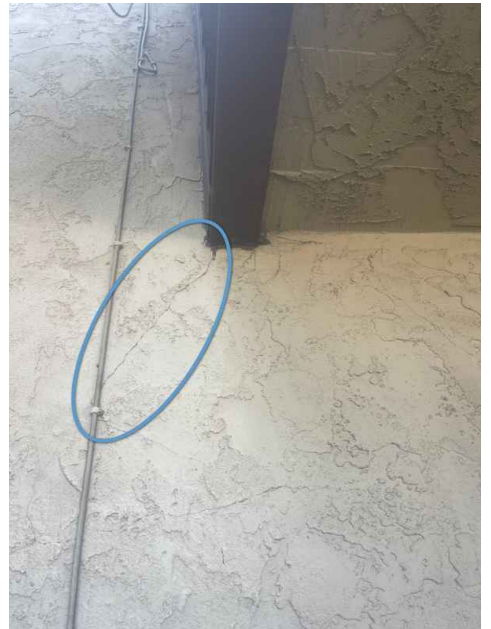
There is a crack in the supporting wall on the underside of the balcony. This crack should be sealed with a waterproof sealant to prevent water and wood boring insect intrusion.

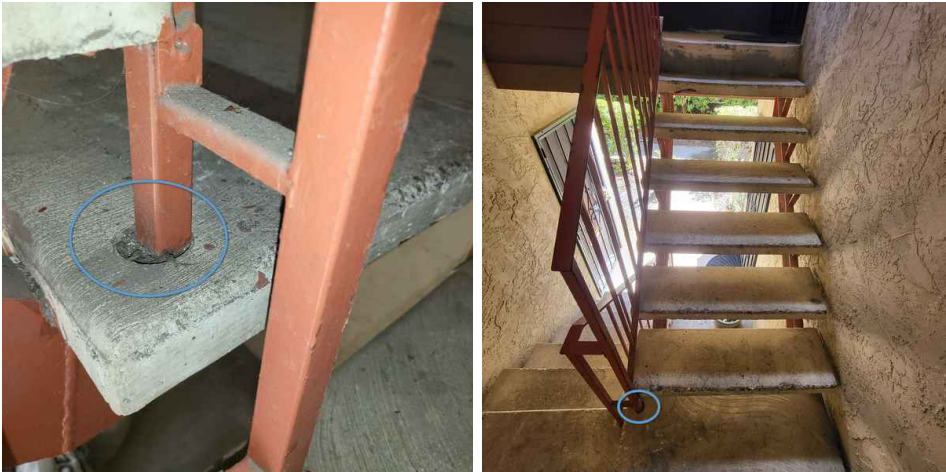
There is an unsealed attachment between railing and the second landing platform. This attachment should be sealed with a waterproof sealant.

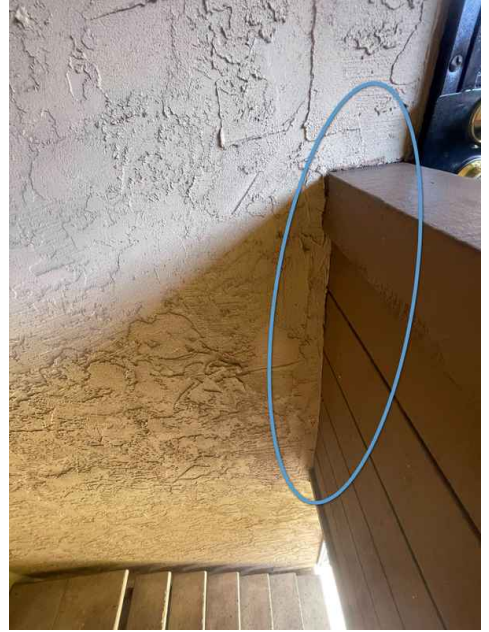
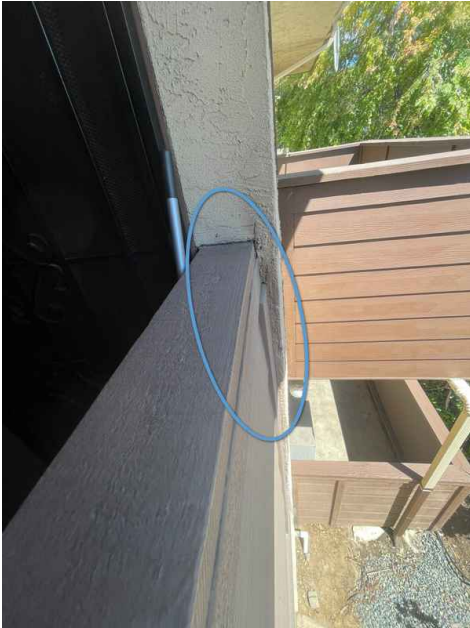
There are unsealed connections between the railing and the wall. These connections should be sealed with a waterproof sealant to prevent water and wood boring insect intrusion.

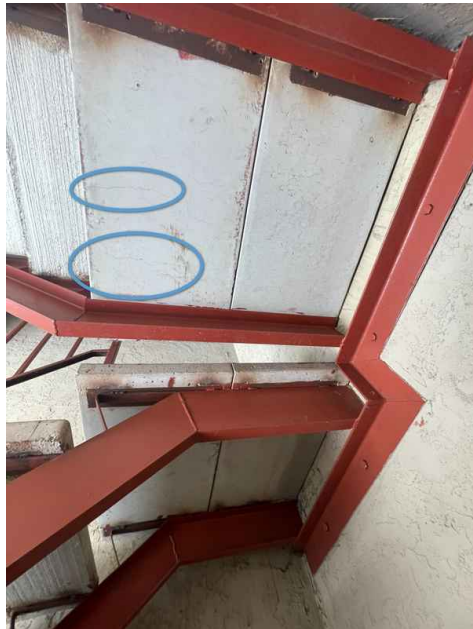
There is minor cracking in one or more slabs of the landing. At a minimum, the affected slabs should be replaced. If not replaced a reinspection is recommended in 2 years.

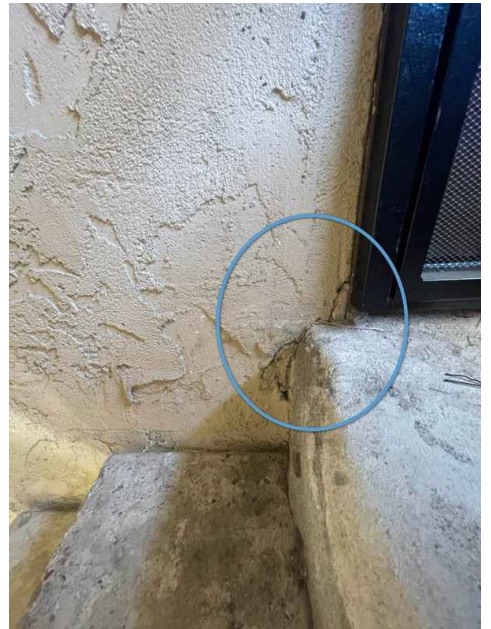
15.4.1 Entry Structure

There is a crack in the supporting wall. This crack should be sealed with a waterproof sealant to prevent water and wood boring insect intrusion.

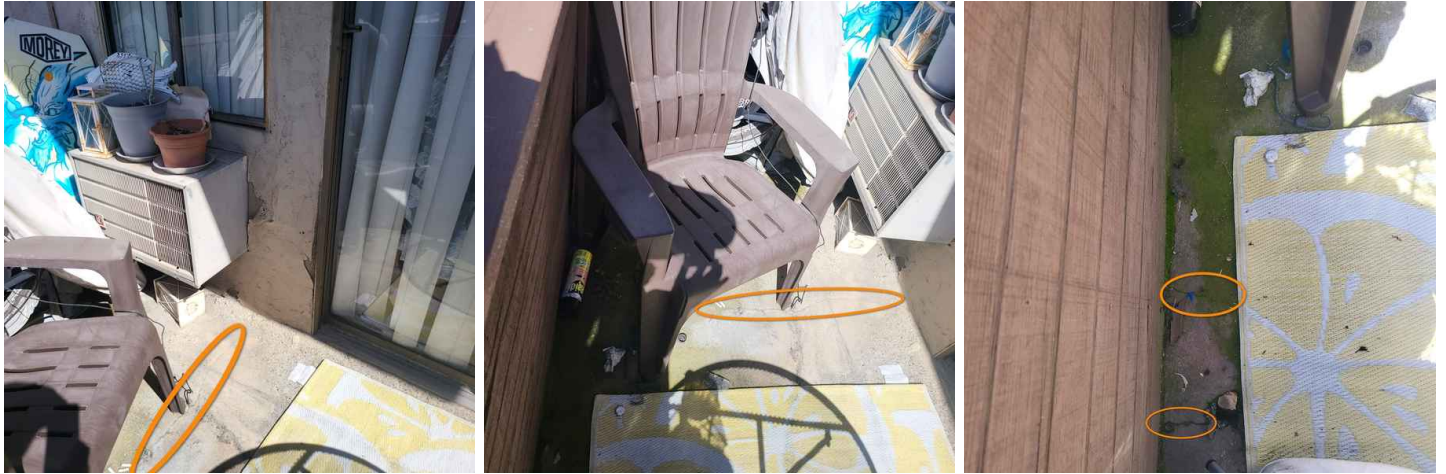
There are cracks in several locations on the deck surface. These cracks may indicate potentially severe water intrusion. Water intrusion can lead to internal deterioration of materials and possible compromise of structural integrity over time. A Phase 2 Pre-721 Evaluation (P2PE) is recommended to determine the extent of any water damage via borescope inspection or larger investigative openings, and to formulate a detailed repair plan.

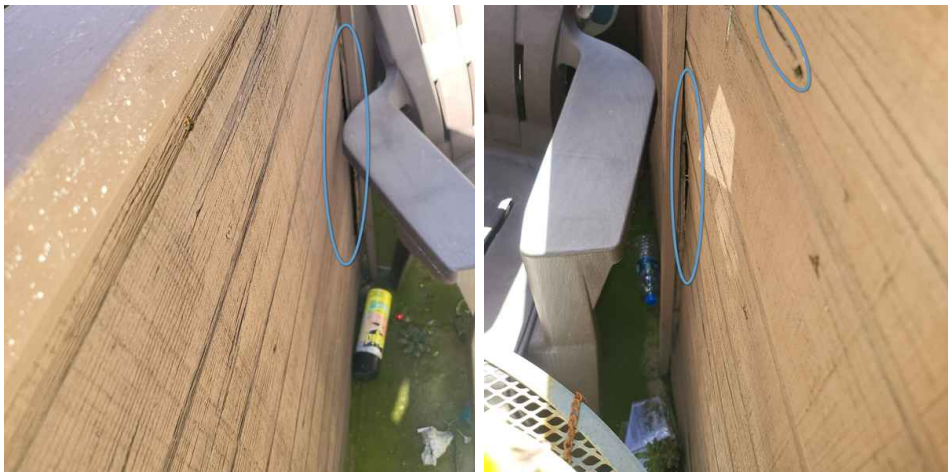
16.2.3 Balcony

There are openings in the wooden railing due to trim separating from water damaged paneling. A Phase 2 Pre-721 Evaluation (P2PE) is recommended to determine the extent of any water damage via borescope inspection or larger investigative openings, and to formulate a detailed repair plan.

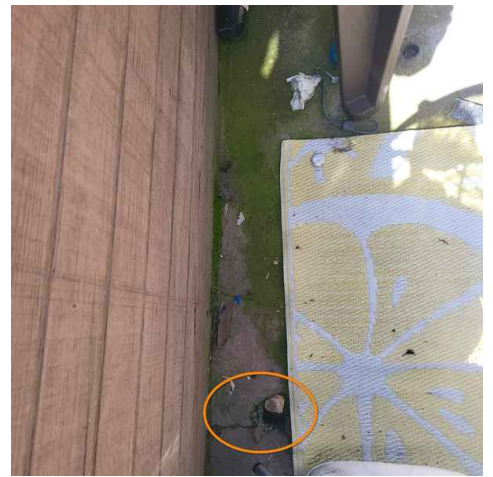
The deck is missing a drain assembly. Without a drain assembly the water is free to flow into the soffit rather than down the drain pipe. This water intrusion will lead to internal deterioration of materials and possible compromise of structural integrity over time. A Phase 2 Pre-721 Evaluation (P2PE) is recommended to determine the extent of any water damage via borescope inspection or larger investigative openings, and to formulate a detailed repair plan.

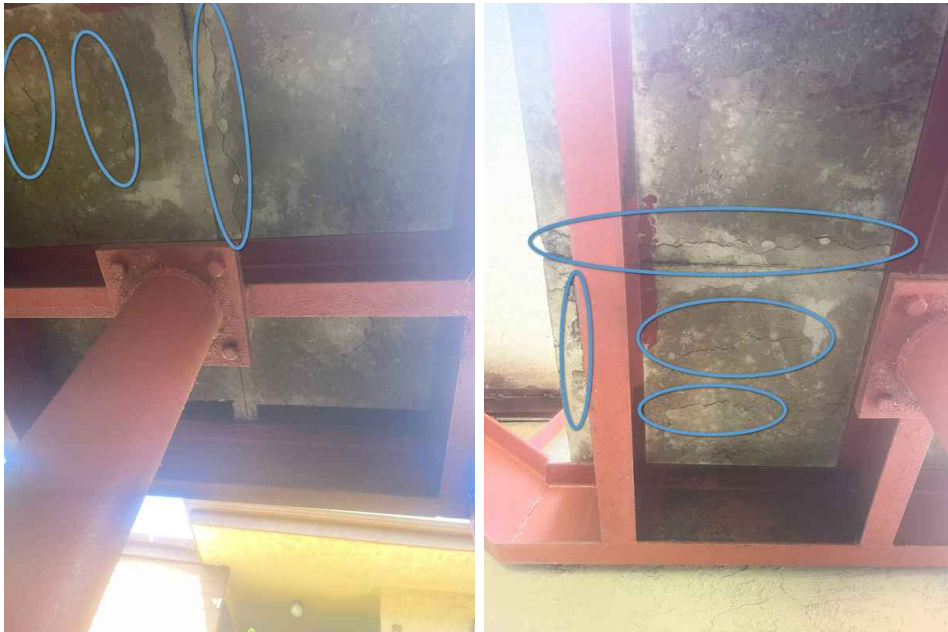
There is minor cracking in one or more slabs of the landing. At a minimum, the affected slabs should be replaced. If not replaced a reinspection is recommended in 2 years.

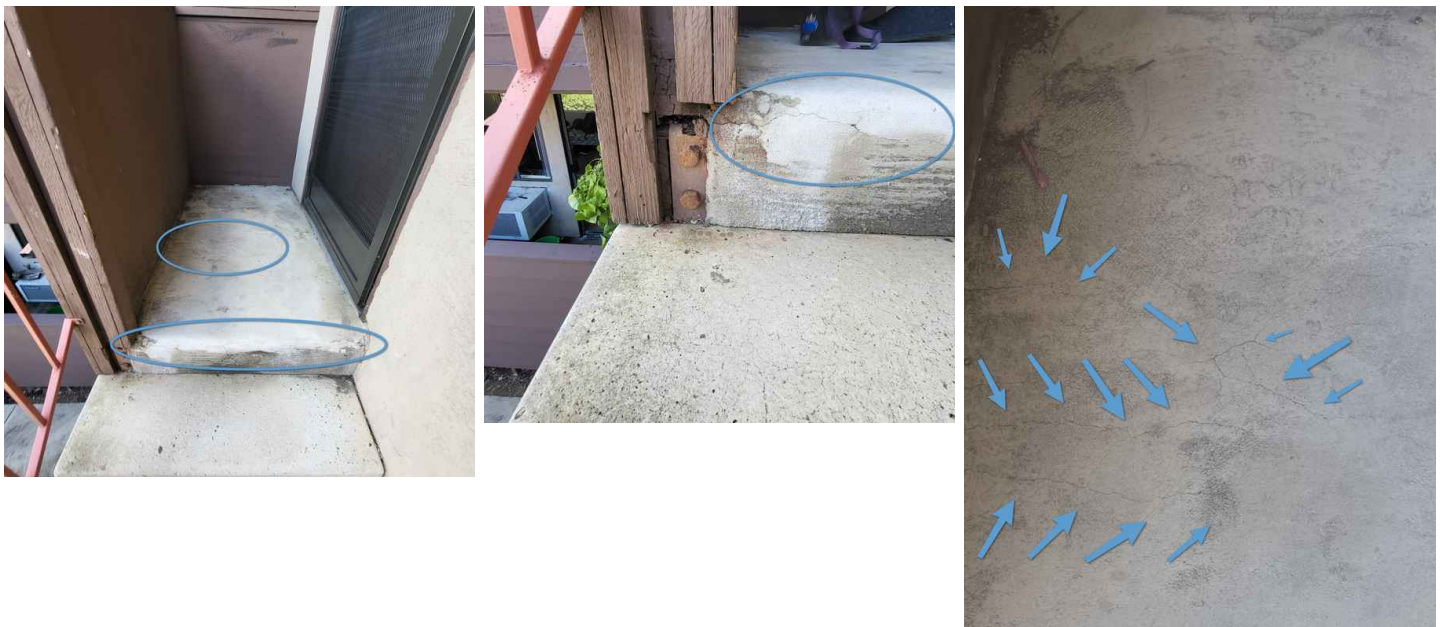
21.4.1 Entry Structure

There are cracks in the tops and side of the entry structure's walking surface. Deck surface should be resealed to prevent water intrusion.

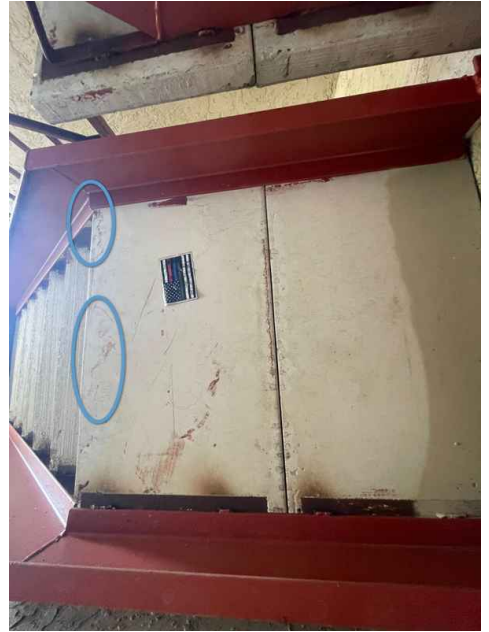
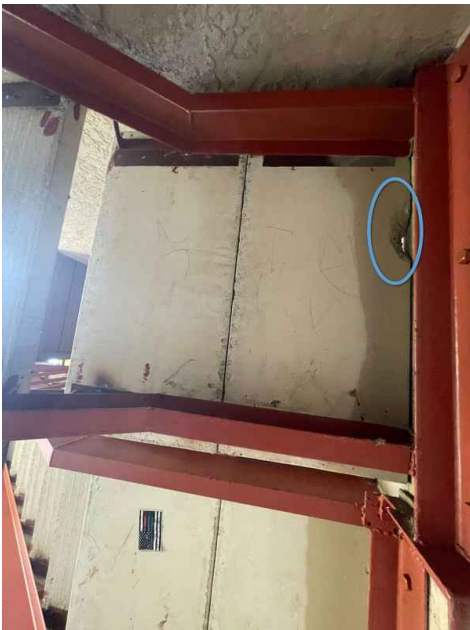
There are minor cracks and breakages in both landing platforms. At a minimum, the affected slabs should be replaced. If not replaced a reinspection is recommended in 2 years.

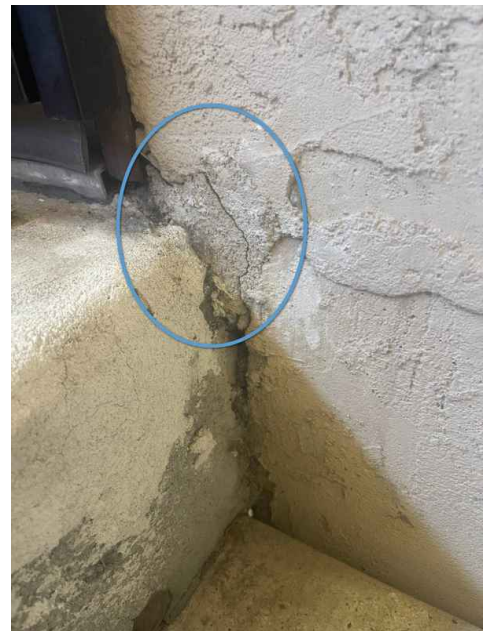
22.4.1 Entry Structure

There is a crack at the transition from the entry structure to the supporting wall. This crack should be sealed.

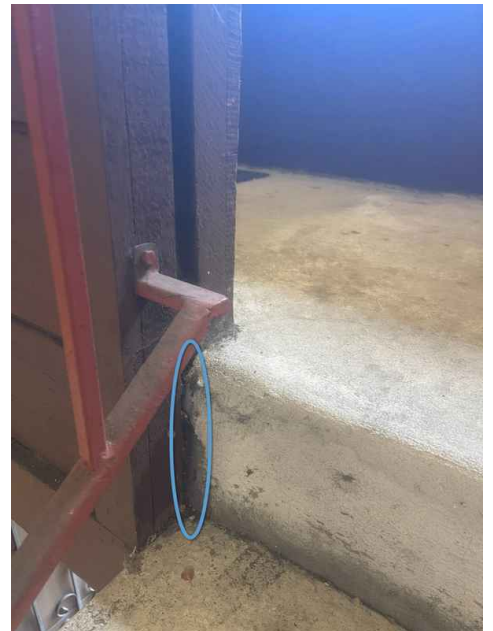
22.4.2 Entry Structure

There is an unsealed attachment between wooden railing and walking surface. This attachment should be sealed.

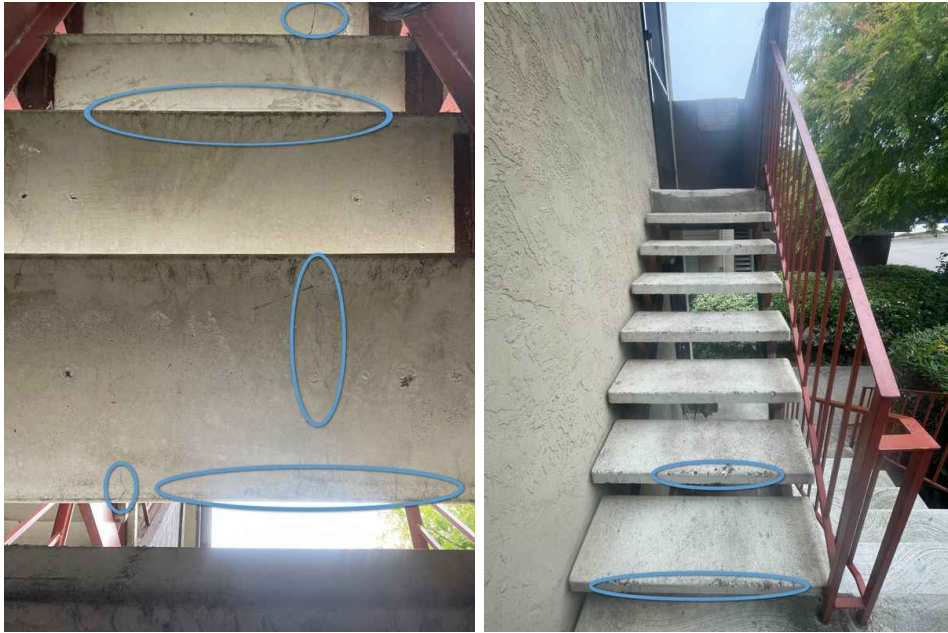
Approximately 5 of 15 treads have cracks or breakages. Most if not all of the stair treads seem to be the same age. At a minimum, the affected tread should be replaced. If not replaced a reinspection is recommended in 2 years.

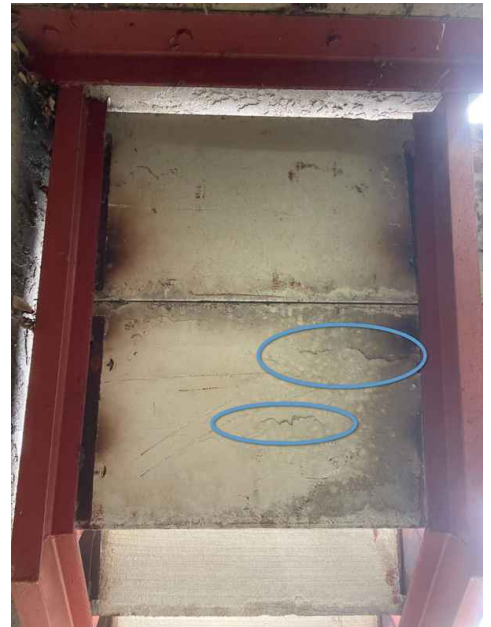
23.3.1 Landing

There is minor cracking in one or more slabs of the landing. At a minimum, the affected slabs should be replaced. If not replaced a reinspection is recommended in 2 years.

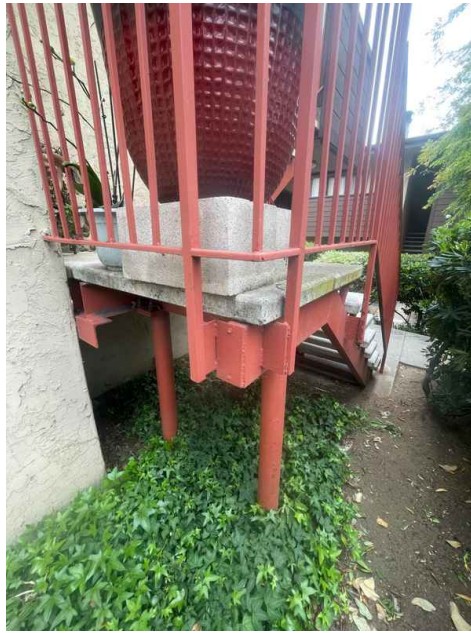
23.3.2 Landing

There is surface corrosion on the support beam. The bottom portion of the beam should be resealed.

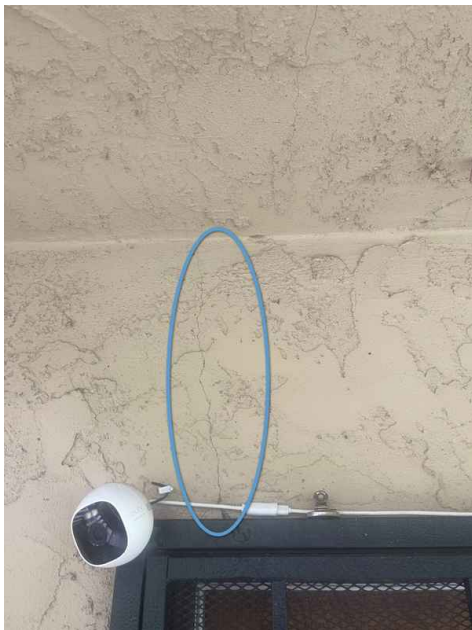
23.4.1 Entry Structure

There are cracks in the supporting wall under the entry structure. These cracks should be sealed with a waterproof sealant to prevent water and wood boring insect intrusion.

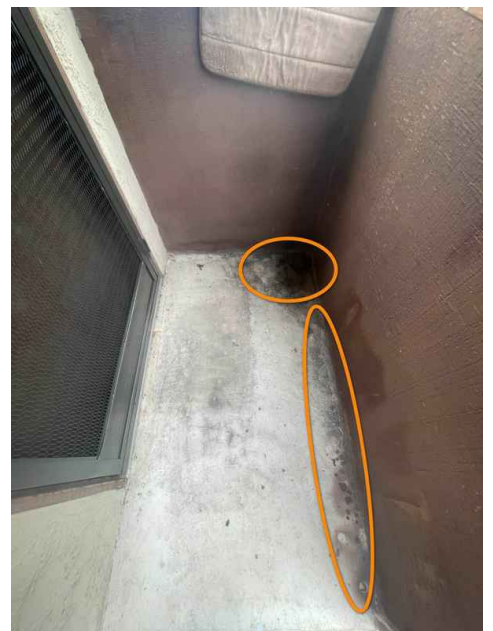
There is discoloration of the walking surface of the deck. Water intrusion is likely at the highlighted locations as there is discoloration in the fascia underneath. These conditions can lead to internal deterioration of materials and possible compromise of structural integrity over time. A Phase 2 Pre-721 Evaluation (P2PE) is recommended to determine the extent of any water damage via borescope inspection or larger investigative openings, and to formulate a detailed repair plan.
