PHASE 1 PRE-SB721 EVALUATION

1234 Main Street
Imperial Beach, CA 91932-1412

Buyer Name
05/02/2024 9:00AM

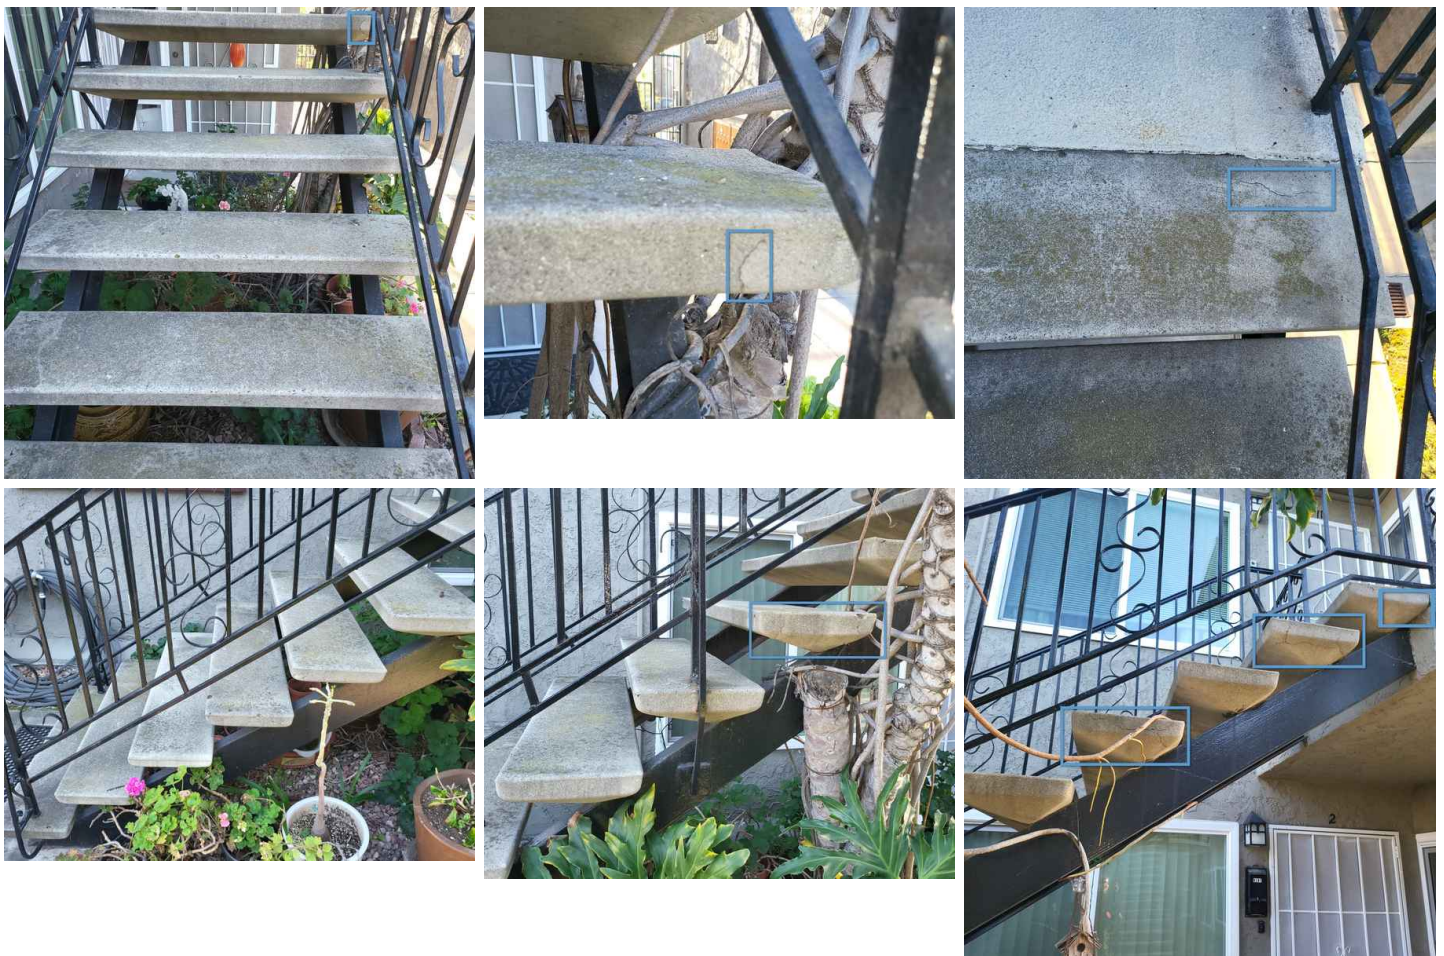
DAMAGED STAIR TREADS (MINORITY)

Approximately 5 out of 15 stair treads have cracks or breakages. Most if not all of the stair treads seem to be the same age and are likely approaching the end of their service life. At a minimum, the affected treads should be replaced. If not replaced a reinspection is recommended in 2 years.

Contact a qualified professional.

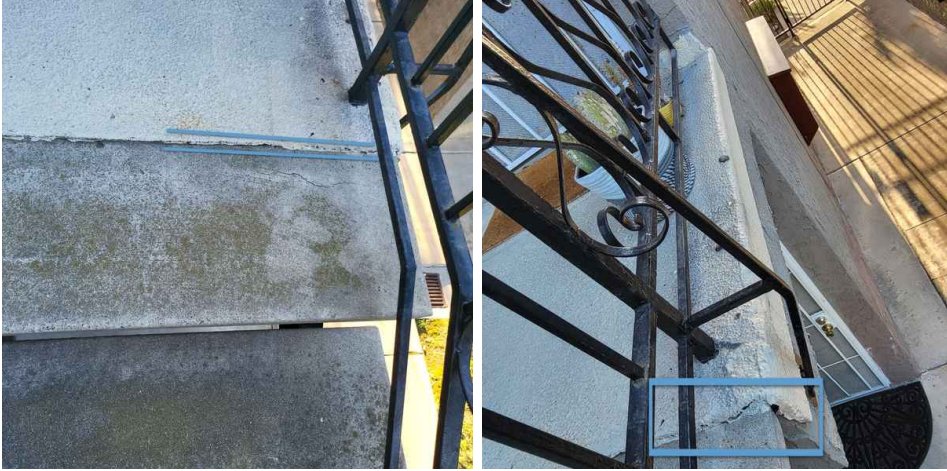
5.3.1 Landing

DECK - OPENING IN WATERPROOFING

There is an opening where the top stair tread meets the landing . Water sealant/weatherproofing should be applied.

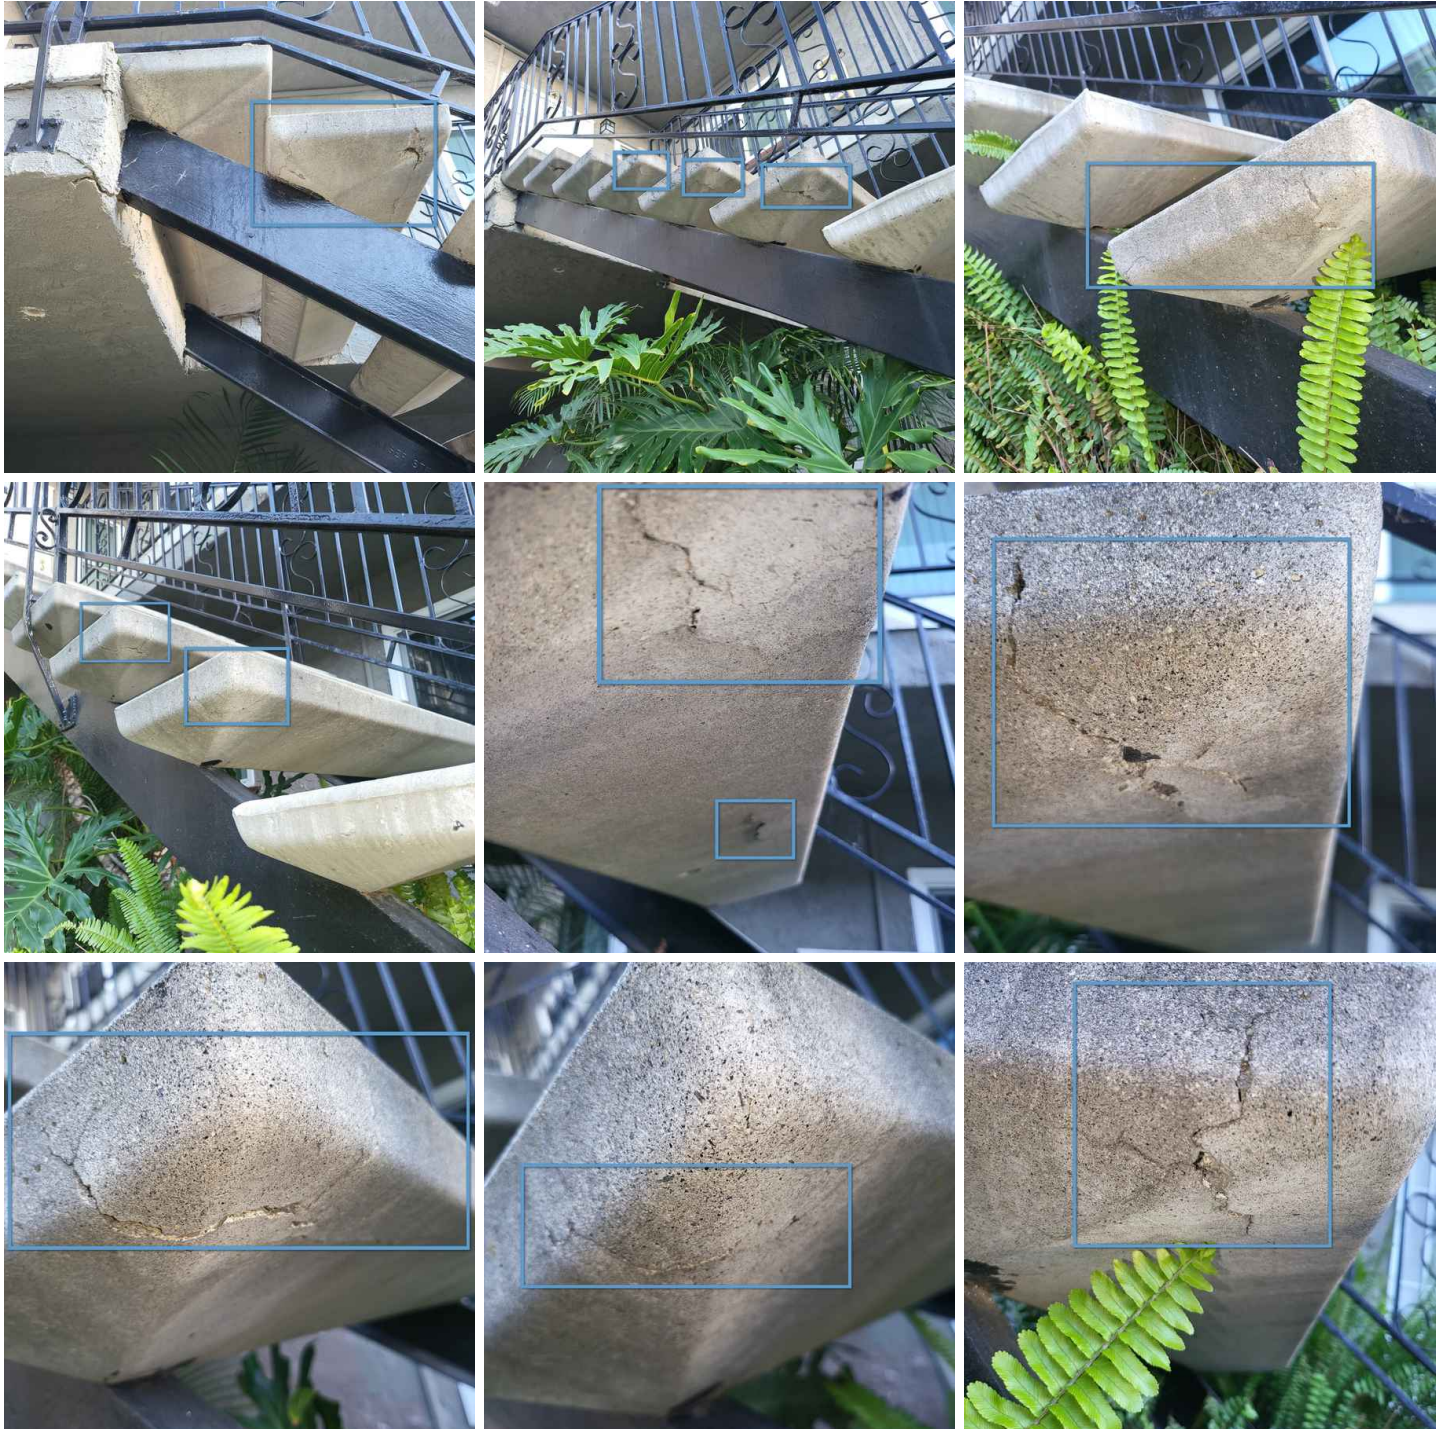
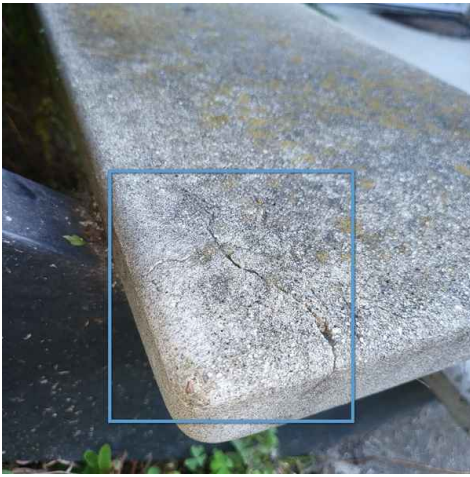
DAMAGED STAIR TREADS (MINORITY)

Approximately 6 out of 15 stair treads have cracks or breakages. Most if not all of the stair treads seem to be the same age and are likely approaching the end of their service life. At a minimum, the affected treads should be replaced. If the treads are not replaced a reinspection is recommended in 2 years.

Contact a qualified professional.

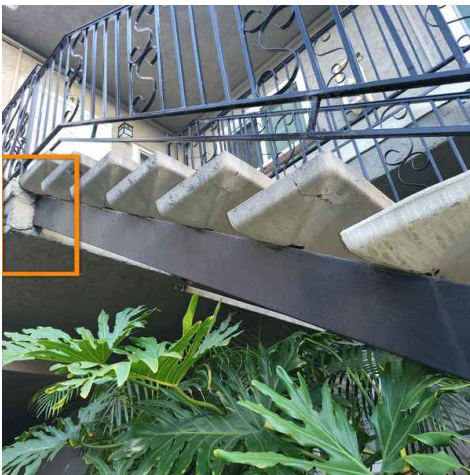
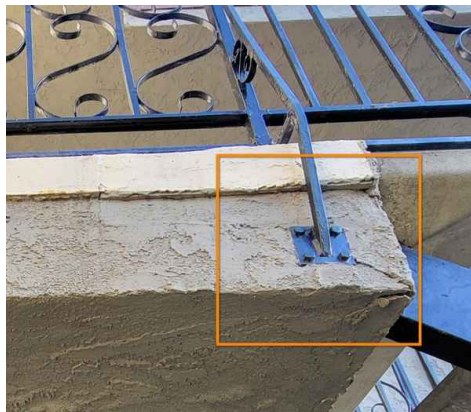
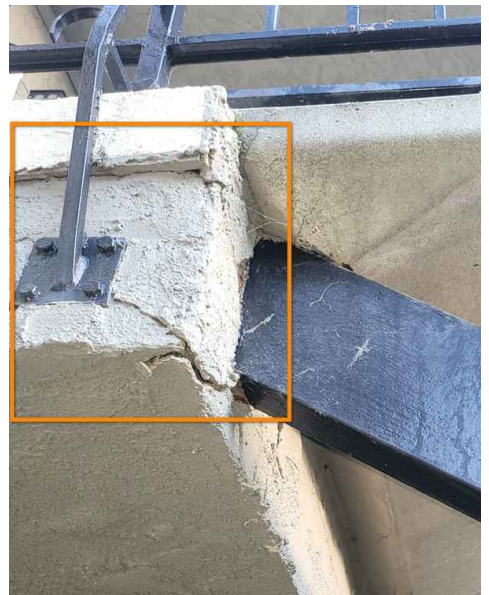
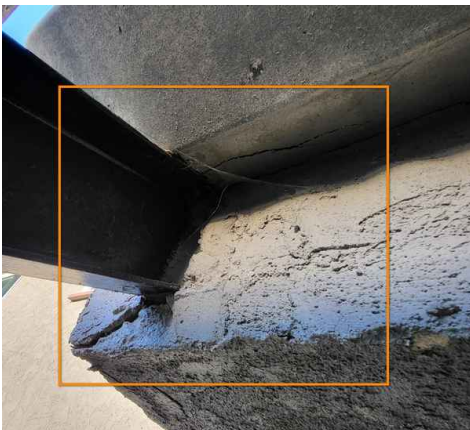
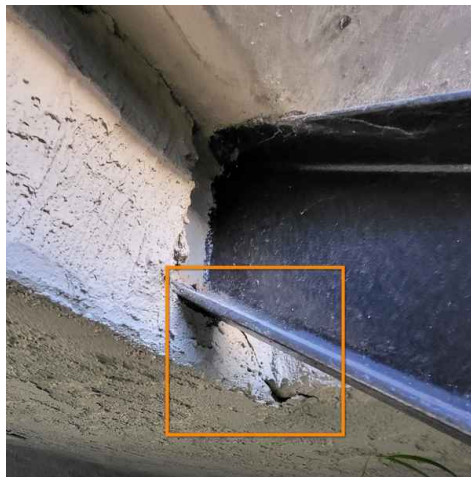
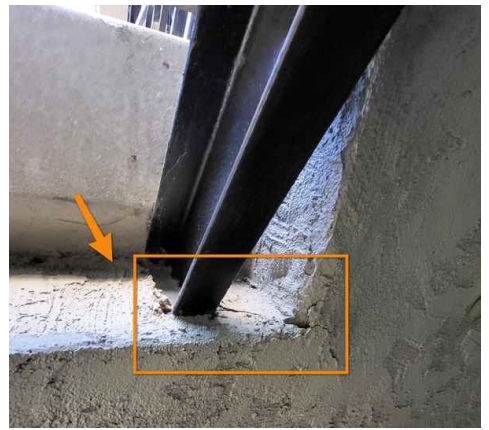
6.3.1 Walkway

STUCCO DAMAGE

There are large cracks in the stucco around both stair stringer connections to the walkway. These cracks correspond to railing connection defects above these locations. This condition raises concerns regarding water intrusion and possible advanced deterioration in the underlying support structure. A Phase 2 Pre-721 Evaluation (P2PE) is recommended to determine the extent of any water damage via borescope investigation or larger investigative openings, and to formulate a detailed repair plan.

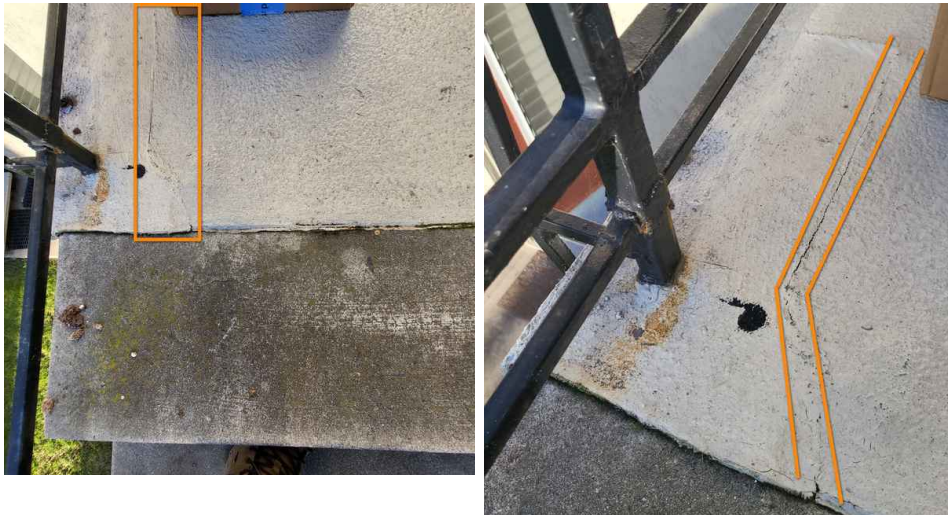
6.3.2 Walkway

PREVIOUS REPAIRS FAILING - MINOR TO MODERATE

Inspection has revealed that previous repair efforts on the structure are failing, indicating either inadequate repair methods were used or the underlying issues have not been fully addressed. This area was previously patched, but a crack has formed around the patch and the deck coating is swelling, indicating water intrusion and wood decay and/or corrosion of railing connection. The deteriorating condition of these repairs could lead to further damage or safety risks. It is essential to re-evaluate these areas with a qualified professional to determine the cause of failure and to implement more effective and lasting repair solutions. Immediate attention is advised to prevent escalation of the defect. A borescope inspection under this defect is recommended and a larger investigative opening.

Contact a qualified professional.

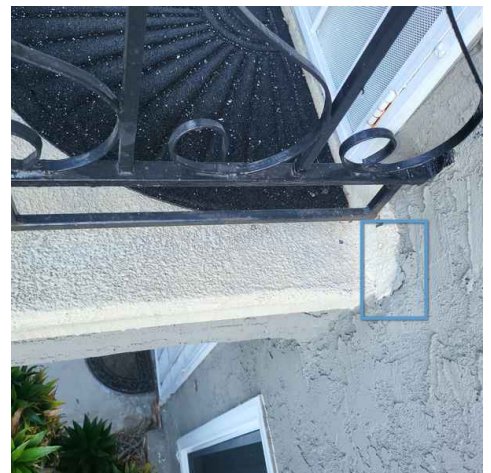
6.3.3 Walkway

DECK - OPENING IN WATERPROOFING

There is minor cracking in the waterproofing at the west end of the walkway under the bottom rail connection. Sealant/waterproofing should be applied.

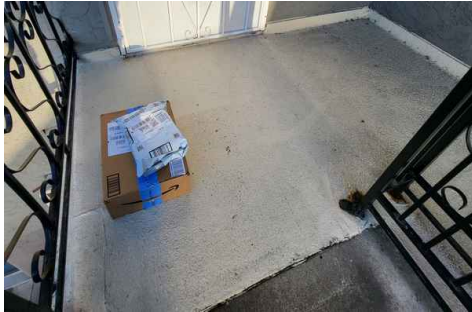
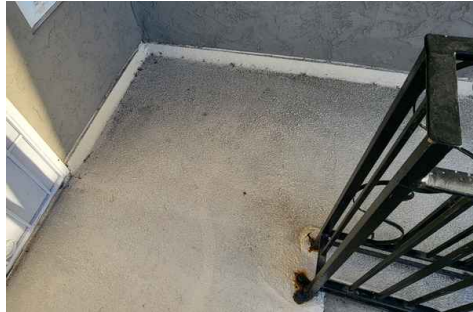
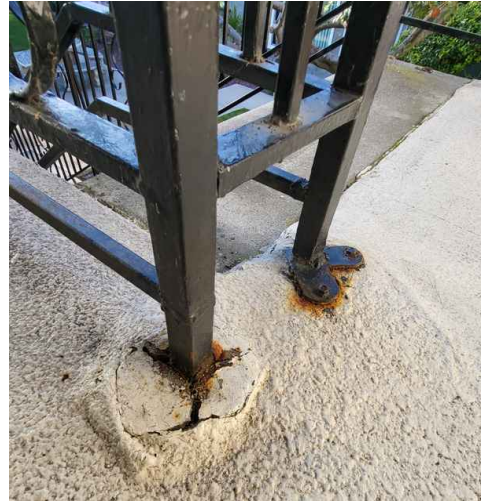
6.3.4 Walkway

WALKWAY RAILING CONNECTION

Corrosion is present at the base of the handrail. There is swelling and cracks in the deck coating indicating water intrusion and deterioration of the underlying support materials. This deterioration could lead to further damage or safety risks. It is essential to re-evaluate these areas with a qualified professional to determine the cause of failure and to implement more effective and lasting repair solutions. Immediate attention is advised to prevent the escalation of this defect. A borescope inspection under this defect is recommended and an investigative opening in the deck may be necessary.

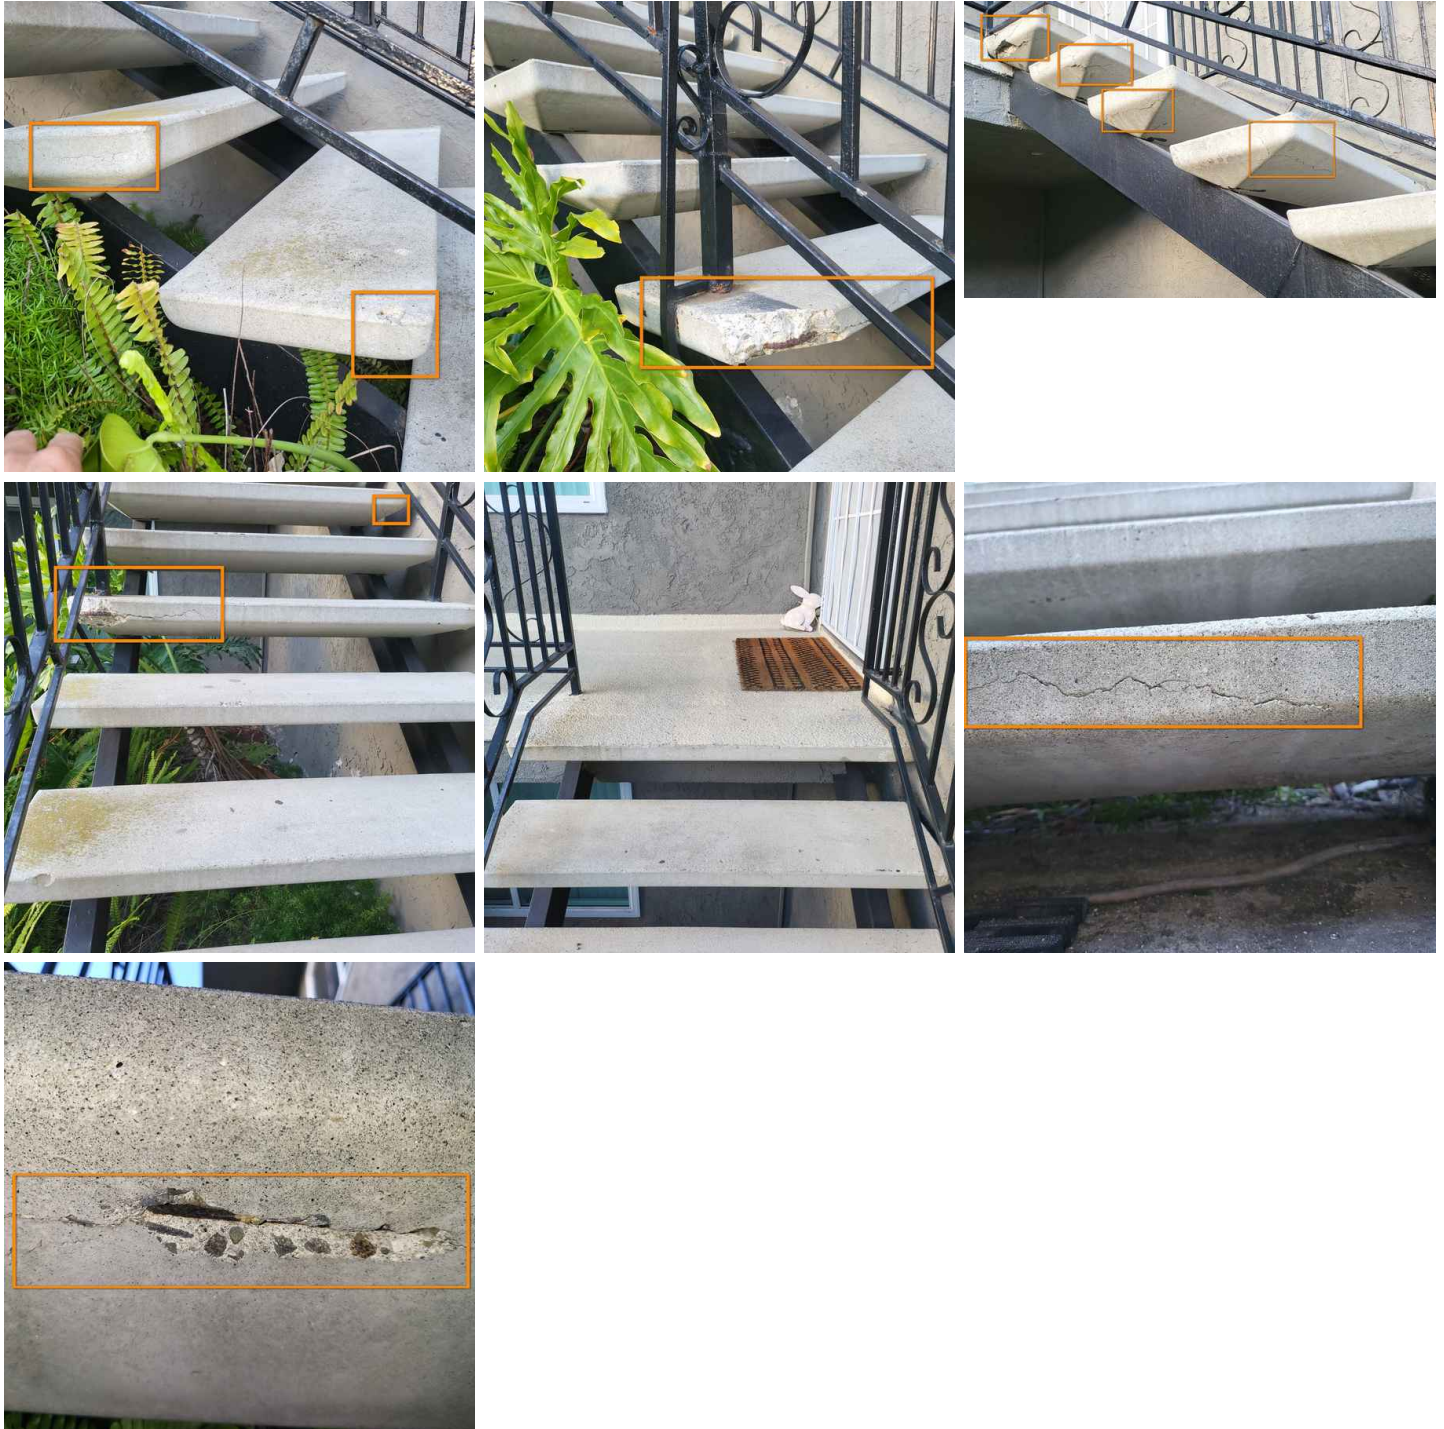
DAMAGED STAIR TREADS (MAJORITY)

Approximately 8 out of 15 stair treads have cracks or breakages. Most if not all of the stair treads seem to be the same age and are likely approaching the end of their service life. At a minimum, the affected treads should be replaced. If the treads are not replaced a reinspection is recommended in 2 years.

Contact a qualified professional.

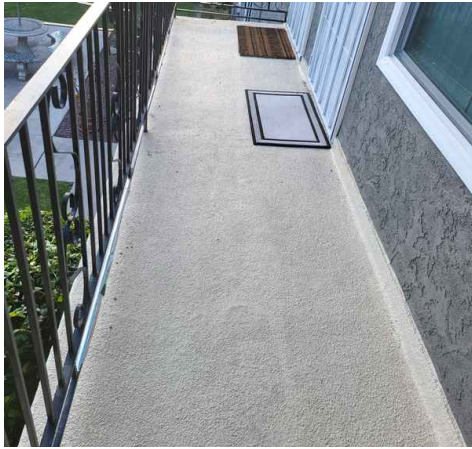
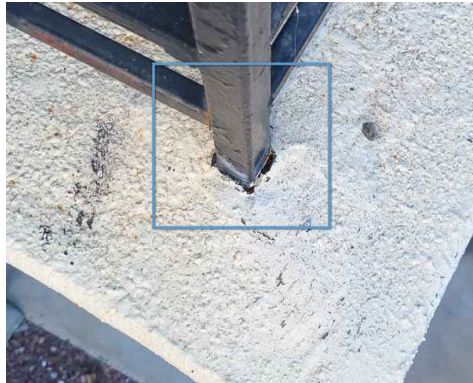
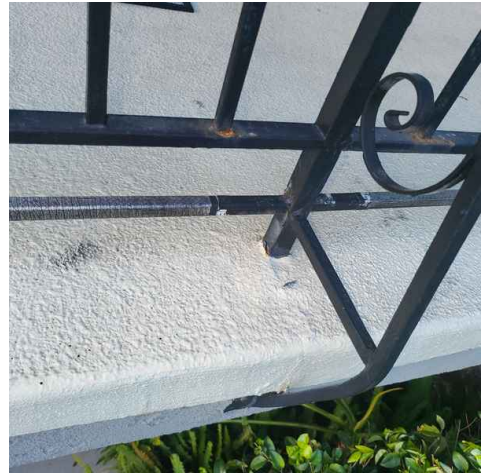
7.3.1 Walkway

WALKWAY RAILING CONNECTION

2 of the rail connections to the deck are not sealed and corrosion is visible. Water intrusion and deterioration of the underlying support materials are likely. This deterioration could lead to further damage or safety risks. A borescope inspection under one or both of these opening is recommended to determine the extent of water damage to the underlying support materials.

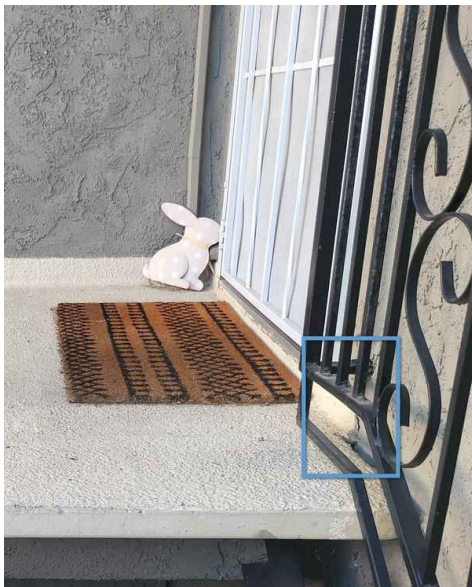
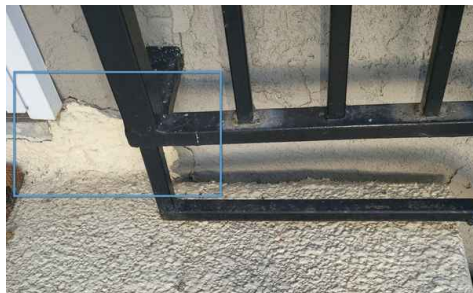
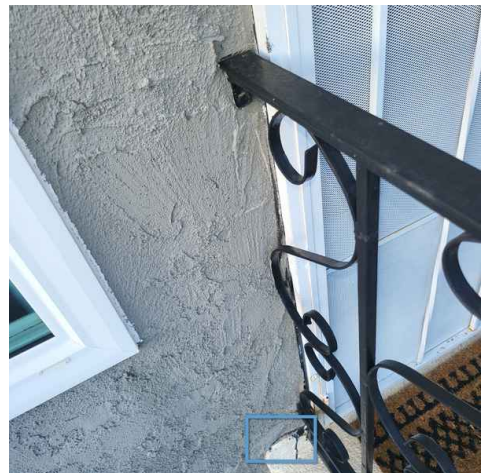
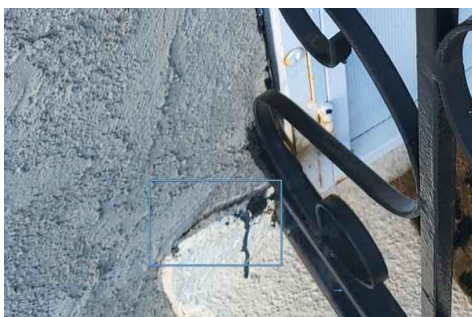
7.3.2 Walkway

DECK - OPENING IN WATERPROOFING

There is minor cracking in the waterproofing at both ends of the walkway under the rail connection to the wall. Sealant/waterproofing should be applied.

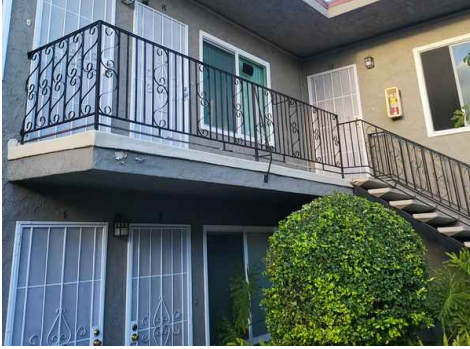
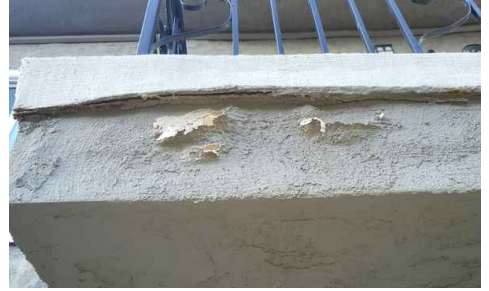
7.3.3 Walkway

STUCCO DAMAGE

There is evidence of water intrusion at the west corner of the walkway. The edge metal is lifting and corrosion is visible. Water has penetrated the stucco causing it to blister. This condition raises concerns regarding water intrusion and possible advanced deterioration in the underlying support structure. A Phase 2 Pre-721 Evaluation (P2PE) is recommended to determine the extent of any water damage via borescope investigation or larger investigative opening, and to formulate a detailed repair plan.

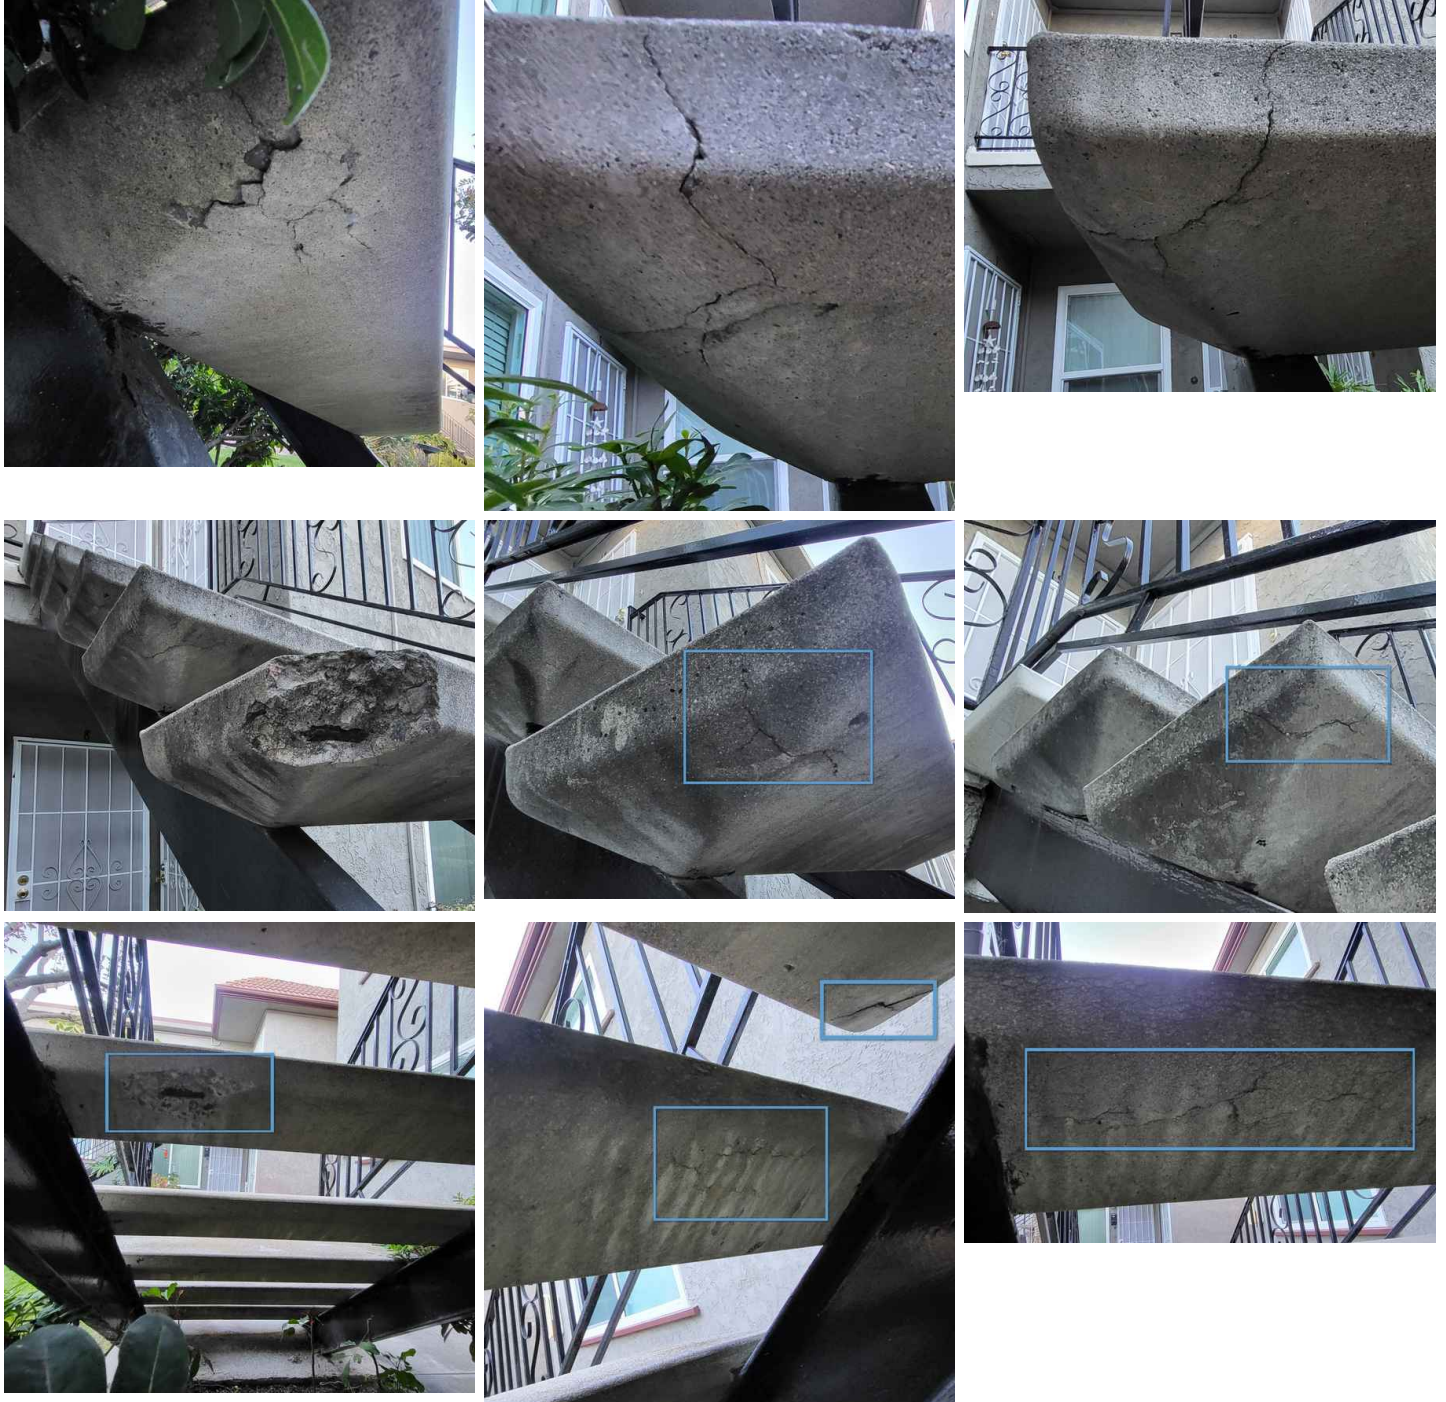
DAMAGED STAIR TREADS (MAJORITY)

Approximately 10 out of 15 stair treads have cracks or breakages. Except for the top stair tread, all the treads seem to be the same age and are most likely at the end of their service life. At a minimum, the affected treads should be replaced. If the treads are not replaced a reinspection is recommended in 1 year.

Contact a qualified professional.

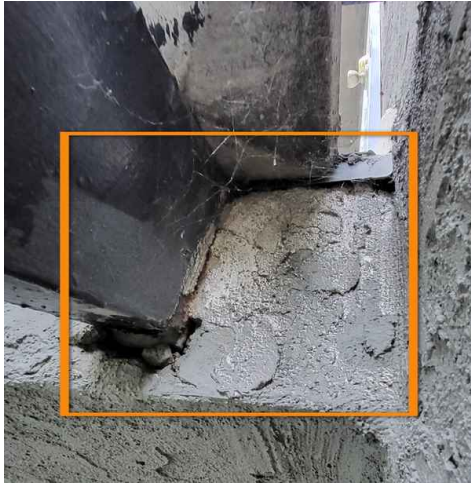
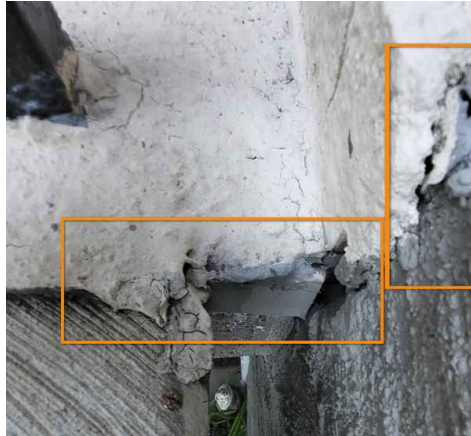
8.3.1 Walkway

POOR DETAILING

The deck coating, the edge metal, and the stucco around the right stair stringer connection to the walkway are not finished properly or sealed. This condition raises concerns regarding water intrusion and possible advanced deterioration in the underlying support structure. A Phase 2 Pre-721 Evaluation (P2PE) is recommended to determine the extent of any water damage via borescope investigation and to formulate a detailed repair plan.

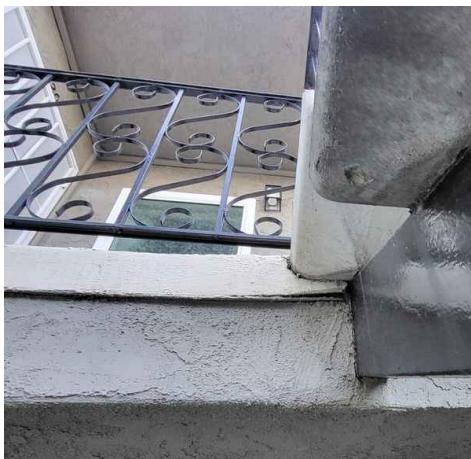
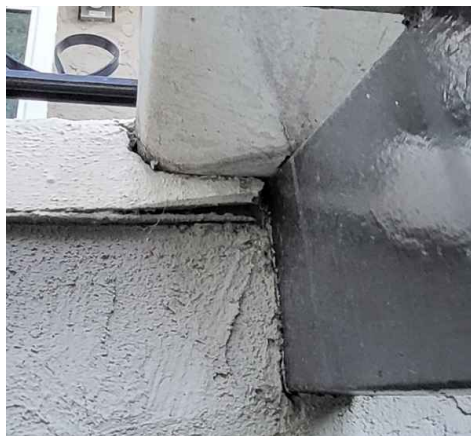
8.3.2 Walkway

There is an opening around the top stair tread where it meets the deck metal. The deck coating on the edge metal is separating. This opening allows water intrusion, potentially leading to wood rot, structural weakness, and mold growth. Immediate steps should include a professional assessment, repair and sealing of the cracks, and regular maintenance to prevent further damage and ensure the deck's longevity and safety.

Contact a qualified professional.
