PRE-721 EVALUATION PHASE 2

1234 Main Street
Imperial Beach, CA 91932-1412

Buyer Name
05/02/2024 9:00AM

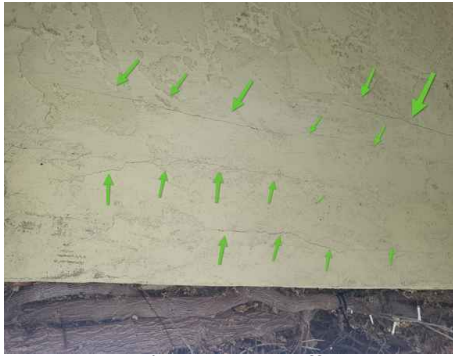
The visual inspection in the P1PE noted cracks in the stucco running parallel to the walkway. See 1st photo.

Cracks in stucco soffit

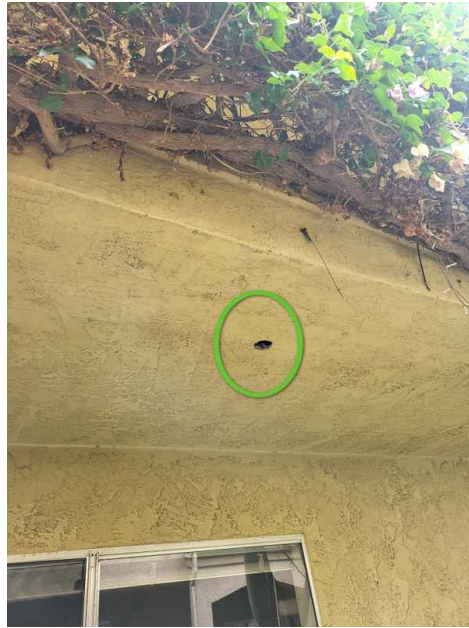
2nd photo shows 1st borescope inspection hole.

The 1st Borescope investigative opening revealed no issues.

At the time of the borescope inspection, no damage to the load-bearing components was observed

1st borescope inspection

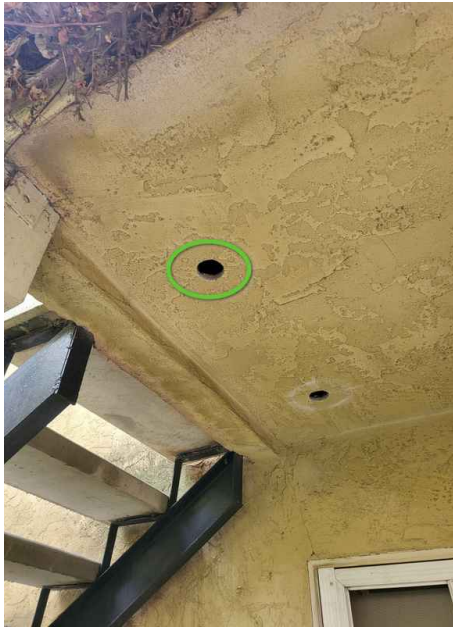
See 1st photo for 2nd borescope location

The visual inspection in P1PE noted openings in the stucco around the right stair stringer. These are likely areas for water intrusion. Stucco soffit is discolored in this area.

The 2nd Borescope investigative opening revealed no issues.

At the time of the borescope inspection, no damage to the load-bearing components was observed.

near right stringer attachment

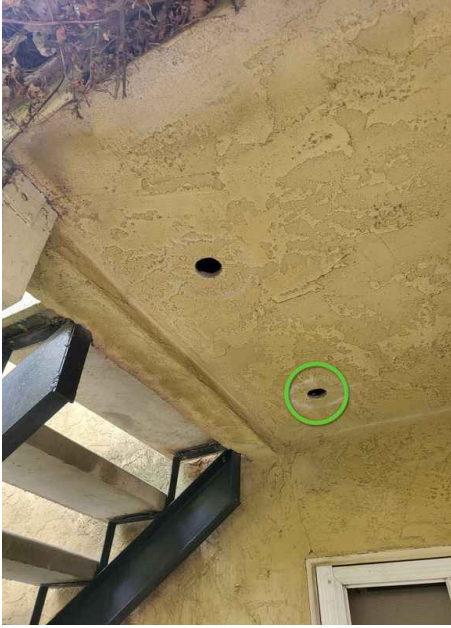
See 1st photo for 3rd borescope location

The visual inspection in P1PE noted openings in the stucco around the left stair stringer. These are likely areas for water intrusion. Stucco is discolored in this area.

The 3rd Borescope investigative opening revealed no issues

At the time of the borescope inspection no damage to the load-bearing components was observed

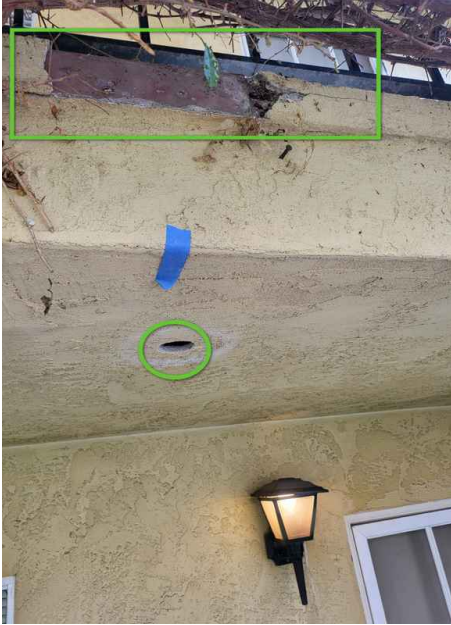
4th borescope hole

See the 1st photo for 4th borescope location

The 4th Borescope investigative opening revealed minor issues.

At the time of the borescope inspection no damage to the load-bearing components was observed.

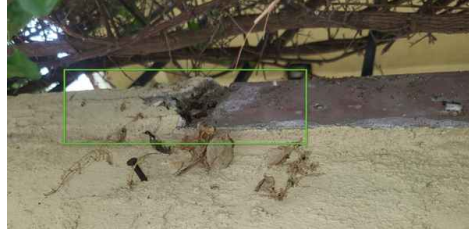
The visual inspection in P1PE noted opening along edge metal. Stucco is falling off the edge metal. See 2nd photo. This is a likely location for water intrusion.

Opening near edgemetal

The edge metal should be repaired or replaced and the waterproofing system above resealed.

Repair or replace the edge metal toward the south end of the walkway.

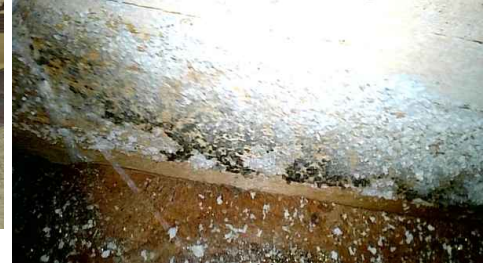
There is evidence of minor water intrusion such as a small amount of mold is present. See 3rd photo stucco overspray has fallen off the deck plywood. See 4th photo.

Mold

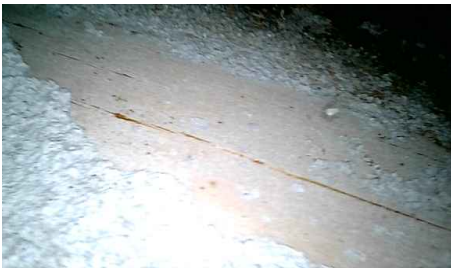
Moisture coming through

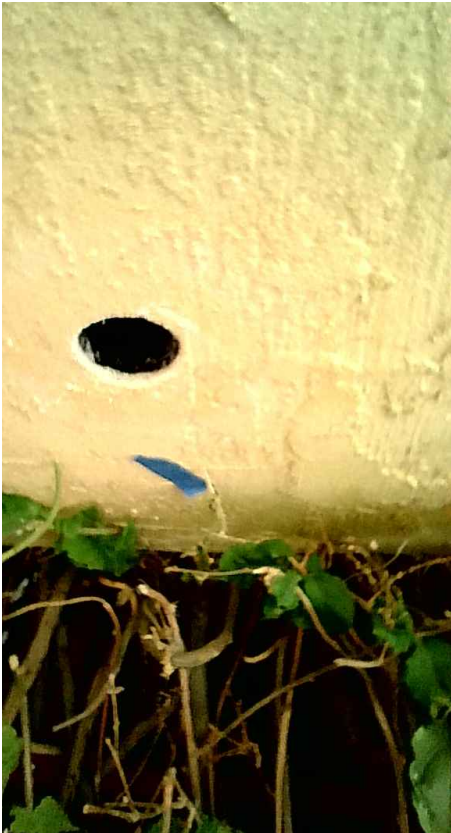
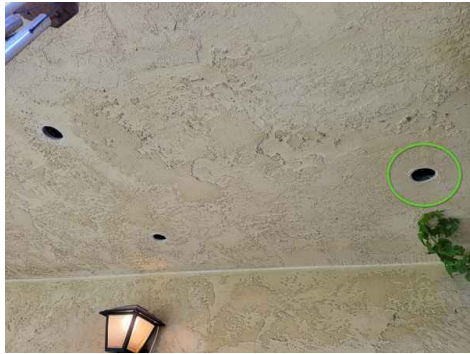
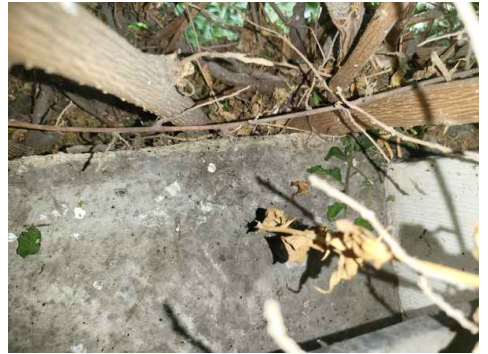
See 1st and second photos for 5th borescope location.

The visual inspection in P1PE at the south end of the walkway noted vine growth tight against the stucco. The stucco covering underneath is discolored.

Deck above 5th hole

Prior to the SB-721 Inspection an area of vine growth should be cleared and a section of stucco removed to investigate the extent of termite damage to the rim board or wood support components.

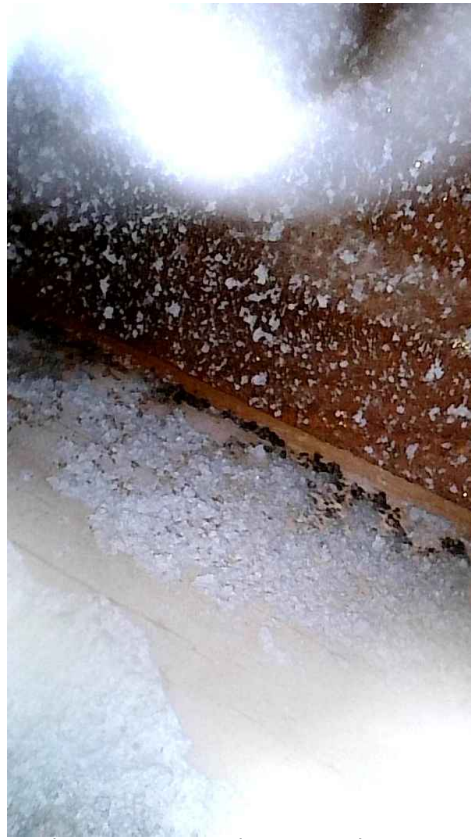
The 5th Borescope investigative opening revealed evidence of termite activity along the rim board. Photos 8 and 10 show termite droppings. There are signs of minor water intrusion such as water stains along the rim board.

Photo# 8 Termite droppings along rim board

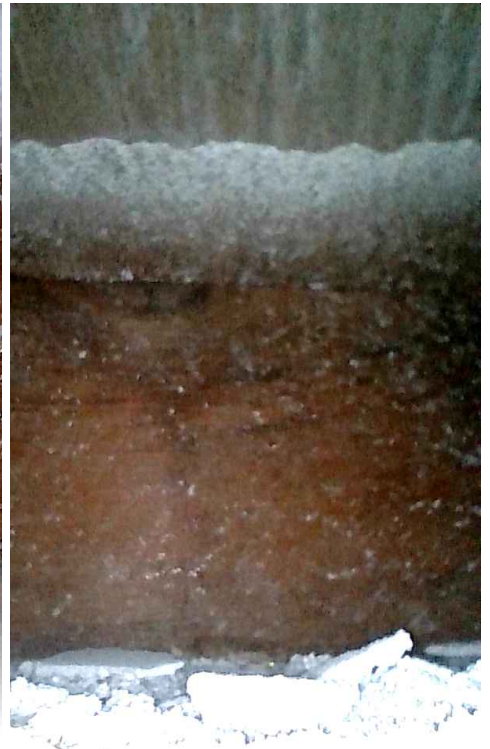
Water stain

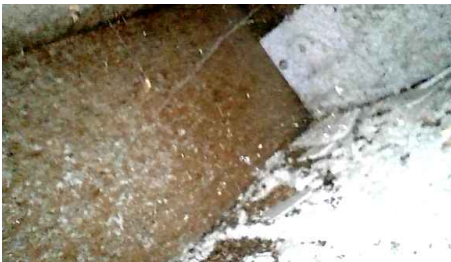
Photo# 10 Termite droppings along rim board

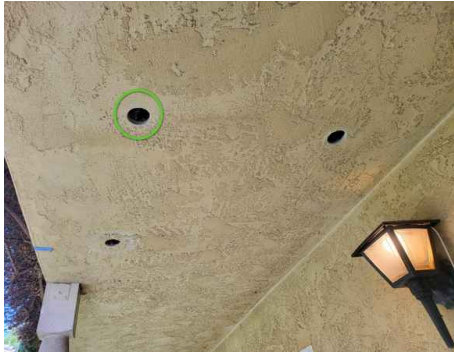
6th borescope hole

The 6th Borescope investigative opening revealed no evidence of water intrusion.

The 6th Borescope investigative opening revealed no issues.

At the time of the borescope inspection no damage to the load-bearing components was observed.

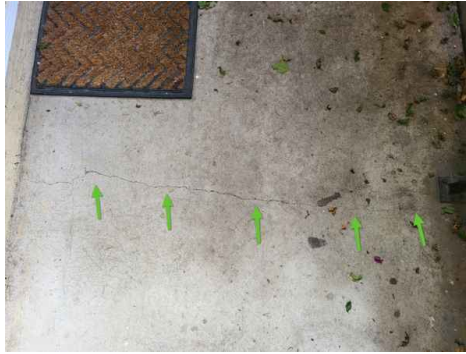
The visual inspection in P1PE noted a crack in the concrete deck. See 2nd photo. This is a potential location for water intrusion.

Crack across concrete deck

The deck crack should be sealed.

Reseal the walkway edge metal around the perimeter, the cracks in the concrete topping, where the concrete deck meets the stucco wall, at all railing connections and around the top stair tread and the stair stringer connections.

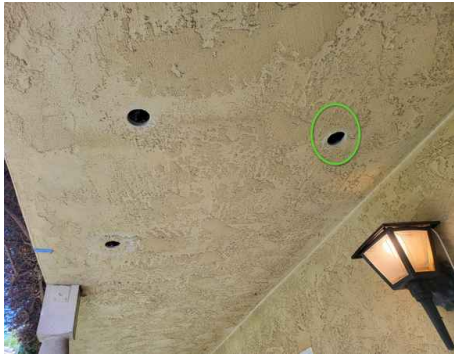
7th borescope hole

The 7th Borescope investigative opening revealed no evidence of water intrusion.

The 7th Borescope investigative opening revealed no issues.

At the time of the borescope inspection no damage to the load-bearing components was observed.

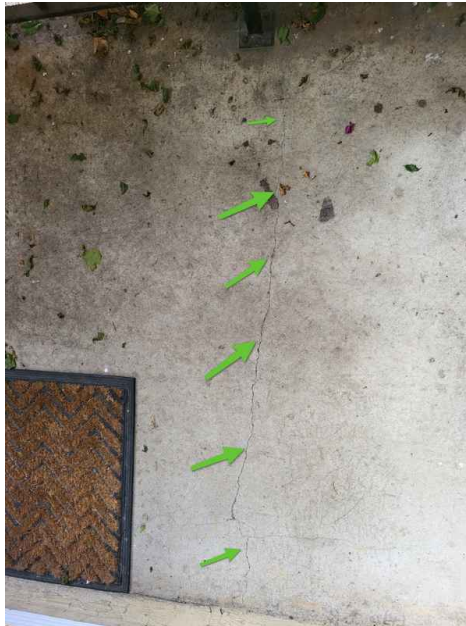
The visual inspection in P1PE noted a crack in the concrete deck. See 2nd photo. This is a potential location for water intrusion.

Crack across concrete deck
