PATRICK'S PROPERTY MAINTENANCE SERVICE

PHASE 1 PRE-SB326 EVALUATION

1234 Main Street
Imperial Beach, CA 91932-1412

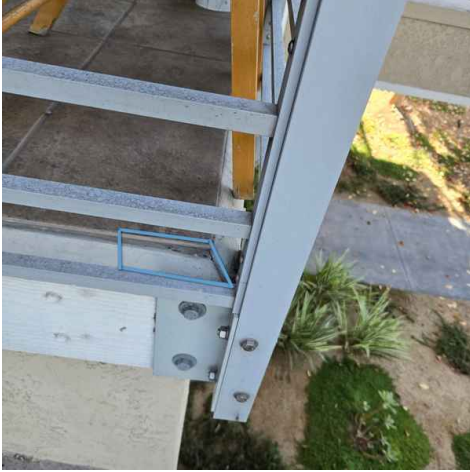
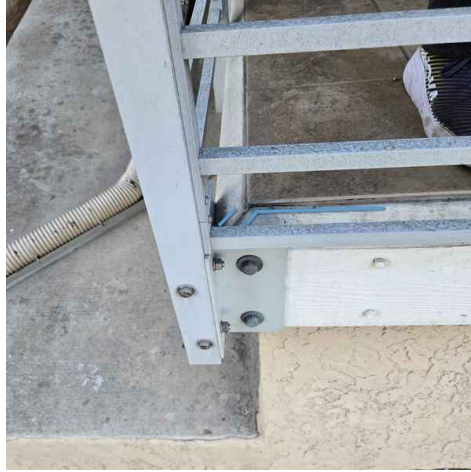
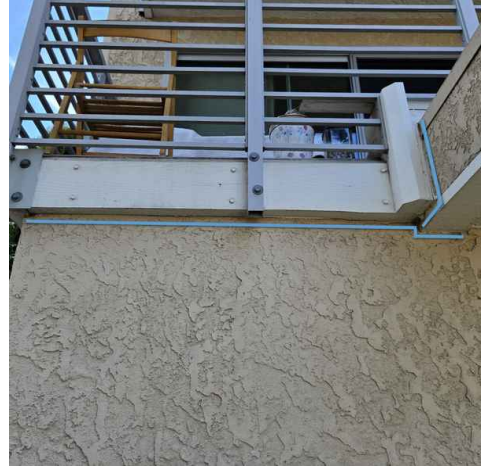
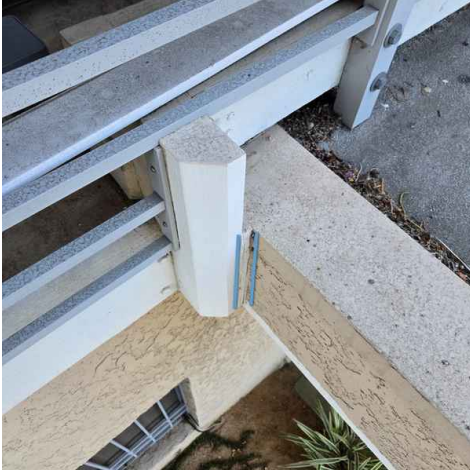
5.2.1 Balcony

OPENINGS IN WATERPROOFING

Minor - There are cracks, openings, or penetrations in the waterproofing. The affected areas should be sealed.

Recommendation

Contact a qualified professional.

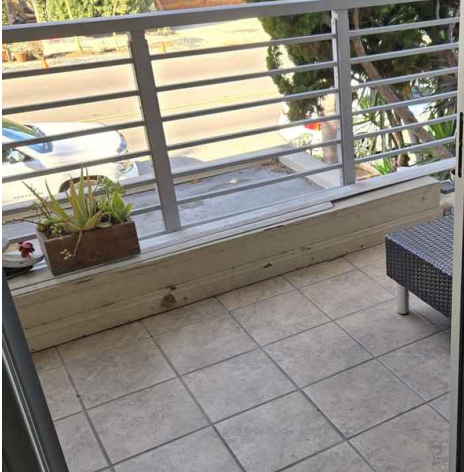
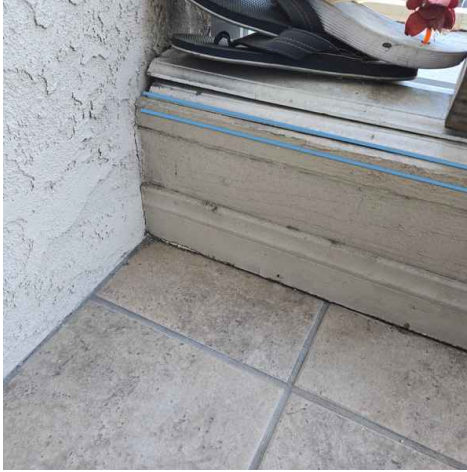
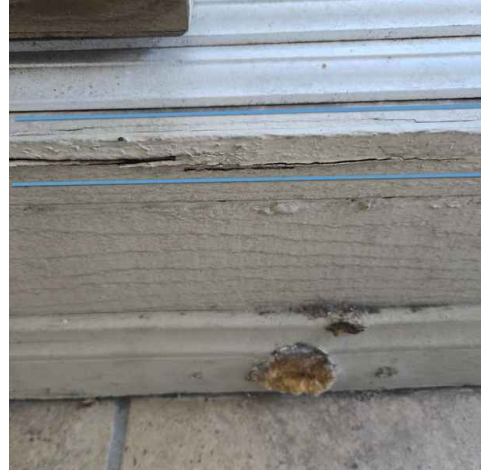
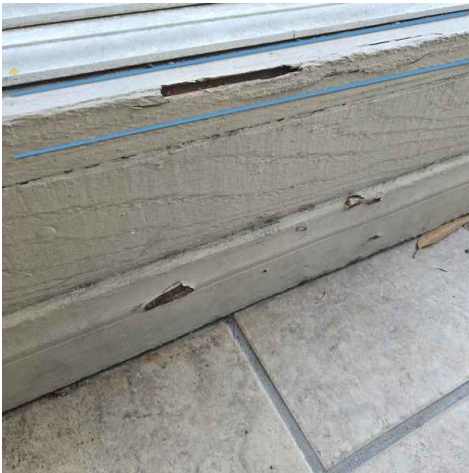
5.2.2 Balcony

TERMITE/WOOD ROT DAMAGE

Minor - There is minor evidence of wood boring insect intrusion and/or wood rot which may include bore-holes or tunnels, pellets and droppings, weakness, softness, live insects, discoloration, crumbling texture, or fungal growth. These condition(s) are minor, the affected components should be treated or replaced.

Recommendation

Contact a qualified professional.

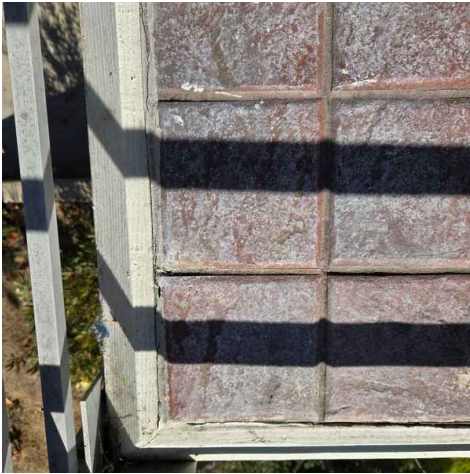
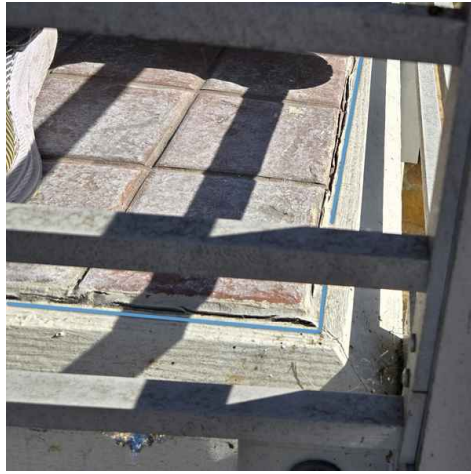
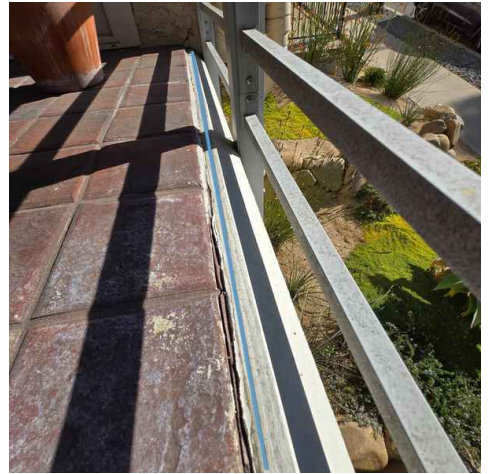
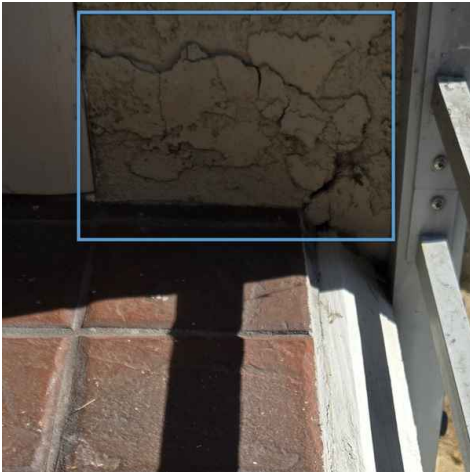
6.2.1 Balcony

OPENINGS IN WATERPROOFING

Minor - There are cracks, openings, or penetrations in the waterproofing. The affected areas should be sealed.

Recommendation

Contact a qualified professional.

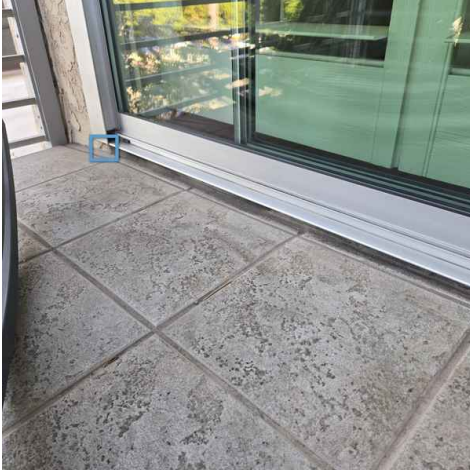
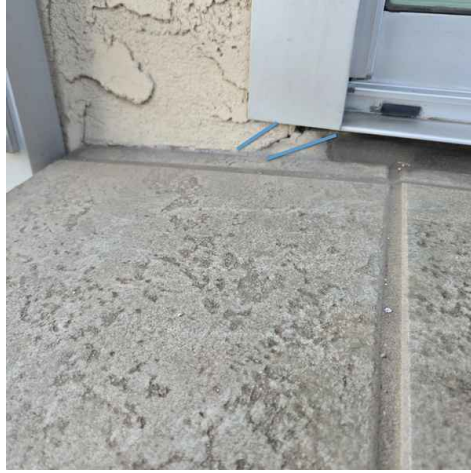
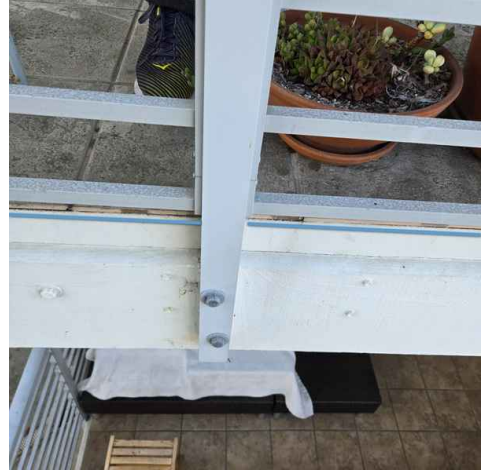
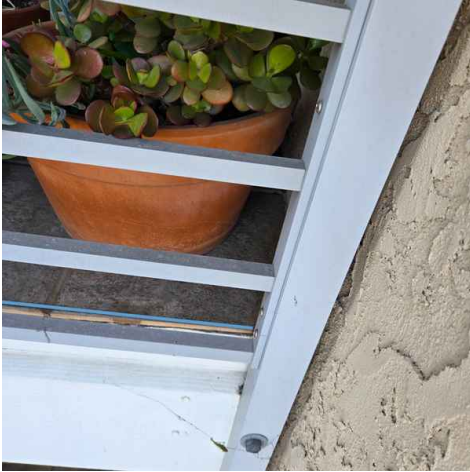
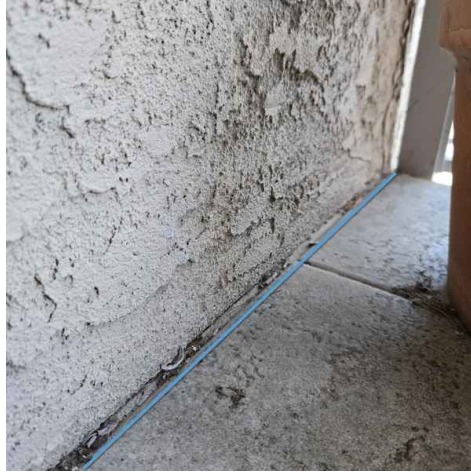
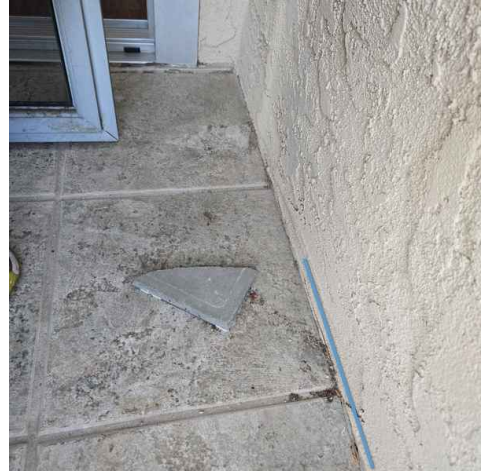
7.2.1 Balcony

OPENINGS IN WATERPROOFING

Minor - There are cracks, openings, or penetrations in the waterproofing. The affected areas should be sealed.

Recommendation

Contact a qualified professional.

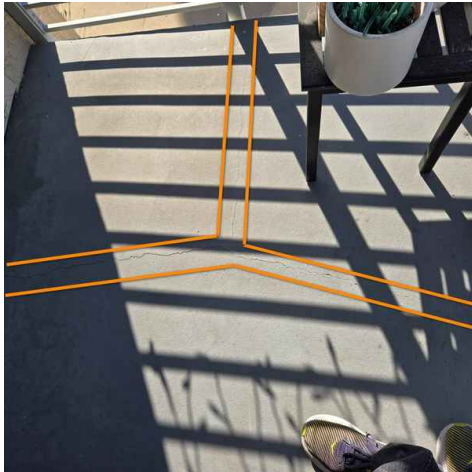
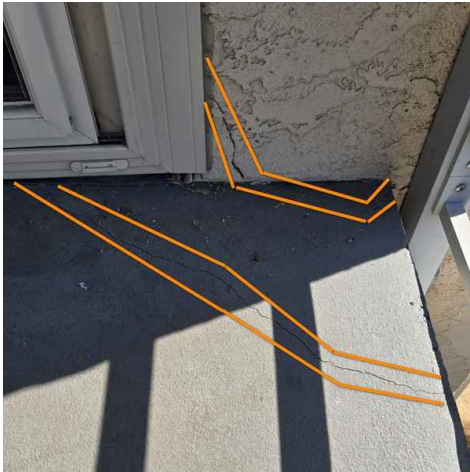
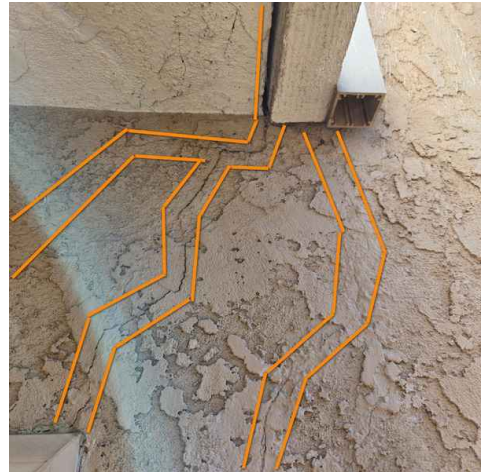
Underside of SE corner of Balcony 4

DAMAGED STUCCO & WALKING SURFACE

Marginal - Stucco and the walking surface are cracked, broken, dropping, separating, or crumbling. This is often the result of a failure in the structural support system. This type of failure can lead to significant structural damage and requires attention to prevent further deterioration or potential collapse. A Phase 2 Pre-326 Evaluation (P2PE) is recommended to determine the extent of any water damage via borescope inspection or larger investigative openings and to formulate a detailed repair plan. See Reference Information: Notification and Follow-Up - Marginal.

Recommendation

Contact a qualified professional.

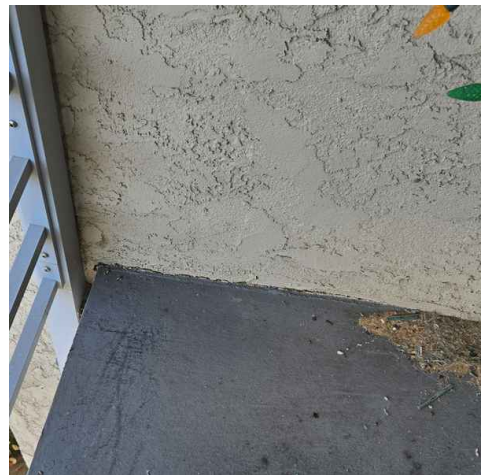
8.2.2 Balcony

OPENINGS IN WATERPROOFING

Minor - There are cracks, openings, or penetrations in the waterproofing. The affected areas should be sealed.

Recommendation

Contact a qualified professional.

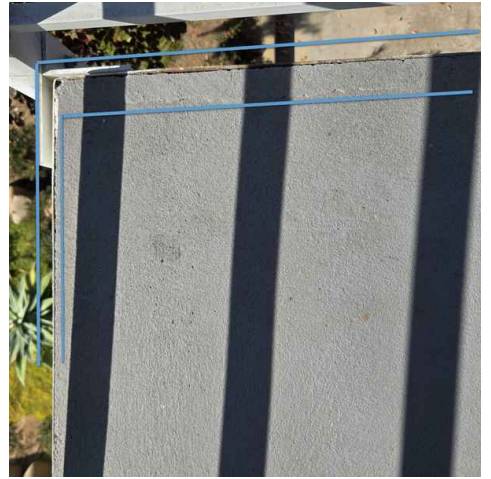
8.2.3 Balcony

CORROSION

Minor - There is an opening in the surface corrosion. The affected area(s) should be repaired.

Openings in the waterproofing at the edge metal allowed water intrusion leading to minor corrosion, expansion, and separation between the concrete deck and the edge metal.

Recommendation

Contact a qualified professional.

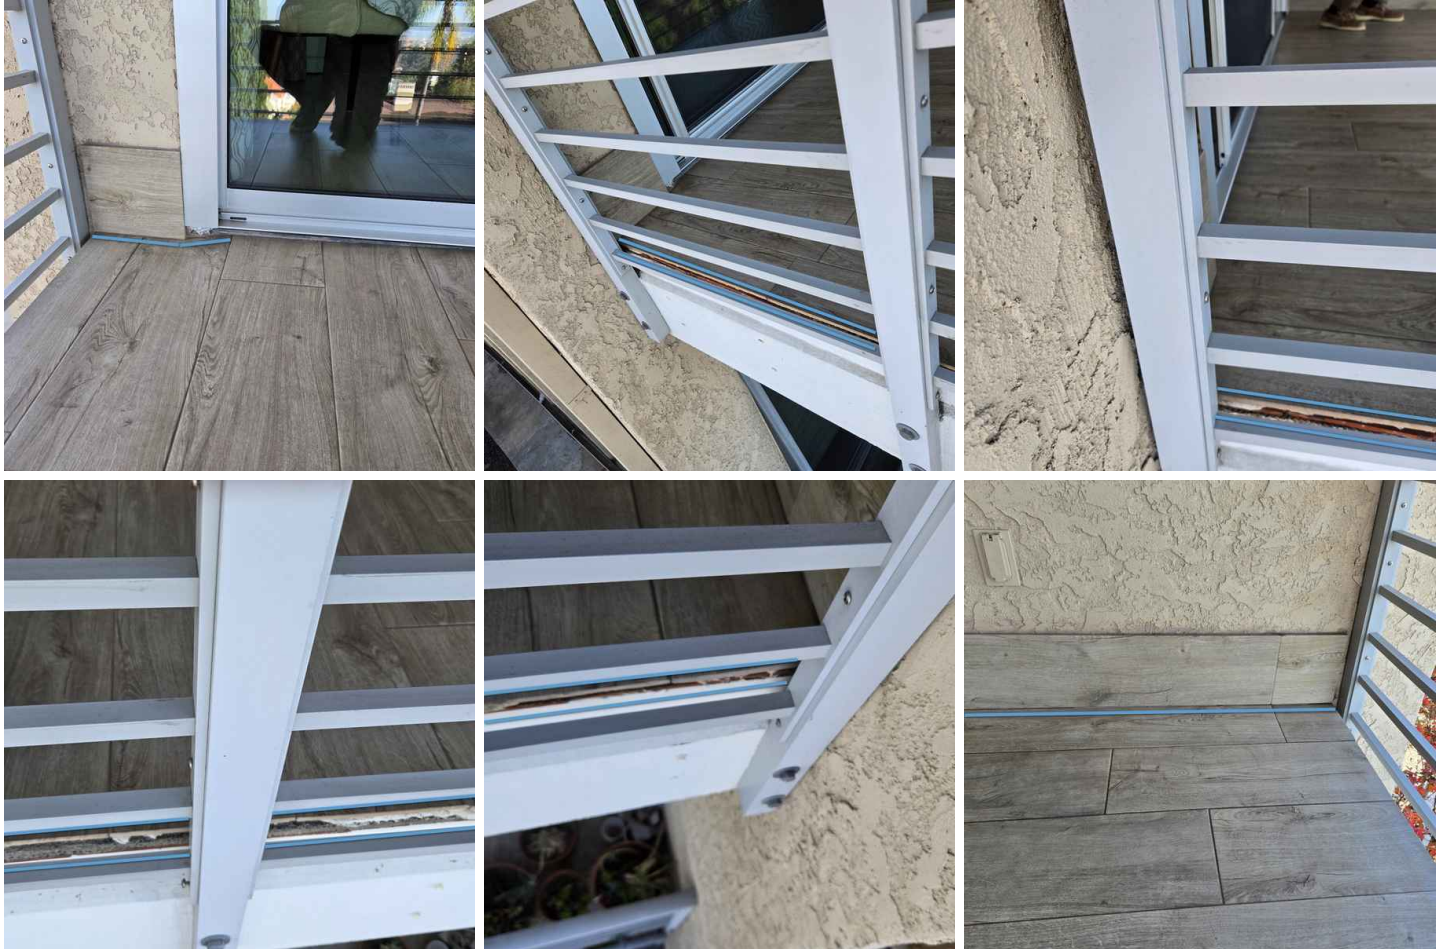
9.2.1 Balcony

OPENINGS IN WATERPROOFING

Minor - There are cracks, openings, or penetrations in the waterproofing. The affected areas should be sealed.

Note: Tile edge is not properly finished or sealed.

Recommendation

Contact a qualified professional.

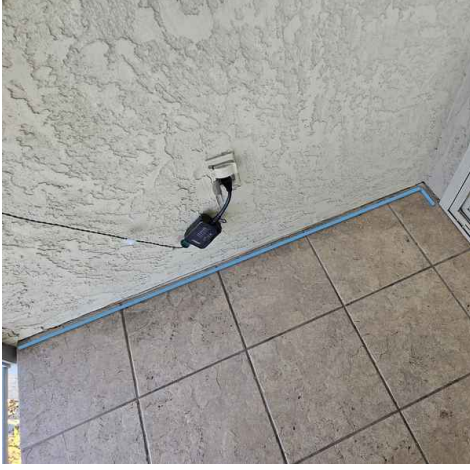
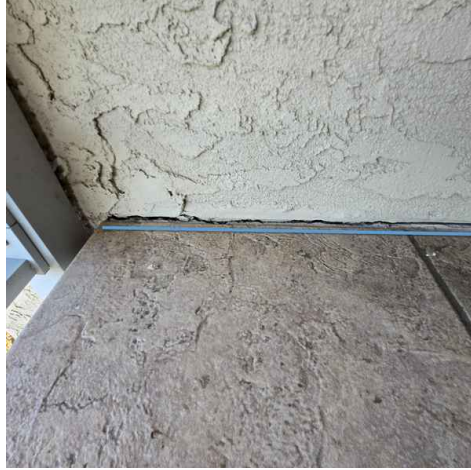
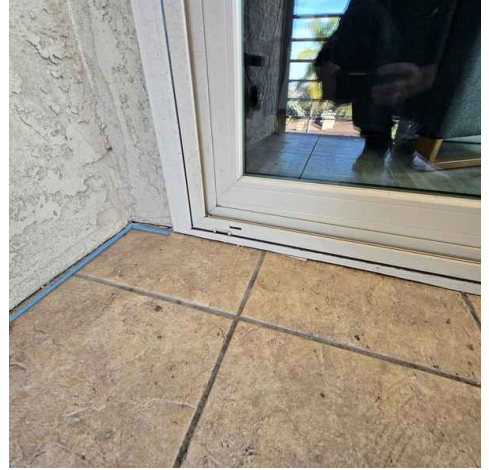
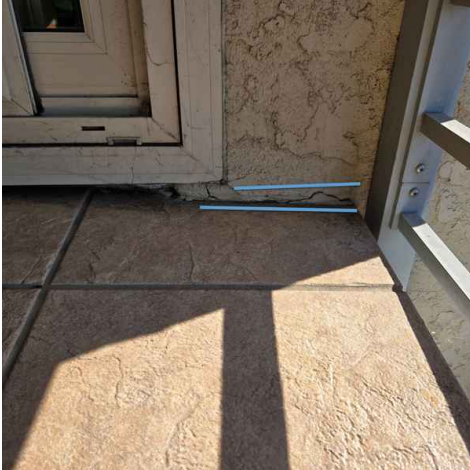
10.2.1 Balcony

OPENINGS IN WATERPROOFING

Minor - There are cracks, openings, or penetrations in the waterproofing. The affected areas should be sealed.

Recommendation

Contact a qualified professional.

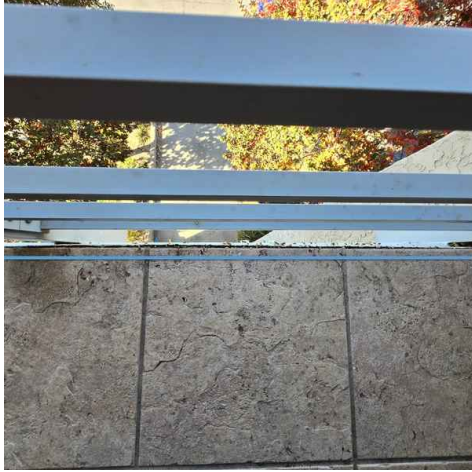
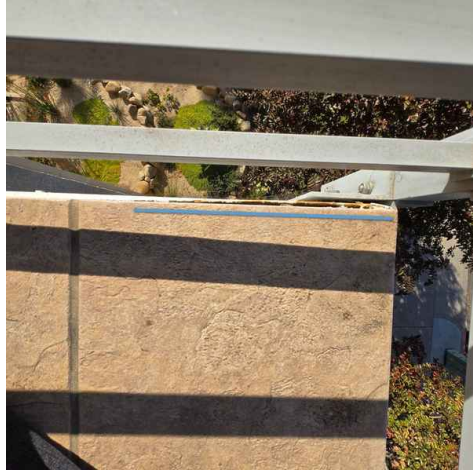
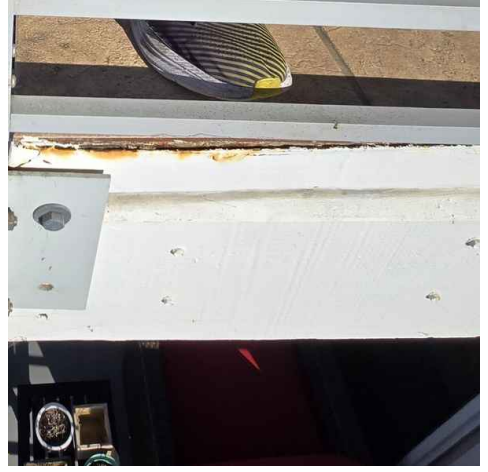
10.2.2 Balcony

CORROSION

Minor - There is surface corrosion. The affected area(s) should be repaired.

Note: Openings in the waterproofing at the edge metal allowed water intrusion leading to minor corrosion, expansion, and separation between the concrete deck and the edge metal.

Recommendation

Contact a qualified professional.
