PATRICK'S PROPERTY MAINTENANCE SERVICE

PHASE 1 PRE-721 EVALUATION (P1PE)

1234 Main Street
Imperial Beach, CA 91932-1412

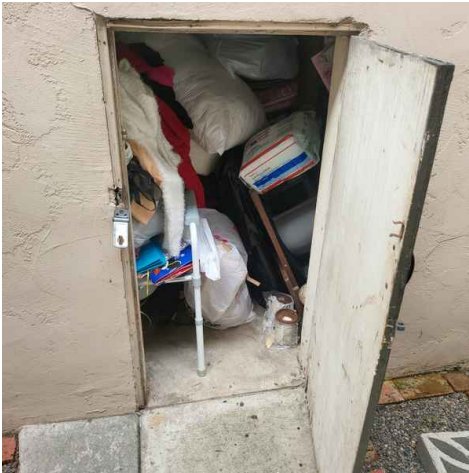
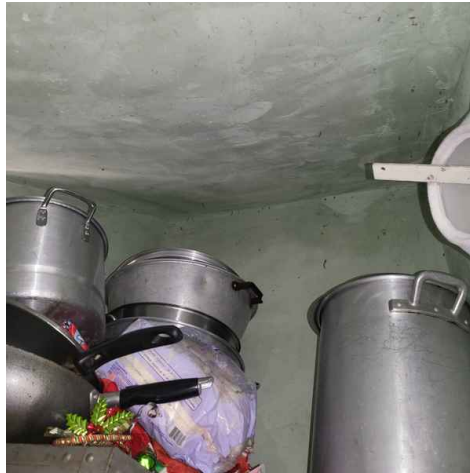
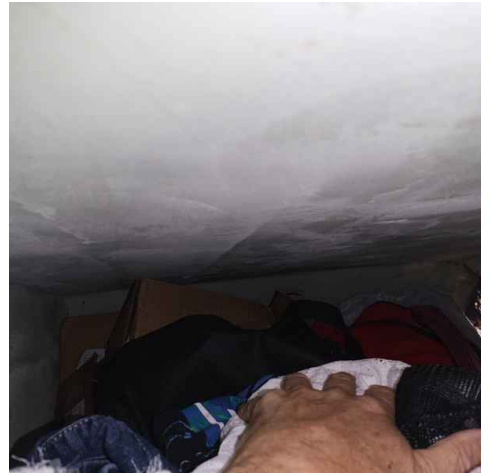
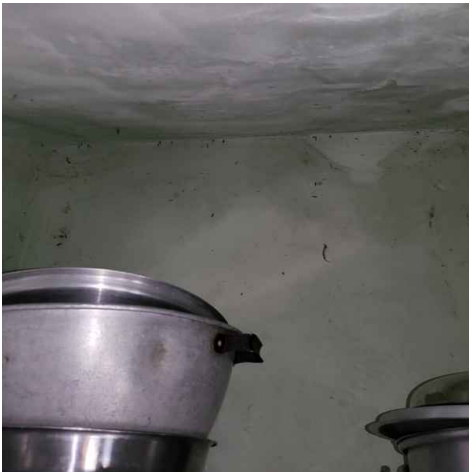
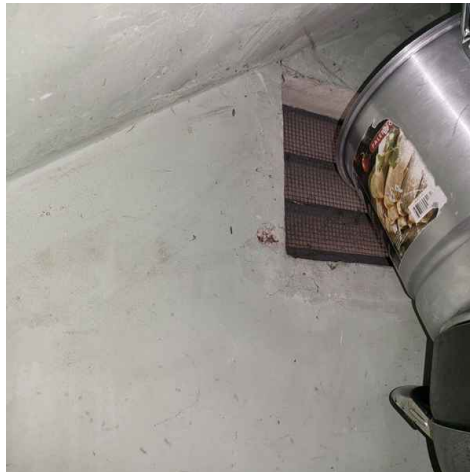
OBSTRUCTED VIEW

To perform a thorough P1PE it is necessary to visually inspect the inside of the stairwell. The stairwell is being used for personal storage. This storage area must be emptied to complete a visual inspection.

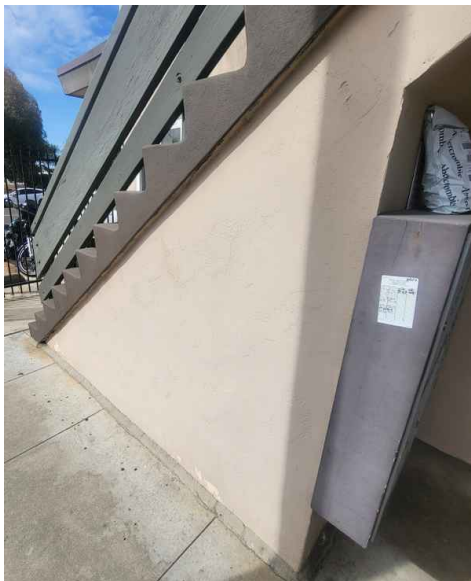
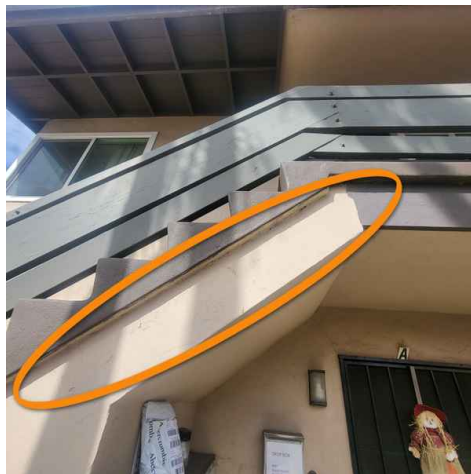
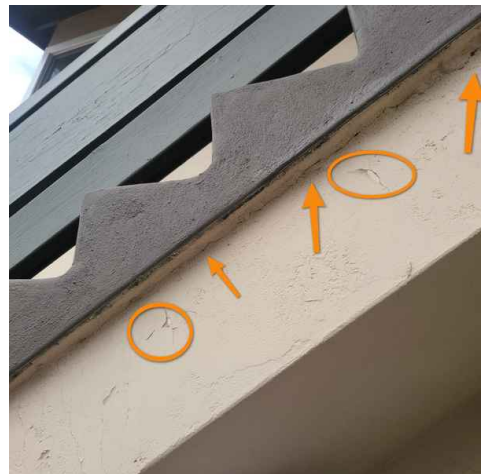
CRACKED STUCCO

Non-Emergency Repairs Required

There is a crack along the transition where the stucco meets the underside of the concrete stairs. The paint is peeling off the stucco under this crack. These areas should be resealed to prevent further water intrusion. Water intrusion can lead to internal deterioration of materials and possible compromise of structural integrity over time. A Phase 2 Pre-721 Evaluation (P2PE) is recommended to determine the extent of any water damage via borescope inspection, and to formulate a detailed repair plan.

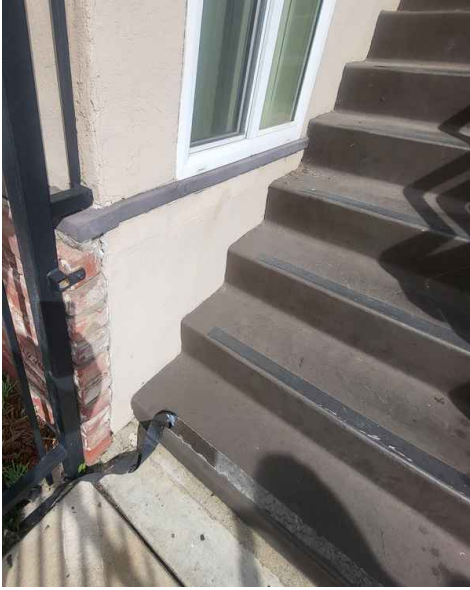
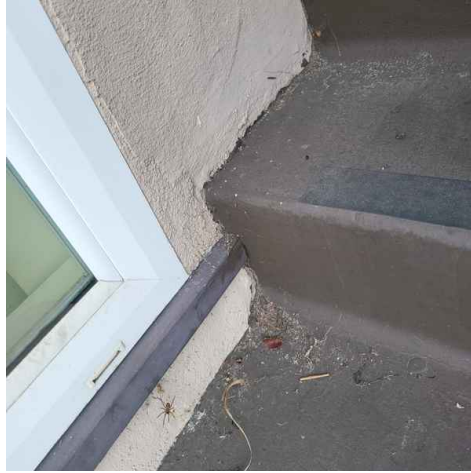
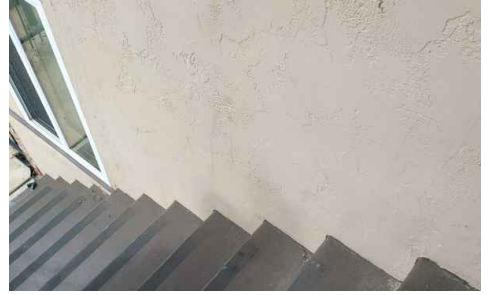
5.2.2 Stairway 1

CRACKS IN WATERPROOFING

There are openings in the waterproofing along the transition where the stairway meets the stucco. Application of sealant is recommended.

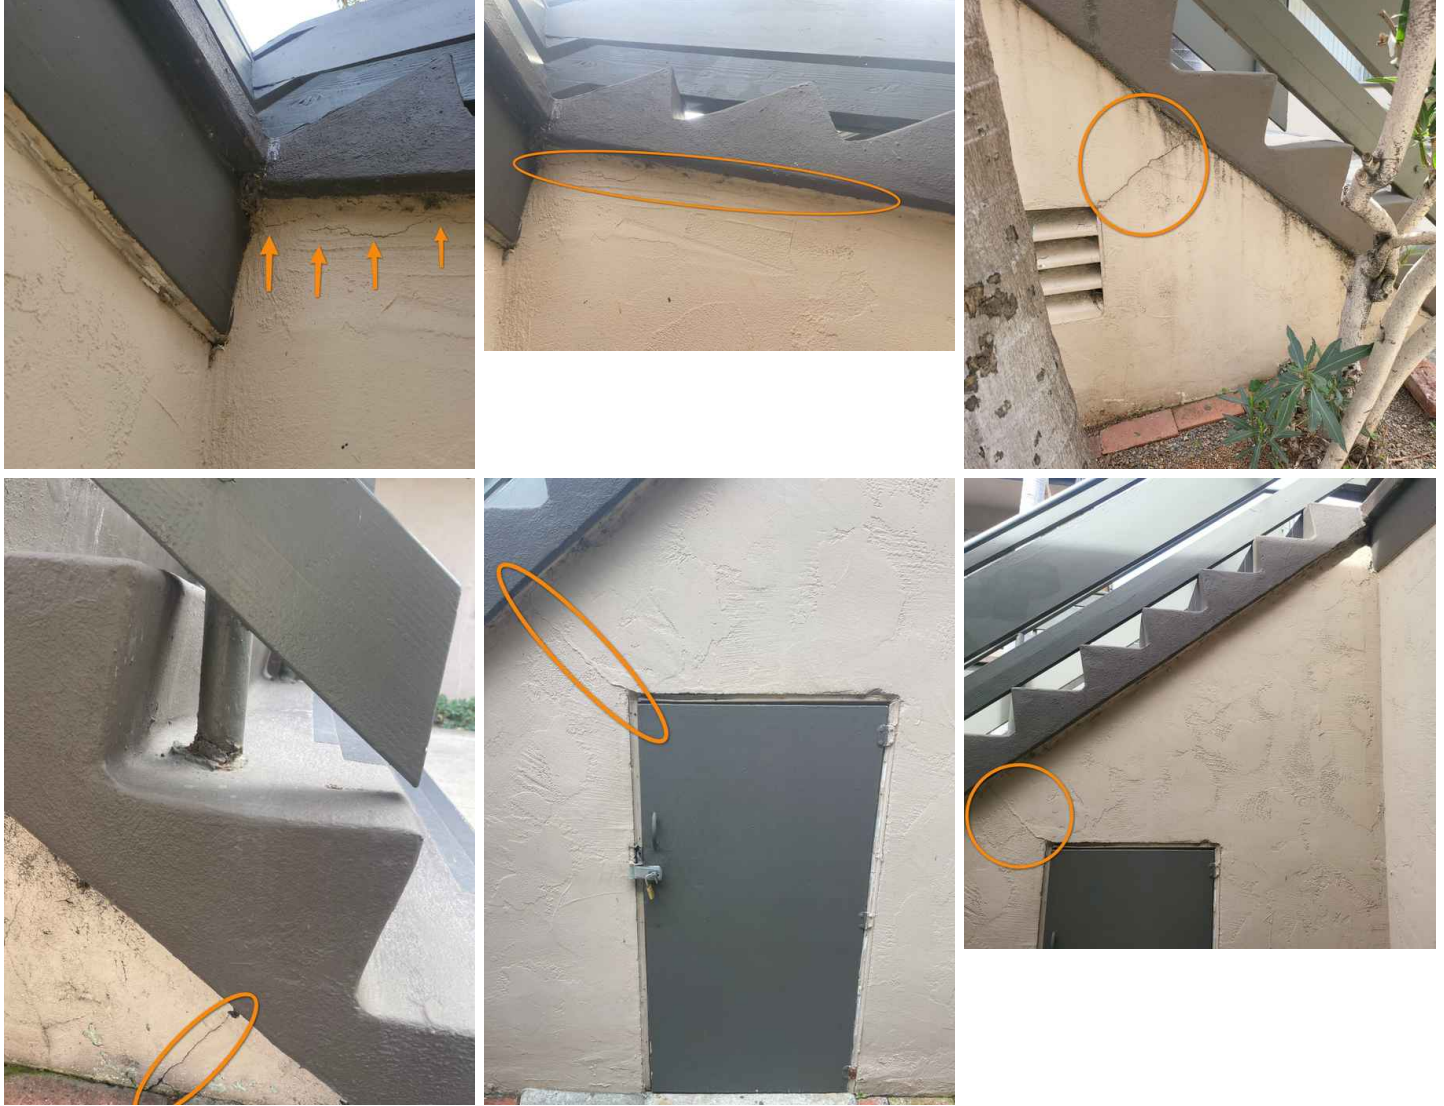
5.3.1 Stairway 2

Non-Emergency Repairs Required

CRACK(S) IN THE STUCCO

There are cracks in the stucco under the concrete stairway on both sides. This condition raises concerns regarding the potential for water intrusion and the long-term integrity of the underlying support structure. Such water intrusion can lead to internal deterioration of materials and possible compromise of structural integrity over time. A Phase 2 Pre-721 Evaluation (P2PE) is recommended to determine the extent of any water damage via borescoping, and to formulate a detailed repair plan.

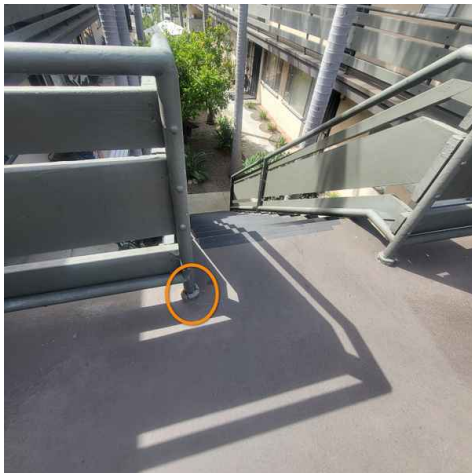
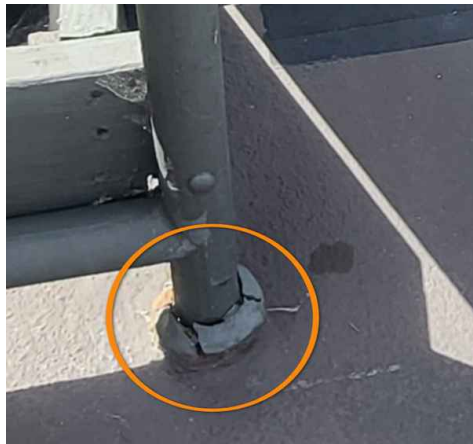
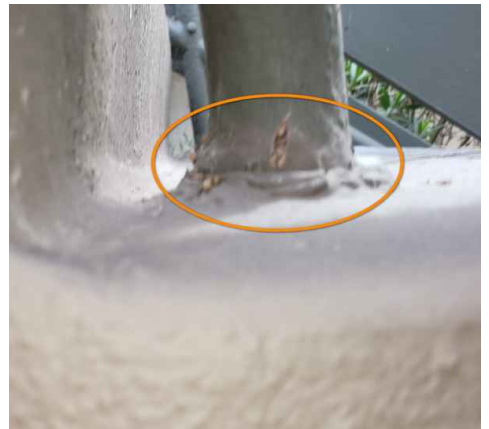
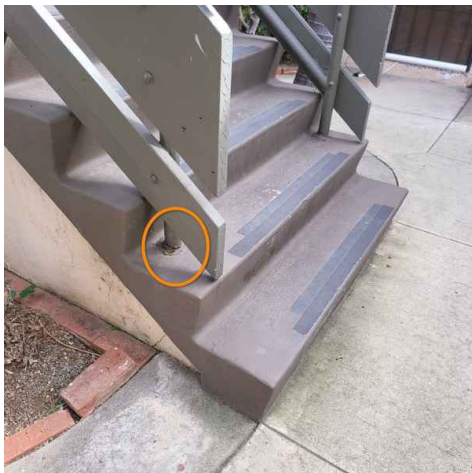
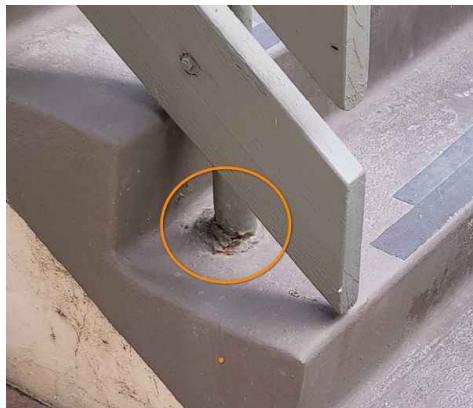
5.3.2 Stairway 2

Non-Emergency Repairs Required

HANDRAIL CORROSION

The base of the handrail is corroded and cracked allowing water intrusion. Corrosion should be removed, repaired, and resealed.

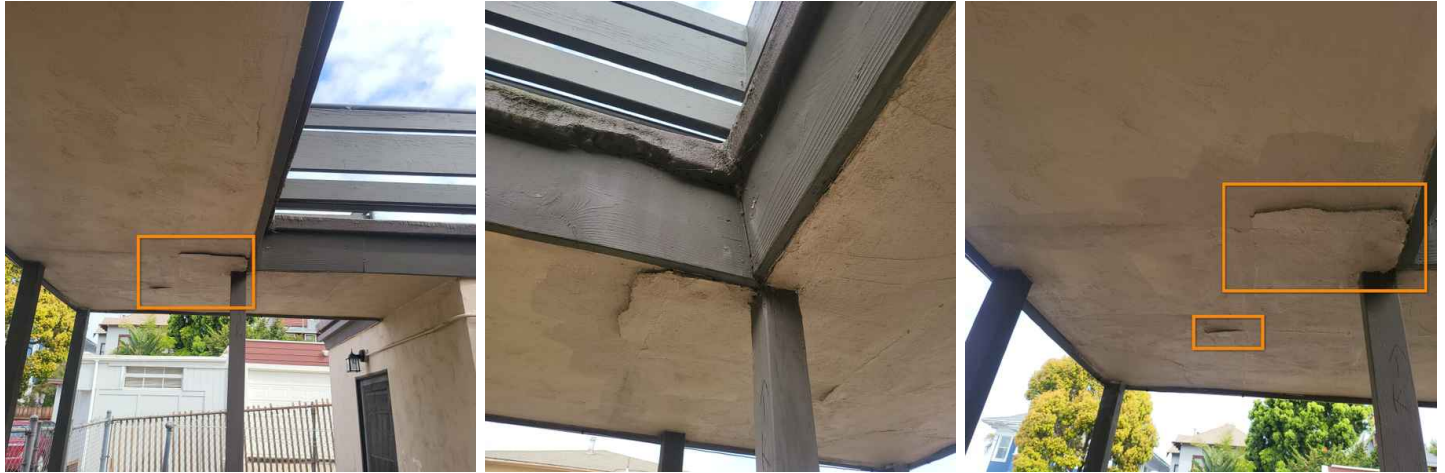
5.4.1 Walkway

Inspector Note: The defects of primary concern are as follows: defect 5.4.1 and 5.4.7.

Non-Emergency Repairs Required

DAMAGED STUCCO

There is evidence of heavy water flow off the deck for a prolonged period at this location. Algae is growing on the edge of the concrete deck. Sections of stucco are hanging from the soffit at the north end of the elevated walkway. This condition raises concerns regarding advanced deterioration in the underlying support structure. A Phase 2 Pre-721 Evaluation (P2PE) is recommended to determine the extent of any water damage via borescope investigation, and to formulate a detailed repair plan.

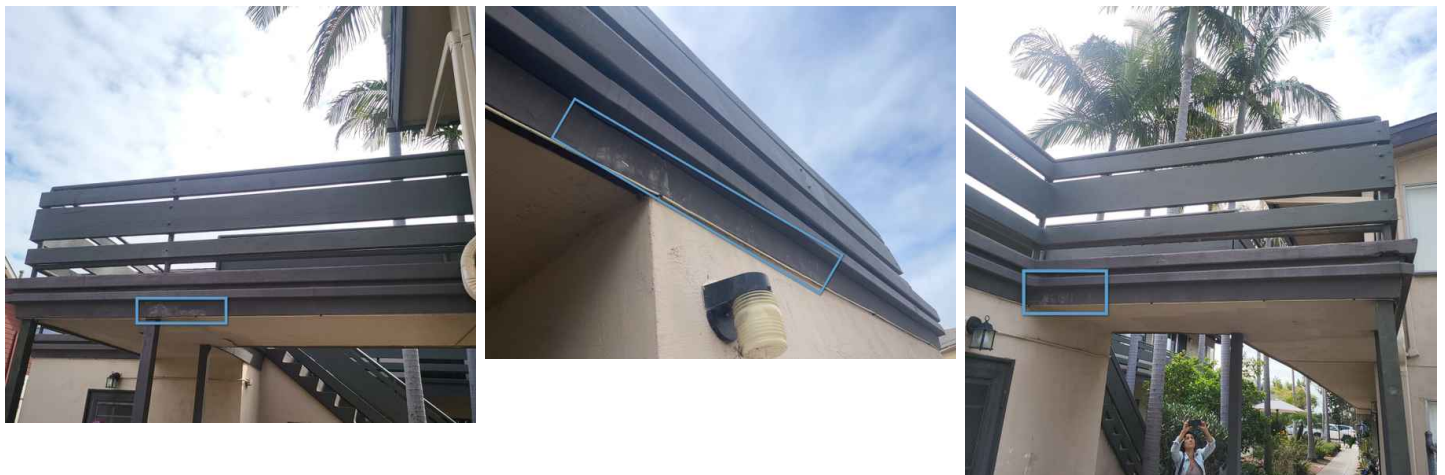
5.4.2 Walkway

FASCIA DISCOLORED

Discoloration of the fascia was observed, indicating potential water intrusion. This water intrusion can lead to internal deterioration of materials and possible compromise of structural integrity over time. Resealing of the fascia is recommended.

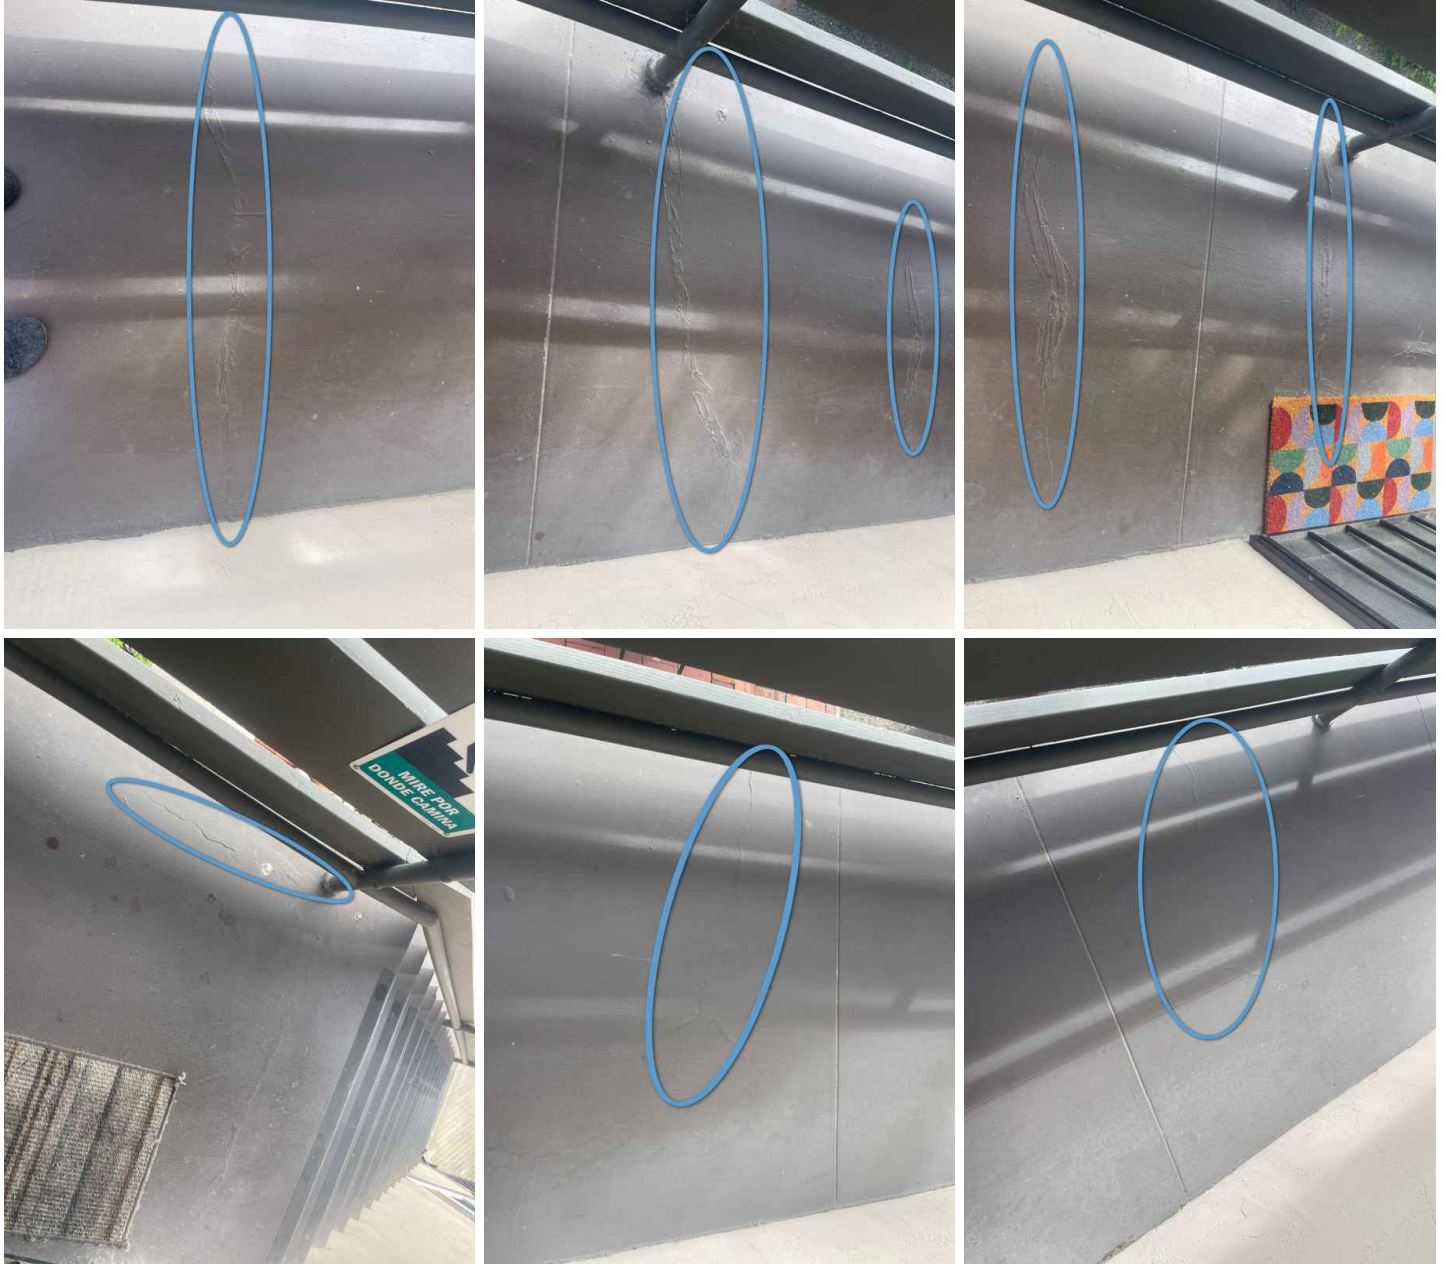
5.4.3 Walkway

WATERPROOFING

The concrete deck waterproofing shows signs of maintenance. Sealant applied to most of the cracks is in good condition. Continued maintenance of the deck waterproofing is recommended.

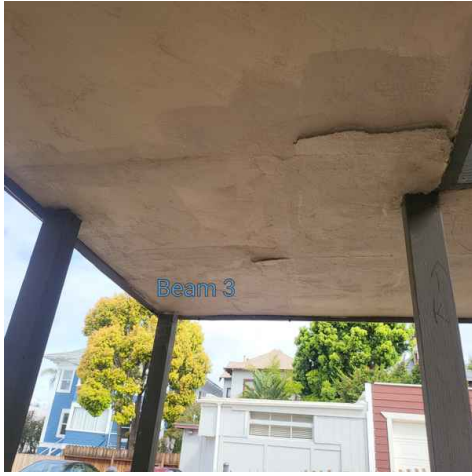
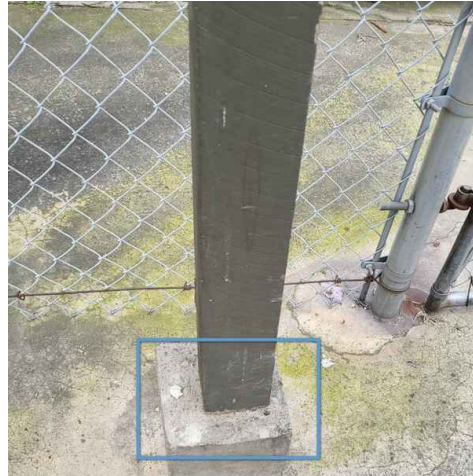
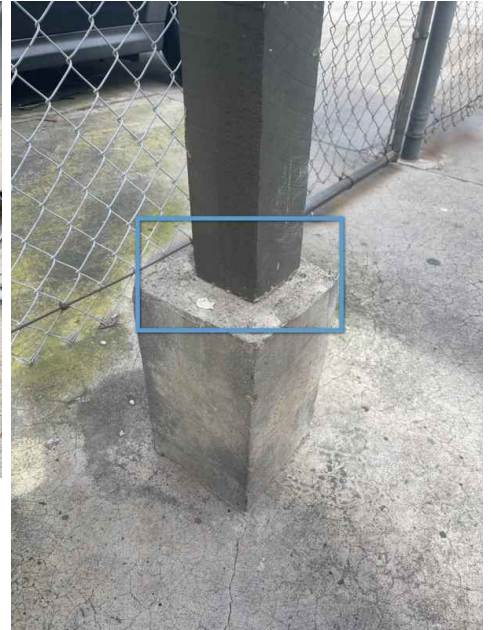
5.4.4 Walkway

MISSING STAND-OFF(S)

Support Beam 3 is missing a standoff. Standoffs are critical components that separate structural wood elements from concrete foundations or ground contact, preventing direct exposure to moisture. Installation of a standoff is recommended.

Missing Standoff

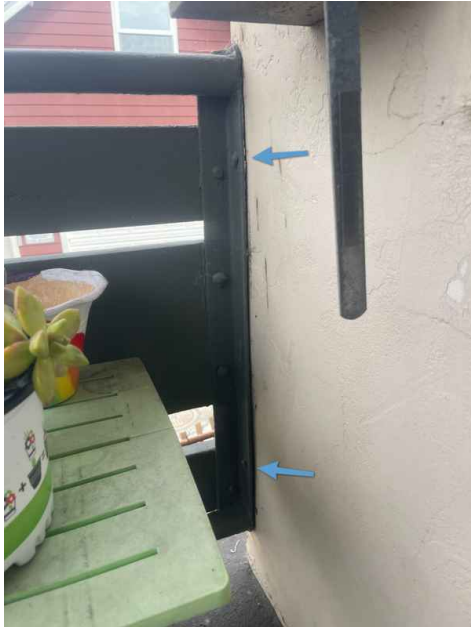
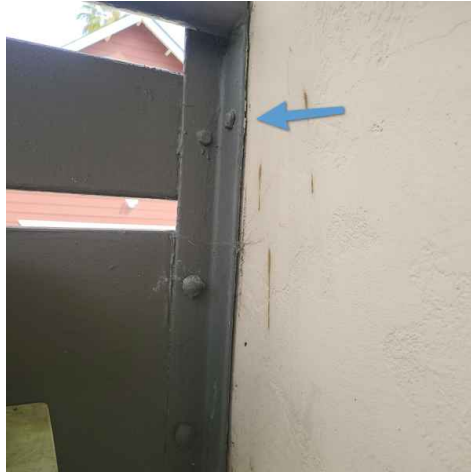
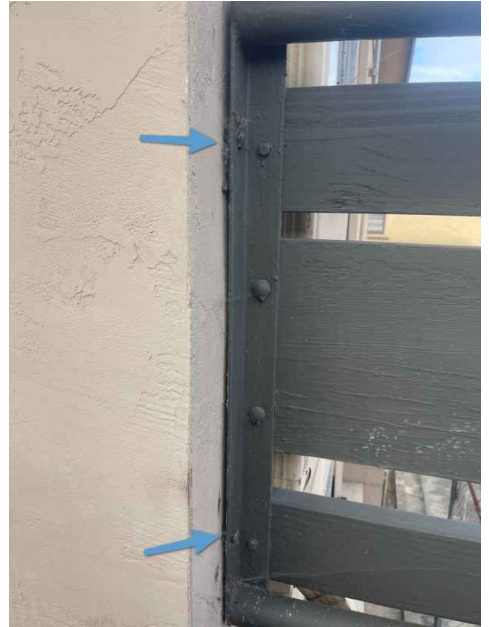
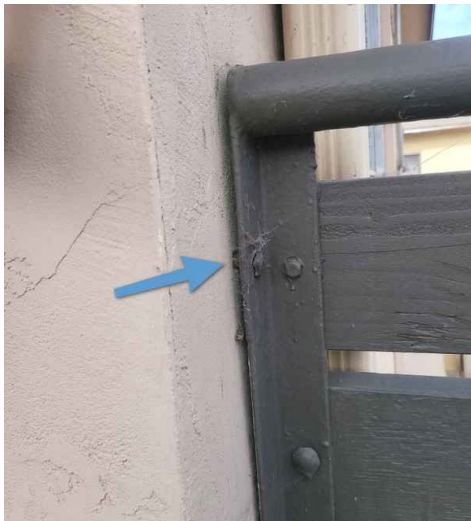
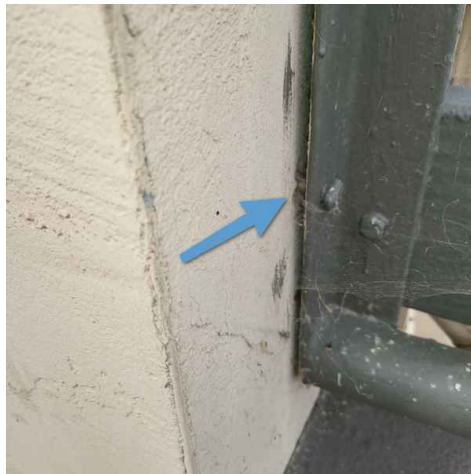
UNSEALED RAILING CONNECTION(S)

Unsealed connections between the railing and the wall were observed. The lack of proper sealing at these junctions raises concerns about potential water intrusion, which can lead to further deterioration of the railing's anchorage and the underlying support structure. This condition may compromise the long-term integrity and stability of the railing system. Sealing these connections with a weather-resistant sealant to prevent water intrusion is recommended.

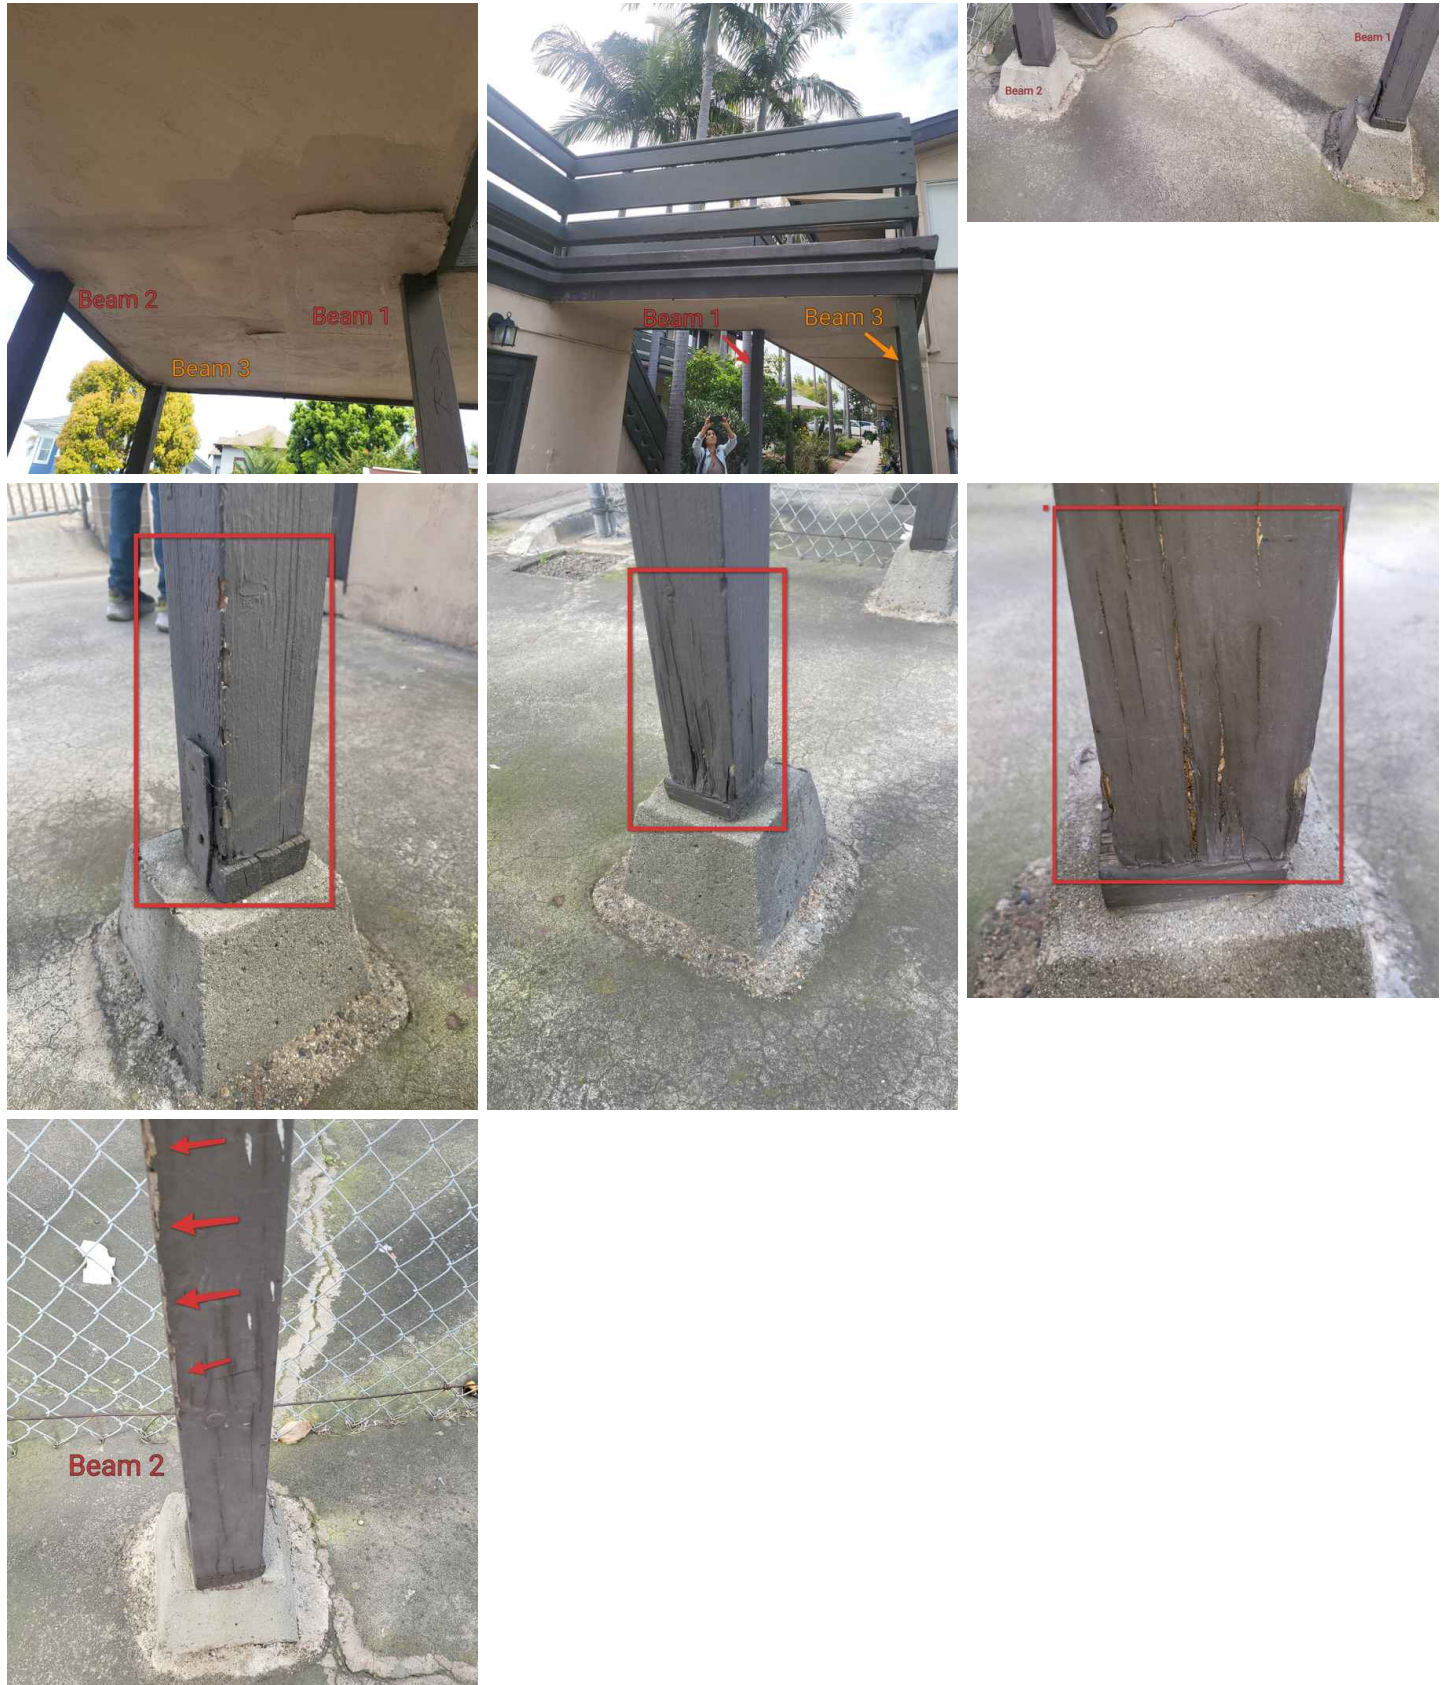
5.4.7 Walkway

Non-Emergency Repairs Required

TERMITES AND/OR DRY ROT DAMAGE TO SUPPORT BEAMS

Evidence of termites and/or dry rot in support beam 1 and 2 was observed. Termite activity is indicated by visible frass (termite droppings) and hollowed wood. The termite infestation poses a critical concern, as it compromises the load-bearing capacity of the support beam. Support beam 1 and 2 must be replaced prior to SB-721 Inspection.

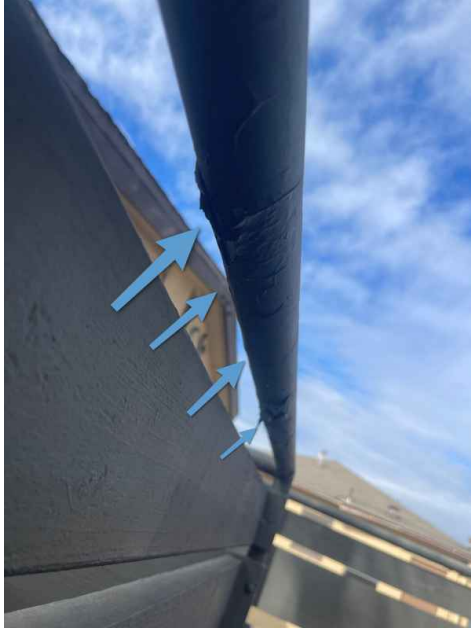
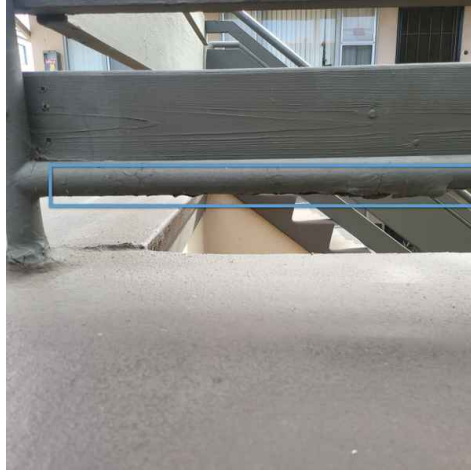
5.4.8 Walkway

GUARDRAIL CORROSION AND SEALANT DETERIORATION

Corrosion and peeling paint on the underside of the guardrail. Cleaning, followed by the application of a rust-inhibiting primer and resealing is recommended.

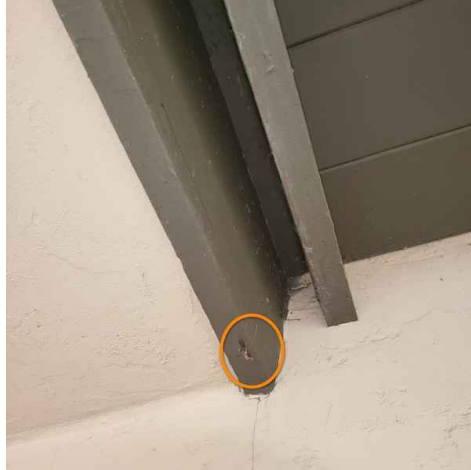
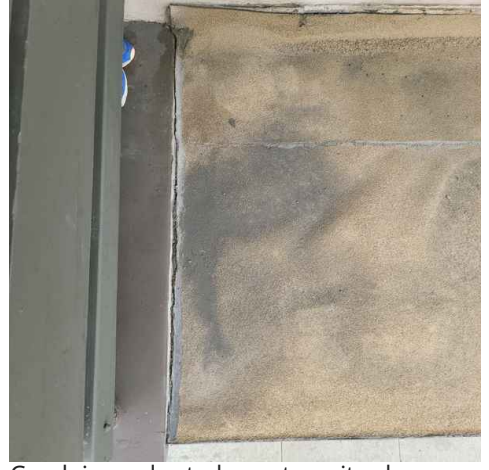
5.4.9 Walkway

Non-Emergency Repairs Required

TERMITE AND OR DRY ROT DAMAGE

Evidence of termites and/or dry rot in fascia was observed. This condition raises concerns regarding the long-term integrity of the underlying support structure. Termite activity is indicated by visible frass (termite droppings) and hollowed wood. The affected areas should be assessed by a licensed pest control professional to determine the full extent of the termite infestation and to administer a suitable termite treatment plan. A Phase 2 Pre-721 Evaluation (P2PE) is recommended to determine the extent of any termite damage via borescoping, and to formulate a detailed repair plan.

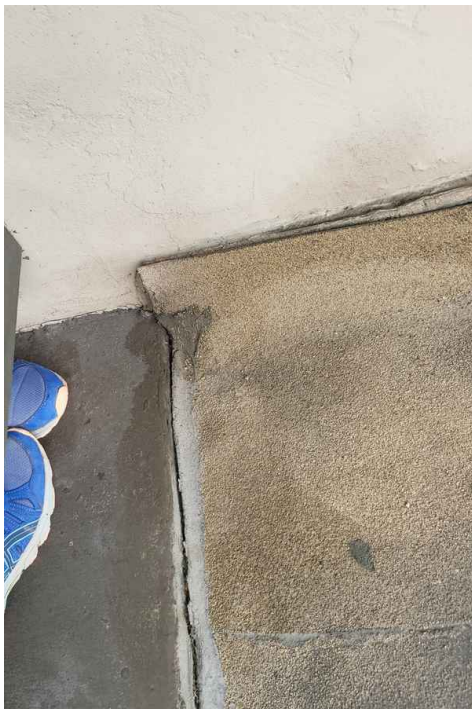
Crack in sealant above termite damage

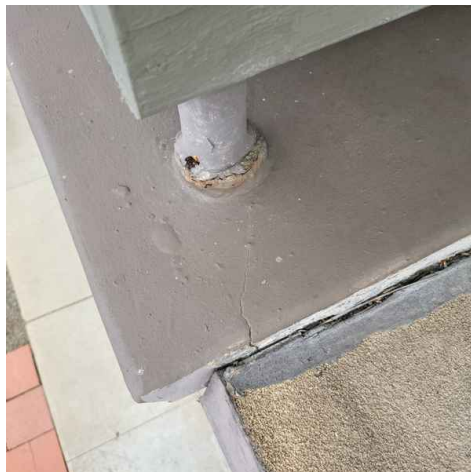
Crack in sealant above termite damage

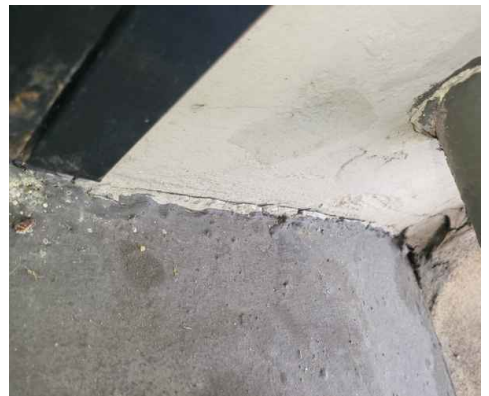
Crack in sealant above termite damage

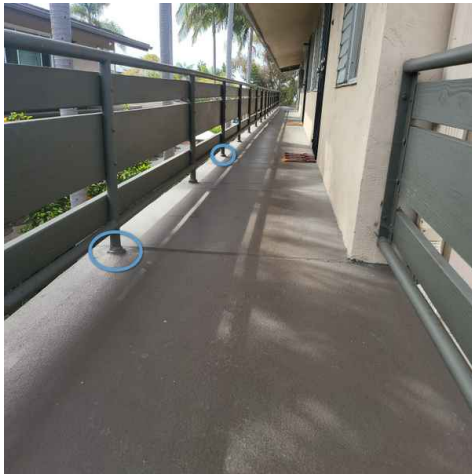
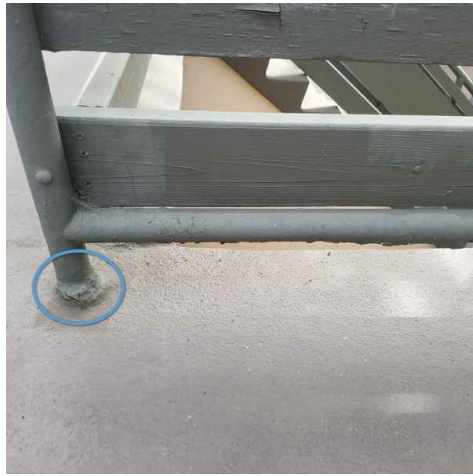
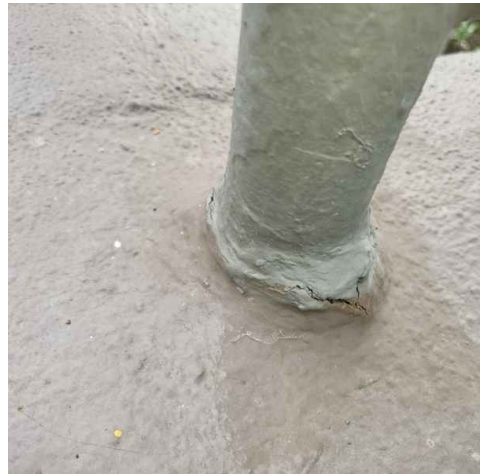
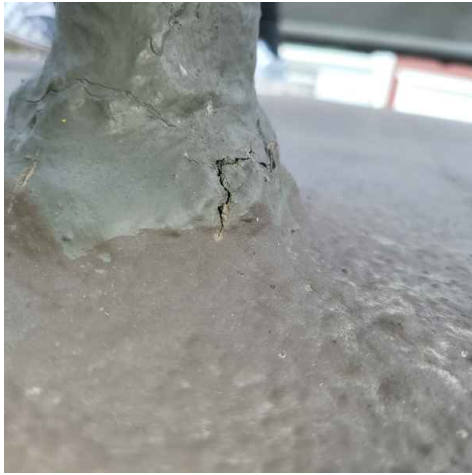
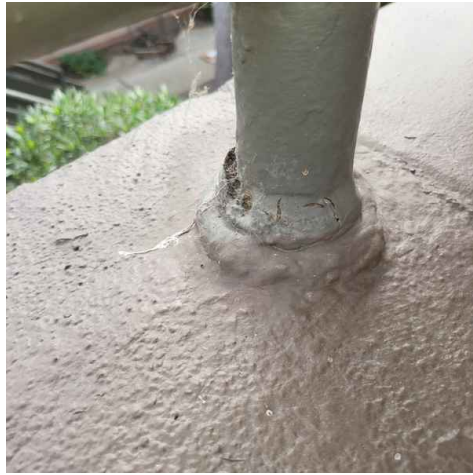
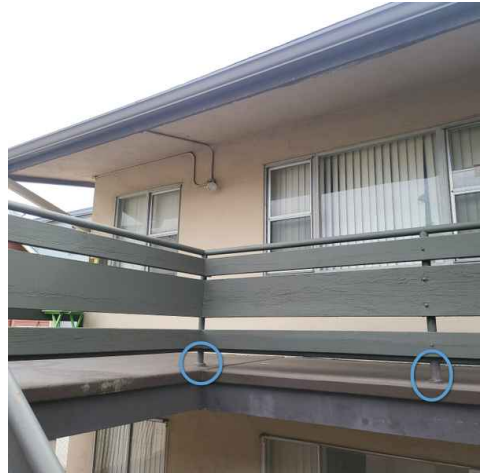
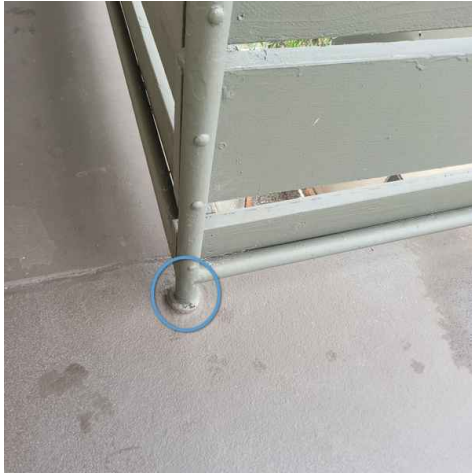
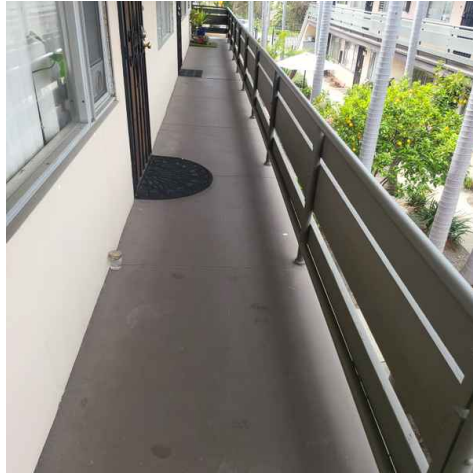
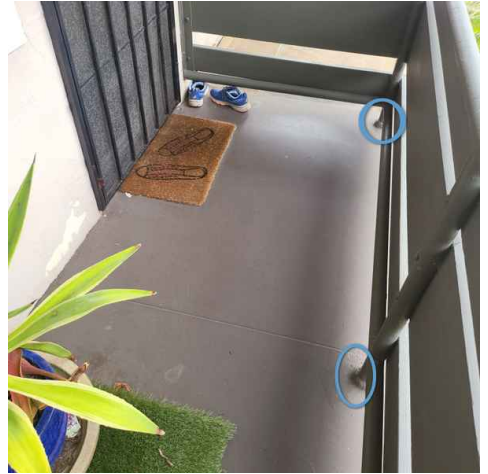
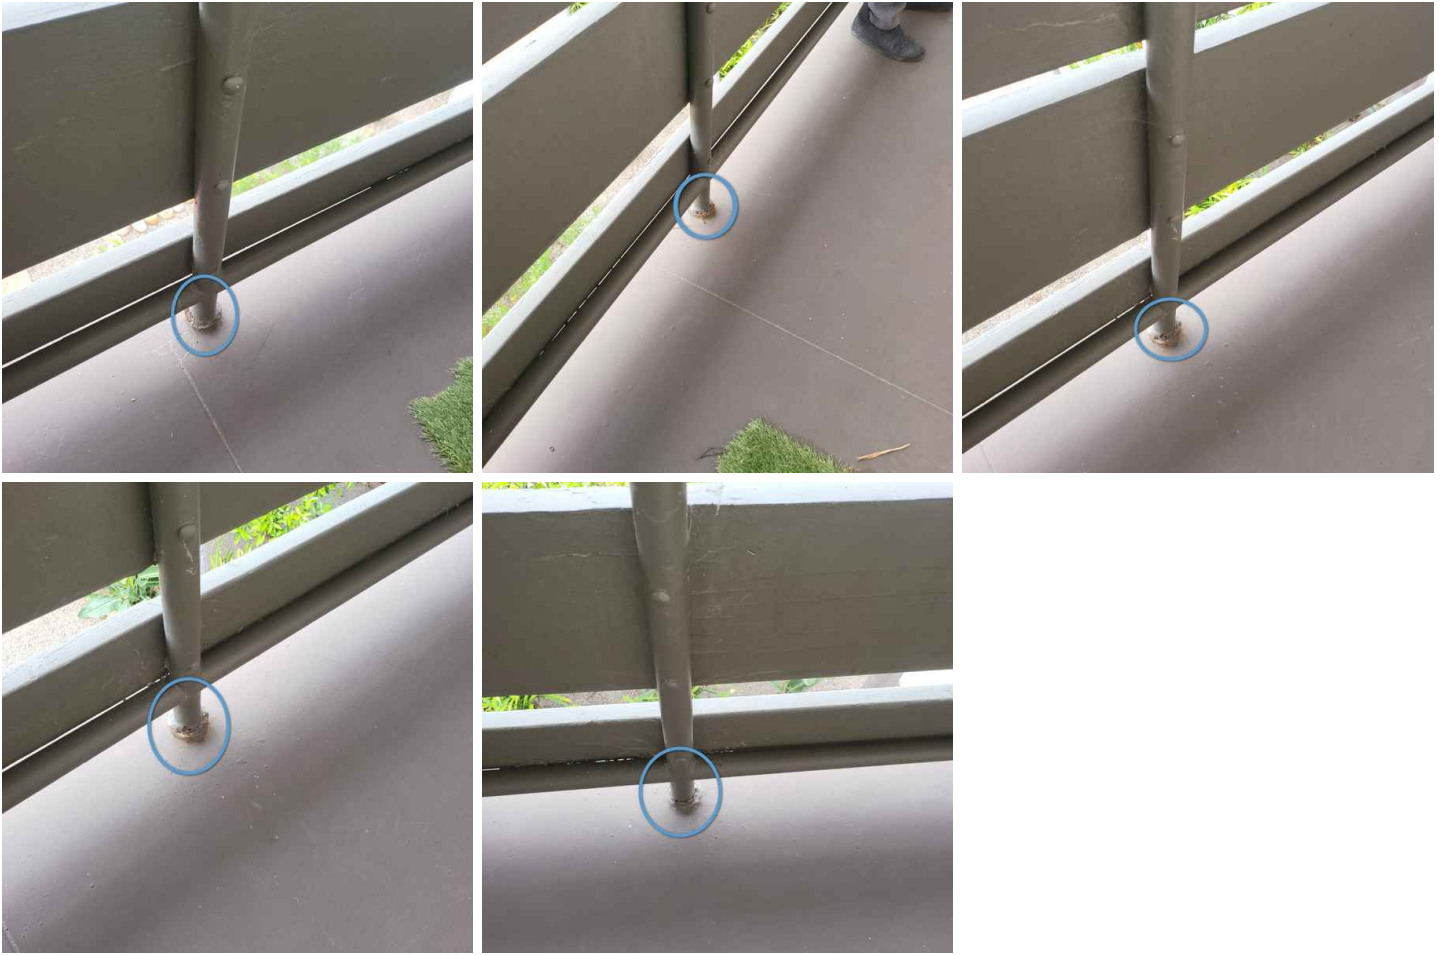
5.4.10 Walkway

HANDRAIL CORROSION

The base of the stairway handrail is corroded and cracked allowing water intrusion. Some of the handrail connections that need attention are highlighted in the photos below. In general, all handrail connections should be examined, corrosion removed, repaired, and resealed.

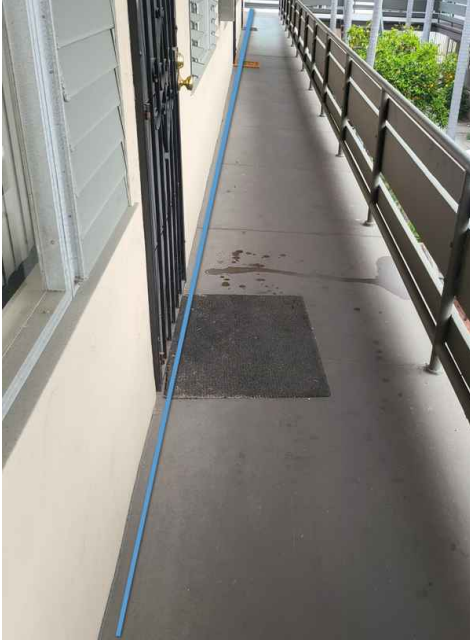
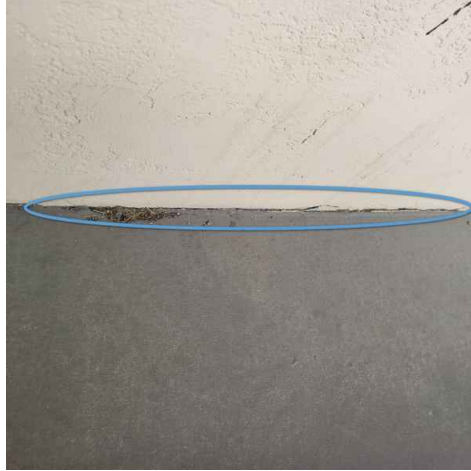
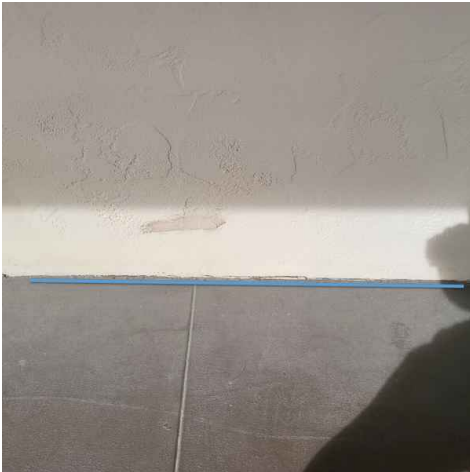
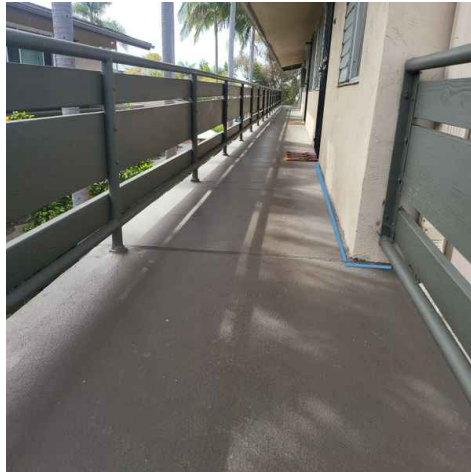
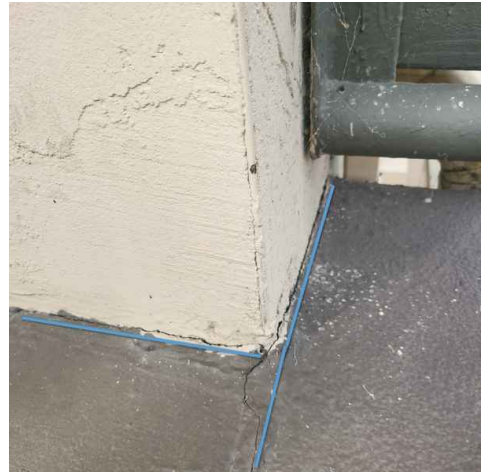
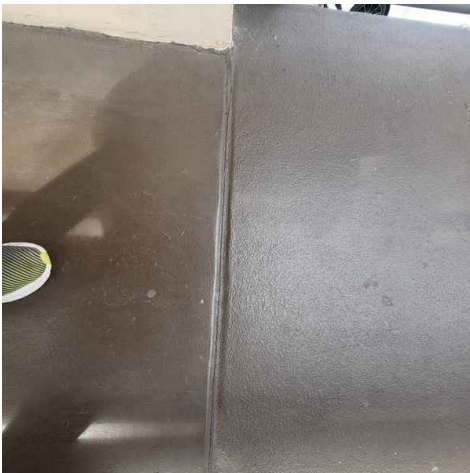
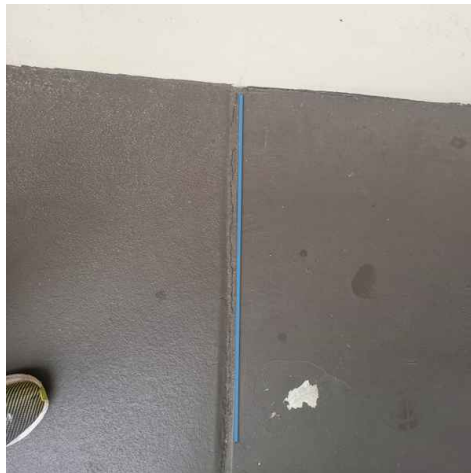
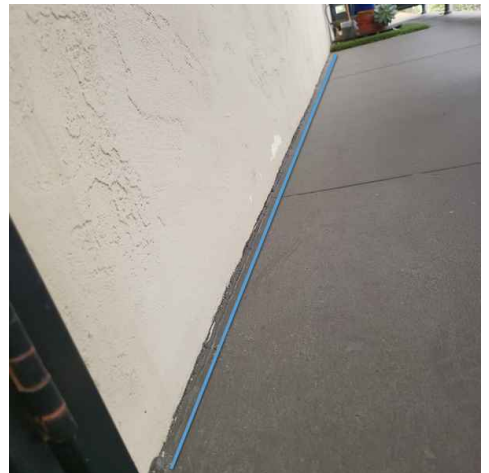
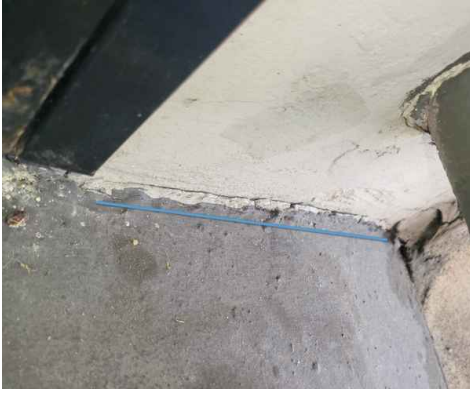
5.4.11 Walkway

CRACKS IN WATERPROOFING

There are cracks in the waterproofing along the transition where the walkway meets the stucco and at other transitions and joints. Application of sealant is recommended.

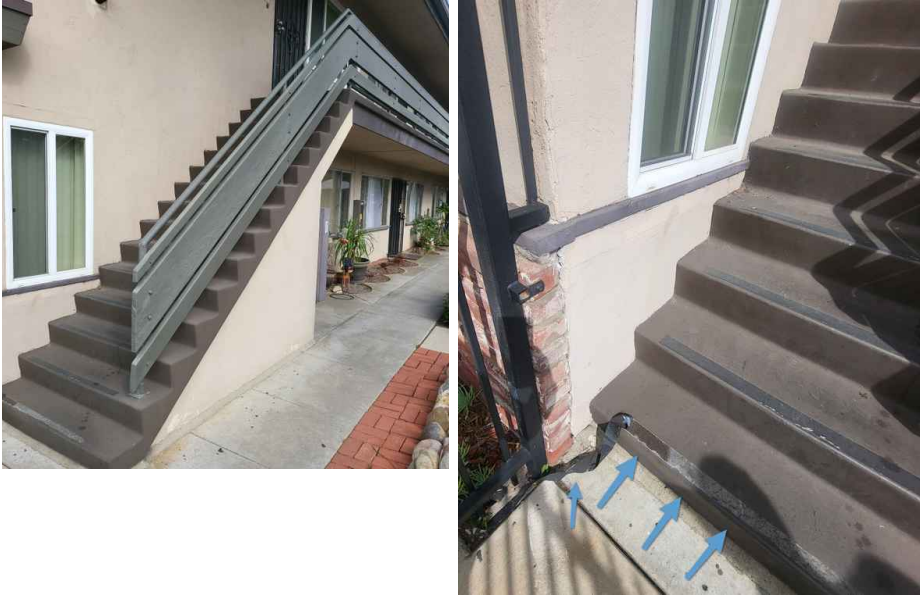
Non-slip Tape on Bottom Stair of Stairway 1

The non-slip tap on the first stair tread has come loose. This old tape should be removed and new tape applied.
