PATRICK'S PROPERTY MAINTENANCE SERVICE

PHASE 1 PRE-SB721 EVALUATION

1234 Main Street
Imperial Beach, CA 91932-1412

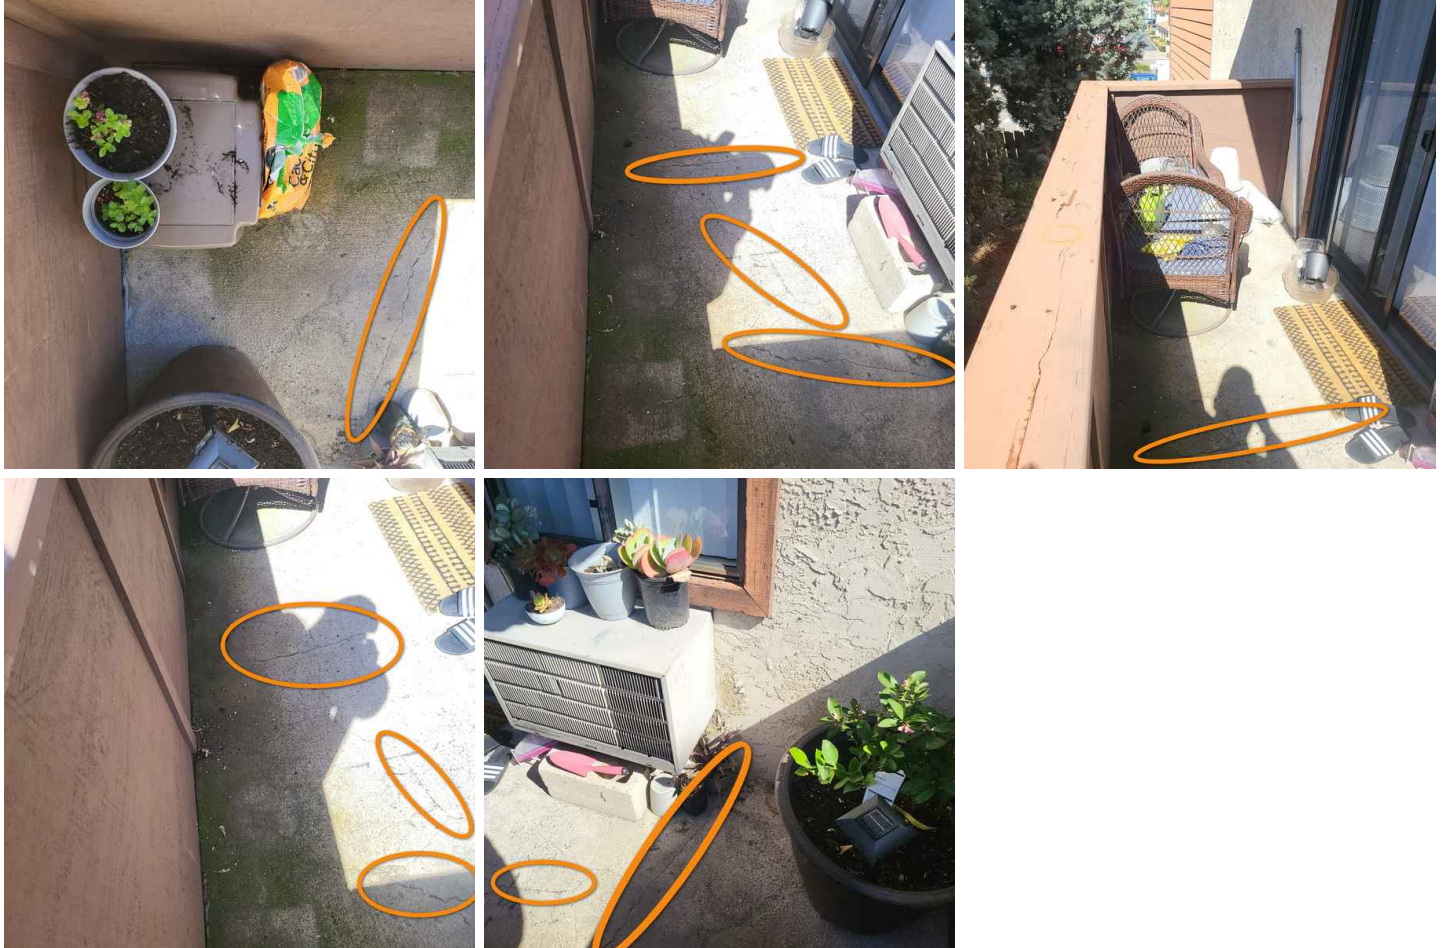
There are cracks in several locations on the deck surface. These cracks may indicate potentially severe water intrusion. Water intrusion can lead to internal deterioration of materials and possible compromise of structural integrity over time. A Phase 2 Pre-721 Evaluation (P2PE) is recommended to determine the extent of any water damage via borescope inspection or larger investigative openings, and to formulate a detailed repair plan.

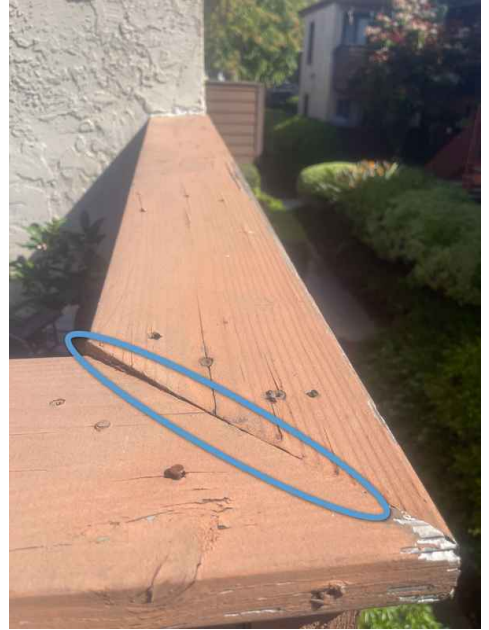
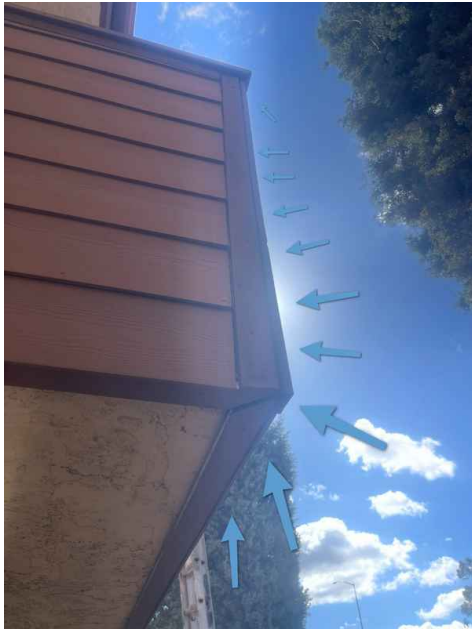
10.2.2 Balcony

There are cracks in the wooden railing. These cracks should be sealed with a waterproof sealant to prevent water and wood boring insect intrusion.

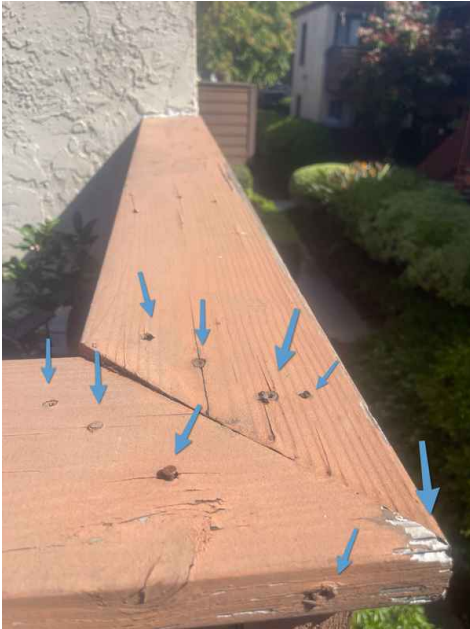
10.2.3 Balcony

There are unsealed penetrations in the wooden railing. These penetrations should be sealed with a waterproof sealant to prevent water and wood boring insect intrusion.

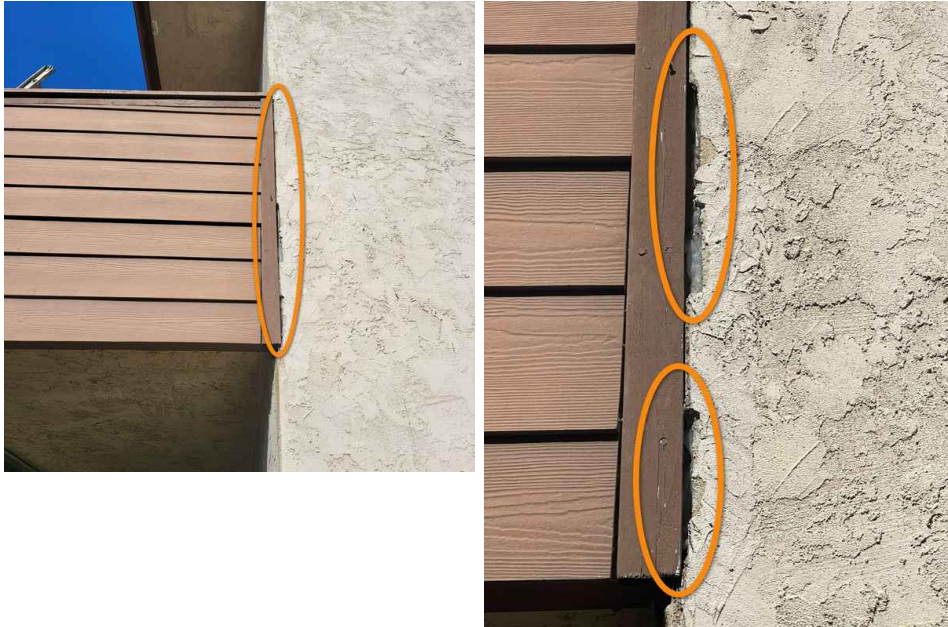
10.2.4 Balcony

There are openings at the connection between the railing and the supporting wall. These openings may indicate potentially severe water intrusion. Water intrusion can lead to internal deterioration of materials and possible compromise of structural integrity over time. A Phase 2 Pre-721 Evaluation (P2PE) is recommended to determine the extent of any water damage via borescope inspection or larger investigative openings, and to formulate a detailed repair plan.

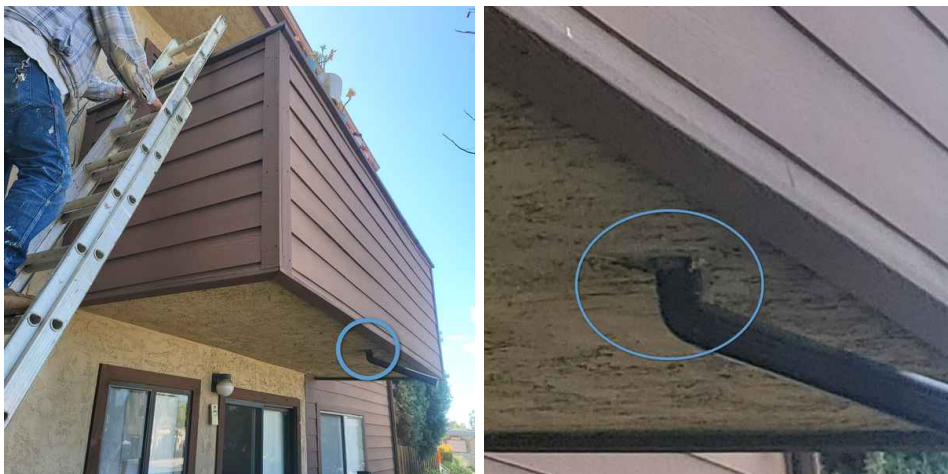
There is an unsealed drainage pipe on the underside of the balcony. This connection should be sealed with a waterproof sealant to prevent wood boring insect intrusion.

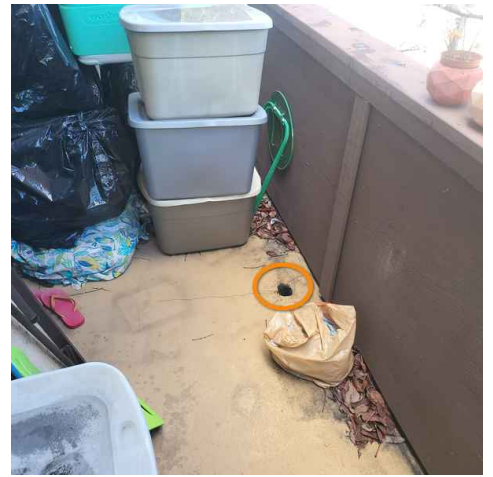
12.2.2 Balcony

The deck is missing a drain assembly. Without a drain assembly the water is free to flow into the soffit rather than down the drain pipe. This water intrusion will lead to internal deterioration of materials and possible compromise of structural integrity over time. A Phase 2 Pre-721 Evaluation (P2PE) is recommended to determine the extent of any water damage via borescope inspection or larger investigative openings, and to formulate a detailed repair plan.

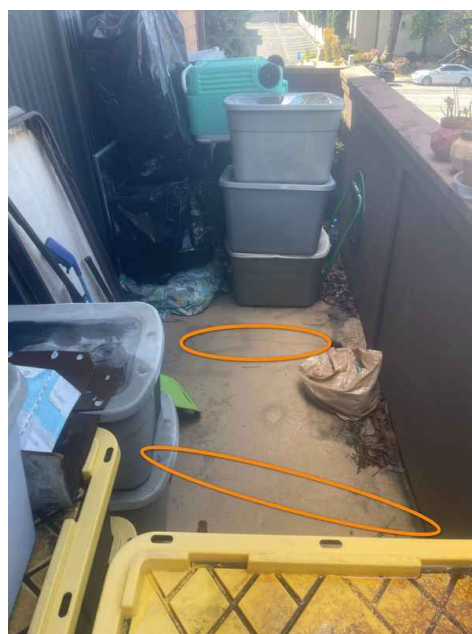
12.2.3 Balcony

There are cracks in the decking, including a crack that intersects the missing drain assembly. These cracks could indicate potentially severe water intrusion. Water intrusion can lead to internal deterioration of materials and possible compromise of structural integrity over time. A Phase 2 Pre-721 Evaluation (P2PE) is recommended to determine the extent of any water damage via borescope inspection or larger investigative openings, and to formulate a detailed repair plan.

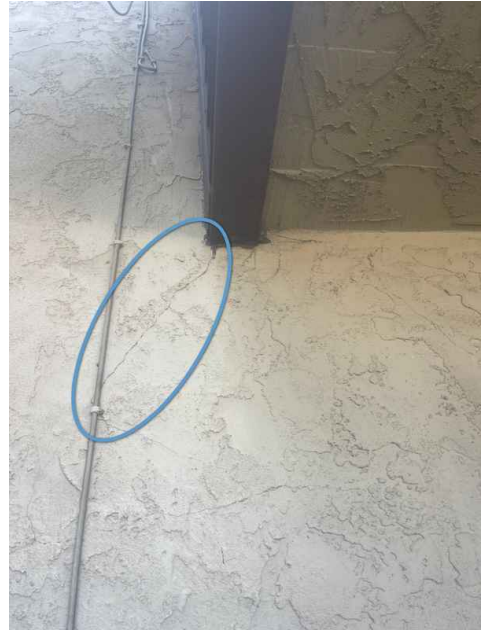
There is a crack in the supporting wall on the underside of the balcony. This crack should be sealed with a waterproof sealant to prevent water and wood boring insect intrusion.

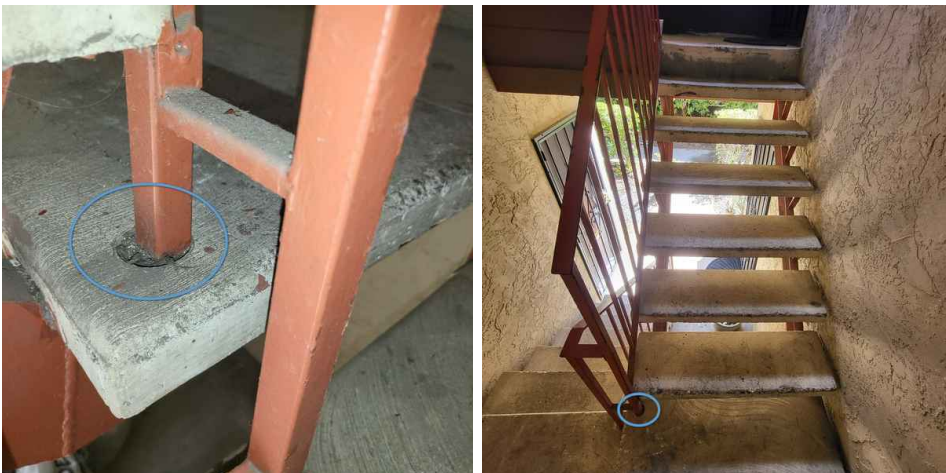
There is an unsealed attachment between railing and the second landing platform. This attachment should be sealed with a waterproof sealant.

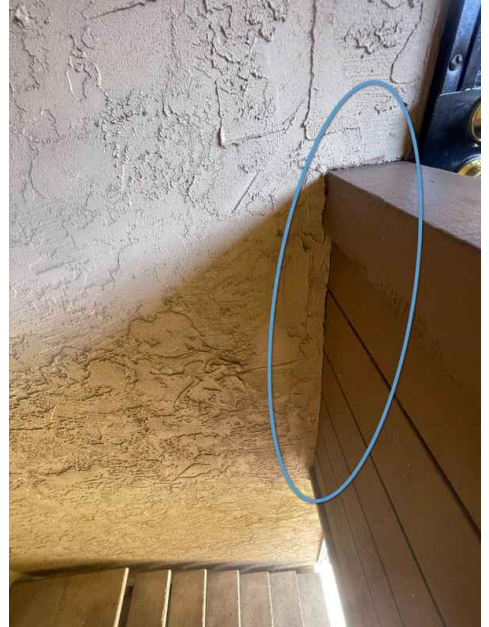
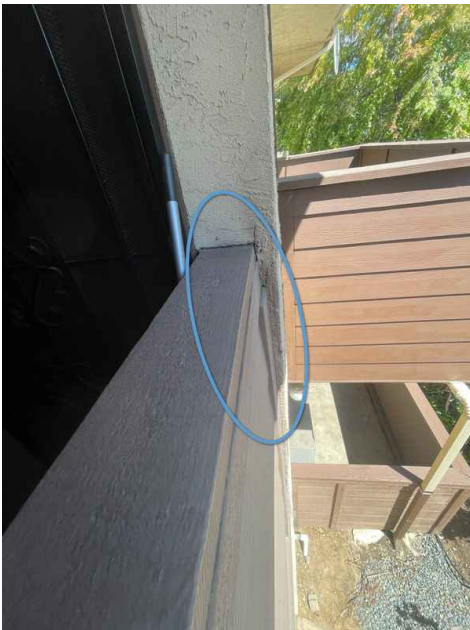
There are unsealed connections between the railing and the wall. These connections should be sealed with a waterproof sealant to prevent water and wood boring insect intrusion.

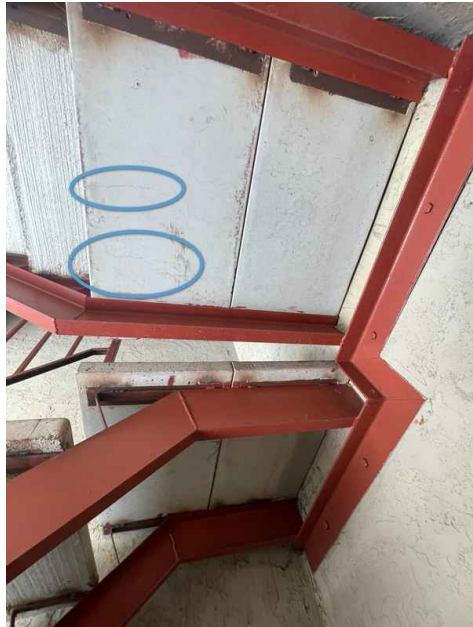
There is minor cracking in one or more slabs of the landing. At a minimum, the affected slabs should be replaced. If not replaced a reinspection is recommended in 2 years.

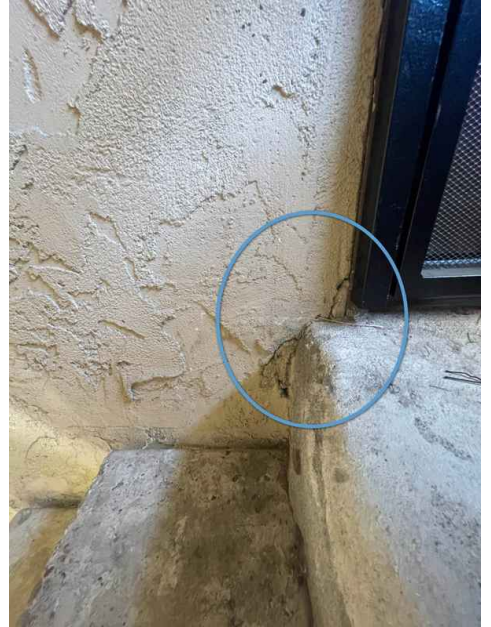
15.4.1 Entry Structure

There is a crack in the supporting wall. This crack should be sealed with a waterproof sealant to prevent water and wood boring insect intrusion.

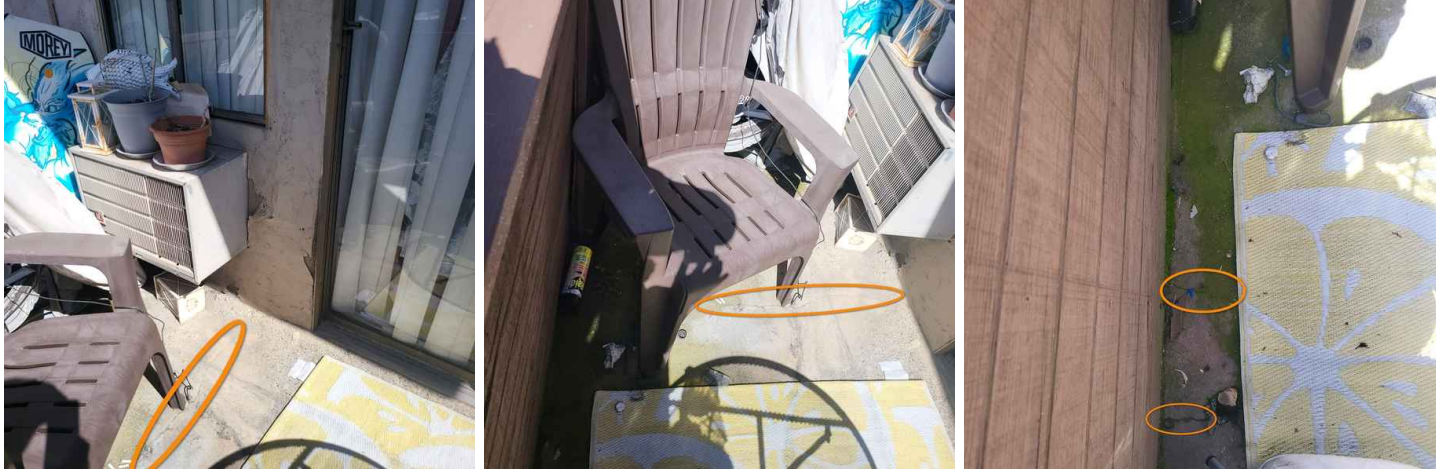
There are cracks in several locations on the deck surface. These cracks may indicate potentially severe water intrusion. Water intrusion can lead to internal deterioration of materials and possible compromise of structural integrity over time. A Phase 2 Pre-721 Evaluation (P2PE) is recommended to determine the extent of any water damage via borescope inspection or larger investigative openings, and to formulate a detailed repair plan.

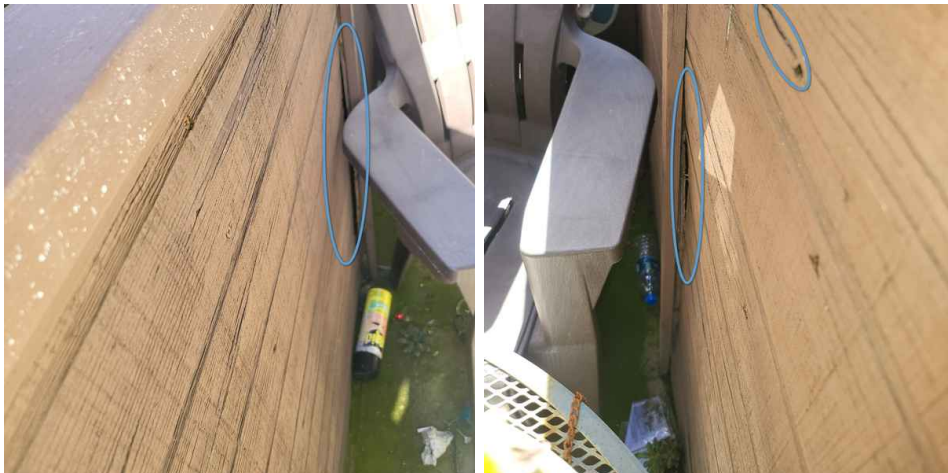
16.2.3 Balcony

There are openings in the wooden railing due to trim separating from water damaged paneling. A Phase 2 Pre-721 Evaluation (P2PE) is recommended to determine the extent of any water damage via borescope inspection or larger investigative openings, and to formulate a detailed repair plan.

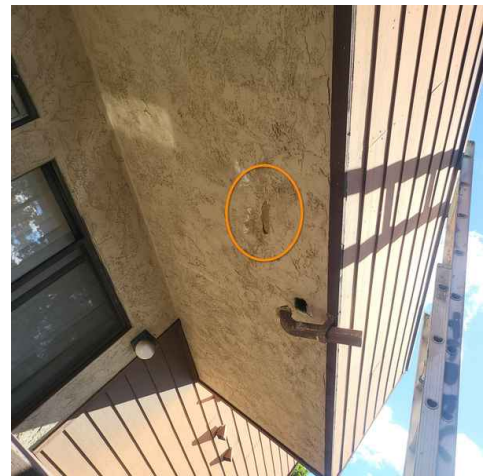
There is evidence of water damaged stucco. Water intrusion can lead to internal deterioration of materials and possible compromise of structural integrity over time. A Phase 2 Pre-721 Evaluation (P2PE) is recommended to determine the extent of any water damage via borescope inspection or larger investigative openings, and to formulate a detailed repair plan.

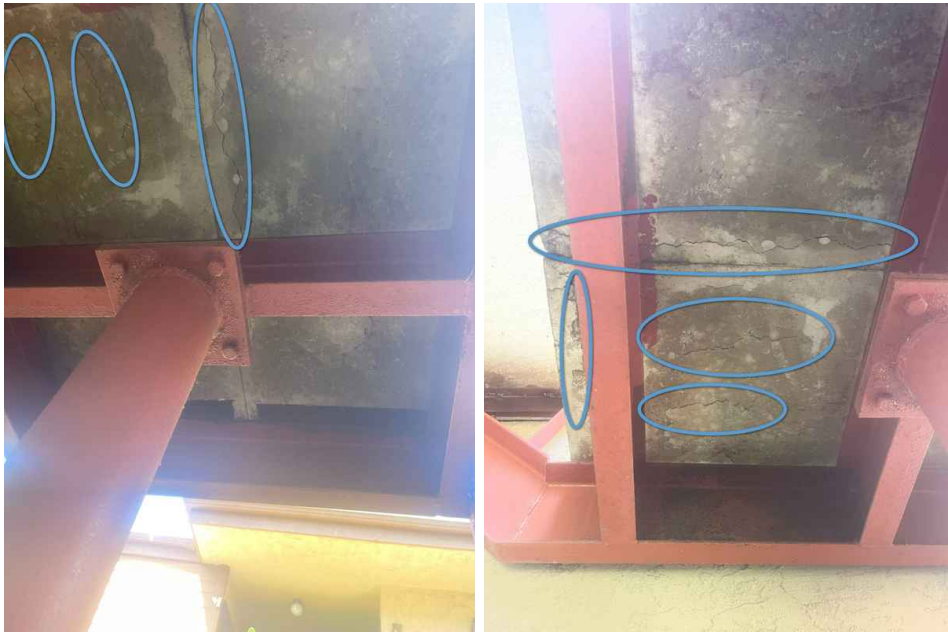
There is minor cracking in one or more slabs of the landing. At a minimum, the affected slabs should be replaced. If not replaced a reinspection is recommended in 2 years.

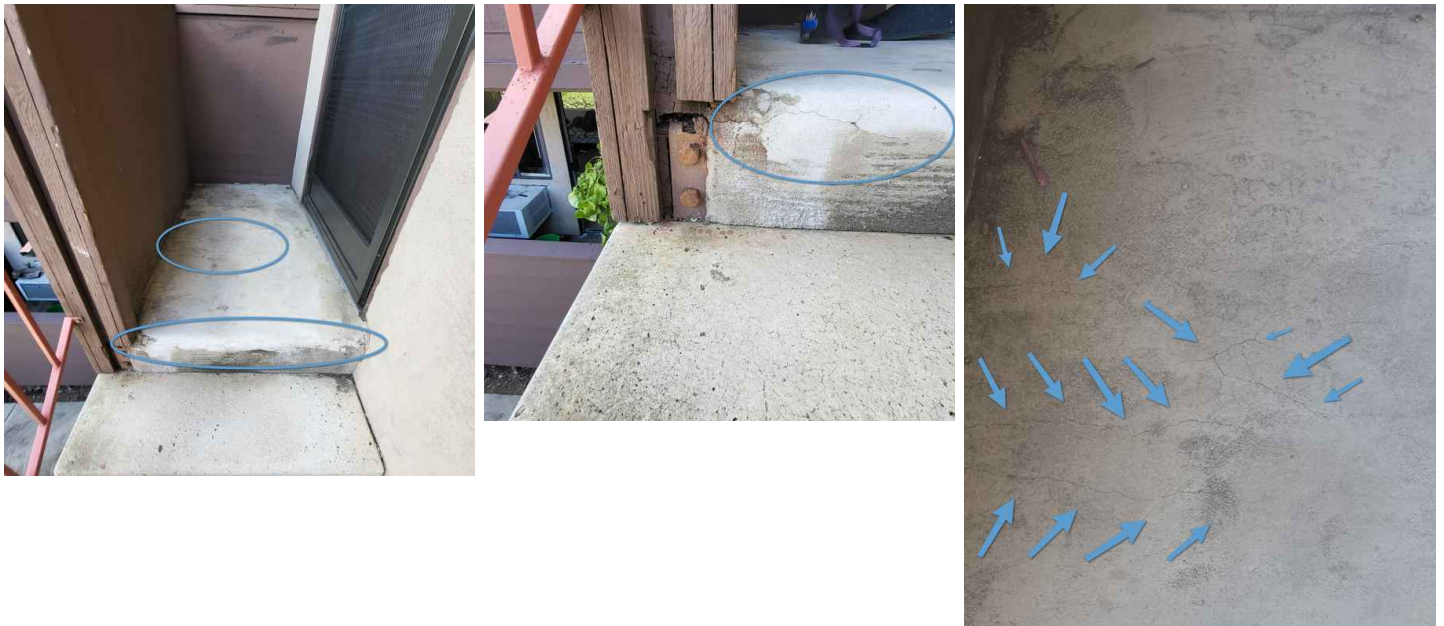
21.4.1 Entry Structure

There are cracks in the tops and side of the entry structure's walking surface. Deck surface should be resealed to prevent water intrusion.

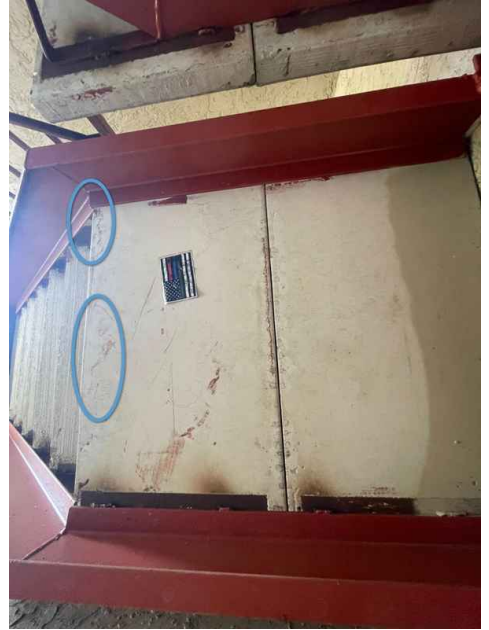
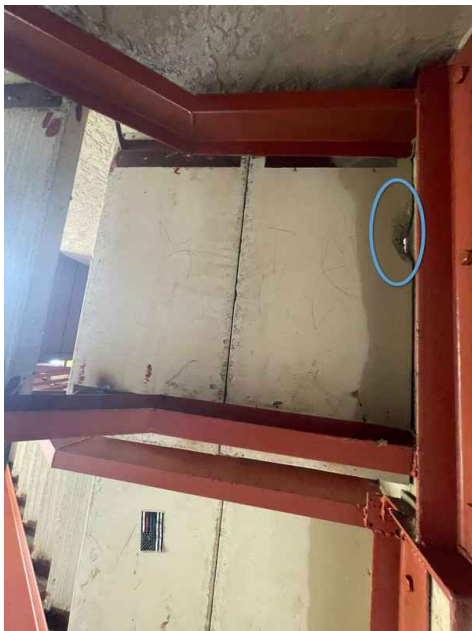
There are minor cracks and breakages in both landing platforms. At a minimum, the affected slabs should be replaced. If not replaced a reinspection is recommended in 2 years.

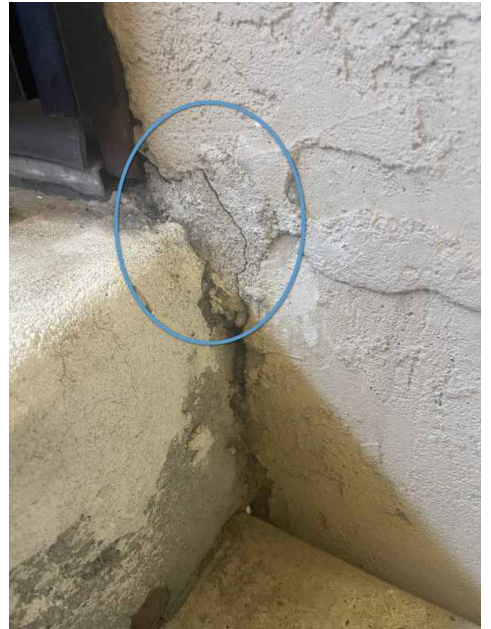
22.4.1 Entry Structure

There is a crack at the transition from the entry structure to the supporting wall. This crack should be sealed.

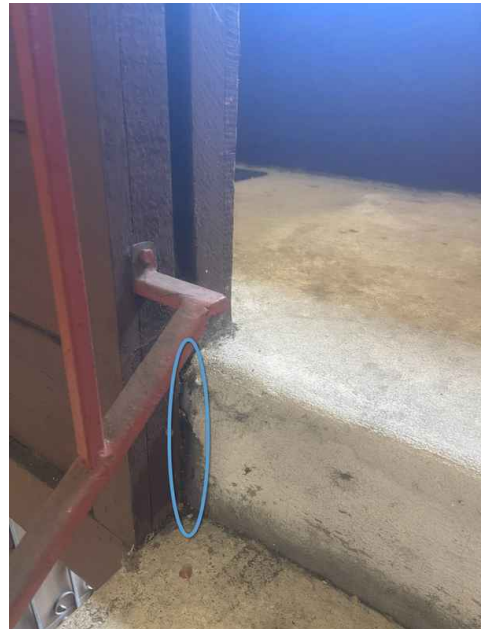
22.4.2 Entry Structure

There is an unsealed attachment between wooden railing and walking surface. This attachment should be sealed.

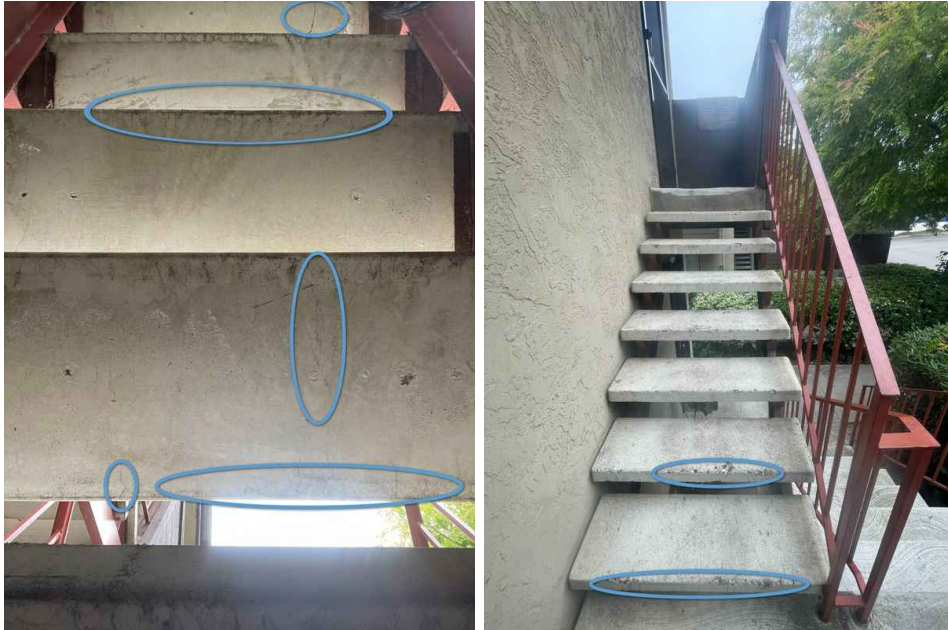
Approximately 5 of 15 treads have cracks or breakages. Most if not all of the stair treads seem to be the same age. At a minimum, the affected tread should be replaced. If not replaced a reinspection is recommended in 2 years.

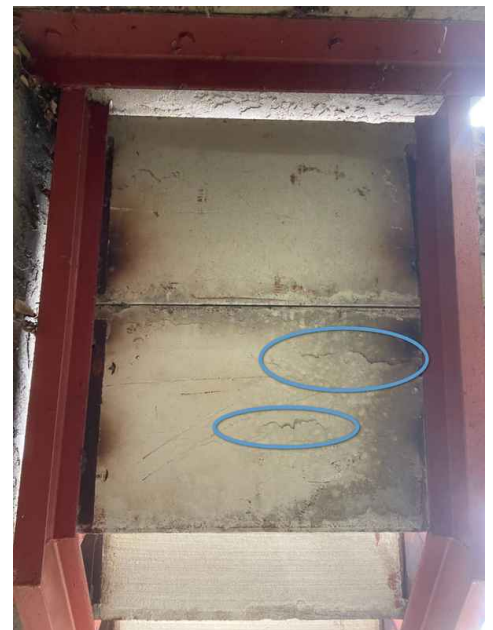
23.3.1 Landing

There is minor cracking in one or more slabs of the landing. At a minimum, the affected slabs should be replaced. If not replaced a reinspection is recommended in 2 years.

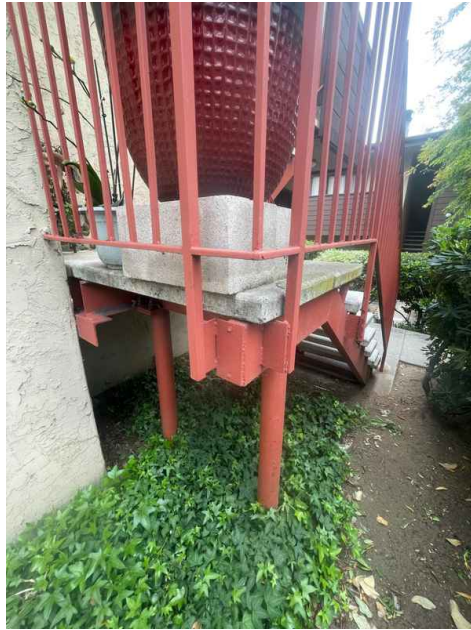
23.3.2 Landing

There is surface corrosion on the support beam. The bottom portion of the beam should be resealed.

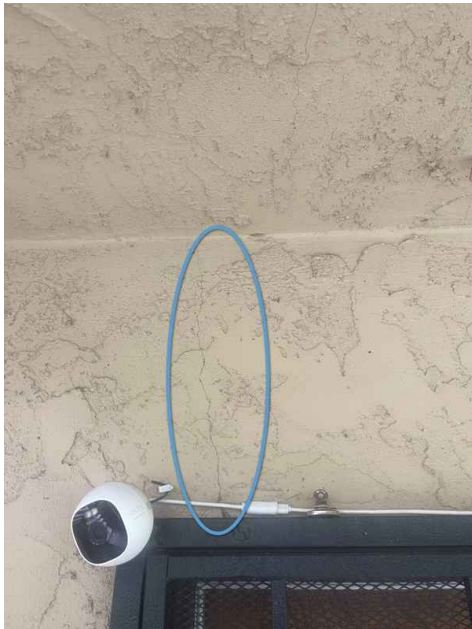
23.4.1 Entry Structure

There are cracks in the supporting wall under the entry structure. These cracks should be sealed with a waterproof sealant to prevent water and wood boring insect intrusion.

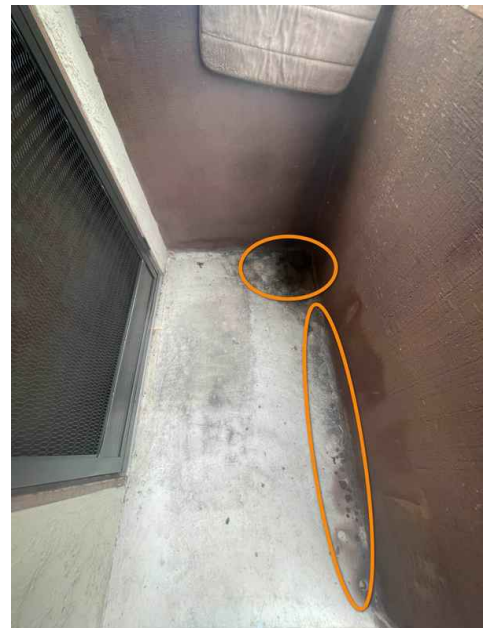
There is discoloration of the walking surface of the deck. Water intrusion is likely at the highlighted locations as there is discoloration in the fascia underneath. These conditions can lead to internal deterioration of materials and possible compromise of structural integrity over time. A Phase 2 Pre-721 Evaluation (P2PE) is recommended to determine the extent of any water damage via borescope inspection or larger investigative openings, and to formulate a detailed repair plan.

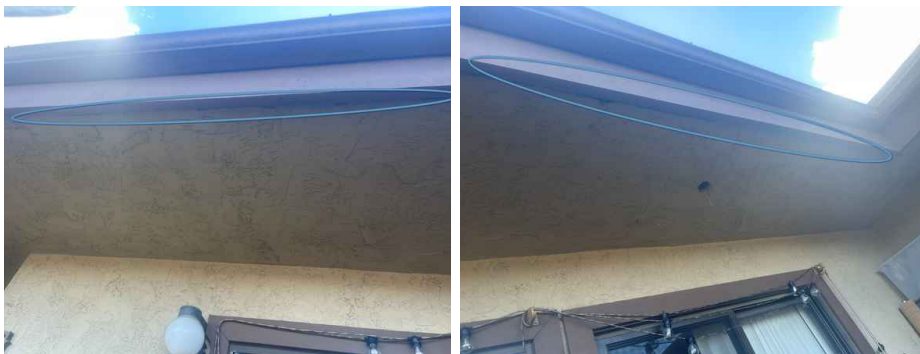
One or more sections of the overhang rim board and/or fascia have separated from the soffit. The resulting gaps should be sealed with a waterproof sealant to prevent water and wood boring insect intrusion.
