PATRICK'S PROPERTY MAINTENANCE SERVICE

PHASE 1 PRE-SB721 EVALUATION

1234 Main Street
Imperial Beach, CA 91932-1412

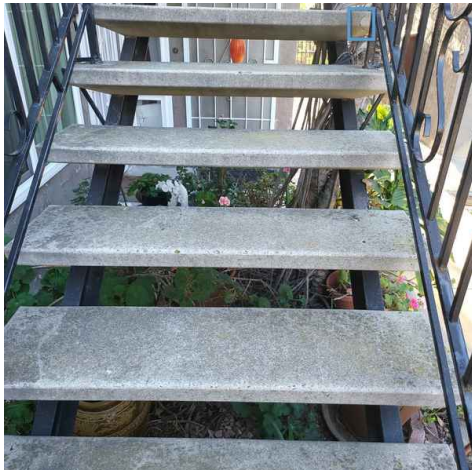
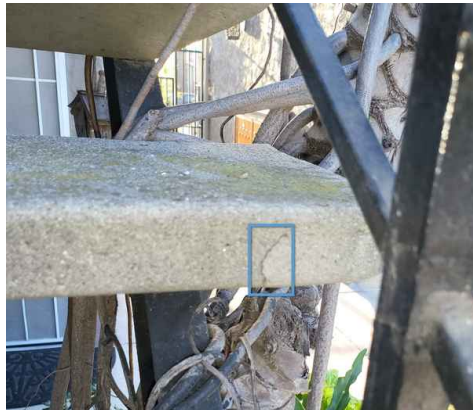
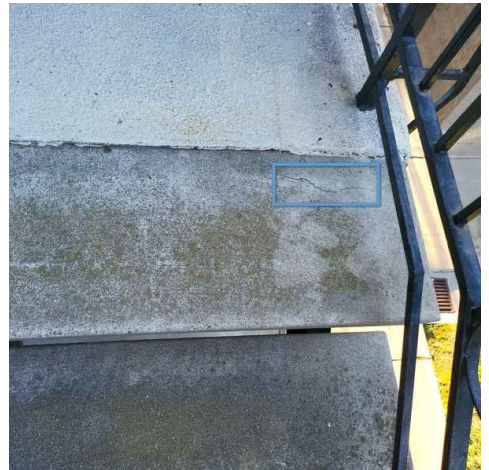
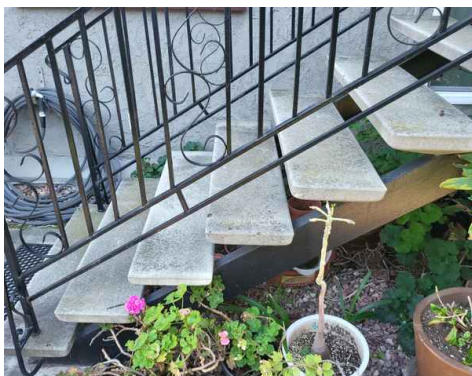
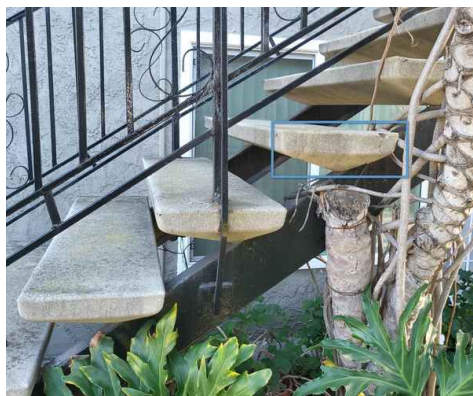
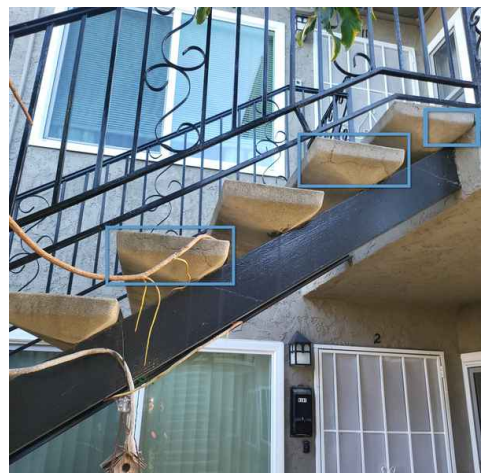
DAMAGED STAIR TREADS (MINORITY)

Approximately 5 out of 15 stair treads have cracks or breakages. Most if not all of the stair treads seem to be the same age and are likely approaching the end of their service life. At a minimum, the affected treads should be replaced. If not replaced a reinspection is recommended in 2 years.

Contact a qualified professional.

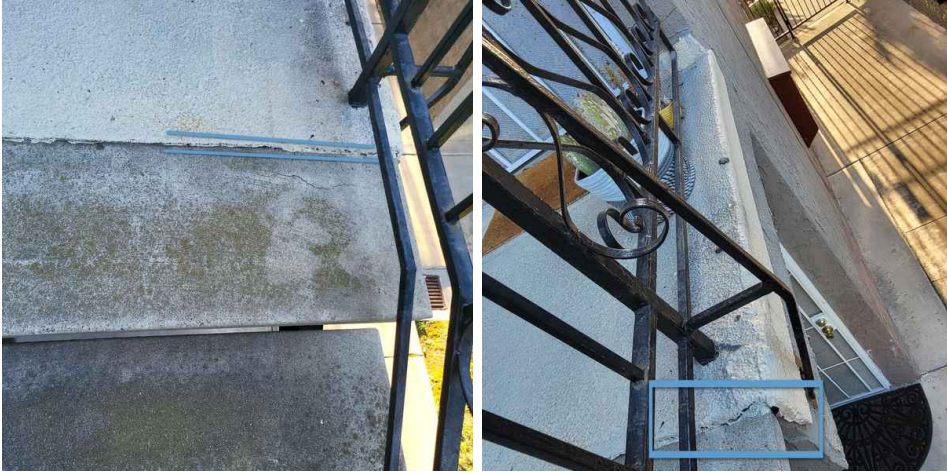
5.3.1 Landing

DECK - OPENING IN WATERPROOFING

There is an opening where the top stair tread meets the landing . Water sealant/weatherproofing should be applied.

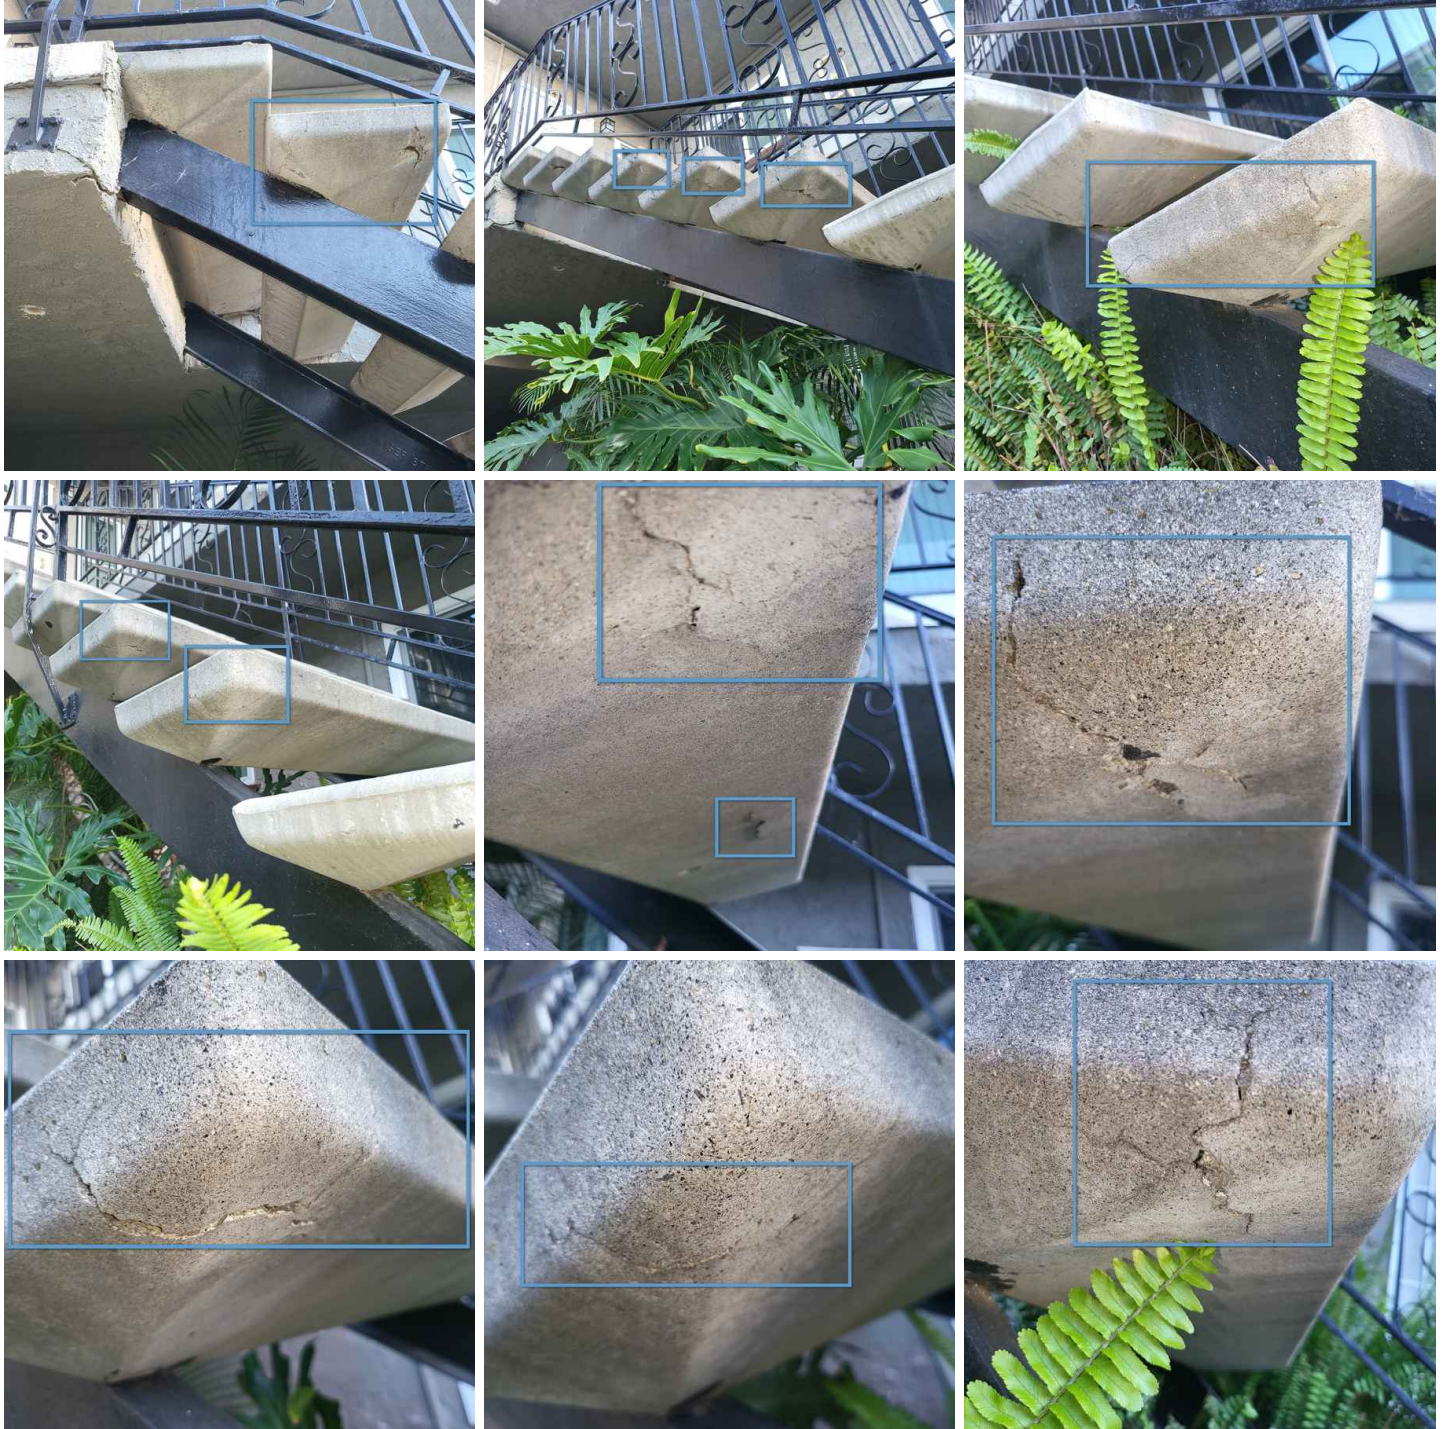
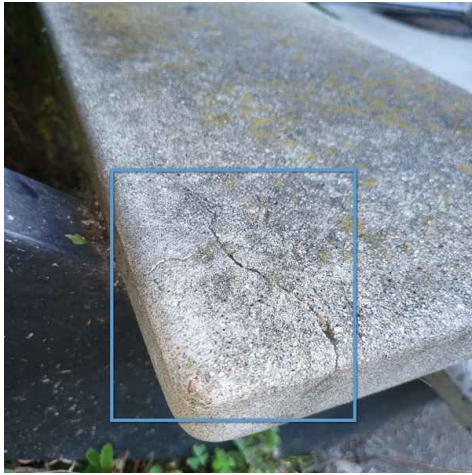
DAMAGED STAIR TREADS (MINORITY)

Approximately 6 out of 15 stair treads have cracks or breakages. Most if not all of the stair treads seem to be the same age and are likely approaching the end of their service life. At a minimum, the affected treads should be replaced. If the treads are not replaced a reinspection is recommended in 2 years.

Contact a qualified professional.

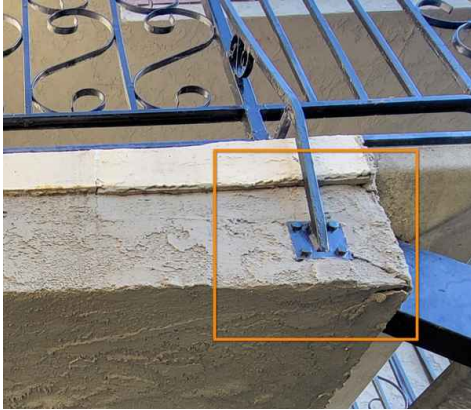
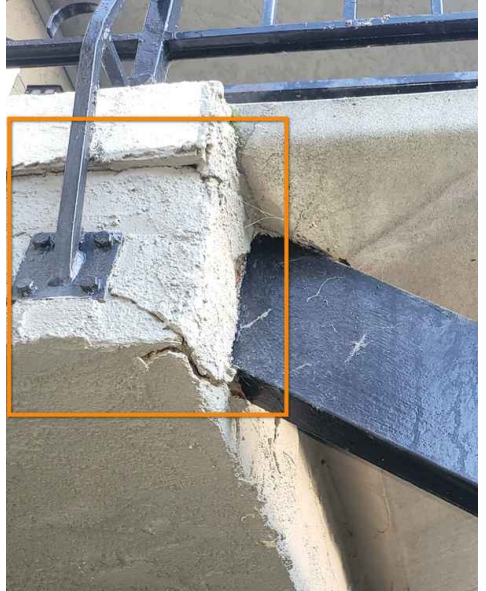
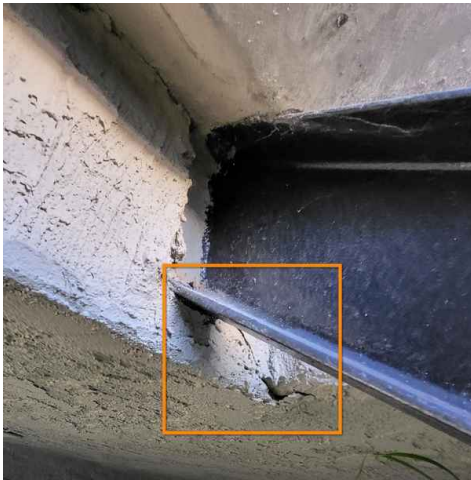
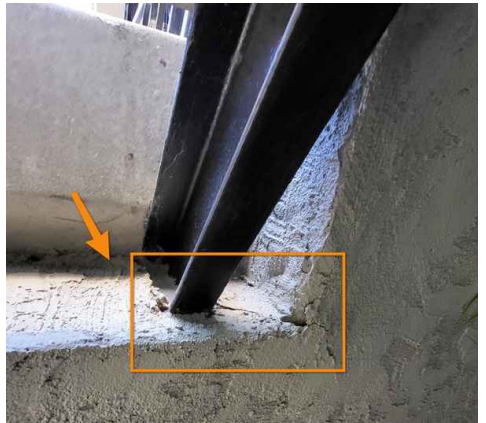
6.3.1 Walkway

STUCCO DAMAGE

There are large cracks in the stucco around both stair stringer connections to the walkway. These cracks correspond to railing connection defects above these locations. This condition raises concerns regarding water intrusion and possible advanced deterioration in the underlying support structure. A Phase 2 Pre-721 Evaluation (P2PE) is recommended to determine the extent of any water damage via borescope investigation or larger investigative openings, and to formulate a detailed repair plan.

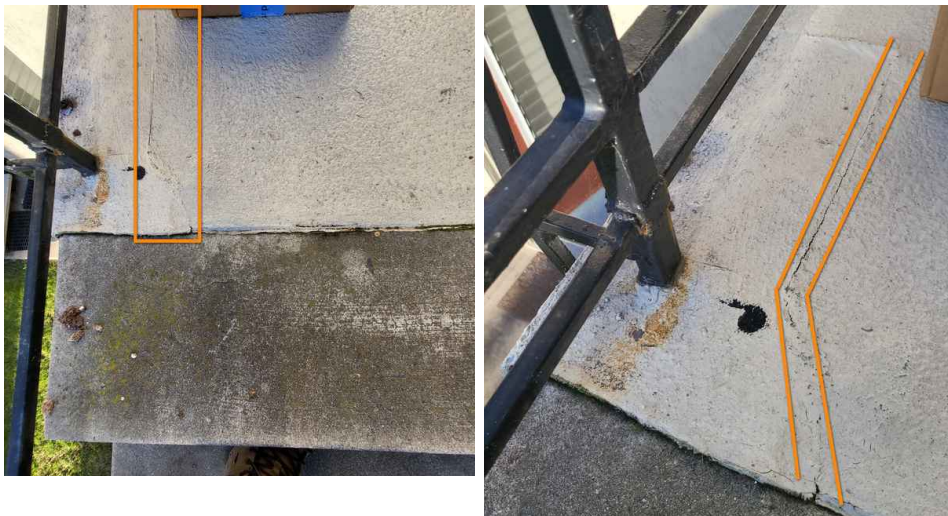
6.3.2 Walkway

PREVIOUS REPAIRS FAILING - MINOR TO MODERATE

Inspection has revealed that previous repair efforts on the structure are failing, indicating either inadequate repair methods were used or the underlying issues have not been fully addressed. This area was previously patched, but a crack has formed around the patch and the deck coating is swelling, indicating water intrusion and wood decay and/or corrosion of railing connection. The deteriorating condition of these repairs could lead to further damage or safety risks. It is essential to re-evaluate these areas with a qualified professional to determine the cause of failure and to implement more effective and lasting repair solutions. Immediate attention is advised to prevent escalation of the defect. A borescope inspection under this defect is recommended and a larger investigative opening.

Contact a qualified professional.

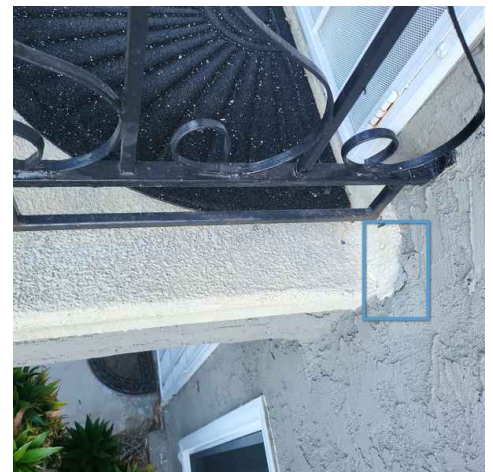
6.3.3 Walkway

DECK - OPENING IN WATERPROOFING

There is minor cracking in the waterproofing at the west end of the walkway under the bottom rail connection. Sealant/waterproofing should be applied.

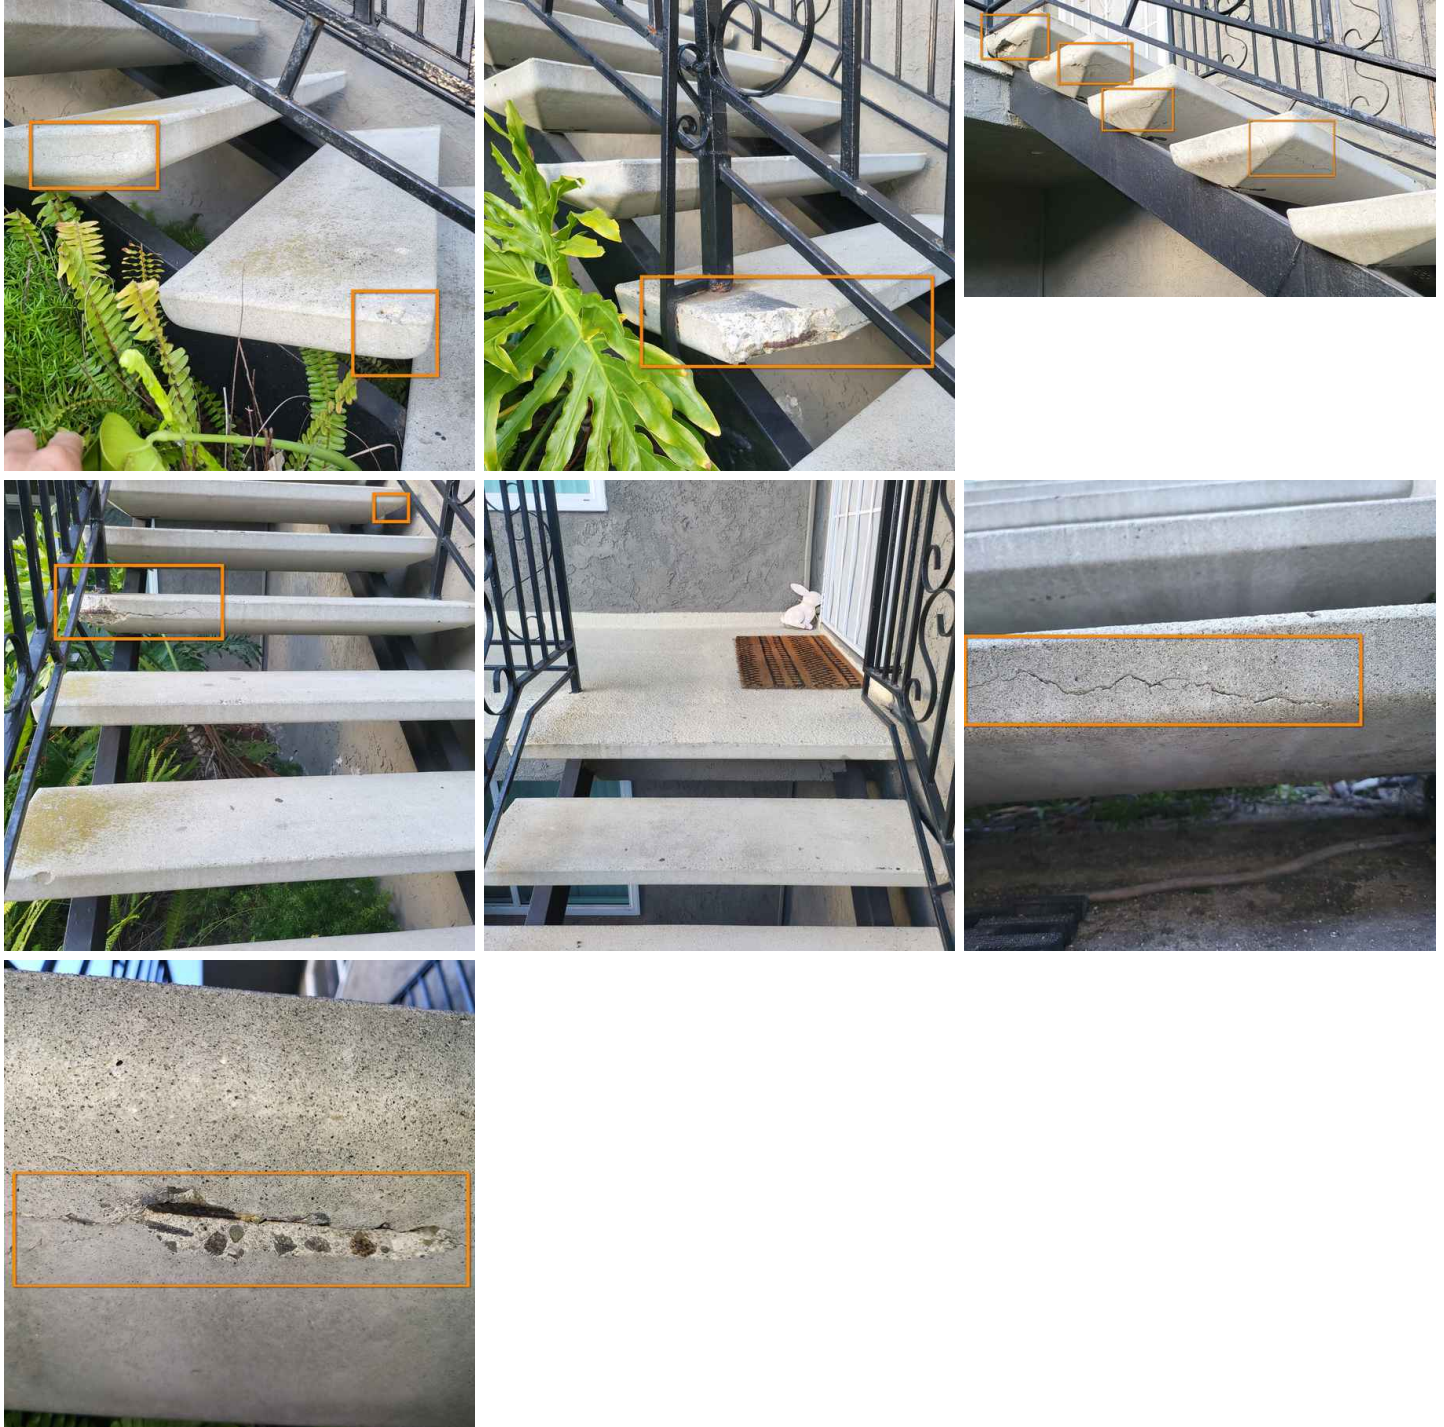
DAMAGED STAIR TREADS (MAJORITY)

Approximately 8 out of 15 stair treads have cracks or breakages. Most if not all of the stair treads seem to be the same age and are likely approaching the end of their service life. At a minimum, the affected treads should be replaced. If the treads are not replaced a reinspection is recommended in 2 years.

Contact a qualified professional.

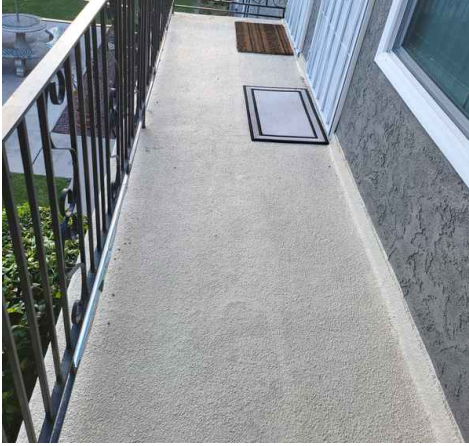
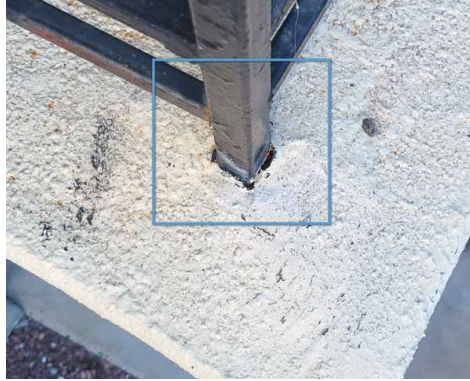
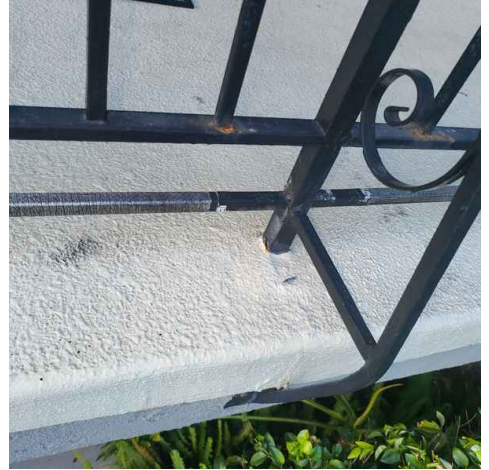
7.3.1 Walkway

WALKWAY RAILING CONNECTION

2 of the rail connections to the deck are not sealed and corrosion is visible. Water intrusion and deterioration of the underlying support materials are likely. This deterioration could lead to further damage or safety risks. A borescope inspection under one or both of these opening is recommended to determine the extent of water damage to the underlying support materials.

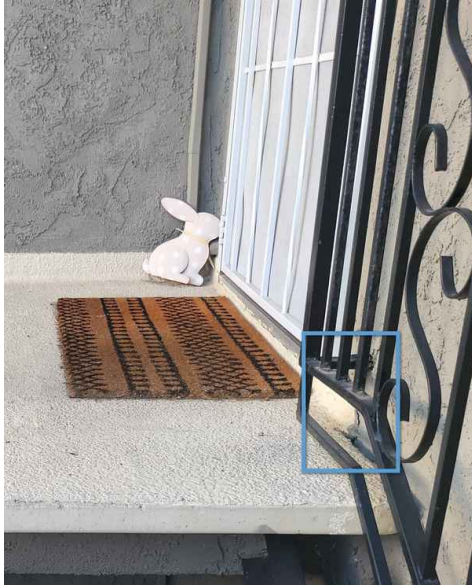
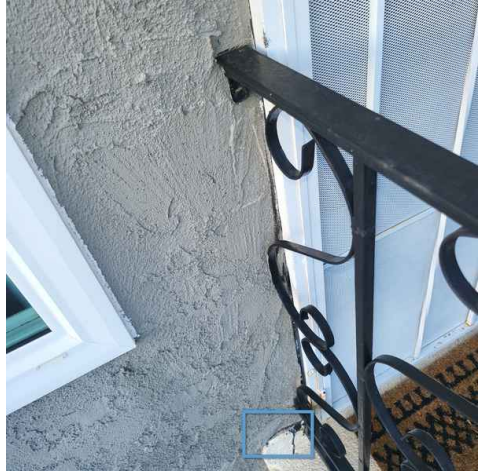
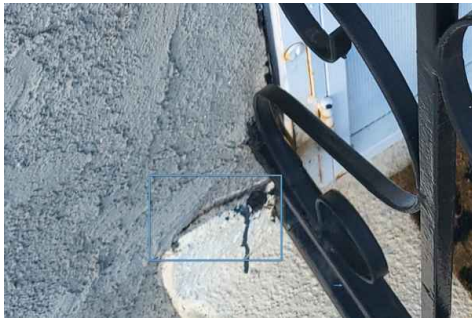
7.3.2 Walkway

DECK - OPENING IN WATERPROOFING

There is minor cracking in the waterproofing at both ends of the walkway under the rail connection to the wall. Sealant/waterproofing should be applied.

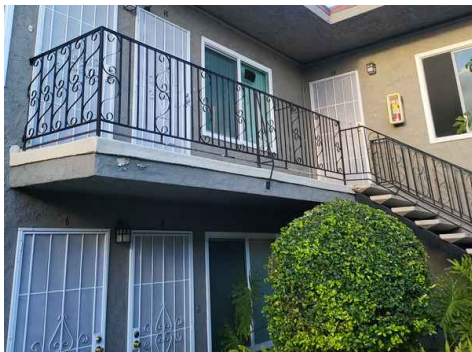
7.3.3 Walkway

STUCCO DAMAGE

There is evidence of water intrusion at the west corner of the walkway. The edge metal is lifting and corrosion is visible. Water has penetrated the stucco causing it to blister. This condition raises concerns regarding water intrusion and possible advanced deterioration in the underlying support structure. A Phase 2 Pre-721 Evaluation (P2PE) is recommended to determine the extent of any water damage via borescope investigation or larger investigative opening, and to formulate a detailed repair plan.

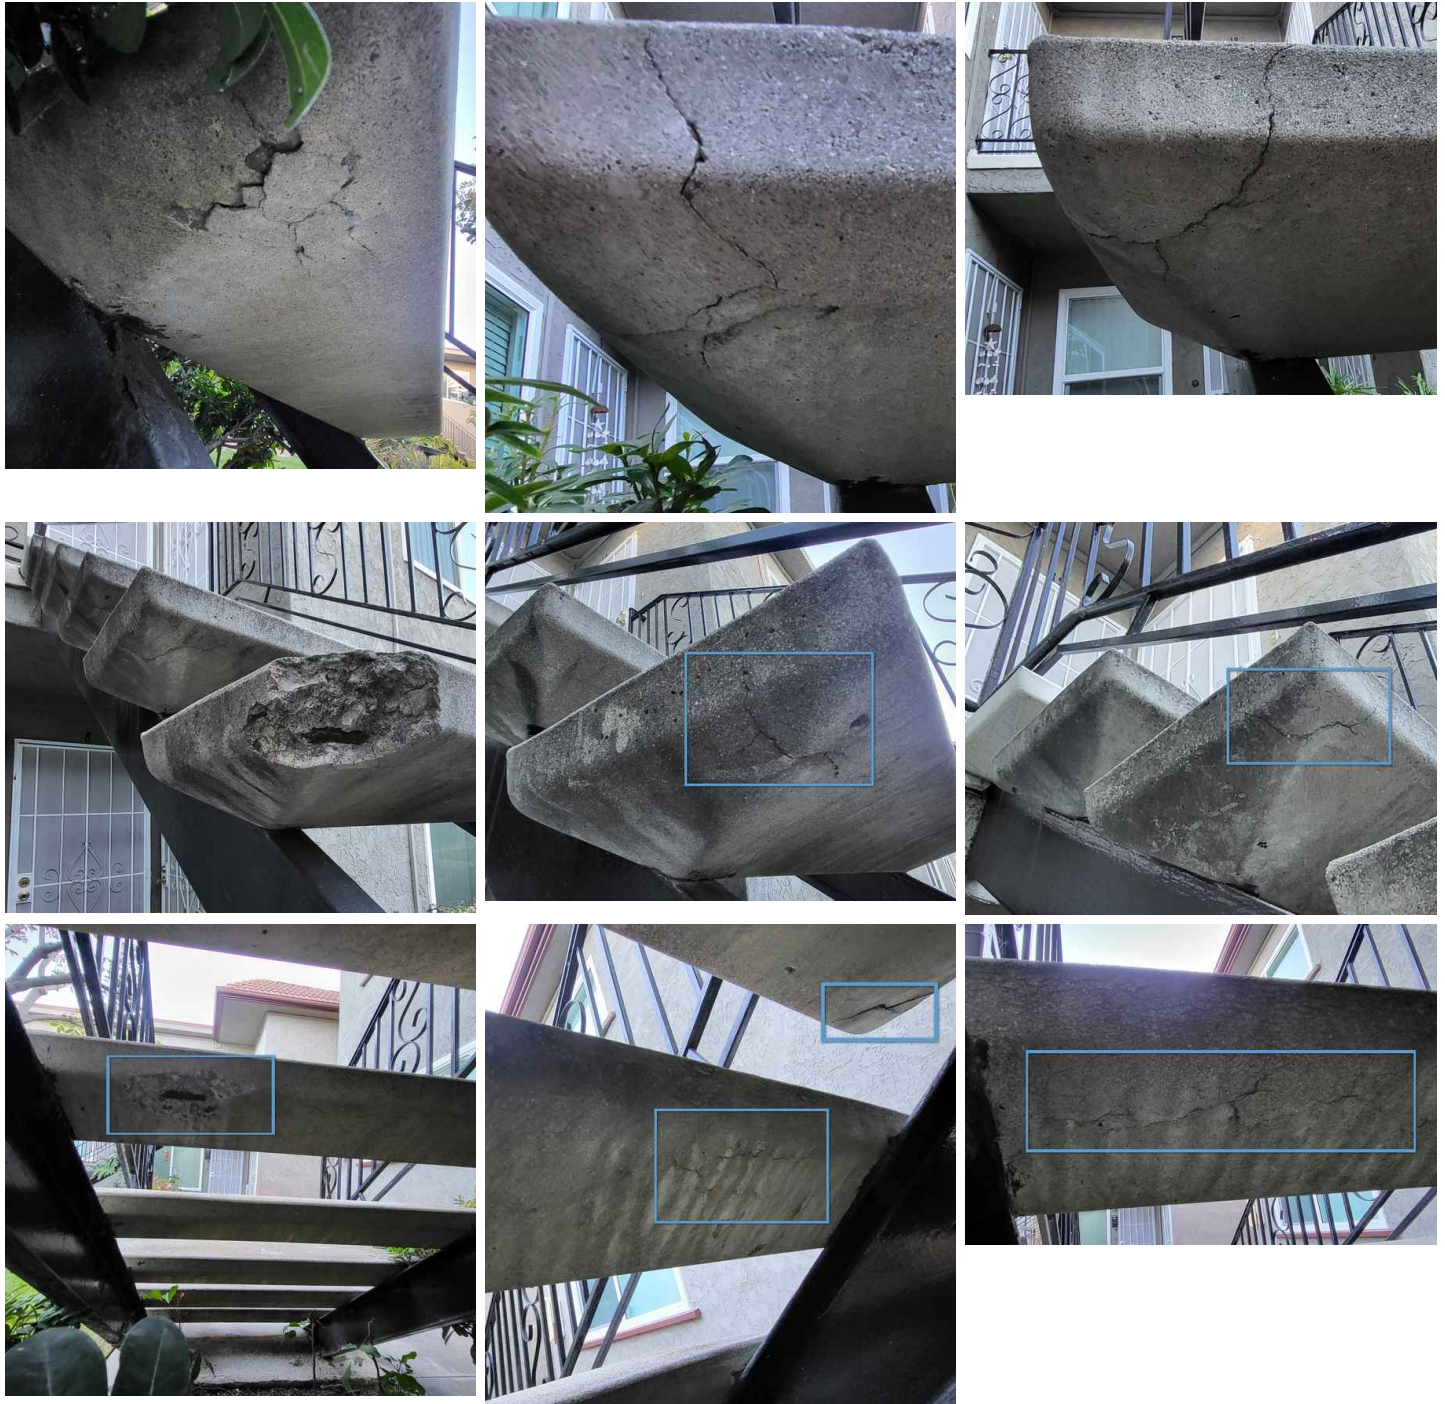
DAMAGED STAIR TREADS (MAJORITY)

Approximately 10 out of 15 stair treads have cracks or breakages. Except for the top stair tread, all the treads seem to be the same age and are most likely at the end of their service life. At a minimum, the affected treads should be replaced. If the treads are not replaced a reinspection is recommended in 1 year.

Contact a qualified professional.

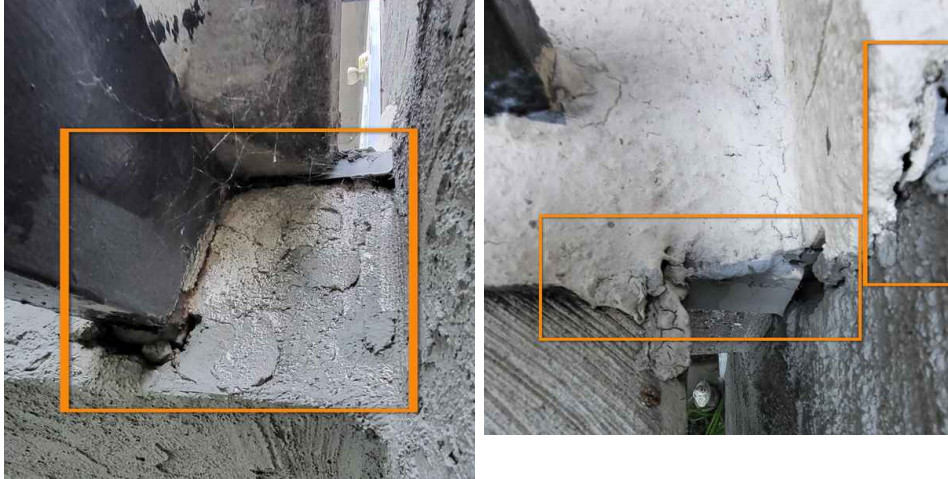
8.3.1 Walkway

POOR DETAILING

The deck coating, the edge metal, and the stucco around the right stair stringer connection to the walkway are not finished properly or sealed. This condition raises concerns regarding water intrusion and possible advanced deterioration in the underlying support structure. A Phase 2 Pre-721 Evaluation (P2PE) is recommended to determine the extent of any water damage via borescope investigation and to formulate a detailed repair plan.

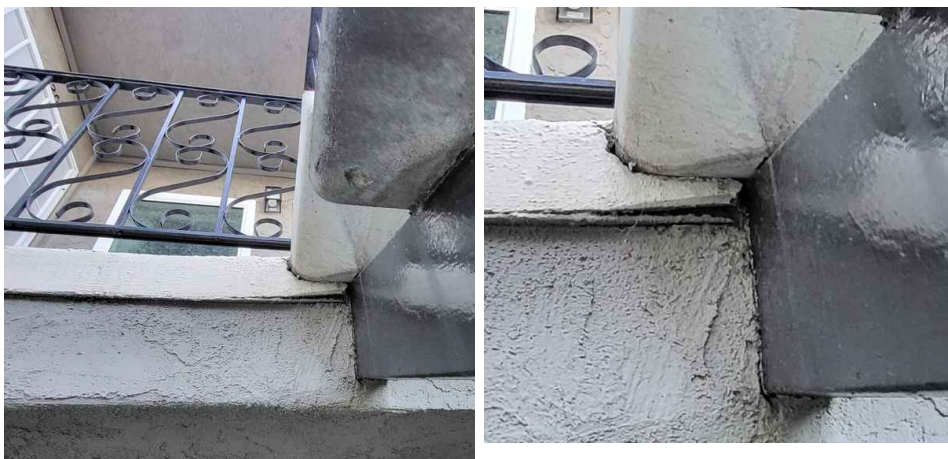
8.3.2 Walkway

There is an opening around the top stair tread where it meets the deck metal. The deck coating on the edge metal is separating. This opening allows water intrusion, potentially leading to wood rot, structural weakness, and mold growth. Immediate steps should include a professional assessment, repair and sealing of the cracks, and regular maintenance to prevent further damage and ensure the deck's longevity and safety.

Contact a qualified professional.
