PATRICK'S PROPERTY MAINTENANCE SERVICE

PHASE 1 PRE-721 EVALUATION

1234 Main Street
Imperial Beach, CA 91932-1412

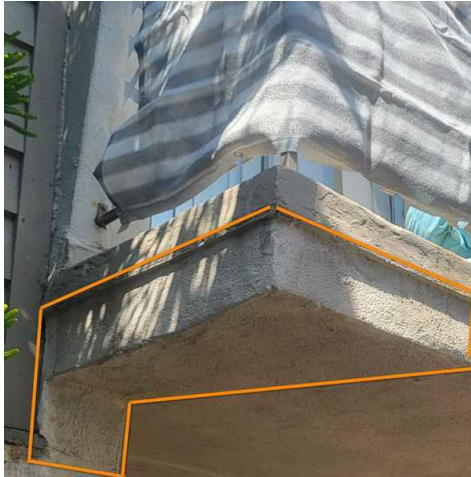
Marginal - Stucco is cracking, stained, bulging, bubbling, blistered, efflorescing, soft, crumbling, discolored or showing signs of mold and mildew. These conditions are marginal. A Phase 2 Pre-721 Evaluation (P2PE) is recommended to determine the extent of any water damage via borescope inspection or larger investigative openings, and to formulate a detailed repair plan. See Reference Information: Notification and Follow Up - Marginal.

cracking, stained, bulging, bubbling, efflorescing

Contact a qualified professional.

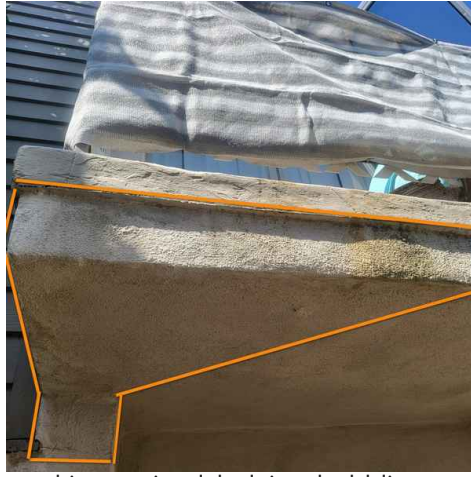
cracking, stained, bulging, bubbling, efflorescing, mold and mildew

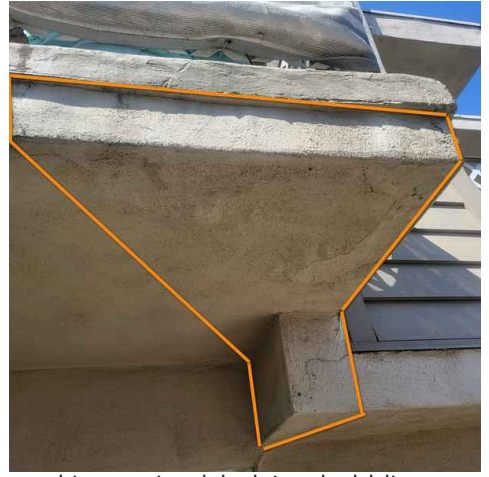
cracking, stained, bulging, bubbling, efflorescing

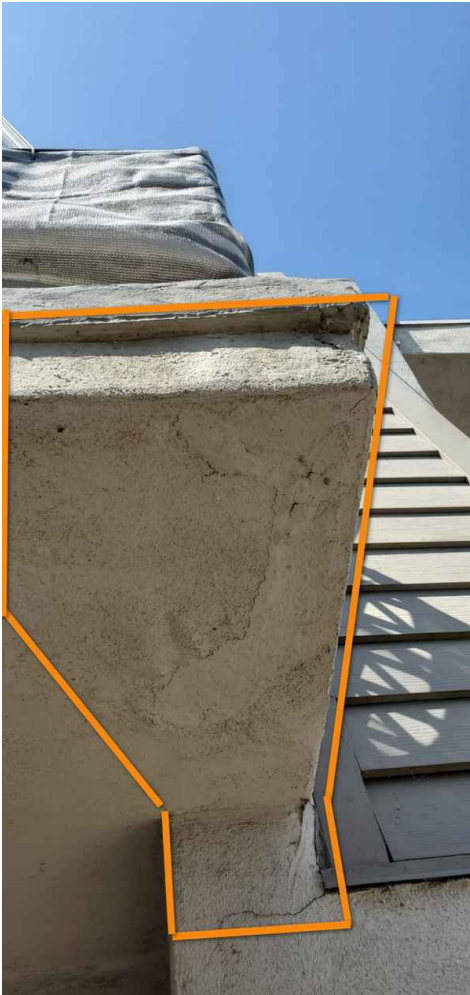
cracking, stained, bulging, bubbling, efflorescing

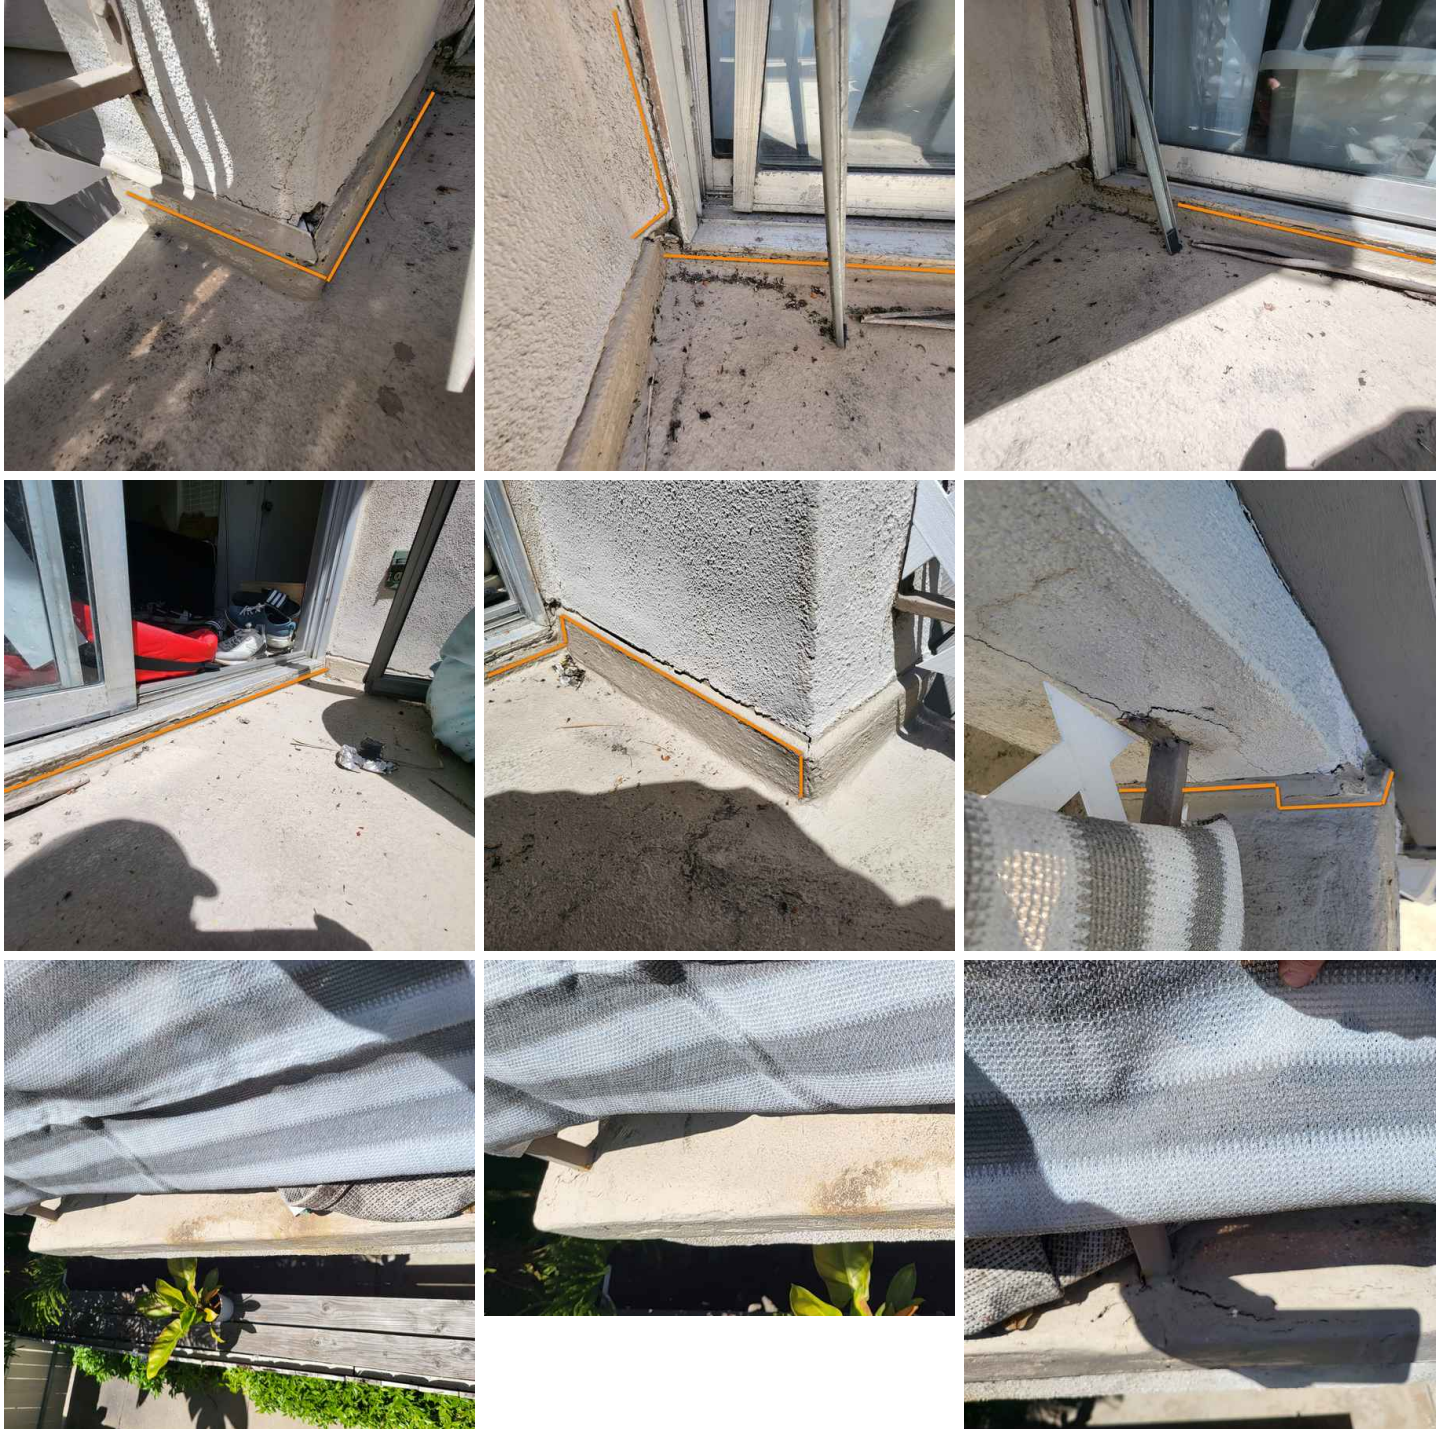
5.2.2 Balcony

Marginal - There are cracks, openings, or penetrations in the waterproofing that allow significant water intrusion. A Phase 2 Pre-721 Evaluation (P2PE) is recommended to determine the extent of any water damage via borescope inspection or larger investigative openings, and to formulate a detailed repair plan. See Reference Information: Notification and Follow Up - Marginal.

Contact a qualified professional.

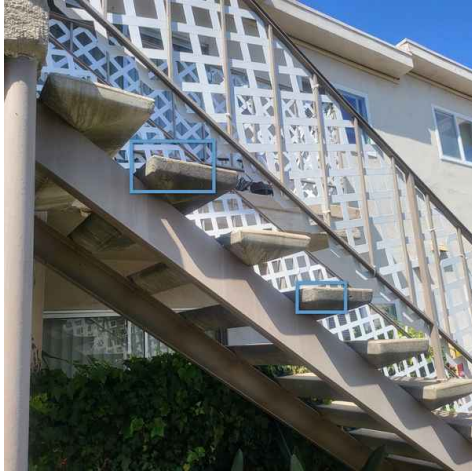
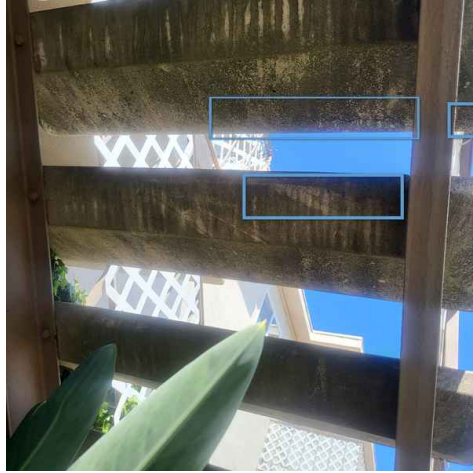
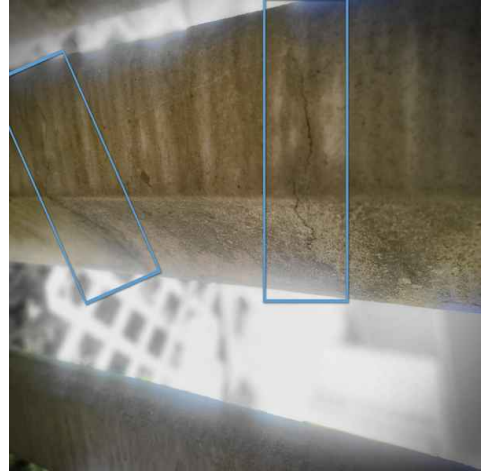
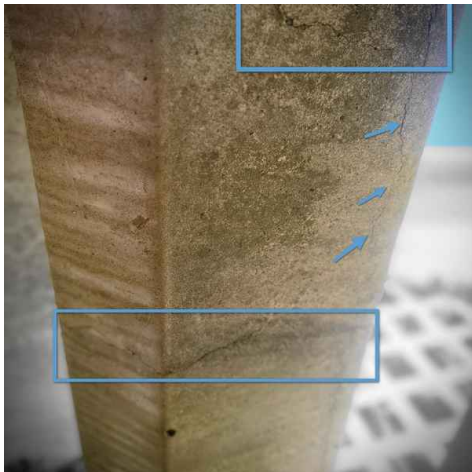
DAMAGED PRECAST TREAD(S)

Minor - Approximately 6 of 13 treads are cracked or broken. Most of the stair treads seem to be the same age. The affected tread(s) are approaching the end of their service life. At a minimum, the affected tread(s) should be replaced. If not replaced a reinspection is recommended in 2 years.

Contact a qualified professional.

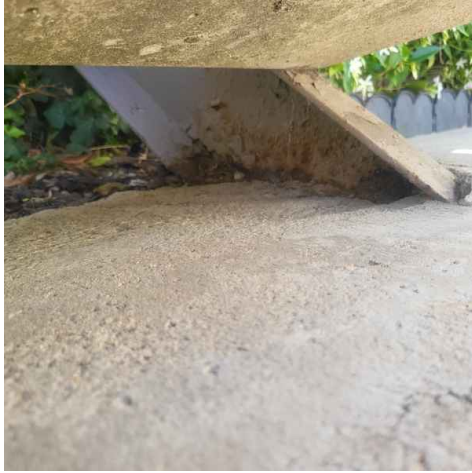
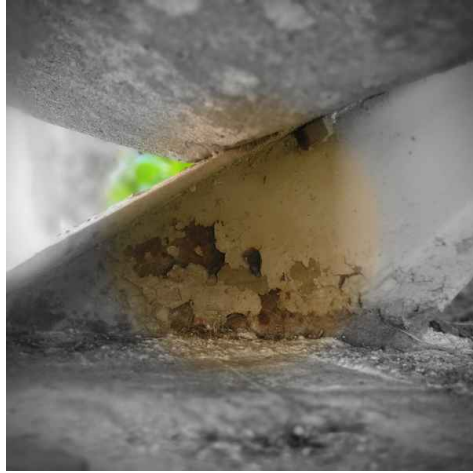
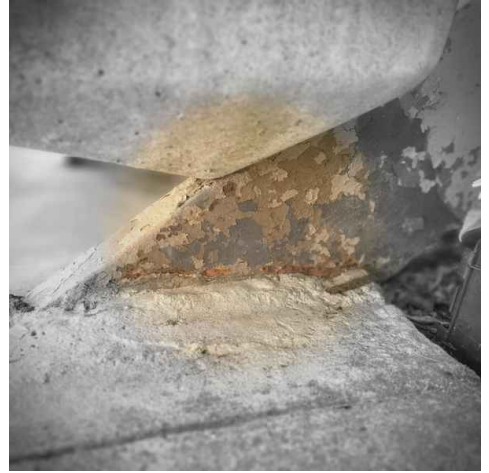
6.2.2 Stairway

Minor - There is surface corrosion. The affected area(s) should be repaired.

Contact a qualified professional.

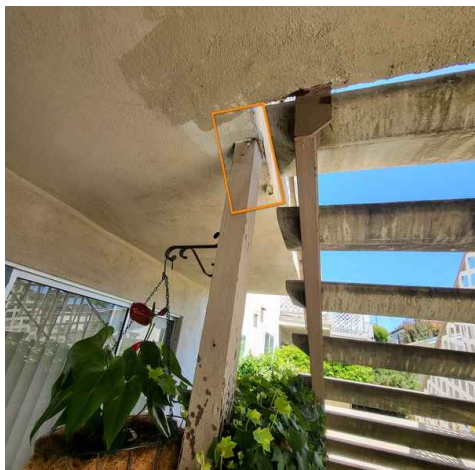
Marginal - Stucco is cracking, stained, bulging, bubbling, blistered, efflorescing, soft, crumbling, discolored or showing signs of mold and mildew. These conditions are marginal. A Phase 2 Pre-721 Evaluation (P2PE) is recommended to determine the extent of any water damage via borescope inspection or larger investigative openings, and to formulate a detailed repair plan. See Reference Information: Notification and Follow Up - Marginal.

blistered

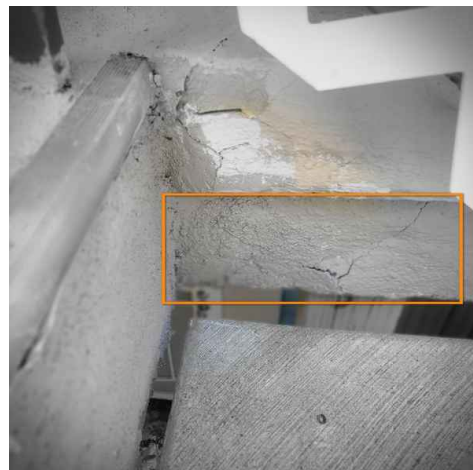
cracked, blistered

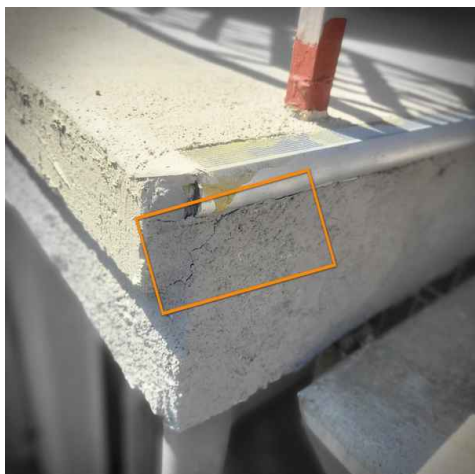
cracked

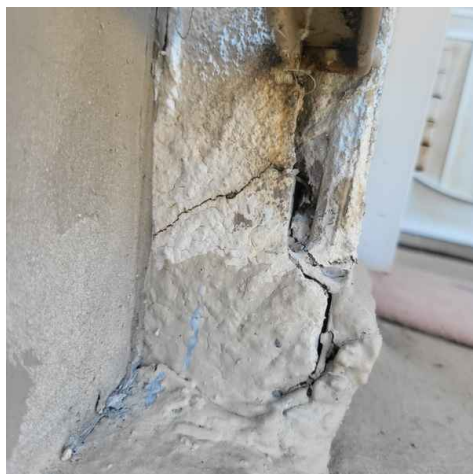
cracked

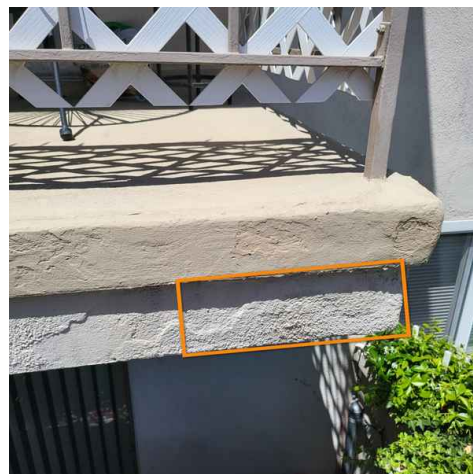
bubbling, efflorescence

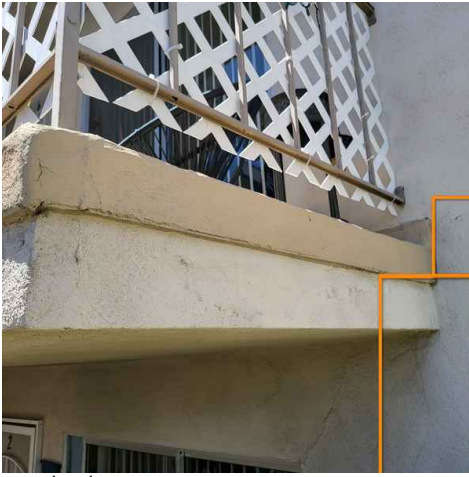
cracked

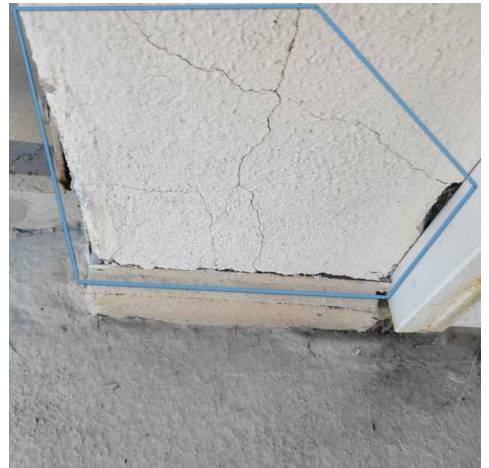
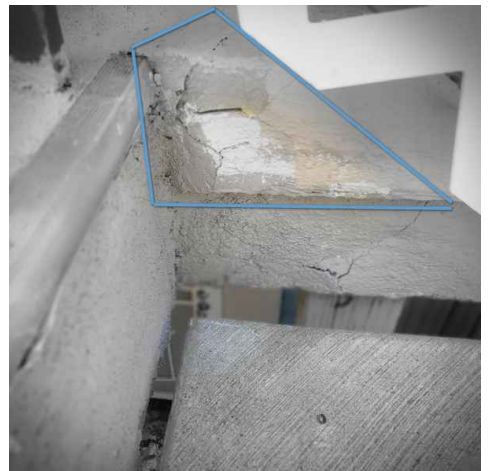
6.3.2 Walkway

Minor - There are cracks, openings, or penetrations in the waterproofing. The affected areas should be sealed.

Contact a qualified professional.

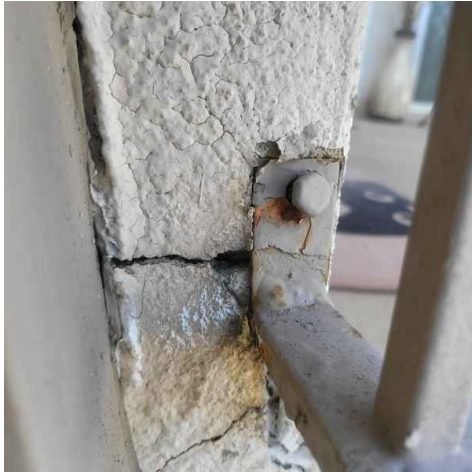
bottom rail to wall

Contact a qualified professional.

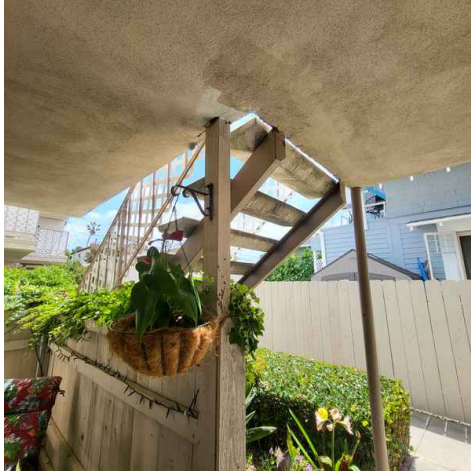
Marginal - The inspection revealed evidence of minor instability in the support structure, possibly due to inadequate or improper construction methods. While currently stable, this condition suggests that the support construction may not adhere to regulatory standards, potentially leading to long-term issues. A Phase 2 Pre-721 Evaluation (P2PE) is recommended to formulate a detailed repair plan. See Reference Information: Notification and Follow Up - Marginal.

support beam or fence post

Contact a qualified professional.

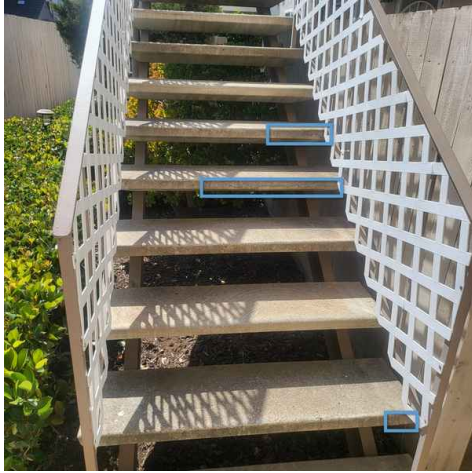
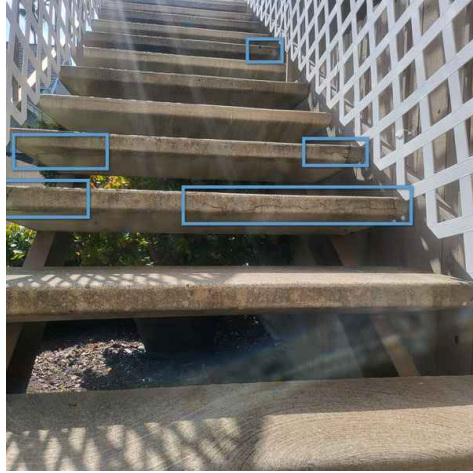
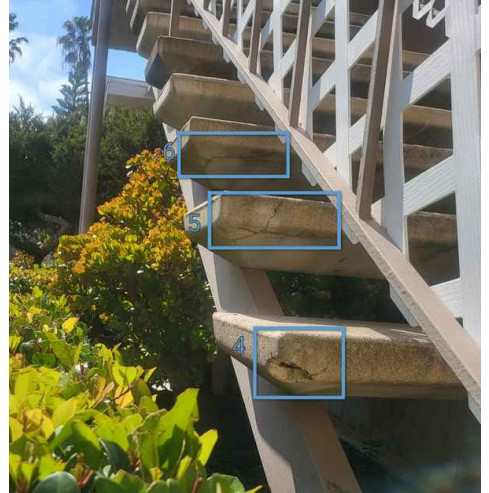
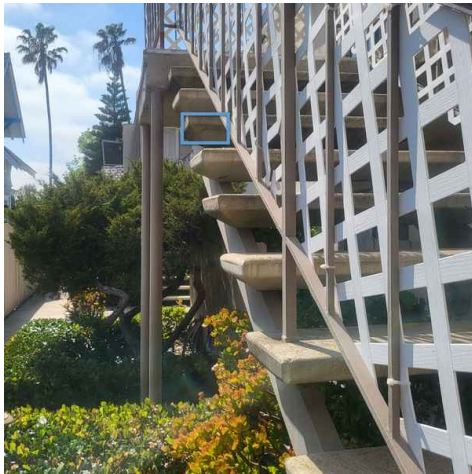
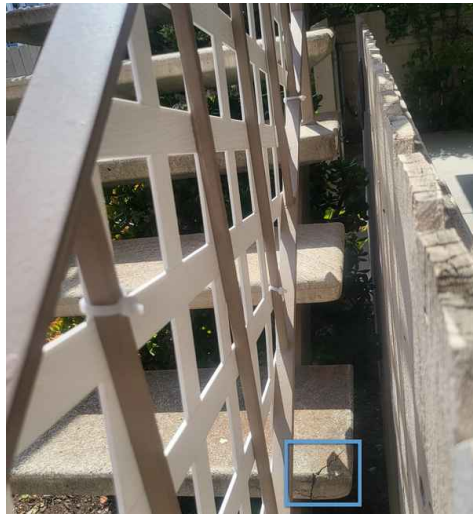
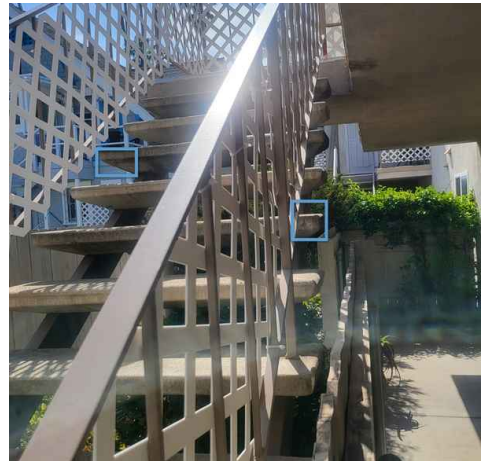
DAMAGED PRECAST TREAD(S)

Minor - Approximately 7 of 14 treads are cracked or broken. Most if not all of the stair treads seem to be the same age. The affected tread(s) are approaching the end of their service life. At a minimum, the affected tread(s) should be replaced. If not replaced a reinspection is recommended in 2 years.

Contact a qualified professional.

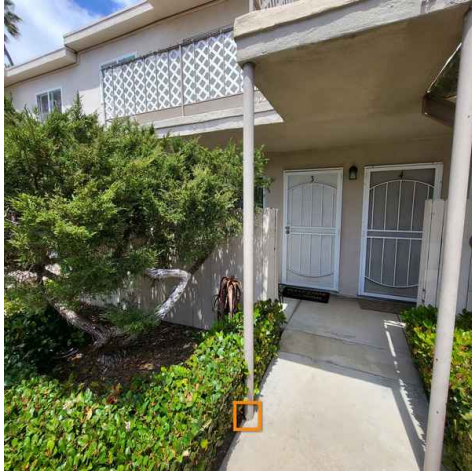
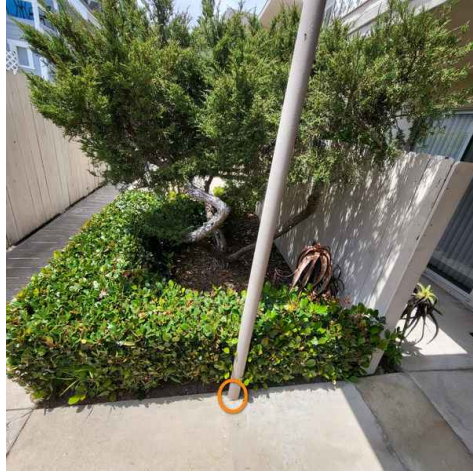
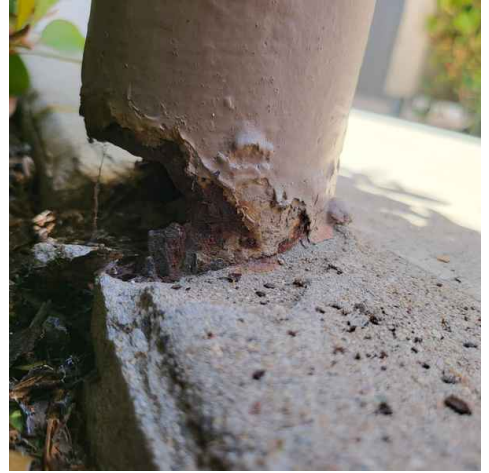
Marginal - There is significant corrosion that is affecting structural integrity. A Phase 2 Pre-721 Evaluation (P2PE) is recommended to formulate a detailed repair plan. See Reference Information: Notification and Follow Up - Marginal.

Support post rusted through

Contact a qualified professional.

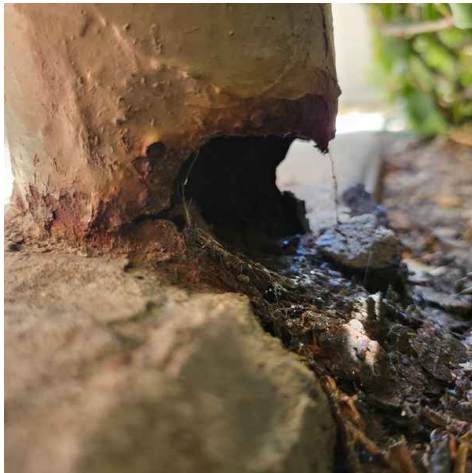
Support post rusted through

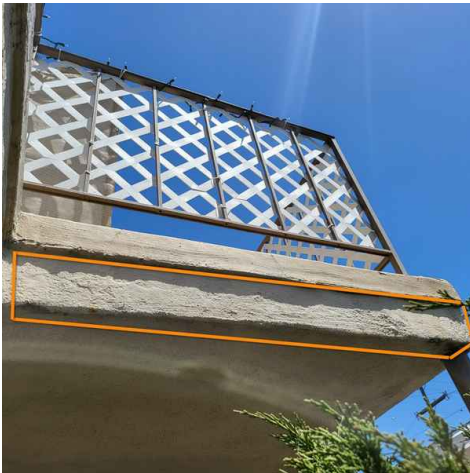
Marginal - Stucco is cracking, stained, bulging, bubbling, blistered, efflorescing, soft, crumbling, discolored or showing signs of mold and mildew. These conditions are marginal. A Phase 2 Pre-721 Evaluation (P2PE) is recommended to determine the extent of any water damage via borescope inspection or larger investigative openings, and to formulate a detailed repair plan. See Reference Information: Notification and Follow Up - Marginal.

cracking, stained, bulging, bubbling, efflorescing

Contact a qualified professional.

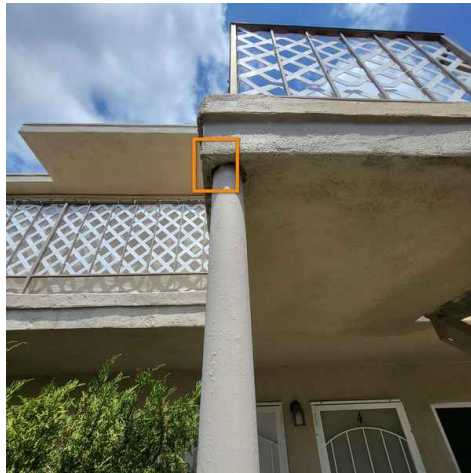
cracking

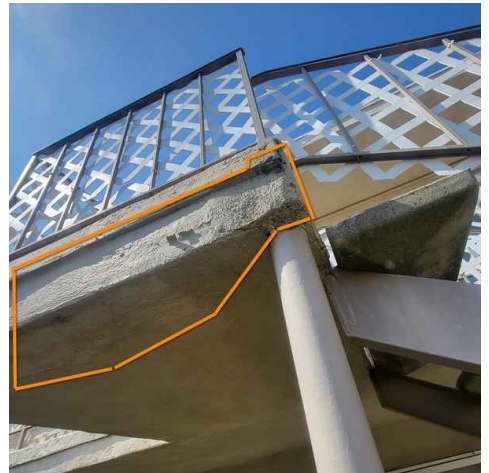
cracking, stained, bulging, bubbling, blistered efflorescing

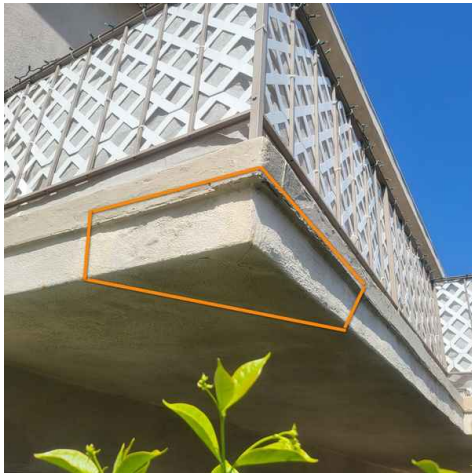
Marginal - Stucco is cracking, stained, bulging, bubbling, blistered, efflorescing, soft, crumbling, discolored or showing signs of mold and mildew. These conditions are marginal. A Phase 2 Pre-721 Evaluation (P2PE) is recommended to determine the extent of any water damage via borescope inspection or larger investigative openings, and to formulate a detailed repair plan. See Reference Information: Notification and Follow Up - Marginal.

cracking, stained, bulging, bubbling

Contact a qualified professional.

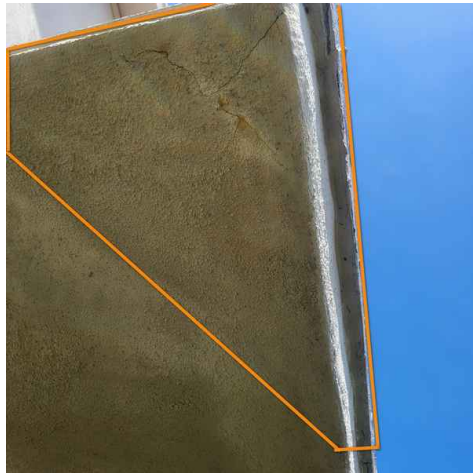
cracking, stained, bulging, bubbling

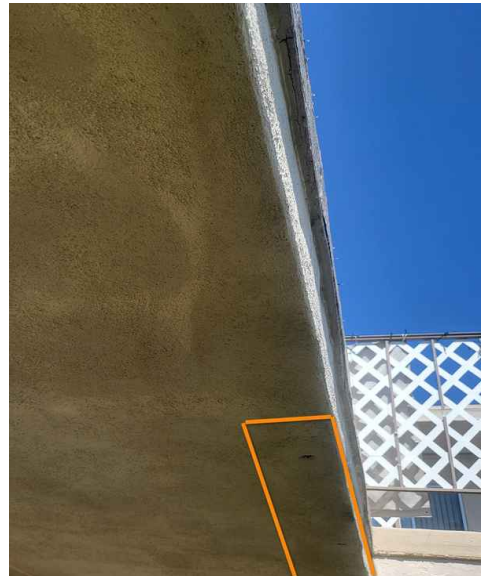
cracking, stained

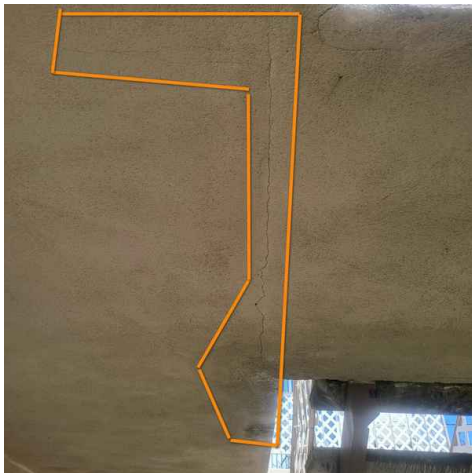
cracking, stained

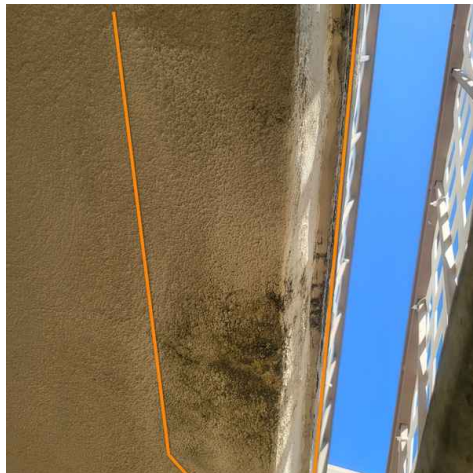
mold and mildew

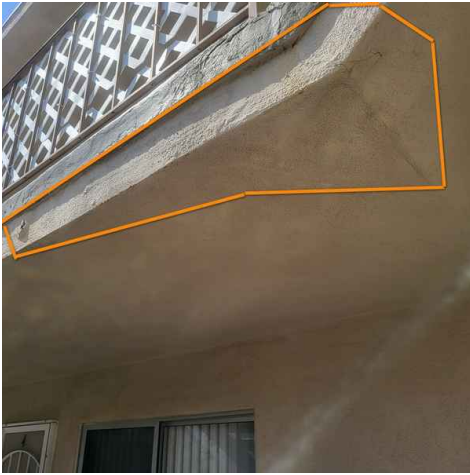
cracking, stained, bulging, bubbling, blistered, efflorescing

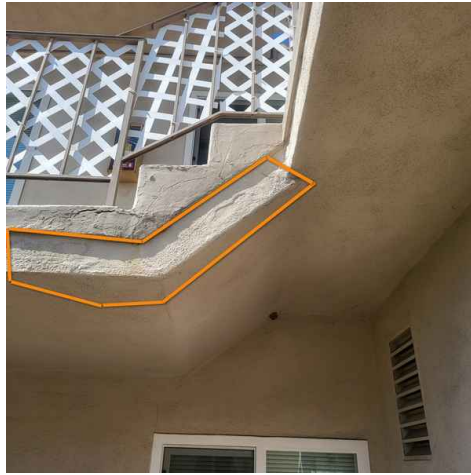
cracking, stained, bulging, bubbling, blistered, efflorescing

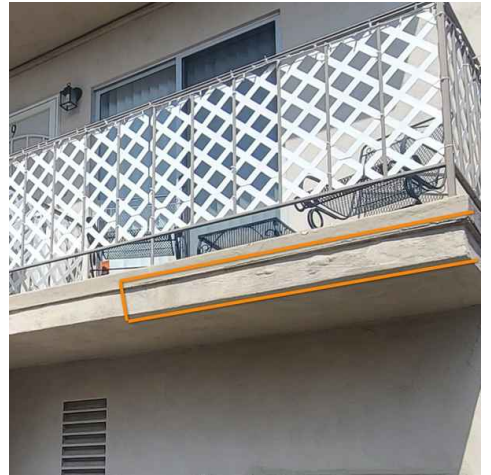
cracking, stained, bulging, bubbling, efflorescing

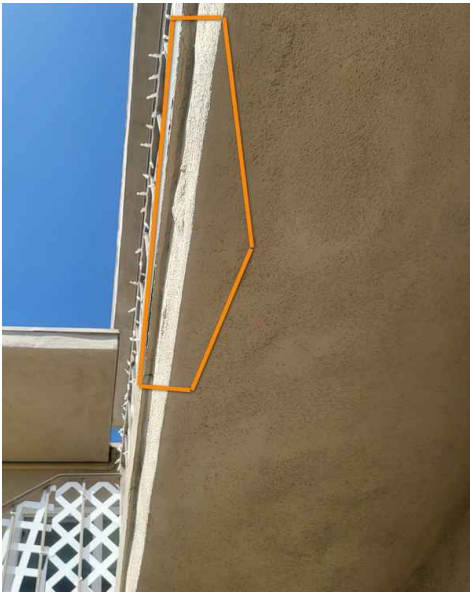
cracking, stained, bulging, bubbling, efflorescing

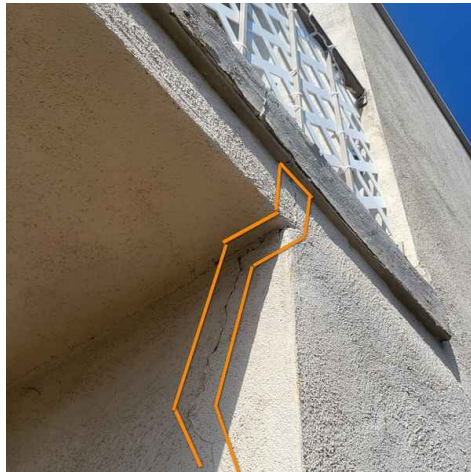
cracking

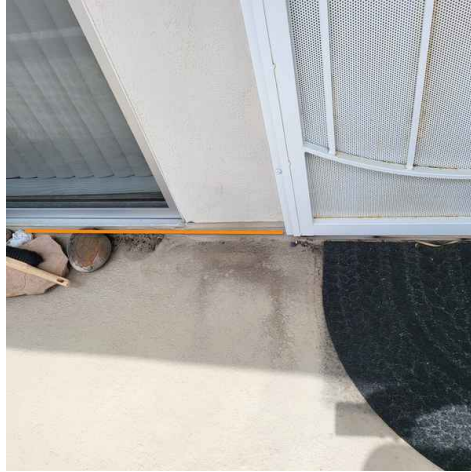
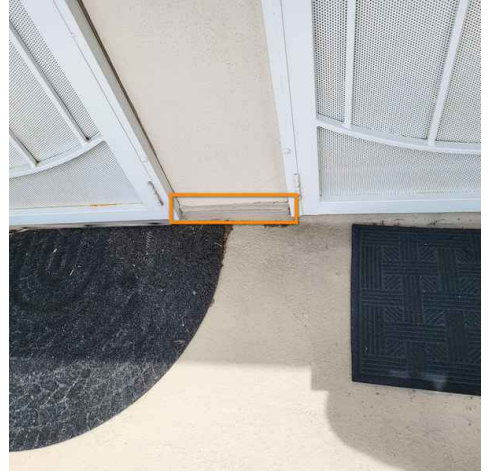
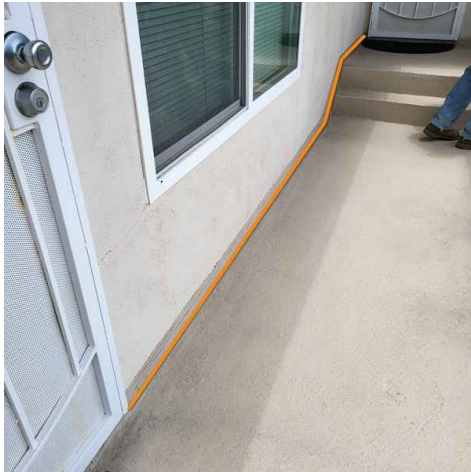
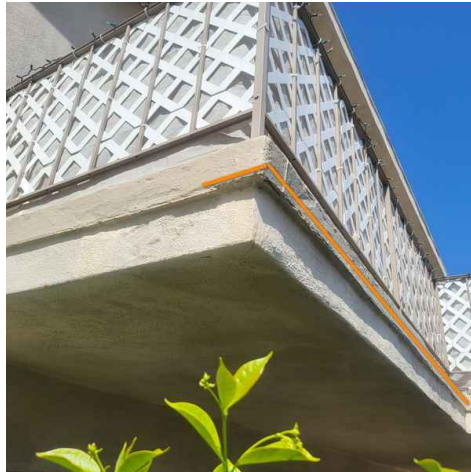
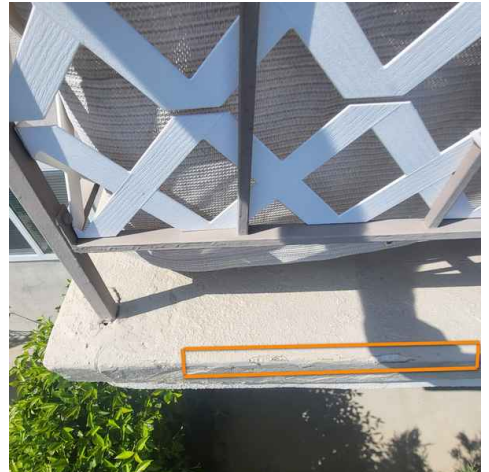
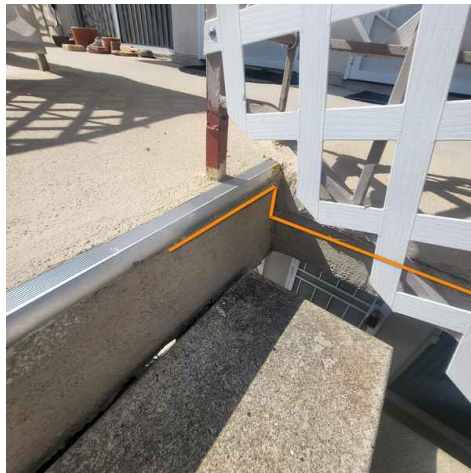
7.4.2 Walkway

Marginal - There are cracks, openings, or penetrations in the waterproofing that allow significant water intrusion. A Phase 2 Pre-721 Evaluation (P2PE) is recommended to determine the extent of any water damage via borescope inspection or larger investigative openings, and to formulate a detailed repair plan. See Reference Information: Notification and Follow Up - Marginal.

Contact a qualified professional.
