# PATRICK'S PROPERTY MAINTENANCE SERVICE

PHASE 1 PRE-721 EVALUATION BUILDING 1 UNITS 1 - 6

1234 Main Street  
Imperial Beach, CA 91932-1412

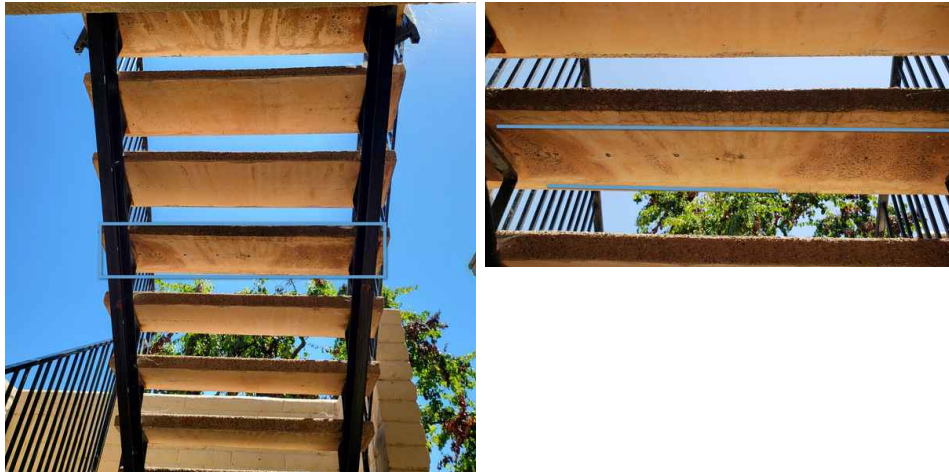
5.2.1 Main Stairway East

**DAMAGED PRECAST TREAD(S)**

Minor - Approximately 1 of 16 treads are cracked or broken. The affected stair treads appear to be the same age and are approaching the end of their service life, at a minimum the effected treads should be replaced, if not replaced a reinspection is recommended in two years.

Contact a qualified professional.

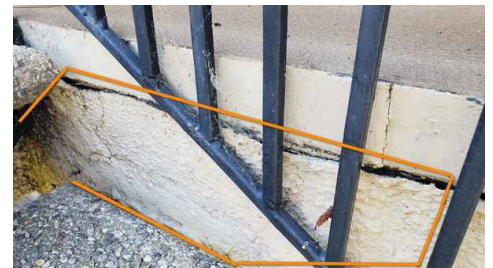
5.3.1 Walkway

**DAMAGED STUCCO 2**

Marginal - Stucco is cracking, stained, bulging, bubbling, efflorescing, soft, crumbling, discolored or showing signs of mold and mildew. These conditions are marginal. A Phase 2 Pre-721 Evaluation (P2PE) is recommended to determine the extent of any water damage via borescope inspection or larger investigative openings, and to formulate a detailed repair plan. See Reference Information: Notification and Follow Up - Marginal.

Contact a qualified professional.

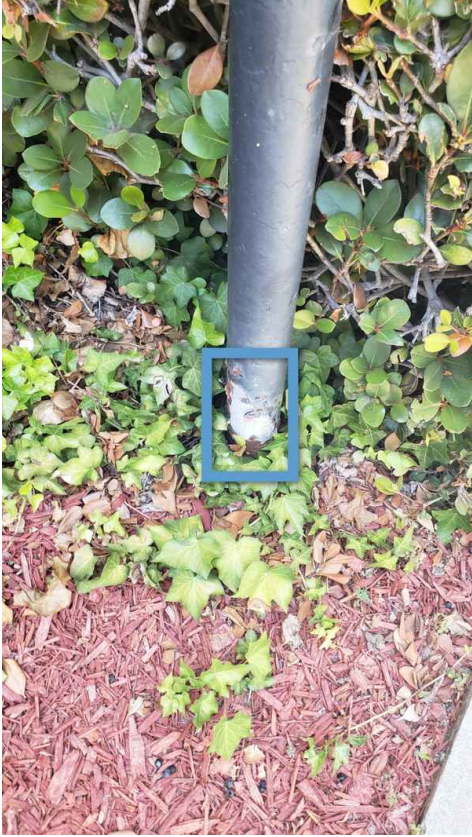
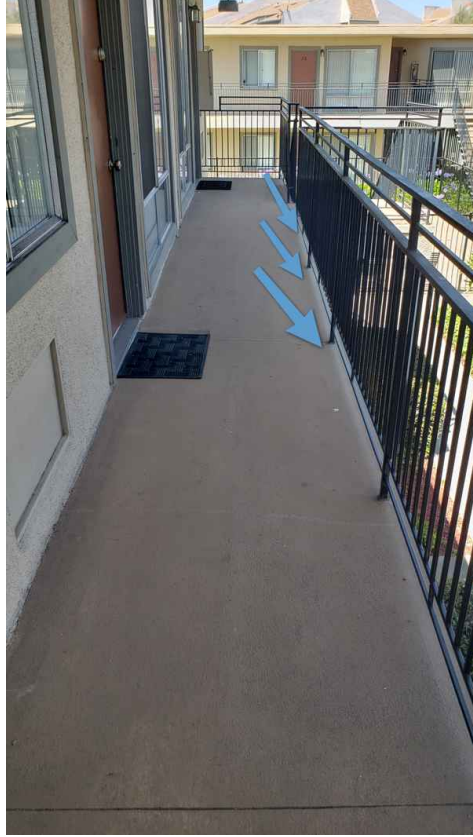
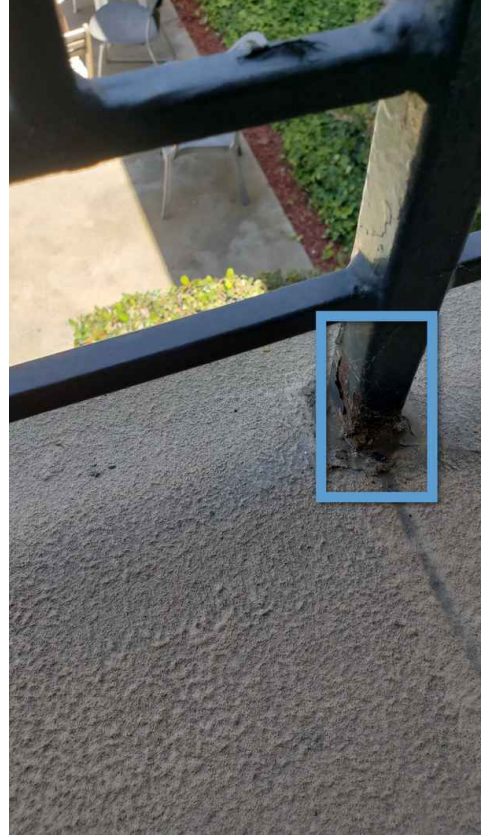
Staircase Landing Support Post

**CORROSION**

Minor - There is surface corrosion. The affected area(s) should be repaired.

Contact a qualified professional.

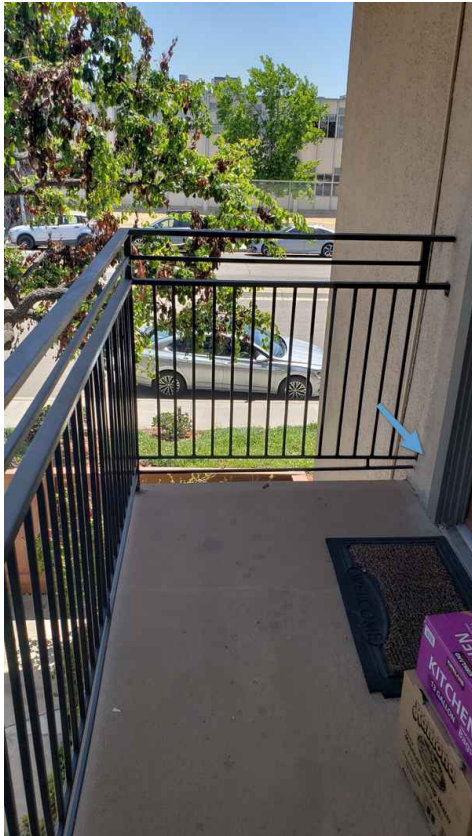
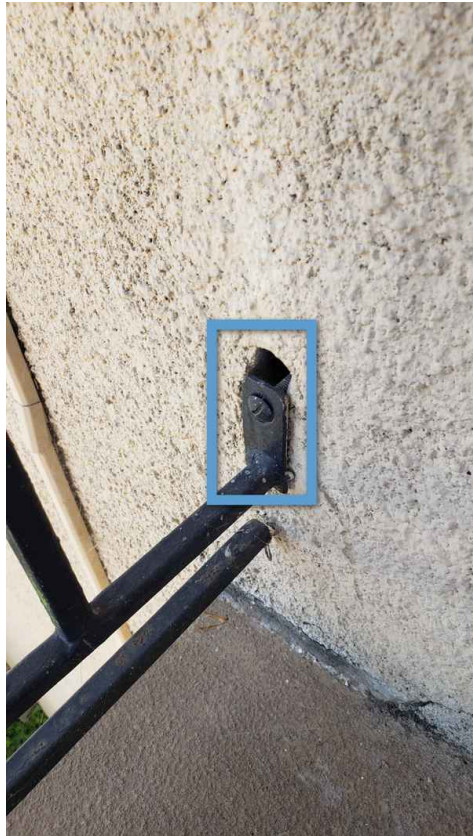
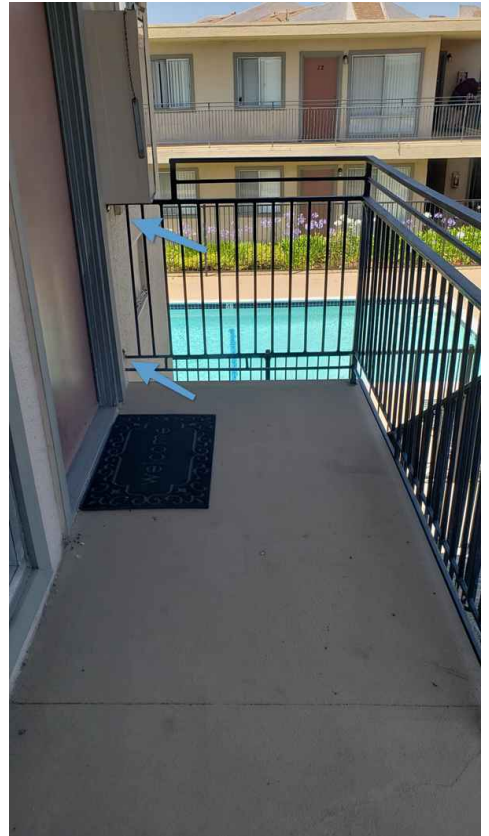
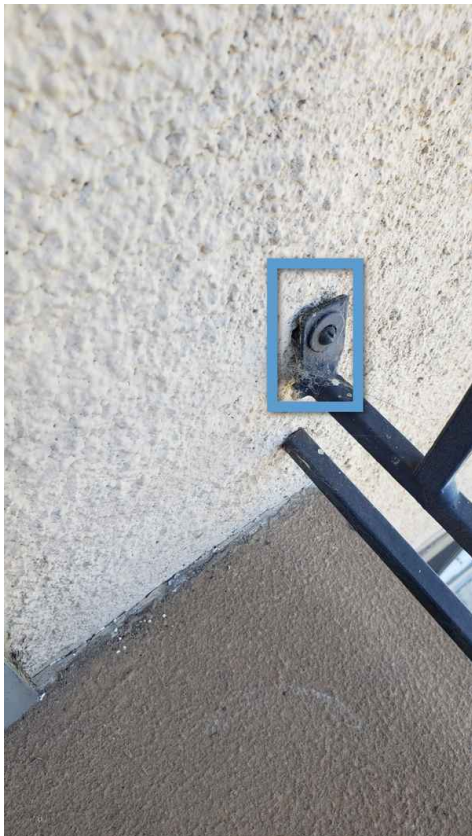
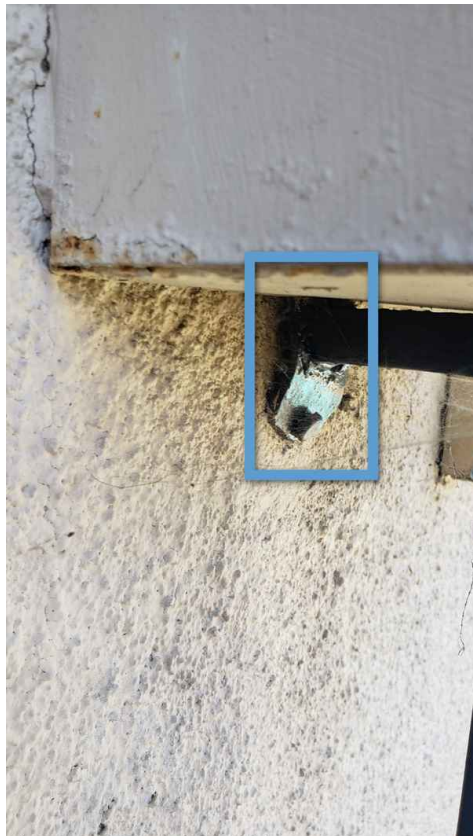
5.3.3 Walkway

**UNSEALED CONNECTION(S)**

WHERE THE RAILING ATTACHES TO THE WALL.

There are unsealed connections. Lack of proper sealing at these junctions raises concerns about potential water intrusion. These connections should be sealed

Contact a qualified professional.

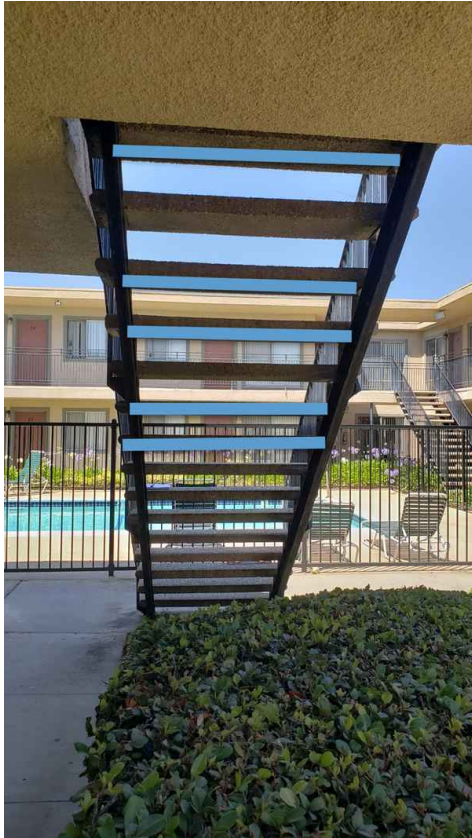
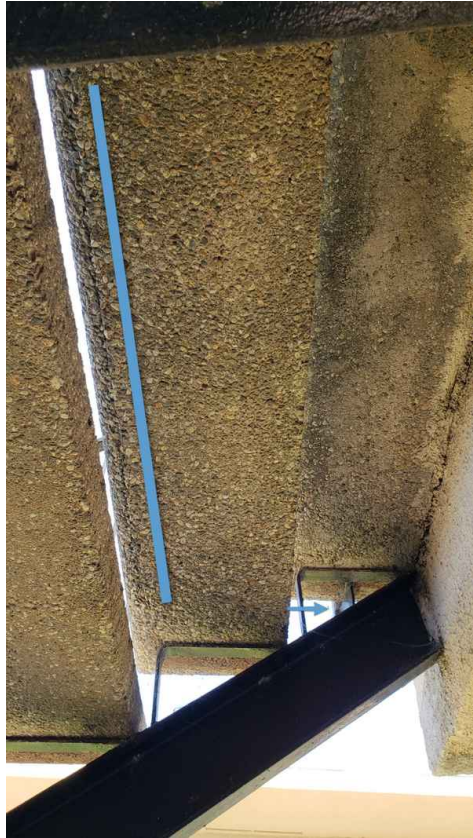
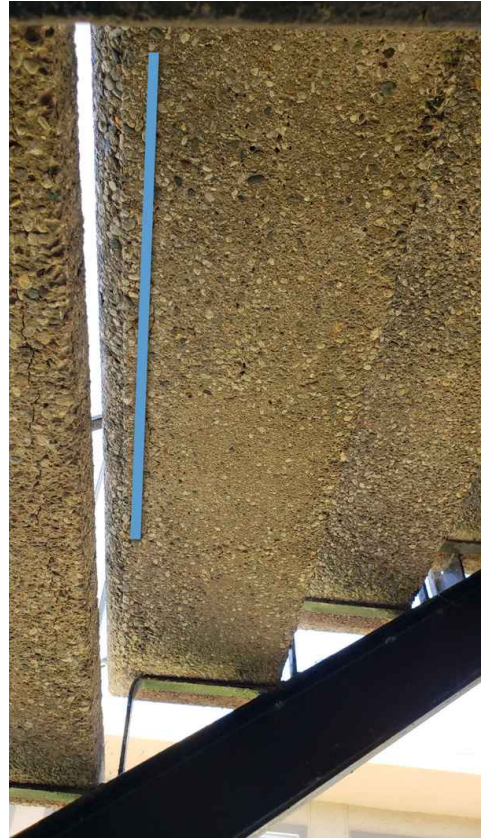
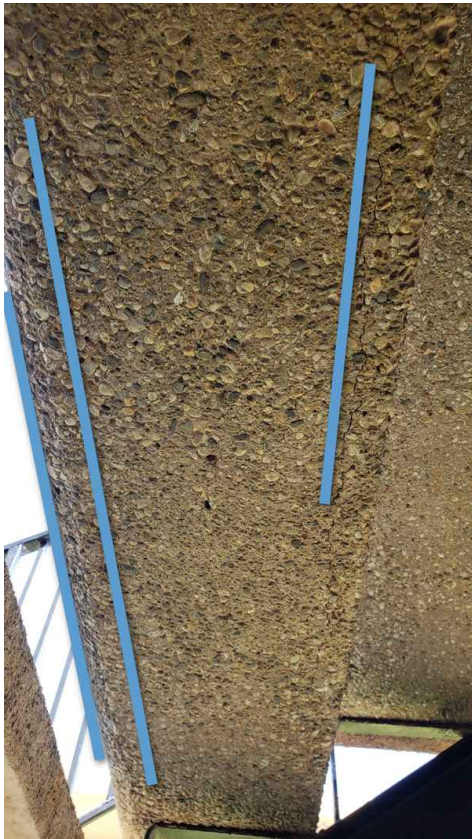
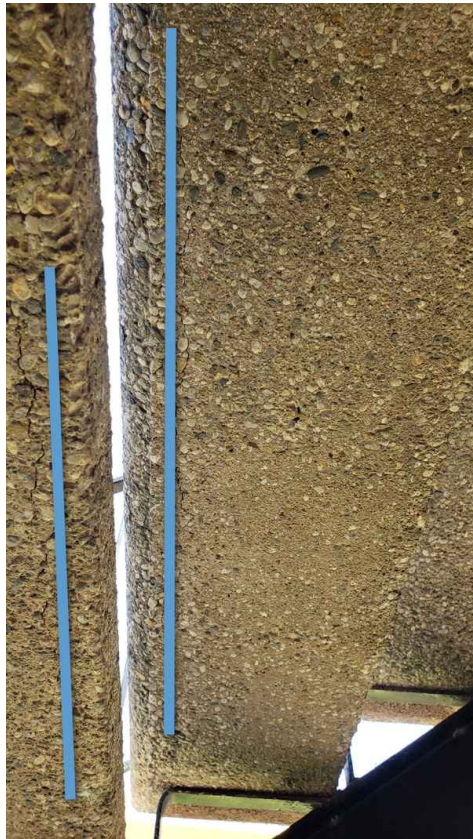
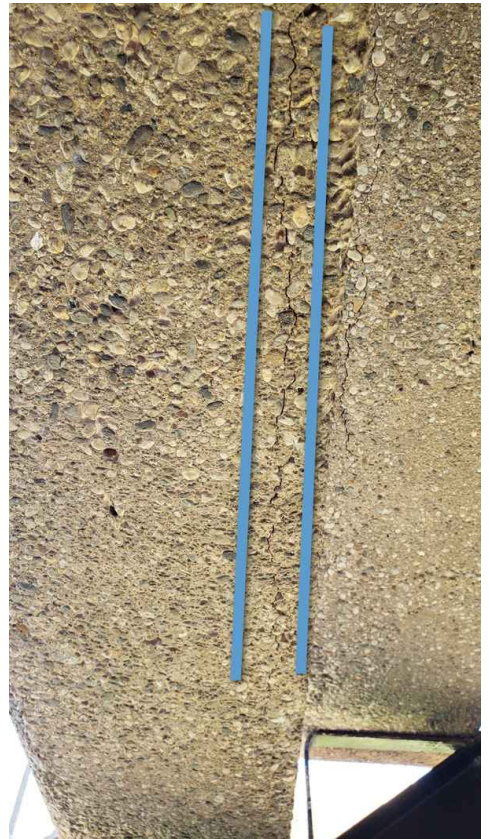
5.4.1 Stairway North

**DAMAGED PRECAST TREAD(S)**

Minor - Approximately 5 of 16 treads are cracked or broken. The affected stair treads appear to be the same age and are approaching the end of their service life, at a minimum the affected treads should be replaced, if not replaced a reinspection is recommended in two years.

Contact a qualified professional.

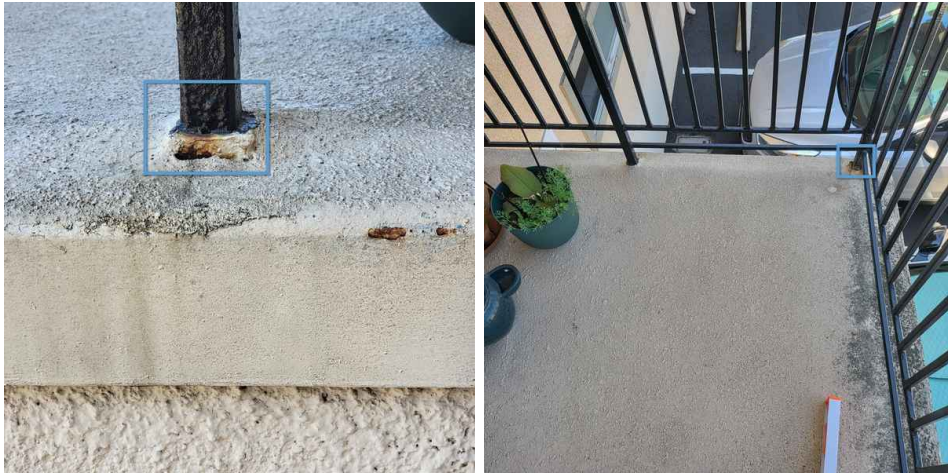
6.2.1 Apt. 2 Balcony

**CORROSION**

Minor - There is surface corrosion. The affected area(s) should be repaired.

Contact a qualified professional.

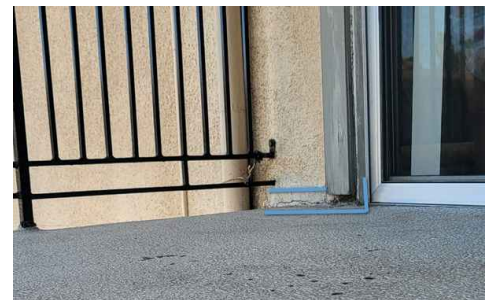
6.3.1 Apt. 4 Balcony

**OPENINGS IN WATERPROOFING**

Minor - There are cracks, openings, or penetrations in the waterproofing. The affected areas should be sealed.

Contact a qualified professional.

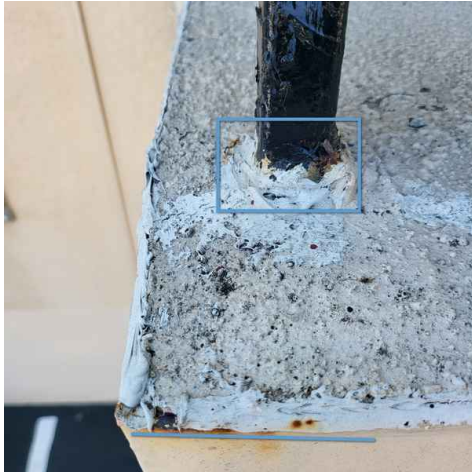
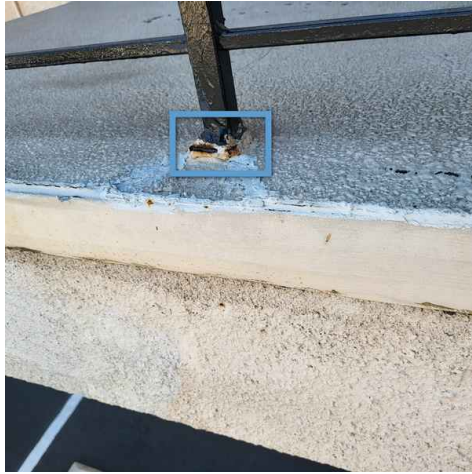
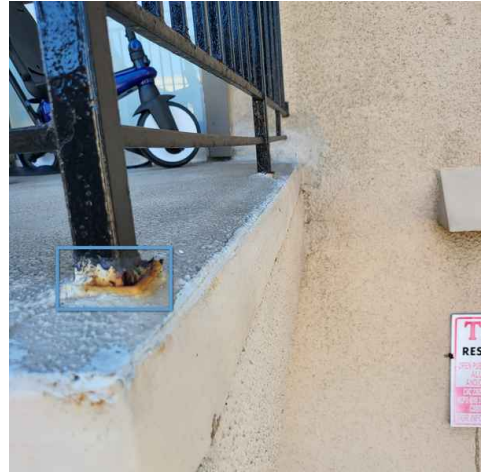
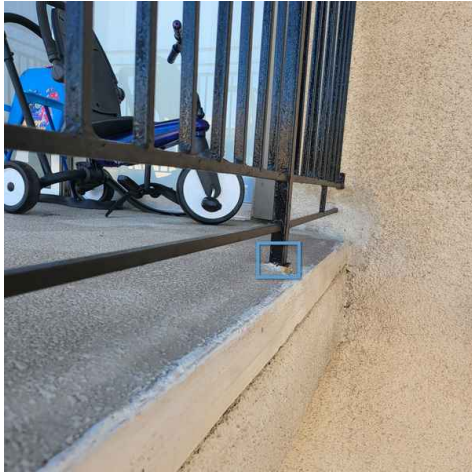
6.3.2 Apt. 4 Balcony

**CORROSION**

Minor - There is surface corrosion. The affected area(s) should be repaired.

Contact a qualified professional.

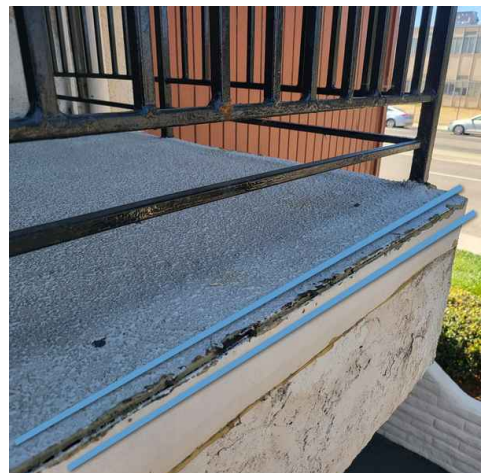
6.4.1 Apt. 6 Balcony

**OPENINGS IN WATERPROOFING**

Minor - There are cracks, openings, or penetrations in the waterproofing. The affected areas should be sealed.

Contact a qualified professional.

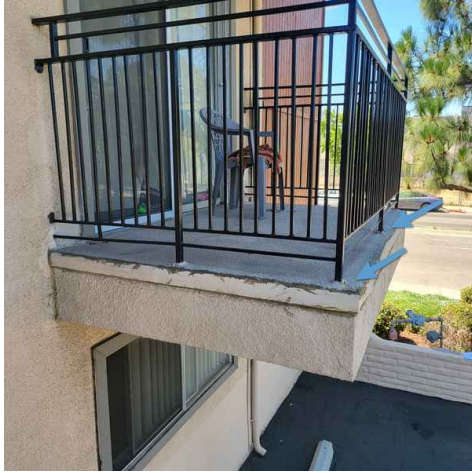
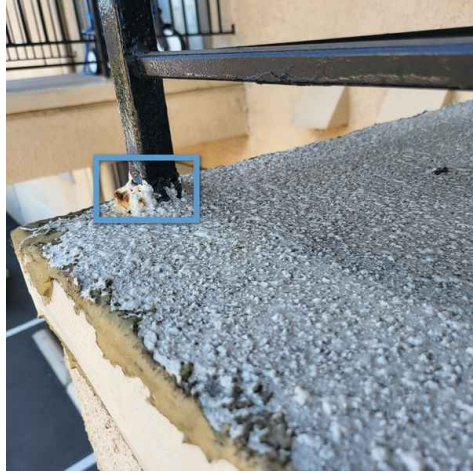
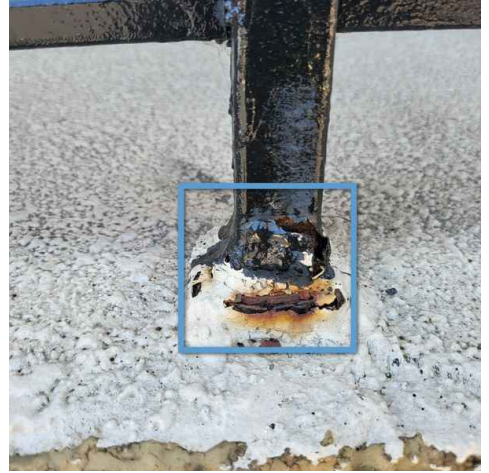
6.4.2 Apt. 6 Balcony

**CORROSION**

Minor - There is surface corrosion. The affected area(s) should be repaired.

Contact a qualified professional.

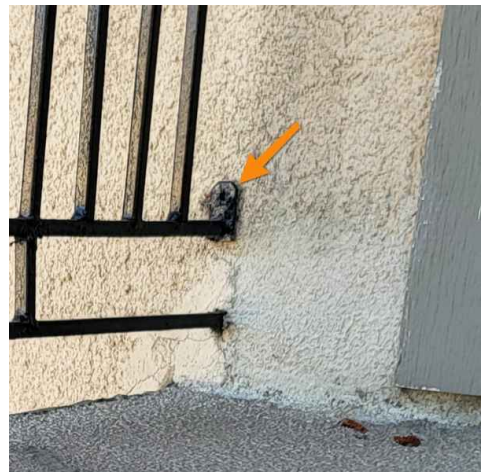
6.4.3 Apt. 6 Balcony

**MISSING OR LOOSE FASTENER(S)**

Hardware is loose or missing from the railing connections. Appropriate hardware must be installed and loose hardware tightened prior to SB-721 Inspection.

Contact a qualified professional.
