# PATRICK'S PROPERTY MAINTENANCE SERVICE

PHASE 1 PRE-721 EVALUATION BUILDING 2 UNITS 7-50

1234 Main Street  
Imperial Beach, CA 91932-1412

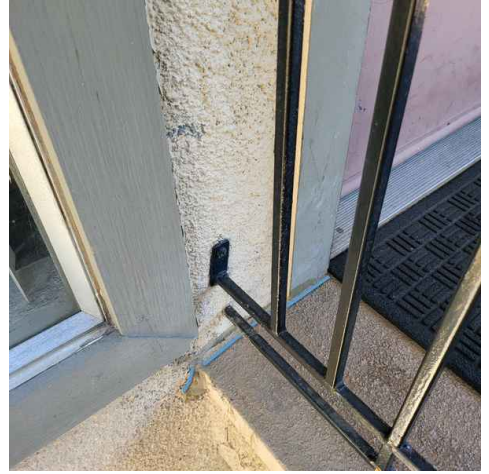
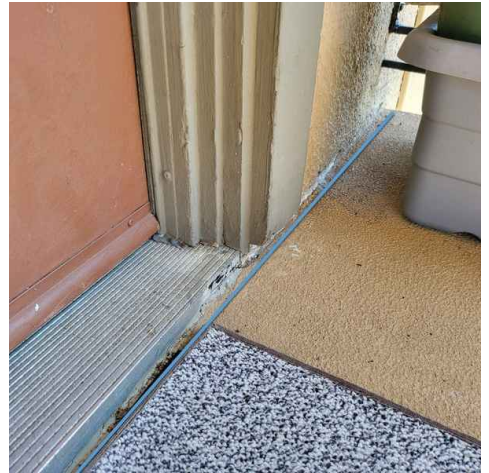
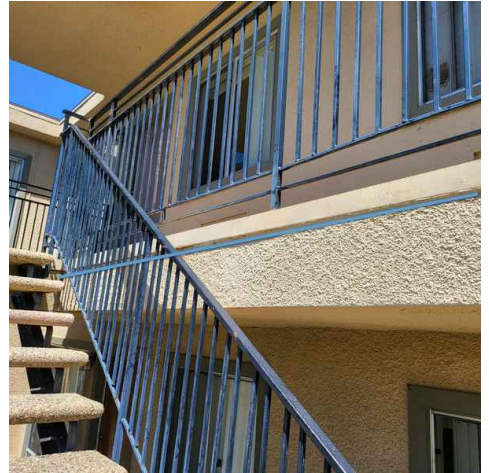
Minor - There are cracks, openings, or penetrations in the waterproofing. The affected areas should be sealed.

Contact a qualified professional.

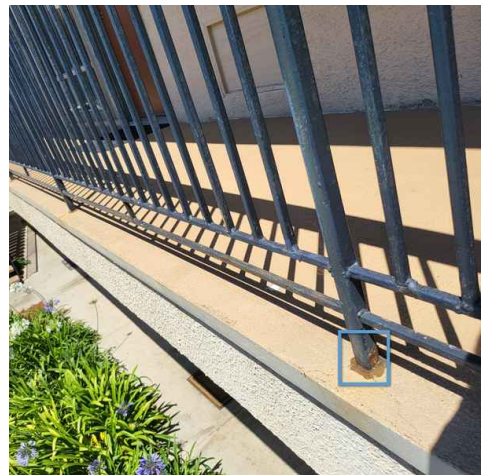
5.2.2 East Walkway

**CORROSION**

Minor - There is surface corrosion. The affected area(s) should be repaired.

Contact a qualified professional.

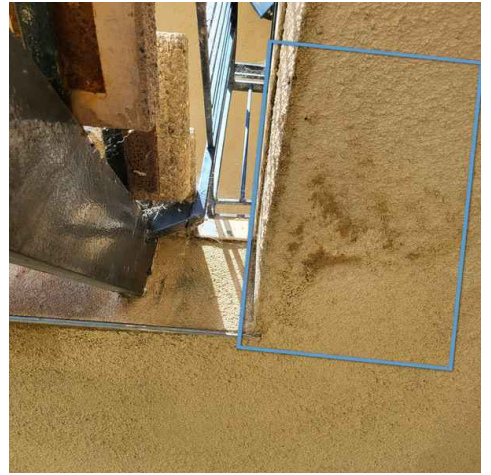
5.2.3 East Walkway

**DAMAGED STUCCO**

Minor - Stucco is cracking, stained, bulging, bubbling, blistering, efflorescing, soft, crumbling, discolored or showing signs of mold and mildew. These condition(s) are minor, and can be addressed as maintenance items.

Discolored

Contact a qualified professional.

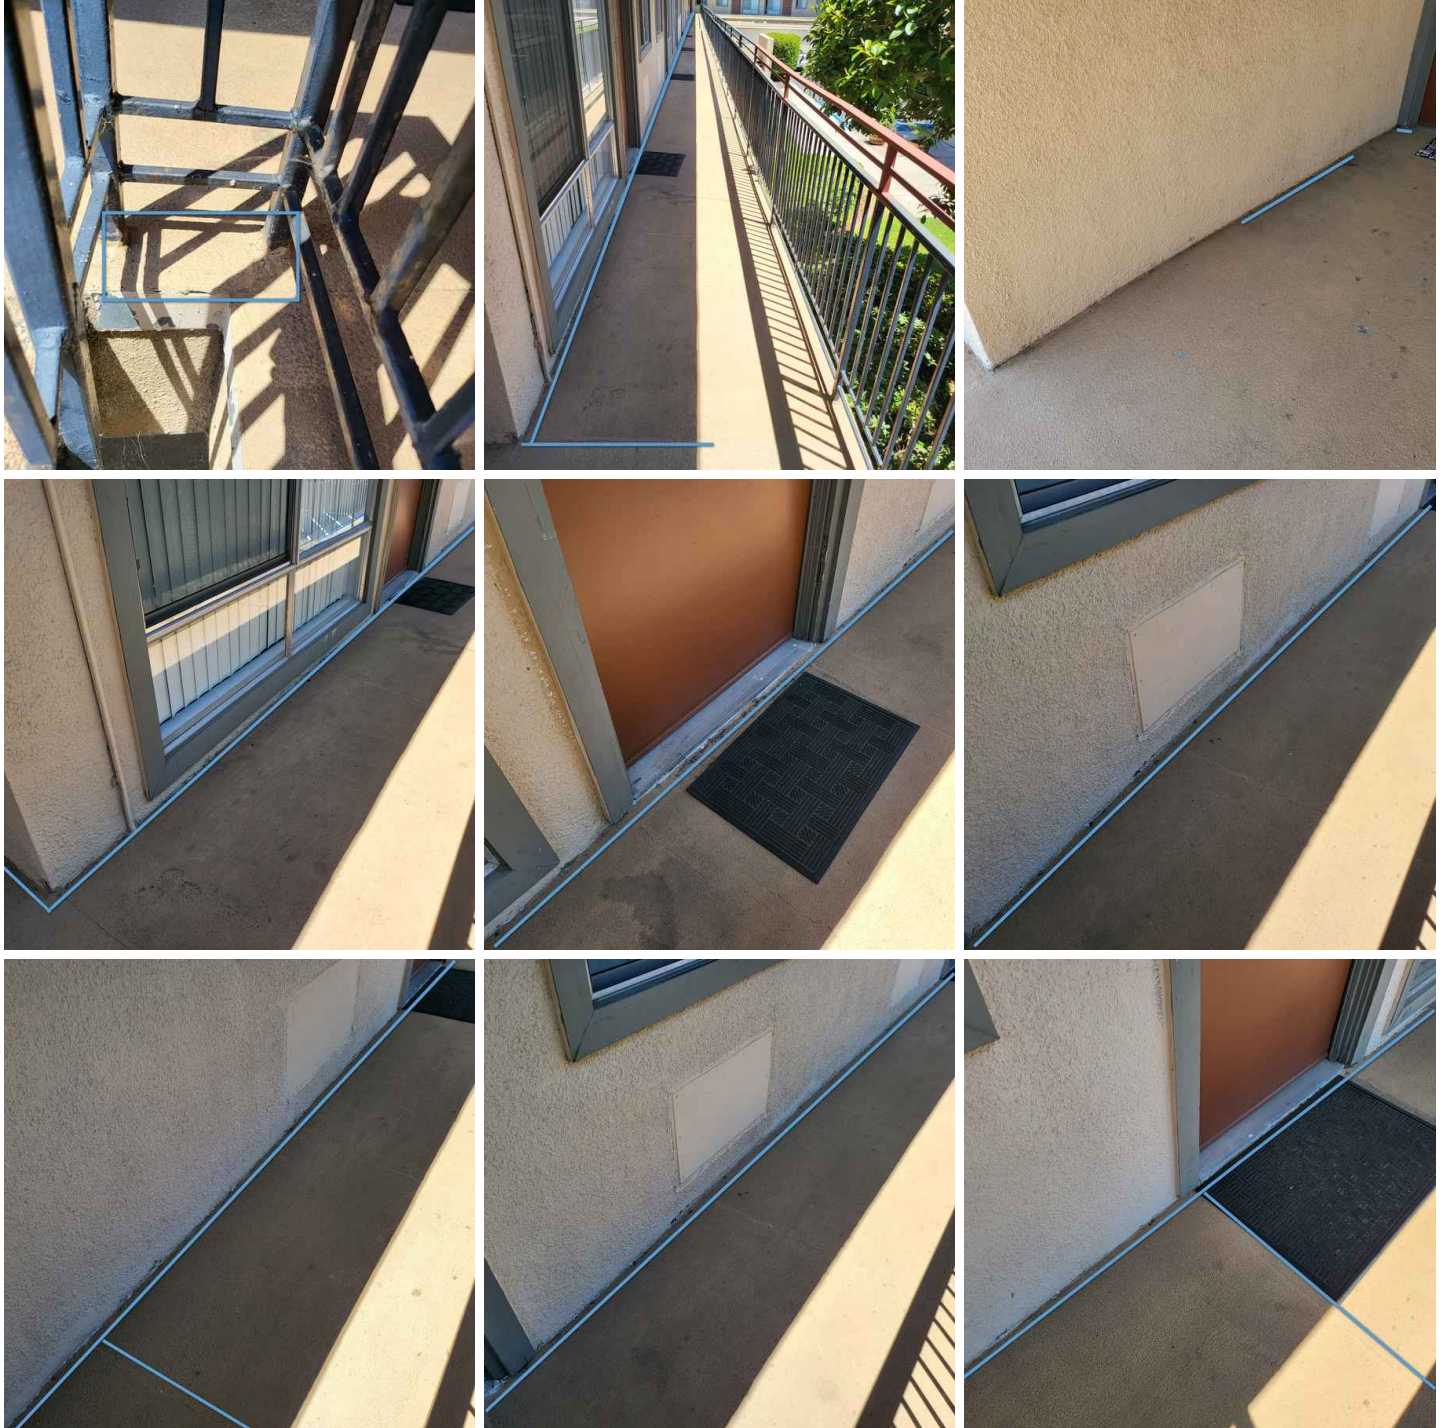
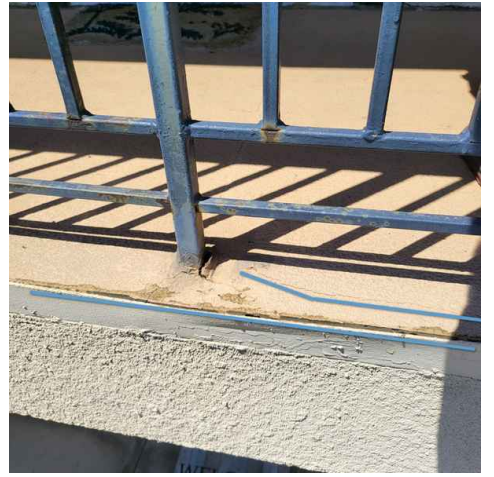
5.3.1 North Walkway

Minor - There are cracks, openings, or penetrations in the waterproofing. The affected areas should be sealed.

Contact a qualified professional.

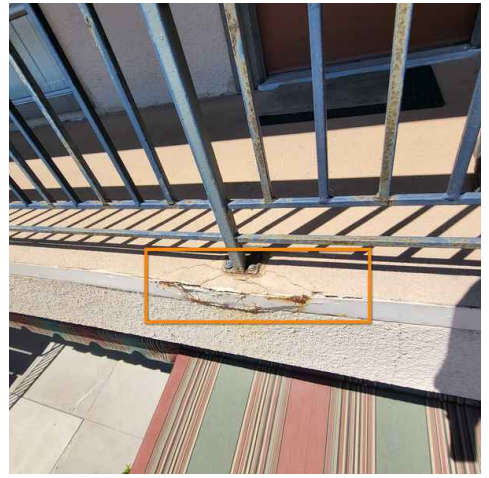
5.3.2 North Walkway

**CORROSION**

Minor - There is surface corrosion. The affected area(s) should be repaired.

Contact a qualified professional.

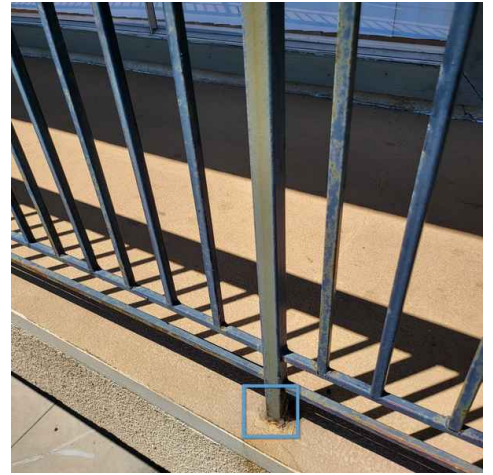
## 5.3.3 North Walkway

**CORROSION 2**

Minor - There is surface corrosion. The affected area(s) should be repaired.

Contact a qualified professional.

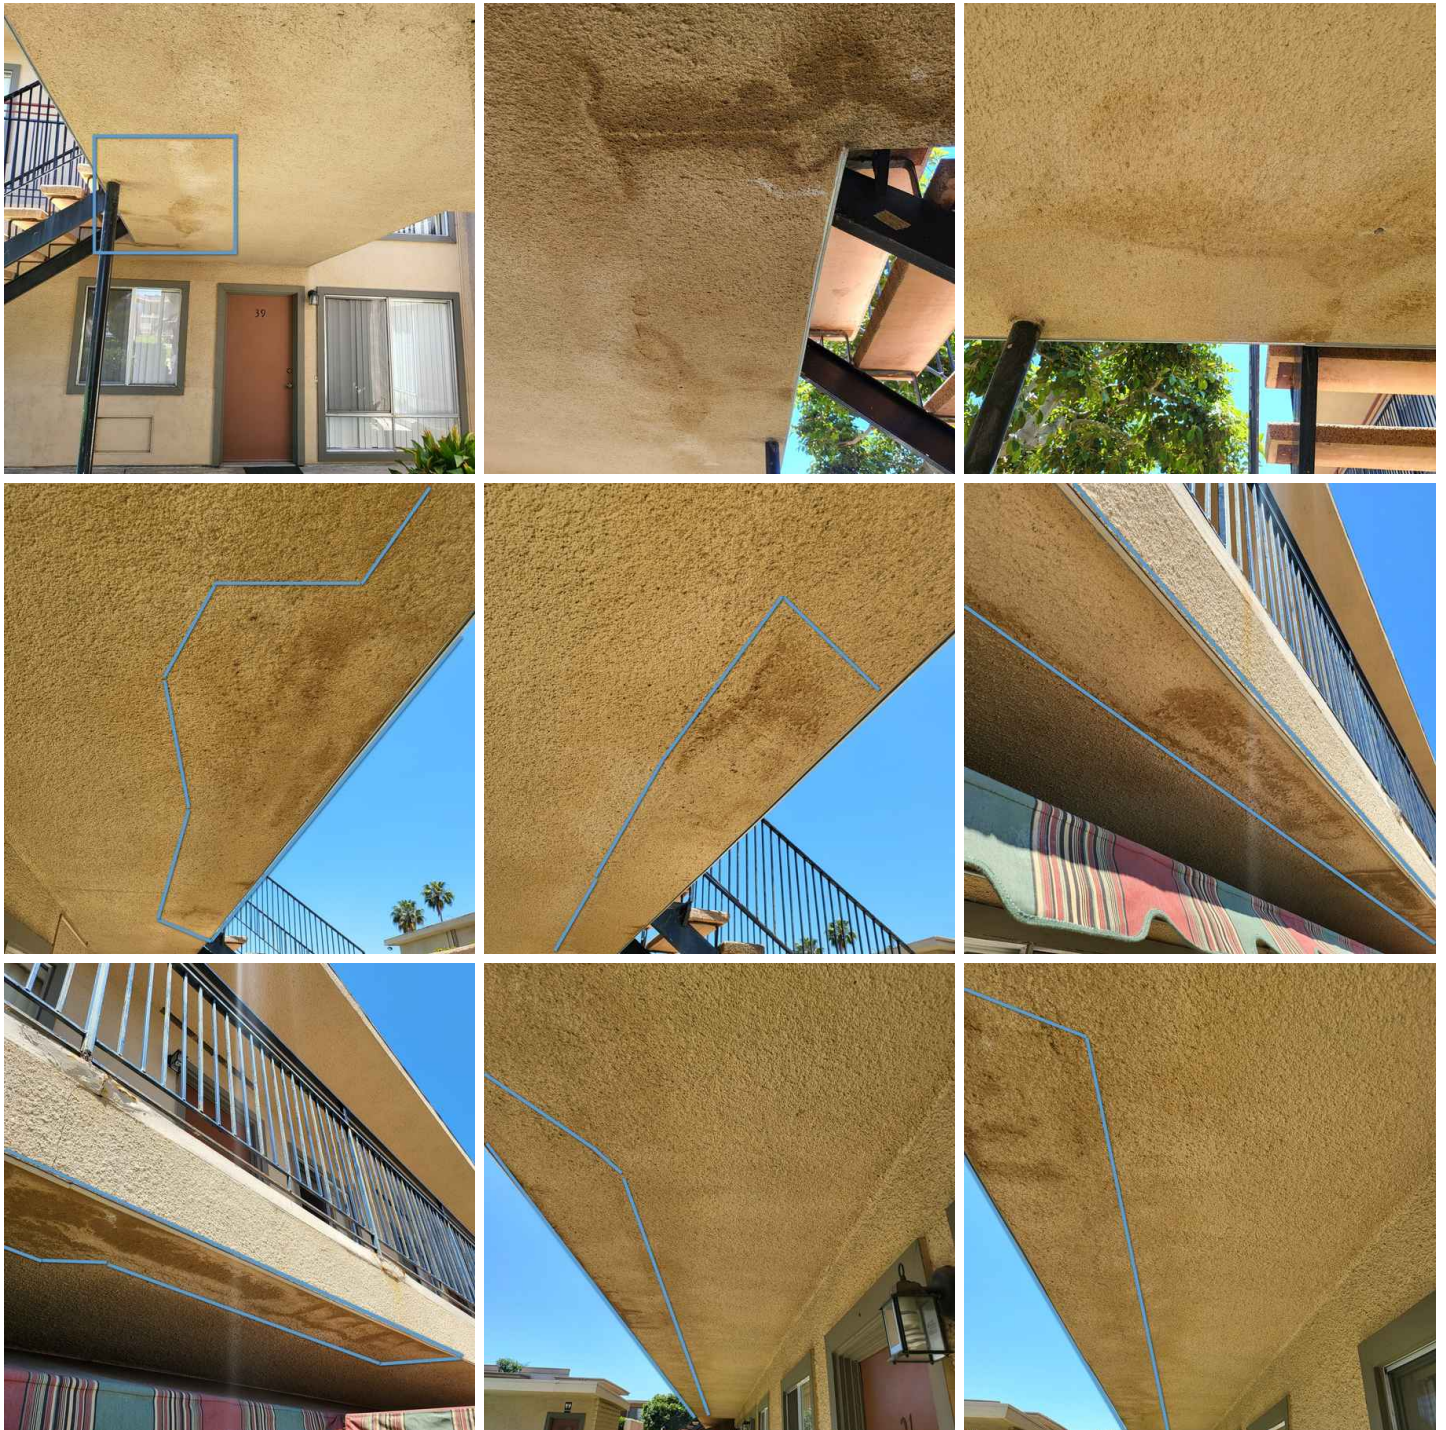
5.3.4 North Walkway

**DAMAGED STUCCO**

Minor - Stucco is cracking, stained, bulging, bubbling, blistering, efflorescing, soft, crumbling, discolored or showing signs of mold and mildew. These condition(s) are minor, and can be addressed as maintenance items.

Contact a qualified professional.

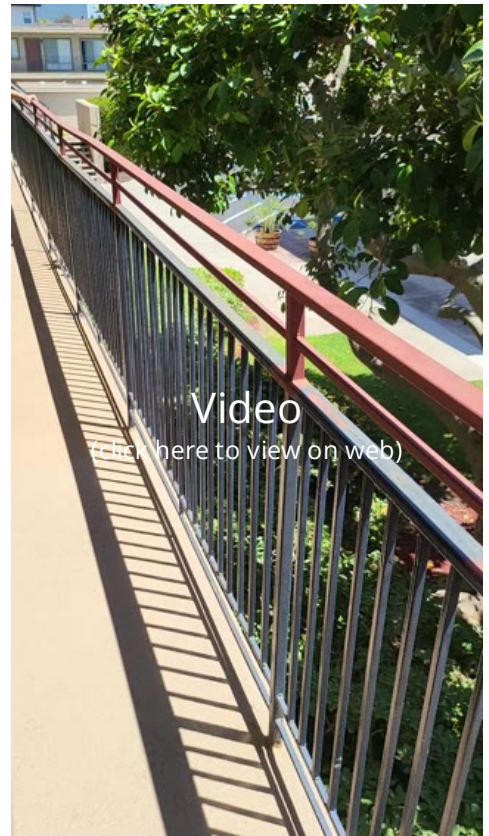
5.3.6 North Walkway

Marginal - The inspection revealed inadequate or improper construction, or evidence of instability in the support structure. This condition suggests that the support construction may not adhere to regulatory standards, potentially leading to long-term issues. A Phase 2 Pre-721 Evaluation (P2PE) is recommended to formulate a detailed repair plan. See Reference Information: Notification and Follow-Up - Marginal.

Contact a qualified professional.

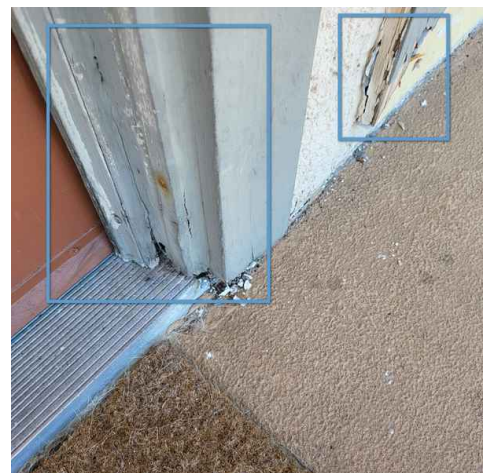
5.3.7 North Walkway

**TERMITE/WOOD ROT DAMAGE**

Minor - There is minor evidence of wood boring insect intrusion and/or wood rot which may include bore-holes or tunnels, pellets and droppings, weakness, softness, live insects, discoloration, crumbling texture, or fungal growth. These condition(s) are minor, the affected components should be treated or replaced.

Contact a qualified professional.

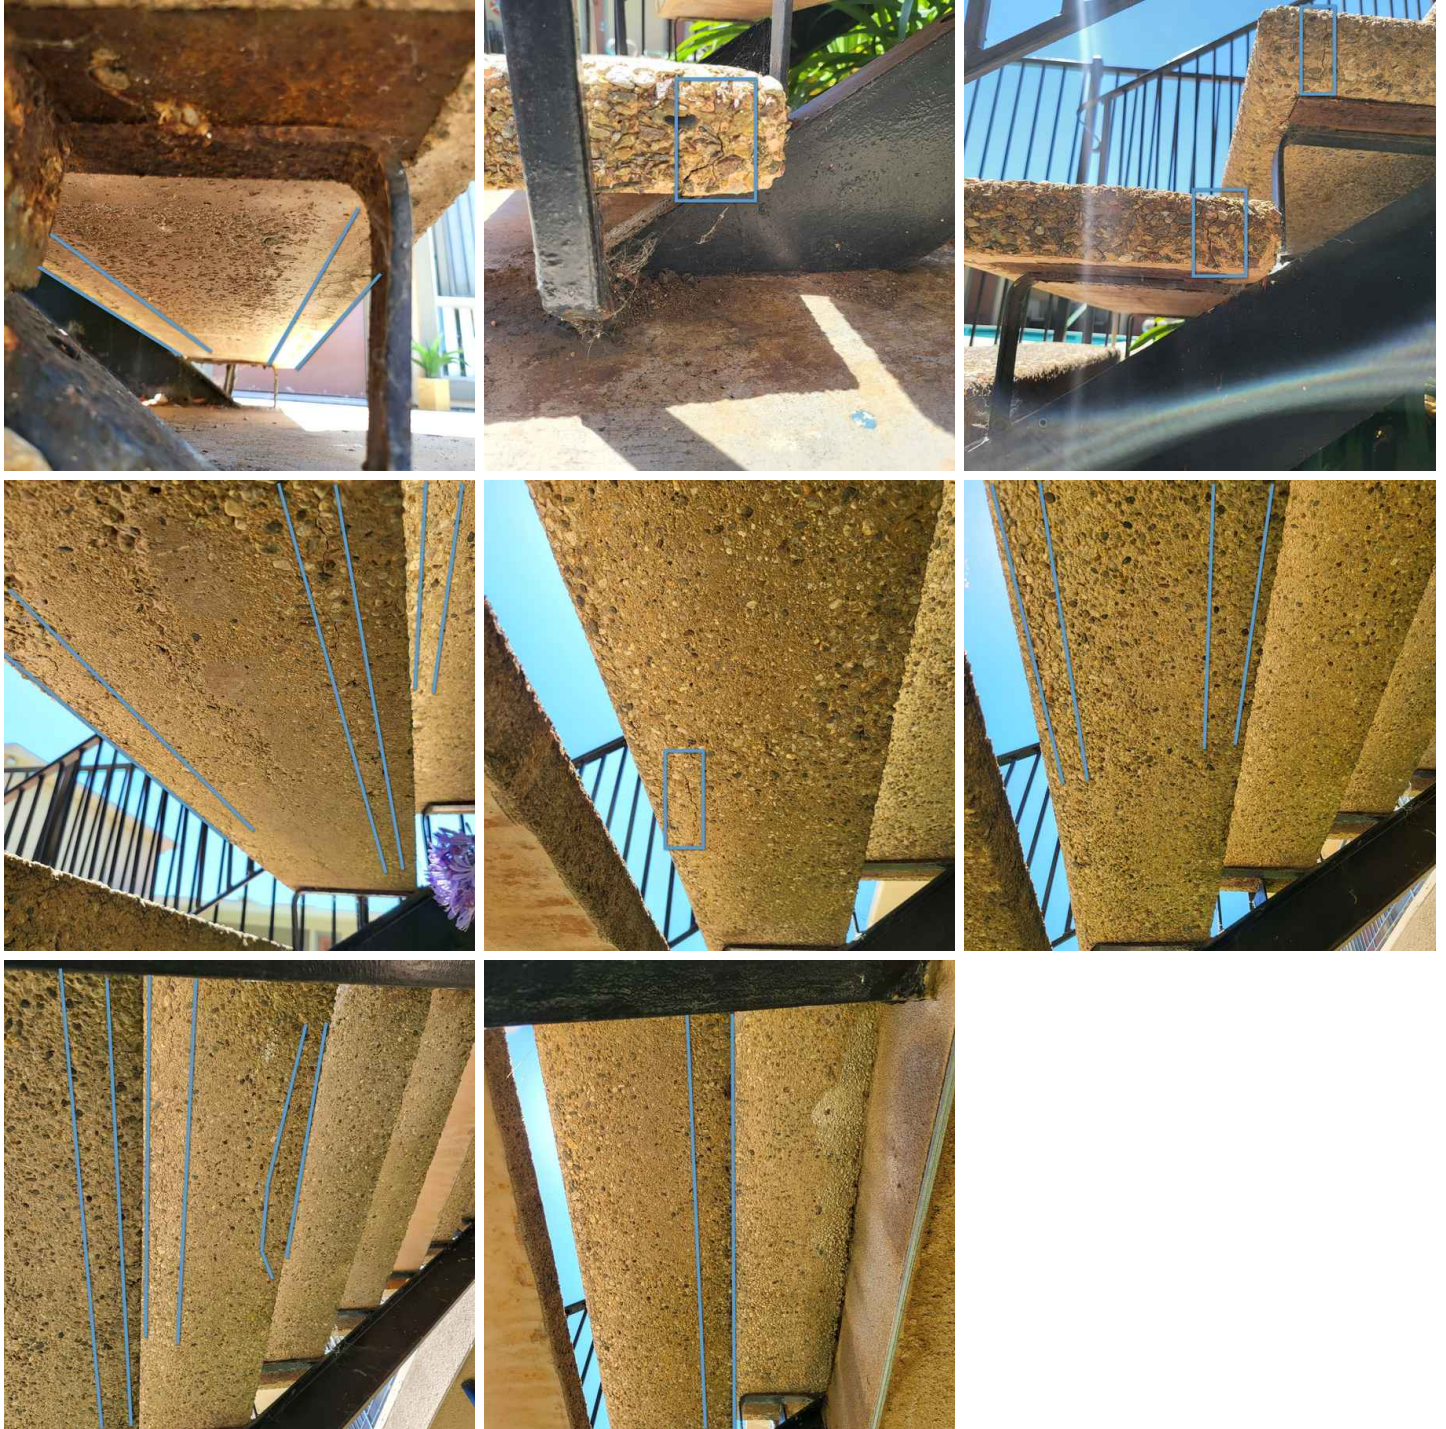
5.4.1 Northeast Stairway

**DAMAGED PRECAST TREAD(S)**

Minor - Approximately 7 of 16 treads are cracked or broken. The affected stair treads appear to be the same age and are approaching the end of their service life, at a minimum the effected treads should be replaced, if not replaced a reinspection is recommended in two years.

Contact a qualified professional.

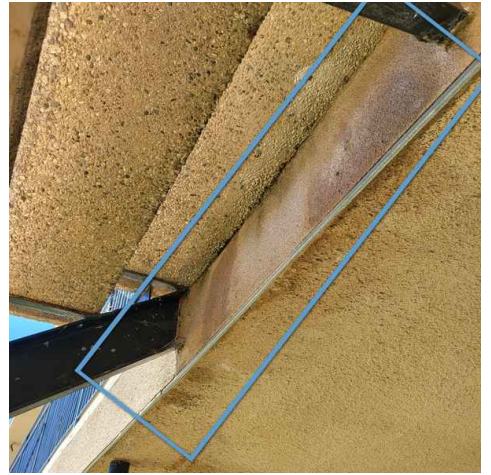
5.4.2 Northeast Stairway

**DAMAGED STUCCO**

Minor - Stucco is cracking, stained, bulging, bubbling, blistering, efflorescing, soft, crumbling, discolored or showing signs of mold and mildew. These condition(s) are minor, and can be addressed as maintenance items.

Staining

Contact a qualified professional.

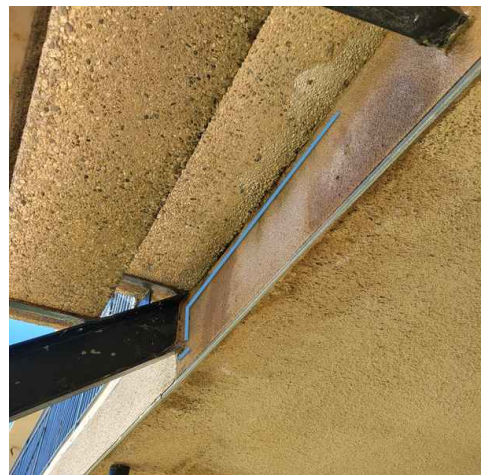
5.4.3 Northeast Stairway

Minor - There are cracks, openings, or penetrations in the waterproofing. The affected areas should be sealed.

Contact a qualified professional.

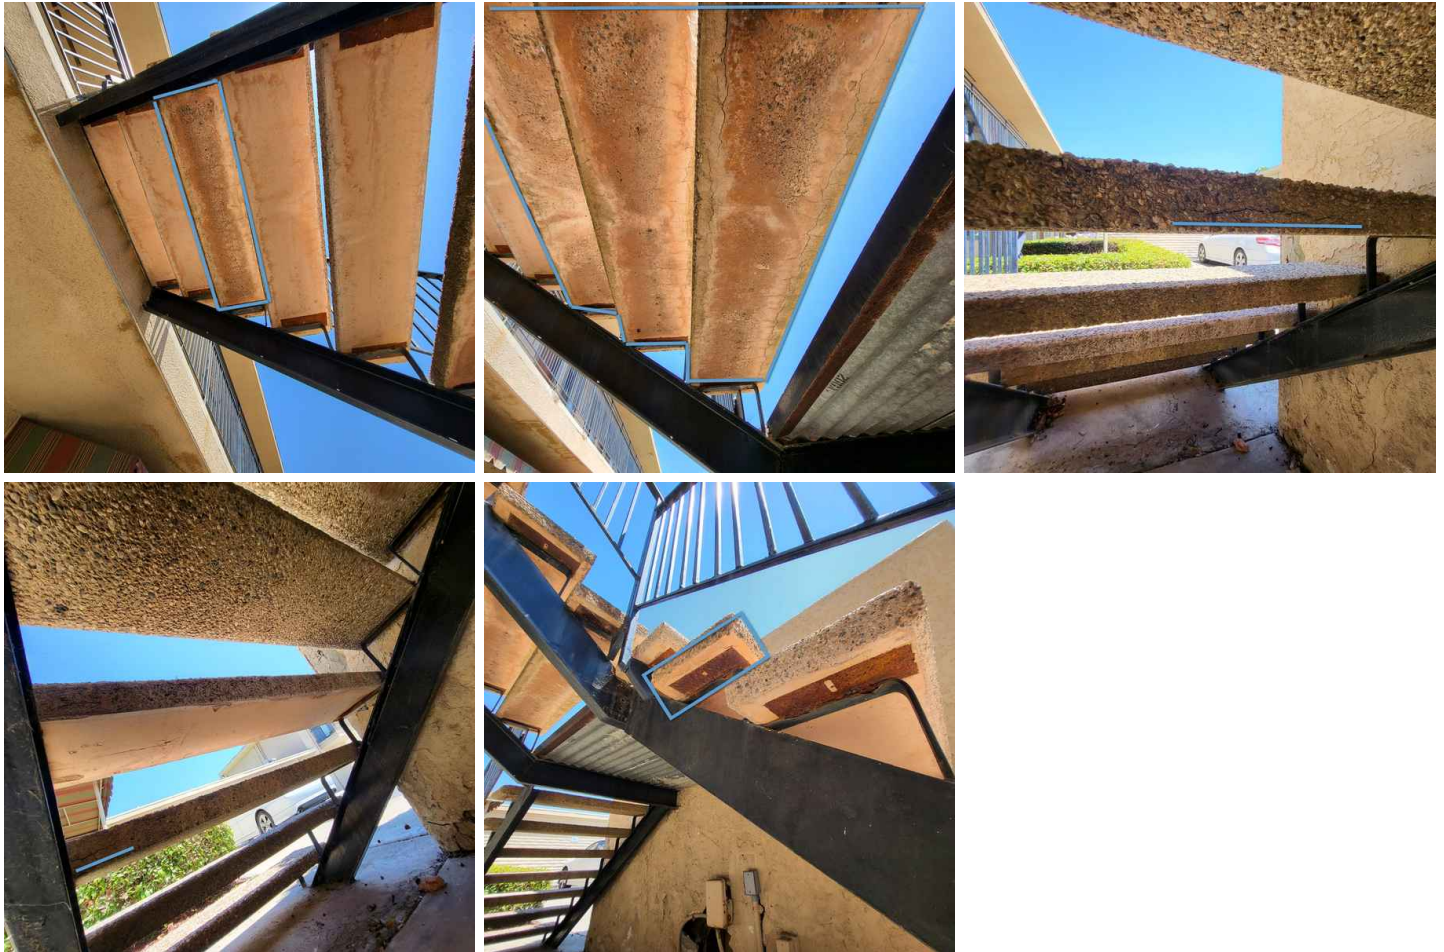
5.5.1 Middle Stairway

**DAMAGED PRECAST TREAD(S)**

Minor - Approximately 7 of 15 treads are cracked or broken. The affected stair treads appear to be the same age and are approaching the end of their service life, at a minimum the effected treads should be replaced, if not replaced a reinspection is recommended in two years.

Contact a qualified professional.

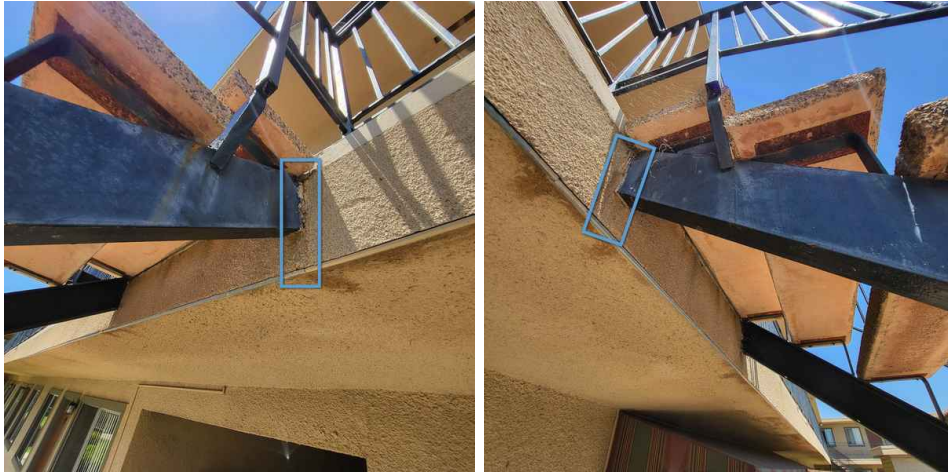
## 5.5.2 Middle Stairway

Minor - There are cracks, openings, or penetrations in the waterproofing. The affected areas should be sealed.

Contact a qualified professional.

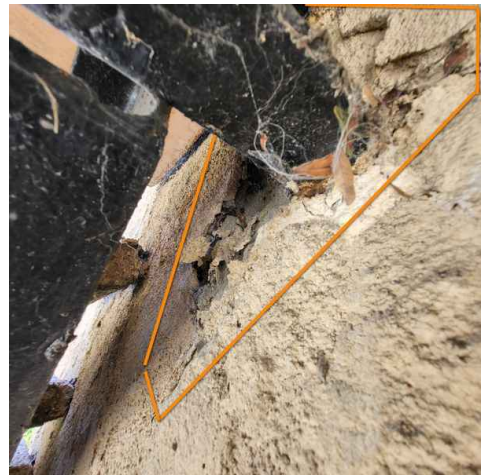
5.5.3 Middle Stairway

**DAMAGED SUPPORT STRUCTURE**

Marginal - There is damage to the support structure which may include sagging, bowing, cracks, warping, splitting, shifting, leaning, falling. These condition(s) are significant and suggest that the integrity of the support structure may be compromised. A Phase 2 Pre-721 Evaluation (P2PE) is recommended to formulate a detailed repair plan. See Reference Information: Notification and Follow Up - Marginal.

Contact a qualified professional.

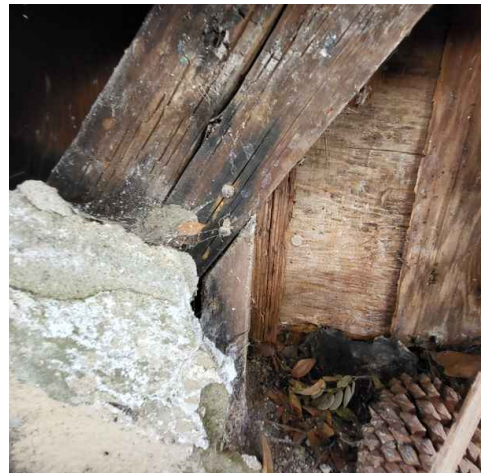
5.5.4 Middle Stairway

**TERMITE/WOOD ROT DAMAGE**

Minor - There is minor evidence of wood boring insect intrusion and/or wood rot which may include bore-holes or tunnels, pellets and droppings, weakness, softness, live insects, discoloration, crumbling texture, or fungal growth. These condition(s) are minor, the affected components should be treated or replaced.

Contact a qualified professional.

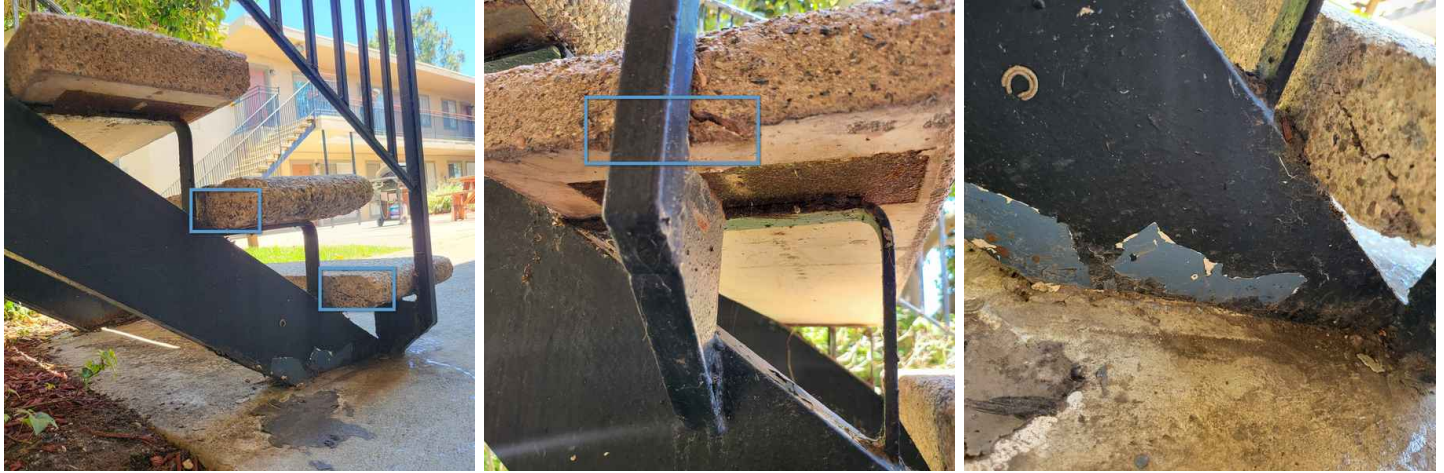
5.6.1 Northwest Stairway

**DAMAGED PRECAST TREAD(S)**

Minor - Approximately 3 of 16 treads are cracked or broken. The affected stair treads appear to be the same age and are approaching the end of their service life, at a minimum the effected treads should be replaced, if not replaced a reinspection is recommended in two years.

Contact a qualified professional.

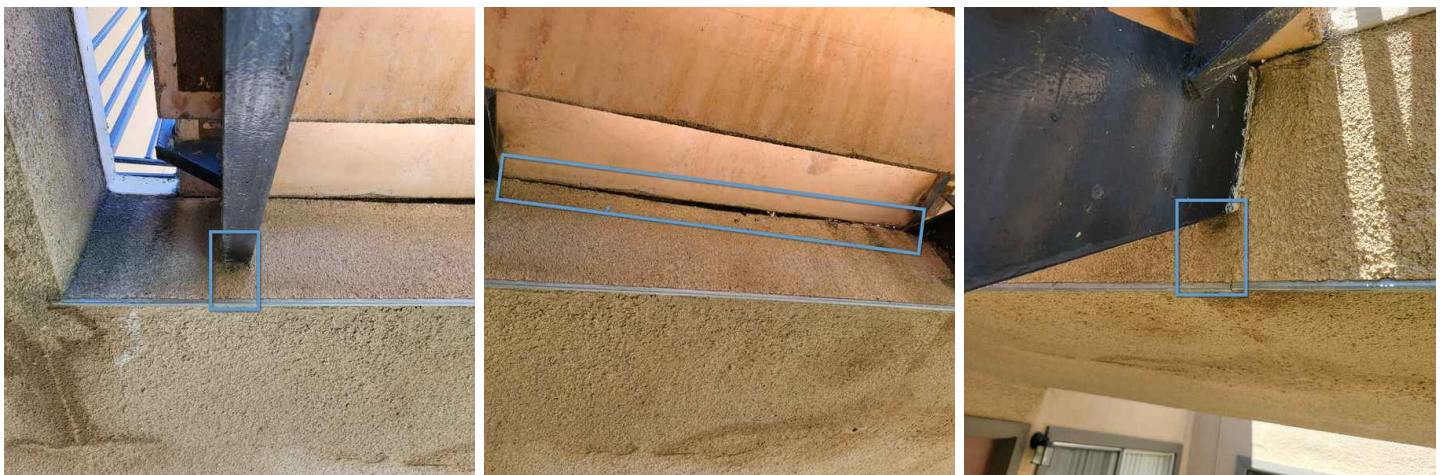
5.6.2 Northwest Stairway

Minor - There are cracks, openings, or penetrations in the waterproofing. The affected areas should be sealed.

Contact a qualified professional.

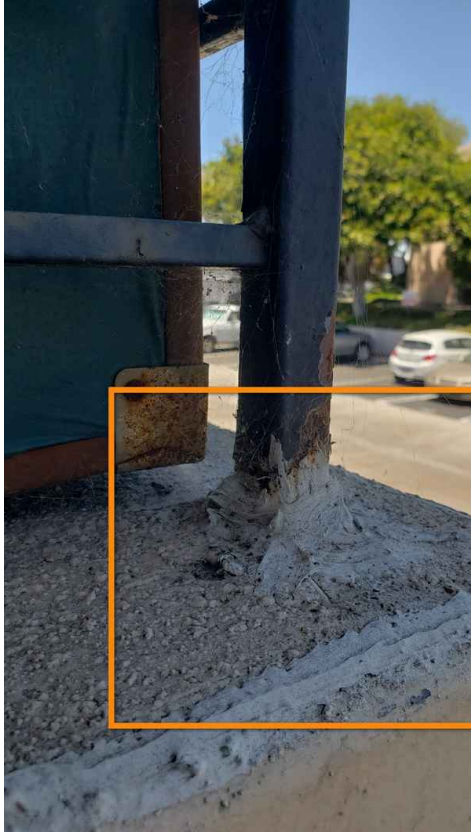
6.15.3 Apt. 32 Balcony

expansion from corrosion

Contact a qualified professional.
