PATRICK'S PROPERTY MAINTENANCE SERVICE

PHASE 1 PRE-721 EVALUATION BUILDING 3 UNITS 51 - 56

1234 Main Street
Imperial Beach, CA 91932-1412

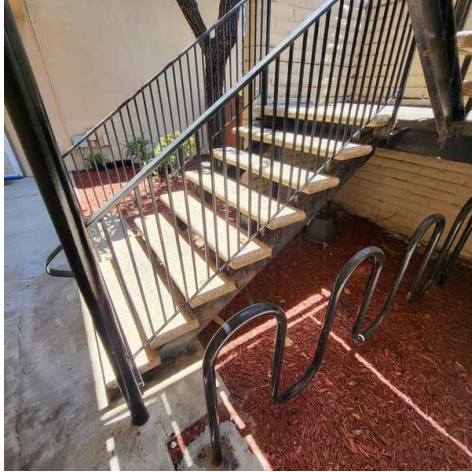
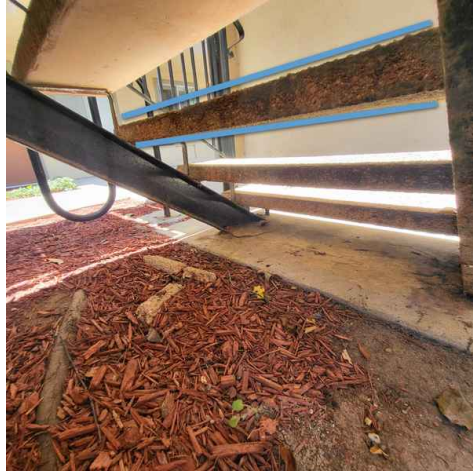
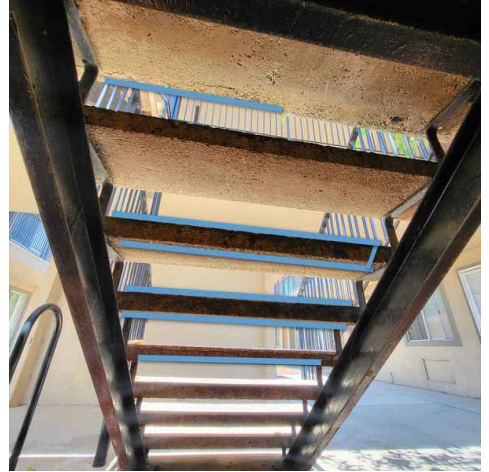
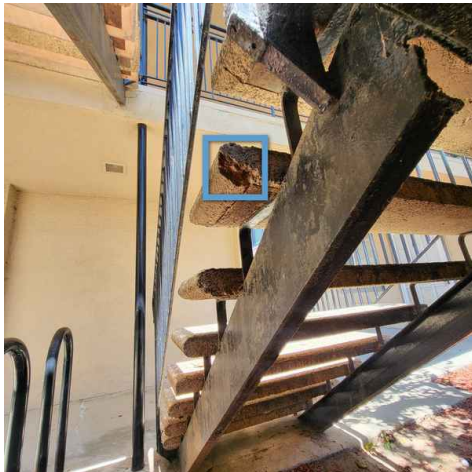
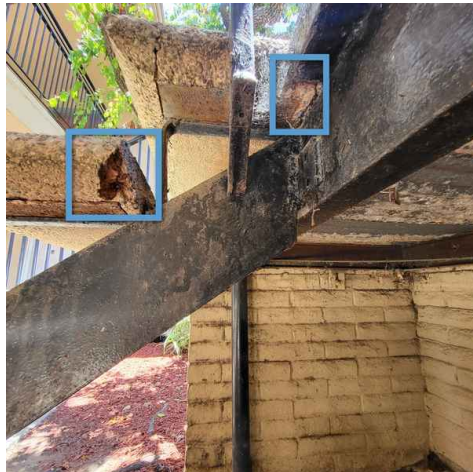
5.2.1 Main Stairway West

DAMAGED PRECAST TREAD(S)

Minor - Approximately 5 of 15 treads are cracked, broken or show severe aging. The affected stair treads appear to be the same age and are approaching the end of their service life, at a minimum the effected treads should be replaced, if not replaced a reinspection is recommended in two years.

Thread shows severe aging

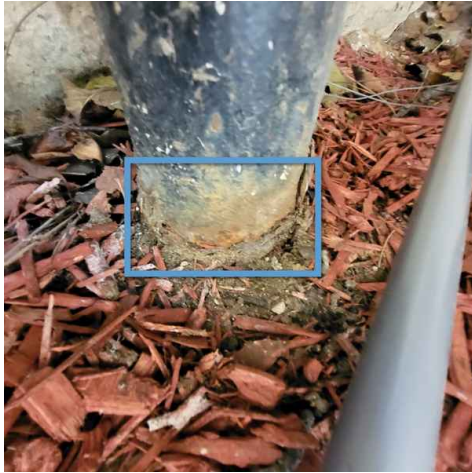
Support Post

CORROSION

Marginal - There is significant corrosion that is affecting structural integrity. A Phase 2 Pre-721 Evaluation (P2PE) is recommended to formulate a detailed repair plan. See Reference Information: Notification and Follow Up - Marginal.

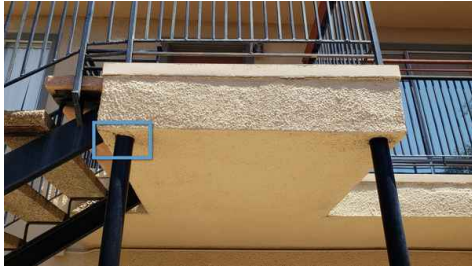
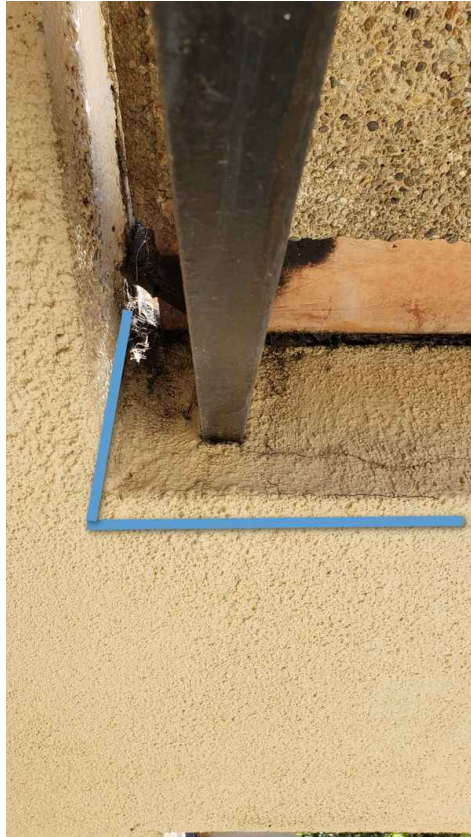
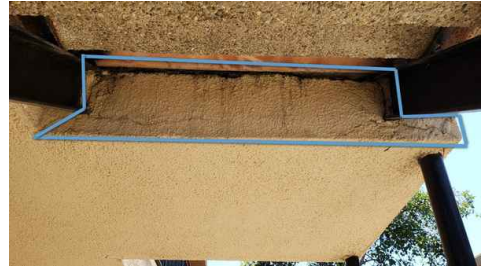
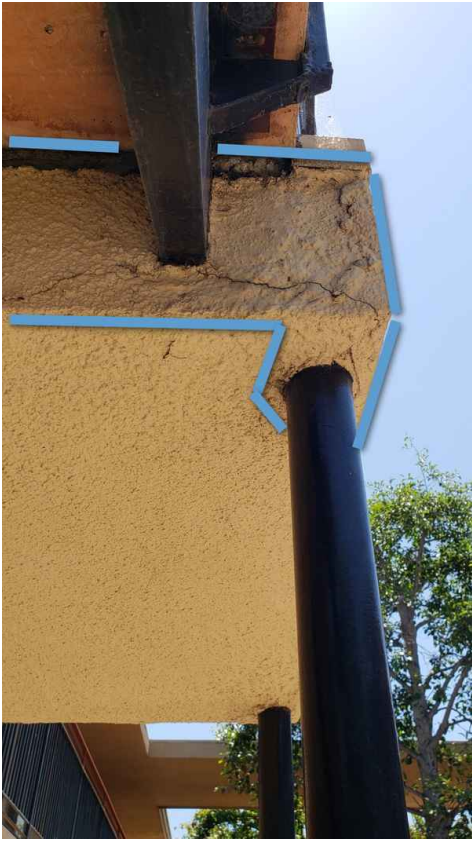
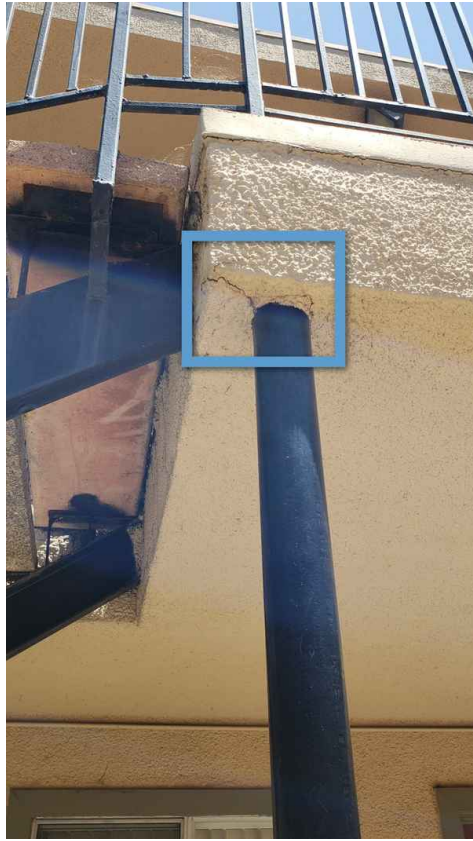
5.3.1 Walkway

DAMAGED STUCCO

Minor - Stucco is cracking, stained, bulging, bubbling, blistering, efflorescing, soft, crumbling, discolored or showing signs of mold and mildew. These condition(s) are minor, and can be addressed as maintenance items.

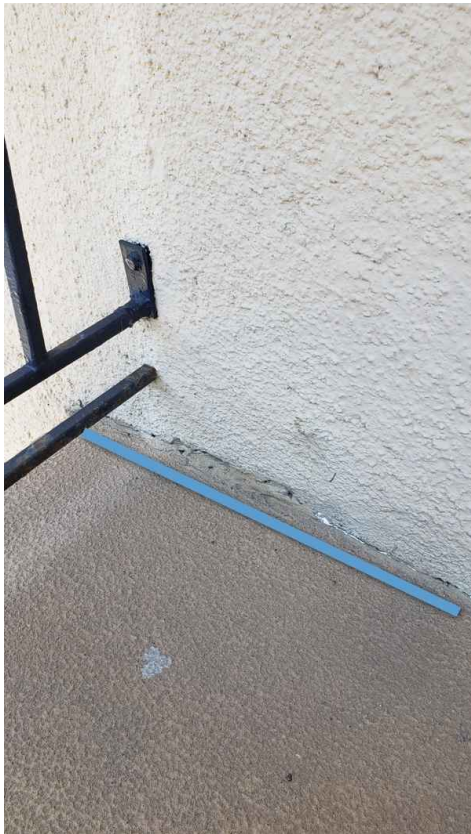
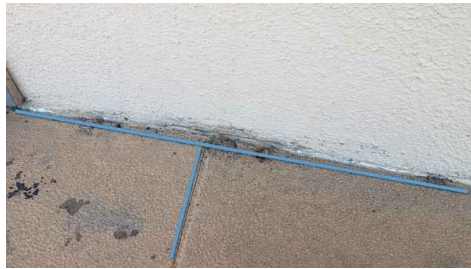
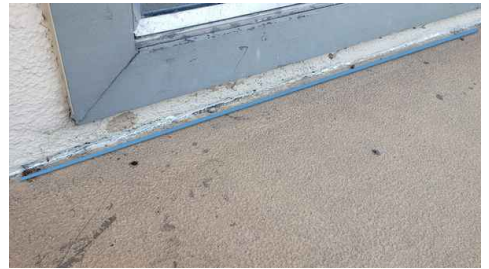
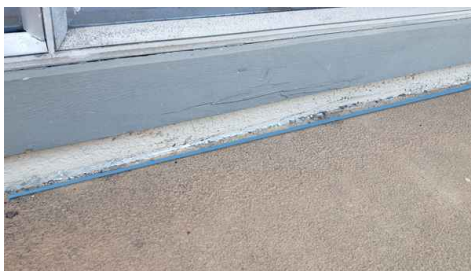
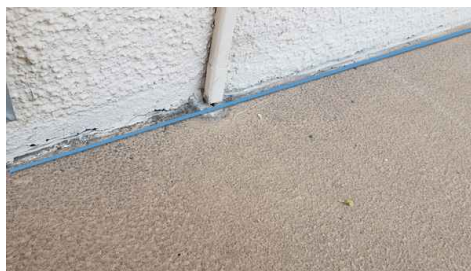
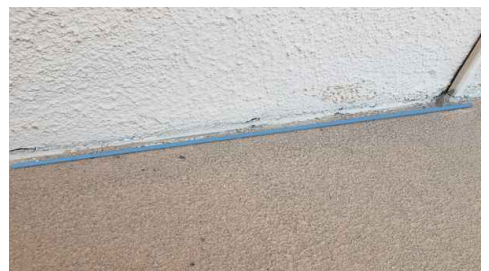
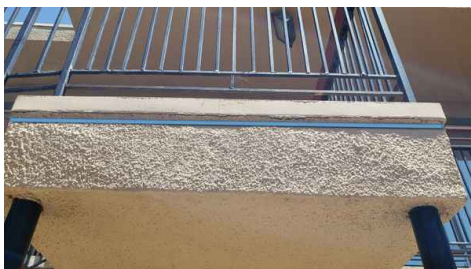
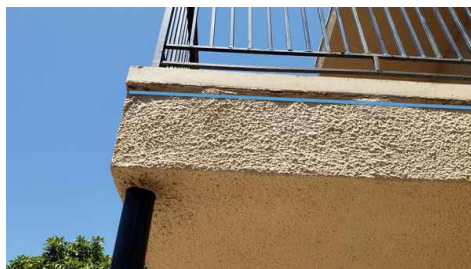
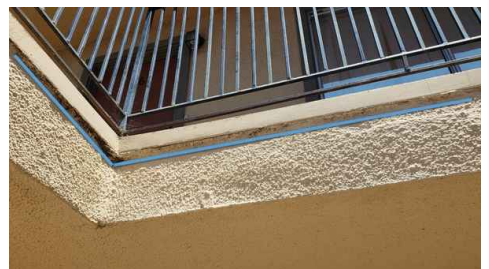
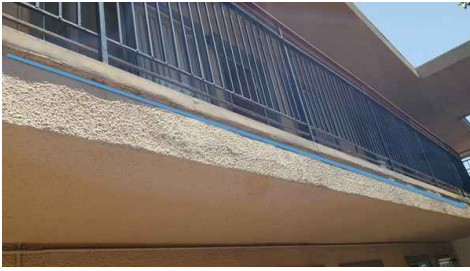
5.3.2 Walkway

OPENINGS IN WATERPROOFING

Minor - There are cracks, openings, or penetrations in the waterproofing. The affected areas should be sealed.

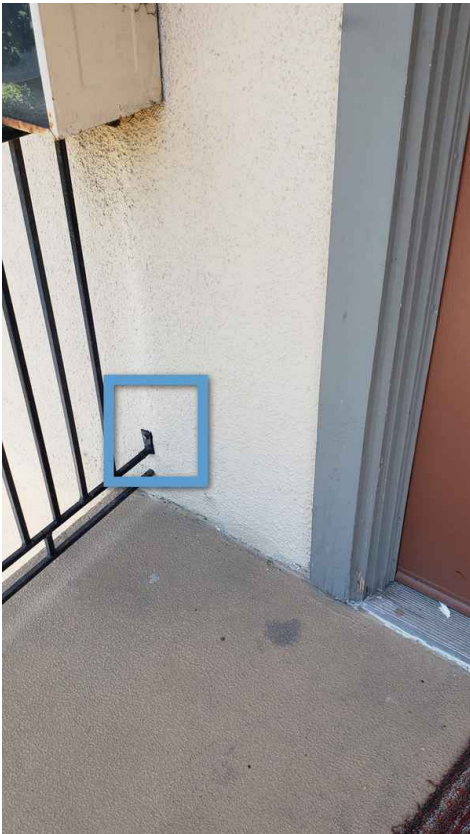
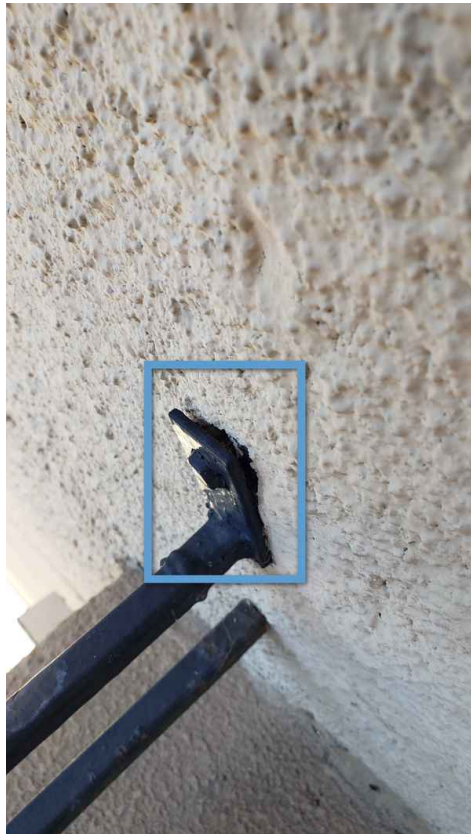
5.3.3 Walkway

UNSEALED CONNECTION(S)

WHERE THE RAILING ATTACHES TO THE WALL.

There are unsealed connections. Lack of proper sealing at these junctions raises concerns about potential water intrusion. These connections should be sealed

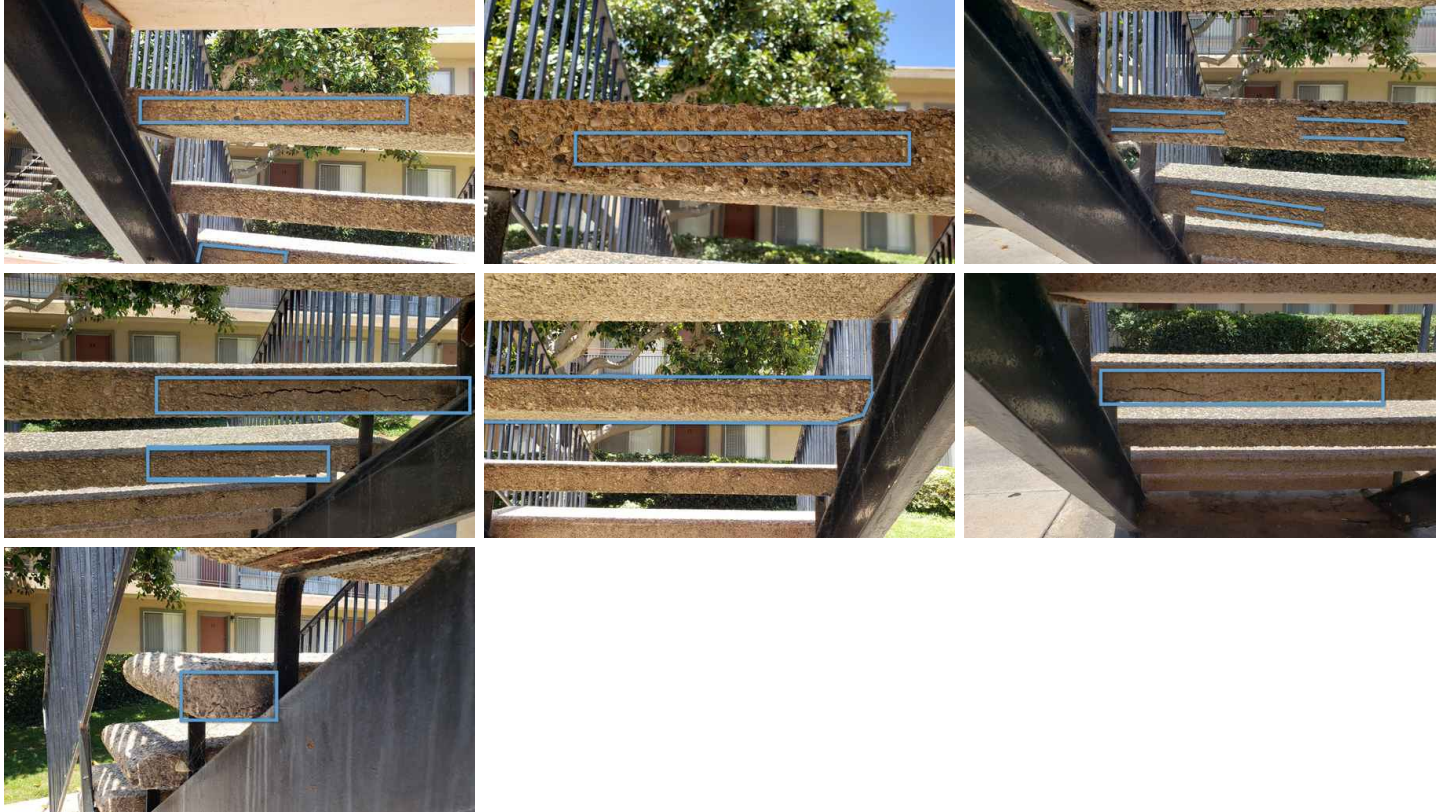
5.4.1 Stairway North

DAMAGED PRECAST TREAD(S)

Minor - Approximately 5 of 16 treads are cracked or broken. The affected stair treads appear to be the same age and are approaching the end of their service life, at a minimum the affected treads should be replaced, if not replaced a reinspection is recommended in two years.

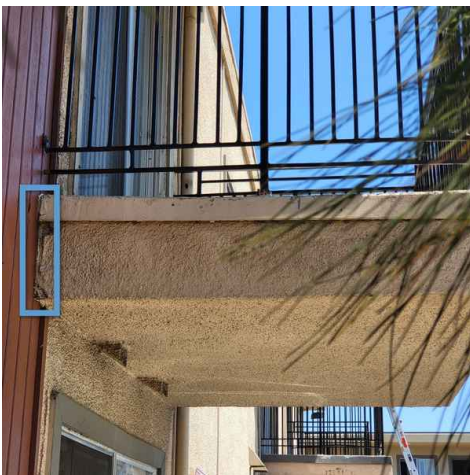
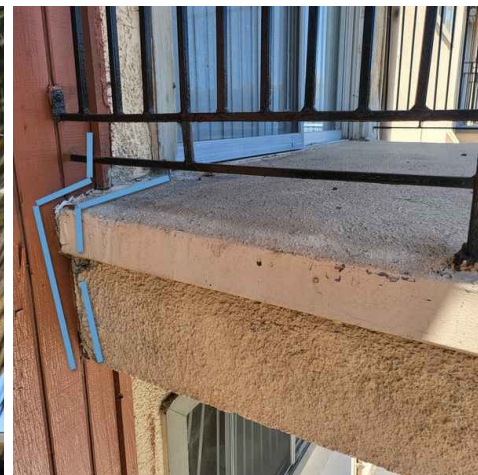
6.2.1 Apt. 52 Balcony

OPENINGS IN WATERPROOFING

Minor - There are cracks, openings, or penetrations in the waterproofing. The affected areas should be sealed.

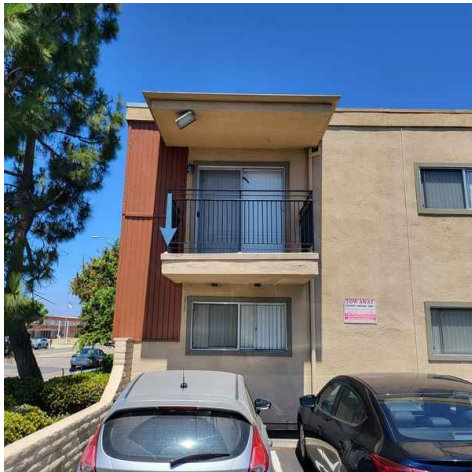
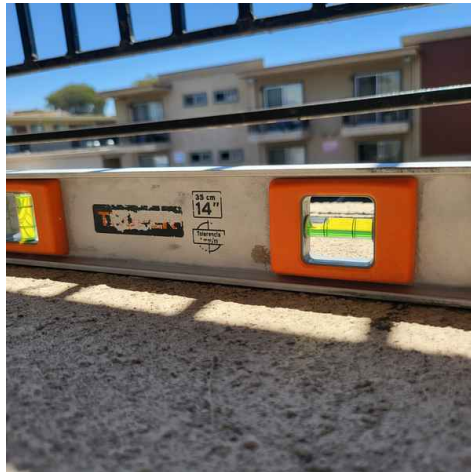
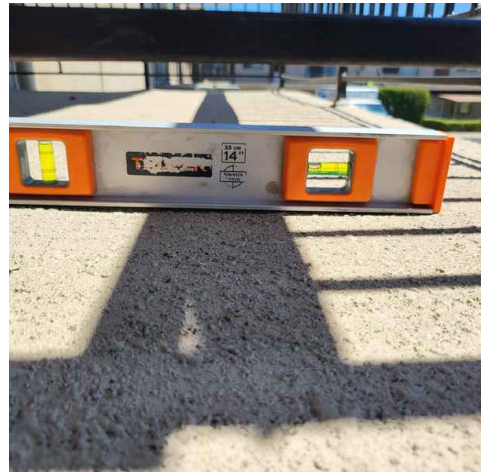
6.2.2 Apt. 52 Balcony

SUPPORT CONSTRUCTION

BALCONY APPEARS TO SHOW EXCESIVE SLANT

The inspection revealed inadequate or improper construction, or evidence of instability in the support structure. This condition suggests that the support construction may not adhere to regulatory standards, potentially leading to long-term issues.

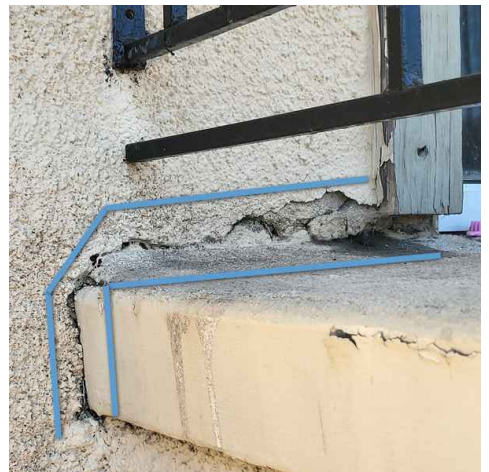
6.3.1 Apt. 54 Balcony

OPENINGS IN WATERPROOFING

Minor - There are cracks, openings, or penetrations in the waterproofing. The affected areas should be sealed.

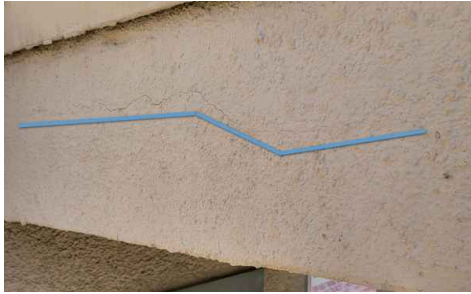
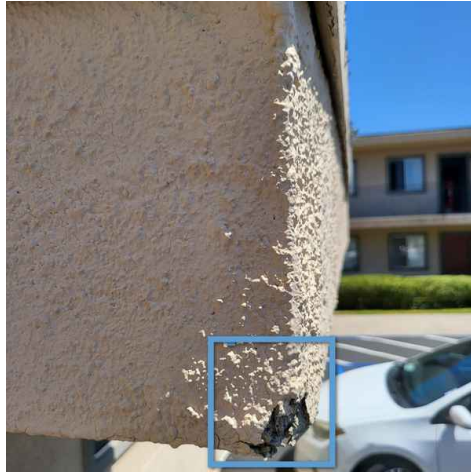
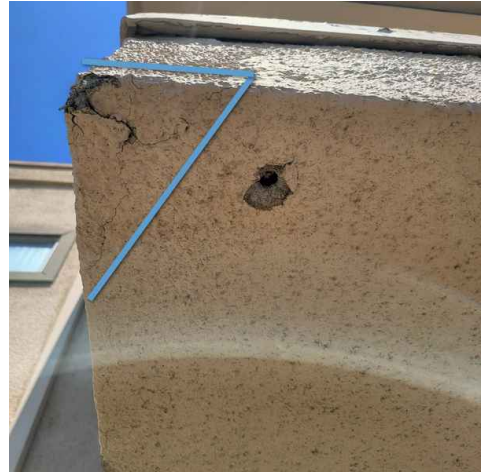
6.4.1 Apt. 56 Balcony

DAMAGED STUCCO

Minor - Stucco is cracking, stained, bulging, bubbling, blistering, efflorescing, soft, crumbling, discolored or showing signs of mold and mildew. These condition(s) are minor, and can be addressed as maintenance items.

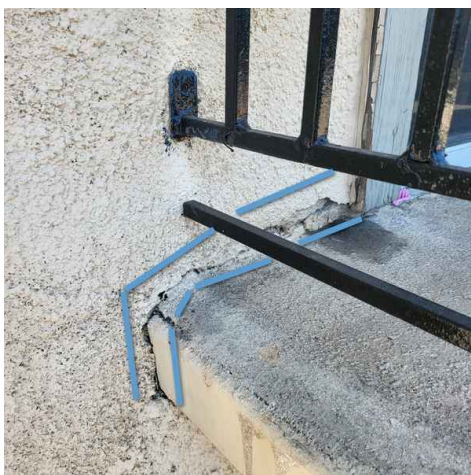
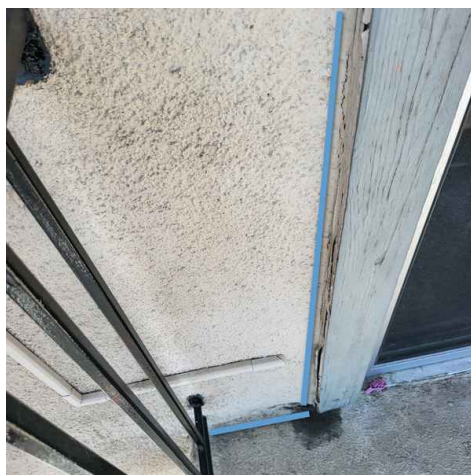
6.4.2 Apt. 56 Balcony

OPENINGS IN WATERPROOFING

Minor - There are cracks, openings, or penetrations in the waterproofing. The affected areas should be sealed.

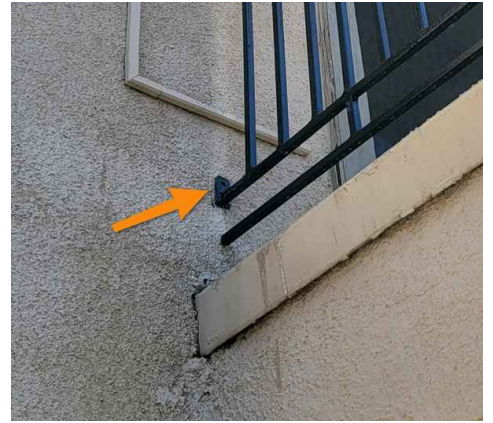
6.4.3 Apt. 56 Balcony

MISSING OR LOOSE FASTENER(S)

Hardware is loose or missing from railing connections. Appropriate hardware must be installed and loose hardware tightened prior to SB-721 Inspection.
