SB-721 INSPECTION

1234 Main Street
Imperial Beach, CA 91932-1412

5: EXTERIOR ELEVATED ELEMENT (E3) 4039 BALCONY

6: EXTERIOR ELEVATED ELEMENT (E3) 4041 BALCONY

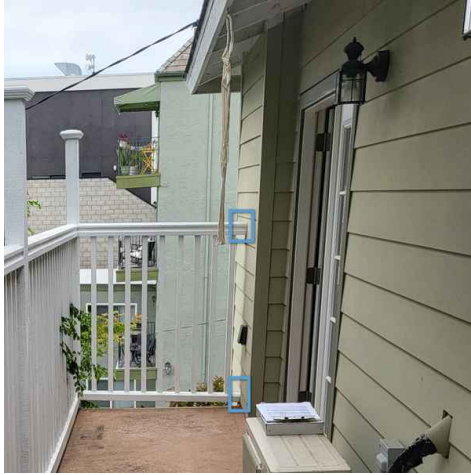
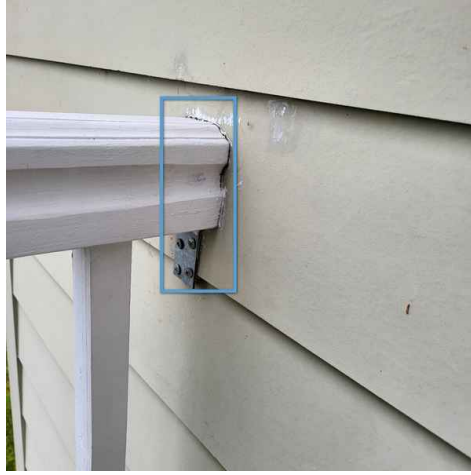
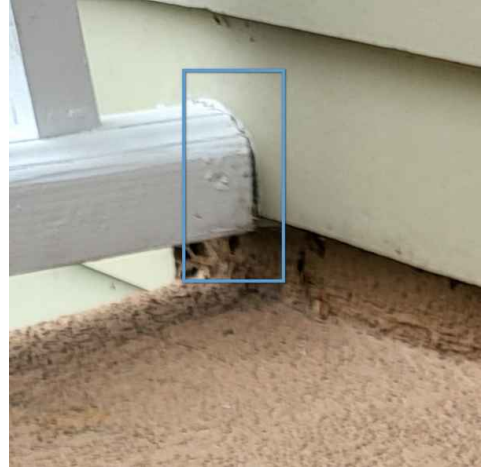
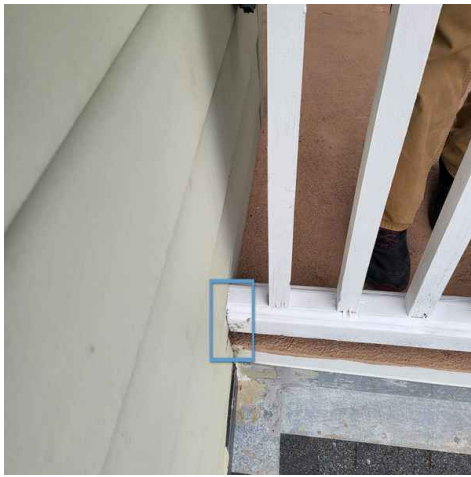
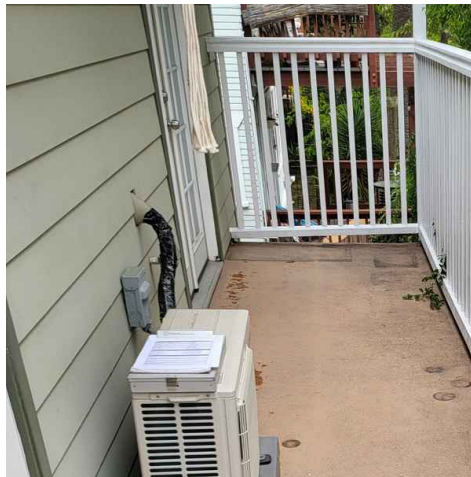
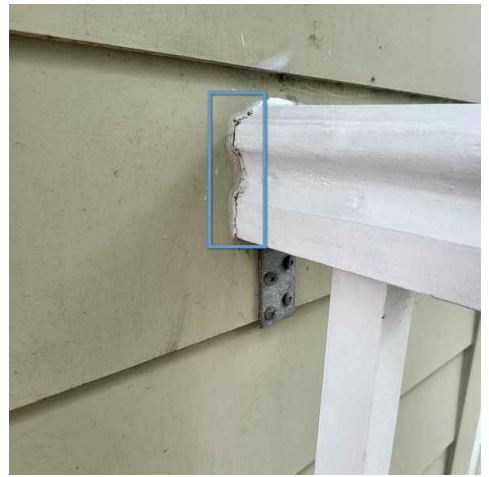
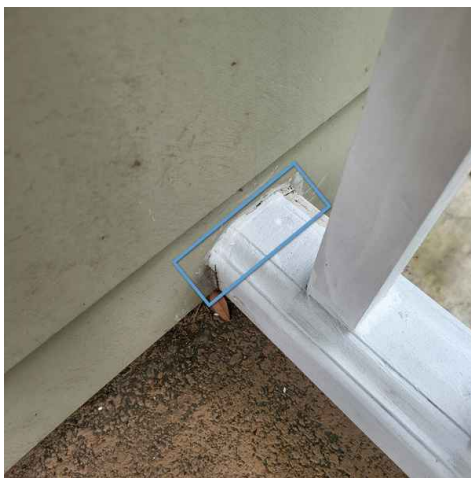
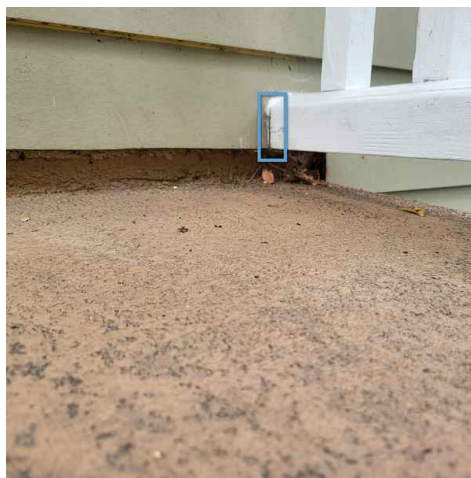
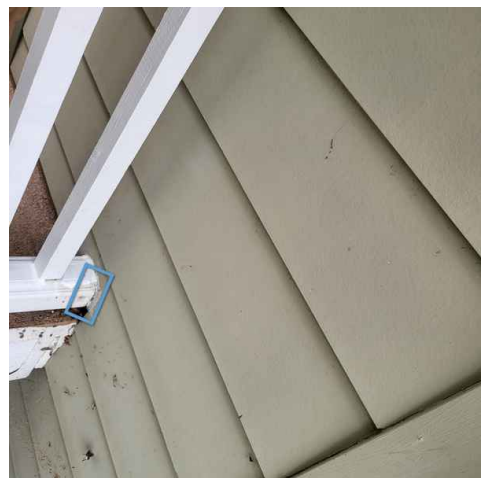
5.2.1 Balcony

UNSEALED CONNECTION(S)

SOUTH AND NORTH RAILING TO WALL

There are unsealed connections. Lack of proper sealing at these junctions raises concerns about potential water intrusion. These connections should be sealed

Contact a qualified professional.

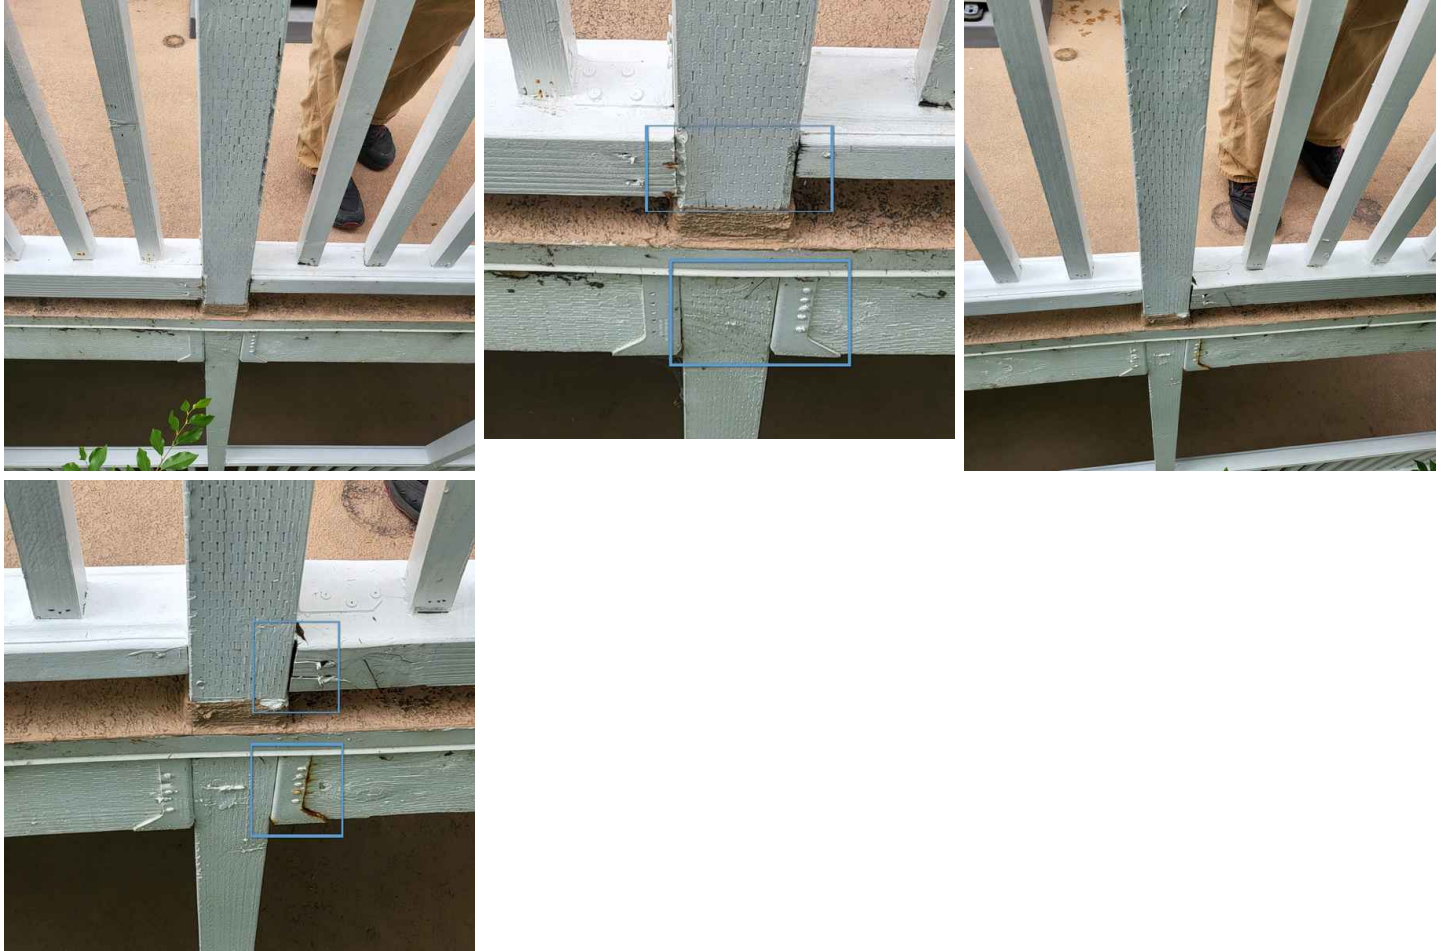
5.2.2 Balcony

UNSEALED CONNECTION(S) 2

HANGER BRACKET & RAIL TO POST

There are unsealed connections. Lack of proper sealing at these junctions raises concerns about potential water intrusion. These connections should be sealed

Contact a qualified professional.

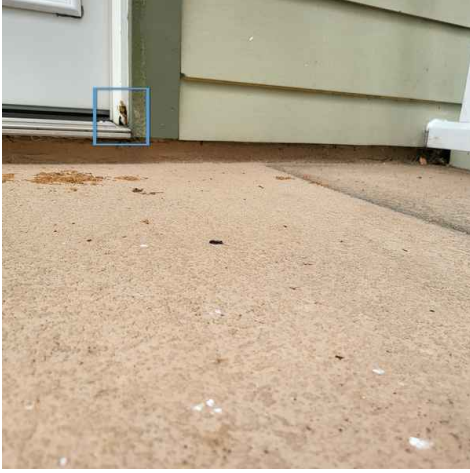
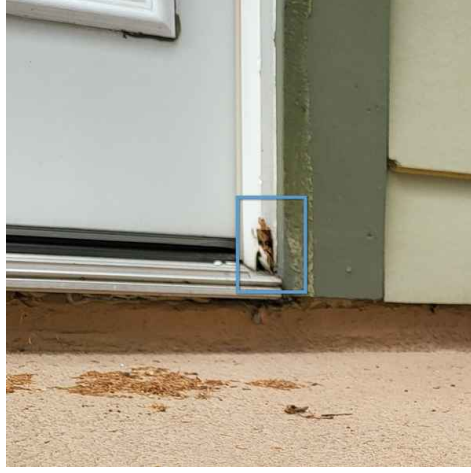
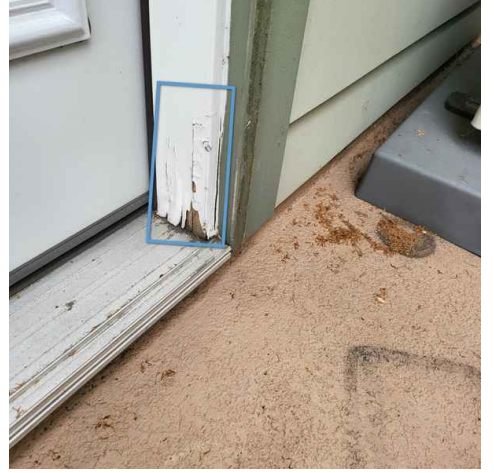
5.2.3 Balcony

TERMITE/DRY ROT DAMAGE

One or more sections of the door jamb have termite and/or dry rot damage. It is recommended that these sections be treated or replaced.

Contact a qualified professional.

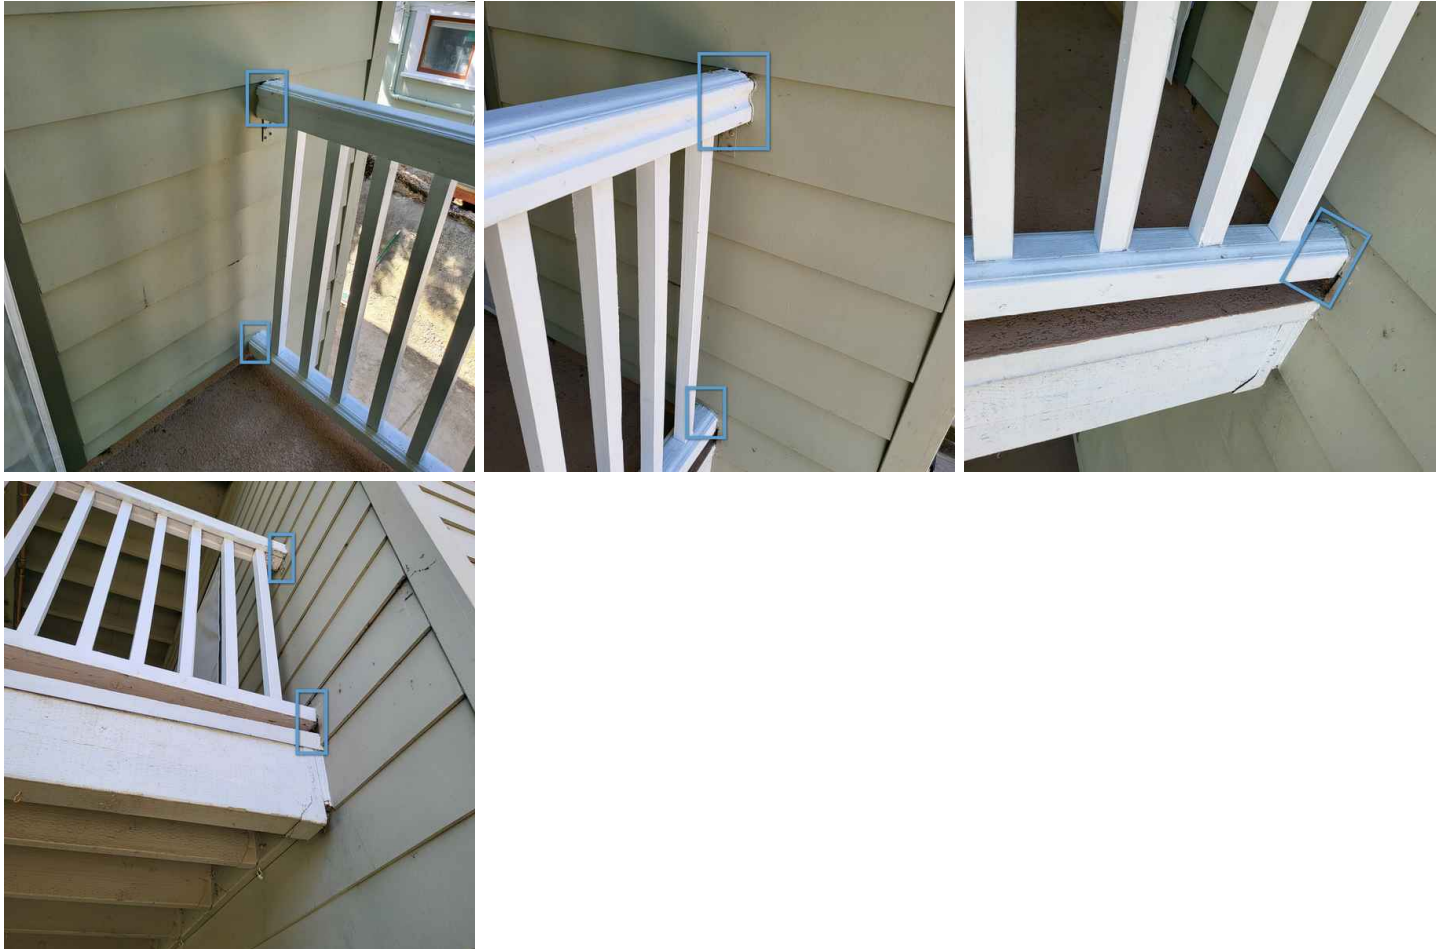
6.2.1 Balcony

UNSEALED CONNECTION(S)

RAIL TO WALL CONNECTION

There are unsealed connections. An improper seal at these junctions raises concerns about potential water intrusion. These connections should be sealed.

Contact a qualified professional.
