PATRICK'S PROPERTY MAINTENANCE SERVICE

PRE-721 EVALUATION

1234 Main Street
Imperial Beach, CA 91932-1412

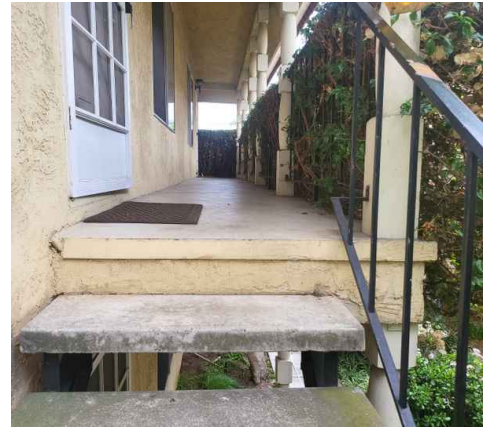
OBSCURED VIEW

Bougainvillea vine growth surrounds most of the outer side of the elevated walkway from the bottom of the soffit up past the top of the railing blocking the view. (see photos). The vine growth limits the inspectors ability to look for signs of water intrusion.

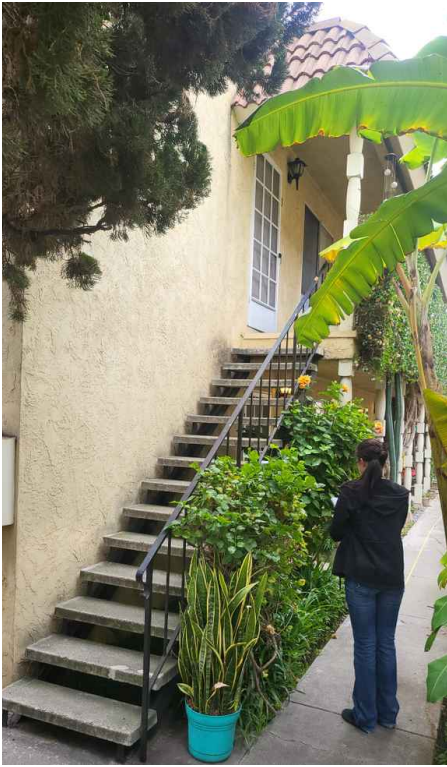
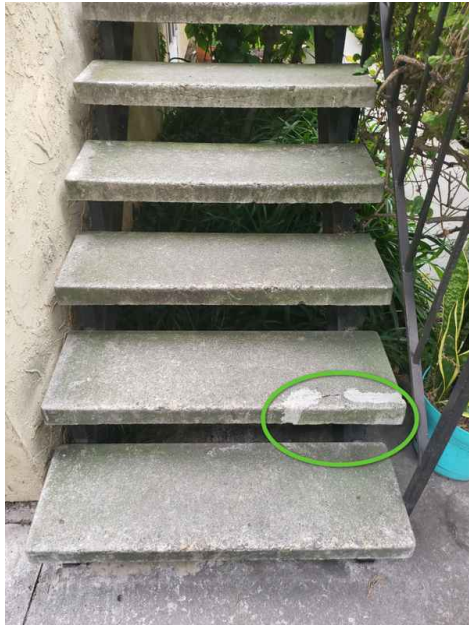
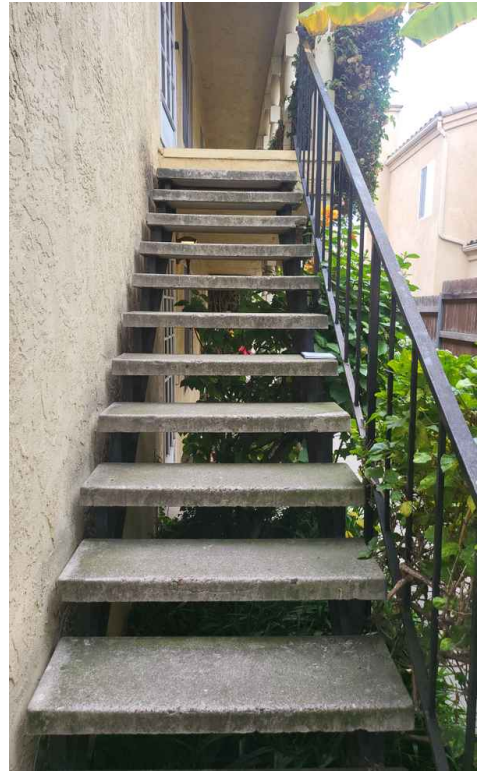
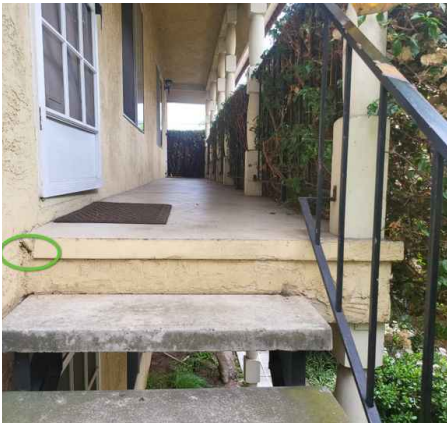
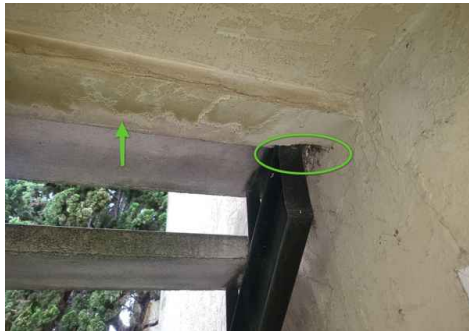
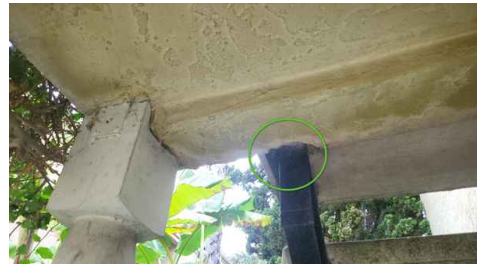
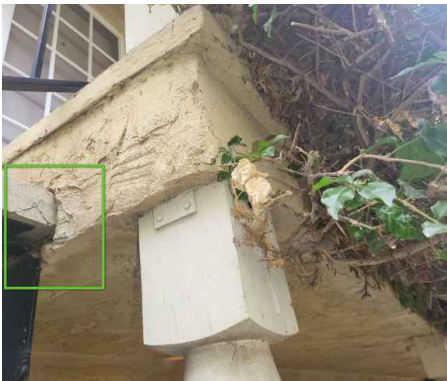
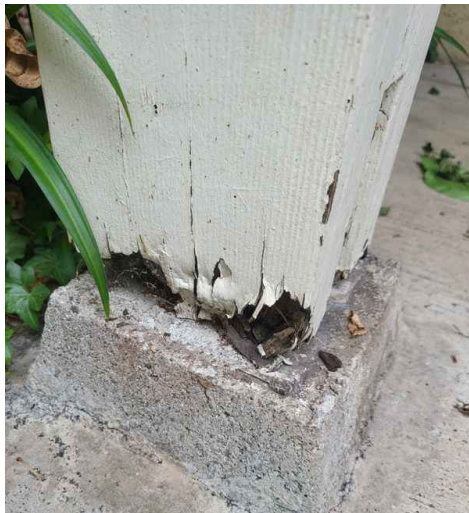
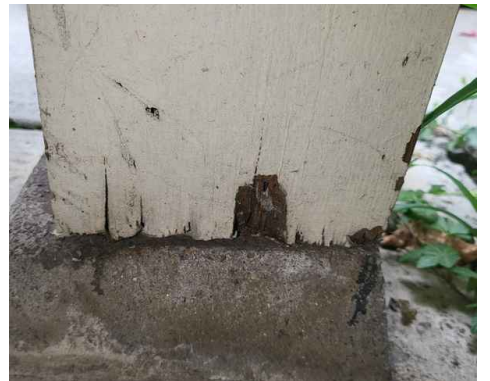
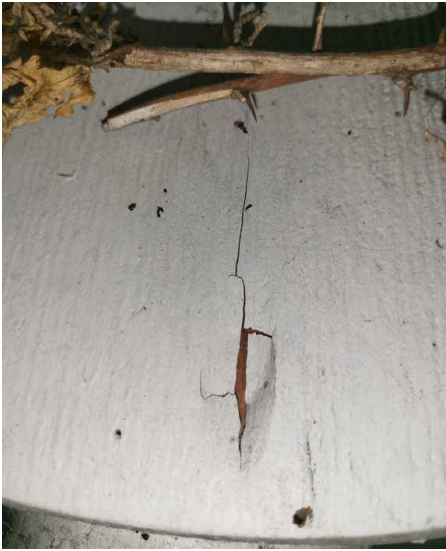
Walkway & Stairs: Stairway

Cracks and broken pieces in the stair treads of the stairway were readily visible. Looking closer I was able to identify 14 welded-on steps that need to be replaced. Recommend changing the square edge metal on the top step to aluminum bullnose (rounded edge metal).

Water intrusion in the following 3 locations:

1. The top of the edge metal is not sealed properly
2. Top Step is embedded into stucco
3. The left corner of the edge metal is not the proper length and should extend approximately 2" under the stucco

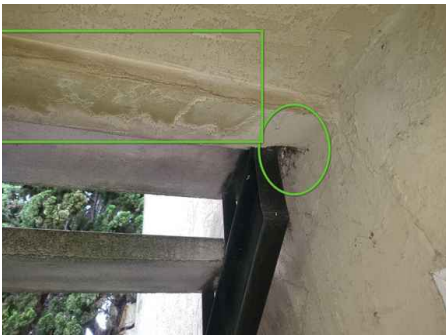
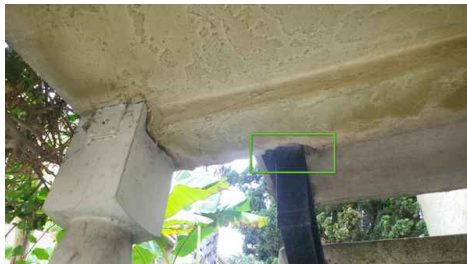
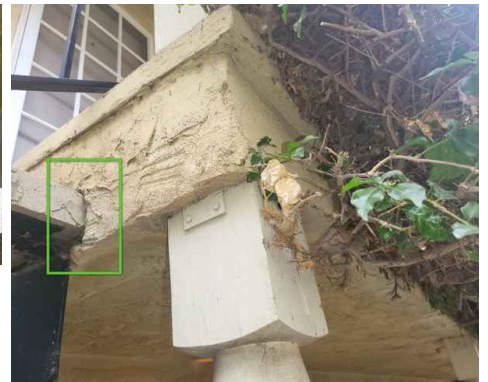
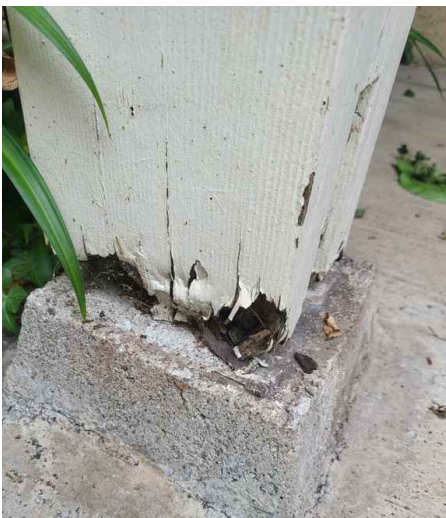
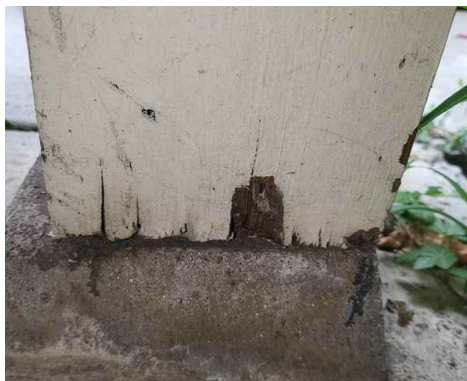
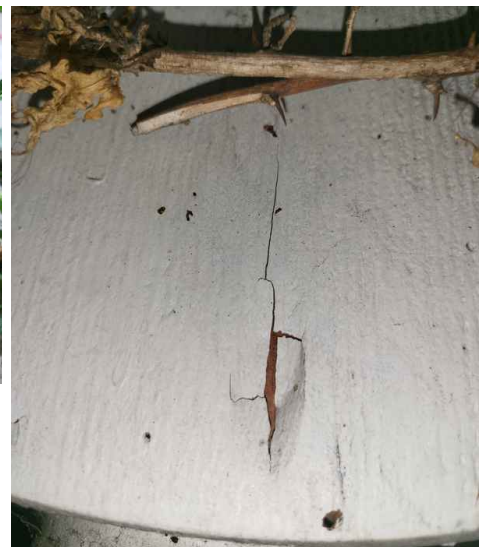
Walkway & Stairs: Bottom of Stairs, Doubler, and Wooden Support Post

Stucco discoloration on the underside of the stair doubler. Suspect water intrusion. Recommend further investigation in Phase II.

The carved Support Post has termite damage on the top and bottom. Recommend replacement.

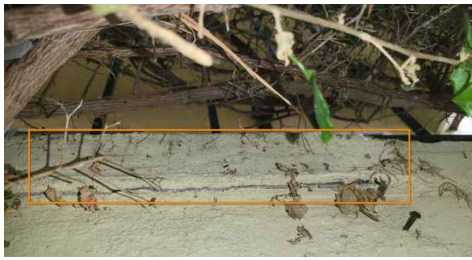
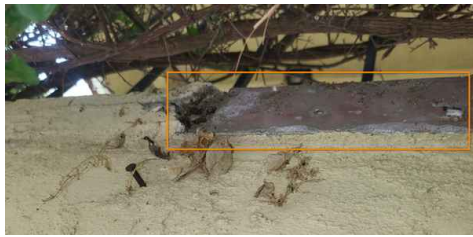
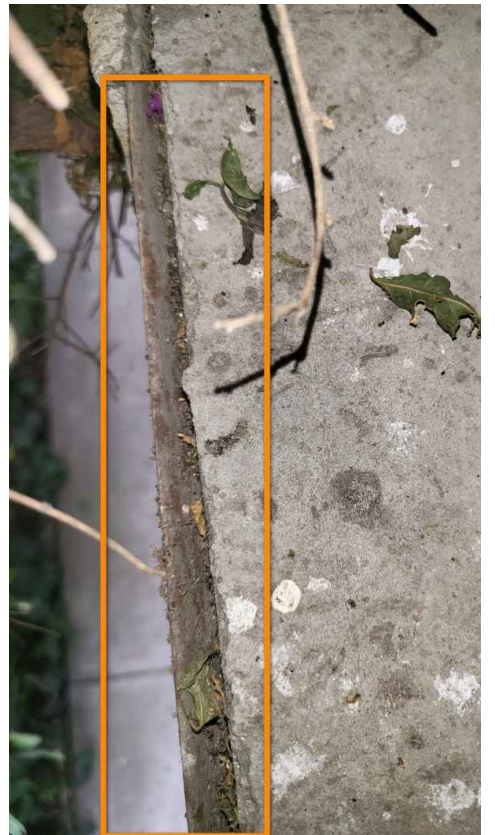
DECKING EDGE METAL

Edge metal is separated from the concrete deck allowing water intrusion. Recommend borescope inspection or a larger investigative opening to determine structural integrity.

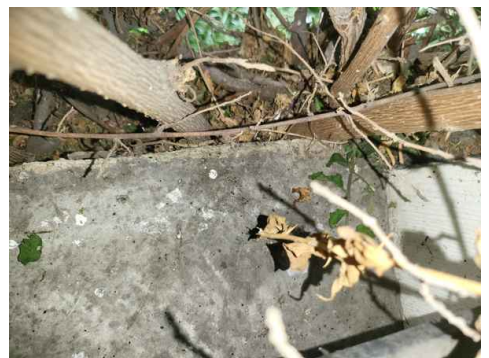
WALKWAY

The south end of the walkway and other areas are covered by bougainvillea preventing a thorough inspection. Recommend removal of plant growth.

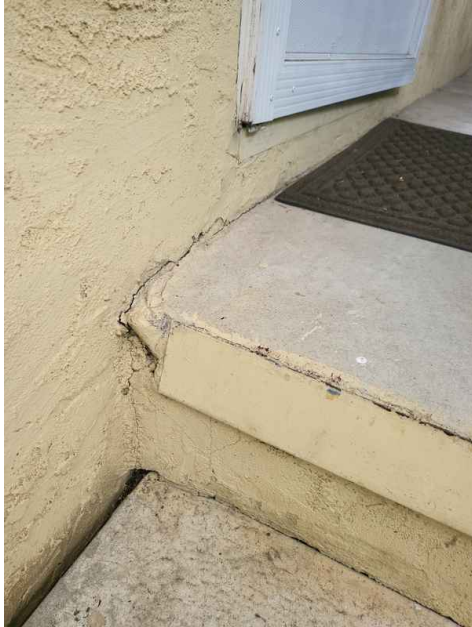
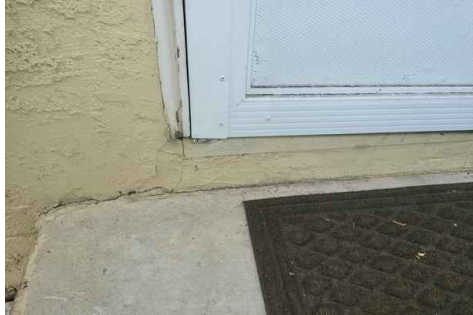
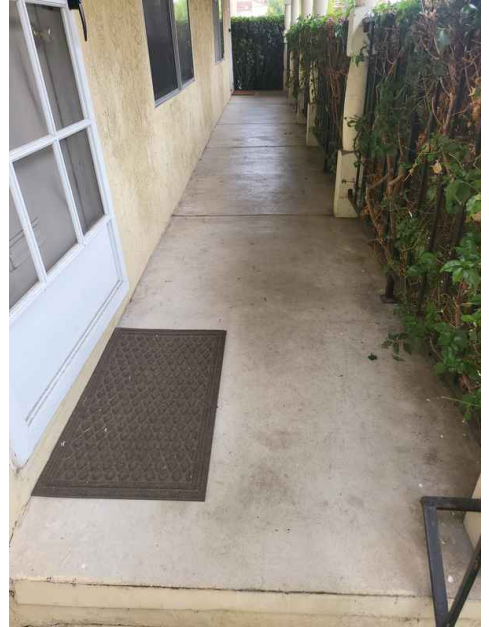
DECK - WATER SEALANT REQUIRED

Sealant is required along the entire 41ft length of the walkway, where the stucco wall meets the concrete walkway.
