PATRICK'S PROPERTY MAINTENANCE SERVICE

PHASE 2 PRE-SB721 EVALUATION

1234 Main Street
Imperial Beach, CA 91932-1412

The property is a two-story apartment complex with 20 units, built in 1968.

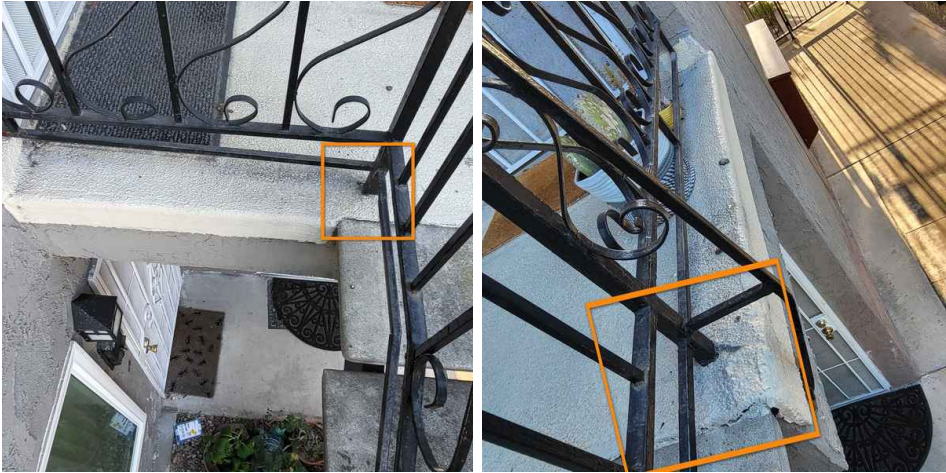
5.3.1 Landing

Non-Emergency Repairs Required**DECK - OPENINGS IN WATERPROOFING REASSESSED**

Phase 1 Observations: There is an opening where the top stair tread meets the landing. Water sealant/weatherproofing should be applied.

Phase 2 Reassessment: Upon closer inspection expansion from corrosion around the railing connections was noted. See the images below. The defect was changed from minor openings in water proofing to marginal corrosion at the railing connections.

Repair Plan: Replace the 2 railing connections highlighted in the images below.

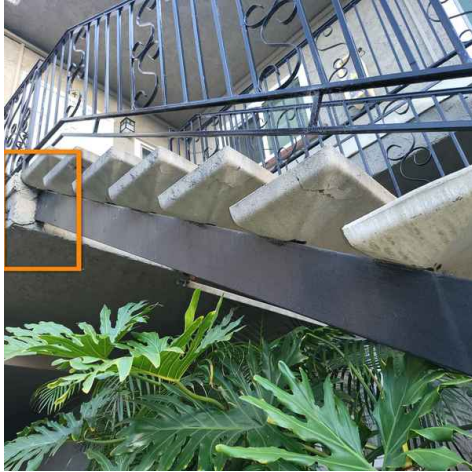
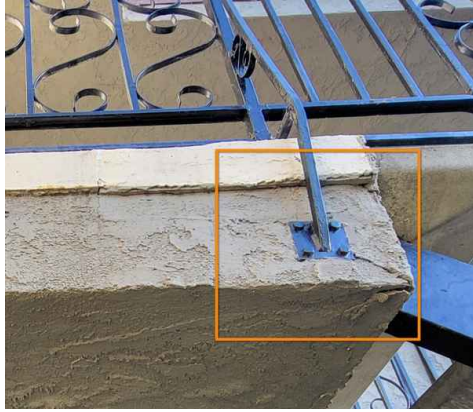
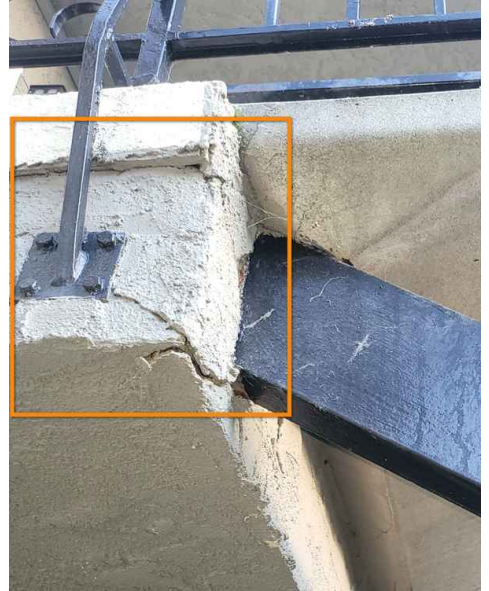
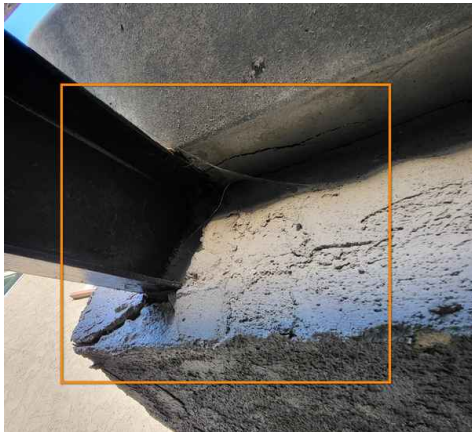
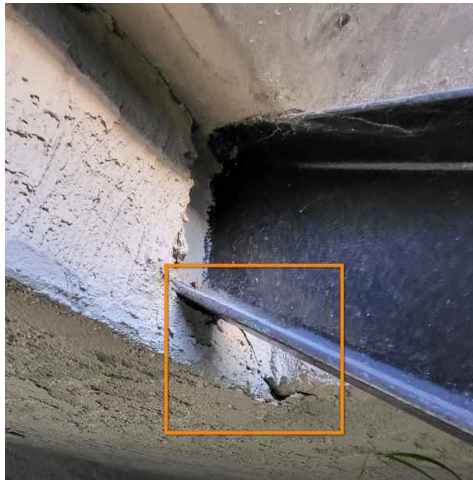
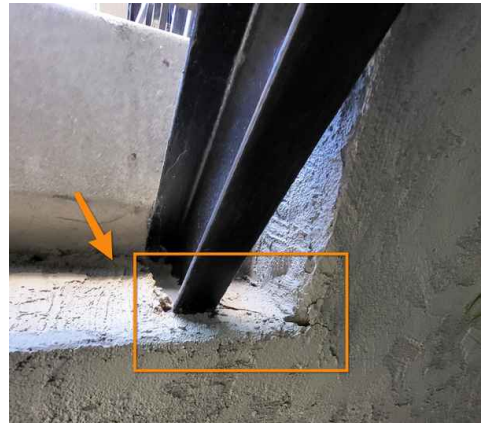
6.3.1 Walkway

STUCCO DAMAGE

There are large cracks in the stucco around both stair stringer connections to the walkway. These cracks correspond to railing connection defects above these locations. This condition raises concerns regarding water intrusion and possible advanced deterioration in the underlying support structure. A Phase 2 Pre-721 Evaluation (P2PE) is recommended to determine the extent of any water damage via borescope investigation or larger investigative openings, and to formulate a detailed repair plan.

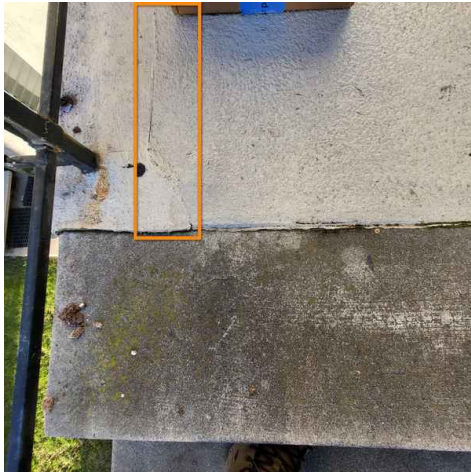
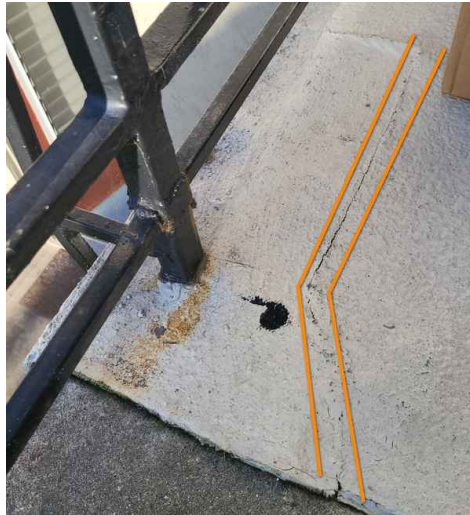
6.3.2 Walkway

PREVIOUS REPAIRS FAILING - MINOR TO MODERATE

Inspection has revealed that previous repair efforts on the structure are failing, indicating either inadequate repair methods were used or the underlying issues have not been fully addressed. This area was previously patched, but a crack has formed around the patch and the deck coating is swelling, indicating water intrusion and wood decay and/or corrosion of railing connection. The deteriorating condition of these repairs could lead to further damage or safety risks. It is essential to re-evaluate these areas with a qualified professional to determine the cause of failure and to implement more effective and lasting repair solutions. Immediate attention is advised to prevent escalation of the defect. A borescope inspection under this defect is recommended and a larger investigative opening.

Contact a qualified professional.

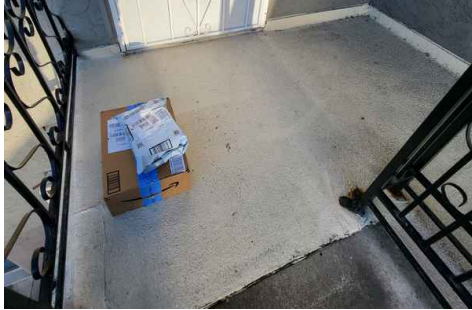
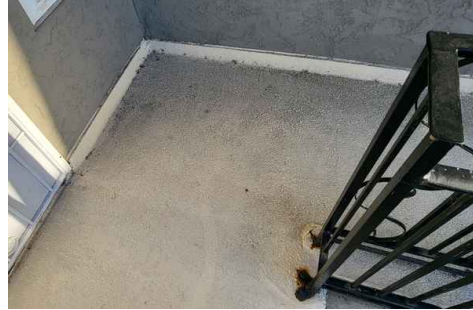
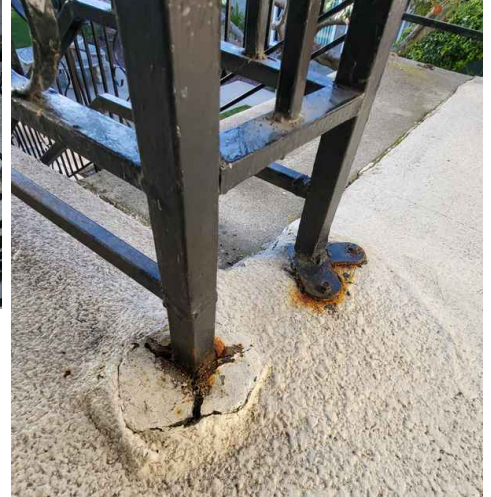
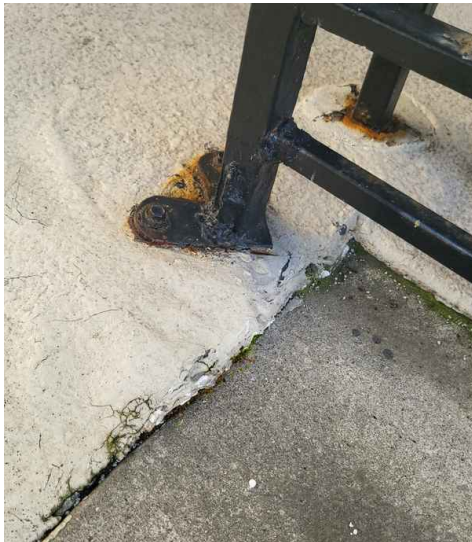
6.3.3 Walkway

WALKWAY RAILING CONNECTION

Corrosion is present at the base of the handrail. There is swelling and cracks in the deck coating indicating water intrusion and deterioration of the underlying support materials. This deterioration could lead to further damage or safety risks. It is essential to re-evaluate these areas with a qualified professional to determine the cause of failure and to implement more effective and lasting repair solutions. Immediate attention is advised to prevent the escalation of this defect. A borescope inspection under this defect is recommended and an investigative opening in the deck may be necessary.

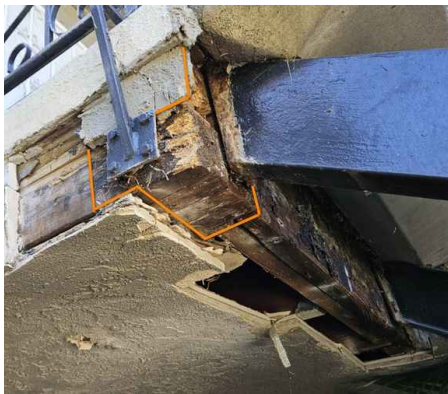
The joist that supports the left stair stringer has dry rot damage. The stringer support construction is substandard and inadequate. The doubler is cracked and has dry rot and termite damage. The railing connections on each side of the stairway are corroded.

rotten joist

- Replace doubler.
- Install a custom 6-inch by 3.5 ft. steel bracket to support stair stringers.
- Replace 3 railing connections.
- Seal all openings in waterproofing.

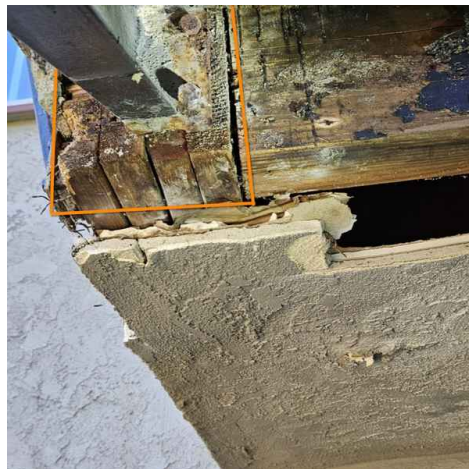
rotten joist, substandard construction

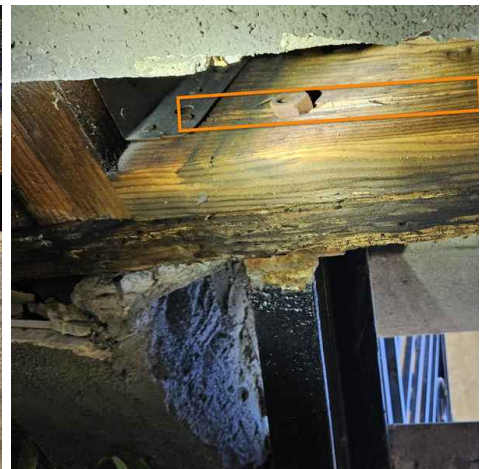
cracked doubler

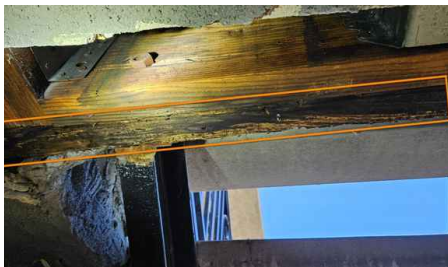
rotten doubler

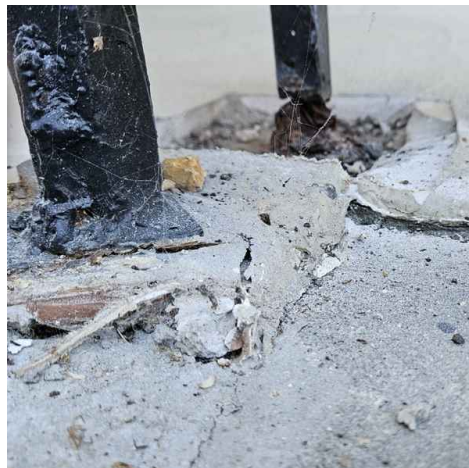
corroded railing connection

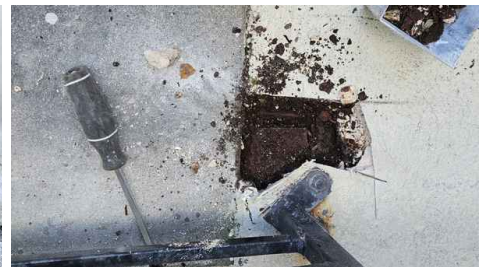
corroded railing connection

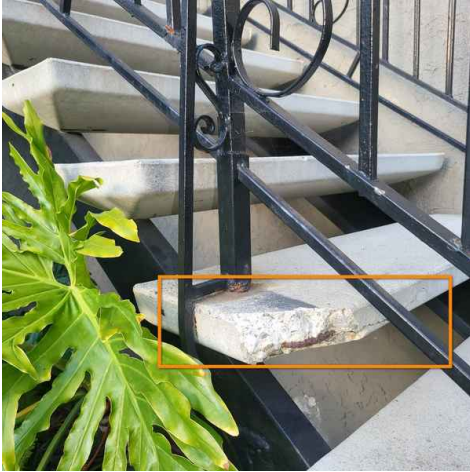
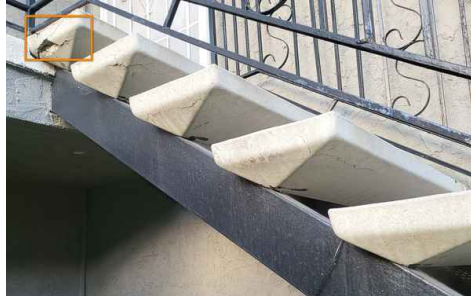
DAMAGED STAIR TREADS (MAJORITY)

Approximately 8 out of 15 stair treads have cracks or breakages. Most if not all of the stair treads seem to be the same age and are likely approaching the end of their service life. At a minimum, the affected treads should be replaced. If the treads are not replaced a reinspection is recommended in 2 years.

Repair Plan: Replace the 2 stair treads highlighted in the images below.

Contact a qualified professional.

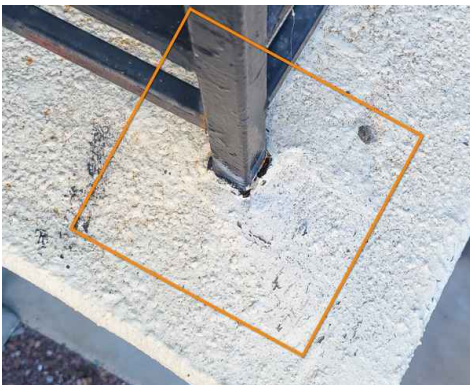
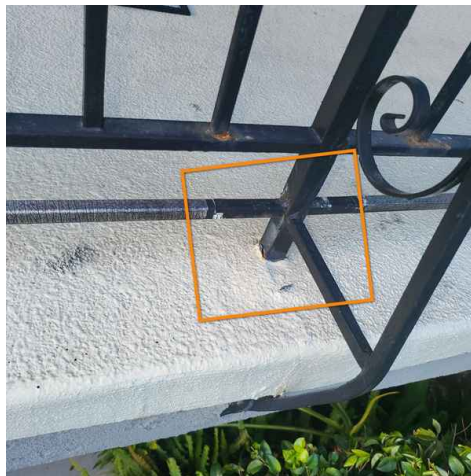
8.3.1 Walkway

Phase 1 Observations: Two of the railing connections to the deck are not sealed and corrosion is visible. Water intrusion and deterioration of the underlying support materials are likely. This deterioration could lead to further damage or safety risks. A borescope inspection under one or both of these openings is recommended to determine the extent of water damage to the underlying support materials.

Phase 2 Reassessment: The defect was changed from minor openings in water proofing to marginal corrosion at the railing connections.

Repair Plan: Replace the 2 railing connections highlighted in the images below.

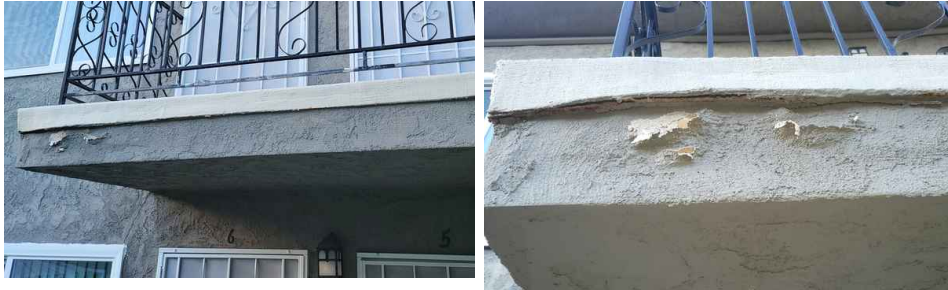
8.3.2 Walkway

Non-Emergency Repairs Required**STUCCO DAMAGE**

There is evidence of water intrusion at the west corner of the walkway. The edge metal is lifting and corrosion is visible. Water has penetrated the stucco causing it to blister. This condition raises concerns regarding water intrusion and possible advanced deterioration in the underlying support structure. A Phase 2 Pre-721 Evaluation (P2PE) is recommended to determine the extent of any water damage via borescope investigation or larger investigative opening and to formulate a detailed repair plan.

Phase 2 observation: The source of water intrusion and stucco damage will be addressed in the previous repair plan above.

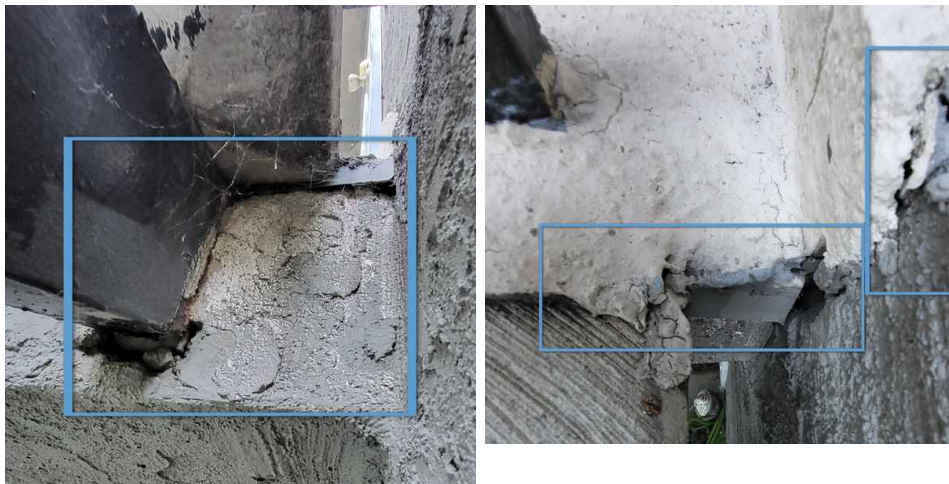
9.3.1 Walkway

Phase 1 Observation: The deck coating, the edge metal, and the stucco around the right stair stringer connection to the walkway are not finished properly or sealed. This condition raises concerns regarding water intrusion and possible advanced deterioration in the underlying support structure. A Phase 2 Pre-721 Evaluation (P2PE) is recommended to determine the extent of any water damage via borescope investigation and to formulate a detailed repair plan.

Phase 2 Reassessment: The defect was changed from marginal poor detailing to minor openings in the waterproofing.

Repair Plan: Seal openings in waterproofing.

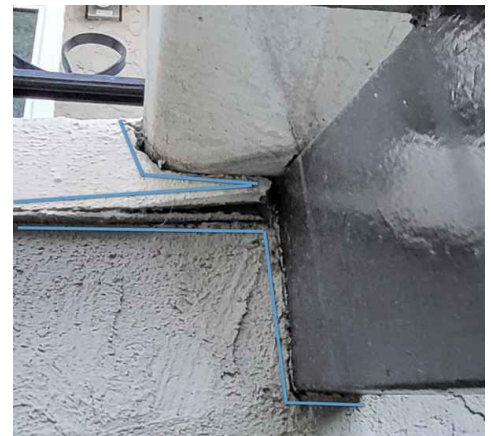
9.3.2 Walkway

Phase 1 Observation: There is an opening around the top stair tread where it meets the deck metal. The deck coating on the edge metal is separating. This opening allows water intrusion, potentially leading to wood rot, structural weakness, and mold growth.

Phase 2 Reassessment: This defect was changed from marginal to minor openings in the waterproofing.

Repair Plan: Seal openings in waterproofing.

Contact a qualified professional.
