# PATRICK'S PROPERTY MAINTENANCE SERVICE

## PRE-721 EVALUATION PHASE 2

1234 Main Street  
Imperial Beach, CA 91932-1412

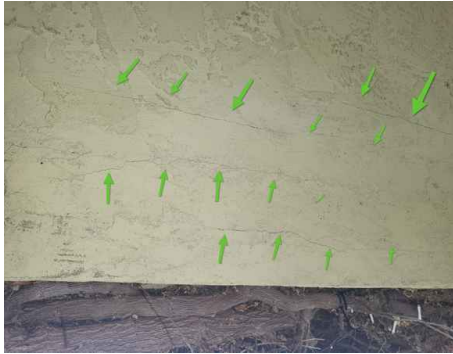
The visual inspection in the P1PE noted cracks in the stucco running parallel to the walkway. See 1st photo.

Cracks in stucco soffit

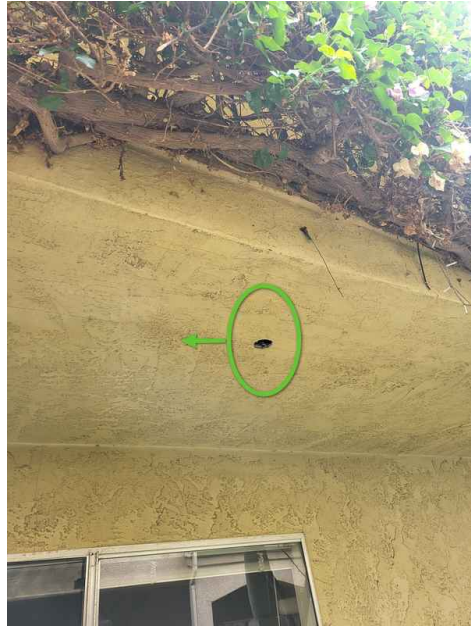
2nd photo shows 1st borescope inspection hole.

The 1st Borescope investigative opening revealed no issues.

At the time of the borescope inspection, no damage to the load-bearing components was observed

1st borescope inspection

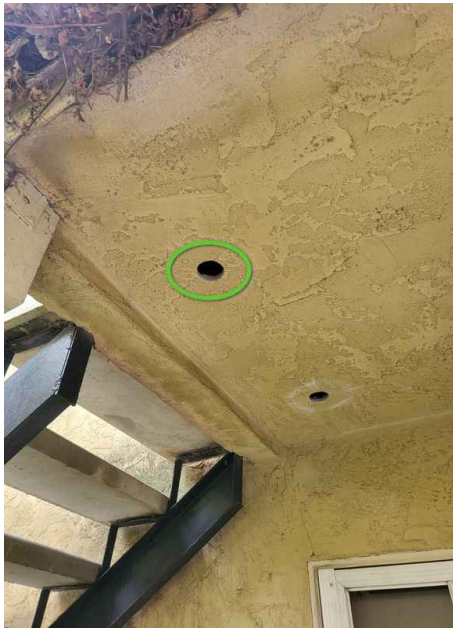
The visual inspection in P1PE noted openings in the stucco around the right stair stringer. These are likely areas for water intrusion. Stucco soffit is discolored in this area.

The 2nd Borescope investigative opening revealed no issues.

At the time of the borescope inspection, no damage to the load-bearing components was observed.

near right stringer attachment

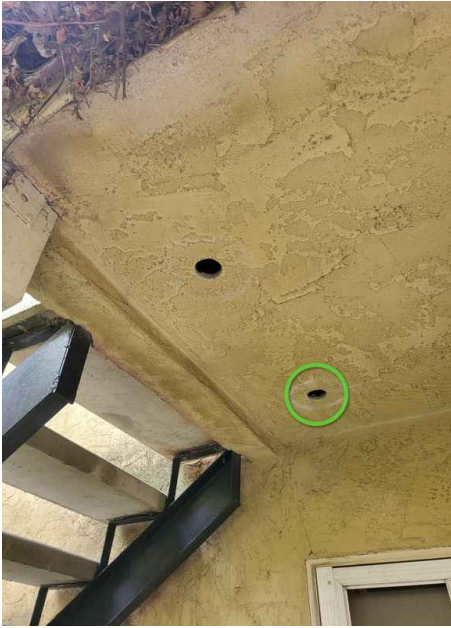
The visual inspection in P1PE noted openings in the stucco around the left stair stringer. These are likely areas for water intrusion. Stucco is discolored in this area.

The 3rd Borescope investigative opening revealed no issues

At the time of the borescope inspection no damage to the load-bearing components was observed

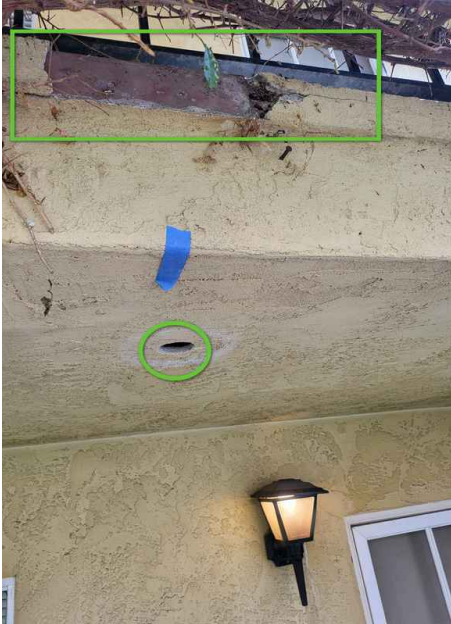
4th borescope hole

The 4th Borescope investigative opening revealed minor issues.

At the time of the borescope inspection no damage to the load-bearing components was observed.

**The edge metal should be repaired or replaced and the waterproofing system above resealed.**

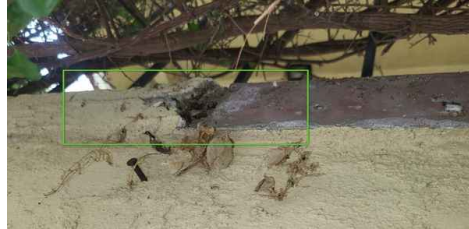
The visual inspection in P1PE noted opening along edge metal. Stucco is falling off the edge metal. See 2nd photo. This is a likely location for water intrusion.

Opening near edgemetal

**Repair or replace the edge metal toward the south end of the walkway.**

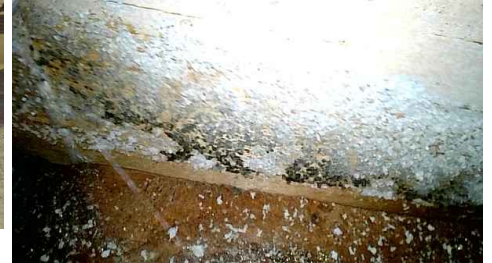
There is evidence of minor water intrusion such as a small amount of mold is present. See 3rd photo stucco overspray has fallen off the deck plywood. See 4th photo.

Mold

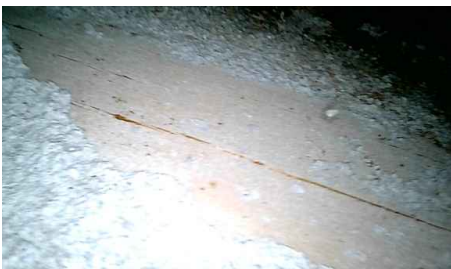
Moisture coming through

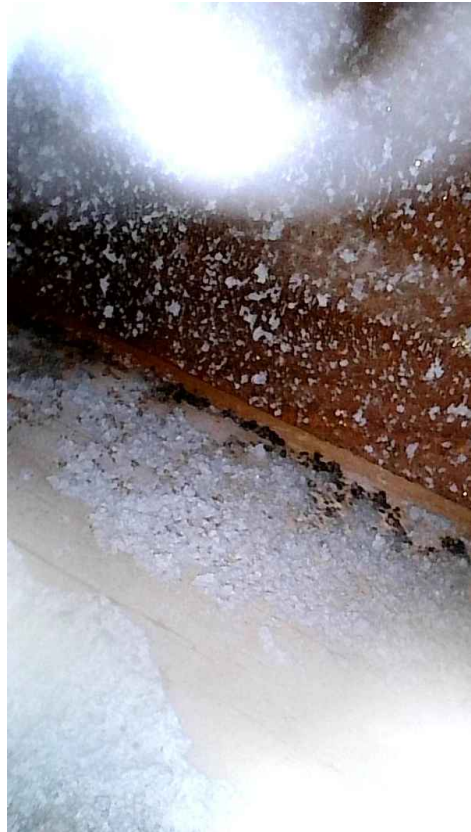
**The 5th Borescope investigative opening revealed evidence of termite activity along the rim board.** Photos 8 and 10 show termite droppings. There are signs of minor water intrusion such as water stains along the rim board.

Photo# 8 Termite droppings along rim board

**Prior to the SB-721 Inspection an area of vine growth should be cleared and a section of stucco removed to investigate the extent of termite damage to the rim board or wood support components.**

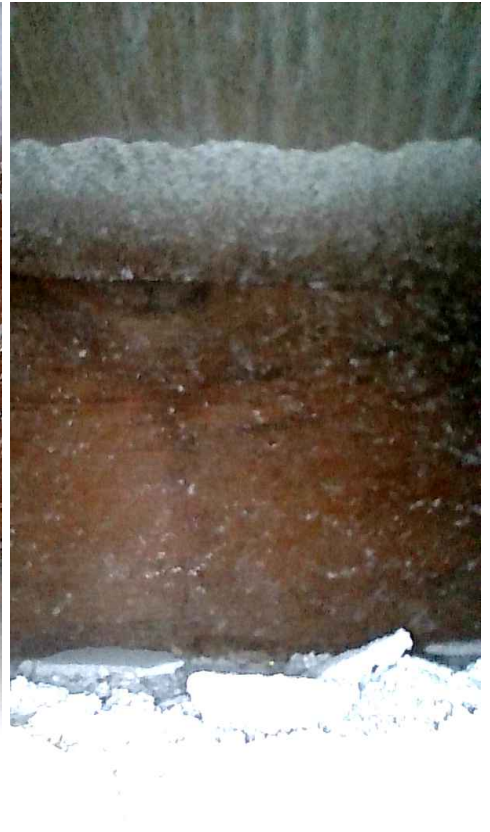
Water stain

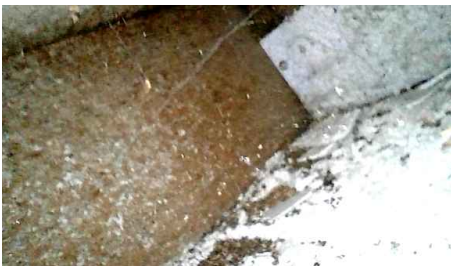
Photo# 10 Termite droppings along rim board

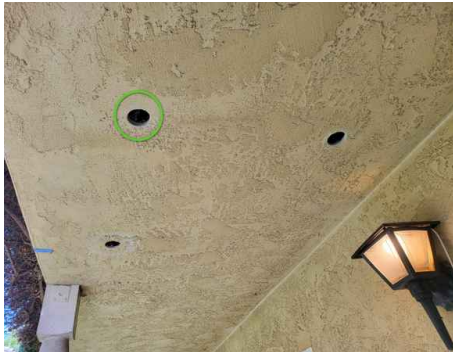
6th borescope hole

The 6th Borescope investigative opening revealed no evidence of water intrusion.

The 6th Borescope investigative opening revealed no issues.

At the time of the borescope inspection no damage to the load-bearing components was observed.

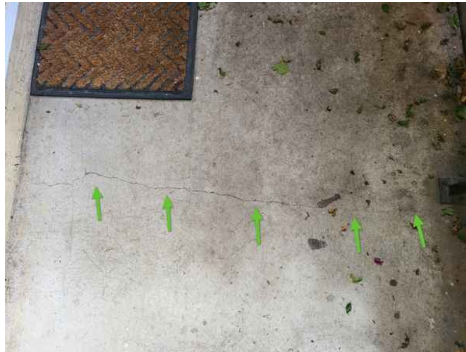
The visual inspection in P1PE noted a crack in the concrete deck. See 2nd photo. This is a potential location for water intrusion.

Crack across concrete deck

**The deck crack should be sealed.**

**Reseal the walkway edge metal around the perimeter, the cracks in the concrete topping, where the concrete deck meets the stucco wall, at all railing connections and around the top stair tread and the stair stringer connections.**

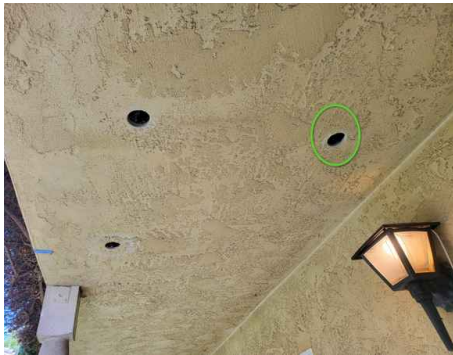
7th borescope hole

The 7th Borescope investigative opening revealed no evidence of water intrusion.

The 7th Borescope investigative opening revealed no issues.

At the time of the borescope inspection no damage to the load-bearing components was observed.

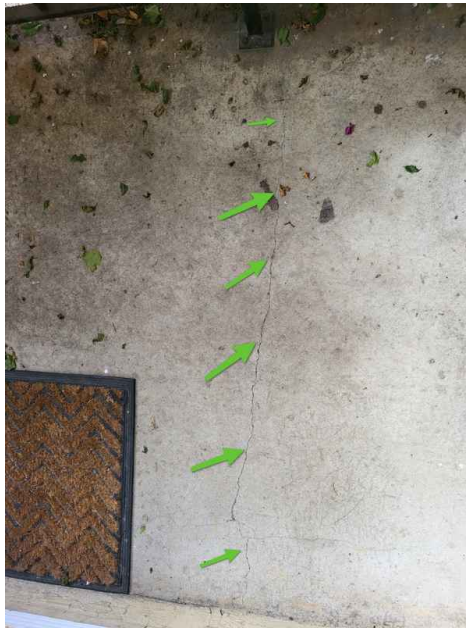
The visual inspection in P1PE noted a crack in the concrete deck. See 2nd photo. This is a potential location for water intrusion.

Crack across concrete deck
