# PATRICK'S PROPERTY MAINTENANCE SERVICE

## SB-721 INSPECTION

1234 Main Street  
Imperial Beach, CA 91932-1412

The property is a two-story apartment building with 9 units, built in 1978. E3s include a balcony, E3 Group 1, and E3 Group 2.

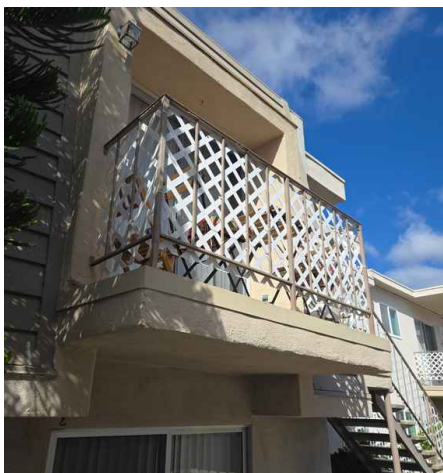
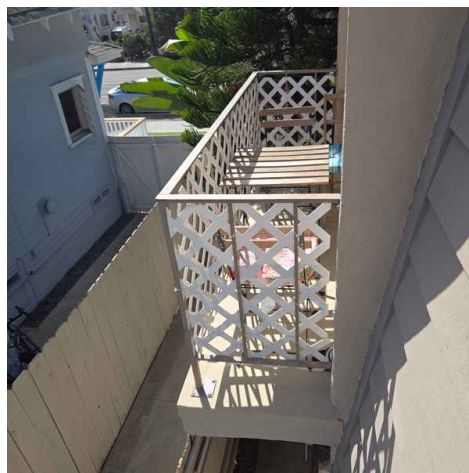
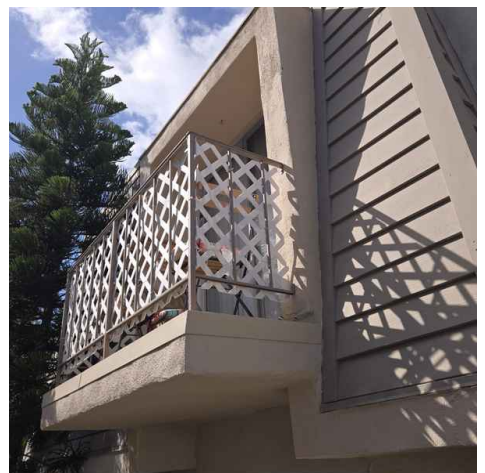
#### Balcony: \*Balcony Inspection Image(s)

This E3 was repaired recently.

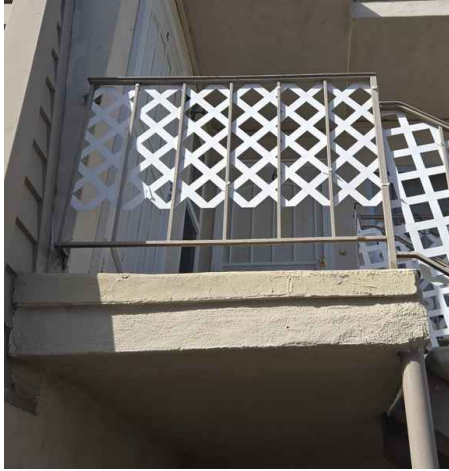
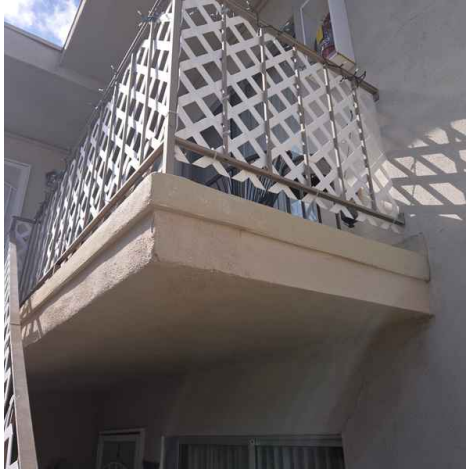
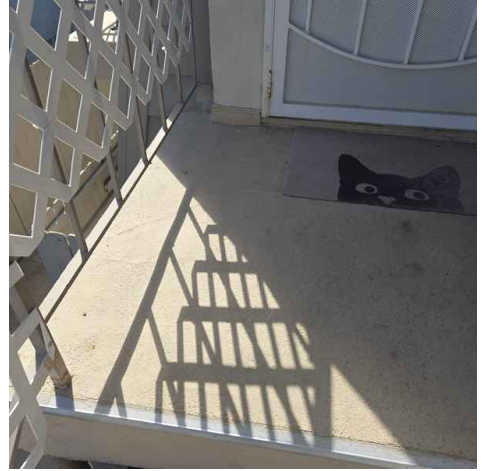
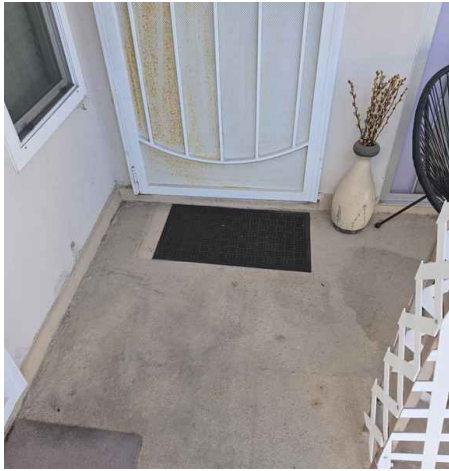
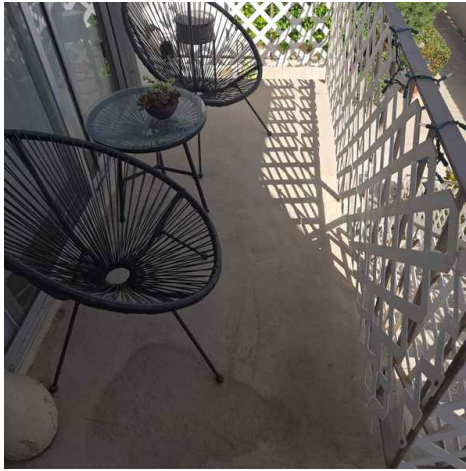
**Walkway: \*Walkway Inspection Image(s)**

This E3 was repaired recently.

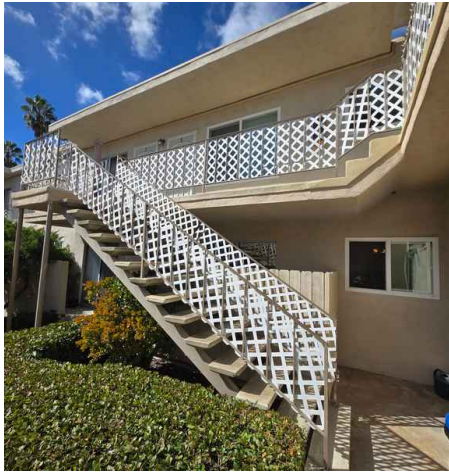
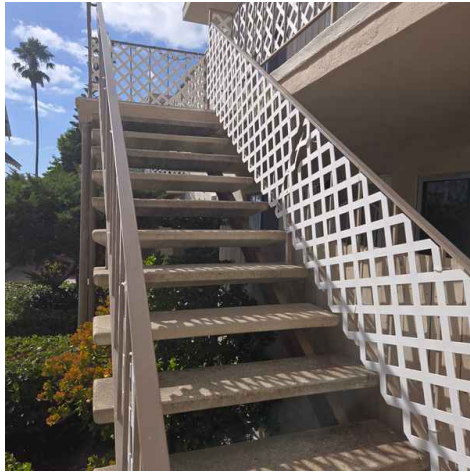
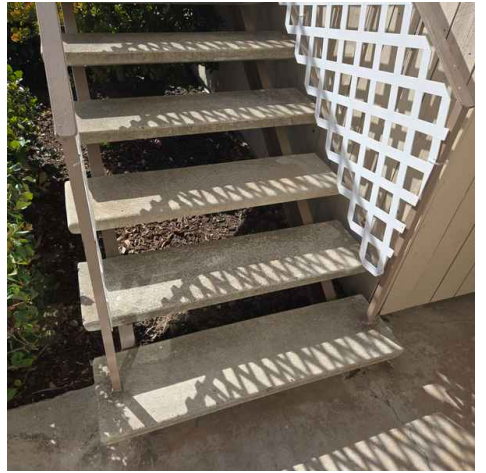
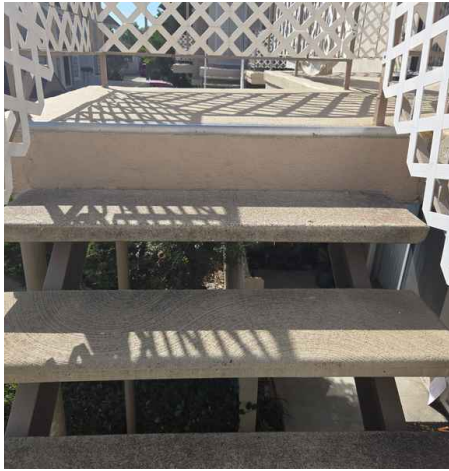
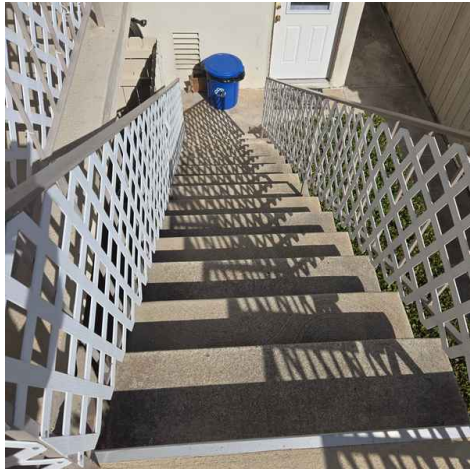
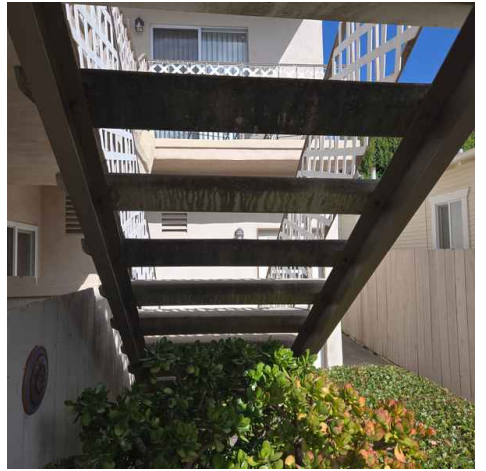
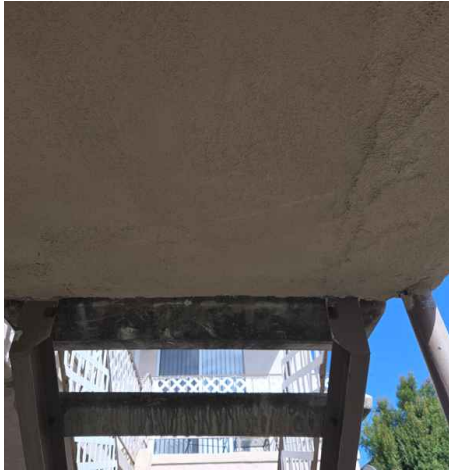
**Stairway: \*Stairway Inspection Image(s)**

This E3 was repaired recently.

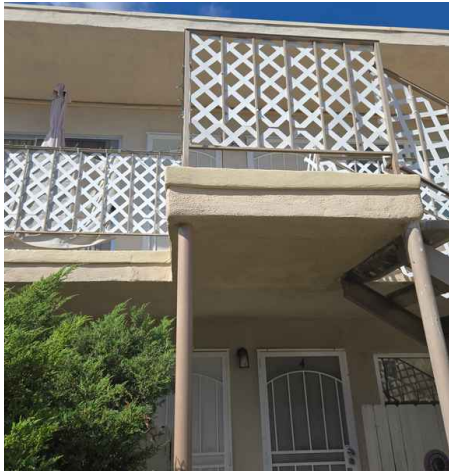
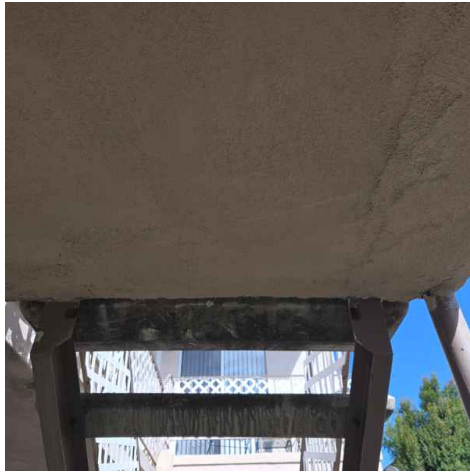
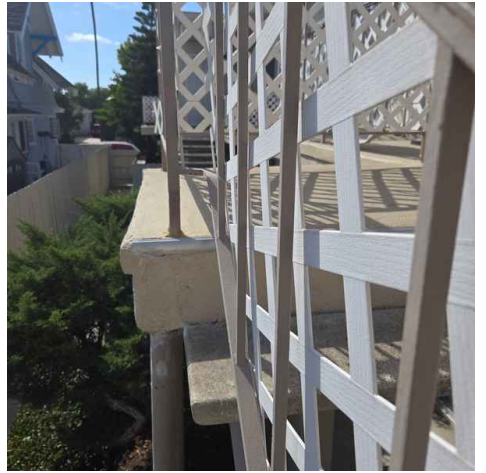
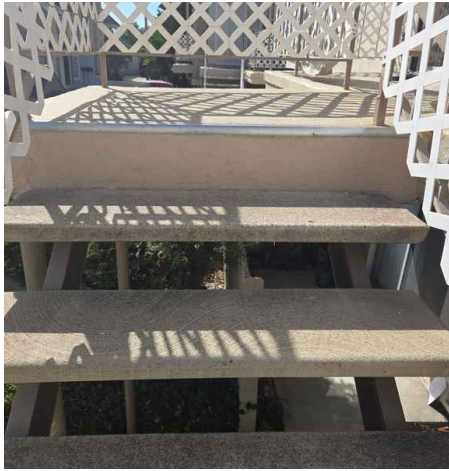
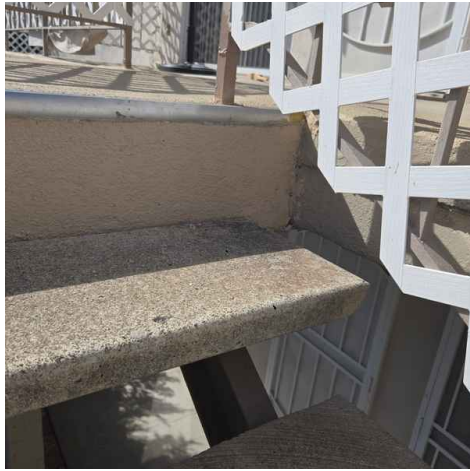
**Landing: \*Landing Inspection Image(s)**

This E3 was repaired recently.

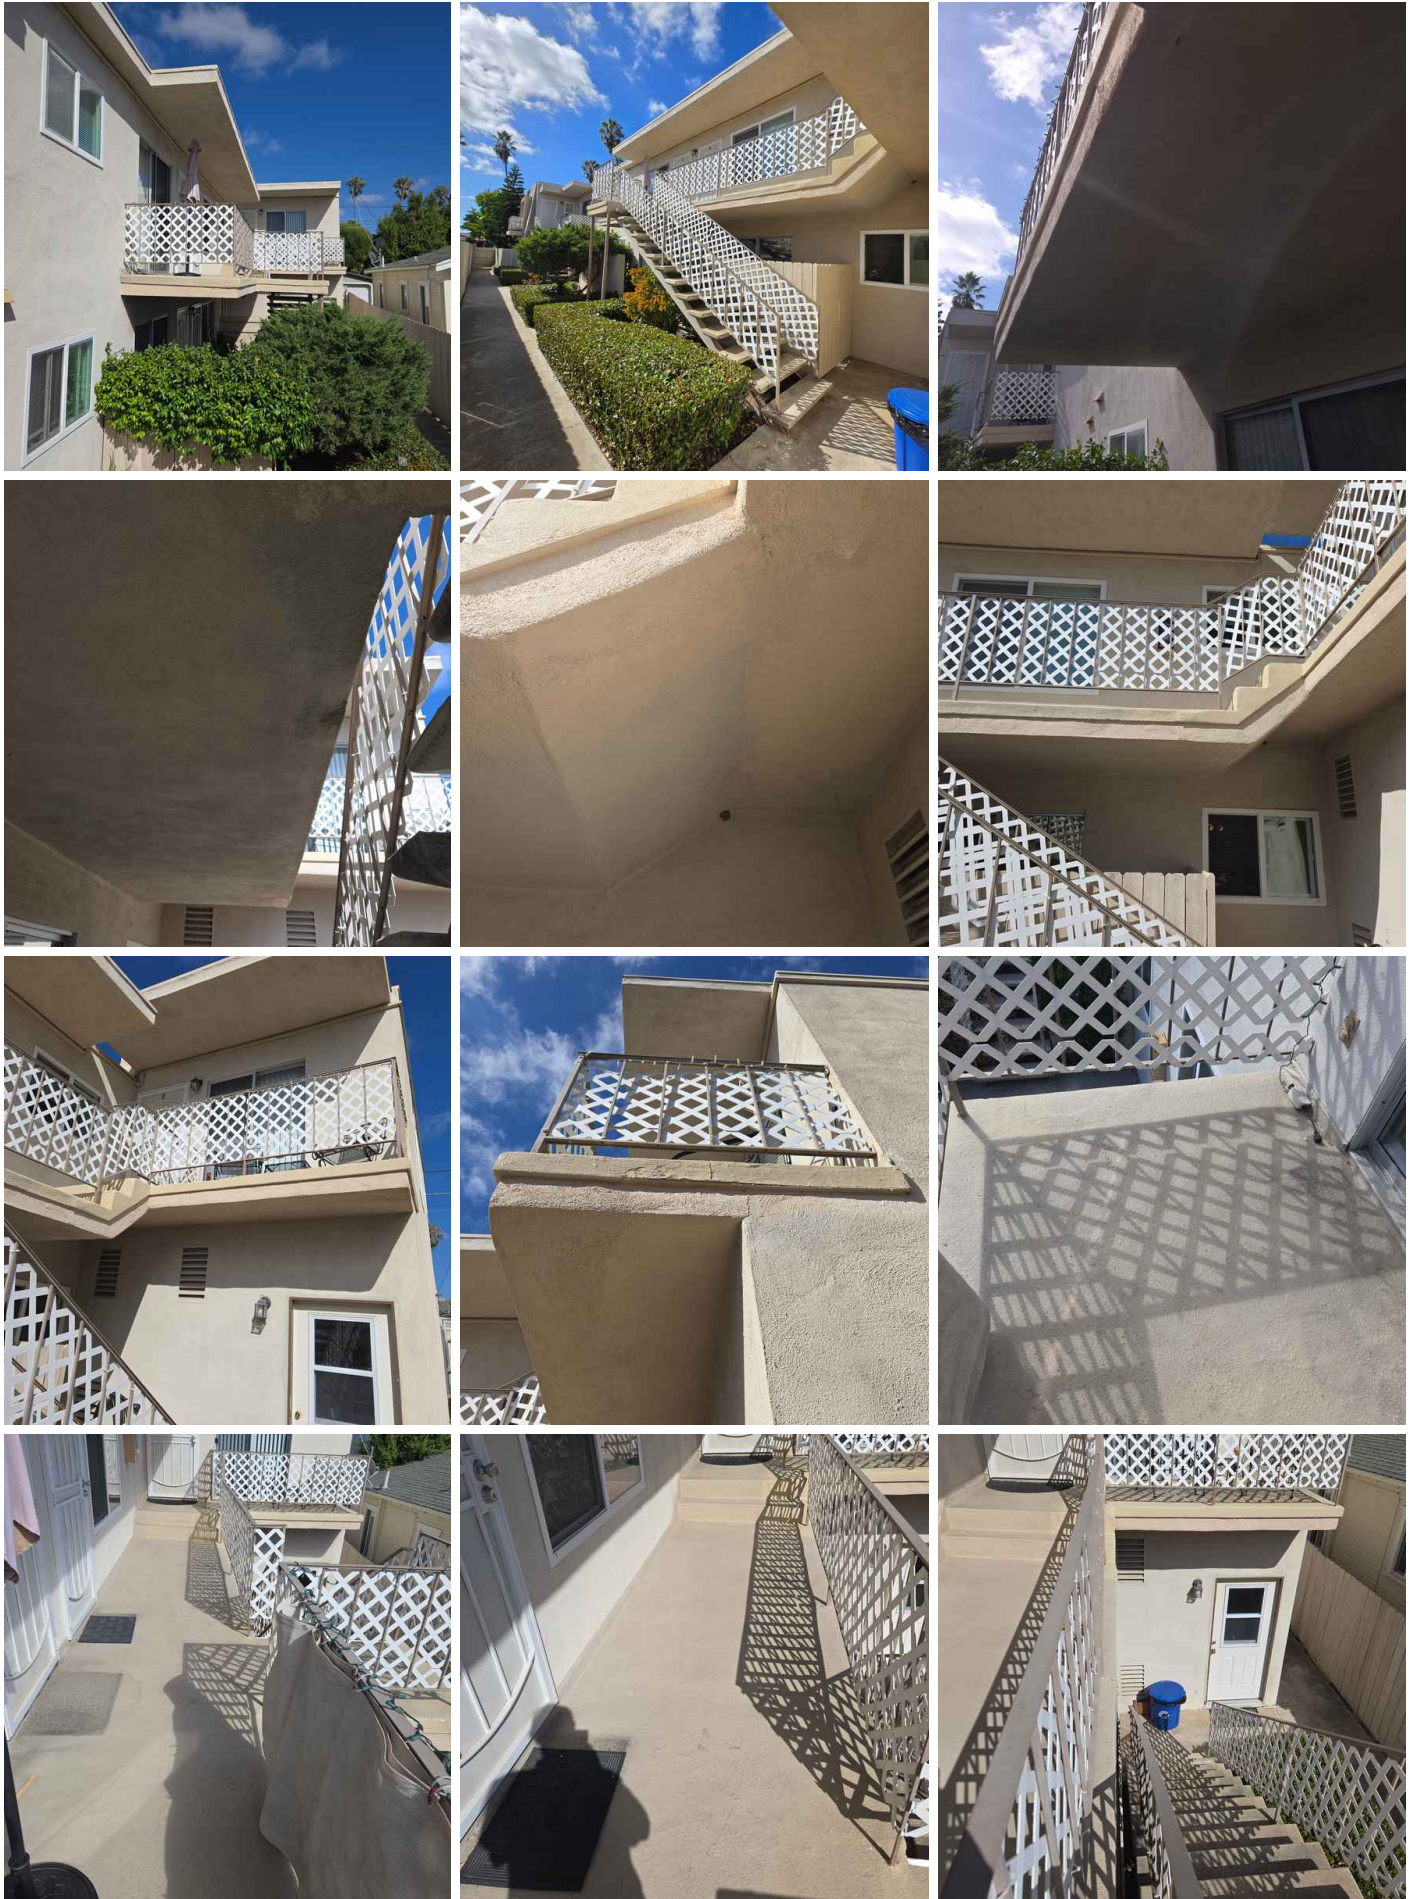
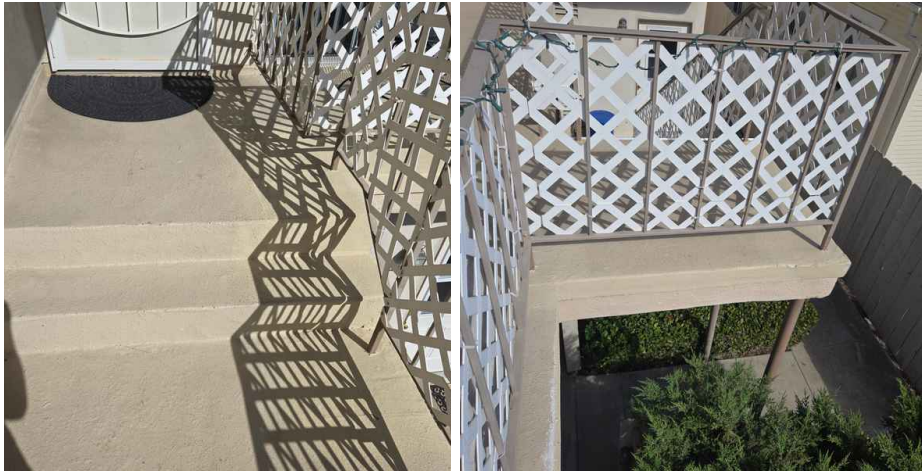
**Walkway: \*Walkway Inspection Image(s)**

This E3 was repaired recently.
