PATRICK'S PROPERTY MAINTENANCE SERVICE

SB-721 INSPECTION

1234 Main Street
Imperial Beach, CA 91932-1412

01/11/2025 9:00AM

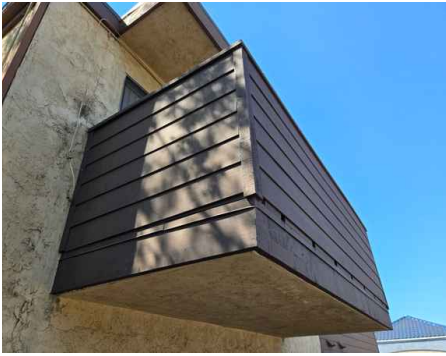
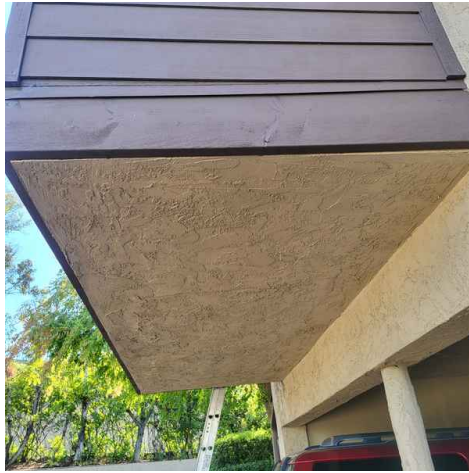
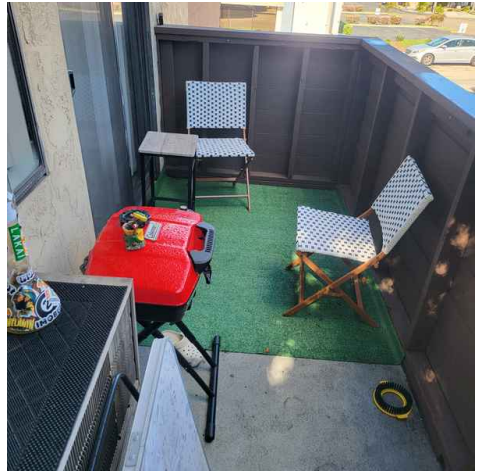
The balcony was repaired within the last 2 years.

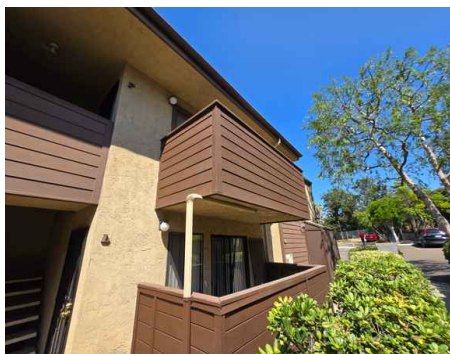
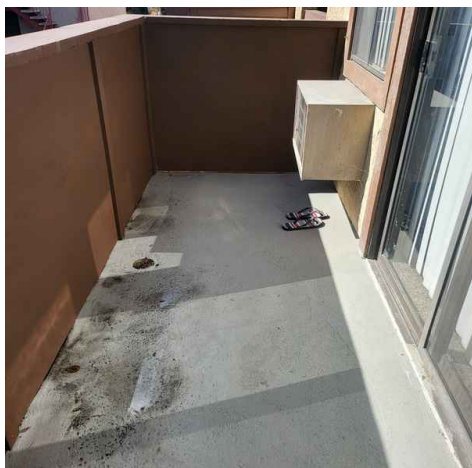
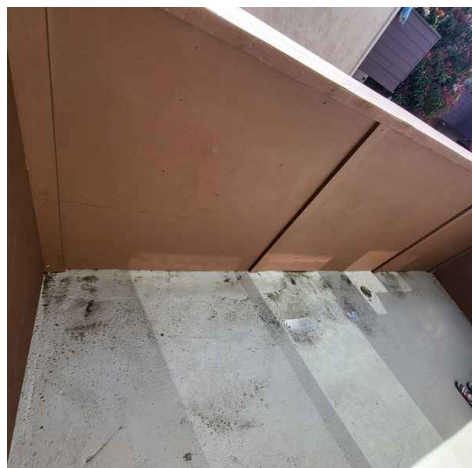
The balcony was repaired within the last 2 years.

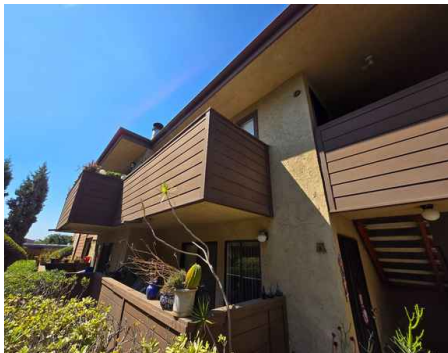
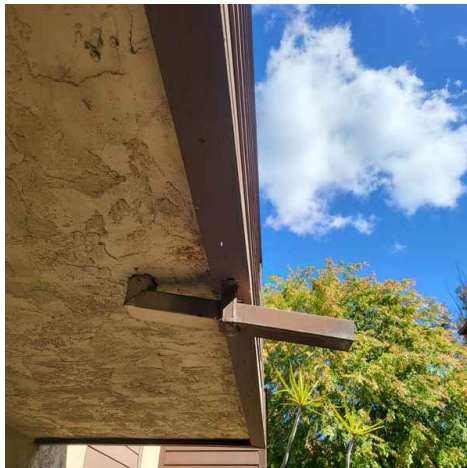
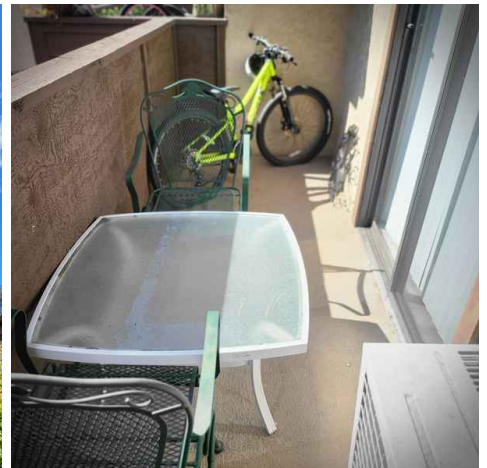
The balcony was repaired within the last 2 years.

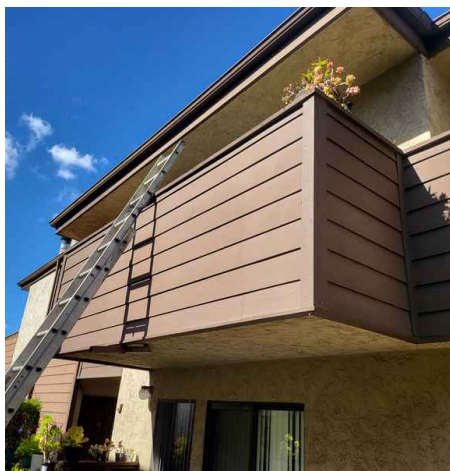
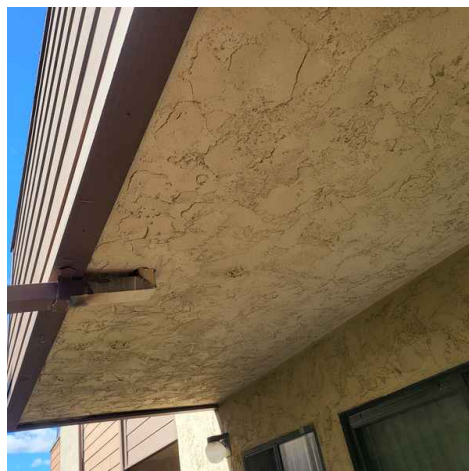
The balcony was repaired within the last 2 years.

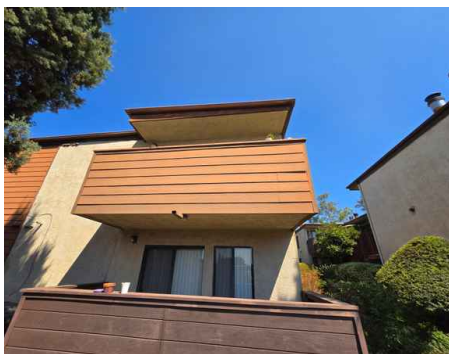
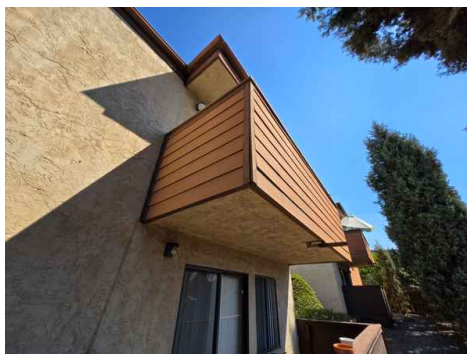
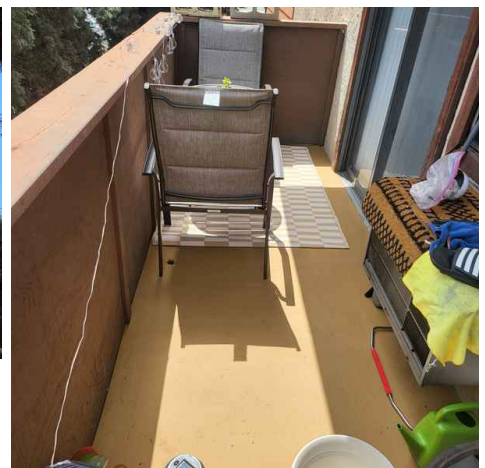
This balcony was recently repaired.

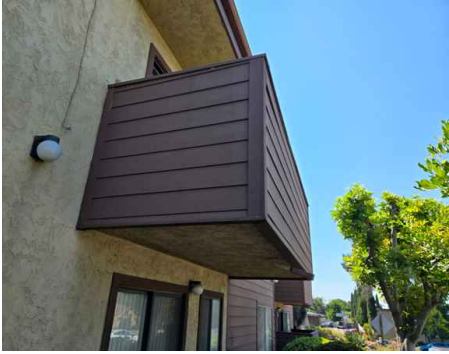
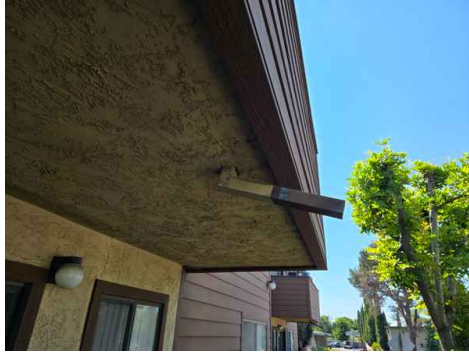
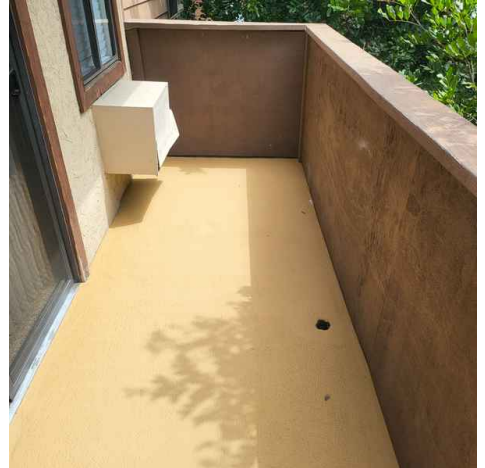
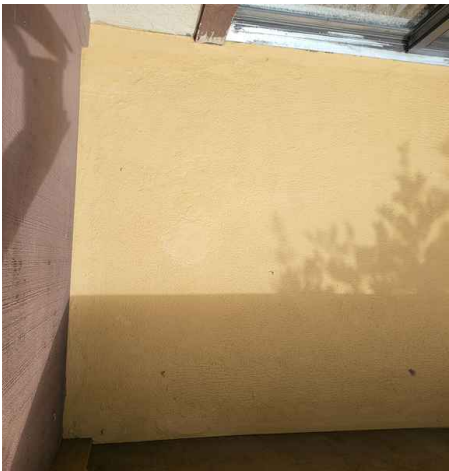
This balcony was recently repaired.

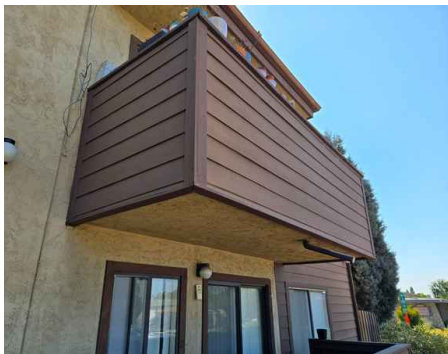
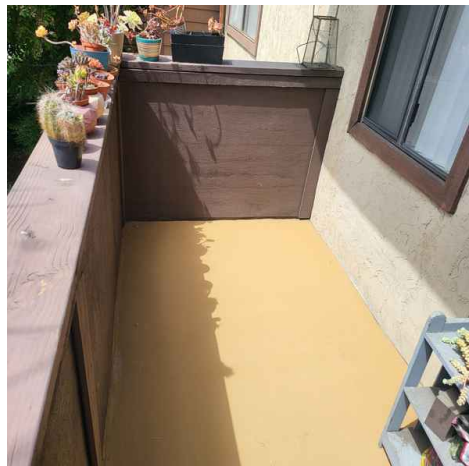
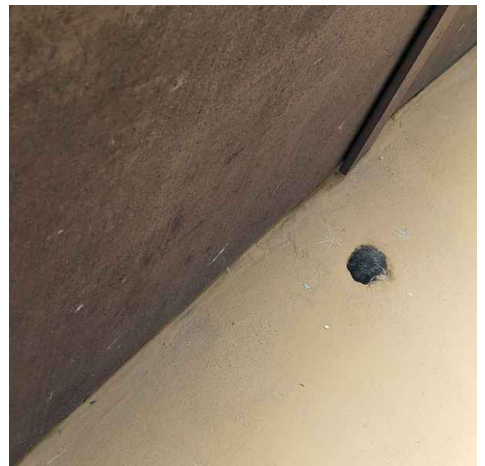
This balcony was recently repaired.

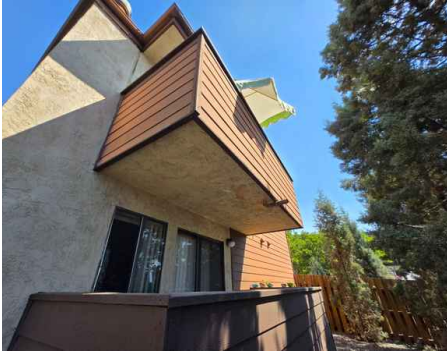
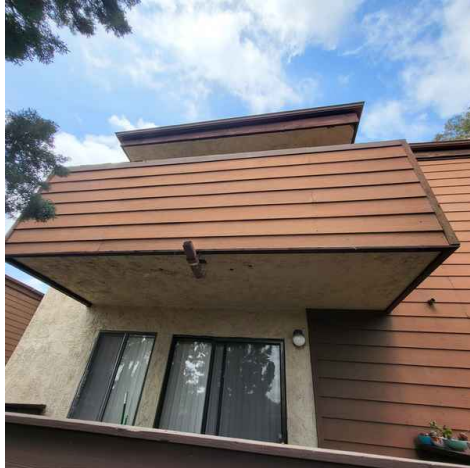
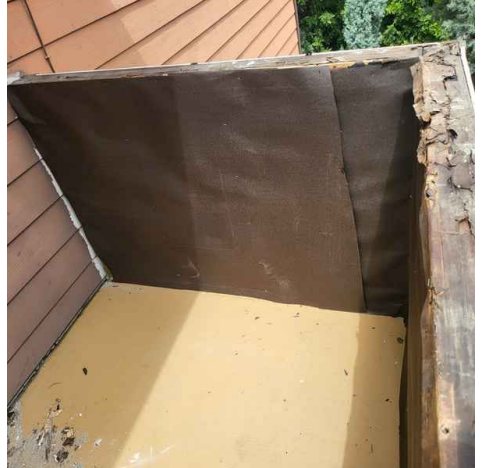
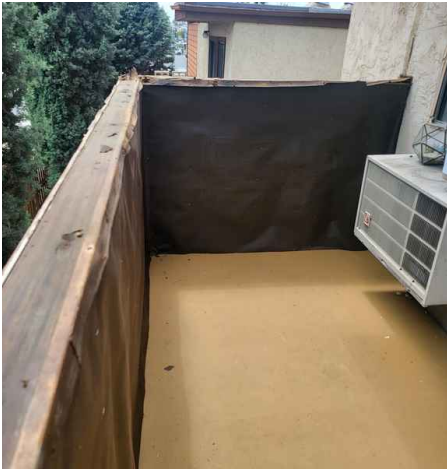
Railing repairs were completed after the photos were taken.

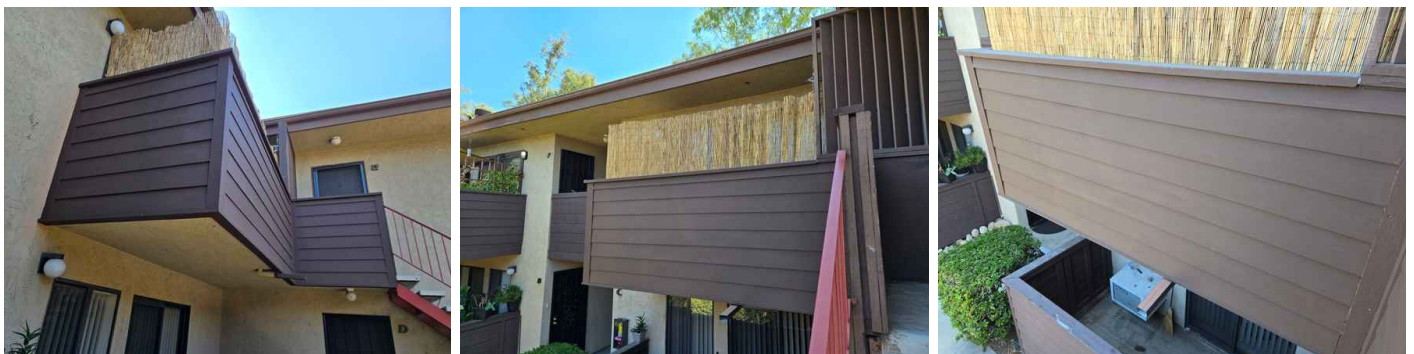
This balcony was recently repaired

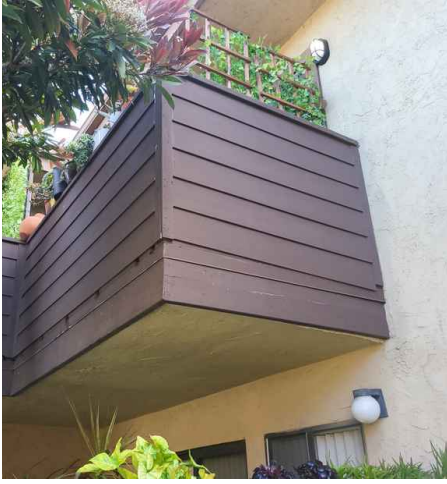
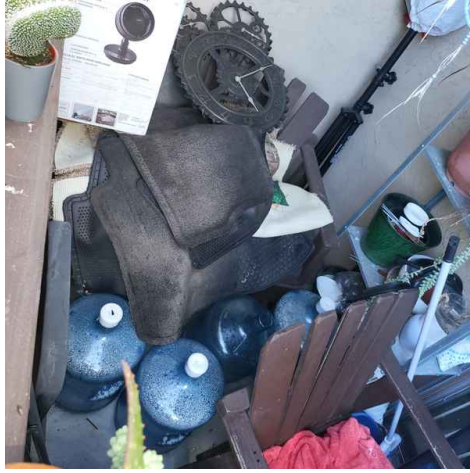
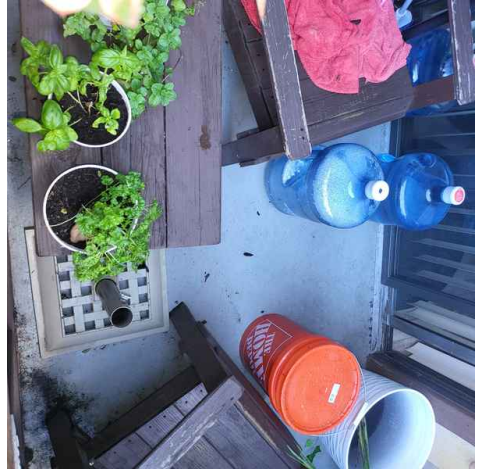
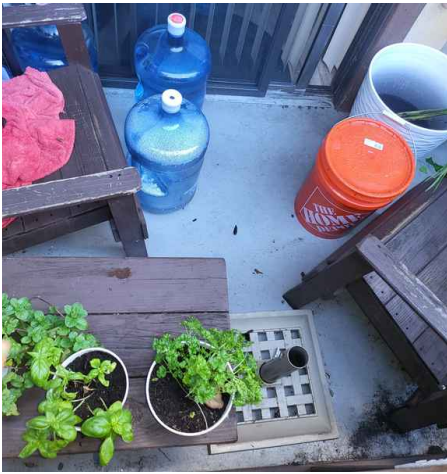
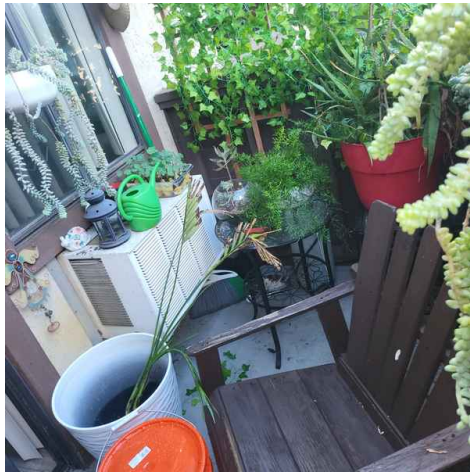
The balcony was repaired within the last 2 years.

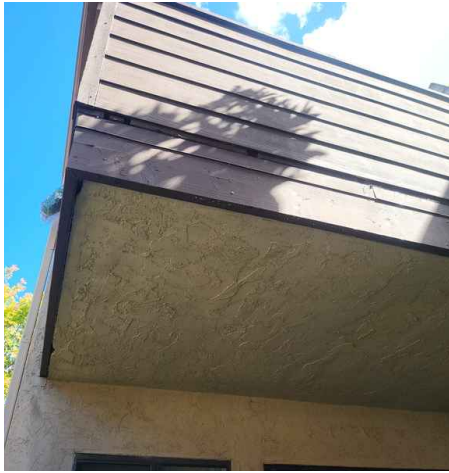
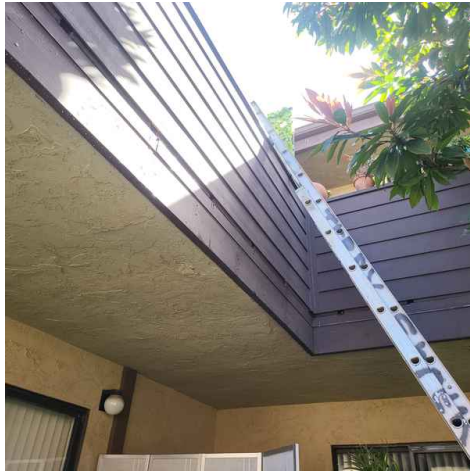
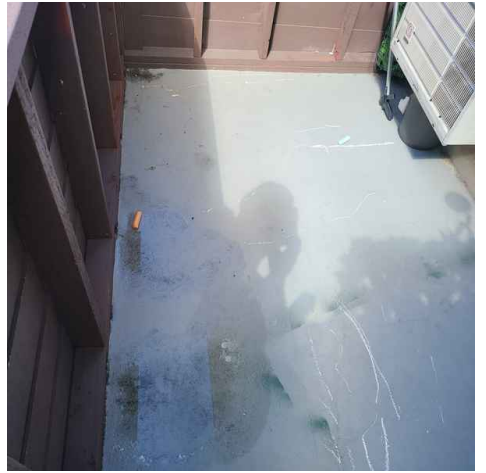
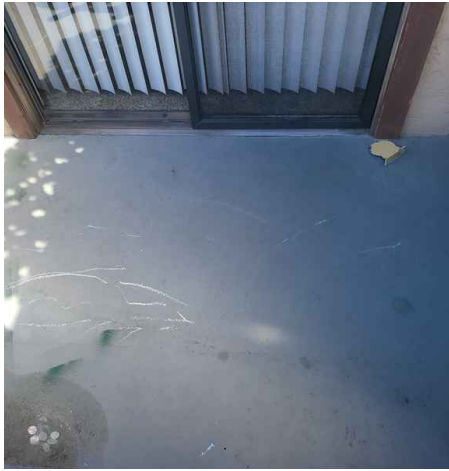
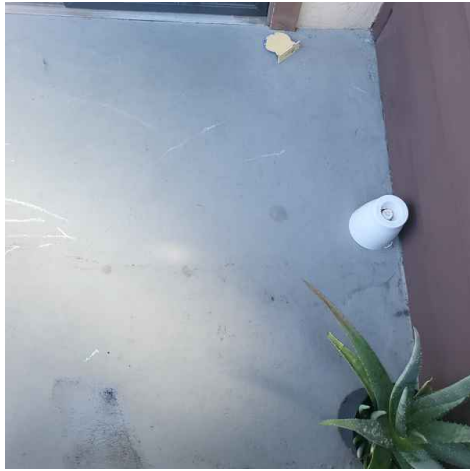
The balcony was repaired within the last 2 years.

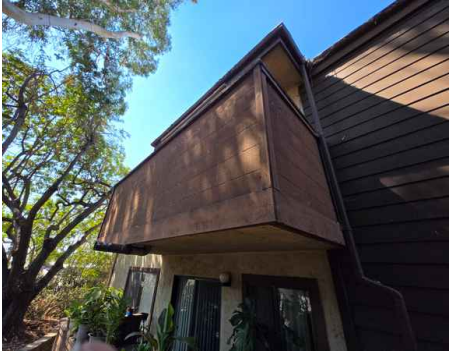
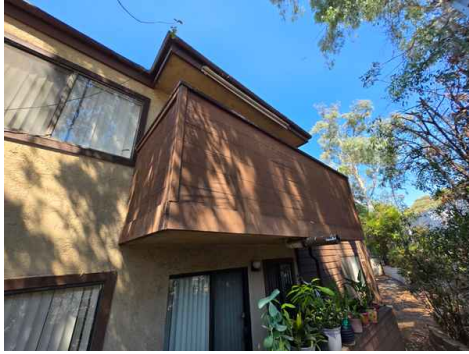
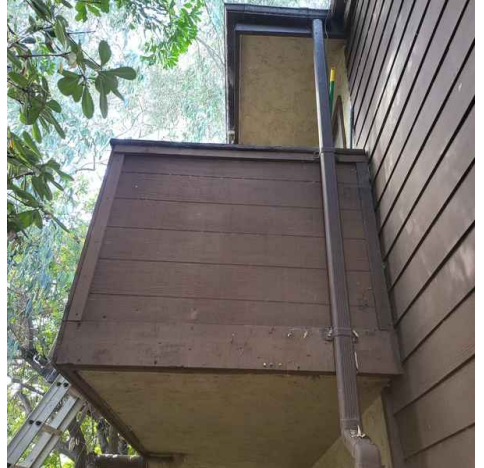
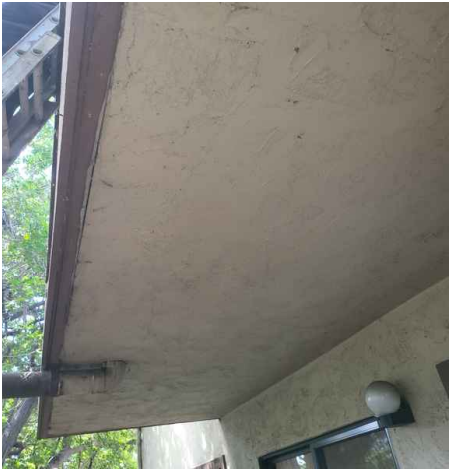
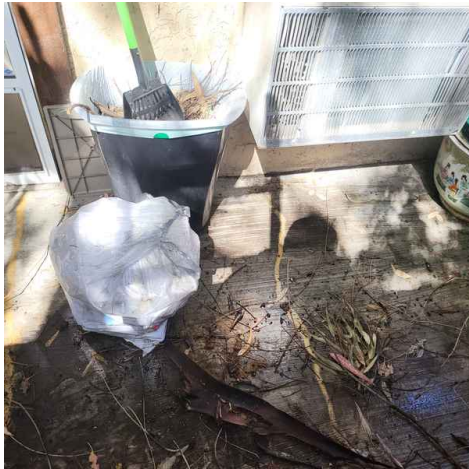
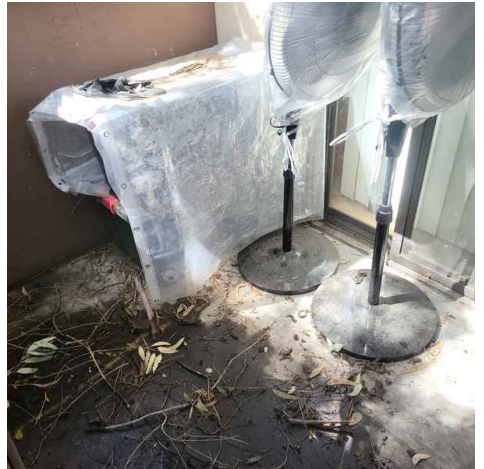
The balcony was repaired within the last 2 years.
