PATRICK'S PROPERTY MAINTENANCE SERVICE

SB-721 INSPECTION

1234 Main Street
Imperial Beach, CA 91932-1412

01/11/2025 9:00AM

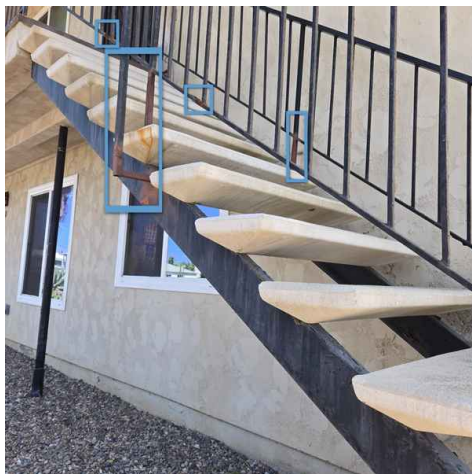
Minor - There is surface corrosion. The affected area(s) should be treated.

Handrail corrosion

Contact a qualified professional.

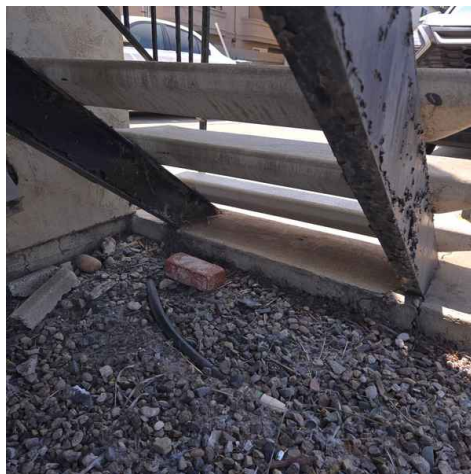
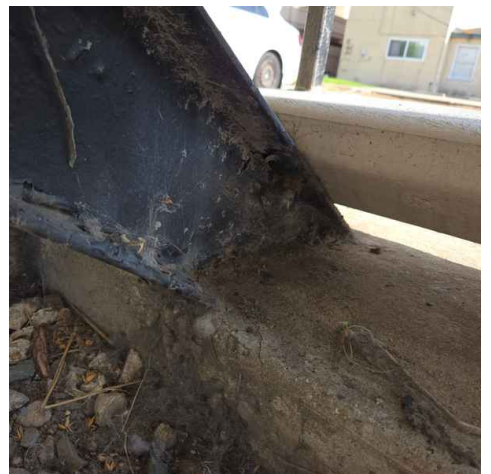
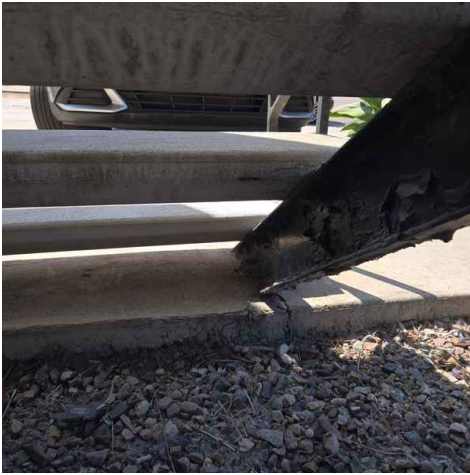
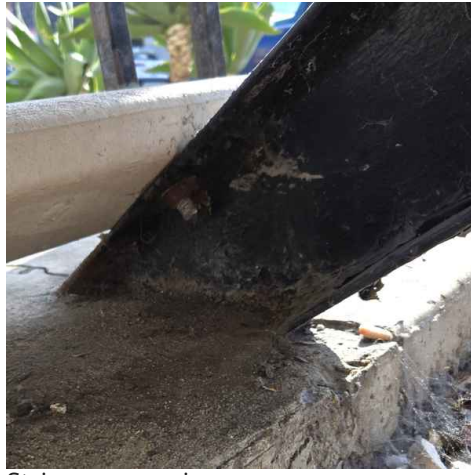
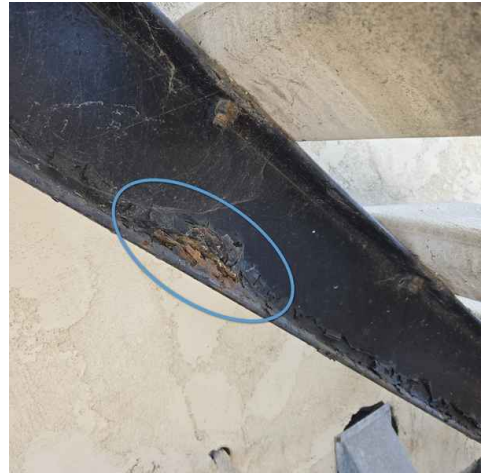
Stringer corrosion

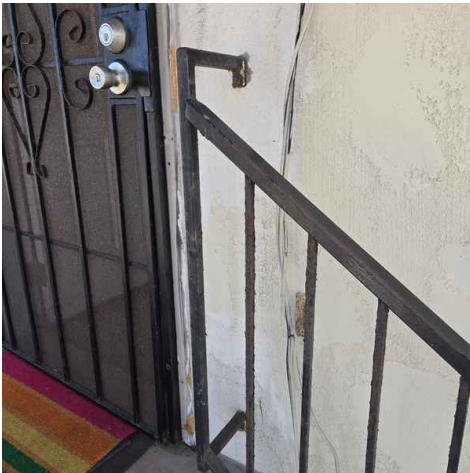
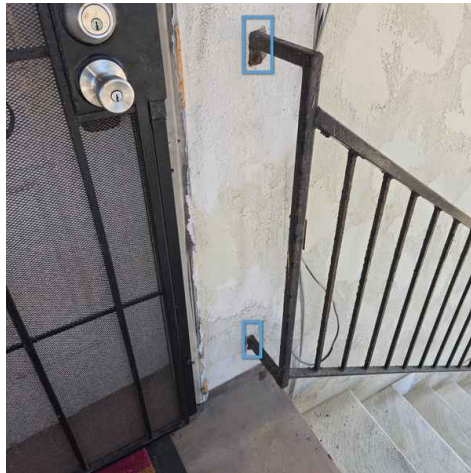
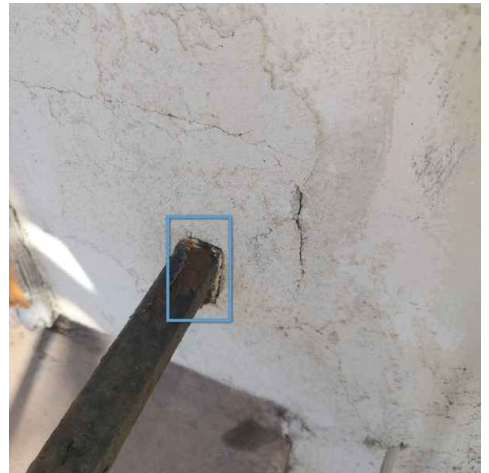
5.2.2 South Stairway

UNSEALED CONNECTION(S)

STAIR RAILING TO STUCCO

There are unsealed connections. Lack of proper sealing at these junctions raises concerns about potential water intrusion. These connections should be sealed.

Contact a qualified professional.

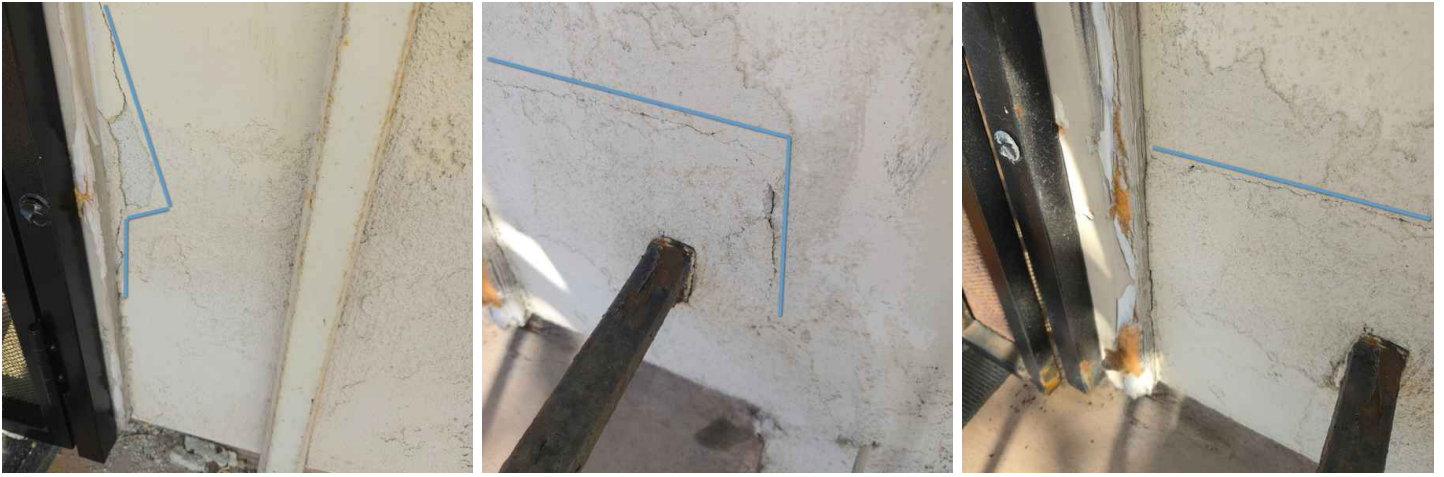
5.3.1 Walkway

DAMAGED STUCCO

Minor - Stucco is cracking, stained, bulging, bubbling, blistering, efflorescing, soft, crumbling, discolored or showing signs of mold and mildew. These condition(s) are minor, and can be addressed as maintenance items.

Contact a qualified professional.

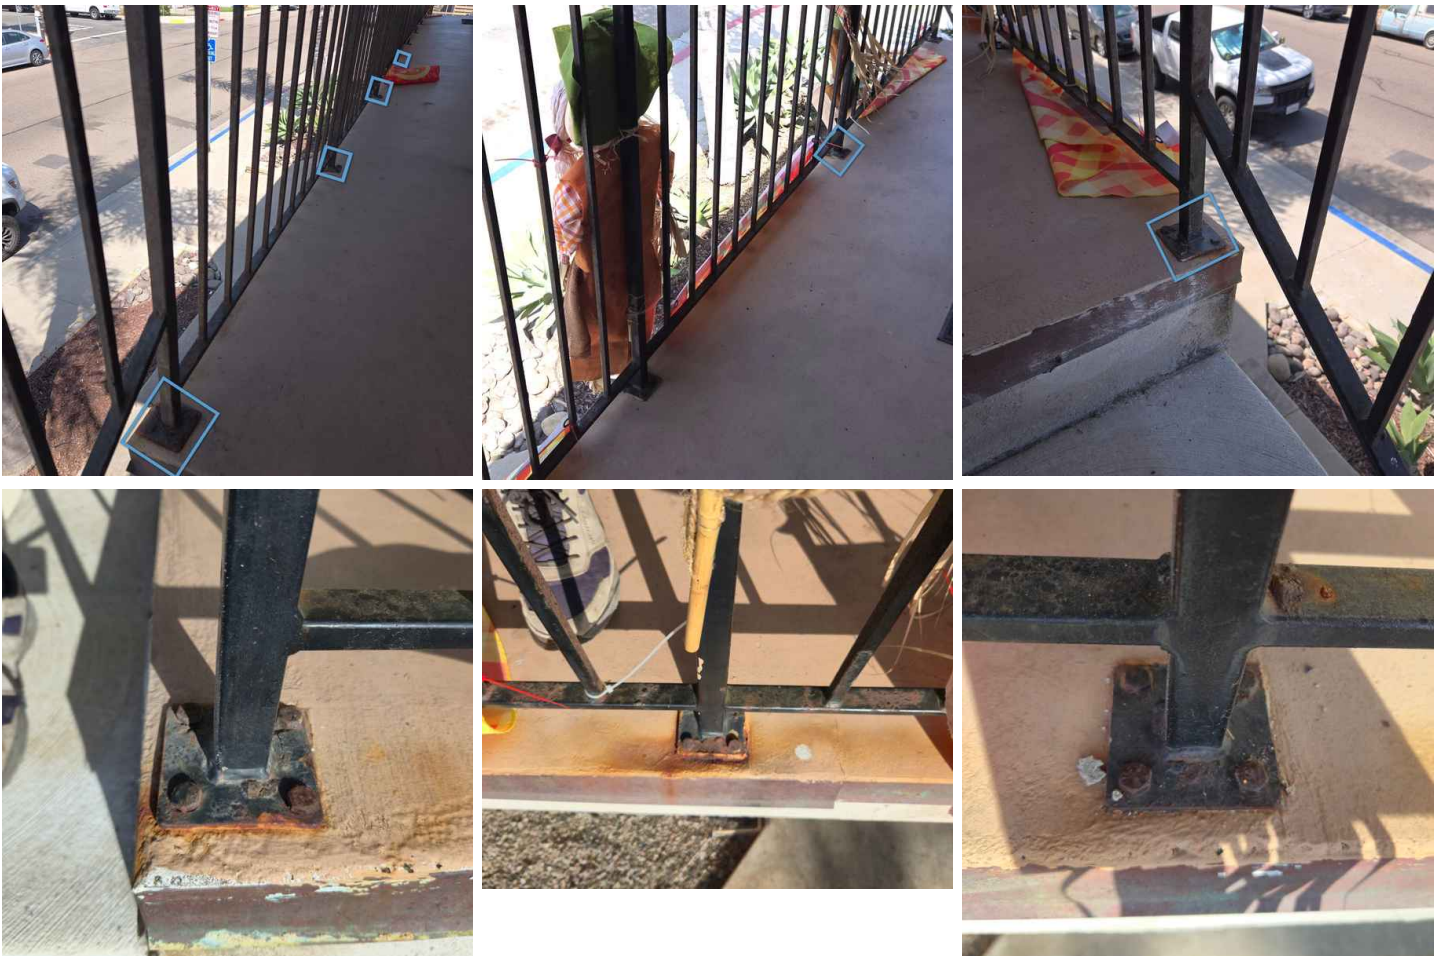
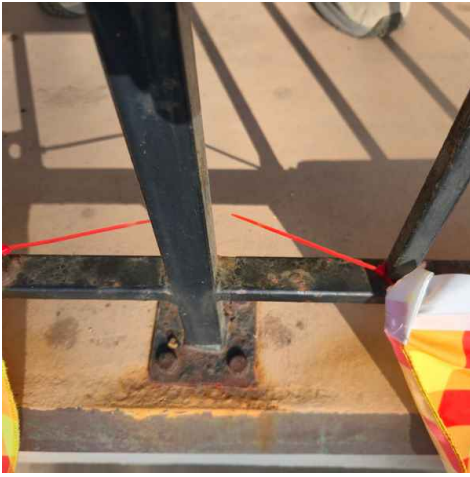
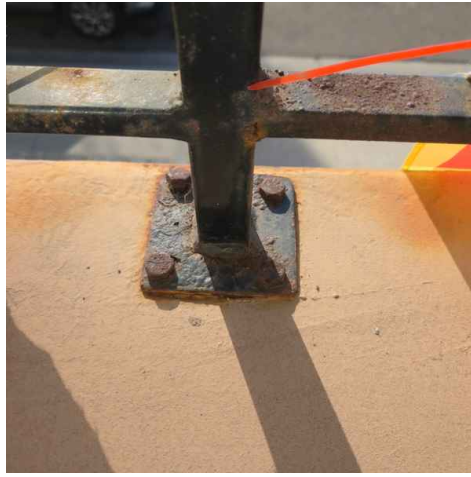
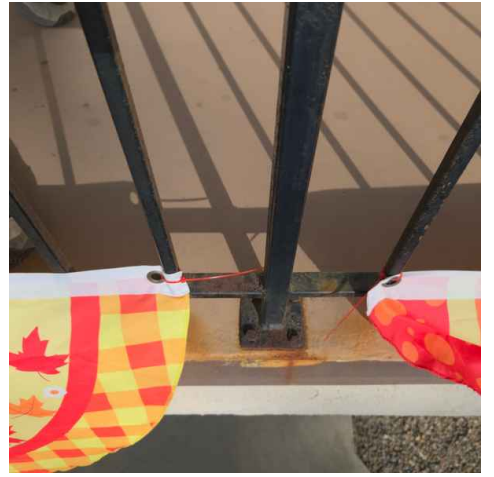
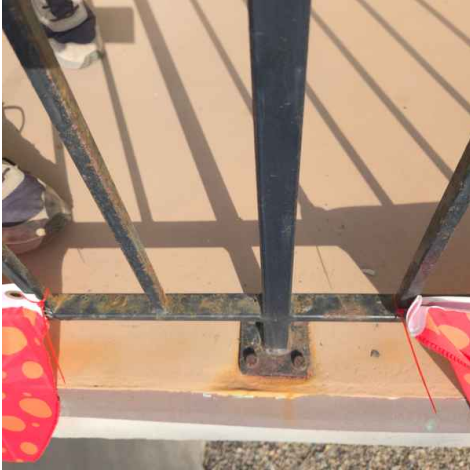
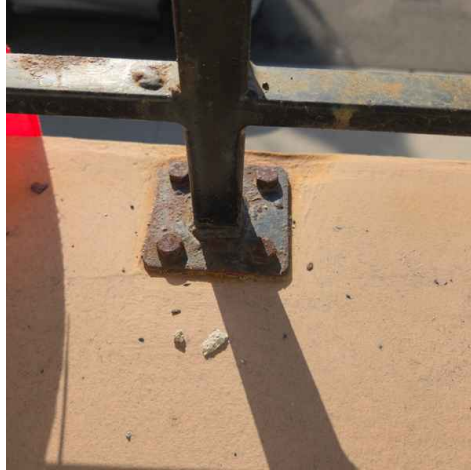
5.3.2 Walkway

UNSEALED CONNECTION(S)

There are unsealed connections. The lack of a proper sealing at these junctions raises potential water intrusion concerns. These connections should be sealed.

Note: There are openings between the handrail mounting hardware, the base plate and the walkway surface.

Contact a qualified professional.

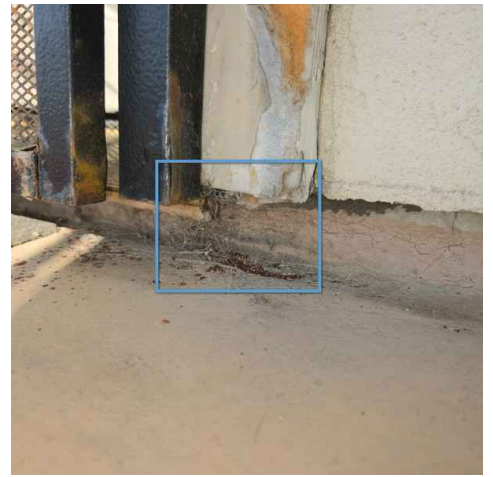
5.3.3 Walkway

TERMITE/WOOD ROT DAMAGE

Minor - There is minor evidence of wood boring insect intrusion and/or wood rot which may include bore-holes or tunnels, pellets and droppings, weakness, softness, live insects, discoloration, crumbling texture, or fungal growth. These condition(s) are minor, the affected components should be treated or replaced.

Contact a qualified professional.

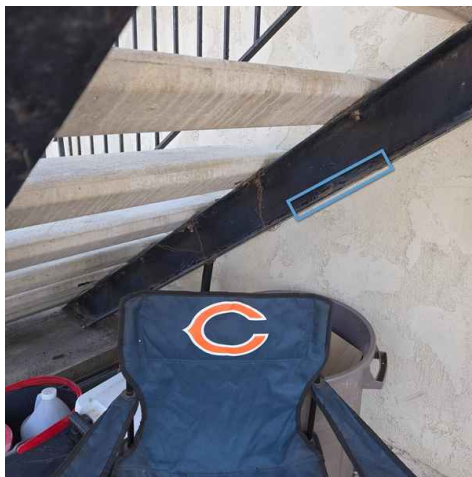
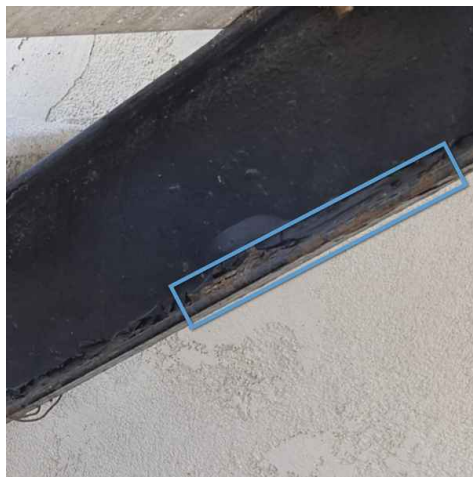
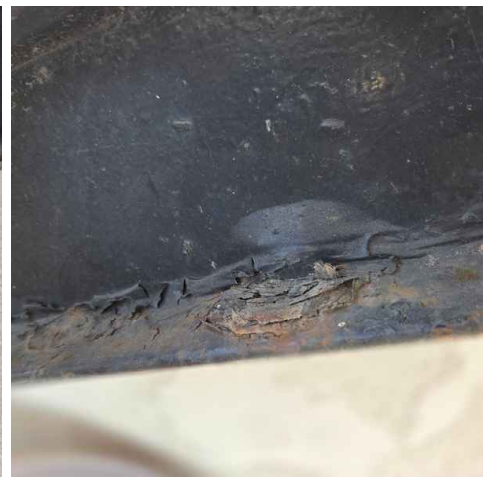
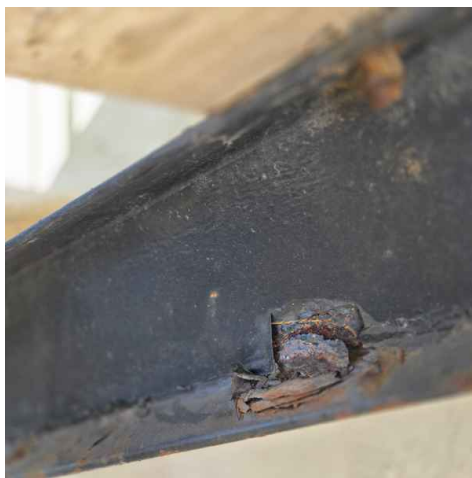
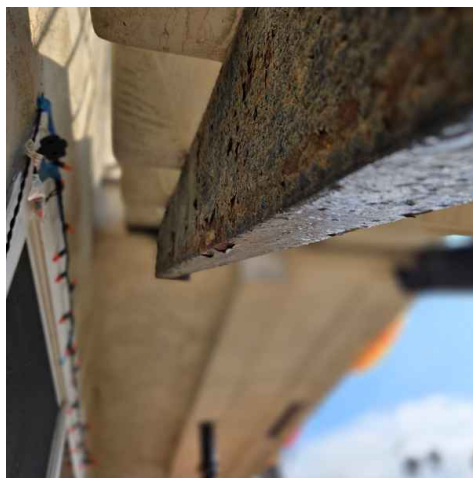
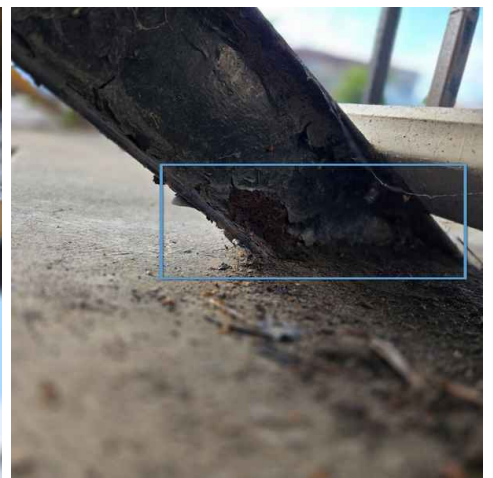
Minor - There is surface corrosion. The affected area(s) should be treated.

Stringer corrosion

Contact a qualified professional.

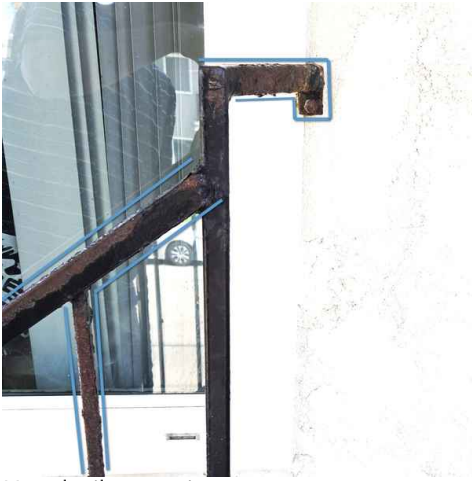
Handrail corrosion

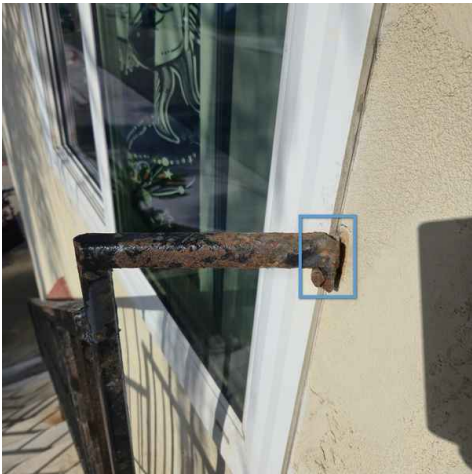
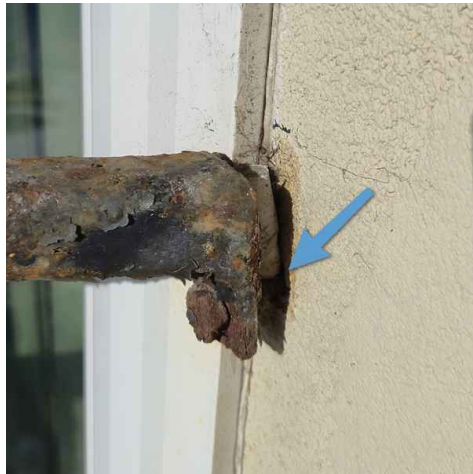
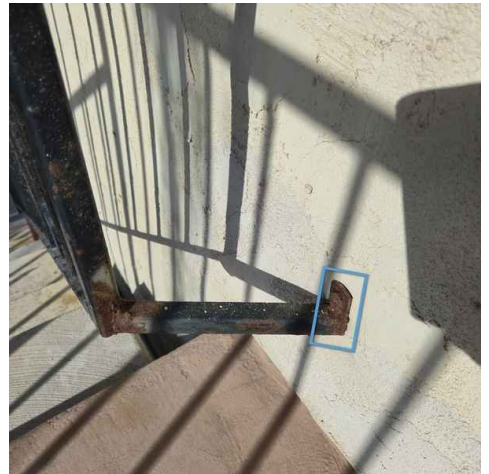
5.4.2 North Stairway

UNSEALED CONNECTION(S)

WHERE THE RAILING ATTACHES TO THE STUCCO

There are unsealed connections. Lack of proper sealing at these junctions raises concerns about potential water intrusion. These connections should be sealed

Contact a qualified professional.

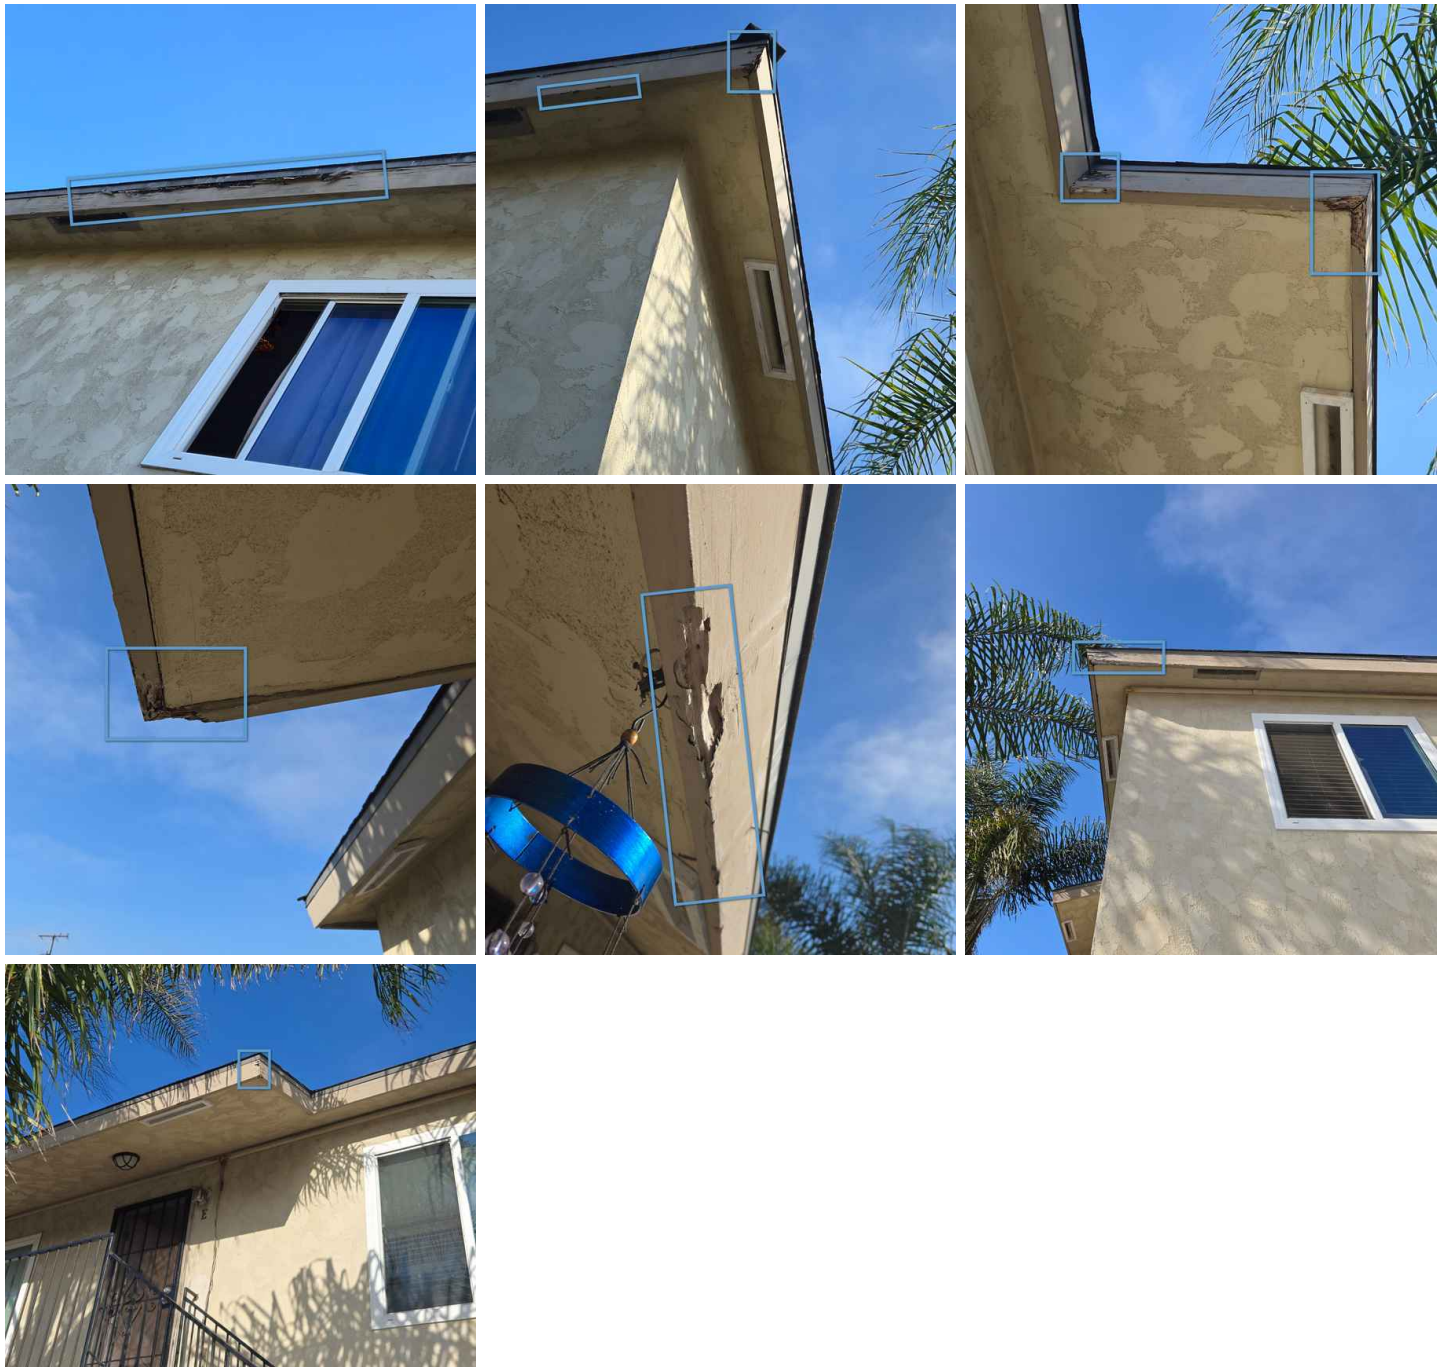
6.1.1

TERMITE DAMAGE

Several sections of fascia have termite damage.

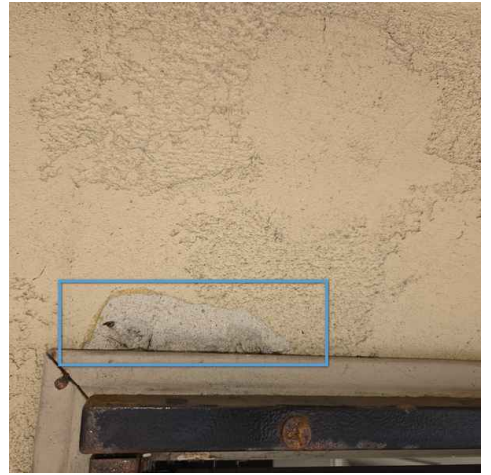
6.1.2

OPENING IN STUCCO
