PATRICK'S PROPERTY MAINTENANCE SERVICE

PHASE 3 SB-721 INSPECTION

1234 Main Street
Imperial Beach, CA 91932-1412

01/11/2025 9:00AM

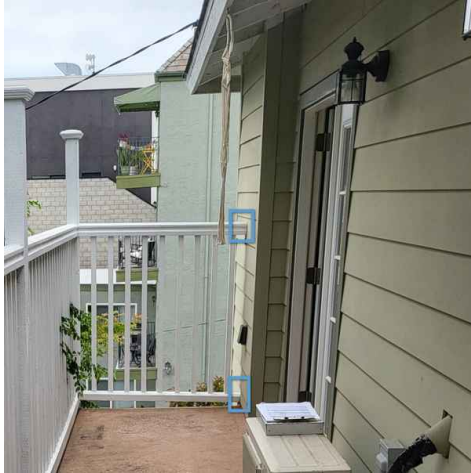
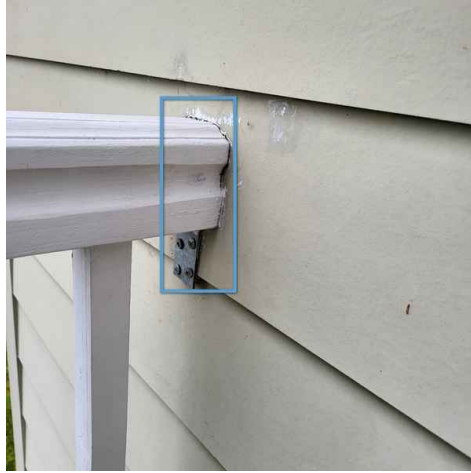
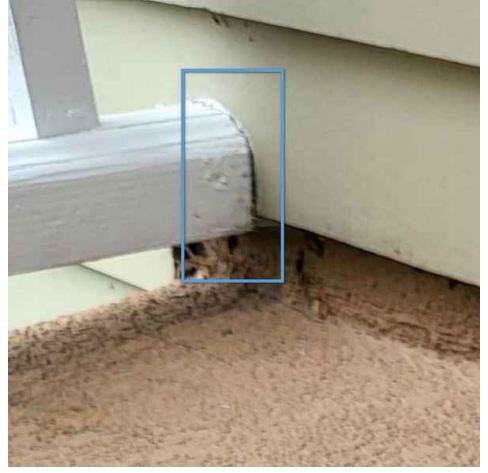
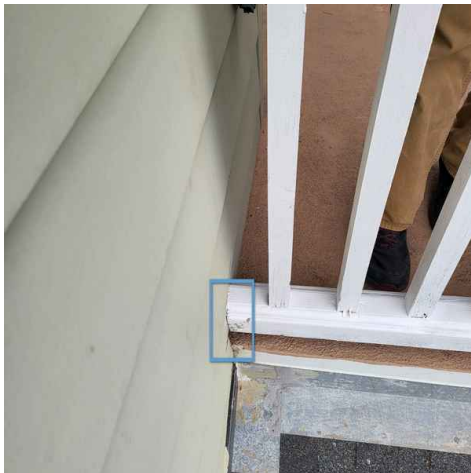
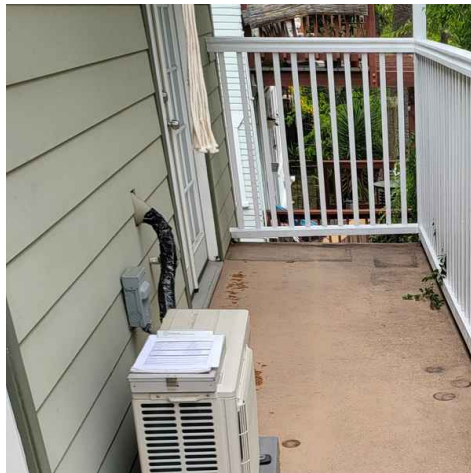
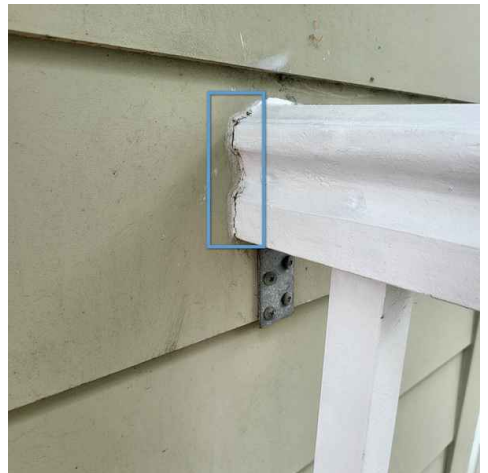
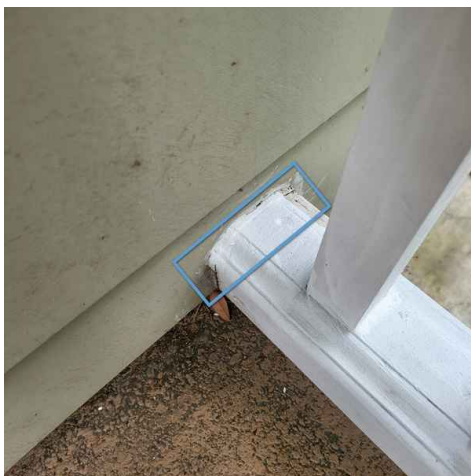
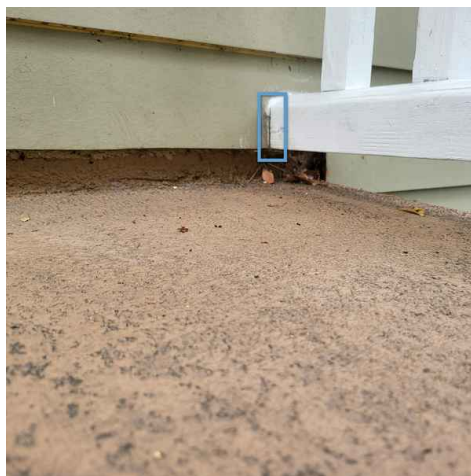
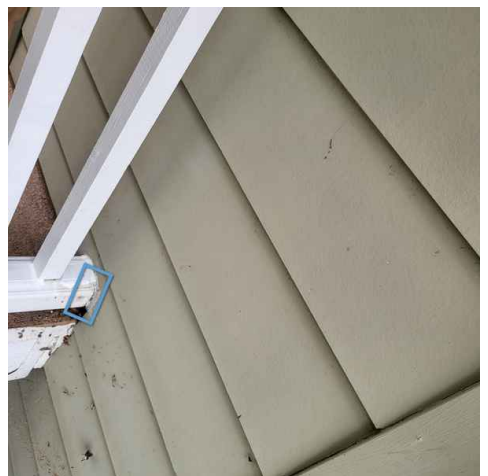
5.2.1 Balcony

UNSEALED CONNECTION(S)

SOUTH AND NORTH RAILING TO WALL

There are unsealed connections. Lack of proper sealing at these junctions raises concerns about potential water intrusion. These connections should be sealed

Contact a qualified professional.

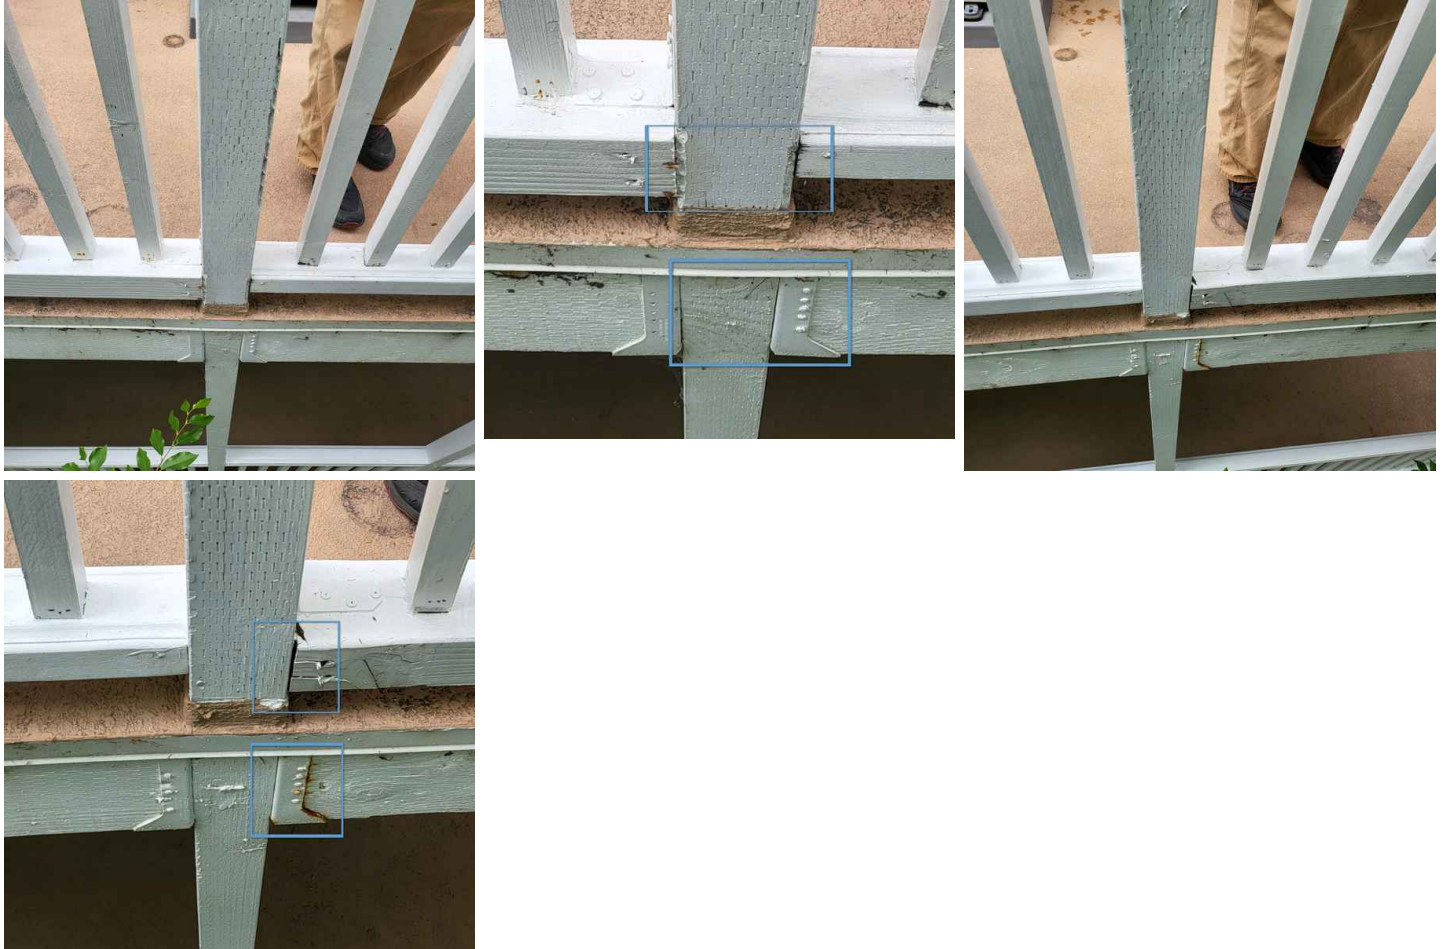
5.2.2 Balcony

UNSEALED CONNECTION(S) 2

HANGER BRACKET & RAIL TO POST

There are unsealed connections. Lack of proper sealing at these junctions raises concerns about potential water intrusion. These connections should be sealed

Contact a qualified professional.

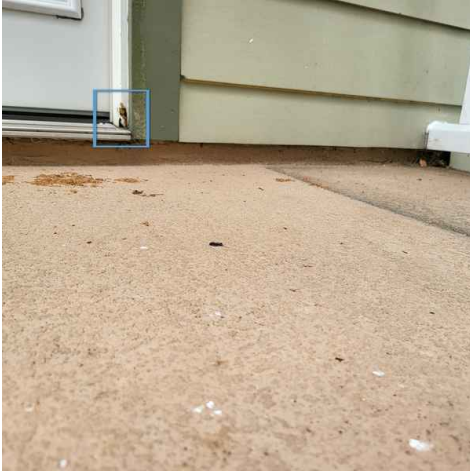
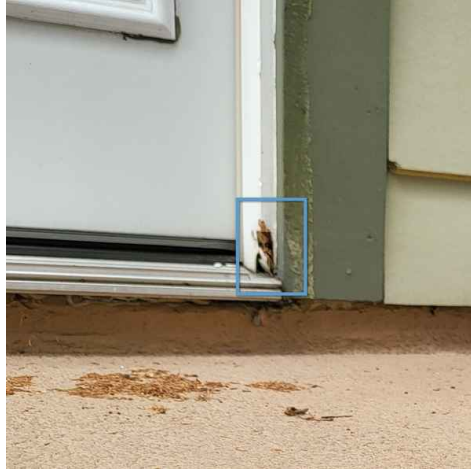
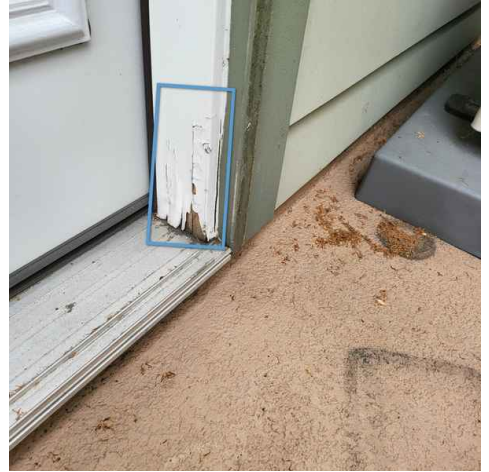
5.2.3 Balcony

TERMITE/DRY ROT DAMAGE

One or more sections of the door jamb have termite and/or dry rot damage. It is recommended that these sections be treated or replaced.

Contact a qualified professional.

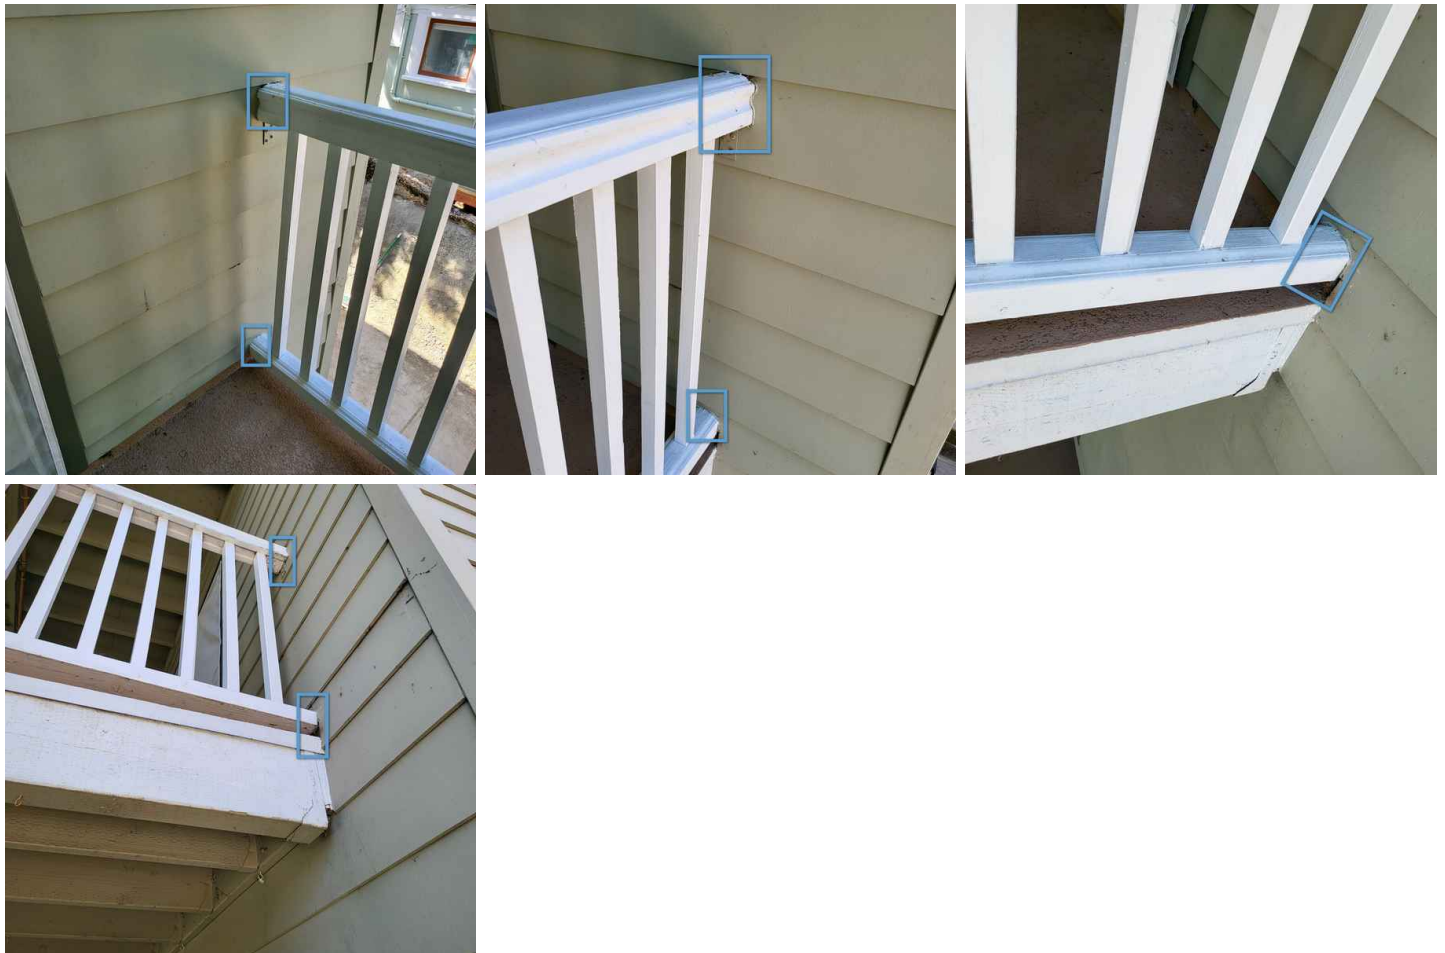
6.2.1 Balcony

UNSEALED CONNECTION(S)

RAIL TO WALL CONNECTION

There are unsealed connections. An improper seal at these junctions raises concerns about potential water intrusion. These connections should be sealed.

Contact a qualified professional.

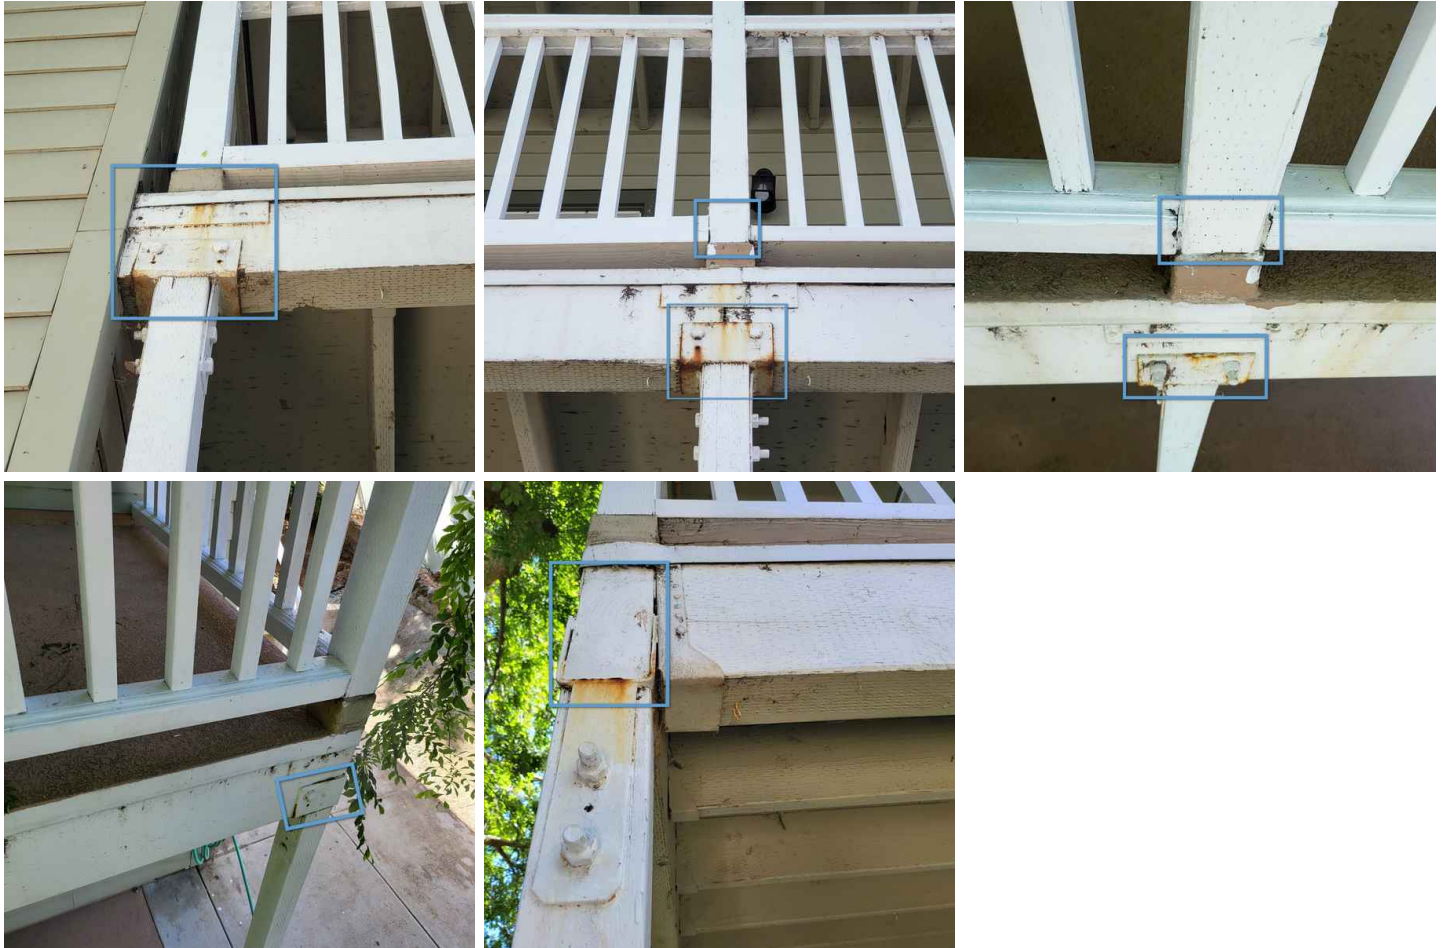
6.2.2 Balcony

UNSEALED CONNECTION AND CORROSION

HANGER BRACKET & RAIL TO POST

There are openings around the hanger brackets and surface corrosion on these brackets. An improper seal at these junctions raises concerns about potential water intrusion and further corrosion. The affected area(s) should be repaired and connections sealed.

Contact a qualified professional.
