PATRICK'S PROPERTY MAINTENANCE SERVICE

PHASE 3 SB-721 INSPECTION

1234 Main Street
Imperial Beach, CA 91932-1412

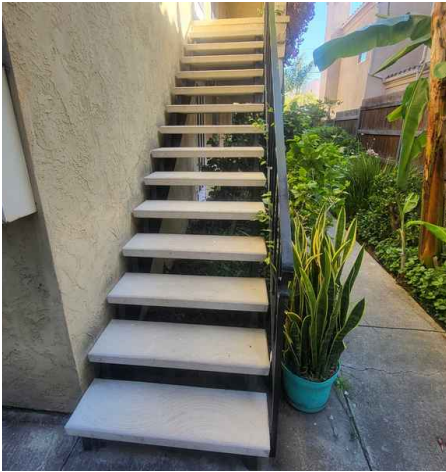
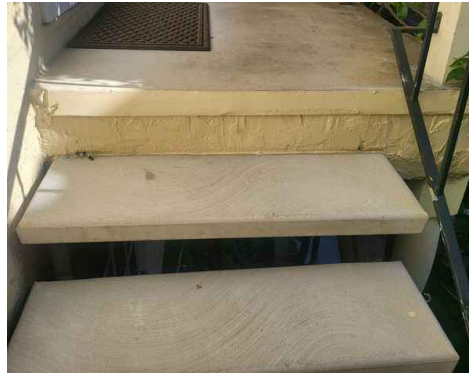
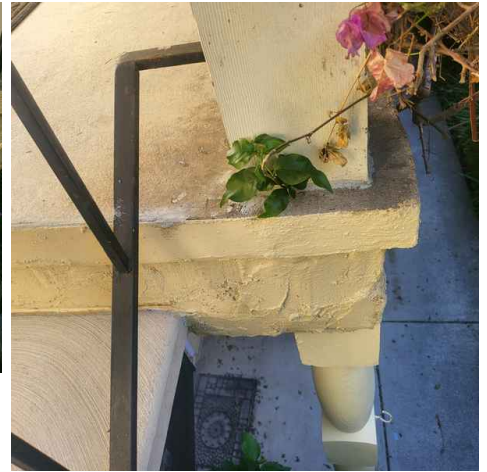
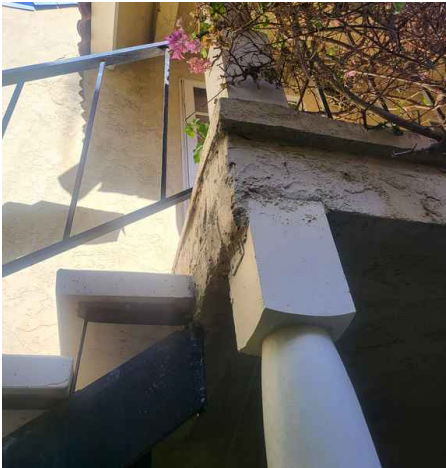
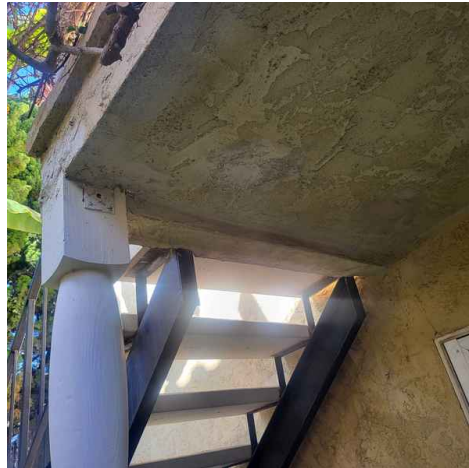
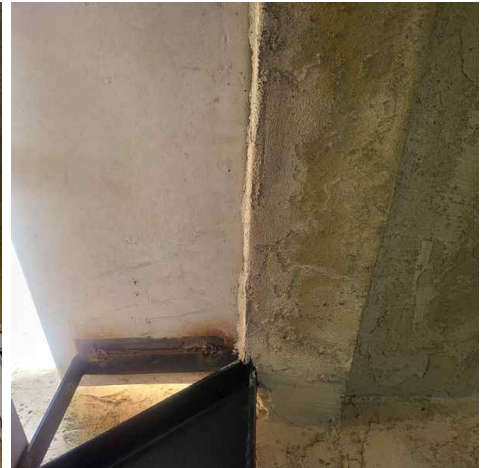
Stairway: *Stairway Inspection Image(s)

Most if not all stair treads were replaced recently.
