PATRICK'S PROPERTY MAINTENANCE SERVICE

SB-721 INSPECTION

1234 Main Street
Imperial Beach, CA 91932-1412

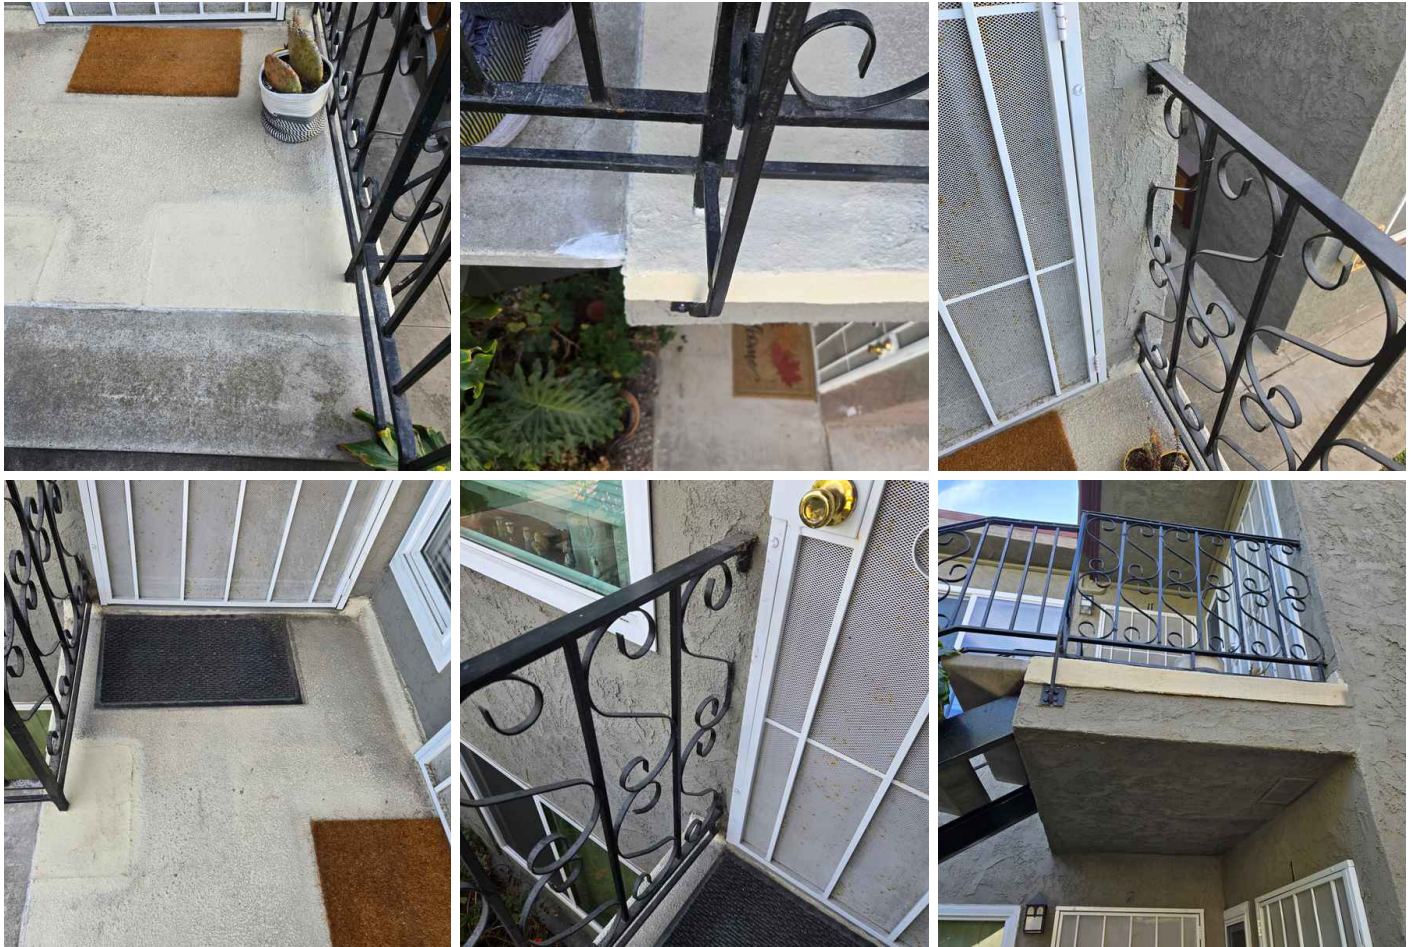
Landing: *Landing Inspection Image(s)

This E3 was repaired recently.

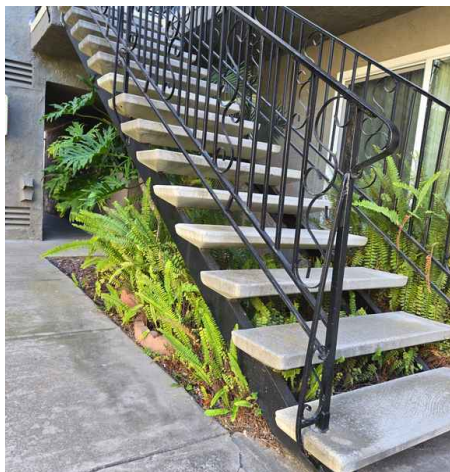
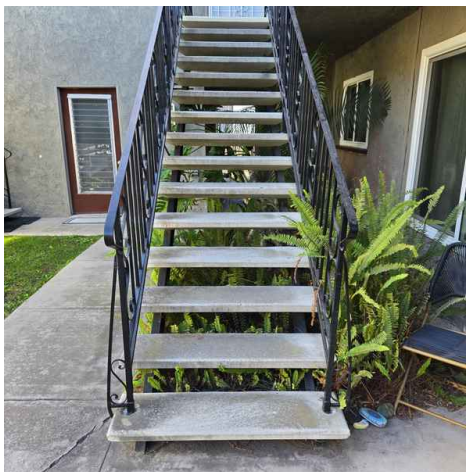
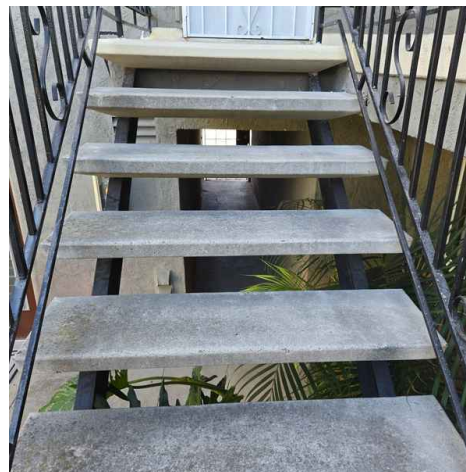
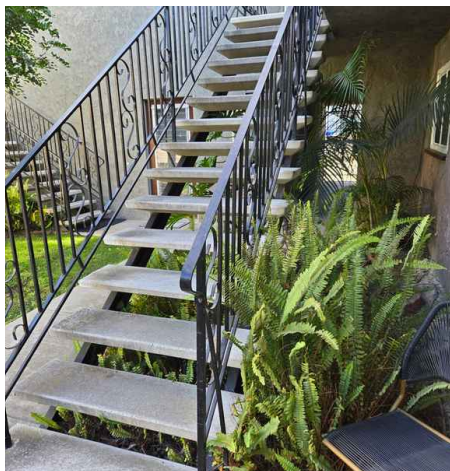
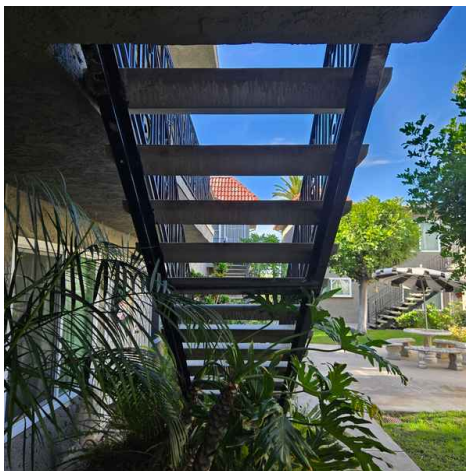
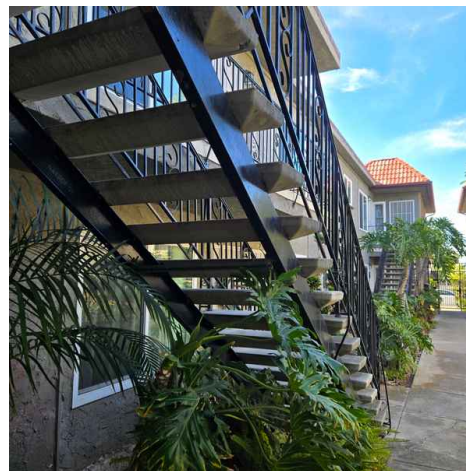
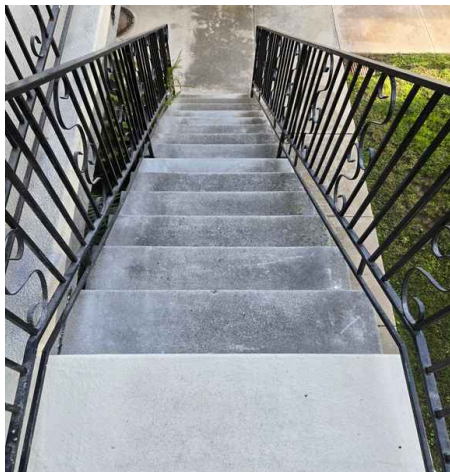
Stairway: *Stairway Inspection Image(s)

This E3 was repaired recently.

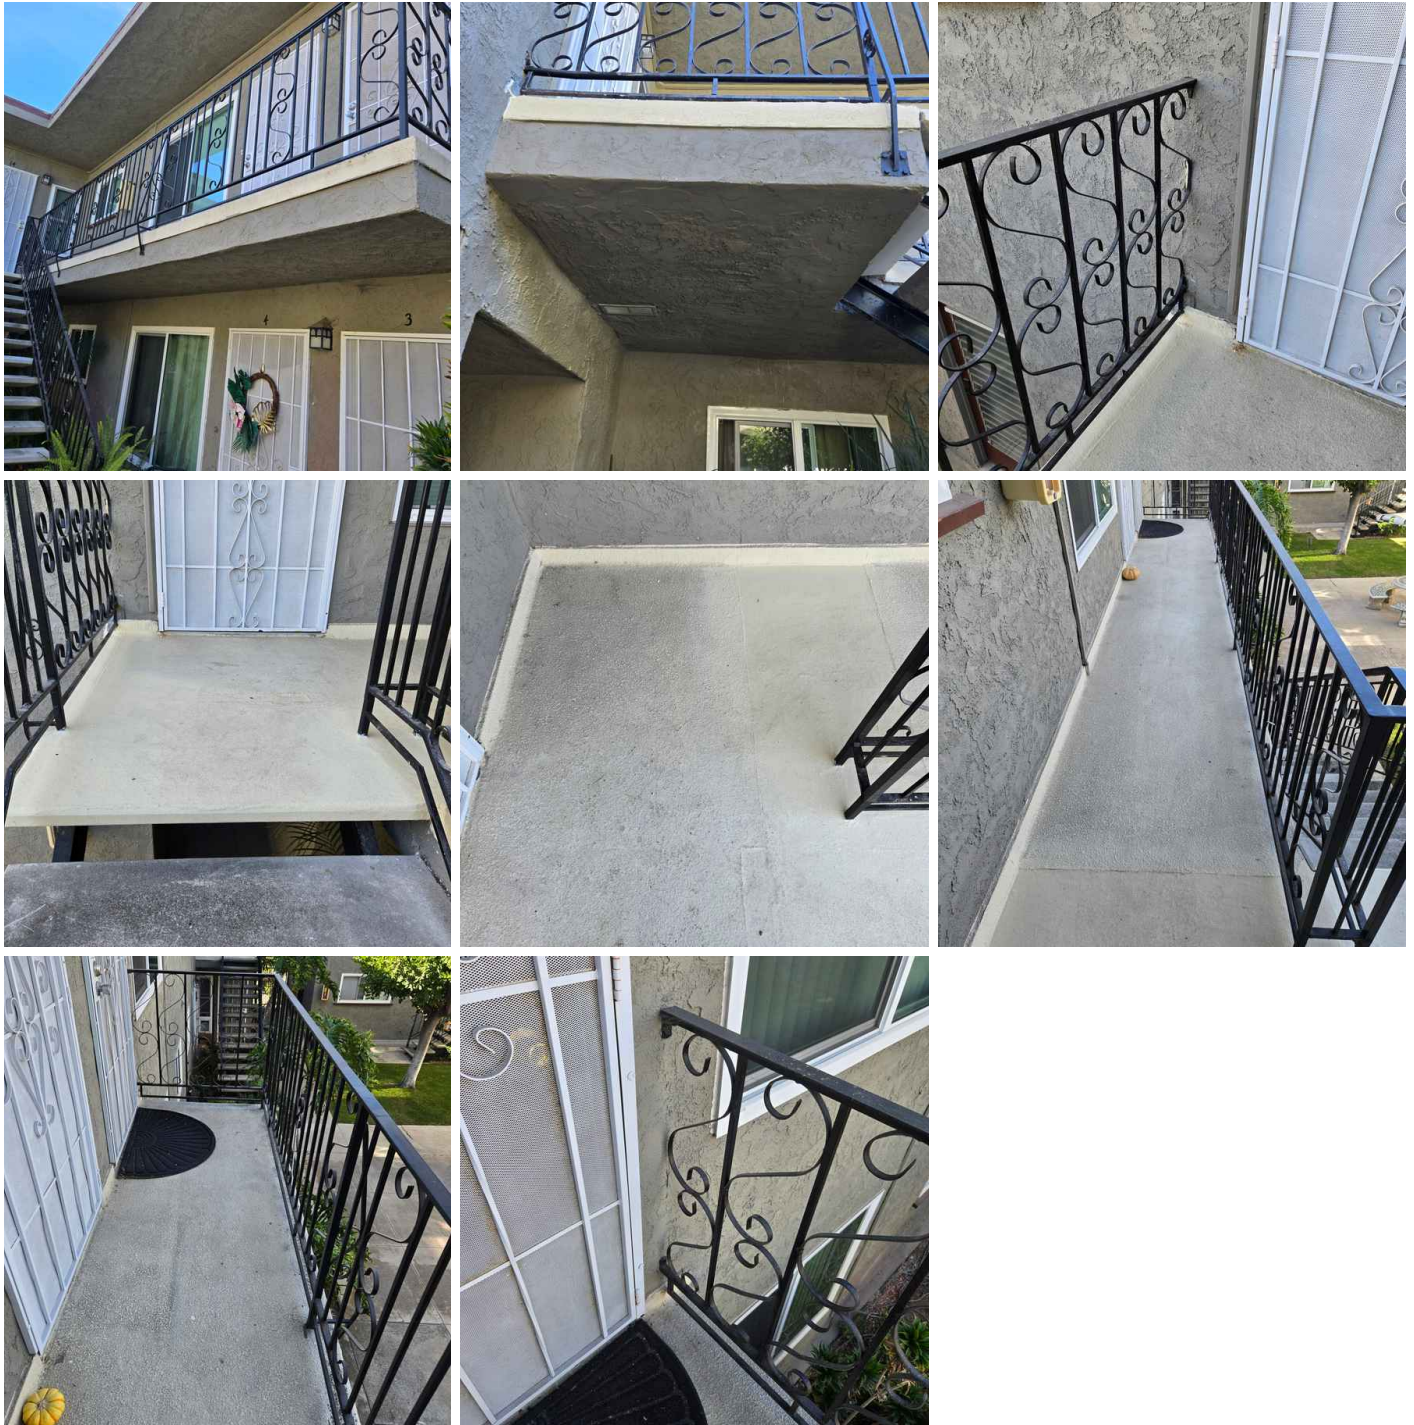
Walkway: *Walkway Inspection Image(s)

This E3 was repaired recently.

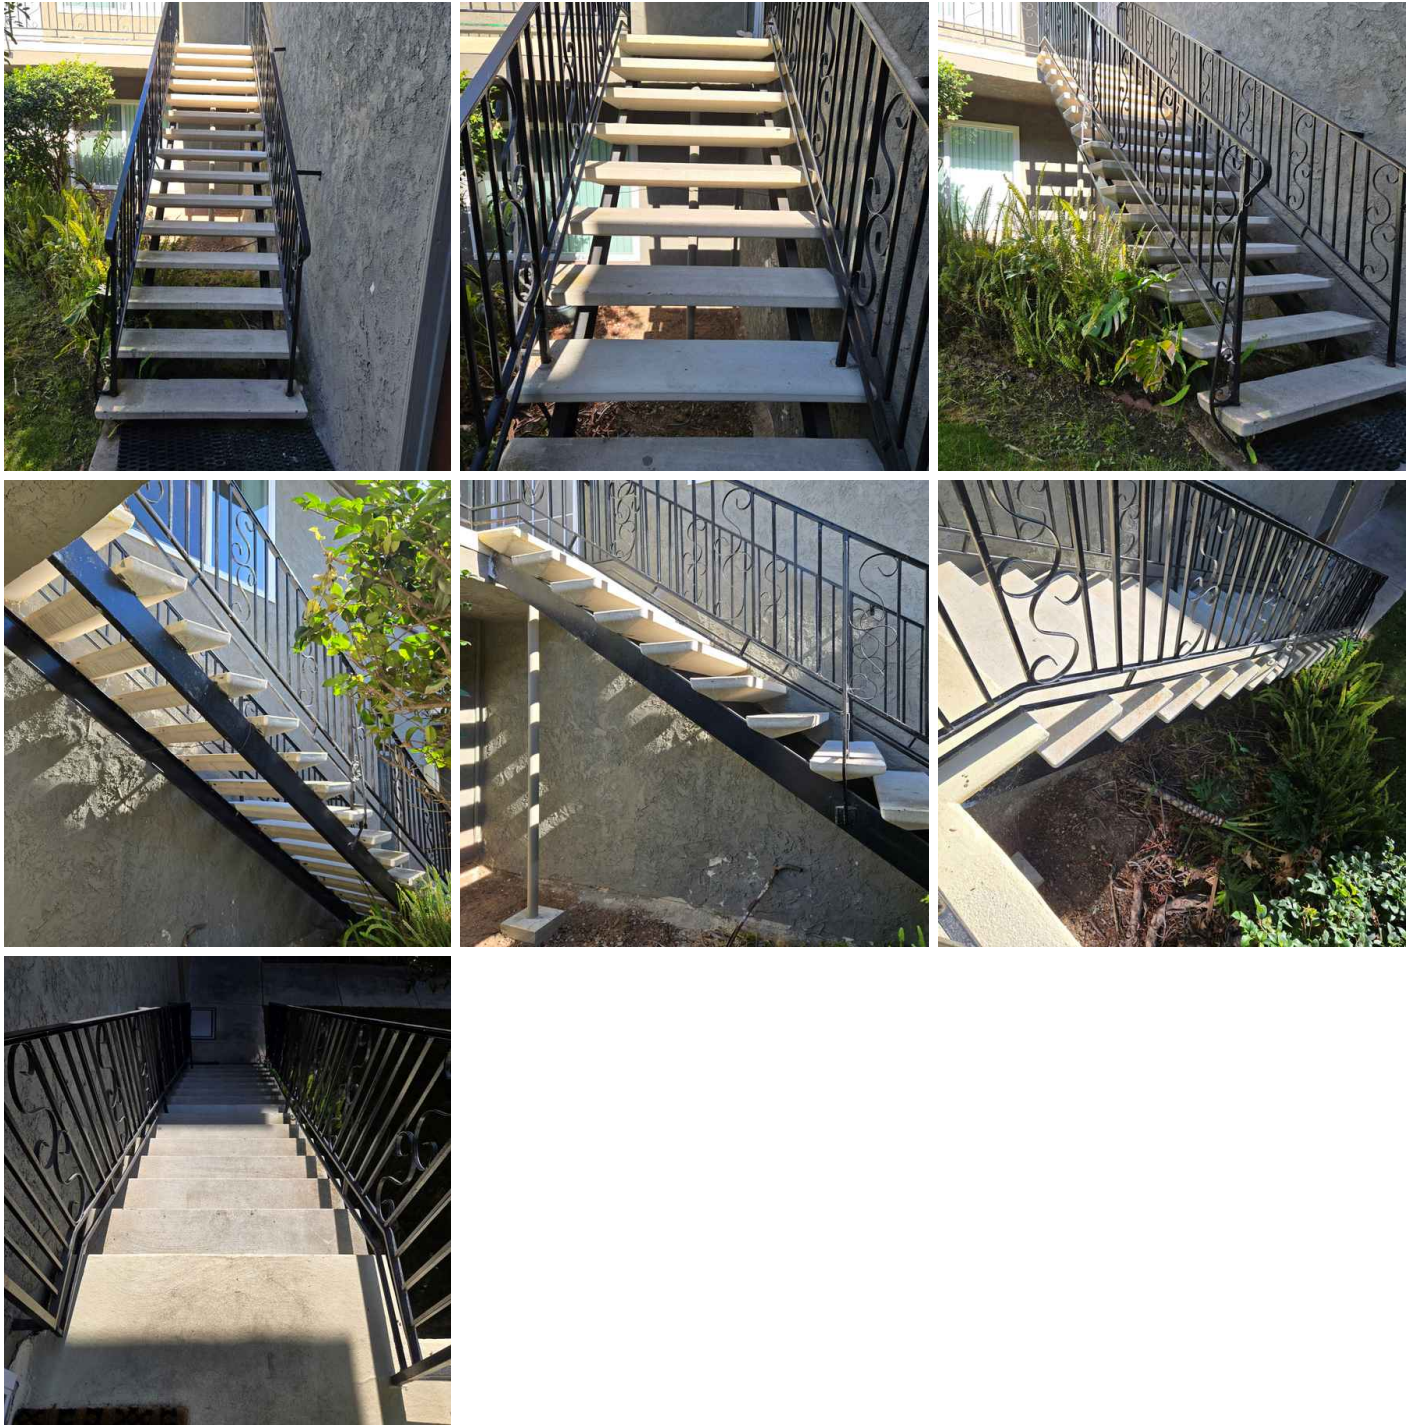
Stairway: *Stairway Inspection Image(s)

This E3 was recently repaired.

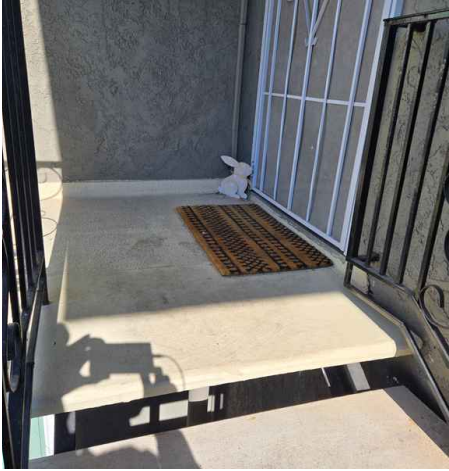
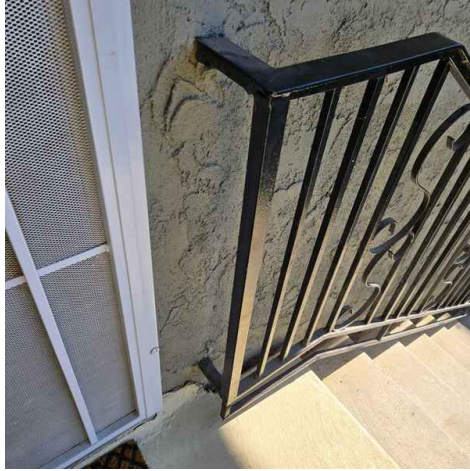
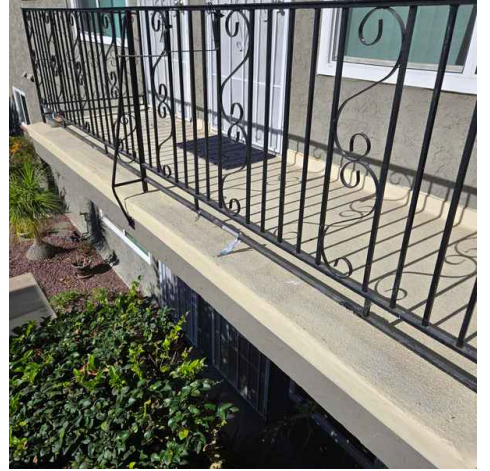
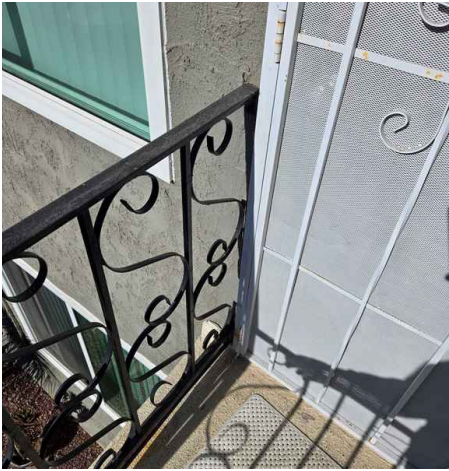
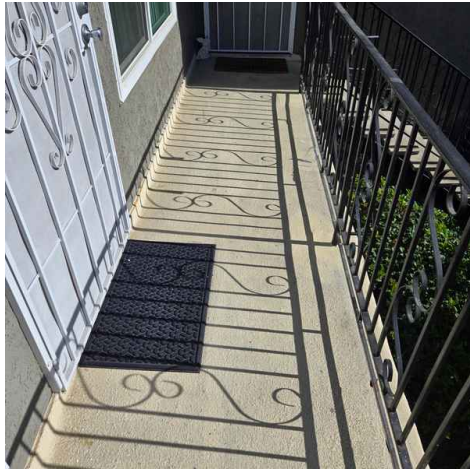
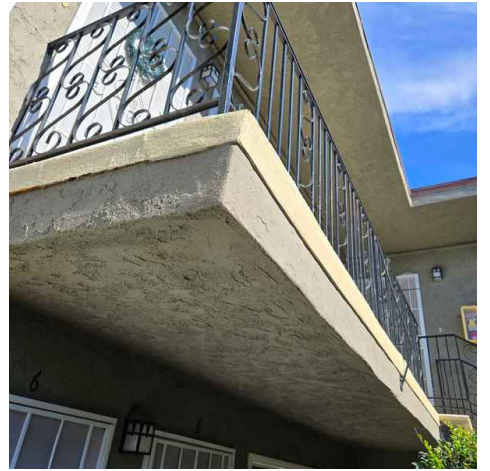
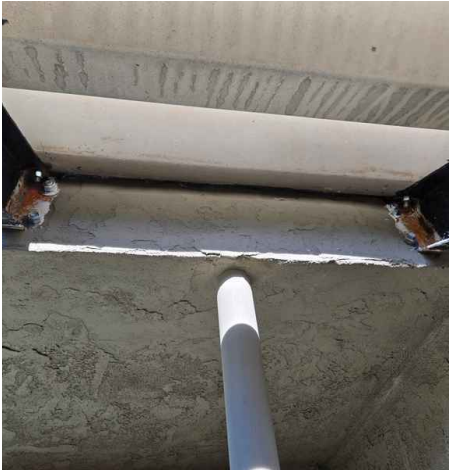
Walkway: *Walkway Inspection Image(s)

This E3 was repaired recently.

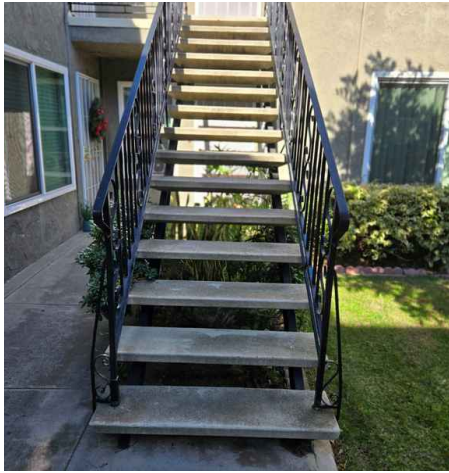
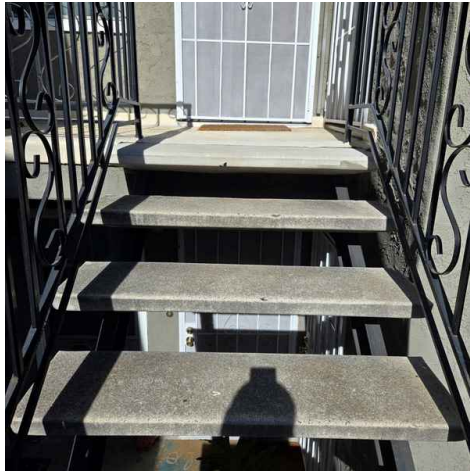
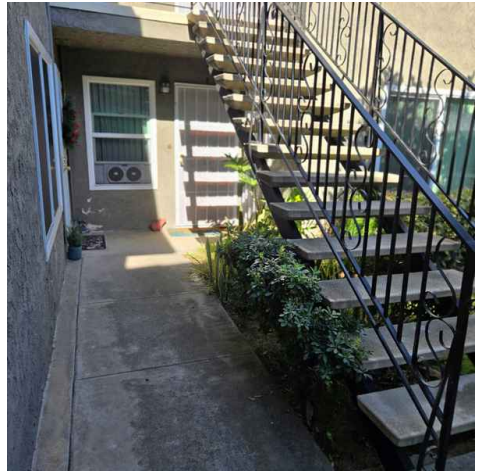
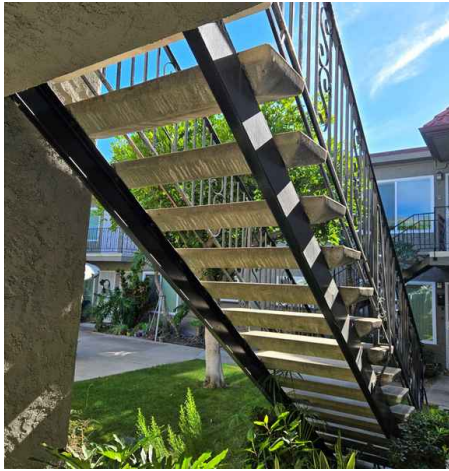
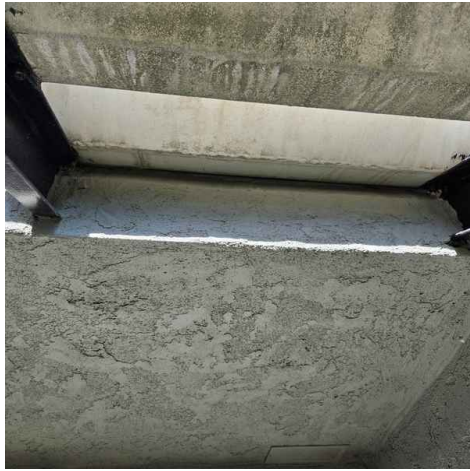
Stairway: *Stairway Inspection Image(s)

This E3 was recently repaired.

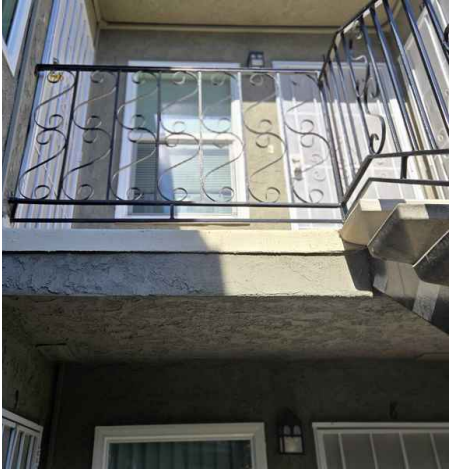
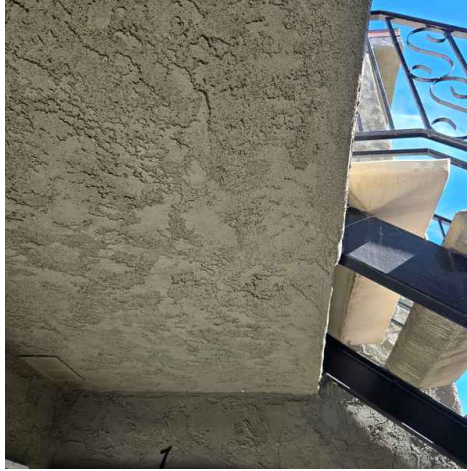
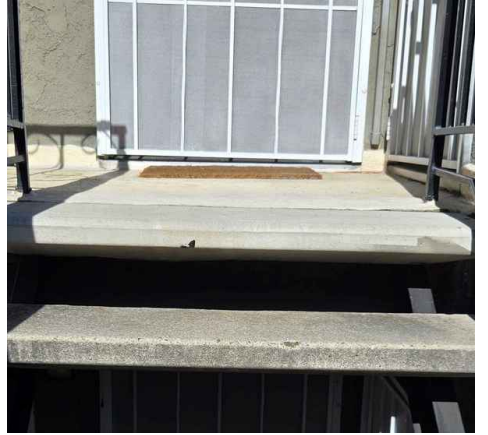
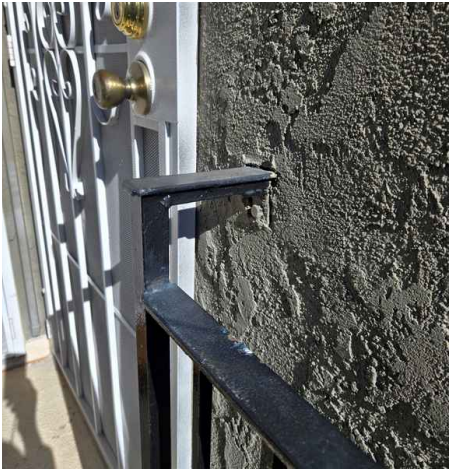
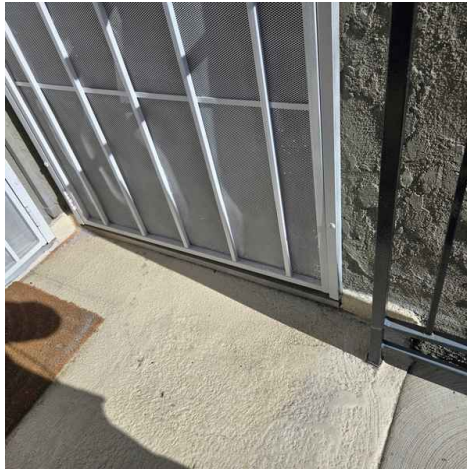
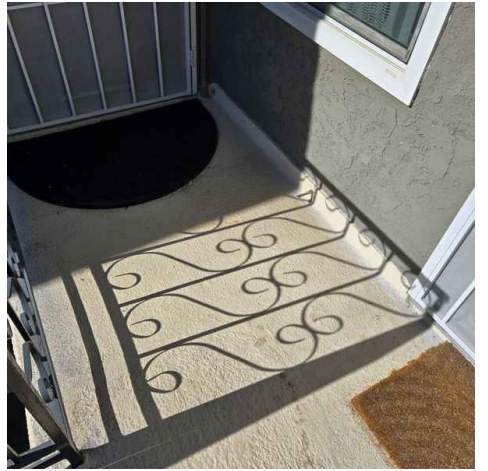
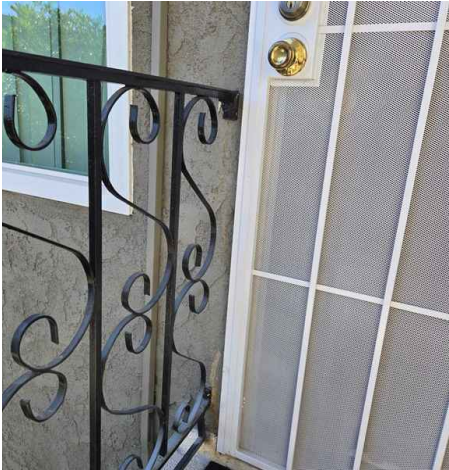
Landing: *Landing Inspection Image(s)

This E3 was recently repaired.
