PHASE 1 PRE-721 EVALUATION (P1PE)

1234 Main Street
Imperial Beach, CA 91932-1412

The property is a 15 unit apartment complex with two 2-story buildings. This property has one exterior elevated element group with two stairways and a single elevated walkway connecting the two buildings. This group will be referred to as Exterior Elevated Element (E3) Group 1.

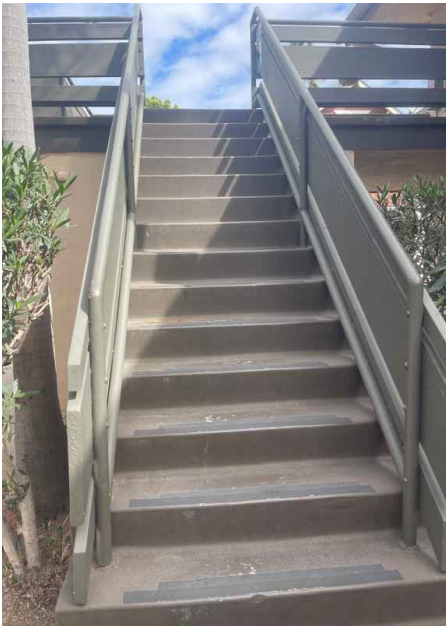
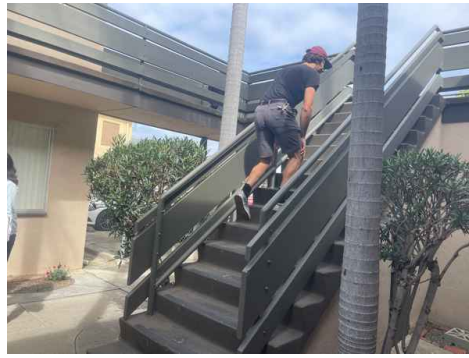
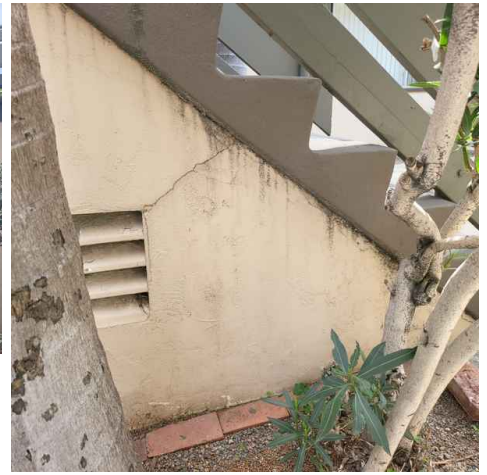
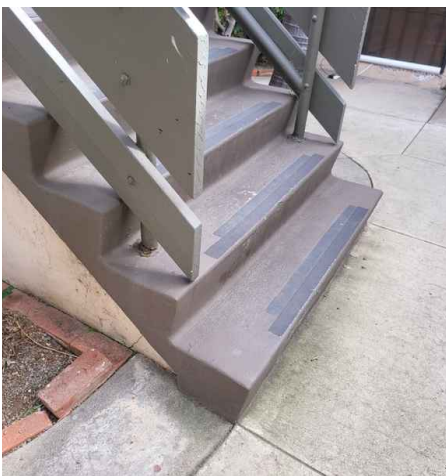
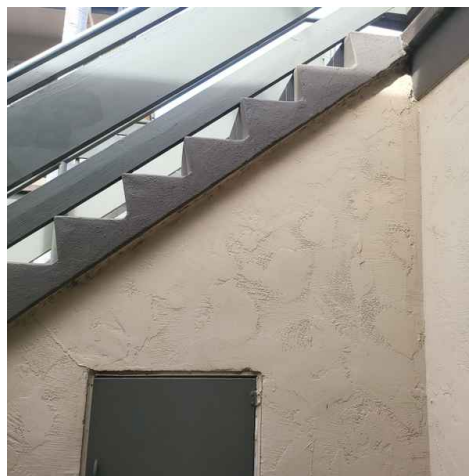
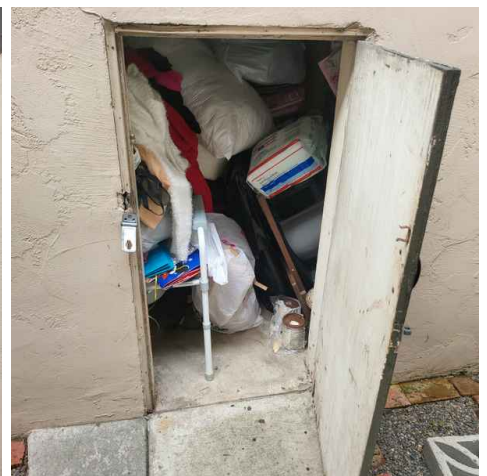
Stairway 2: *Stairway Inspection Image(s)

Stairway 2: Marginal Condition

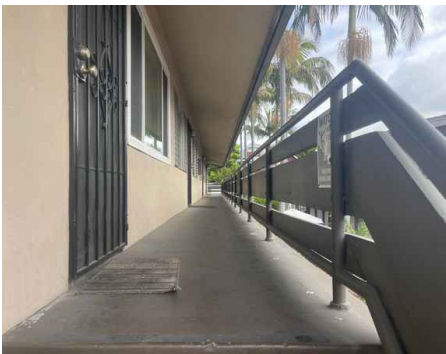
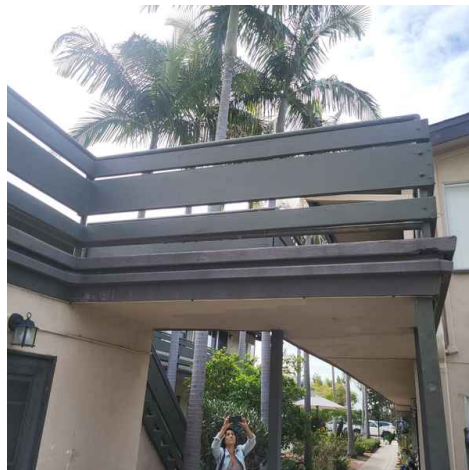
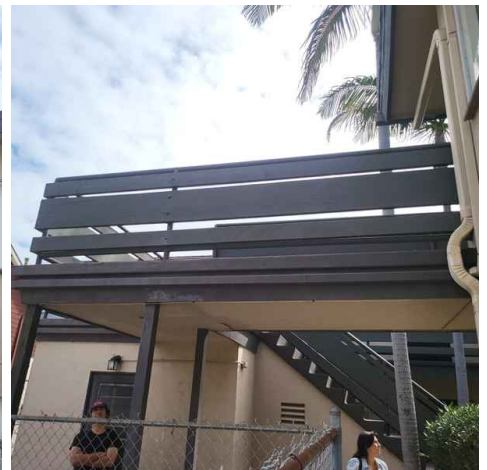
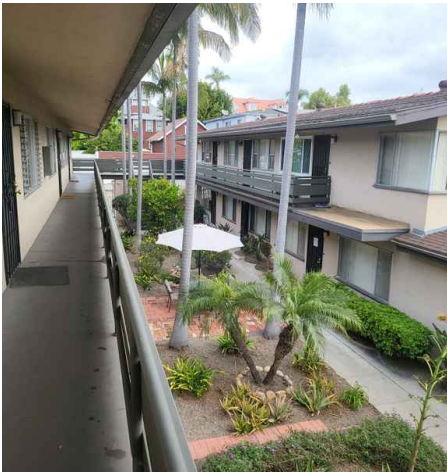
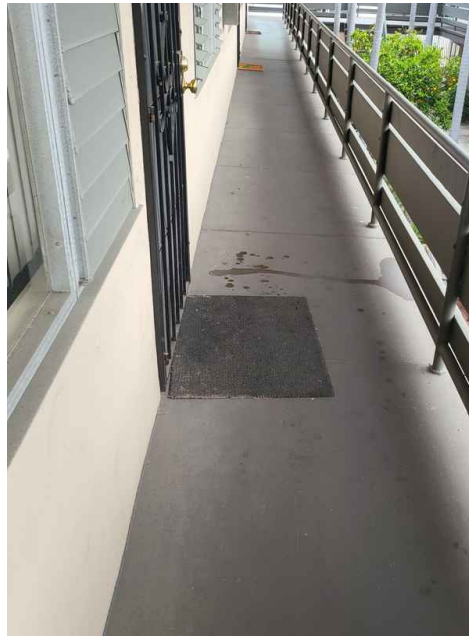
Walkway: *Walkway Inspection Image(s)

Walkway: Poor Condition

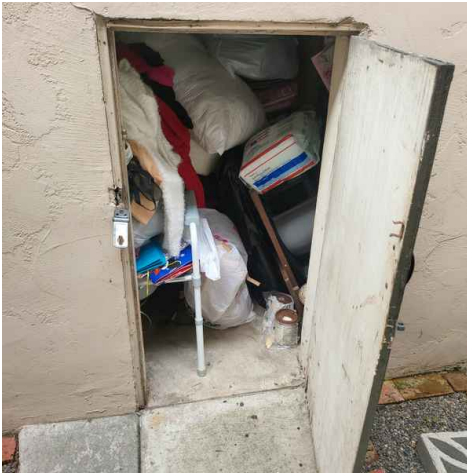
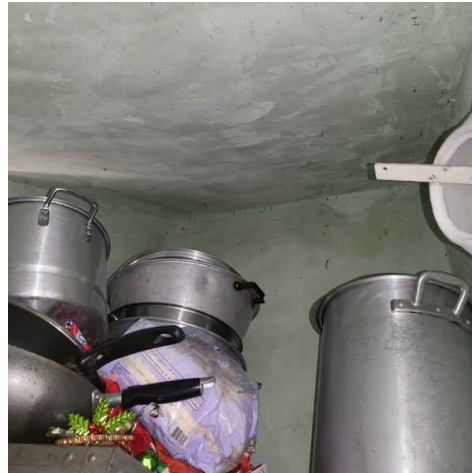
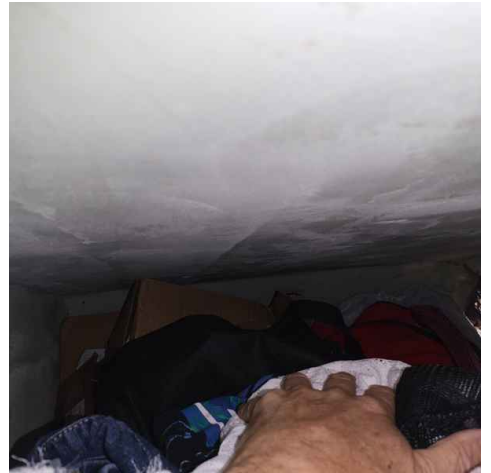
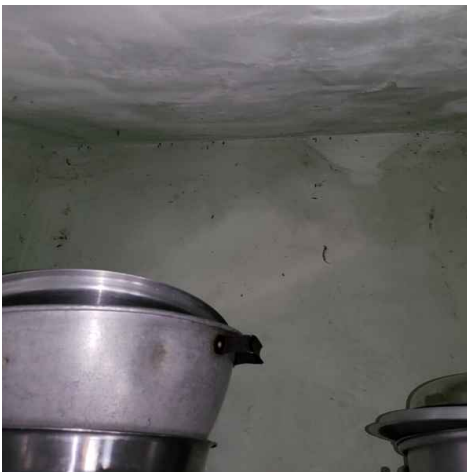
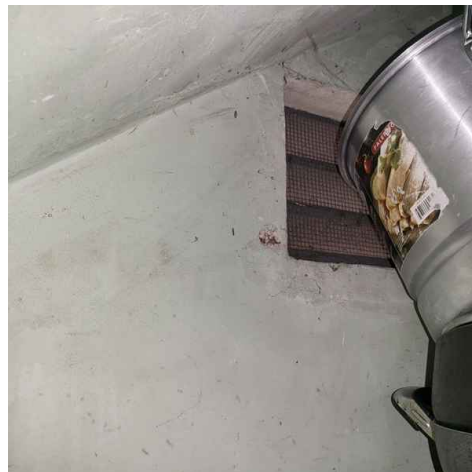
OBSTRUCTED VIEW

To perform a thorough P1PE it is necessary to visually inspect the inside of the stairwell. The stairwell is being used for personal storage. This storage area must be emptied to complete a visual inspection.

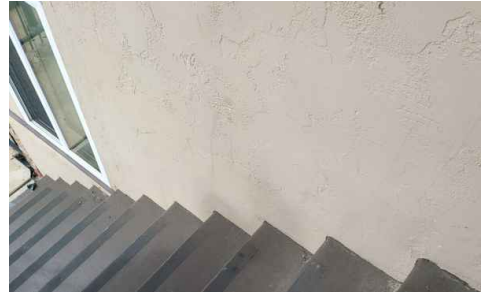
CRACKS IN WATERPROOFING

There are openings in the waterproofing along the transition where the stairway meets the stucco. Application of sealant is recommended.

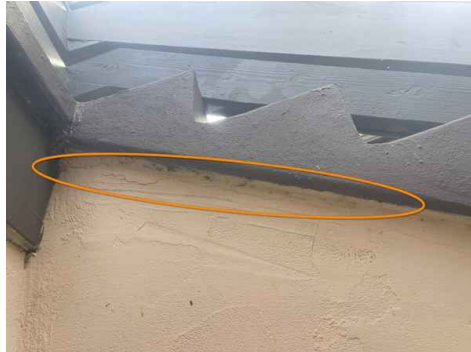
CRACK(S) IN THE STUCCO

There are cracks in the stucco under the concrete stairway on both sides. This condition raises concerns regarding the potential for water intrusion and the long-term integrity of the underlying support structure. Such water intrusion can lead to internal deterioration of materials and possible compromise of structural integrity over time. A Phase 2 Pre-721 Evaluation (P2PE) is recommended to determine the extent of any water damage via borescoping, and to formulate a detailed repair plan.

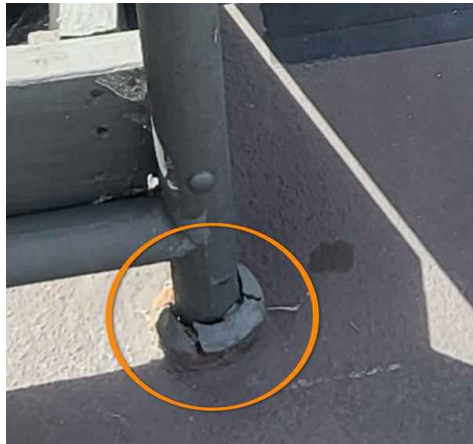
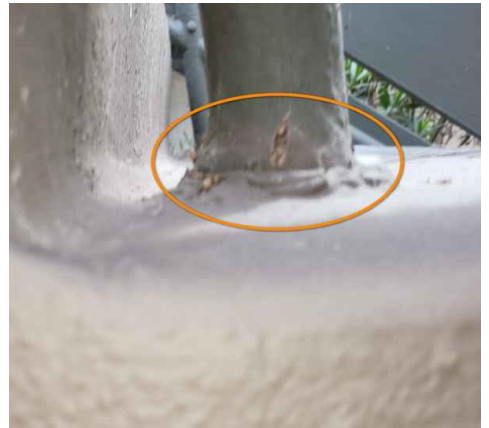
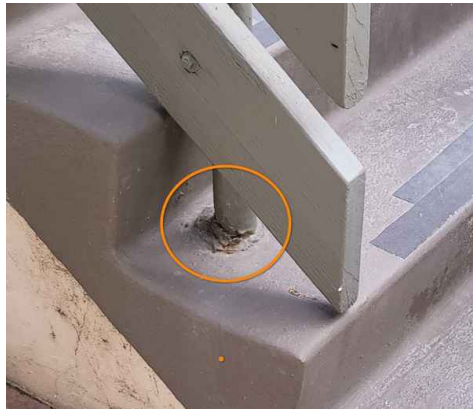
HANDRAIL CORROSION

The base of the handrail is corroded and cracked allowing water intrusion. Corrosion should be removed, repaired, and resealed.

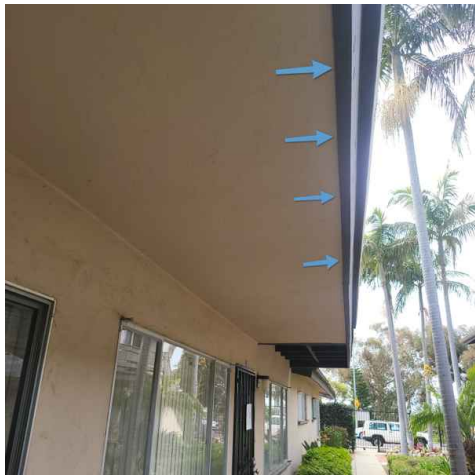
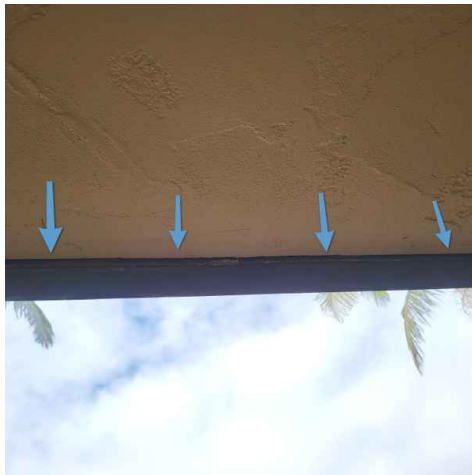
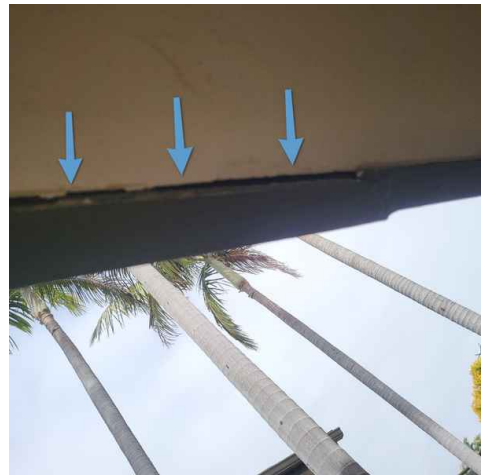
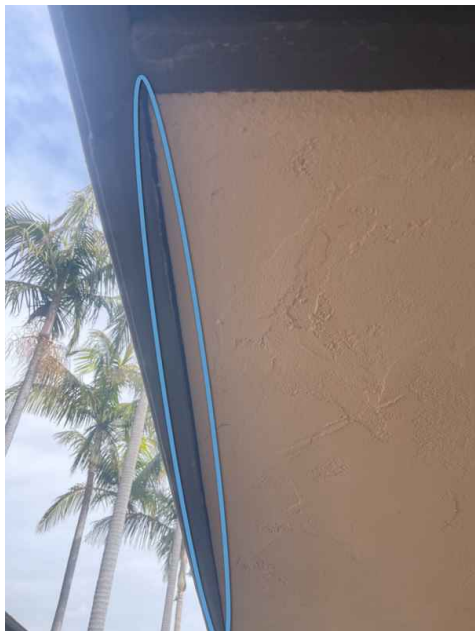
FASCIA SEPARATING FROM SOFFIT

One or more sections of the rim board and/or fascia have separated from the soffit. The resulting gaps are potential entry points for water intrusion, insect swarms including termites and bees. The gap should be closed and sealed.

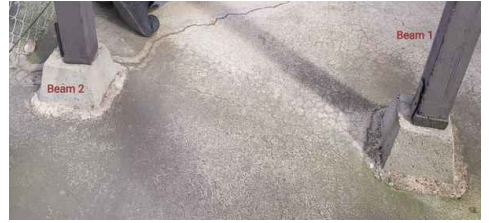
TERMITES AND/OR DRY ROT DAMAGE TO SUPPORT BEAMS

Evidence of termites and/or dry rot in support beam 1 and 2 was observed. Termite activity is indicated by visible frass (termite droppings) and hollowed wood. The termite infestation poses a critical concern, as it compromises the load-bearing capacity of the support beam. Support beam 1 and 2 must be replaced prior to SB-721 Inspection.

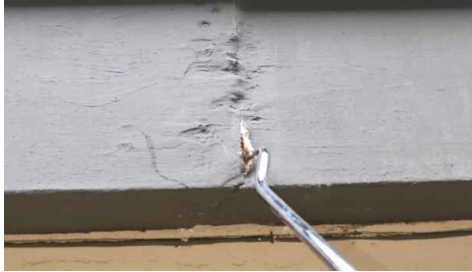
TERMITE AND OR DRY ROT DAMAGE

Evidence of termites and/or dry rot in fascia was observed. This condition raises concerns regarding the long-term integrity of the underlying support structure. Termite activity is indicated by visible frass (termite droppings) and hollowed wood. The affected areas should be assessed by a licensed pest control professional to determine the full extent of the termite infestation and to administer a suitable termite treatment plan. A Phase 2 Pre-721 Evaluation (P2PE) is recommended to determine the extent of any termite damage via borescoping, and to formulate a detailed repair plan.

Crack in sealant above termite damage

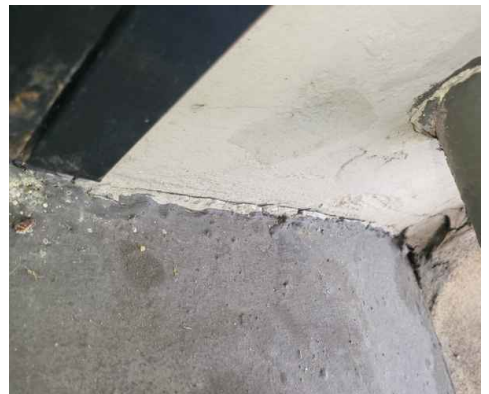
Crack in sealant above termite damage

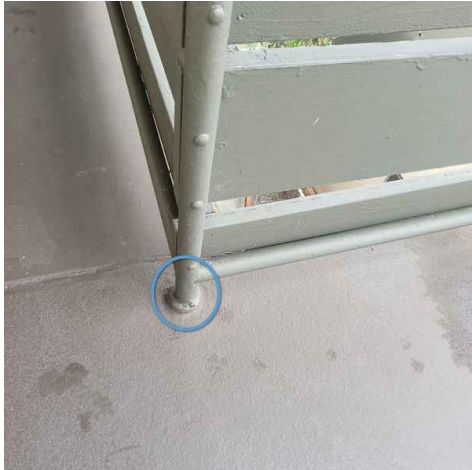
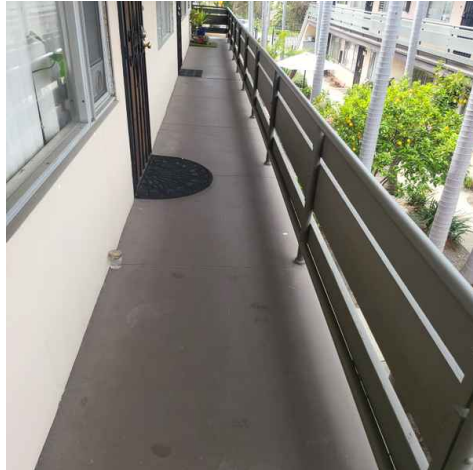
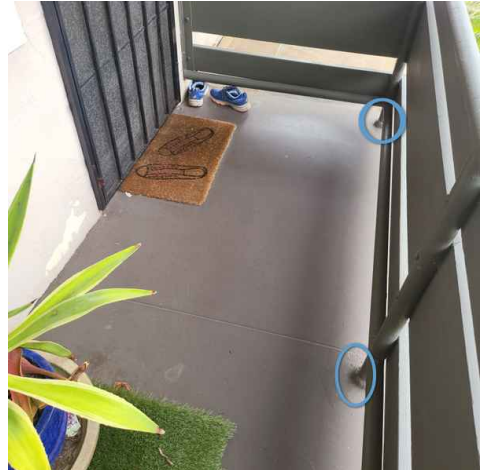
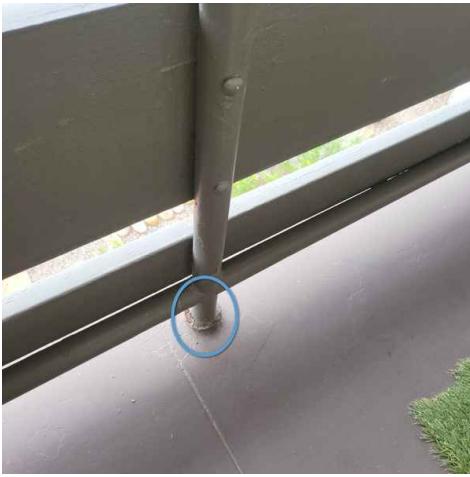
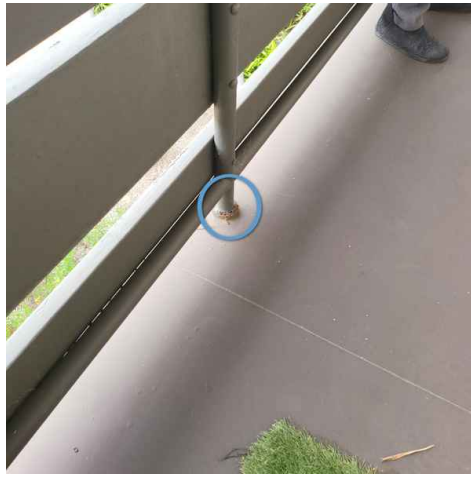
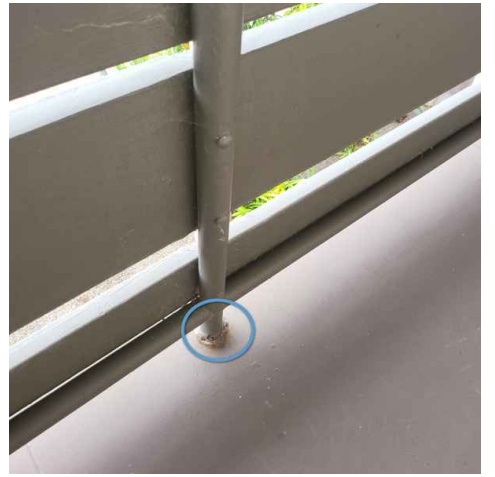
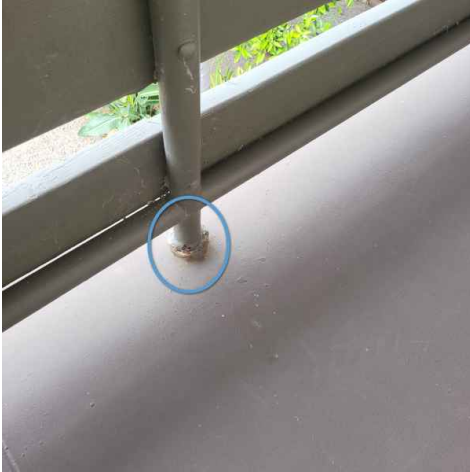
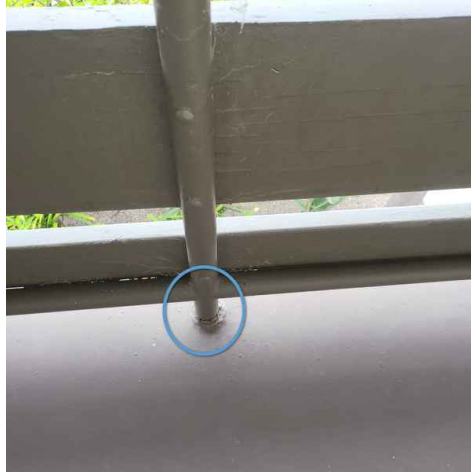
HANDRAIL CORROSION

The base of the stairway handrail is corroded and cracked allowing water intrusion. Some of the handrail connections that need attention are highlighted in the photos below. In general, all handrail connections should be examined, corrosion removed, repaired, and resealed.

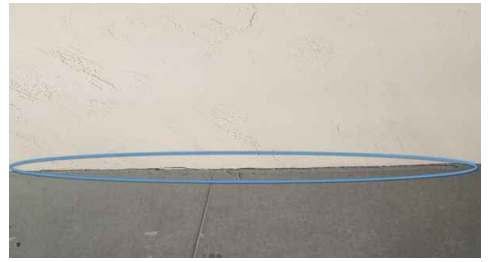
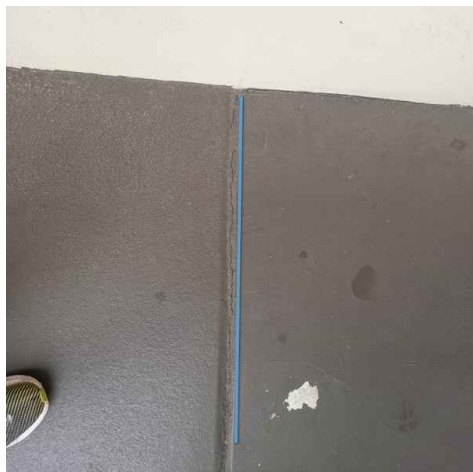
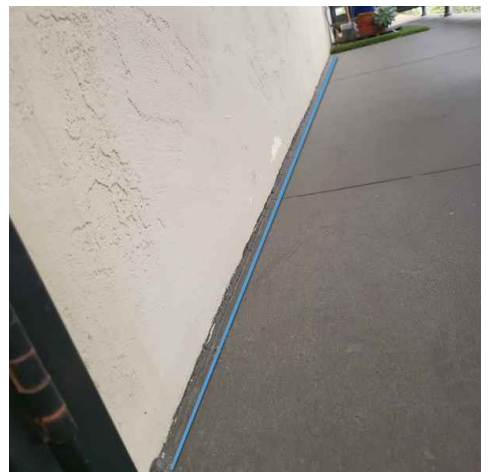
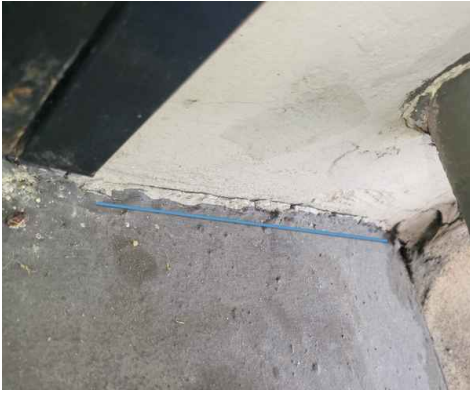
CRACKS IN WATERPROOFING

There are cracks in the waterproofing along the transition where the walkway meets the stucco and at other transitions and joints. Application of sealant is recommended.

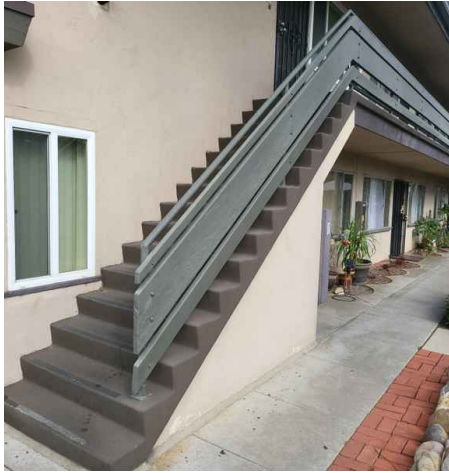
Non-slip Tape on Bottom Stair of Stairway 1

The non-slip tap on the first stair tread has come loose. This old tape should be removed and new tape applied.
