PHASE 1 PRE-SB721 EVALUATION (P1PE)

1234 Main Street  
Imperial Beach, CA 91932-1412

Buyer Name  
05/02/2024 9:00AM

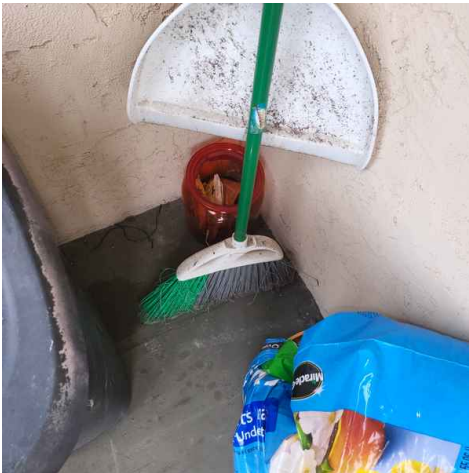
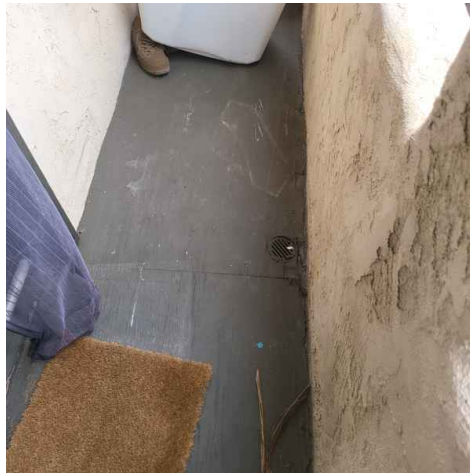
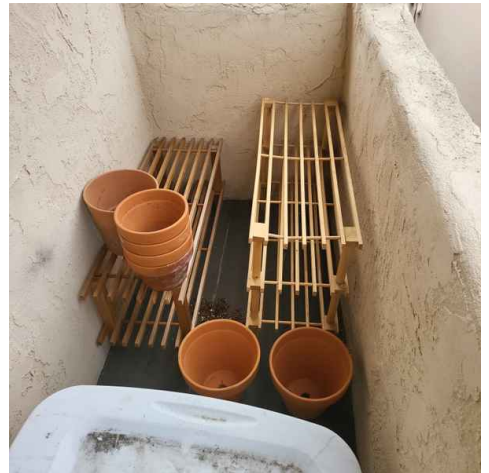
Walkway

Some personal items were stored on the walkway, obstructing the view and preventing a thorough visual inspection.

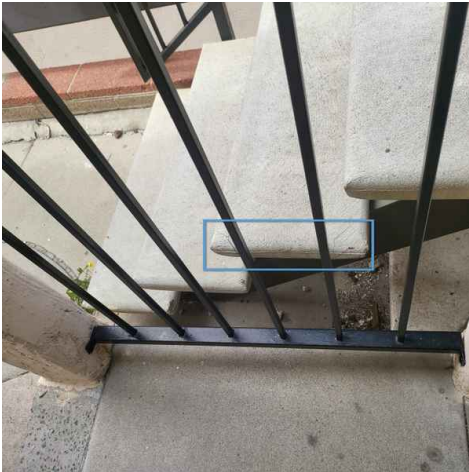
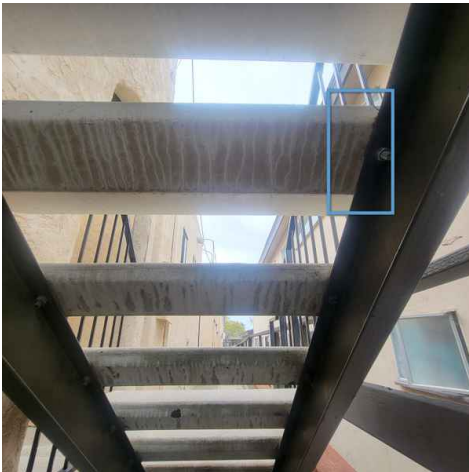
5.3.1 Landing

Non-Emergency Repairs Required

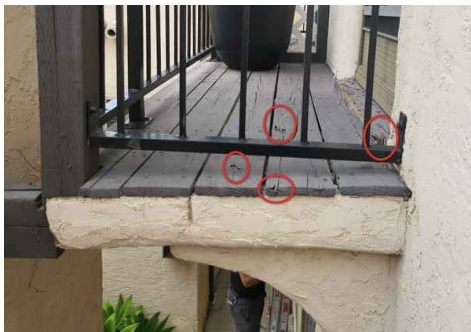
**TERMITE DAMAGE**

One or more deck boards have termite damage and/or dry rot. This matter requires immediate attention and the necessary repairs should be carried out prior to the SB-721 Inspection.

Contact a qualified professional.

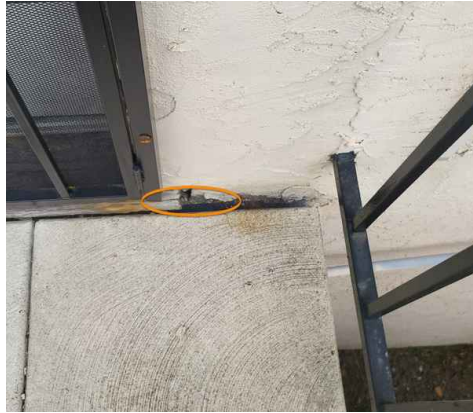
**TERMITE DAMAGE**

There is termite and/or dry rot damage to the threshold above the support frame for the landing. Part of the threshold on the right side has rotted away leaving a large opening in the stucco where water intrusion is likely. This condition raises concerns regarding advanced deterioration in the underlying support structure. A Phase 2 Pre-721 Evaluation (P2PE) is recommended to determine the extent of any water damage via borescope investigation and to formulate a detailed repair plan.
