PHASE 1 PRE-SB721 EVALUATION

1234 Main Street
Imperial Beach, CA 91932-1412

Buyer Name
05/02/2024 9:00AM

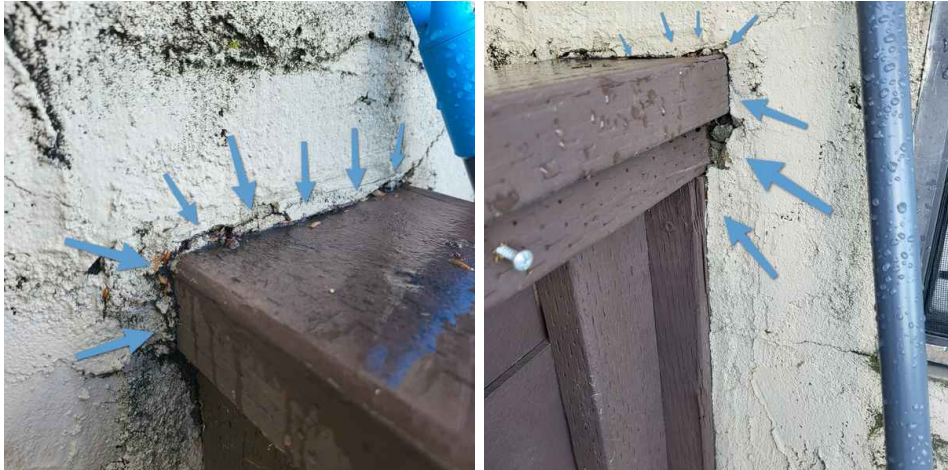
UNSEALED RAILING CONNECTION(S)

There are unsealed connections between the railing and the wall. These connections should be sealed with a waterproof sealant to prevent water and wood boring insect intrusion.

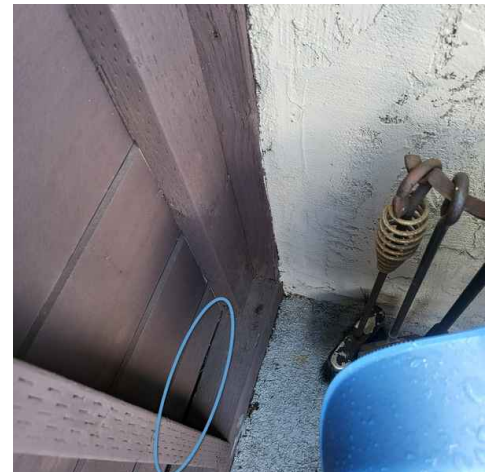
6.2.2 Balcony

CRACK(S) IN WOODEN RAILING

There is a crack in the bottom of the wooden railing. This crack should be sealed with a waterproof sealant to prevent water intrusion.

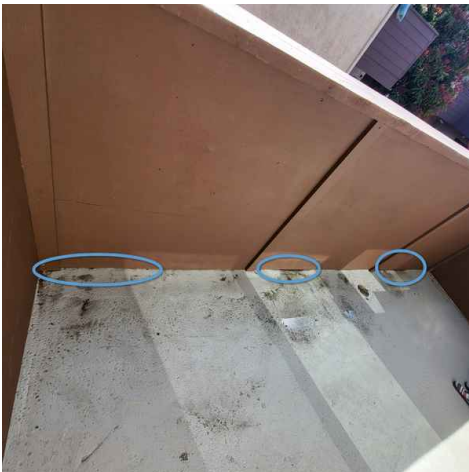
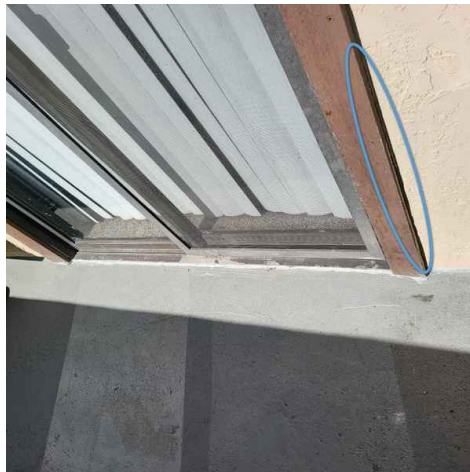
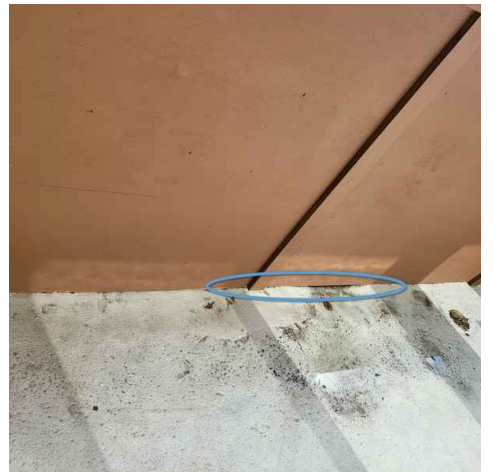
There are minor openings at the connections between the railing and deck surface and between the doorframe and wall. These openings should be sealed with a waterproof sealant to prevent water and wood boring insect intrusion.

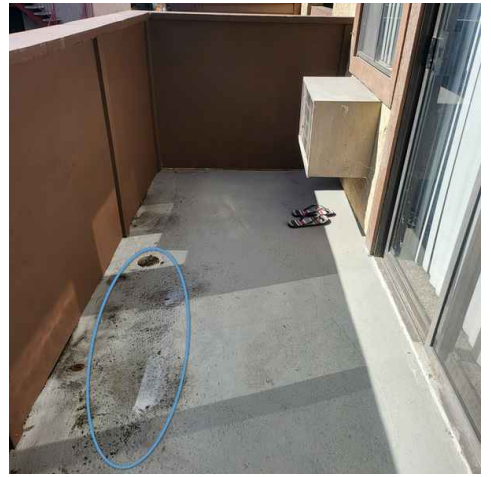
7.2.2 Balcony

POOLING

There is pooling on the deck. Deck may need to be leveled to ensure proper drainage and prevent water intrusion.

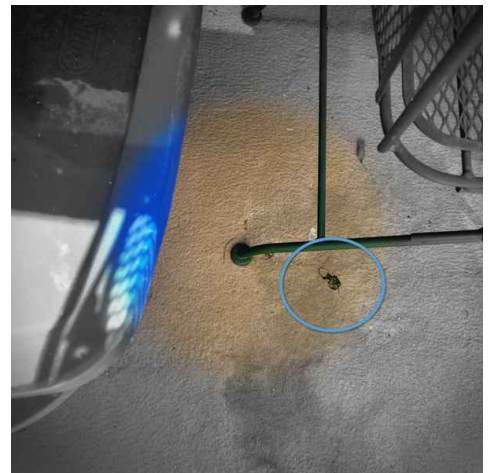
There is a perforation in the walking surface of the deck. This perforation should be sealed with a waterproof sealant to prevent water intrusion.

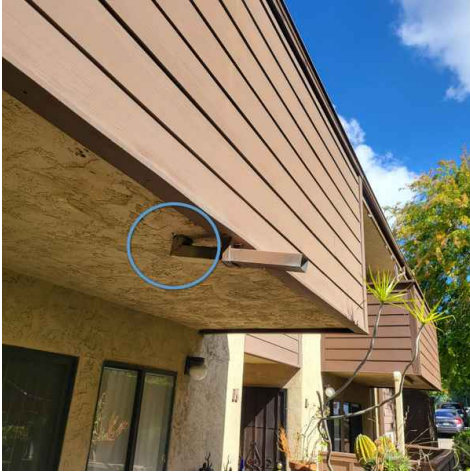
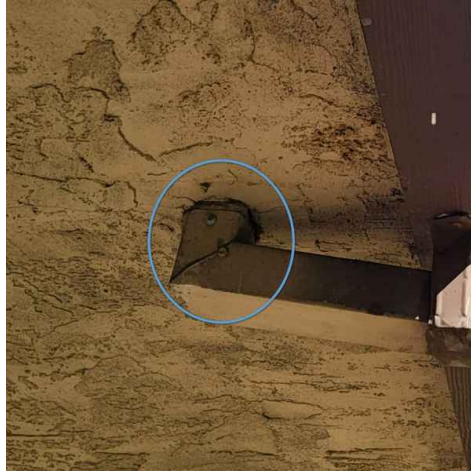
8.2.2 Balcony

UNSEALED DRAINAGE CONNECTION

There is an unsealed drainage pipe on the underside of the balcony. This connection should be sealed with a waterproof sealant to prevent wood boring insect intrusion.

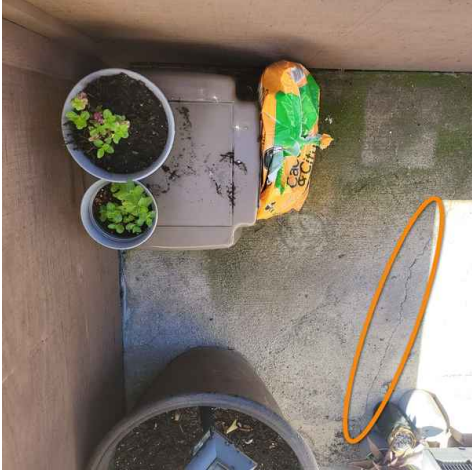
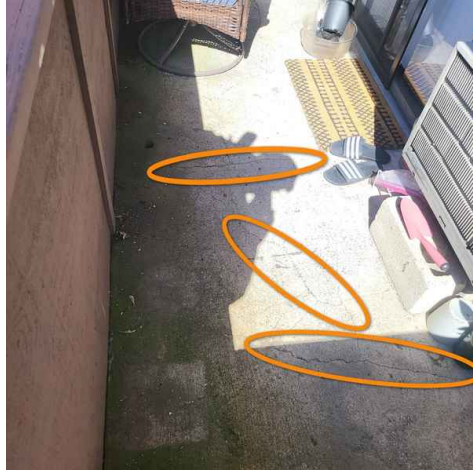
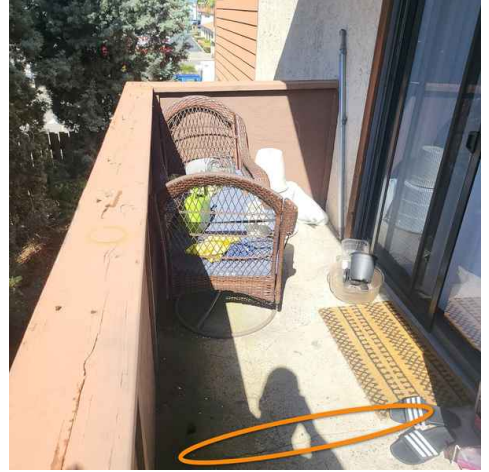
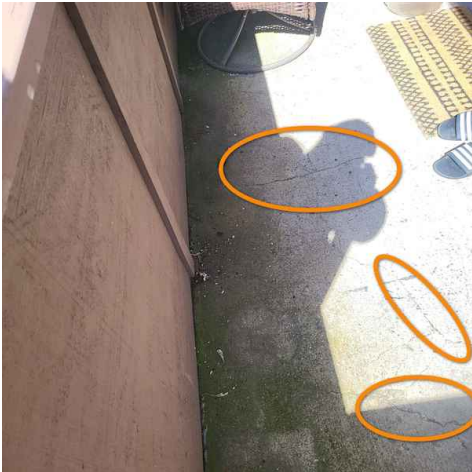
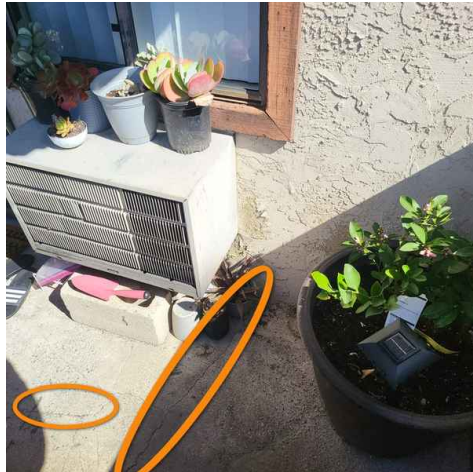
CRACK(S) IN DECK

There are cracks in several locations on the deck surface. These cracks may indicate potentially severe water intrusion. Water intrusion can lead to internal deterioration of materials and possible compromise of structural integrity over time. A Phase 2 Pre-721 Evaluation (P2PE) is recommended to determine the extent of any water damage via borescope inspection or larger investigative openings, and to formulate a detailed repair plan.

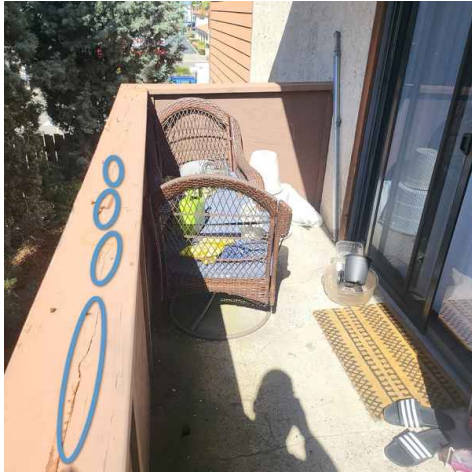
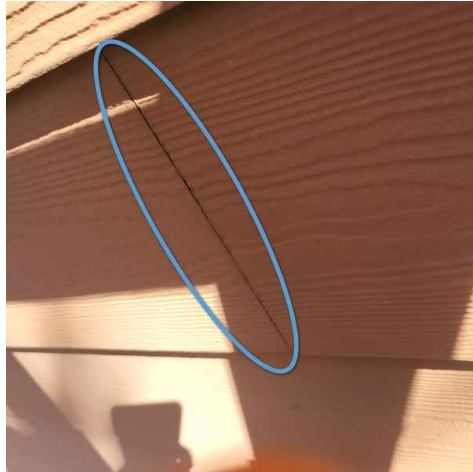
CRACK(S) IN RAILING

There are cracks in the wooden railing. These cracks should be sealed with a waterproof sealant to prevent water and wood boring insect intrusion.

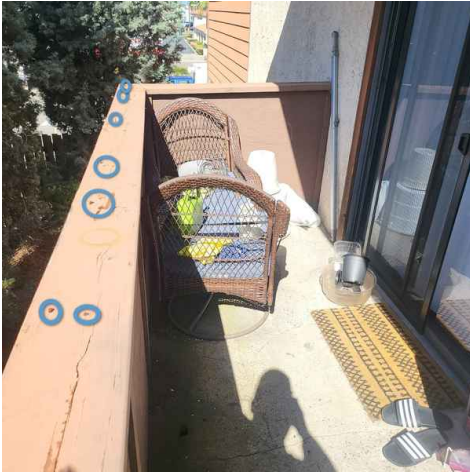
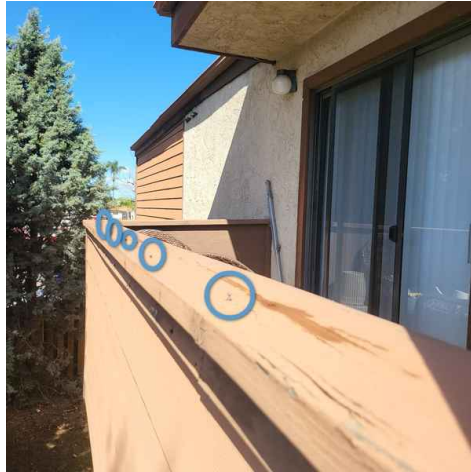
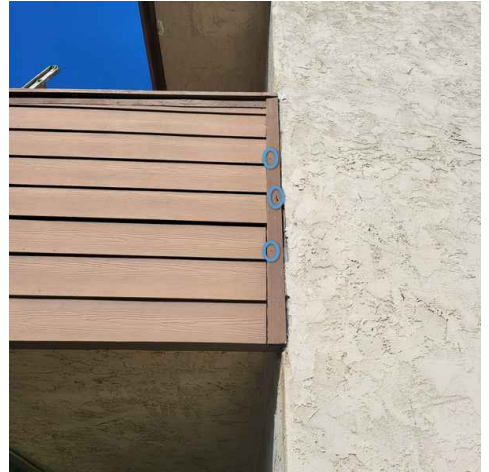
UNSEALED PENETRATION(S) IN RAILING

There are unsealed penetrations in the wooden railing. These penetrations should be sealed with a waterproof sealant to prevent water and wood boring insect intrusion.

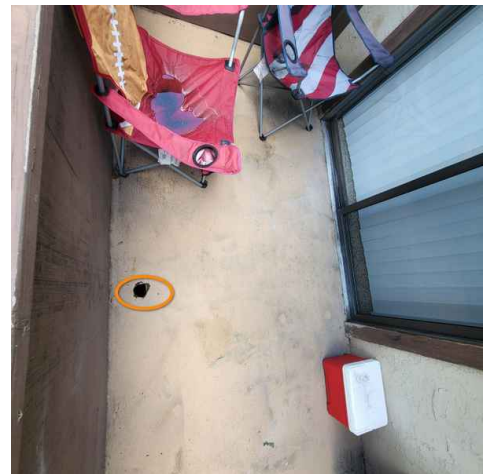
MISSING DRAIN ASSEMBLY

The deck is missing a drain assembly. Without a drain assembly the water is free to flow into the soffit rather than down the drain pipe. This water intrusion will lead to internal deterioration of materials and possible compromise of structural integrity over time. A Phase 2 Pre-721 Evaluation (P2PE) is recommended to determine the extent of any water damage via borescope inspection or larger investigative openings, and to formulate a detailed repair plan.

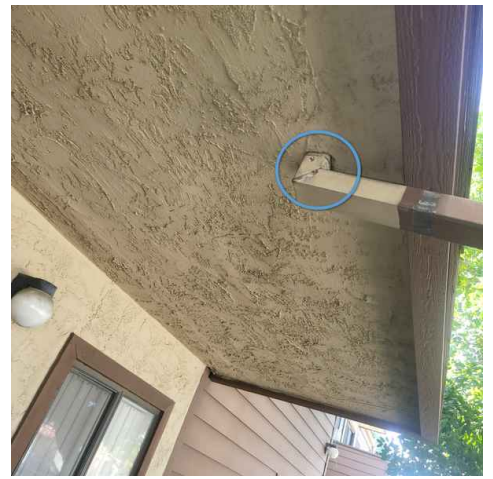
11.2.2 Balcony

UNSEALED DRAINAGE CONNECTION

There is an unsealed drainage pipe on the underside of the balcony. This connection should be sealed with a waterproof sealant to prevent wood boring insect intrusion.

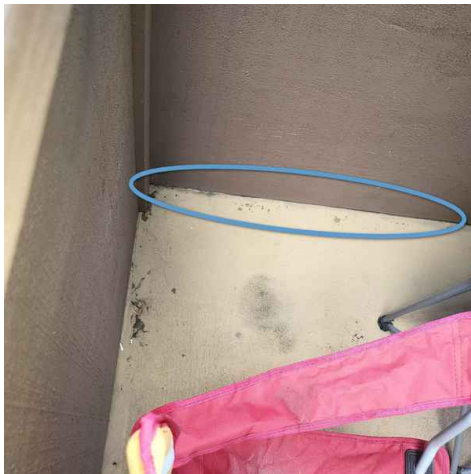
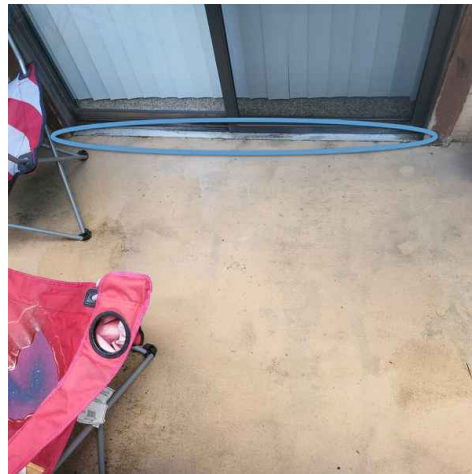
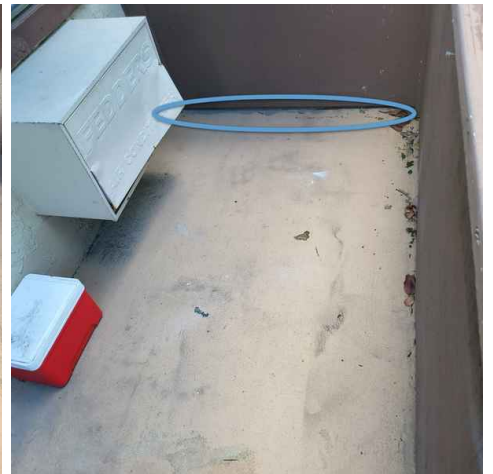
11.2.3 Balcony

POOR DETAILING

There are gaps between the railing and decking and between the doorframe and decking. These gap should be sealed with a waterproof sealant to prevent water and wood boring insect intrusion.

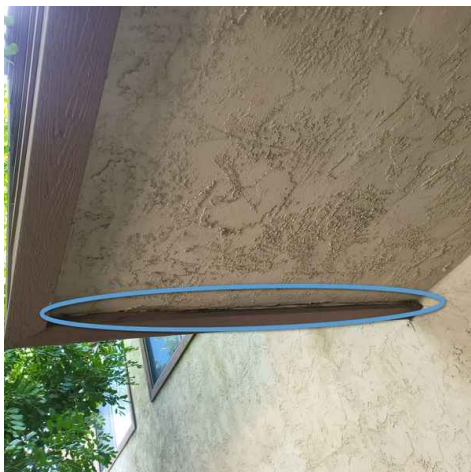
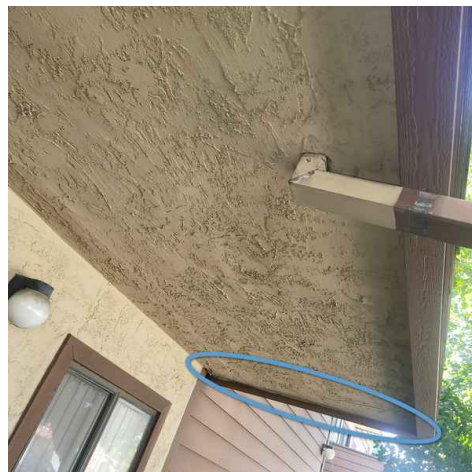
11.2.4 Balcony

FASCIA SEPARATING FROM SOFFIT

One or more sections of the rim board and/or fascia have separated from the soffit on the underside of the balcony. The resulting gaps should be sealed with a waterproof sealant to prevent wood boring insect intrusion.

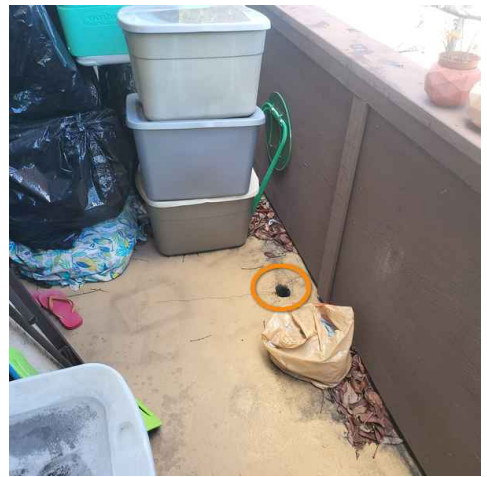
MISSING DRAIN ASSEMBLY

The deck is missing a drain assembly. Without a drain assembly the water is free to flow into the soffit rather than down the drain pipe. This water intrusion will lead to internal deterioration of materials and possible compromise of structural integrity over time. A Phase 2 Pre-721 Evaluation (P2PE) is recommended to determine the extent of any water damage via borescope inspection or larger investigative openings, and to formulate a detailed repair plan.

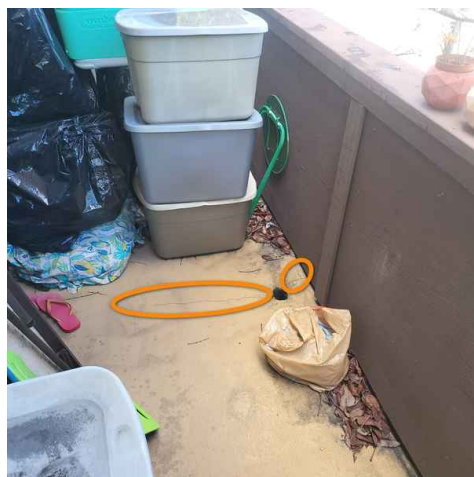
12.2.3 Balcony

CRACK(S) IN DECK

There are cracks in the decking, including a crack that intersects the missing drain assembly. These cracks could indicate potentially severe water intrusion. Water intrusion can lead to internal deterioration of materials and possible compromise of structural integrity over time. A Phase 2 Pre-721 Evaluation (P2PE) is recommended to determine the extent of any water damage via borescope inspection or larger investigative openings, and to formulate a detailed repair plan.

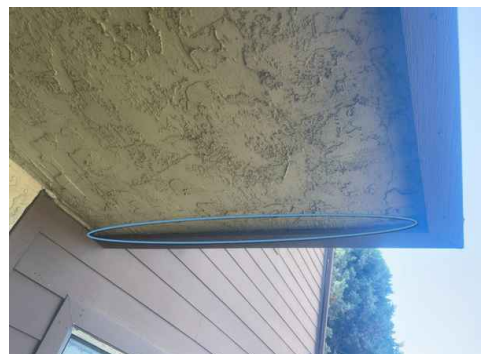
12.2.4 Balcony

FASCIA SEPARATING FROM SOFFIT

One or more sections of the rim board and/or fascia have separated from the soffit on the underside of the balcony. The resulting gaps should be sealed with a waterproof sealant to prevent wood boring insect intrusion.

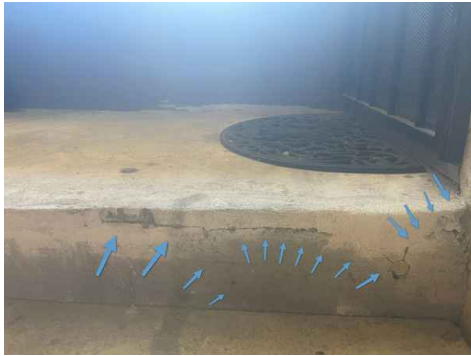
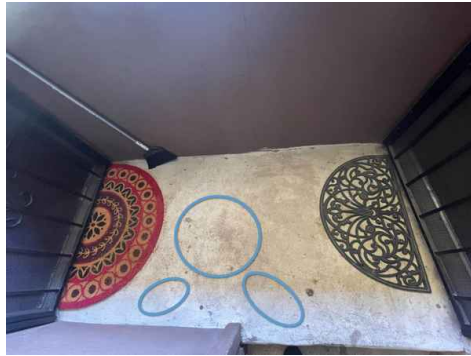
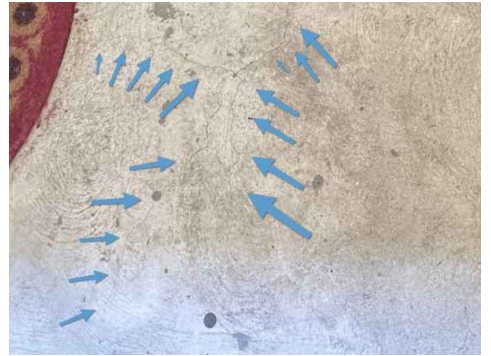
CRACK(S) IN DECK

There are cracks in the tops and side of the entry structure's walking surface. These cracks may indicate underlying structural compromise. A Phase 2 Pre-721 Evaluation (P2PE) is recommended to determine the extent of any damage via borescope inspection or larger investigative openings, and to formulate a detailed repair plan.

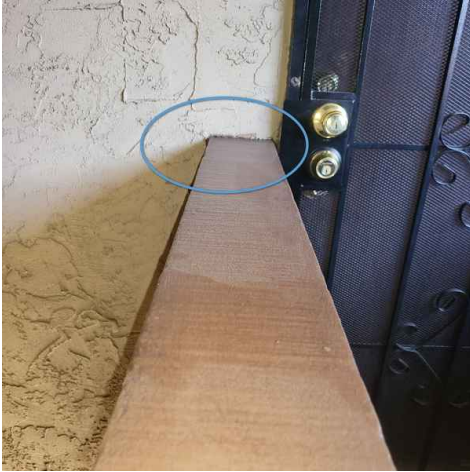
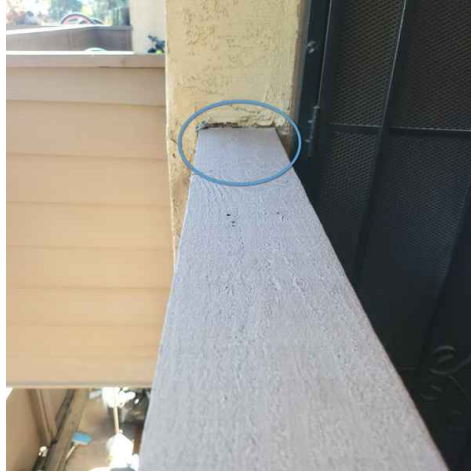
14.4.2 Entry Structure

UNSEALED RAILING CONNECTION(S)

There are unsealed connections between the railing and the wall. These connections should be sealed with a waterproof sealant to prevent water and wood boring insect intrusion.

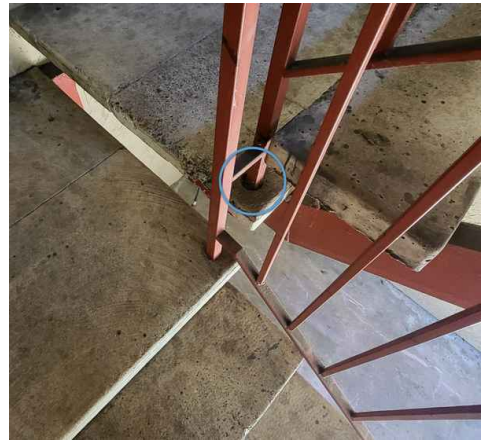
UNSEALED RAILING ATTACHMENT(S)

There is an unsealed attachment between railing and the second landing platform. This attachment should be sealed with a waterproof sealant to prevent water intrusion.

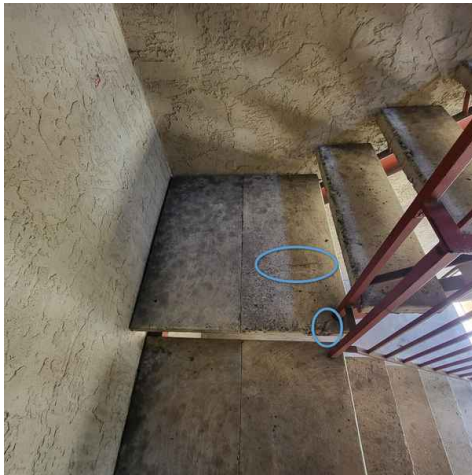
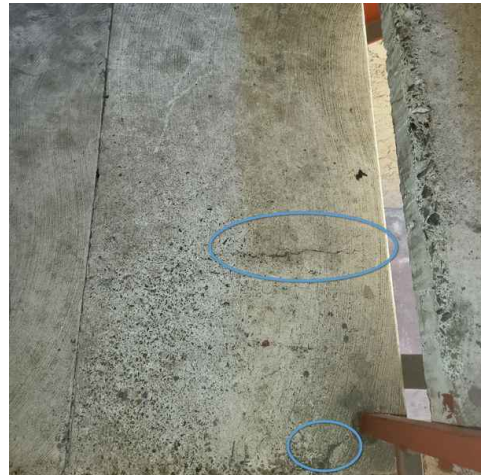
15.3.2 Landing

CRACK(S) IN LANDING

There is minor cracking in one or more slabs of the landing. At a minimum, the affected slabs should be replaced. If not replaced a reinspection is recommended in 2 years.

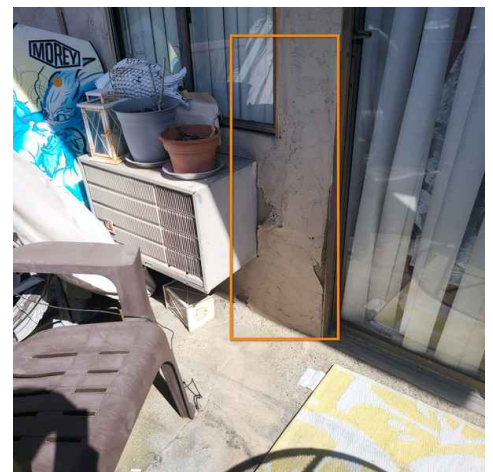
DETERIORATING STUCCO ON SUPPORTING WALL

The stucco on the supporting wall has water damage and is deteriorating. A Phase 2 Pre-721 Evaluation (P2PE) is recommended to determine the extent of any water damage via borescope inspection or larger investigative openings, and to formulate a detailed repair plan.

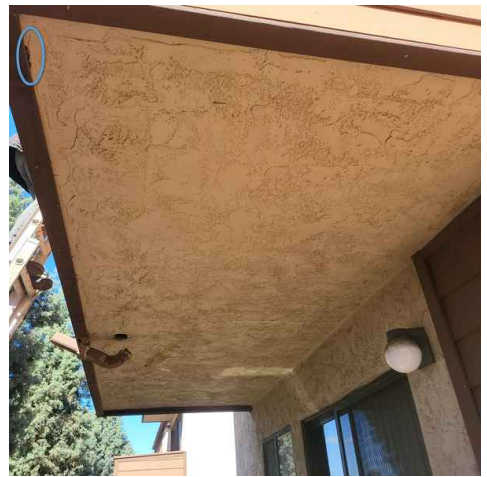
OPENING IN STUCCO

There is an opening in the stucco on the underside of balcony. This opening should be sealed with a waterproof sealant to prevent wood boring insect intrusion.

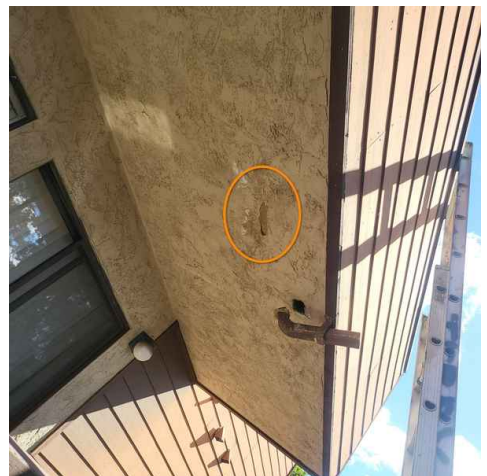
16.2.5 Balcony

DAMAGED SOFFIT

There is evidence of water damaged stucco. Water intrusion can lead to internal deterioration of materials and possible compromise of structural integrity over time. A Phase 2 Pre-721 Evaluation (P2PE) is recommended to determine the extent of any water damage via borescope inspection or larger investigative openings, and to formulate a detailed repair plan.

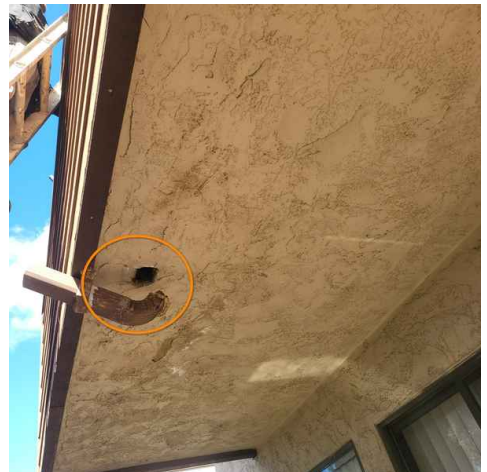
16.2.6 Balcony

DISCONNECTED DRAIN SPOUT

The drain spout on the underside of the balcony is disconnected. Water is seeping through the stucco. Water intrusion can lead to internal deterioration of materials and possible compromise of structural integrity over time. A Phase 2 Pre-721 Evaluation (P2PE) is recommended to determine the extent of any water damage via borescope inspection or larger investigative openings, and to formulate a detailed repair plan.

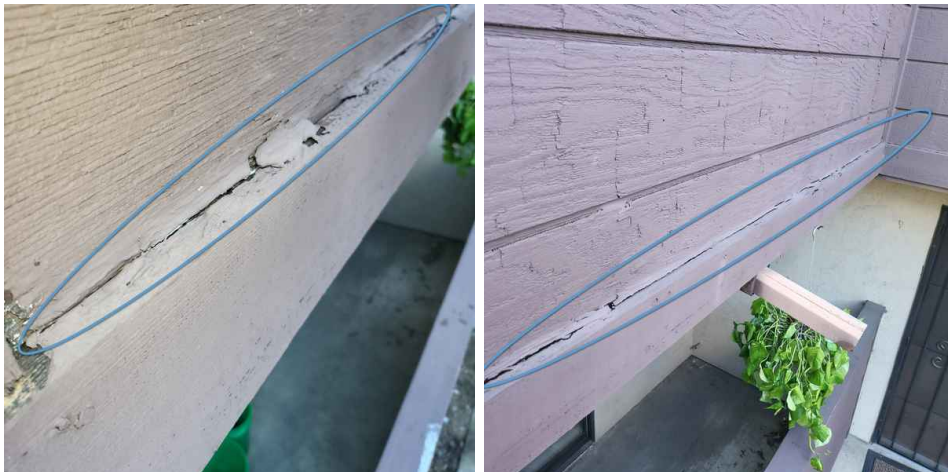
POOR DETAILING

There are openings at the connection between the plywood and trim on the outside of the balcony. These openings should be sealed.

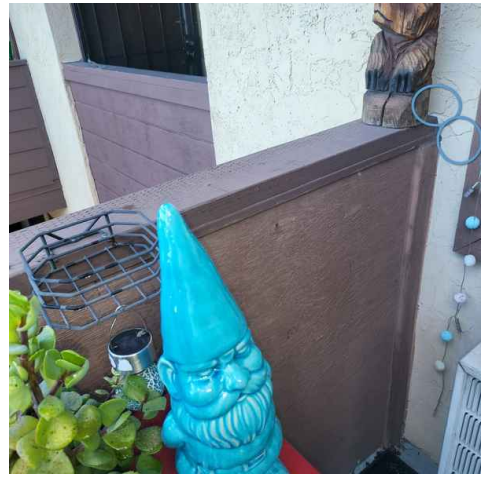
17.2.2 Balcony

CRACK(S) IN SUPPORTING WALL

There are cracks in the supporting wall. These cracks should be sealed.

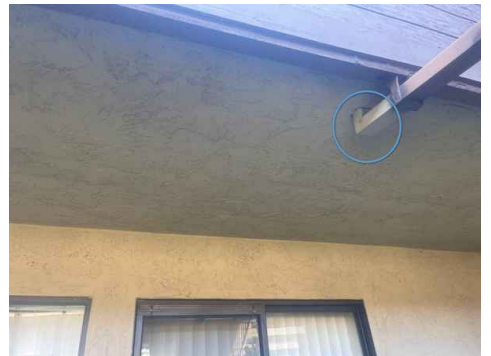
17.2.3 Balcony

UNSEALED DRAINAGE CONNECTION

There is an unsealed drainage pipe on the underside of the balcony. This connection should be sealed with a waterproof sealant to prevent wood boring insect intrusion.

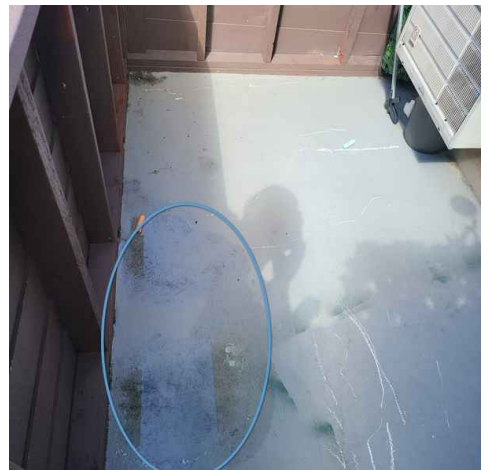
There is pooling on the deck. Deck may need to be leveled to ensure proper drainage and prevent water intrusion.

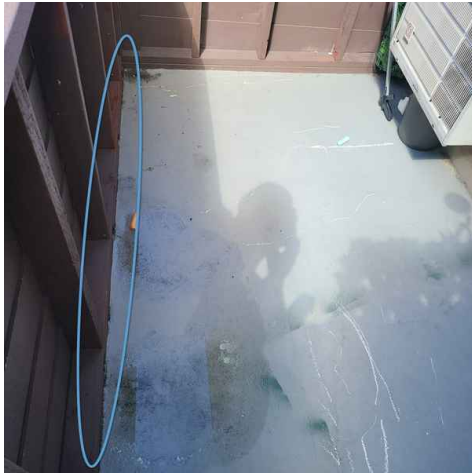
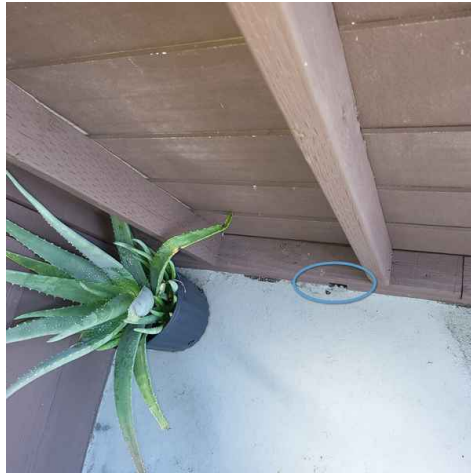
19.2.2 Balcony

POOR DETAILING

There are minor openings at the connections between the railing and deck surface and between the doorsill and deck. These openings should be sealed with a waterproof sealant to prevent water and wood boring insect intrusion.

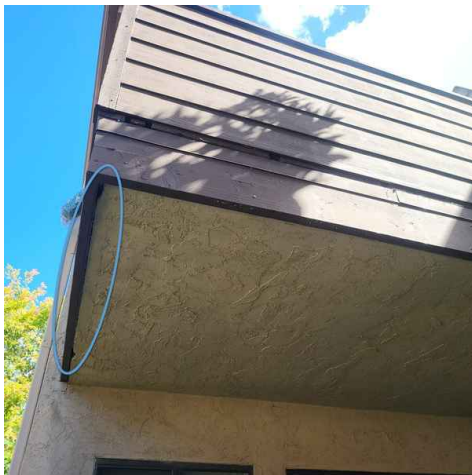
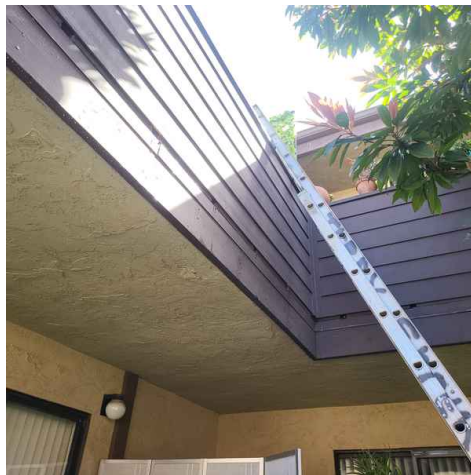
19.2.3 Balcony

FASCIA SEPARATING FROM SOFFIT

One or more sections of the rim board and/or fascia on the underside of the balcony have separated from the soffit. The resulting gaps should be sealed with a waterproof sealant to prevent water and wood boring insect intrusion.

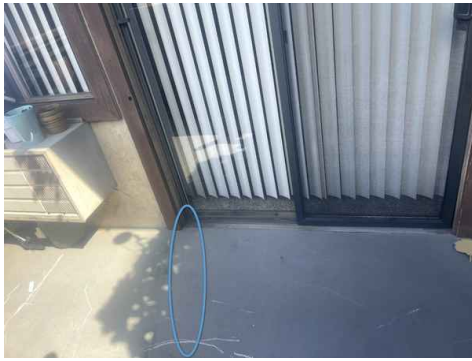
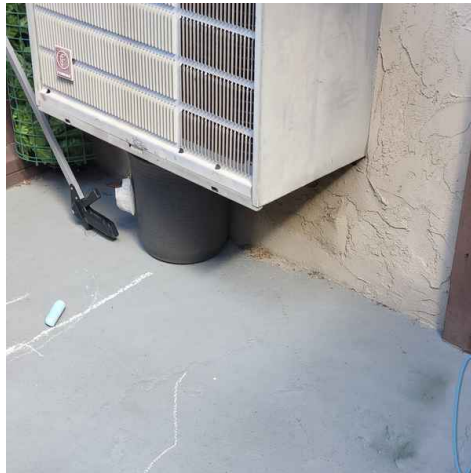
CRACK(S) IN DECK

There is a crack in the deck surface. This crack should be sealed with a waterproof sealant to prevent water intrusion.

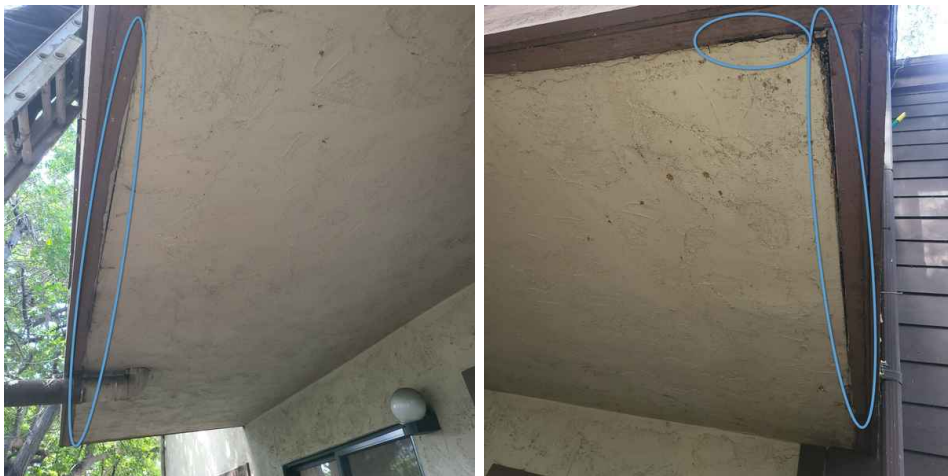
FASCIA SEPARATING FROM SOFFIT

One or more sections of the rim board and/or fascia on the underside of the balcony have separated from the soffit. The resulting gaps should be sealed with a waterproof sealant to prevent wood boring insect intrusion.

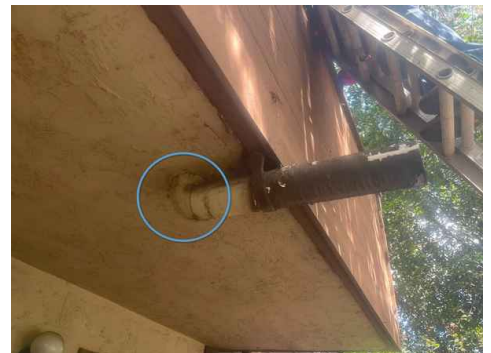
20.2.2 Balcony

UNSEALED DRAINAGE CONNECTION

There is an unsealed drainage pipe on the underside of the balcony. This connection should be sealed with a waterproof sealant to prevent wood boring insect intrusion.

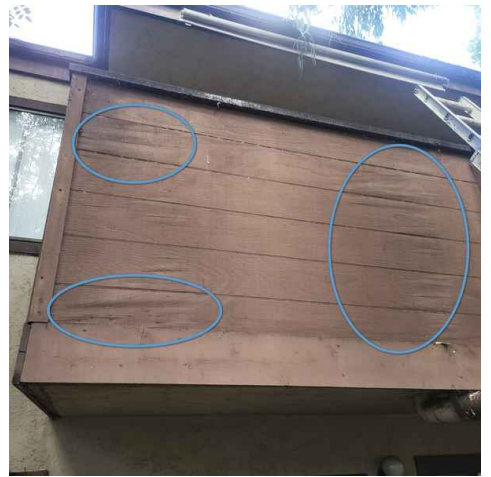
20.2.3 Balcony

DAMAGED PANELING

Balcony paneling and trim of the railing is showing signs of water damage. The paneling on the outside of the railing is warped and delaminated. This paneling should be replaced.

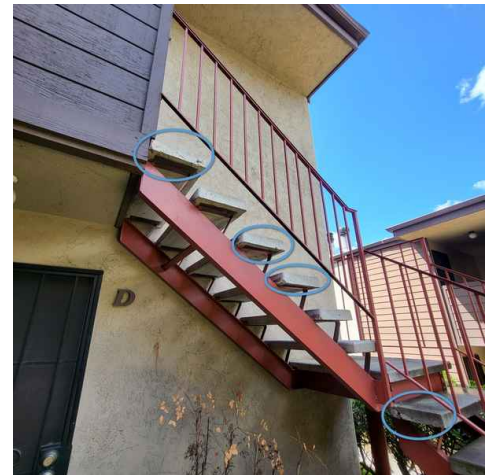
DAMAGED TREADS (MINORITY)

Approximately 4 of 18 treads contain cracks or breakages. Most if not all of the stair treads seem to be the same age. At a minimum, the affected tread should be replaced. If not replaced a reinspection is recommended in 2 years.

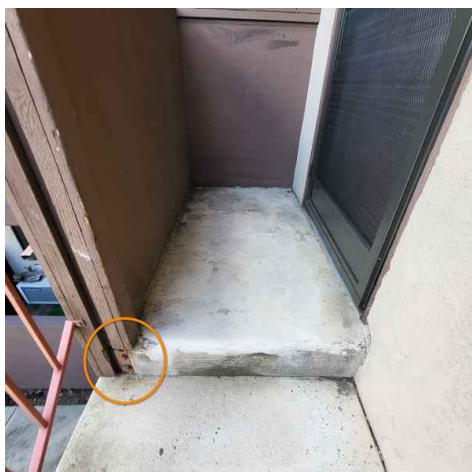
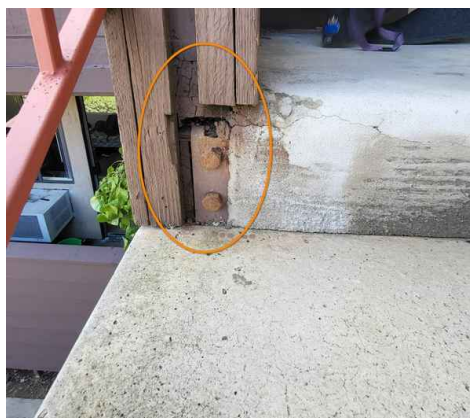
21.2.2 Stairway

DAMAGED STRINGER ATTACHMENT(S)

Stairway is structurally compromised where the the stair stringer attaches to the entry structure. Corrosion and dry rot/termite damage are present in surrounding wood and indicates potentially severe water intrusion. A Phase 2 Pre-721 Evaluation (P2PE) is recommended to determine the extent of any water damage via borescope inspection or larger investigative openings, and to formulate a detailed repair plan.

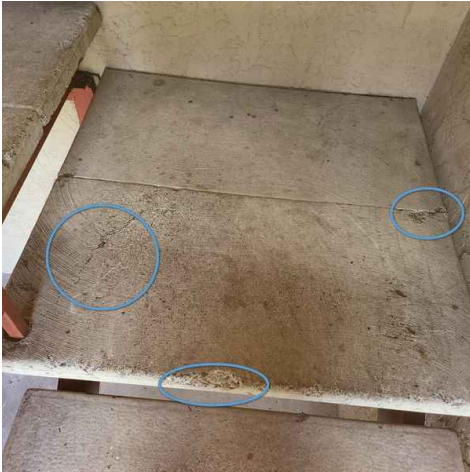
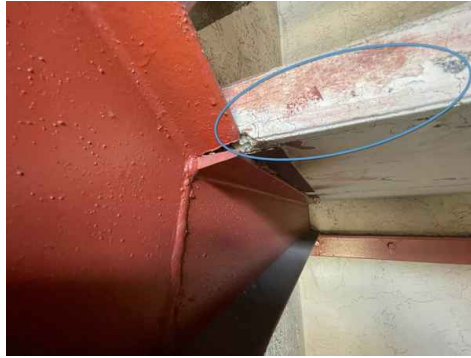
DAMAGED LANDING

There are minor cracks and breakages in both landing platforms. At a minimum, the affected slabs should be replaced. If not replaced a reinspection is recommended in 2 years.

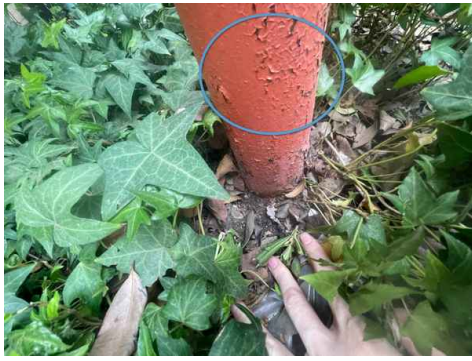
SUPPORT BEAM SURFACE CORROSION

There is surface corrosion on the support beam. The bottom portion of the beam should be resealed.

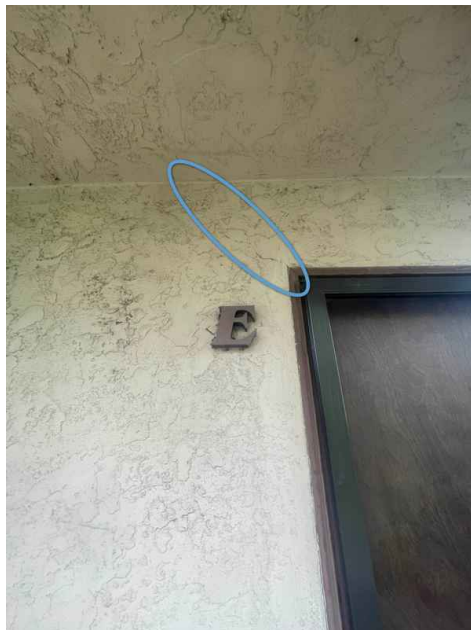
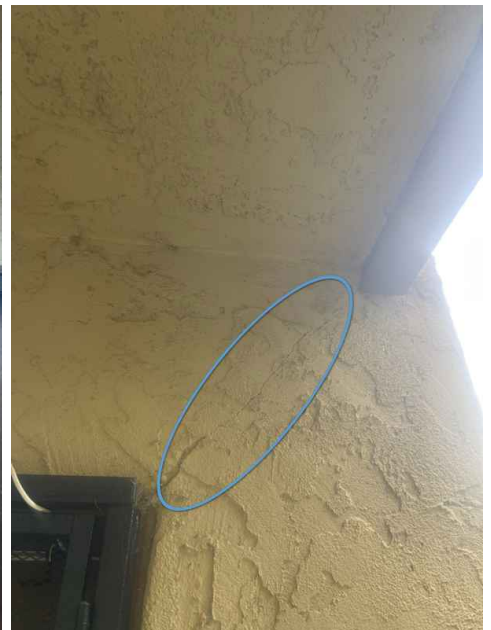
Underside of Entry Structure

CRACK(S) IN SUPPORTING WALL

There are cracks in the supporting wall under the entry structure. These cracks should be sealed with a waterproof sealant to prevent water and wood boring insect intrusion.

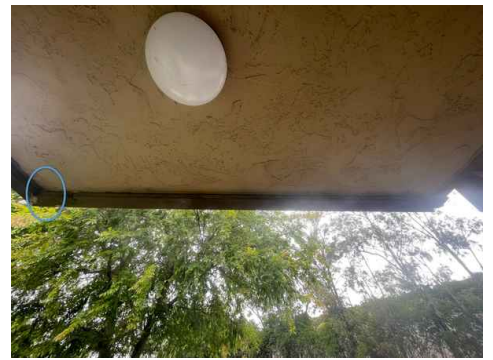
23.4.2 Entry Structure

DISCOLORATION OF FASCIA

There is a discoloration of the fascia on the underside of the entry structure. This may be evidence of water intrusion in the soffit and bears further investigation during a phase 2 inspection.

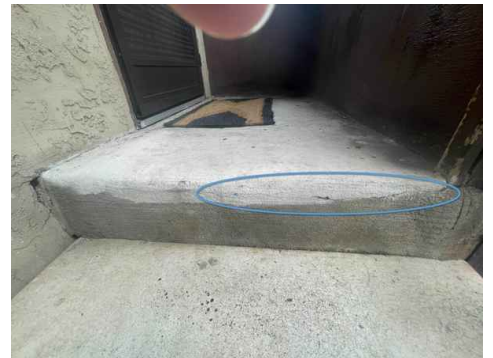
23.4.3 Entry Structure

CRACK(S) IN DECK

There is a crack in the walking surface of the entry structure. A deck coating should be applied to the entire walking surface.

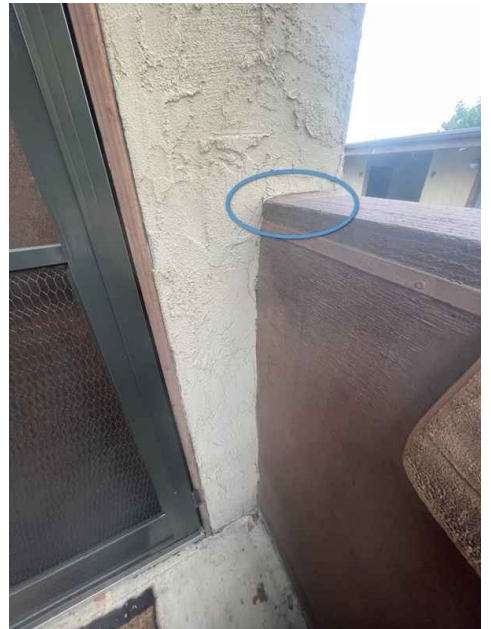
UNSEALED RAILING CONNECTION(S)

there is an opening where the railing meets the supporting wall of the entry structure. This opening should be sealed.

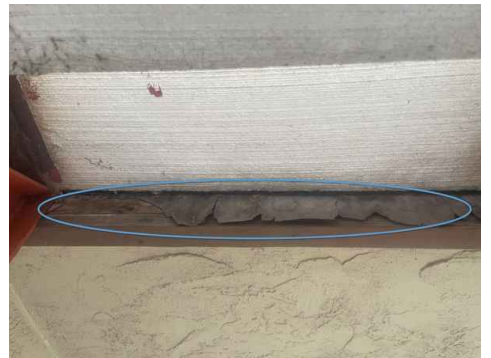
23.4.6 Entry Structure

POOR DETAILING

There is an unfinished area under where the top stair tread meets the entry structure. The supporting wood frame is exposed and the tar paper is showing. This area should be finished and sealed.

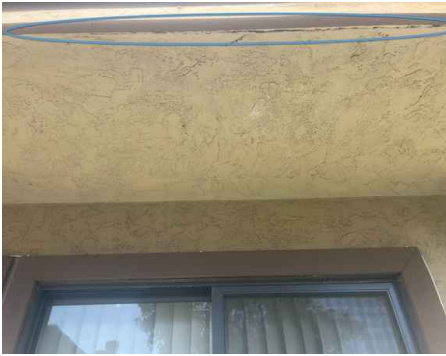
Building 1: Balcony N-East, Fascia Separating from Soffit in Overhang

One or more sections of the overhang rim board and/or fascia have separated from the soffit. The resulting gaps should be sealed with a waterproof sealant to prevent water and wood boring insect intrusion.

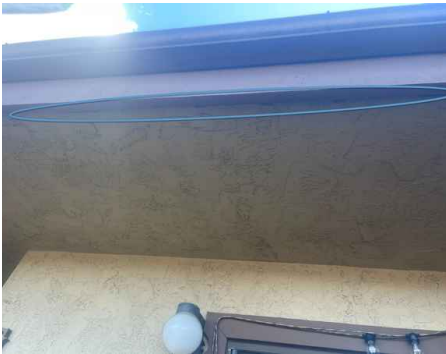
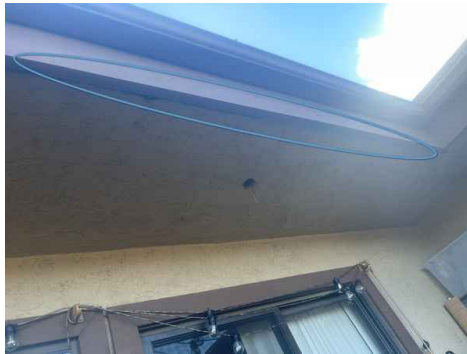
Building 2: Balcony G, Fascia Separating from Soffit in Overhang

One or more sections of the overhang rim board and/or fascia have separated from the soffit. The resulting gaps should be sealed with a waterproof sealant to prevent water and wood boring insect intrusion.

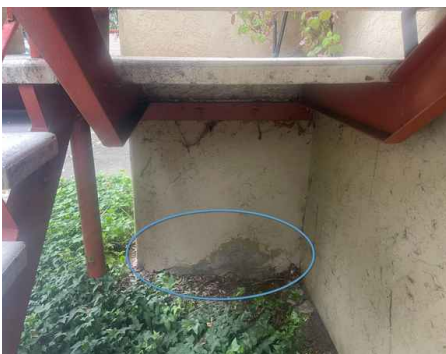
Building 2: Stairway E, Deteriorating Stucco on Supporting Wall

The stucco on the supporting wall under the landing is severely deteriorating and should be resurfaced and sealed.
