PHASE 1 PRE-SB721 EVALUATION

1234 Main Street
Imperial Beach, CA 91932-1412

Buyer Name
05/02/2024 9:00AM

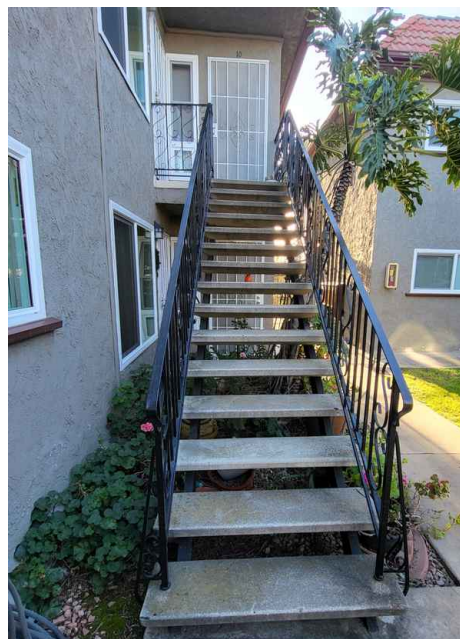
Stairway: *Stairway Inspection Image(s)

- 🔧 5.1.1 Exterior Elevated Element (E3) Group 1 - Overall Condition Evaluation: Acceptable Condition
- 🔧 5.2.1 Exterior Elevated Element (E3) Group 1 - Stairway: Damaged Stair Treads (Minority)

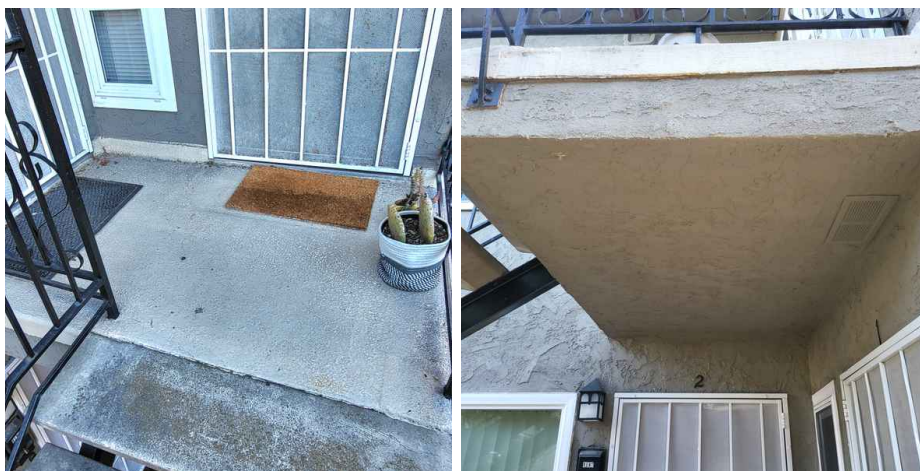
Landing: *Landing Inspection Image(s)

- 🔧 5.3.1 Exterior Elevated Element (E3) Group 1 - Landing: Deck - Opening in Waterproofing
- ⚠️ 6.1.1 Exterior Elevated Element (E3) Group 2 - Overall Condition Evaluation: Marginal Condition

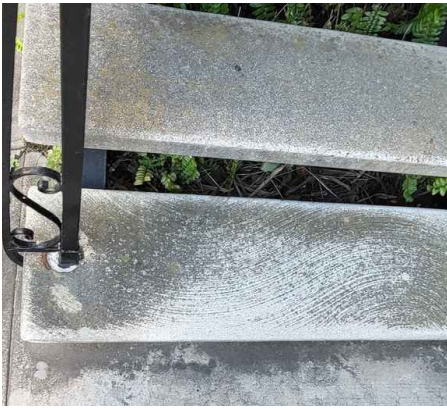
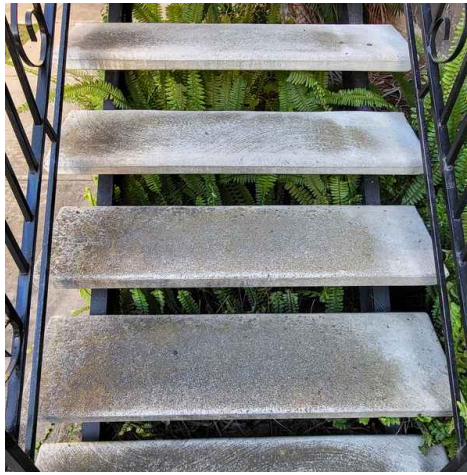
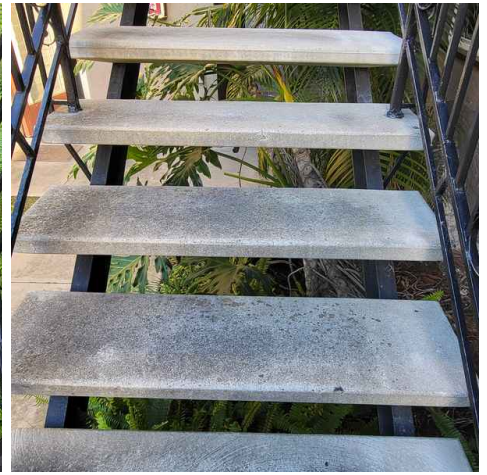
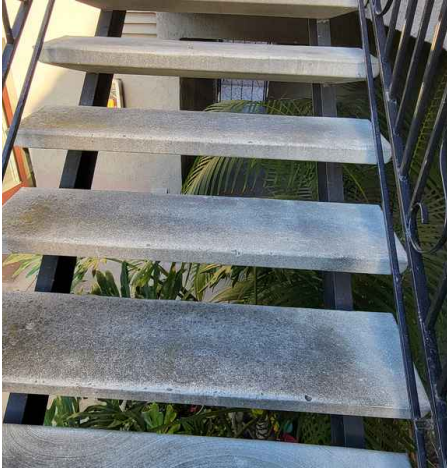
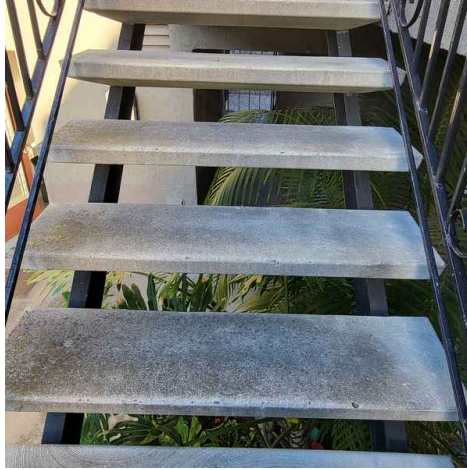
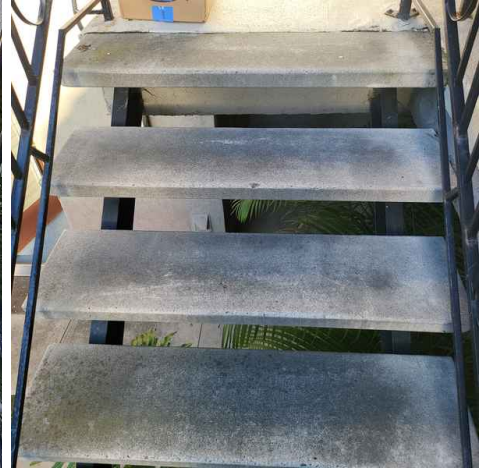
Stairway: *Stairway Inspection Image(s)

- 🔧 6.2.1 Exterior Elevated Element (E3) Group 2 - Stairway: Damaged Stair Treads (Minority)
- ⚠️ 6.3.1 Exterior Elevated Element (E3) Group 2 - Walkway: Stucco Damage

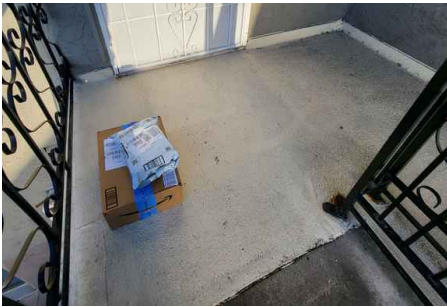
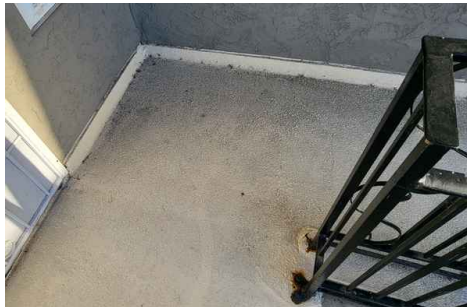
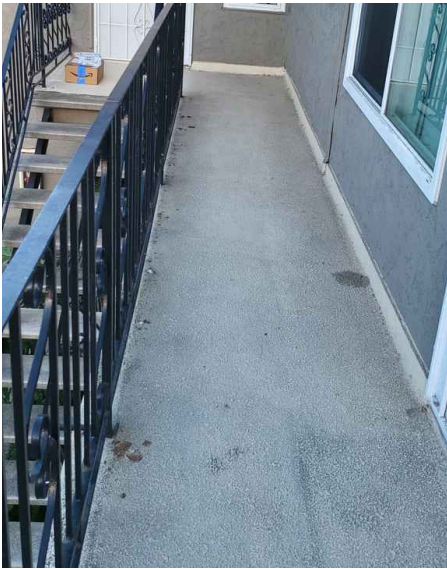
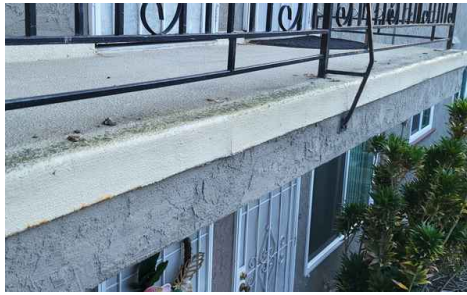
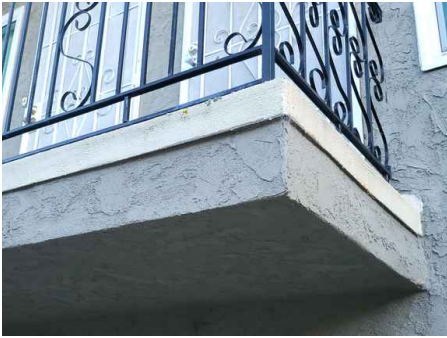
Walkway: *Walkway Inspection Image(s)

- ⚠️ 6.3.2 Exterior Elevated Element (E3) Group 2 - Walkway: Previous Repairs Failing - Minor to Moderate
- 🔧 6.3.3 Exterior Elevated Element (E3) Group 2 - Walkway: Deck - Opening in Waterproofing

- ⚠️ 6.3.4 Exterior Elevated Element (E3) Group 2 - Walkway: Walkway Railing Connection
- ⚠️ 7.1.1 Exterior Elevated Element (E3) Group 3 - Overall Condition Evaluation: Marginal Condition

Walkway: Marginal Condition

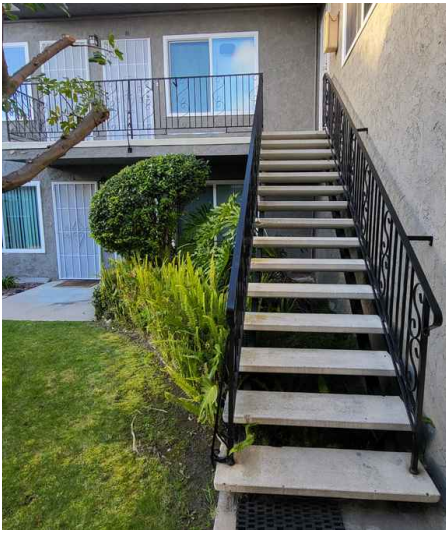
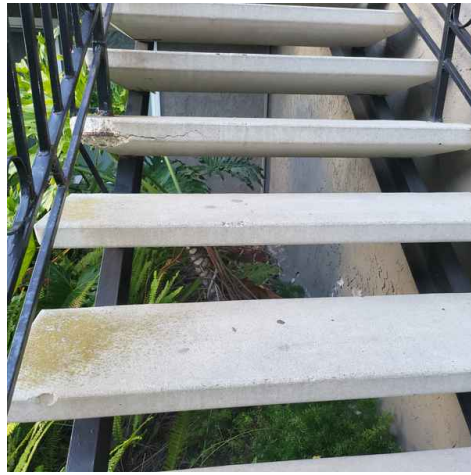
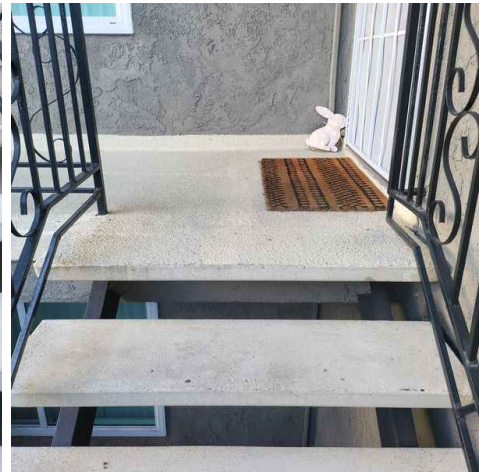
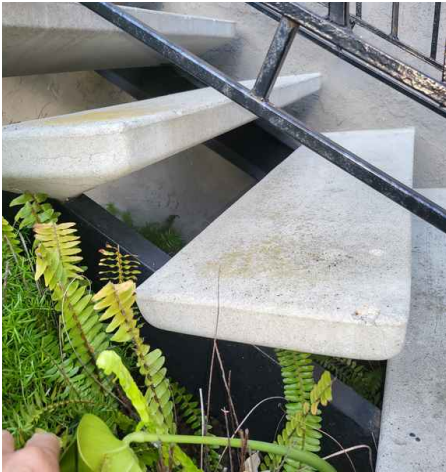
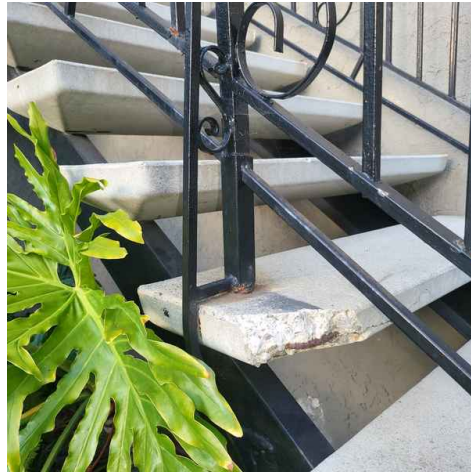
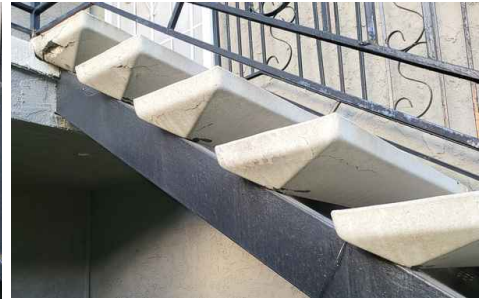
Stairway: *Stairway Inspection Image(s)

- 🔧 7.2.1 Exterior Elevated Element (E3) Group 3 - Stairway: Damaged Stair Treads (Majority)
- 🔧 7.3.1 Exterior Elevated Element (E3) Group 3 - Walkway: Walkway Railing Connection

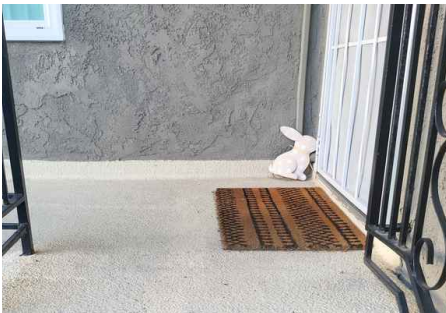
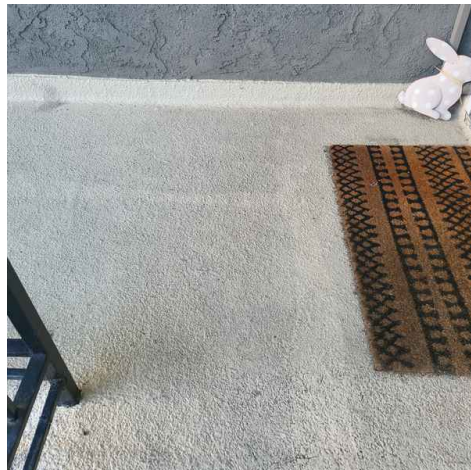
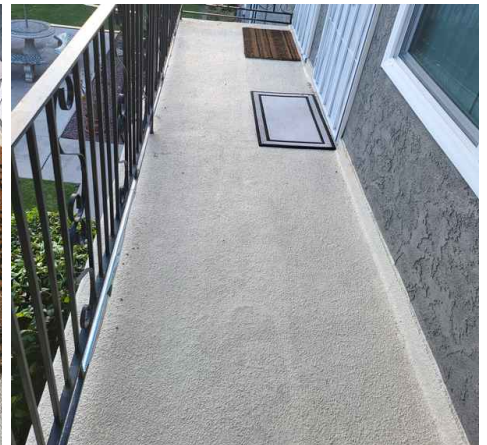
Walkway: *Walkway Inspection Image(s)

2 of the rail connections to the deck are not sealed and corrosion is visible. Water intrusion and deterioration of the underlying support materials are likely. This deterioration could lead to further damage or safety risks. A borescope inspection under one or both of these opening is recommended to determine the extent of water damage to the underlying support materials.

There is minor cracking in the waterproofing at both ends of the walkway under the rail connection to the wall. Sealant/waterproofing should be applied.

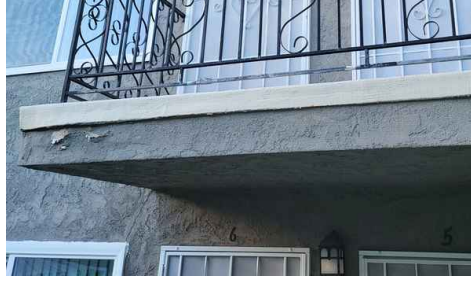
STUCCO DAMAGE

There is evidence of water intrusion at the west corner of the walkway. The edge metal is lifting and corrosion is visible. Water has penetrated the stucco causing it to blister. This condition raises concerns regarding water intrusion and possible advanced deterioration in the underlying support structure. A Phase 2 Pre-721 Evaluation (P2PE) is recommended to determine the extent of any water damage via borescope investigation or larger investigative opening, and to formulate a detailed repair plan.

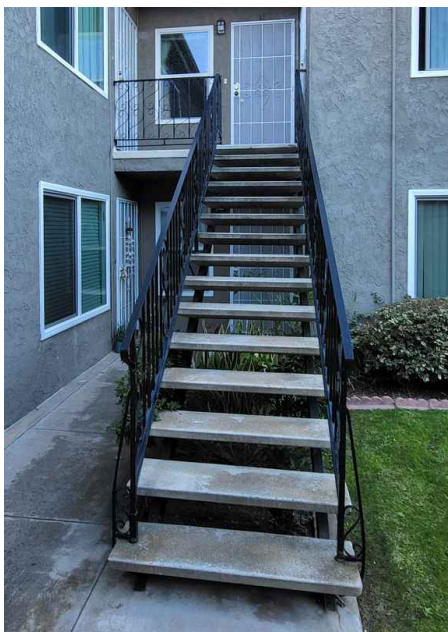
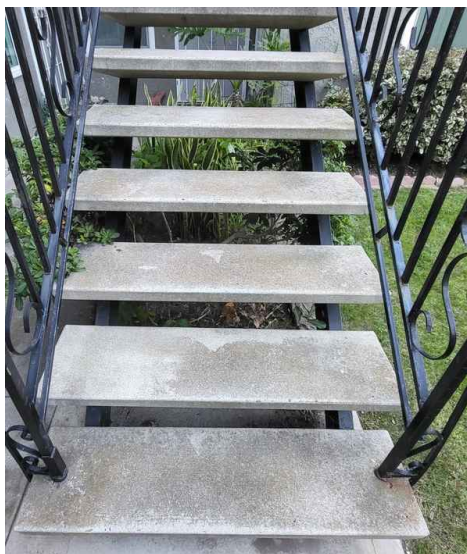
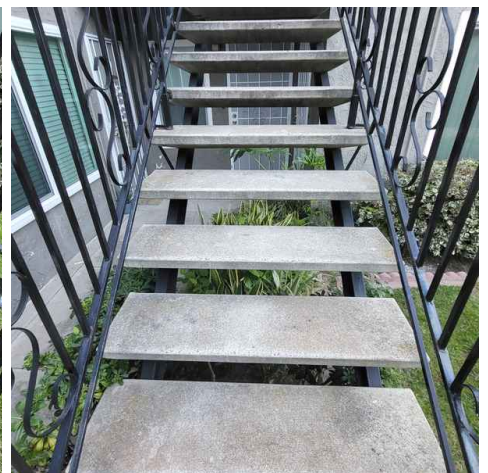
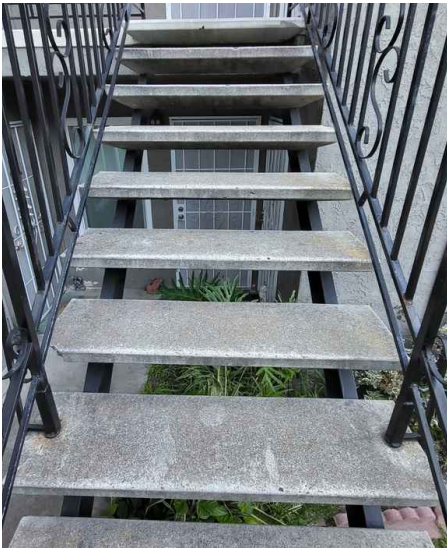
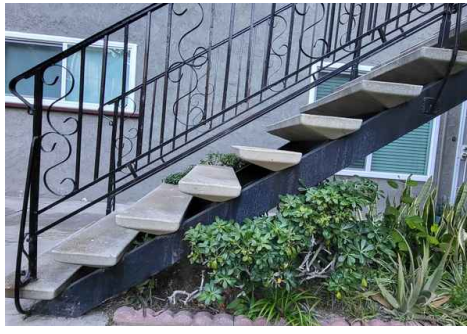
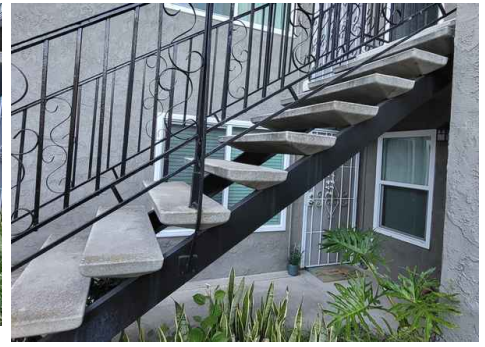
Stairway: *Stairway Inspection Image(s)

DAMAGED STAIR TREADS (MAJORITY)

Approximately 10 out of 15 stair treads have cracks or breakages. Except for the top stair tread, all the treads seem to be the same age and are most likely at the end of their service life. At a minimum, the affected treads should be replaced. If the treads are not replaced a reinspection is recommended in 1 year.

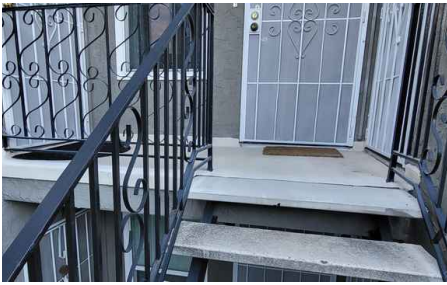
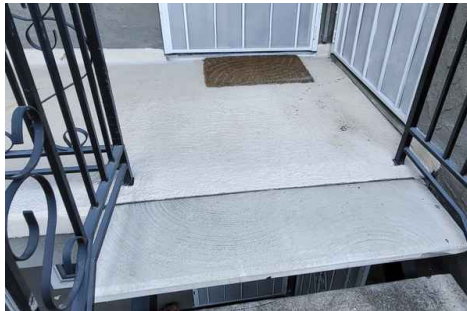
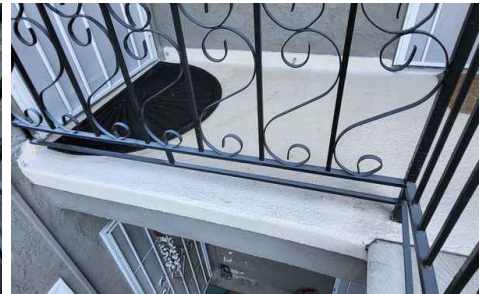
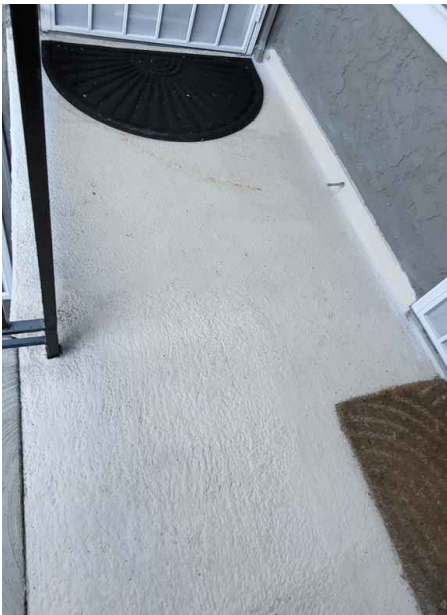
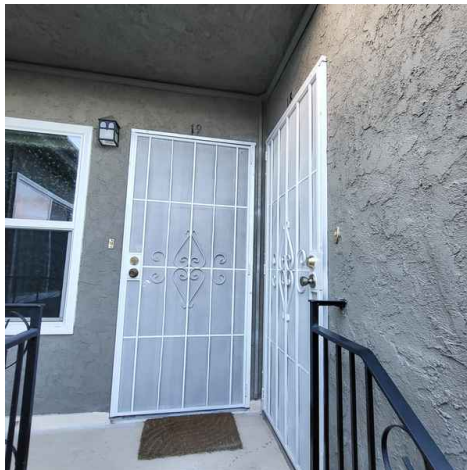
Walkway: *Walkway Inspection Image(s)

The deck coating, the edge metal, and the stucco around the right stair stringer connection to the walkway are not finished properly or sealed. This condition raises concerns regarding water intrusion and possible advanced deterioration in the underlying support structure. A Phase 2 Pre-721 Evaluation (P2PE) is recommended to determine the extent of any water damage via borescope investigation and to formulate a detailed repair plan.
