PRE-721 EVALUATION PHASE 2

1234 Main Street
Imperial Beach, CA 91932-1412

Buyer Name
05/02/2024 9:00AM

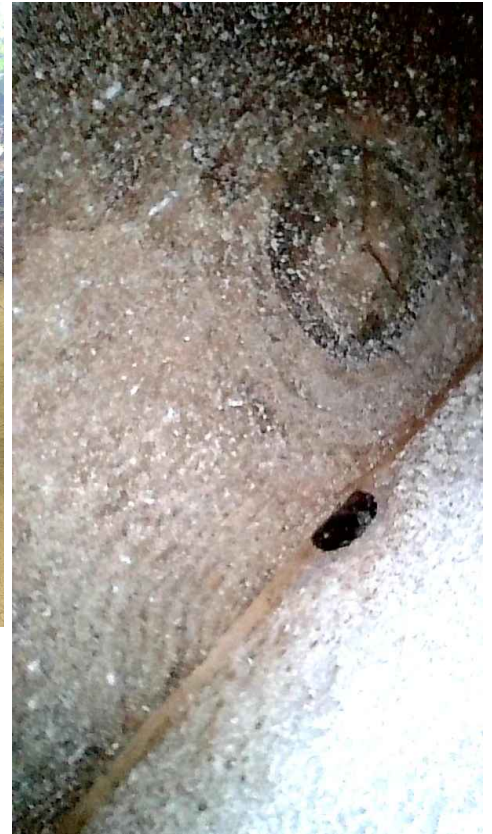
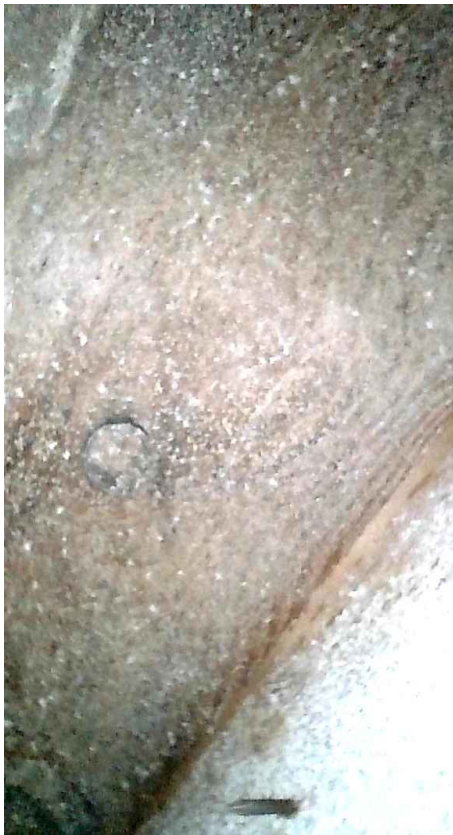
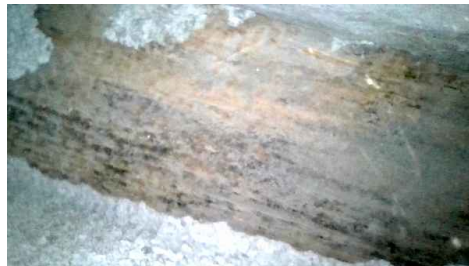
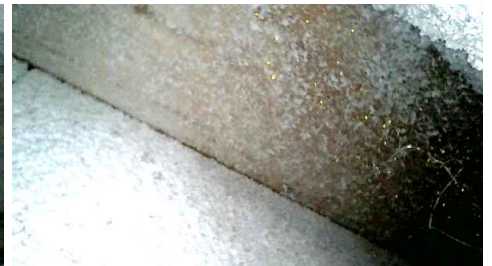
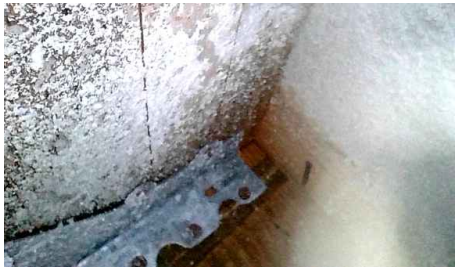
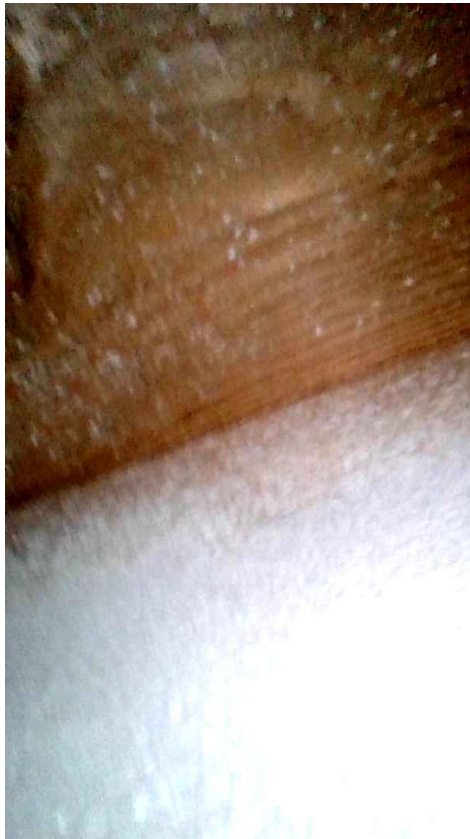
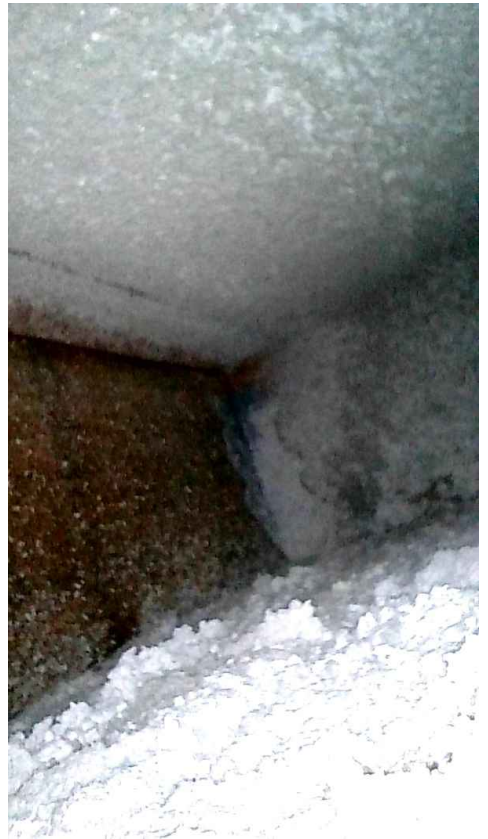
Elevated Walkway : Borescope Hole Location 1:

The visual inspection in the P1PE noted cracks in the stucco running parallel to the walkway. See 1st photo.

At the time of the borescope inspection, no damage to the load-bearing components was observed

1st borescope inspection

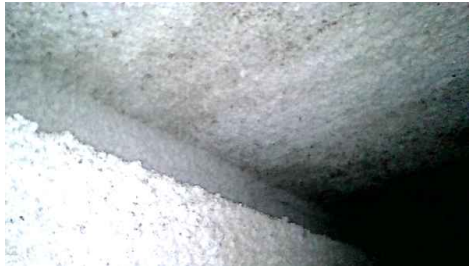
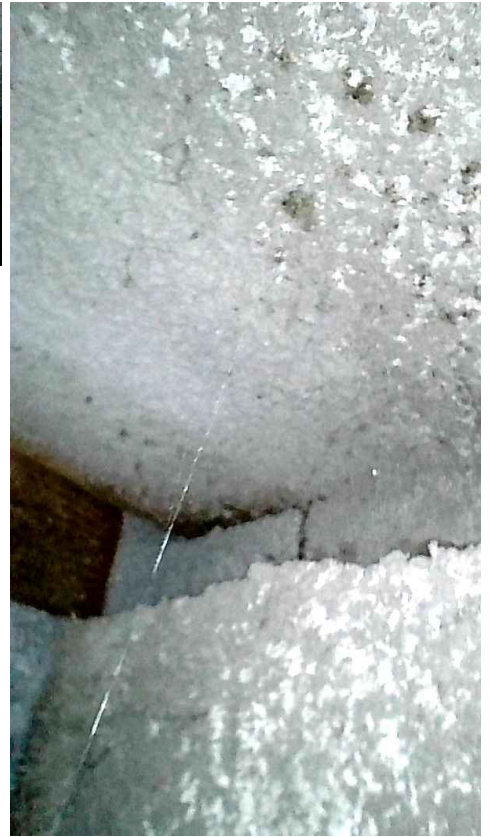
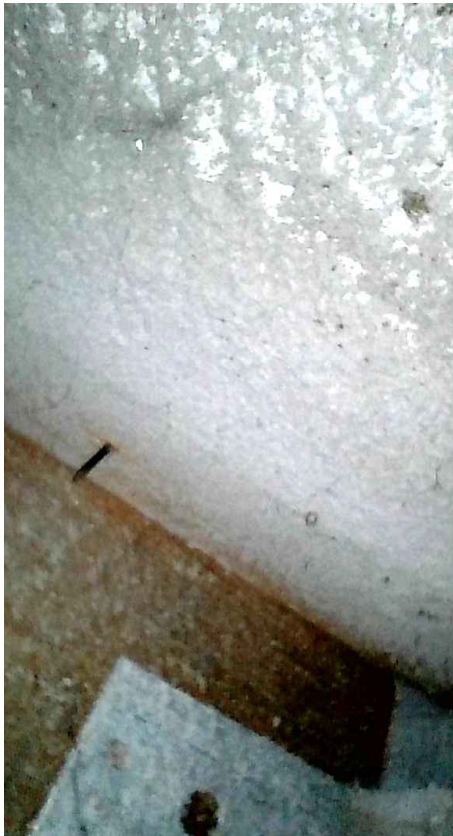
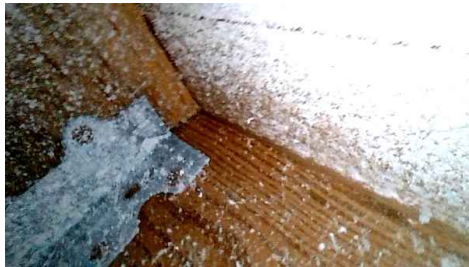
Elevated Walkway : Borescope Hole Location 2

The visual inspection in P1PE noted openings in the stucco around the right stair stringer. These are likely areas for water intrusion. Stucco soffit is discolored in this area.

At the time of the borescope inspection, no damage to the load-bearing components was observed.

near right stringer attachment

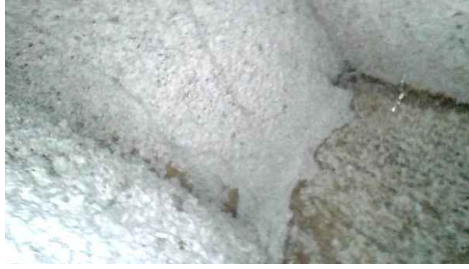
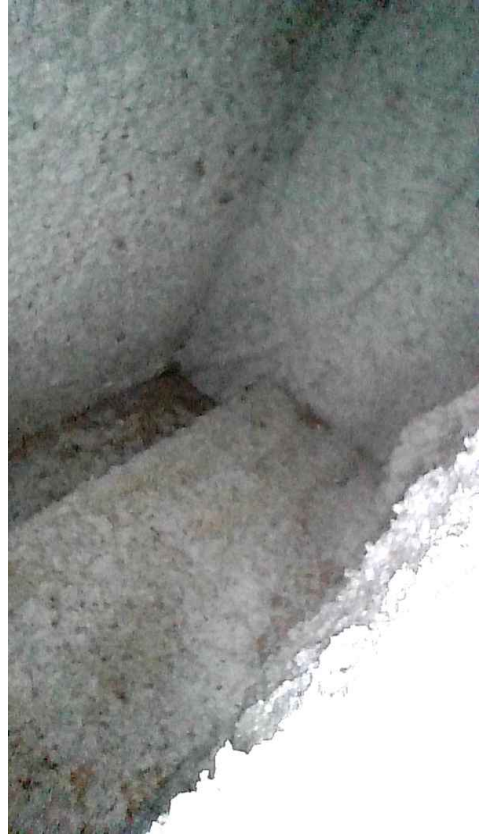
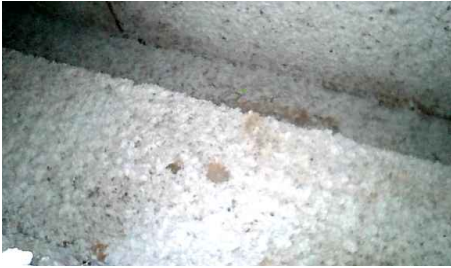
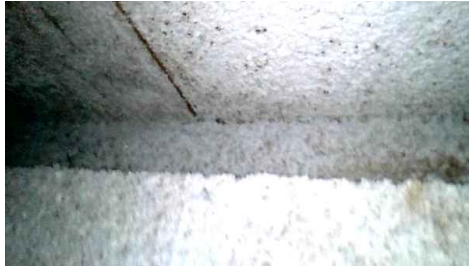
Elevated Walkway : Borescope Hole Location 3

The visual inspection in P1PE noted openings in the stucco around the left stair stringer. These are likely areas for water intrusion. Stucco is discolored in this area.

The 3rd Borescope investigative opening revealed no issues

At the time of the borescope inspection no damage to the load-bearing components was observed

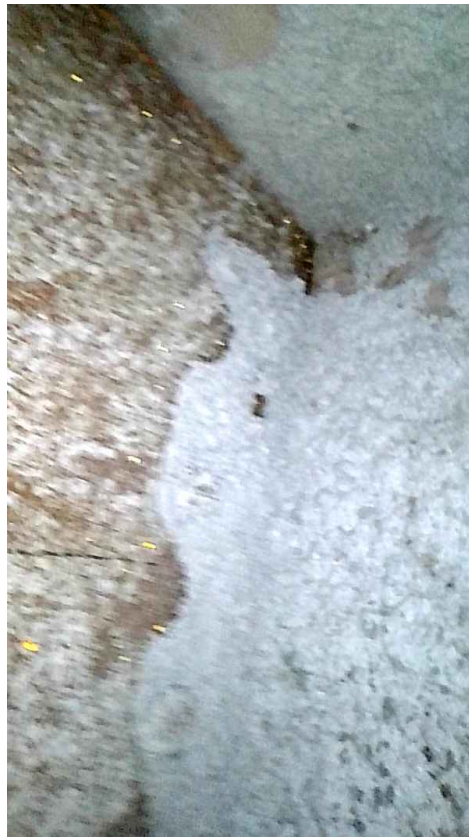
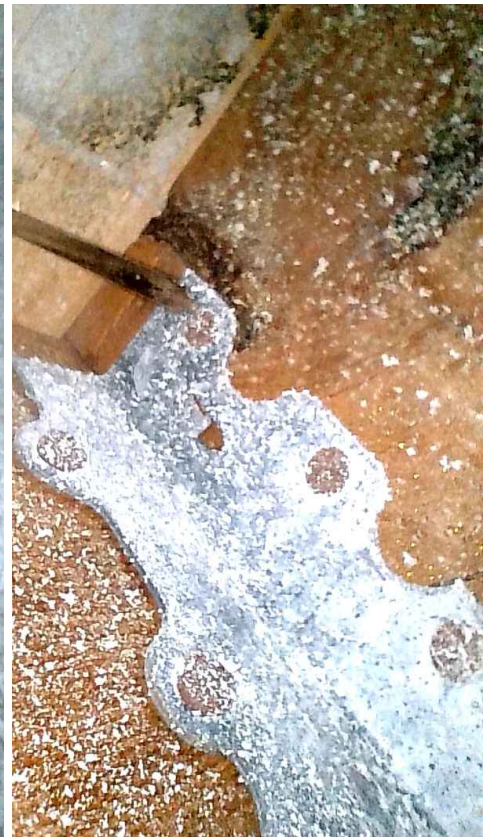
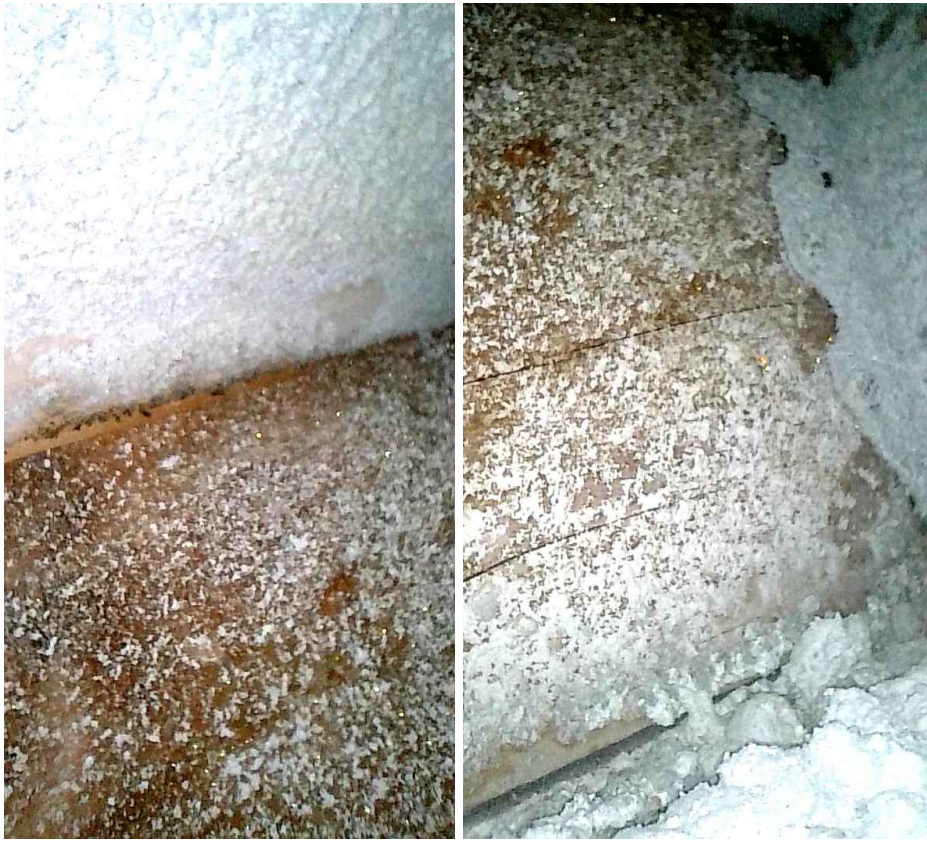
Elevated Walkway : Borescope Hole Location 4

The visual inspection in P1PE noted opening along edge metal. Stucco is falling off the edge metal. See 2nd photo. This is a likely location for water intrusion.

At the time of the borescope inspection no damage to the load-bearing components was observed.

Moisture coming through

The edge metal should be repaired or replaced and the waterproofing system above resealed.

Repair or replace the edge metal toward the south end of the walkway.

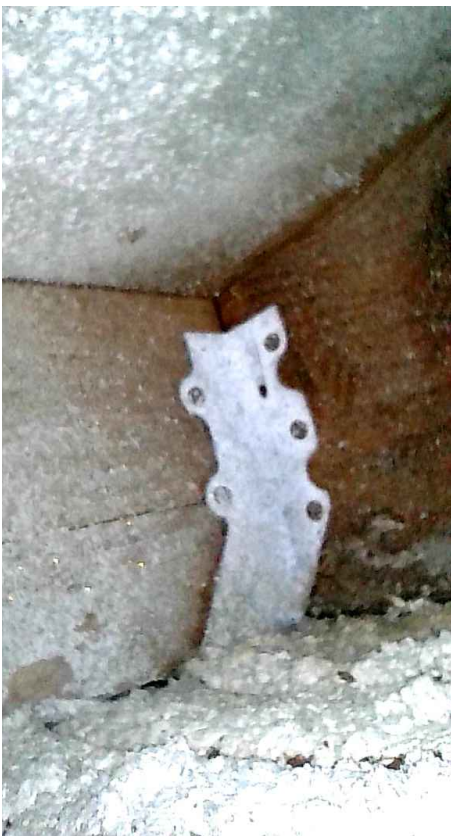
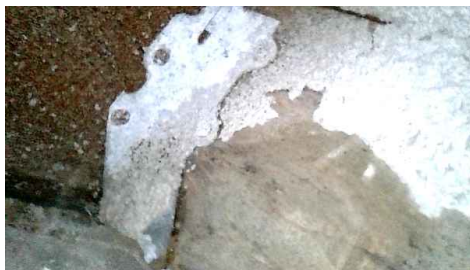
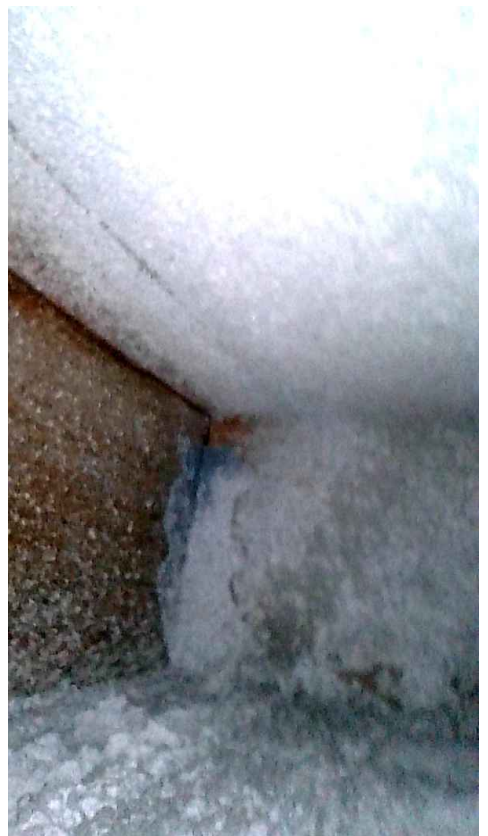
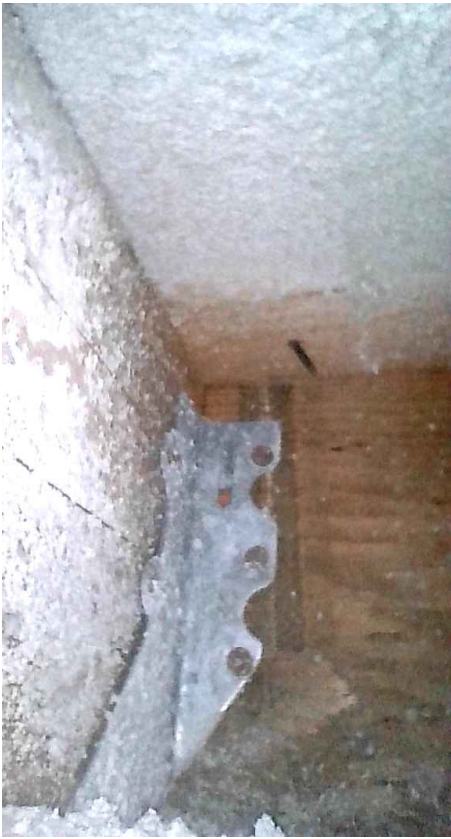
Elevated Walkway : Borescope Hole Location 5

The visual inspection in P1PE at the south end of the walkway noted vine growth tight against the stucco. The stucco covering underneath is discolored.

The 5th Borescope investigative opening revealed evidence of termite activity along the rim board. Photos 8 and 10 show termite droppings. There are signs of minor water intrusion such as water stains along the rim board.

Photo# 8 Termite droppings along rim board

Prior to the SB-721 Inspection an area of vine growth should be cleared and a section of stucco removed to investigate the extent of termite damage to the rim board or wood support components.

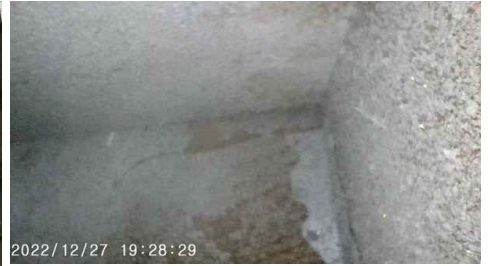
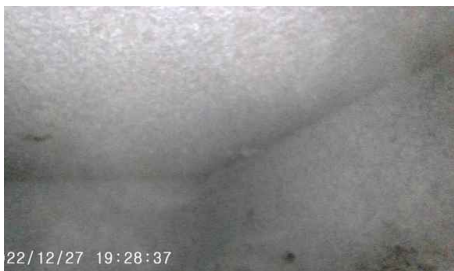
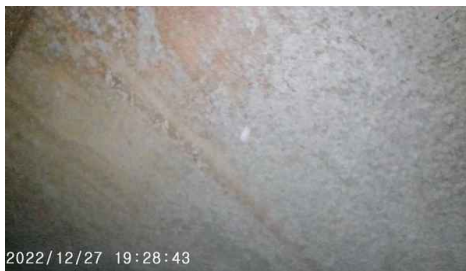
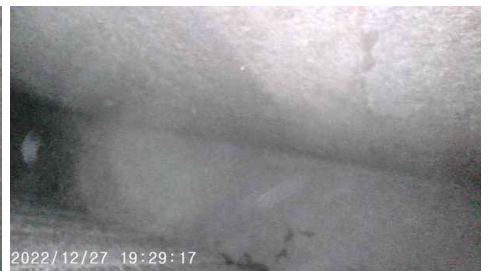
The visual inspection in P1PE noted a crack in the concrete deck. See 2nd photo. This is a potential location for water intrusion.

At the time of the borescope inspection no damage to the load-bearing components was observed.

Crack across concrete deck

The deck crack should be sealed.

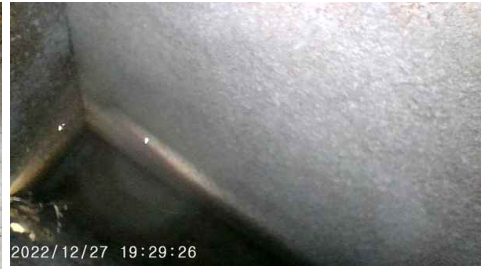
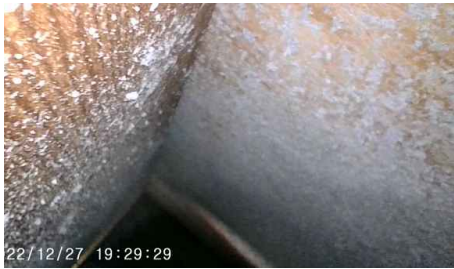
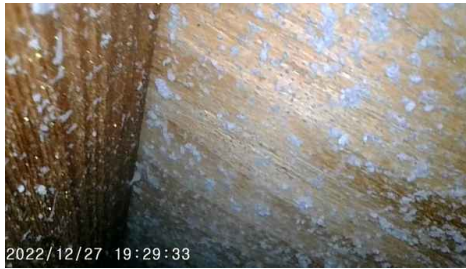
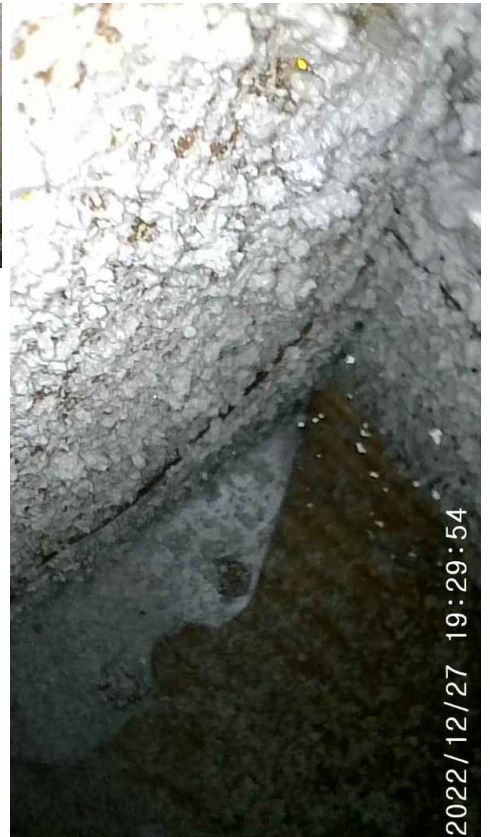
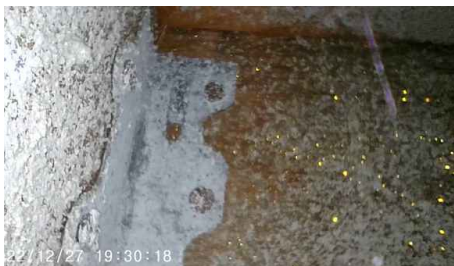
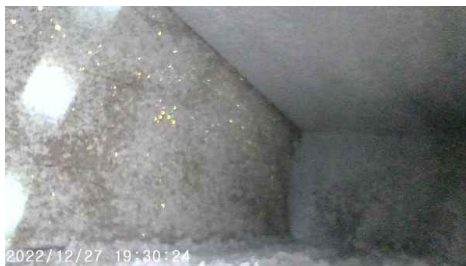
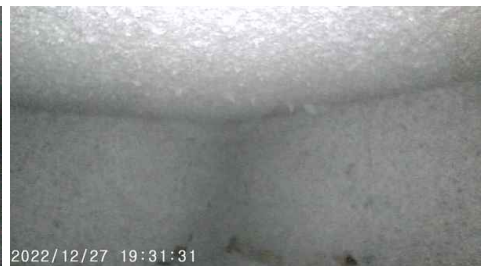
The visual inspection in P1PE noted a crack in the concrete deck. See 2nd photo. This is a potential location for water intrusion.

At the time of the borescope inspection no damage to the load-bearing components was observed.

Crack across concrete deck
