PATRICK'S PROPERTY MAINTENANCE SERVICE

PHASE 1 PRE-SB326 EVALUATION

1234 Main Street
Imperial Beach, CA 91932-1412

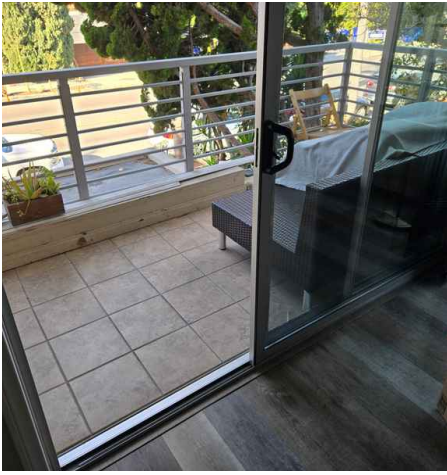
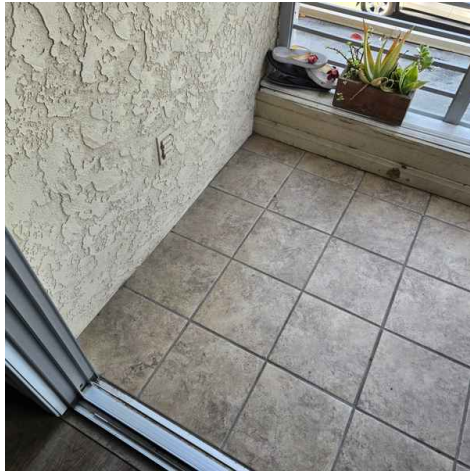
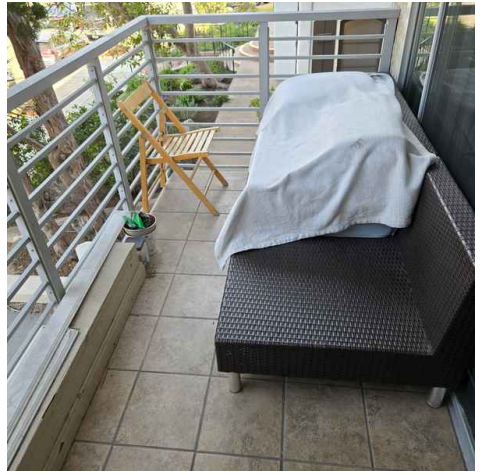
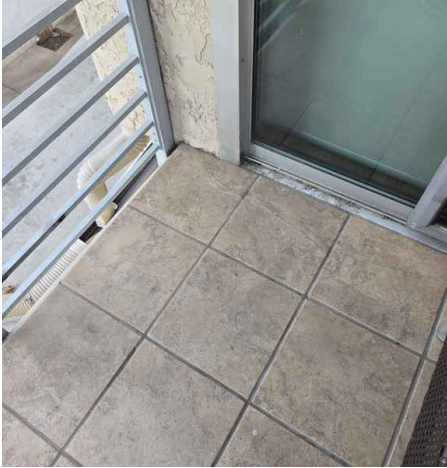
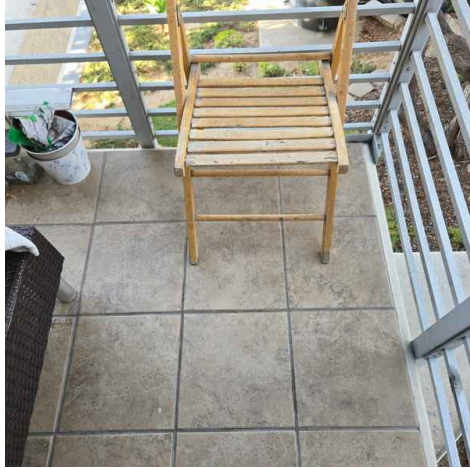
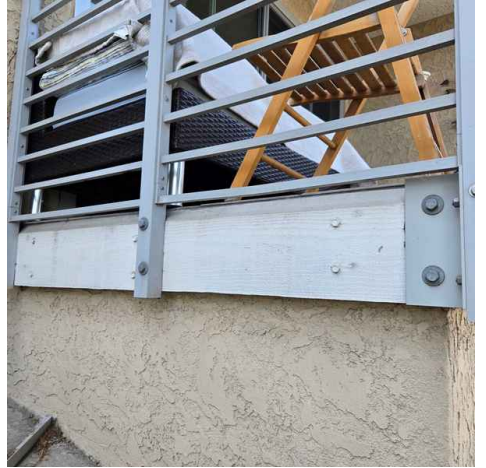
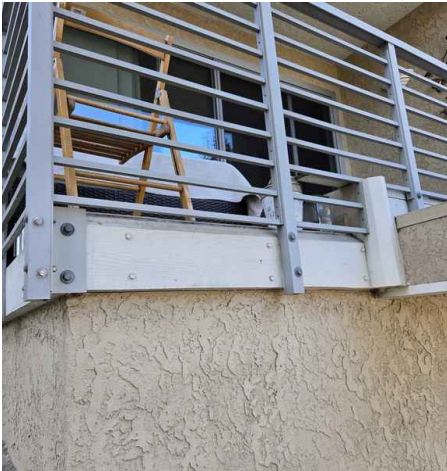
Balcony: *Balcony Inspection Image(s)

Minor - There are cracks, openings, or penetrations in the waterproofing. The affected areas should be sealed.

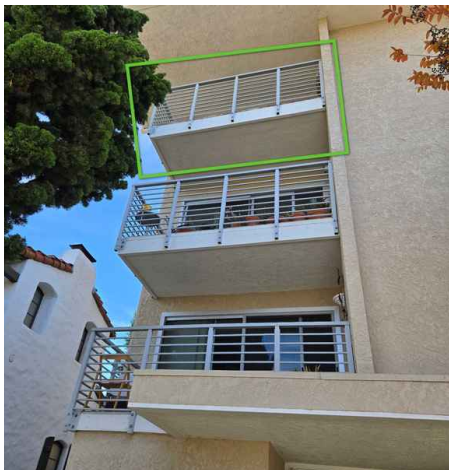
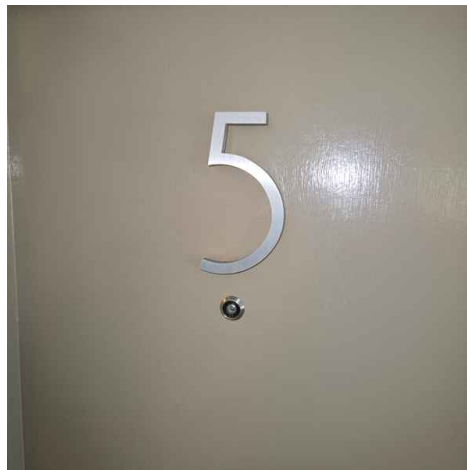
Overall Condition Evaluation: Acceptable Condition

Railing is solid. Railing connections are sealed with no corrosion, Support structure(s) are functioning as intended
Continued regular maintenance is recommended.

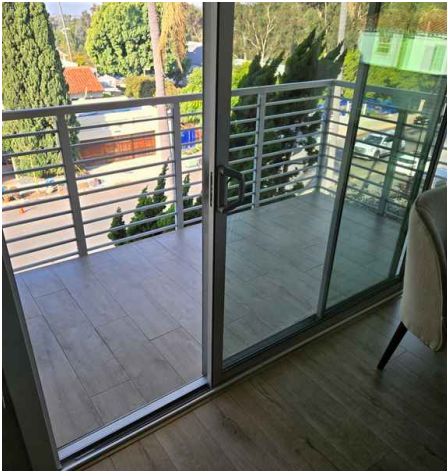
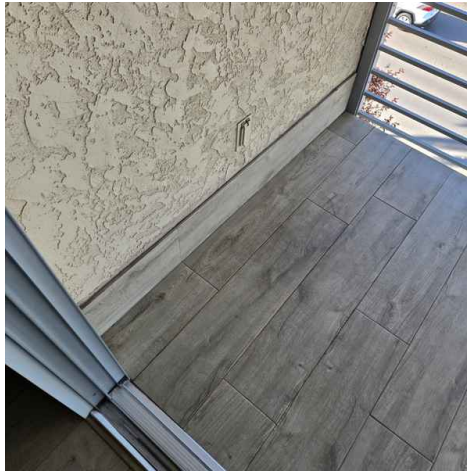
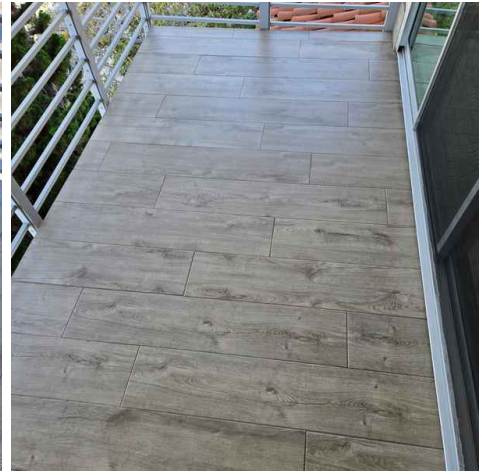
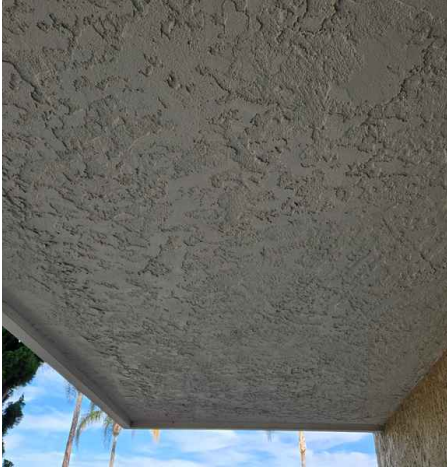
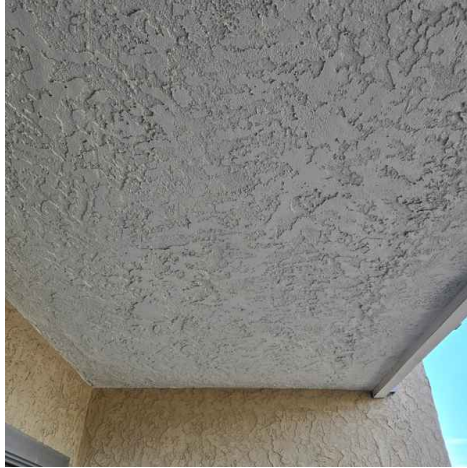
9.2.1 Balcony

Minor - There are cracks, openings, or penetrations in the waterproofing. The affected areas should be sealed.

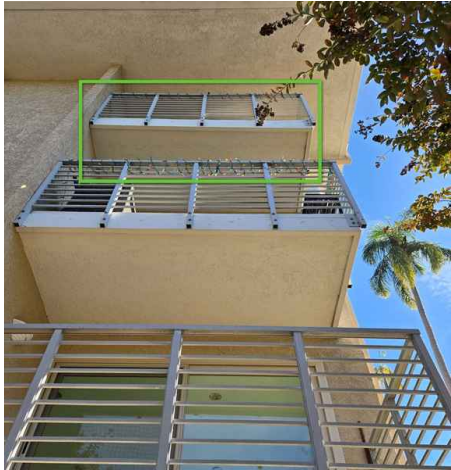
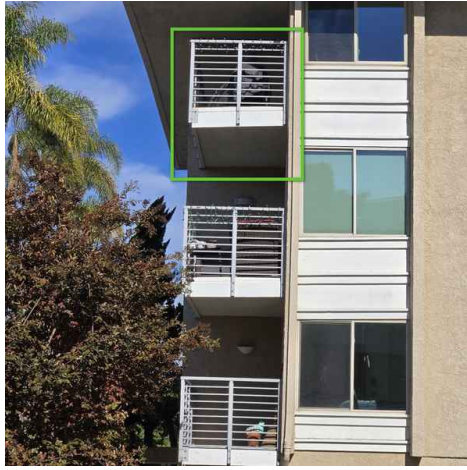
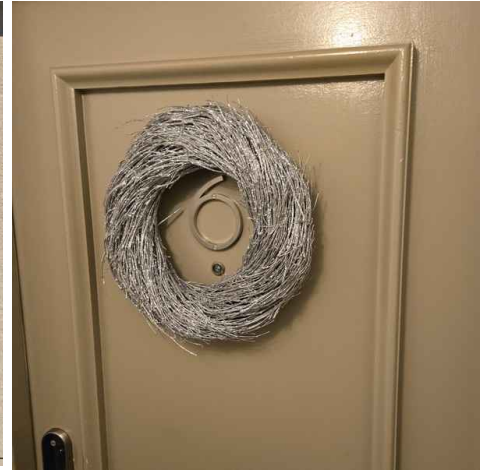
Acceptable Condition

Railing is solid. Railing connections are sealed with no corrosion, Support structure(s) are functioning as intended
Continued regular maintenance is recommended.

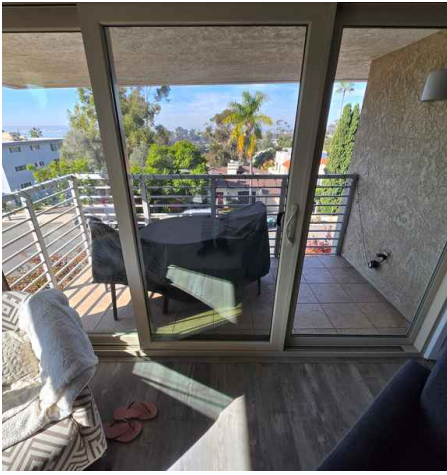
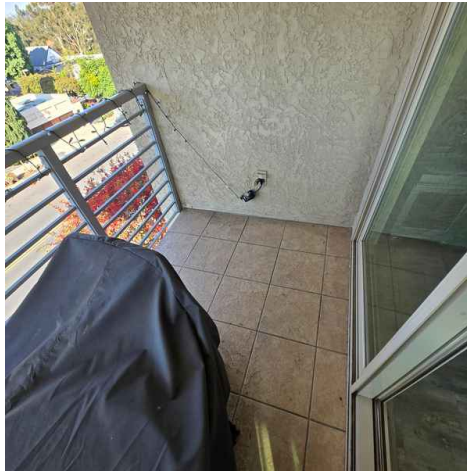
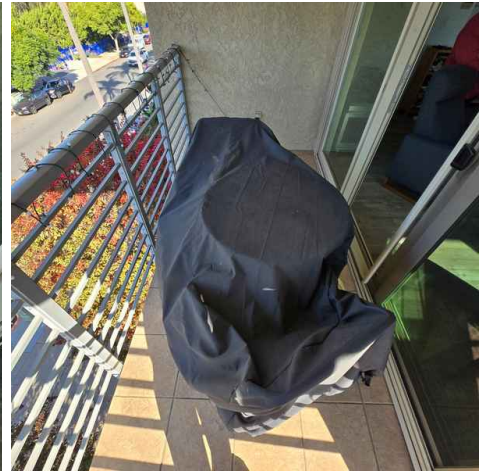
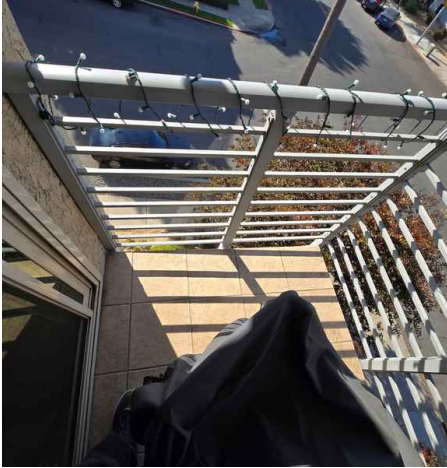
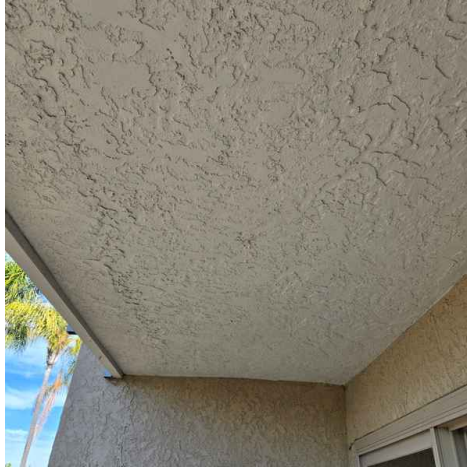
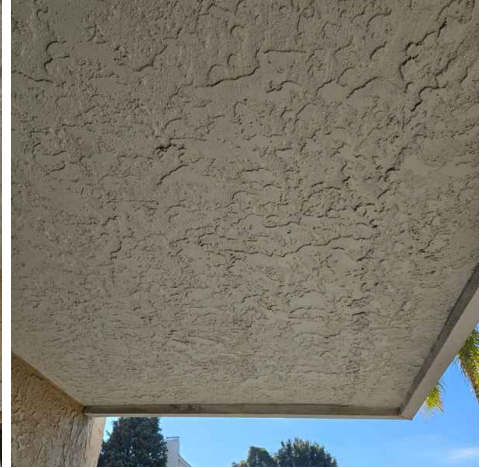
10.2.1 Balcony

Minor - There are cracks, openings, or penetrations in the waterproofing. The affected areas should be sealed.

Minor - There is surface corrosion. The affected area(s) should be repaired.

Note: Openings in the waterproofing at the edge metal allowed water intrusion leading to minor corrosion, expansion, and separation between the concrete deck and the edge metal.
