PATRICK'S PROPERTY MAINTENANCE SERVICE

PHASE 1 PRE-721 EVALUATION (P1PE)

1234 Main Street
Imperial Beach, CA 91932-1412

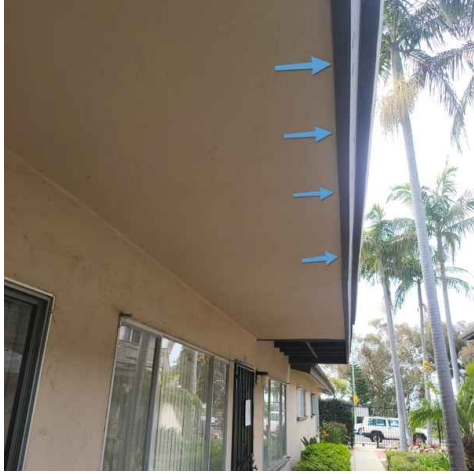
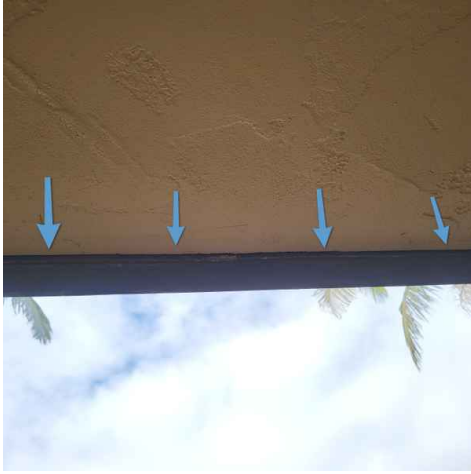
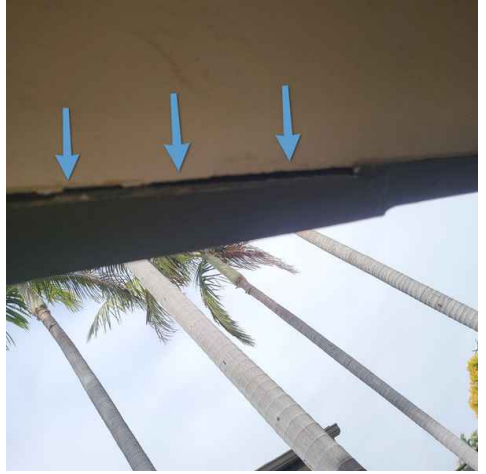
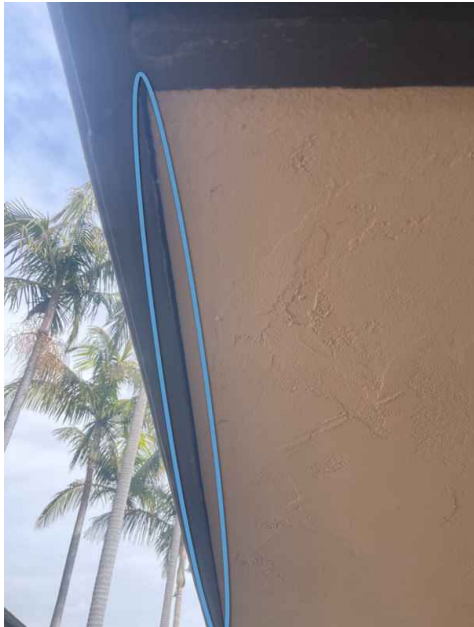
FASCIA SEPARATING FROM SOFFIT

One or more sections of the rim board and/or fascia have separated from the soffit. The resulting gaps are potential entry points for water intrusion, insect swarms including termites and bees. The gap should be closed and sealed.

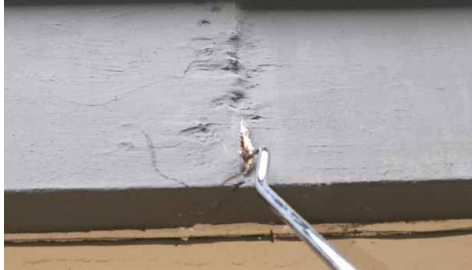
TERMITE AND OR DRY ROT DAMAGE

Evidence of termites and/or dry rot in fascia was observed. This condition raises concerns regarding the long-term integrity of the underlying support structure. Termite activity is indicated by visible frass (termite droppings) and hollowed wood. The affected areas should be assessed by a licensed pest control professional to determine the full extent of the termite infestation and to administer a suitable termite treatment plan. A Phase 2 Pre-721 Evaluation (P2PE) is recommended to determine the extent of any termite damage via borescoping, and to formulate a detailed repair plan.

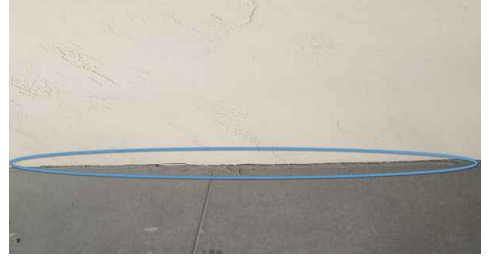
CRACKS IN WATERPROOFING

There are cracks in the waterproofing along the transition where the walkway meets the stucco and at other transitions and joints. Application of sealant is recommended.
