PATRICK'S PROPERTY MAINTENANCE SERVICE

PHASE 1 PRE-SB721 EVALUATION

1234 Main Street
Imperial Beach, CA 91932-1412

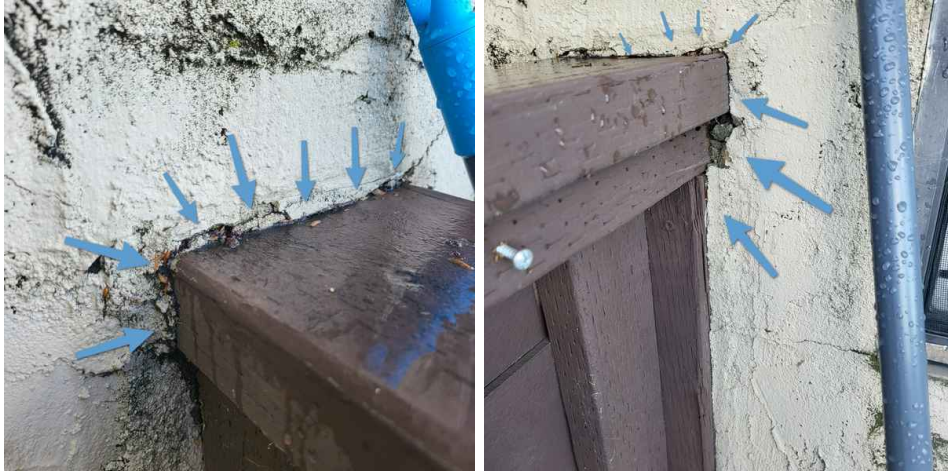
UNSEALED RAILING CONNECTION(S)

There are unsealed connections between the railing and the wall. These connections should be sealed with a waterproof sealant to prevent water and wood boring insect intrusion.

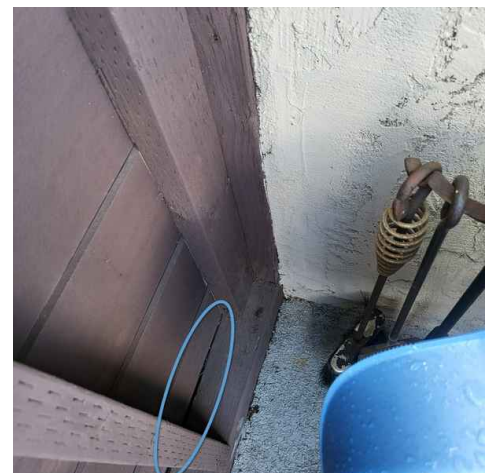
6.2.2 Balcony

CRACK(S) IN WOODEN RAILING

There is a crack in the bottom of the wooden railing. This crack should be sealed with a waterproof sealant to prevent water intrusion.

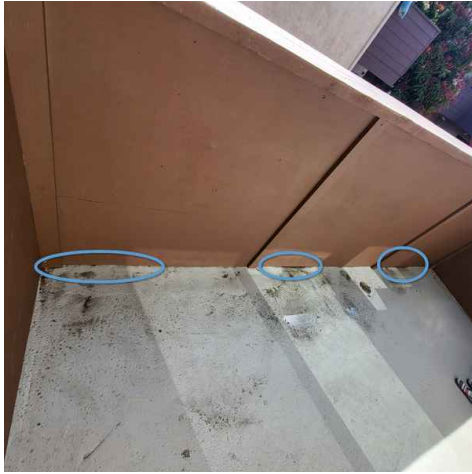
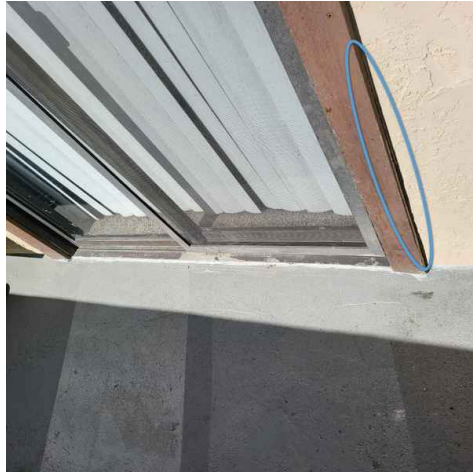
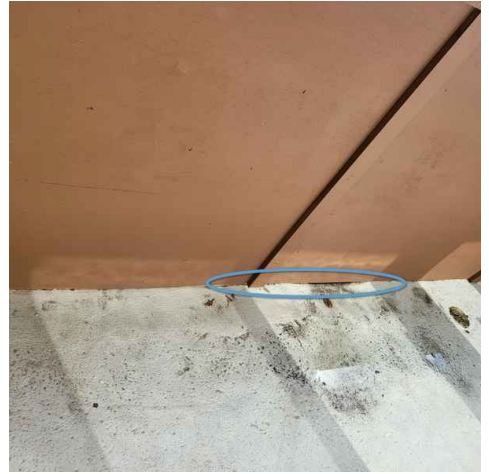
POOR DETAILING

There are minor openings at the connections between the railing and deck surface and between the doorframe and wall. These openings should be sealed with a waterproof sealant to prevent water and wood boring insect intrusion.

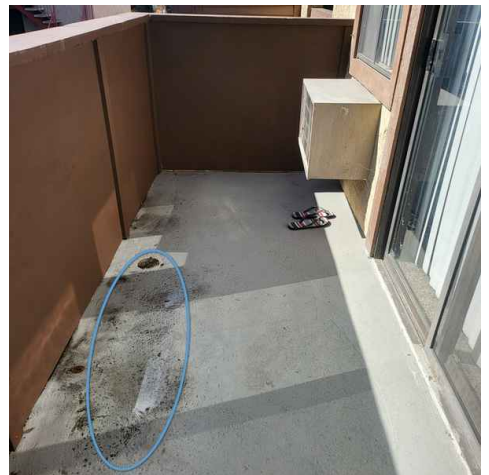
7.2.2 Balcony

POOLING

There is pooling on the deck. Deck may need to be leveled to ensure proper drainage and prevent water intrusion.

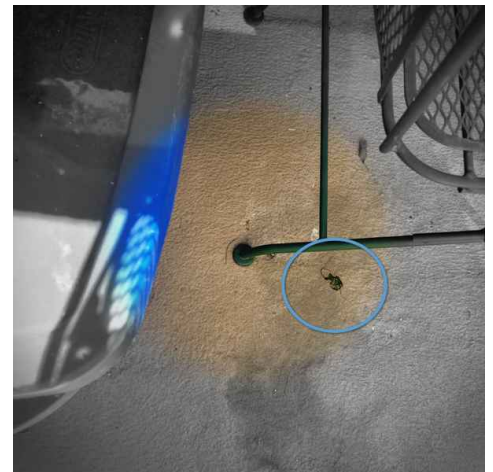
There is a perforation in the walking surface of the deck. This perforation should be sealed with a waterproof sealant to prevent water intrusion.

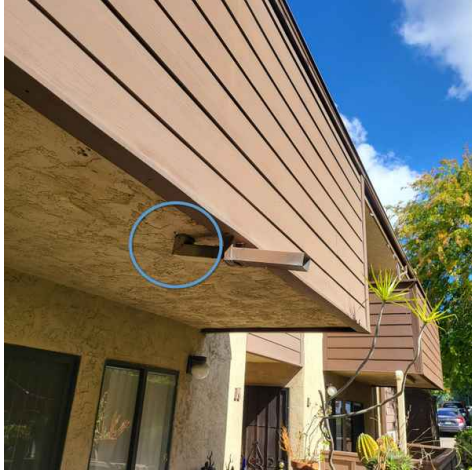
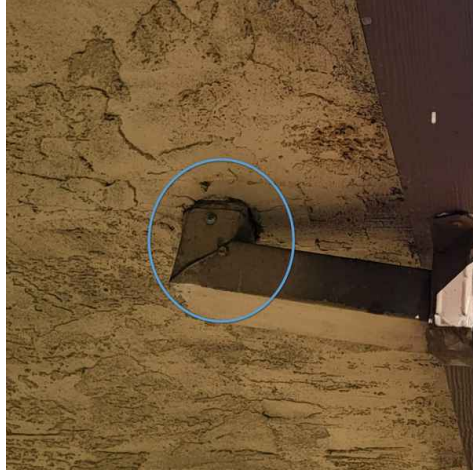
8.2.2 Balcony

UNSEALED DRAINAGE CONNECTION

There is an unsealed drainage pipe on the underside of the balcony. This connection should be sealed with a waterproof sealant to prevent wood boring insect intrusion.

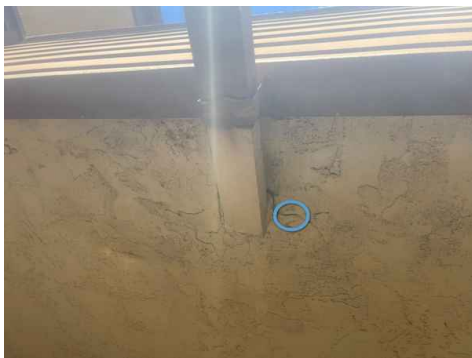
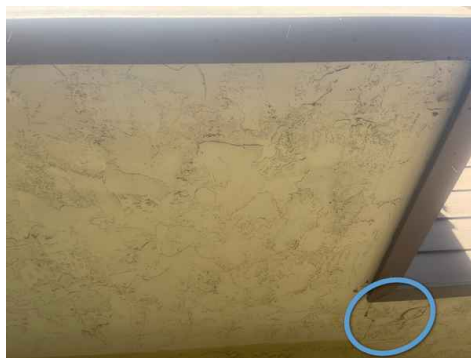
CRACK(S) IN SOFFIT

There are cracks in the soffit on the underside of the balcony. These cracks should be sealed with a waterproof sealant to prevent wood boring insect intrusion.

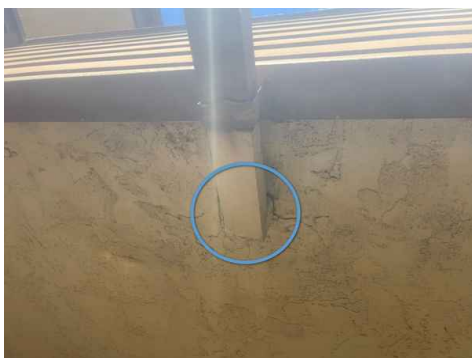
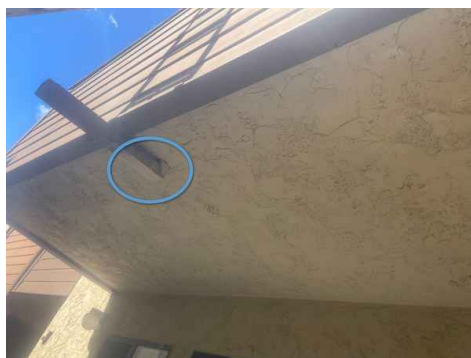
9.2.2 Balcony

UNSEALED DRAINAGE CONNECTION

There is an unsealed drainage pipe on the underside of the balcony. This connection should be sealed with a waterproof sealant to prevent wood boring insect intrusion.

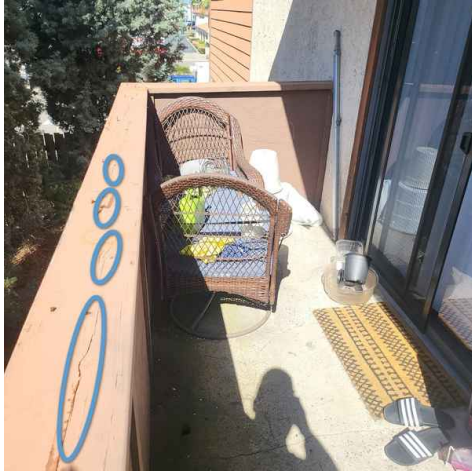
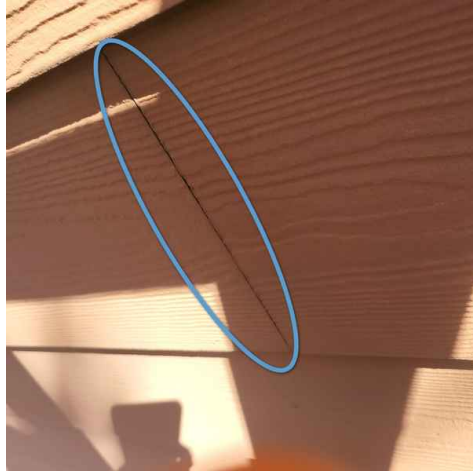
CRACK(S) IN RAILING

There are cracks in the wooden railing. These cracks should be sealed with a waterproof sealant to prevent water and wood boring insect intrusion.

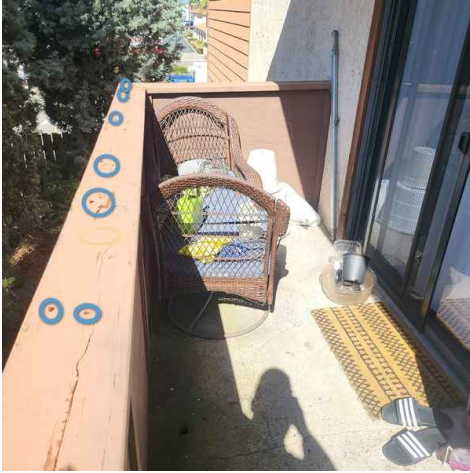
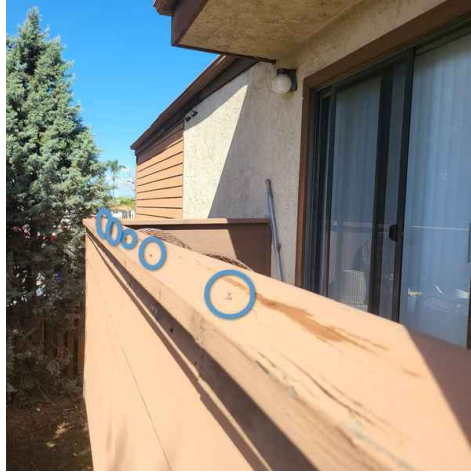
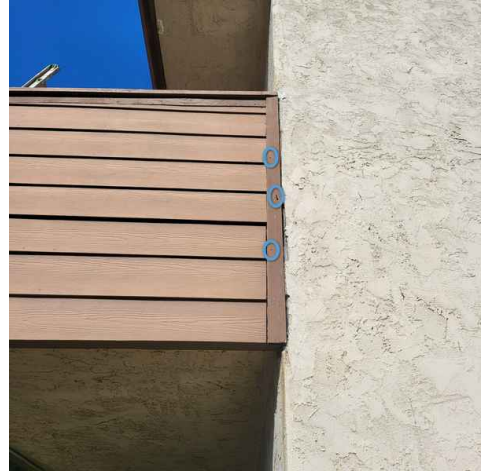
10.2.3 Balcony

UNSEALED PENETRATION(S) IN RAILING

There are unsealed penetrations in the wooden railing. These penetrations should be sealed with a waterproof sealant to prevent water and wood boring insect intrusion.

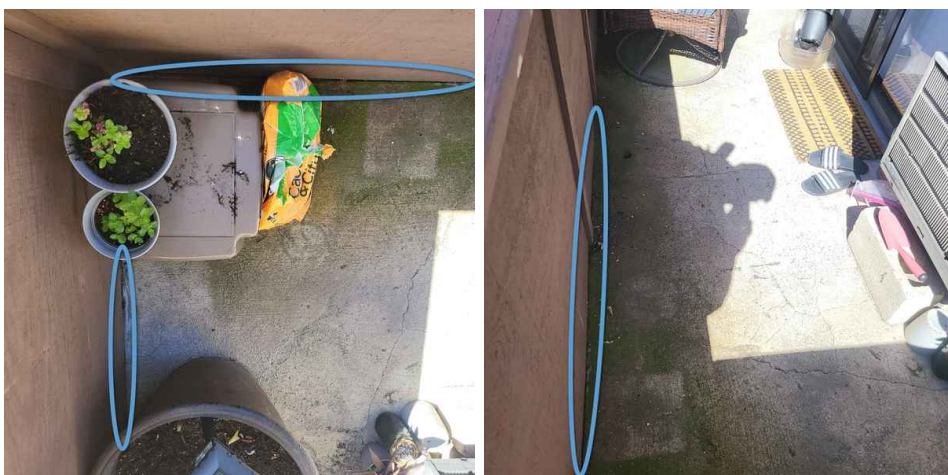
POOR DETAILING

There is a gap between the railing and decking. This gap should be sealed with a waterproof sealant to prevent water and wood boring insect intrusion.

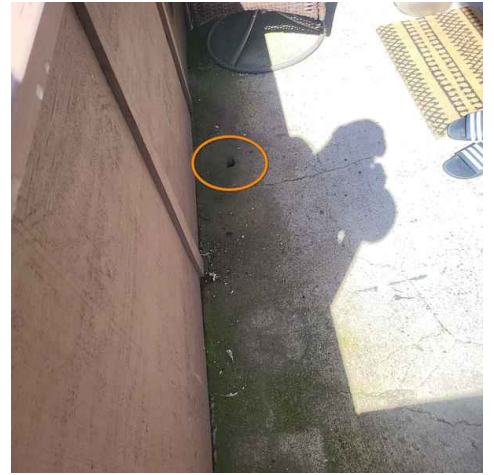
10.2.6 Balcony

Non-Emergency Repairs Required**MISSING DRAIN ASSEMBLY**

The deck is missing a drain assembly. Without a drain assembly the water is free to flow into the soffit rather than down the drain pipe. This water intrusion will lead to internal deterioration of materials and possible compromise of structural integrity over time. A Phase 2 Pre-721 Evaluation (P2PE) is recommended to determine the extent of any water damage via borescope inspection or larger investigative openings, and to formulate a detailed repair plan.

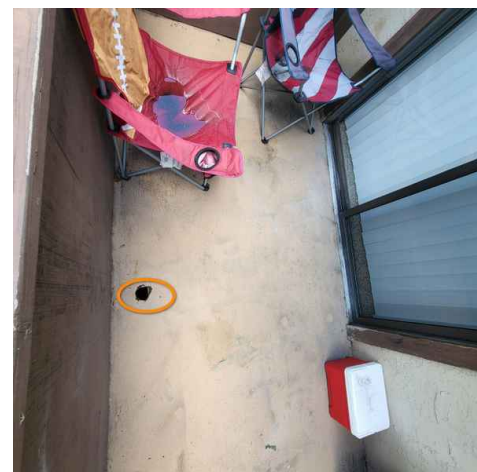
MISSING DRAIN ASSEMBLY

The deck is missing a drain assembly. Without a drain assembly the water is free to flow into the soffit rather than down the drain pipe. This water intrusion will lead to internal deterioration of materials and possible compromise of structural integrity over time. A Phase 2 Pre-721 Evaluation (P2PE) is recommended to determine the extent of any water damage via borescope inspection or larger investigative openings, and to formulate a detailed repair plan.

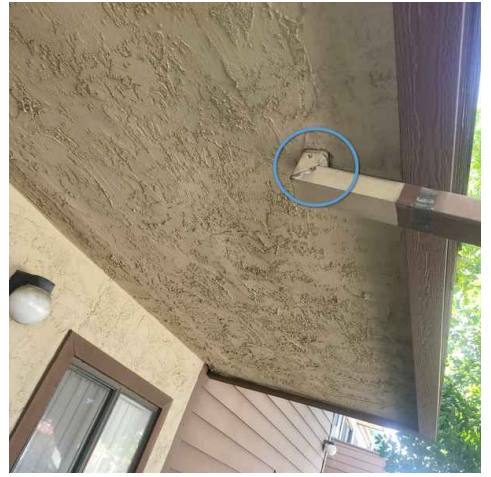
11.2.2 Balcony

UNSEALED DRAINAGE CONNECTION

There is an unsealed drainage pipe on the underside of the balcony. This connection should be sealed with a waterproof sealant to prevent wood boring insect intrusion.

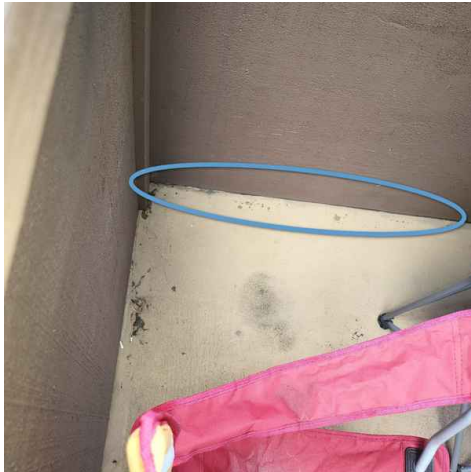
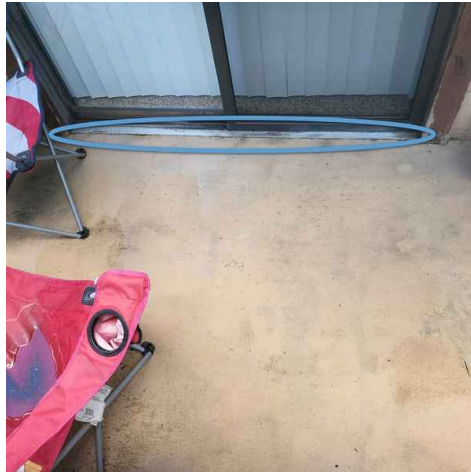
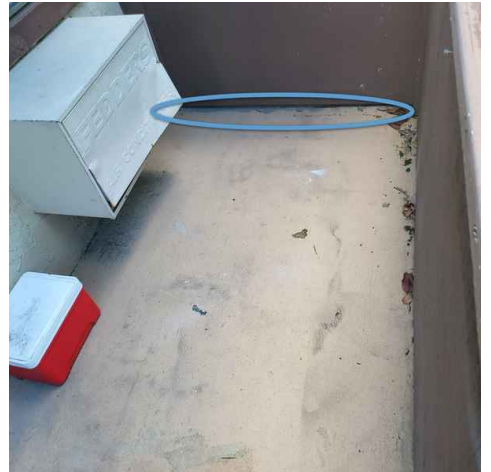
11.2.3 Balcony

POOR DETAILING

There are gaps between the railing and decking and between the doorframe and decking. These gap should be sealed with a waterproof sealant to prevent water and wood boring insect intrusion.

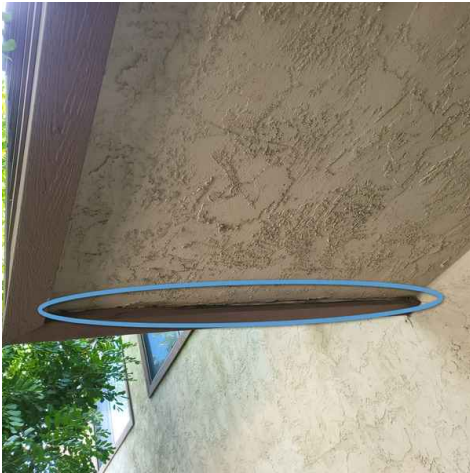
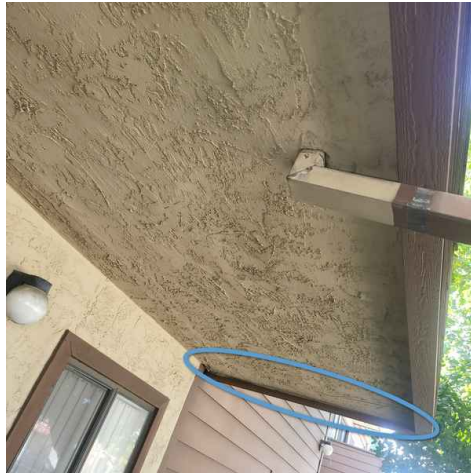
11.2.4 Balcony

FASCIA SEPARATING FROM SOFFIT

One or more sections of the rim board and/or fascia have separated from the soffit on the underside of the balcony. The resulting gaps should be sealed with a waterproof sealant to prevent wood boring insect intrusion.

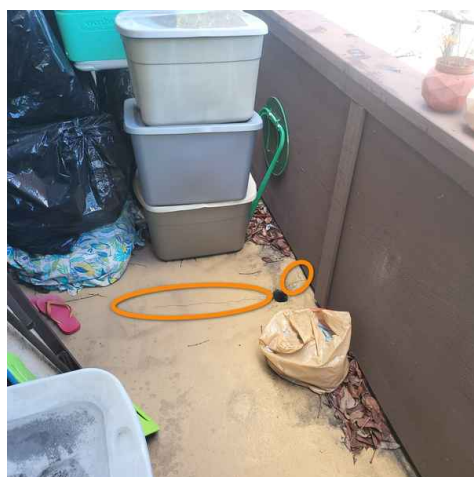
CRACK(S) IN DECK

There are cracks in the decking, including a crack that intersects the missing drain assembly. These cracks could indicate potentially severe water intrusion. Water intrusion can lead to internal deterioration of materials and possible compromise of structural integrity over time. A Phase 2 Pre-721 Evaluation (P2PE) is recommended to determine the extent of any water damage via borescope inspection or larger investigative openings, and to formulate a detailed repair plan.

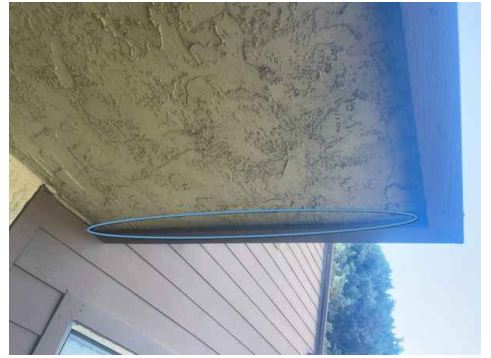
12.2.4 Balcony

**FASCIA SEPARATING FROM SOFFIT**

One or more sections of the rim board and/or fascia have separated from the soffit on the underside of the balcony. The resulting gaps should be sealed with a waterproof sealant to prevent wood boring insect intrusion.

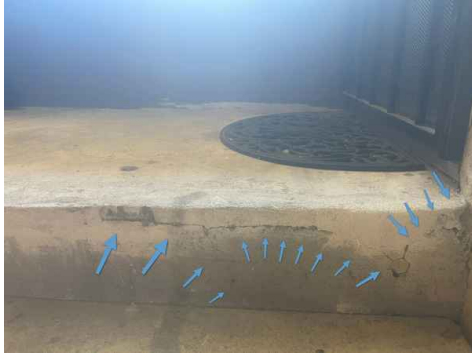
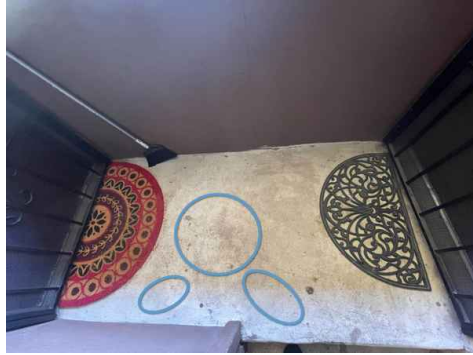
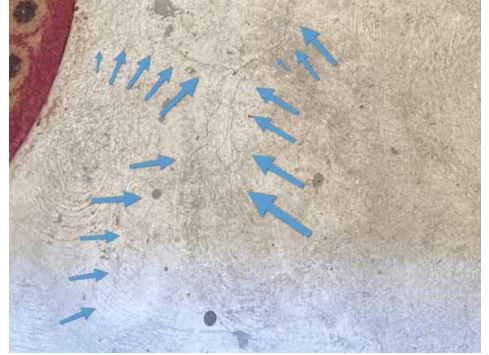
CRACK(S) IN DECK

There are cracks in the tops and side of the entry structure's walking surface. These cracks may indicate underlying structural compromise. A Phase 2 Pre-721 Evaluation (P2PE) is recommended to determine the extent of any damage via borescope inspection or larger investigative openings, and to formulate a detailed repair plan.

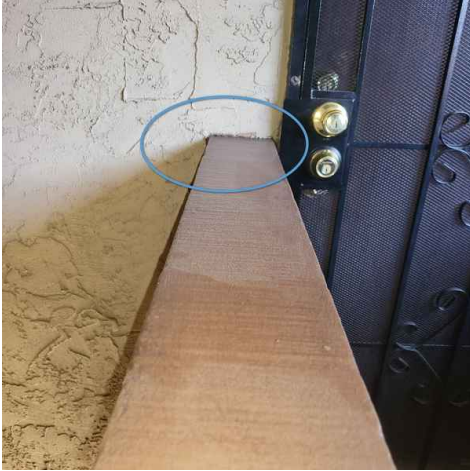
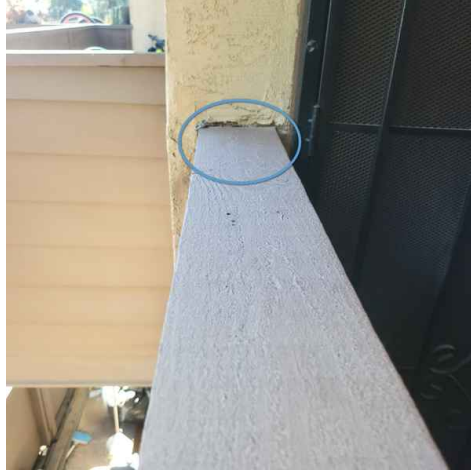
14.4.2 Entry Structure

UNSEALED RAILING CONNECTION(S)

There are unsealed connections between the railing and the wall. These connections should be sealed with a waterproof sealant to prevent water and wood boring insect intrusion.

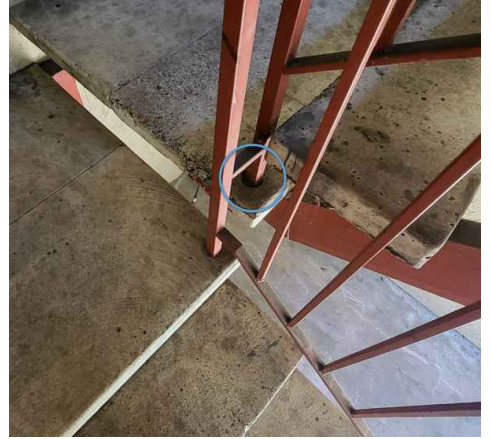
UNSEALED RAILING ATTACHMENT(S)

There is an unsealed attachment between railing and the second landing platform. This attachment should be sealed with a waterproof sealant to prevent water intrusion.

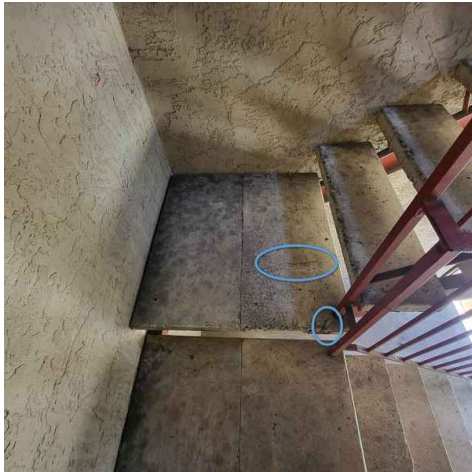
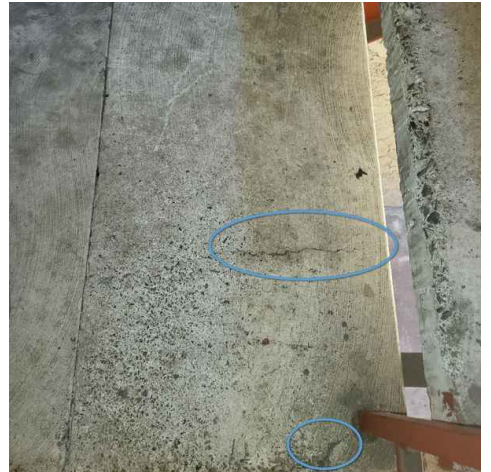
15.3.2 Landing

CRACK(S) IN LANDING

There is minor cracking in one or more slabs of the landing. At a minimum, the affected slabs should be replaced. If not replaced a reinspection is recommended in 2 years.

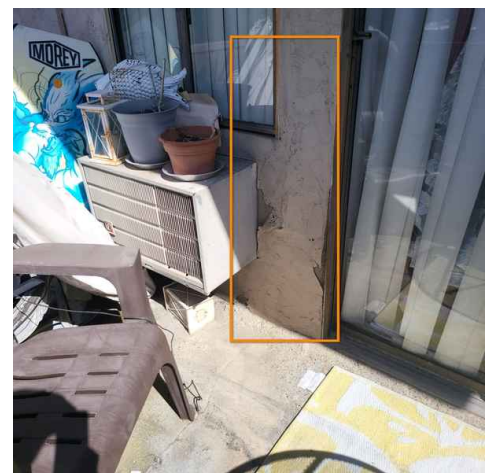
DETERIORATING STUCCO ON SUPPORTING WALL

The stucco on the supporting wall has water damage and is deteriorating. A Phase 2 Pre-721 Evaluation (P2PE) is recommended to determine the extent of any water damage via borescope inspection or larger investigative openings, and to formulate a detailed repair plan.

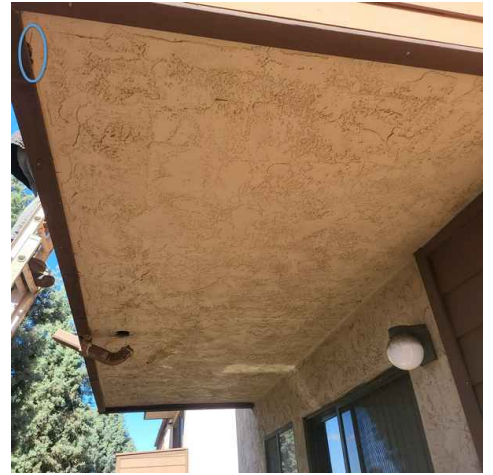
OPENING IN STUCCO

There is an opening in the stucco on the underside of balcony. This opening should be sealed with a waterproof sealant to prevent wood boring insect intrusion.

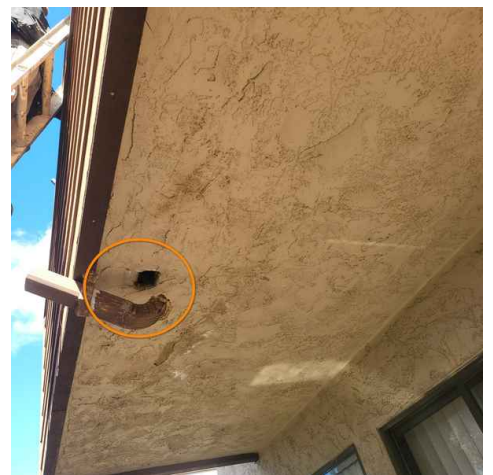
DISCONNECTED DRAIN SPOUT

The drain spout on the underside of the balcony is disconnected. Water is seeping through the stucco. Water intrusion can lead to internal deterioration of materials and possible compromise of structural integrity over time. A Phase 2 Pre-721 Evaluation (P2PE) is recommended to determine the extent of any water damage via borescope inspection or larger investigative openings, and to formulate a detailed repair plan.

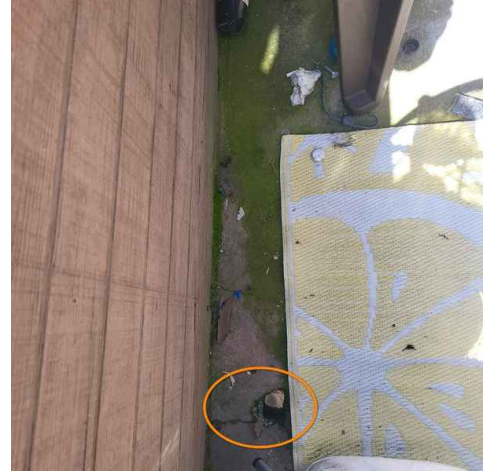
16.2.7 Balcony

Non-Emergency Repairs Required**MISSING DRAIN ASSEMBLY**

The deck is missing a drain assembly. Without a drain assembly the water is free to flow into the soffit rather than down the drain pipe. This water intrusion will lead to internal deterioration of materials and possible compromise of structural integrity over time. A Phase 2 Pre-721 Evaluation (P2PE) is recommended to determine the extent of any water damage via borescope inspection or larger investigative openings, and to formulate a detailed repair plan.

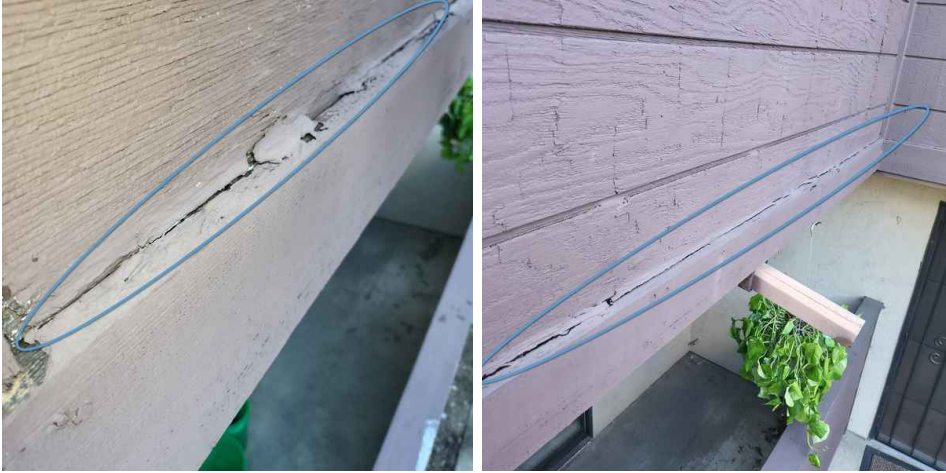
POOR DETAILING

There are openings at the connection between the plywood and trim on the outside of the balcony. These openings should be sealed.

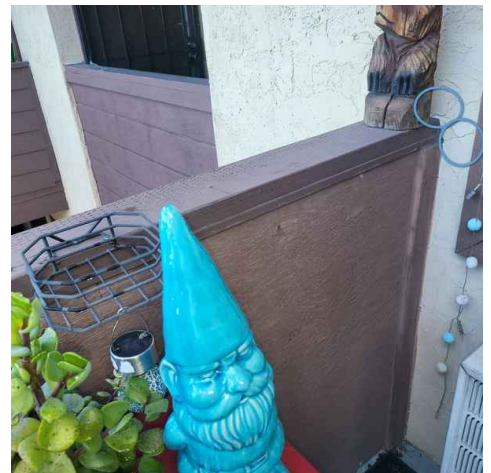
17.2.2 Balcony

CRACK(S) IN SUPPORTING WALL

There are cracks in the supporting wall. These cracks should be sealed.

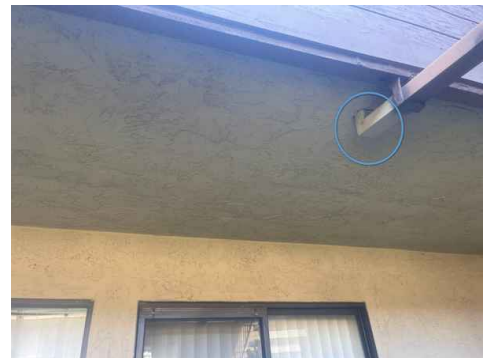
17.2.3 Balcony

UNSEALED DRAINAGE CONNECTION

There is an unsealed drainage pipe on the underside of the balcony. This connection should be sealed with a waterproof sealant to prevent wood boring insect intrusion.

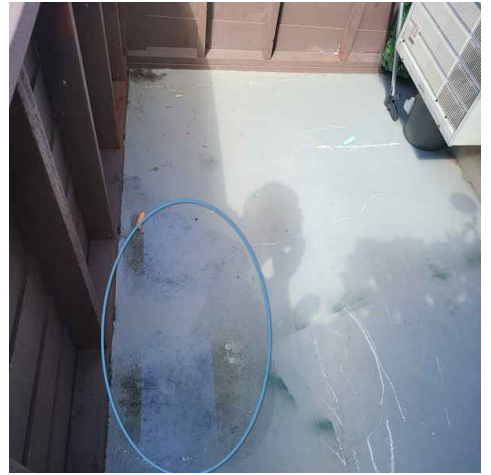
POOLING

There is pooling on the deck. Deck may need to be leveled to ensure proper drainage and prevent water intrusion.

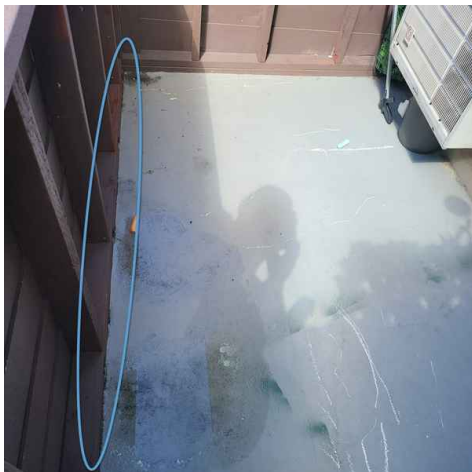
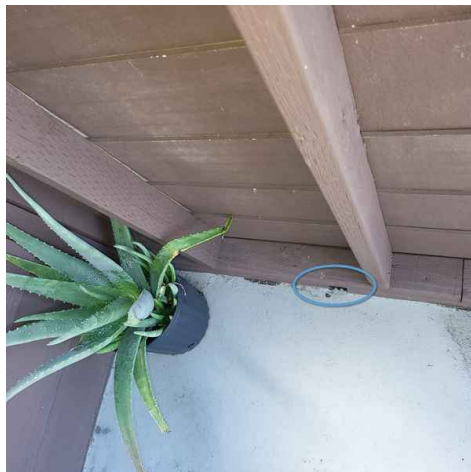
POOR DETAILING

There are minor openings at the connections between the railing and deck surface and between the doorsill and deck. These openings should be sealed with a waterproof sealant to prevent water and wood boring insect intrusion.

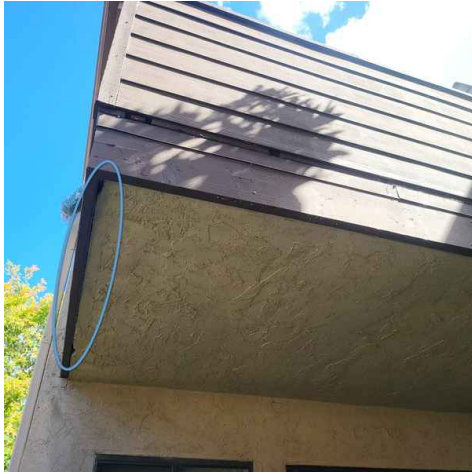
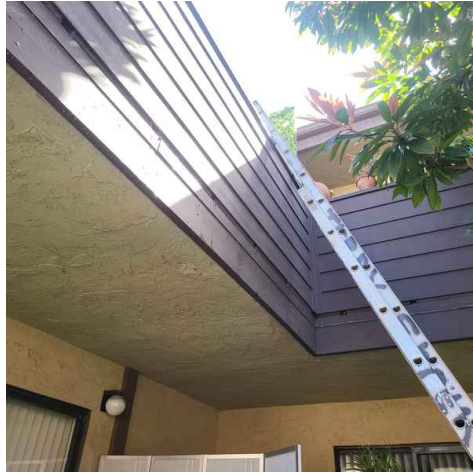
19.2.3 Balcony

FASCIA SEPARATING FROM SOFFIT

One or more sections of the rim board and/or fascia on the underside of the balcony have separated from the soffit. The resulting gaps should be sealed with a waterproof sealant to prevent water and wood boring insect intrusion.

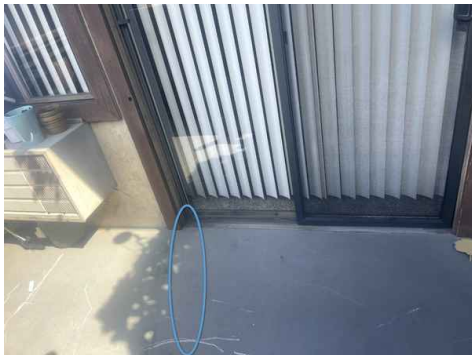
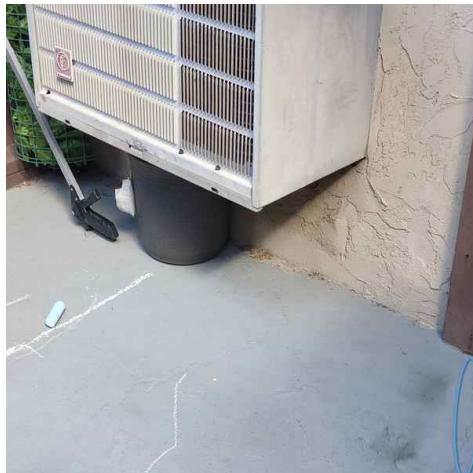
19.2.4 Balcony

CRACK(S) IN DECK

There is a crack in the deck surface. This crack should be sealed with a waterproof sealant to prevent water intrusion.

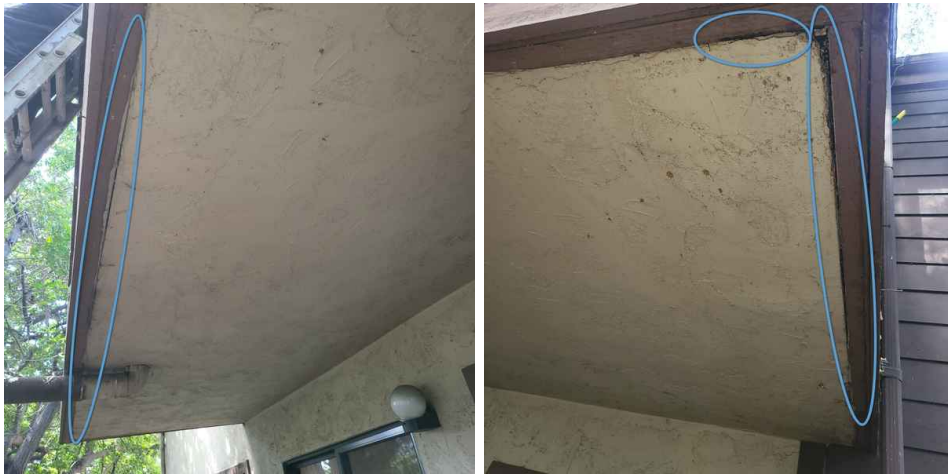
FASCIA SEPARATING FROM SOFFIT

One or more sections of the rim board and/or fascia on the underside of the balcony have separated from the soffit. The resulting gaps should be sealed with a waterproof sealant to prevent wood boring insect intrusion.

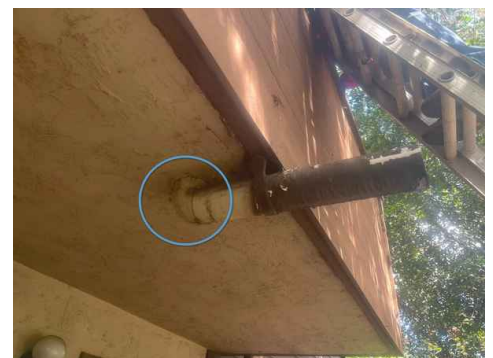
20.2.2 Balcony

UNSEALED DRAINAGE CONNECTION

There is an unsealed drainage pipe on the underside of the balcony. This connection should be sealed with a waterproof sealant to prevent wood boring insect intrusion.

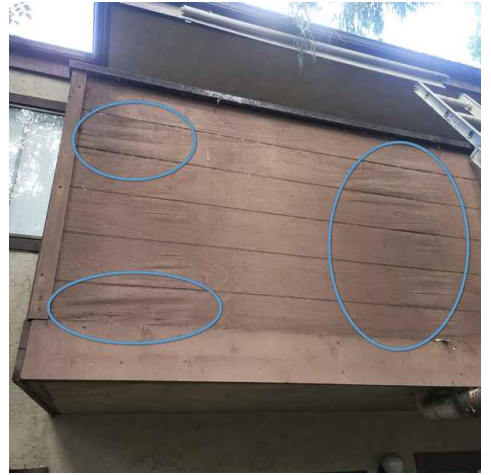
20.2.3 Balcony

DAMAGED PANELING

Balcony paneling and trim of the railing is showing signs of water damage. The paneling on the outside of the railing is warped and delaminated. This paneling should be replaced.

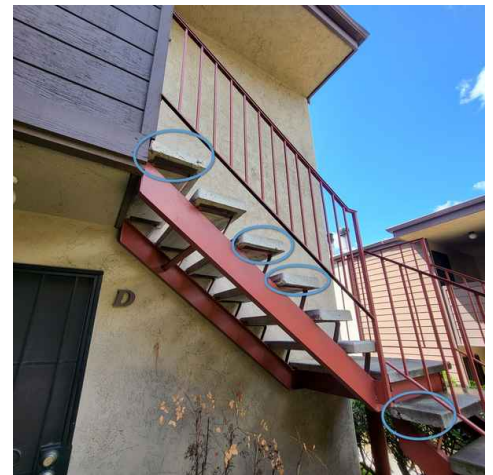
DAMAGED TREADS (MINORITY)

Approximately 4 of 18 treads contain cracks or breakages. Most if not all of the stair treads seem to be the same age. At a minimum, the affected tread should be replaced. If not replaced a reinspection is recommended in 2 years.

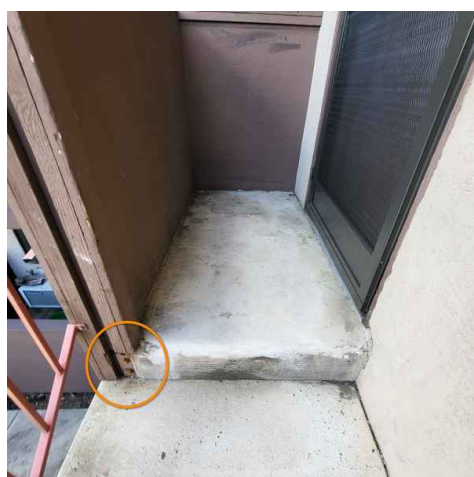
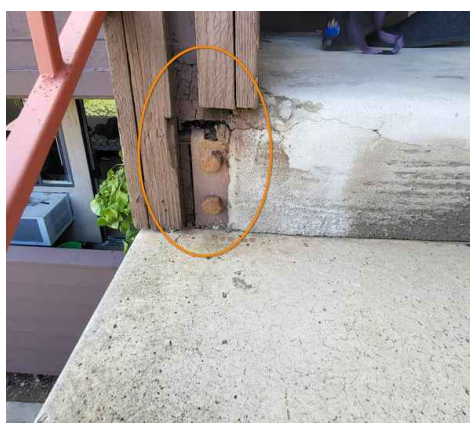
21.2.2 Stairway

DAMAGED STRINGER ATTACHMENT(S)

Stairway is structurally compromised where the the stair stringer attaches to the entry structure. Corrosion and dry rot/termite damage are present in surrounding wood and indicates potentially severe water intrusion. A Phase 2 Pre-721 Evaluation (P2PE) is recommended to determine the extent of any water damage via borescope inspection or larger investigative openings, and to formulate a detailed repair plan.

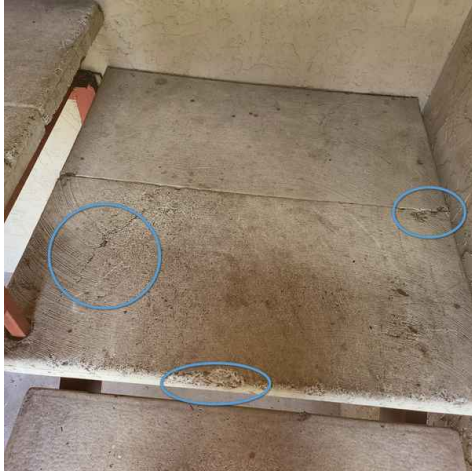
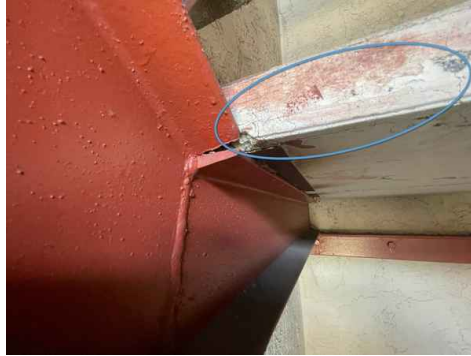
DAMAGED LANDING

There are minor cracks and breakages in both landing platforms. At a minimum, the affected slabs should be replaced. If not replaced a reinspection is recommended in 2 years.

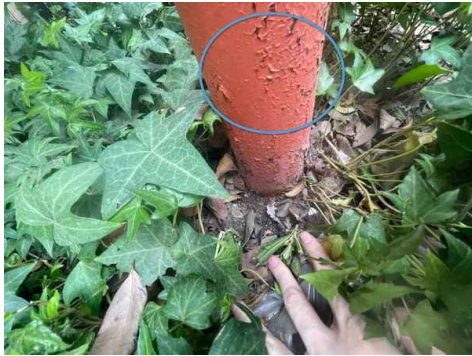
SUPPORT BEAM SURFACE CORROSION

There is surface corrosion on the support beam. The bottom portion of the beam should be resealed.

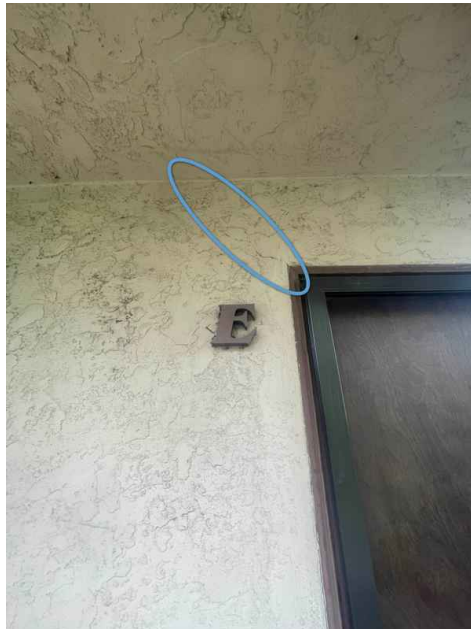
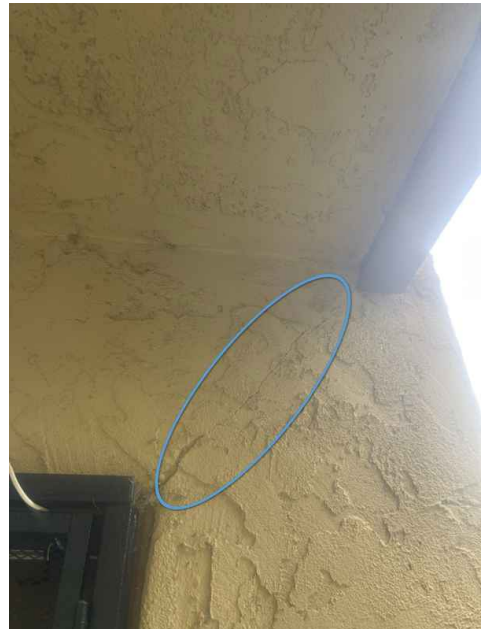
Underside of Entry Structure

CRACK(S) IN SUPPORTING WALL

There are cracks in the supporting wall under the entry structure. These cracks should be sealed with a waterproof sealant to prevent water and wood boring insect intrusion.

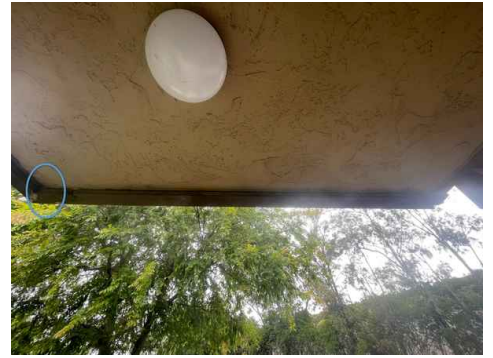
23.4.2 Entry Structure

DISCOLORATION OF FASCIA

There is a discoloration of the fascia on the underside of the entry structure. This may be evidence of water intrusion in the soffit and bears further investigation during a phase 2 inspection.

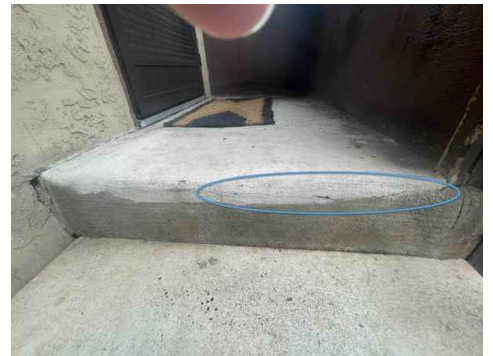
23.4.3 Entry Structure

CRACK(S) IN DECK

There is a crack in the walking surface of the entry structure. A deck coating should be applied to the entire walking surface.

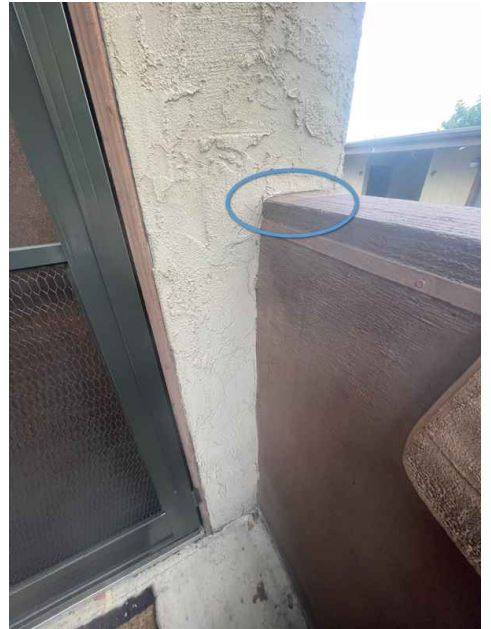
**UNSEALED RAILING CONNECTION(S)**

there is an opening where the railing meets the supporting wall of the entry structure. This opening should be sealed.

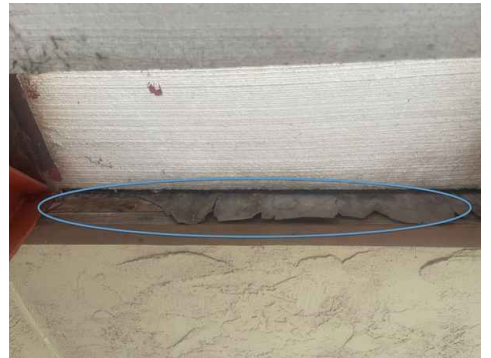
23.4.6 Entry Structure

**POOR DETAILING**

There is an unfinished area under where the top stair tread meets the entry structure. The supporting wood frame is exposed and the tar paper is showing. This area should be finished and sealed.

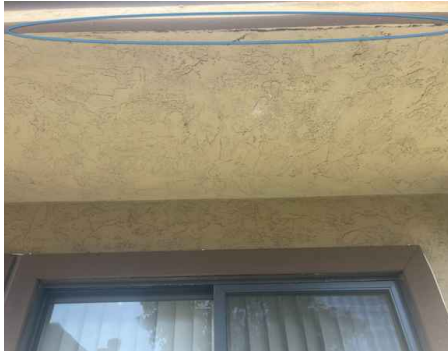
Building 1: Balcony N-East, Fascia Separating from Soffit in Overhang

One or more sections of the overhang rim board and/or fascia have separated from the soffit. The resulting gaps should be sealed with a waterproof sealant to prevent water and wood boring insect intrusion.

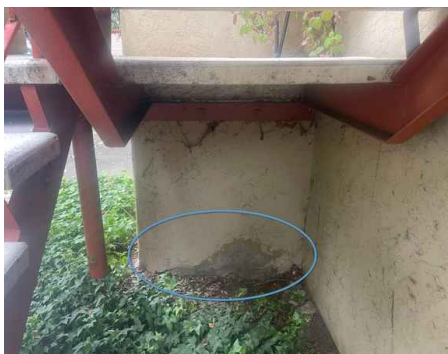
Building 2: Stairway E, Deteriorating Stucco on Supporting Wall

The stucco on the supporting wall under the landing is severely deteriorating and should be resurfaced and sealed.
