PATRICK'S PROPERTY MAINTENANCE SERVICE

PHASE 1 PRE-SB721 EVALUATION

1234 Main Street
Imperial Beach, CA 91932-1412

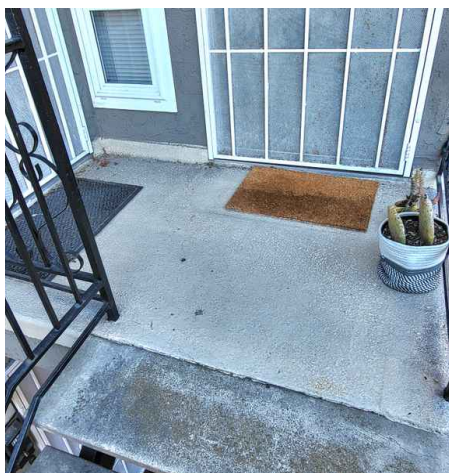
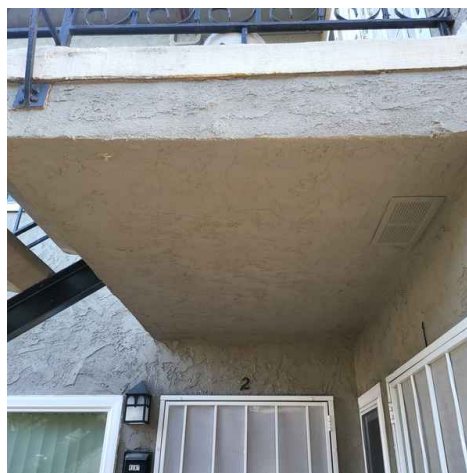
Landing: *Landing Inspection Image(s)

Landing: Acceptable Condition

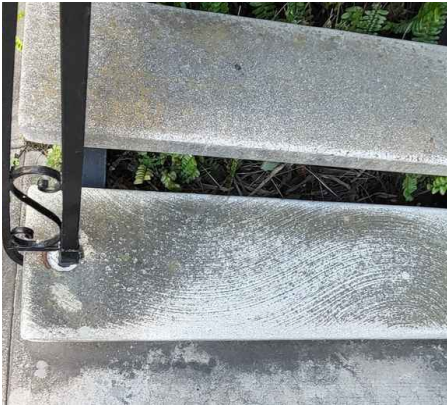
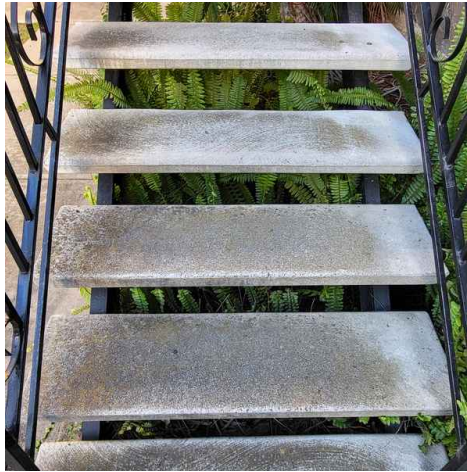
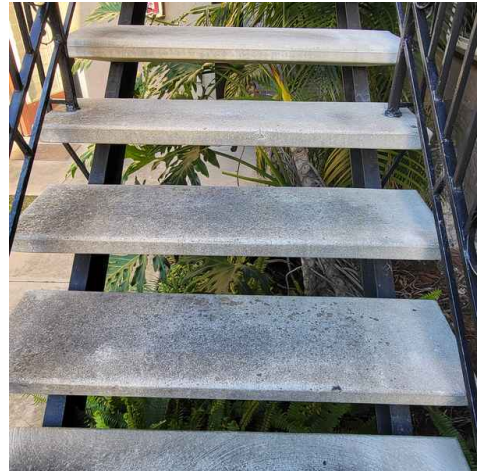
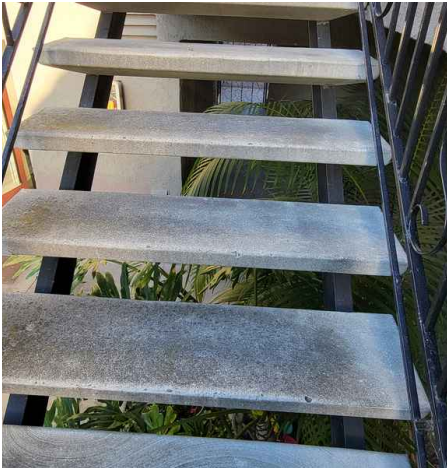
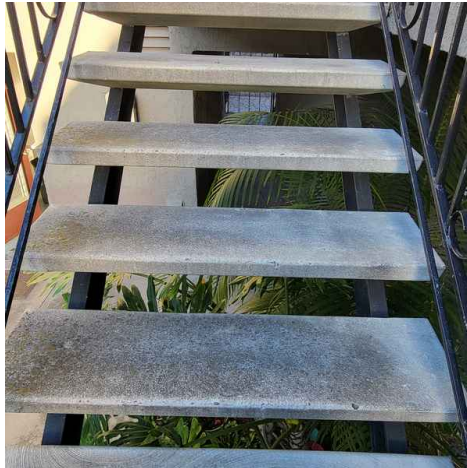
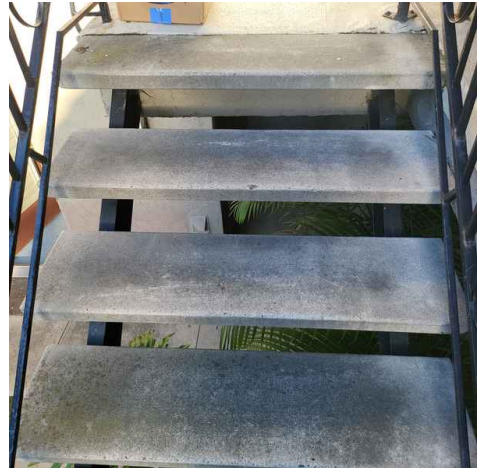
Stairway: *Stairway Inspection Image(s)

Stairway: Acceptable Condition

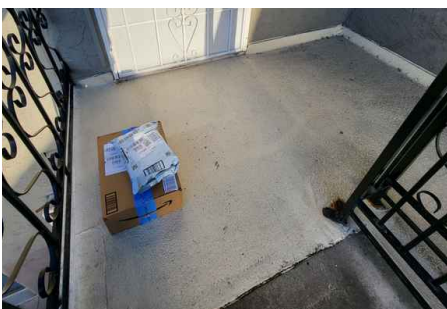
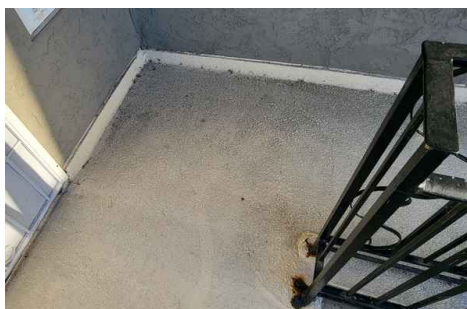
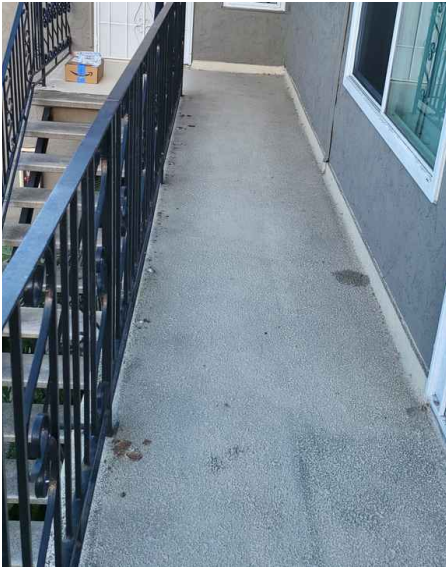
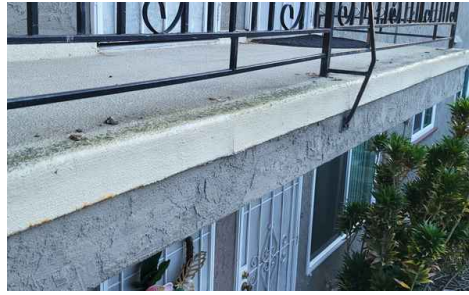
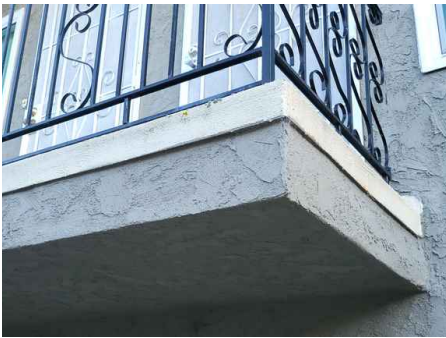
Walkway: *Walkway Inspection Image(s)

Walkway: Marginal Condition

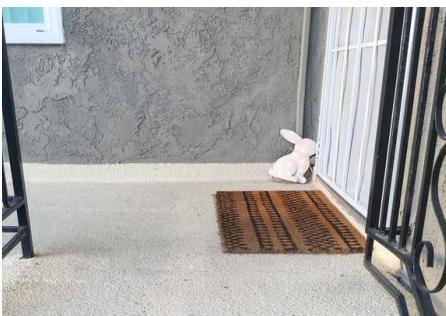
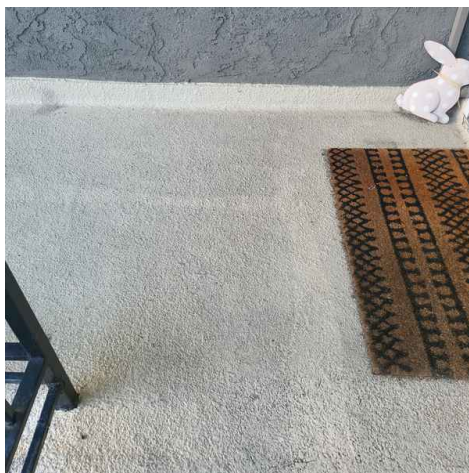
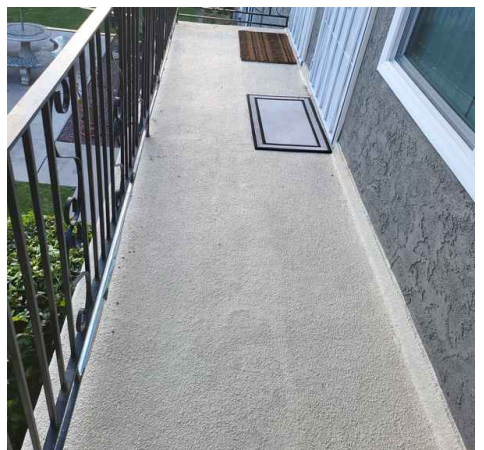
Walkway: *Walkway Inspection Image(s)

Walkway: Marginal Condition

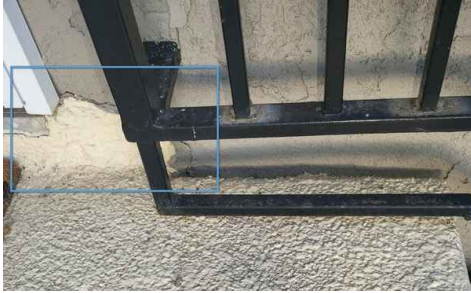
DECK - OPENING IN WATERPROOFING

There is minor cracking in the waterproofing at both ends of the walkway under the rail connection to the wall. Sealant/waterproofing should be applied.

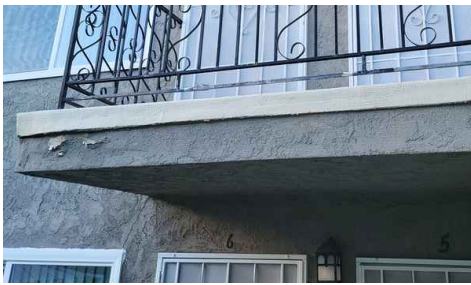
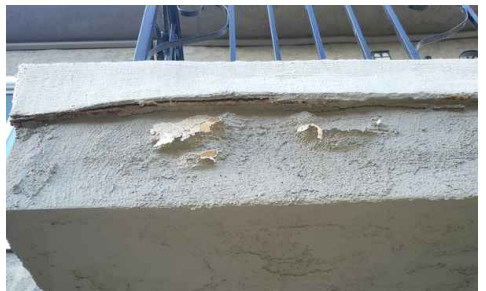
7.3.3 Walkway

STUCCO DAMAGE

There is evidence of water intrusion at the west corner of the walkway. The edge metal is lifting and corrosion is visible. Water has penetrated the stucco causing it to blister. This condition raises concerns regarding water intrusion and possible advanced deterioration in the underlying support structure. A Phase 2 Pre-721 Evaluation (P2PE) is recommended to determine the extent of any water damage via borescope investigation or larger investigative opening, and to formulate a detailed repair plan.

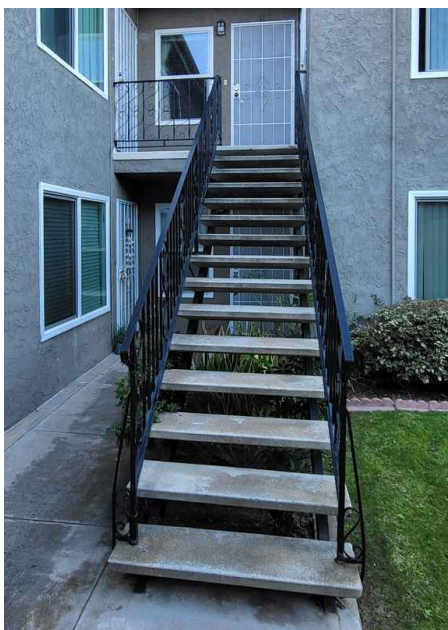
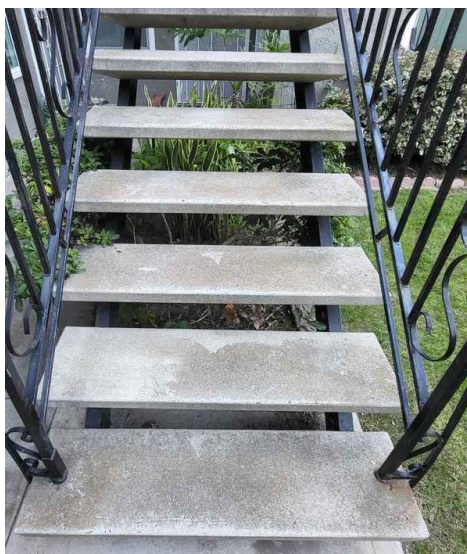
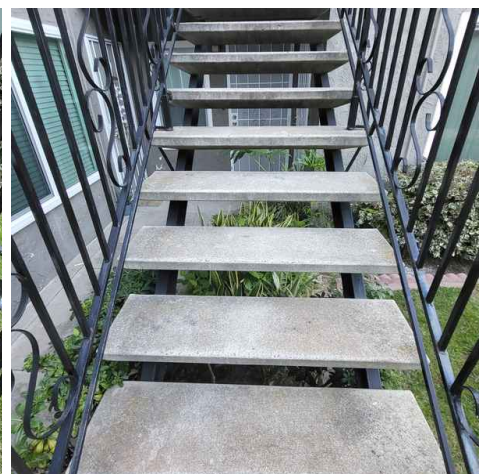
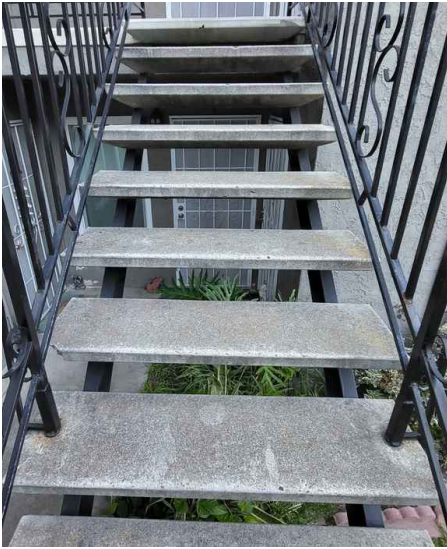
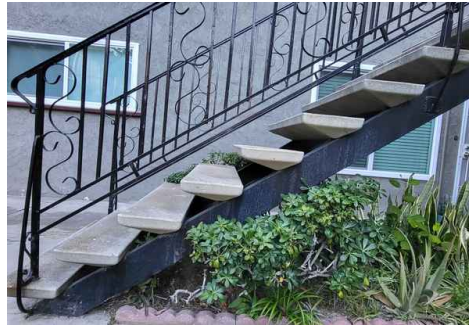
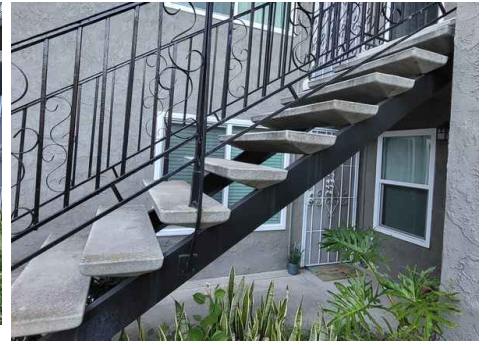
Stairway: *Stairway Inspection Image(s)

DAMAGED STAIR TREADS (MAJORITY)

Approximately 10 out of 15 stair treads have cracks or breakages. Except for the top stair tread, all the treads seem to be the same age and are most likely at the end of their service life. At a minimum, the affected treads should be replaced. If the treads are not replaced a reinspection is recommended in 1 year.

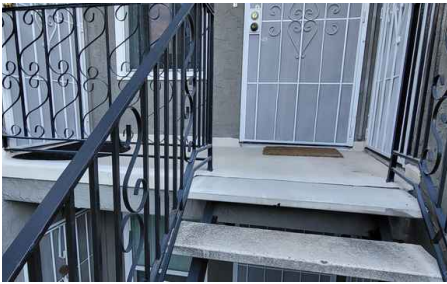
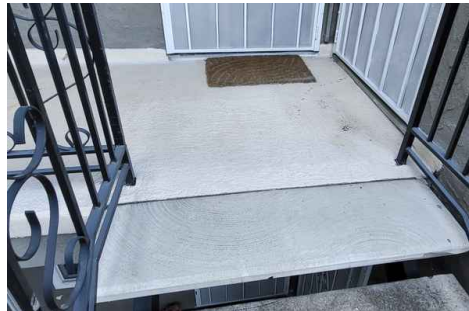
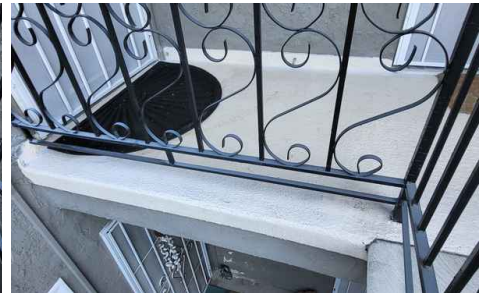
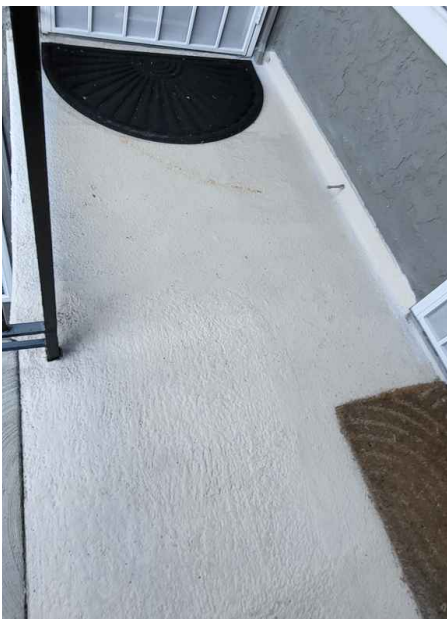
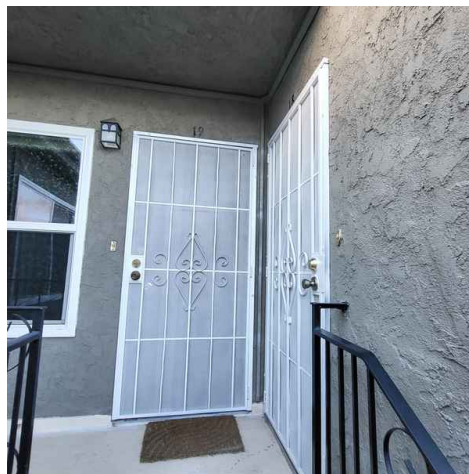
Walkway: *Walkway Inspection Image(s)

Walkway: Marginal Condition

The deck coating, the edge metal, and the stucco around the right stair stringer connection to the walkway are not finished properly or sealed. This condition raises concerns regarding water intrusion and possible advanced deterioration in the underlying support structure. A Phase 2 Pre-721 Evaluation (P2PE) is recommended to determine the extent of any water damage via borescope investigation and to formulate a detailed repair plan.
