PATRICK'S PROPERTY MAINTENANCE SERVICE

PHASE 1 PRE-721 EVALUATION

1234 Main Street
Imperial Beach, CA 91932-1412

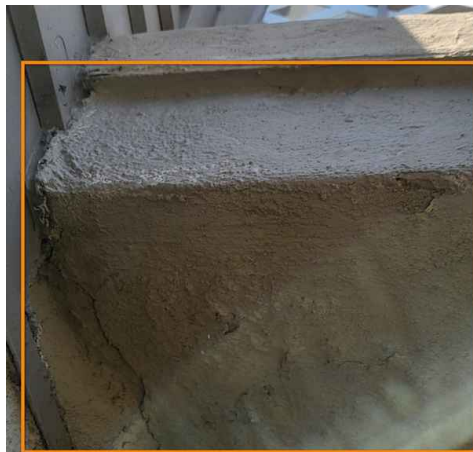
bubbling, efflorescence, blistered

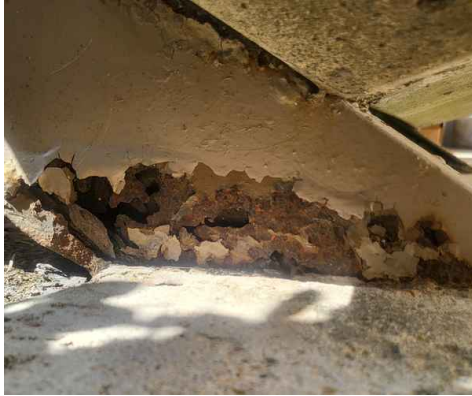
Marginal - There is significant corrosion that is affecting structural integrity. A Phase 2 Pre-721 Evaluation (P2PE) is recommended to formulate a detailed repair plan. See Reference Information: Notification and Follow Up - Marginal.

Stringer bottom rusted through

Contact a qualified professional.

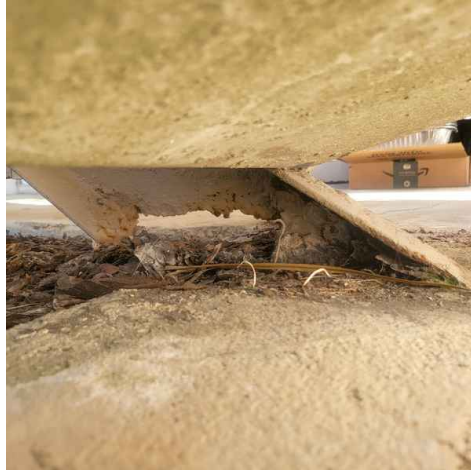
Stringer bottom rusted through

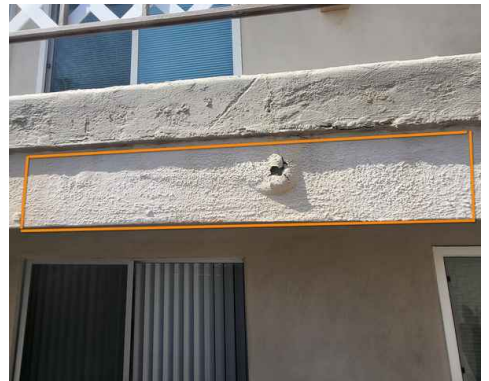
Marginal - Stucco is cracking, stained, bulging, bubbling, blistered, efflorescing, soft, crumbling, discolored or showing signs of mold and mildew. These conditions are marginal. A Phase 2 Pre-721 Evaluation (P2PE) is recommended to determine the extent of any water damage via borescope inspection or larger investigative openings, and to formulate a detailed repair plan. See Reference Information: Notification and Follow Up - Marginal.

bulging, bubbling, blistered, efflorescing

Recommendation
