# PATRICK'S PROPERTY MAINTENANCE SERVICE

PHASE 1 PRE-721 EVALUATION BUILDING 1 UNITS 1 - 6

1234 Main Street  
Imperial Beach, CA 91932-1412

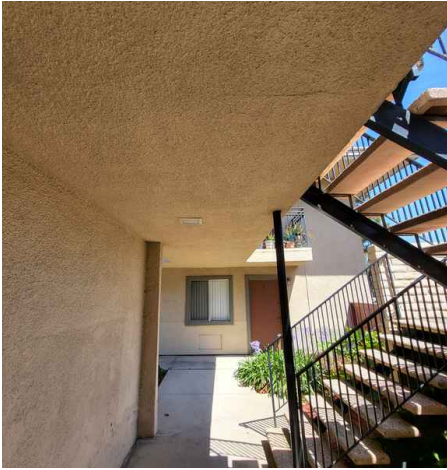
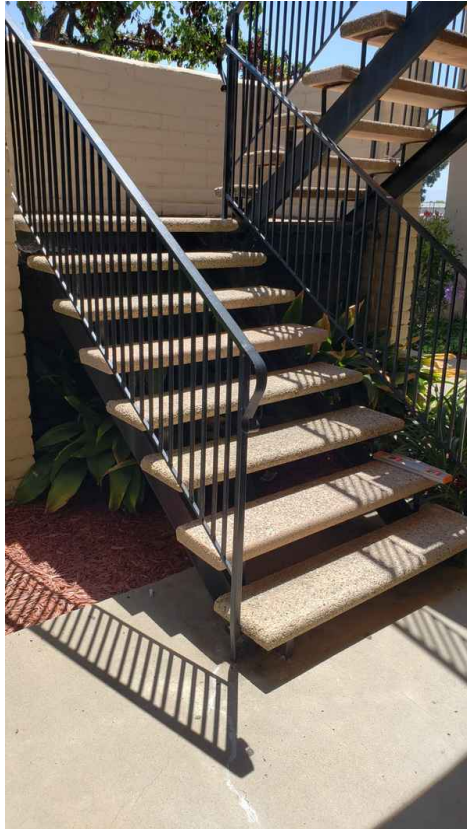
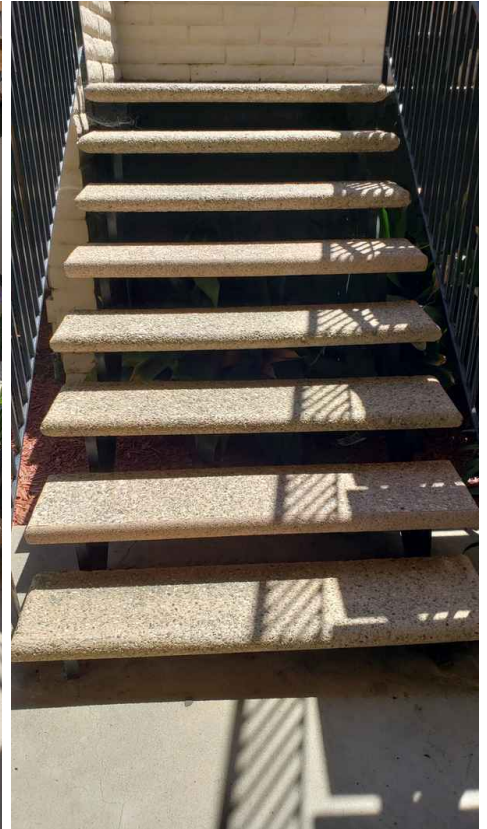
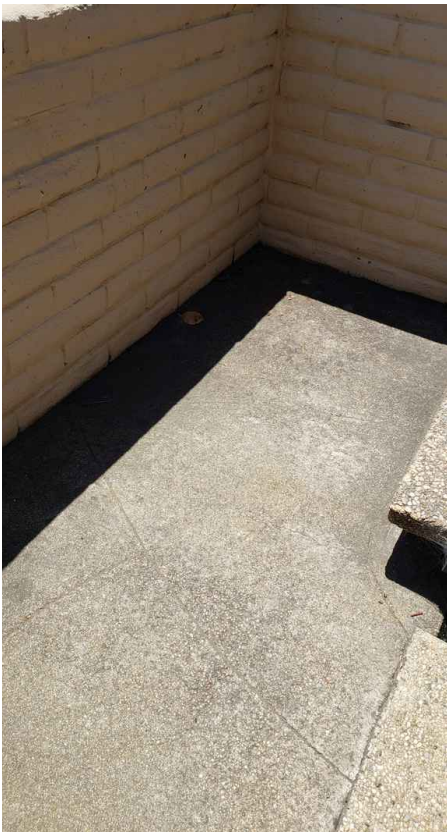
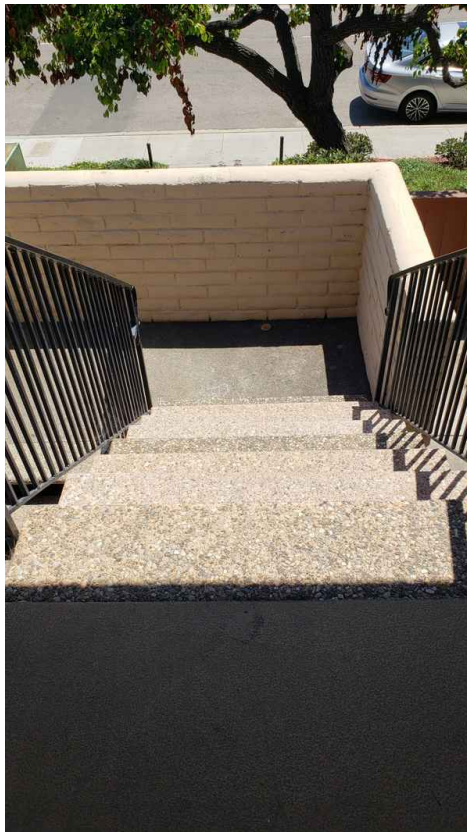
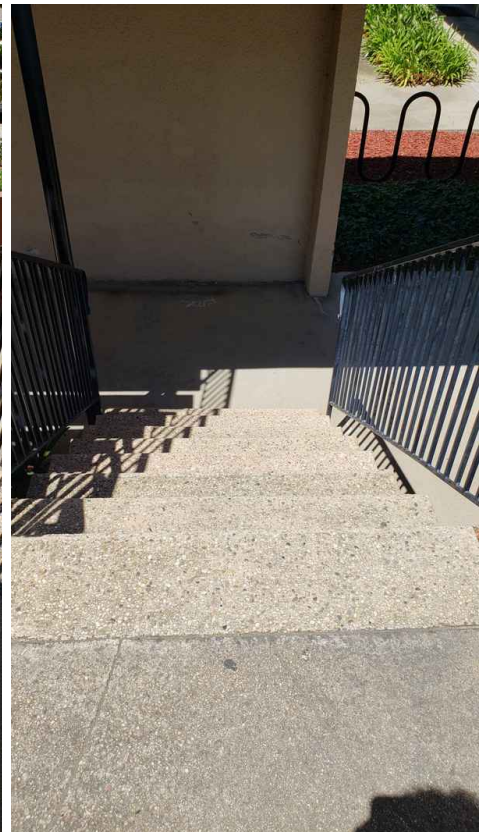
**Main Stairway East: \*Stairway Inspection Image(s)**

-   5.1.1 Building 1: Exterior Elevated Element (E3) Group 1 - Overall Condition Evaluation: Acceptable Condition
-   5.2.1 Building 1: Exterior Elevated Element (E3) Group 1 - Main Stairway East: Damaged Precast Tread(s)

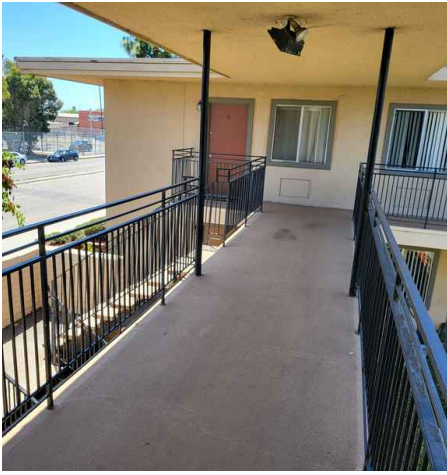
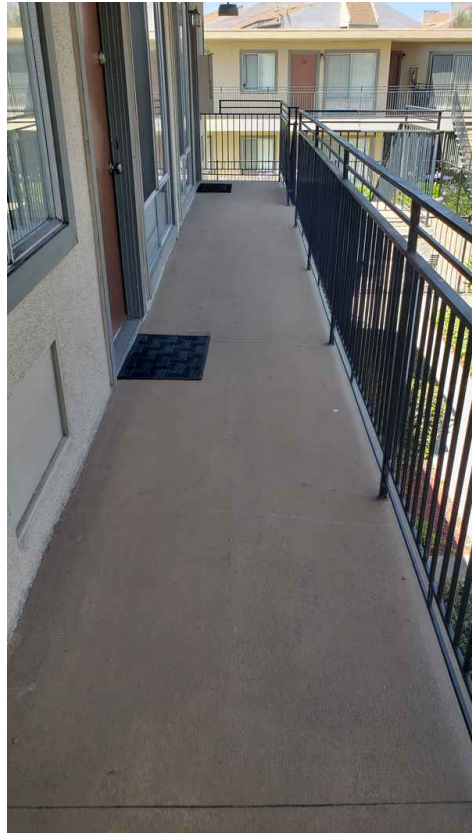
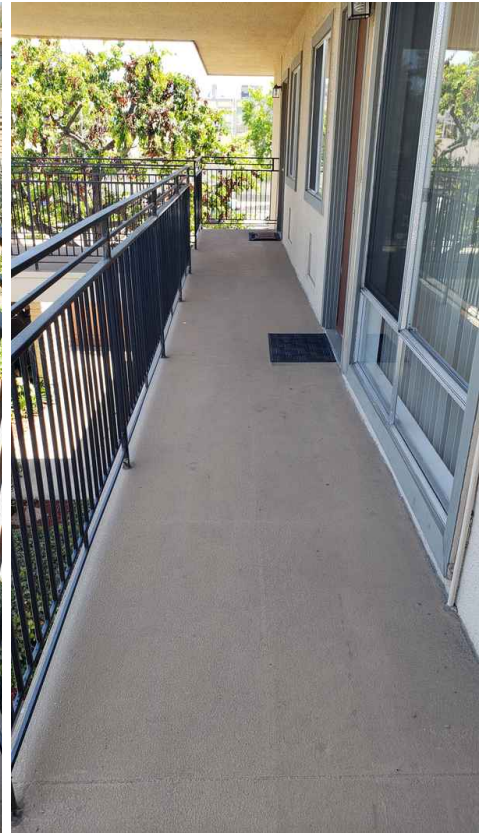
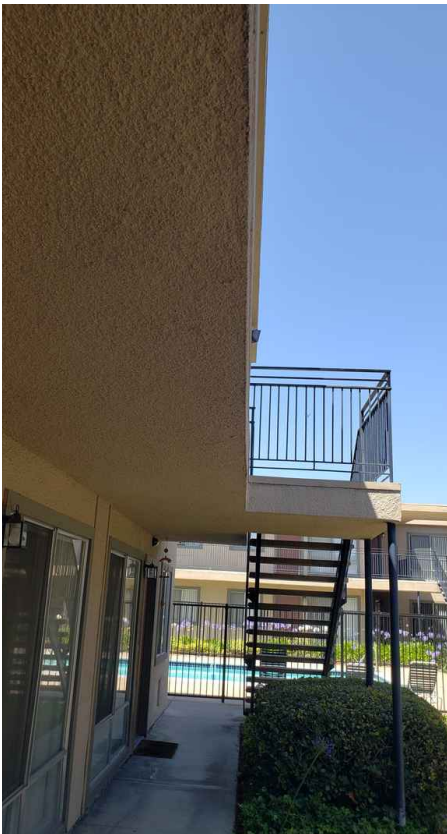
**Walkway: \*Walkway Inspection Image(s)**

-   5.3.1 Building 1: Exterior Elevated Element (E3) Group 1 - Walkway: Damaged Stucco 2
-   5.3.2 Building 1: Exterior Elevated Element (E3) Group 1 - Walkway: Corrosion

-   5.3.3 Building 1: Exterior Elevated Element (E3) Group 1 - Walkway: Unsealed Connection(s)
-   5.4.1 Building 1: Exterior Elevated Element (E3) Group 1 - Stairway North : Damaged Precast Tread(s)

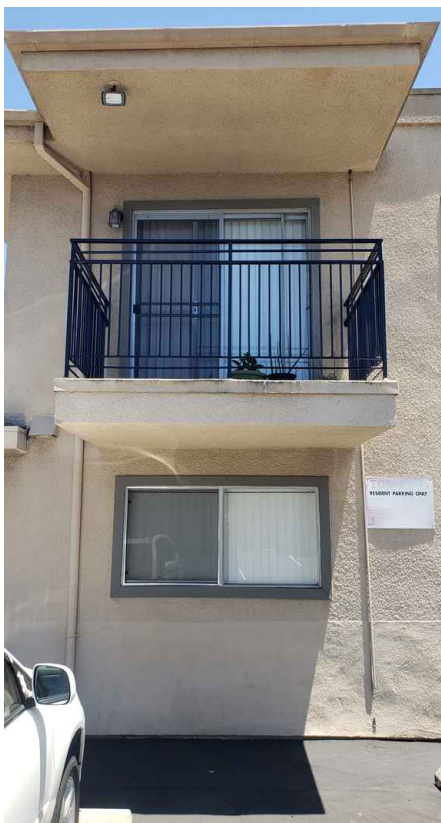
**Apt. 2 Balcony : \*Balcony Inspection Image(s)**

6.2.1 Building 1: Balconies - Apt. 2 Balcony : Corrosion
-   6.3.1 Building 1: Balconies - Apt. 4 Balcony : Openings in Waterproofing

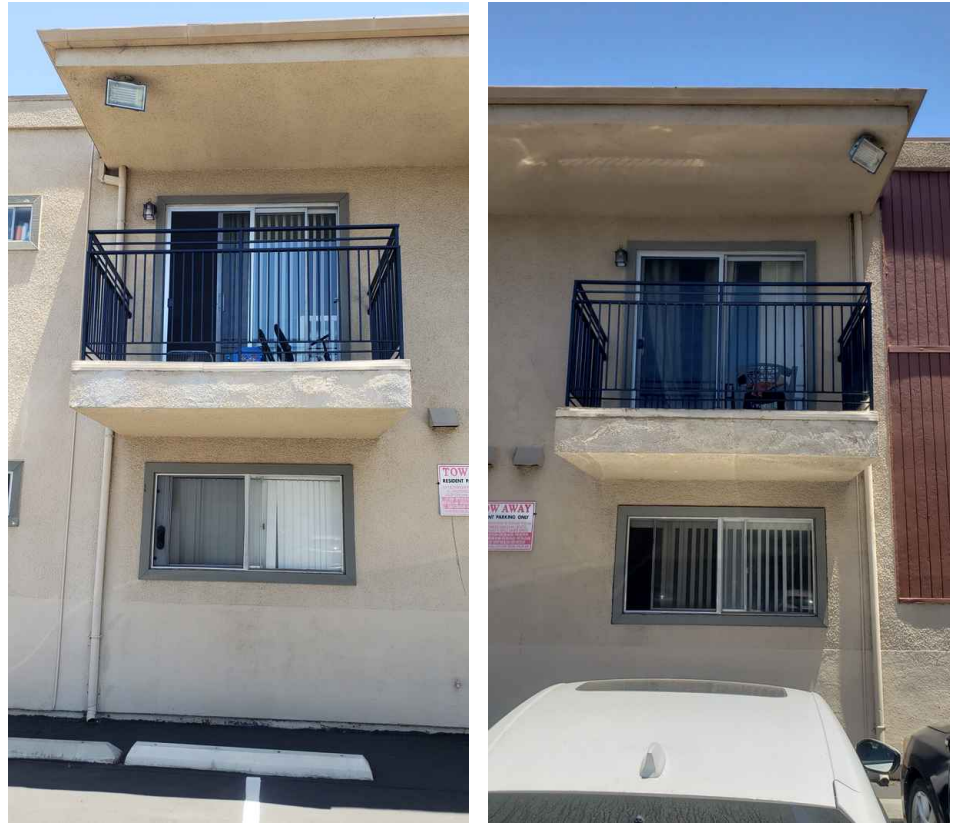
**Apt. 6 Balcony : \*Balcony Inspection Image(s)**

-   6.3.2 Building 1: Balconies - Apt. 4 Balcony : Corrosion
-   6.4.1 Building 1: Balconies - Apt. 6 Balcony : Openings in Waterproofing
-   6.4.2 Building 1: Balconies - Apt. 6 Balcony : Corrosion

-   6.4.3 Building 1: Balconies - Apt. 6 Balcony : Missing or loose Fastener(s)
