# PATRICK'S PROPERTY MAINTENANCE SERVICE

PHASE 1 PRE-721 EVALUATION BUILDING 2 UNITS 7-50

1234 Main Street  
Imperial Beach, CA 91932-1412

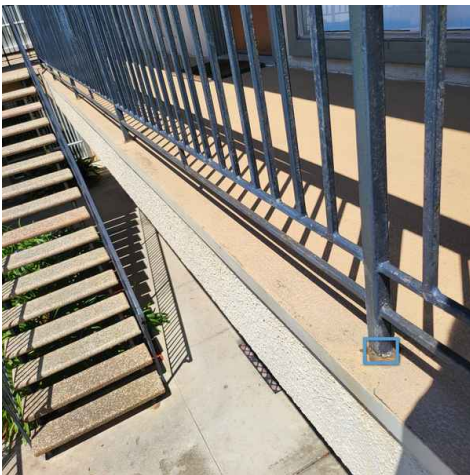
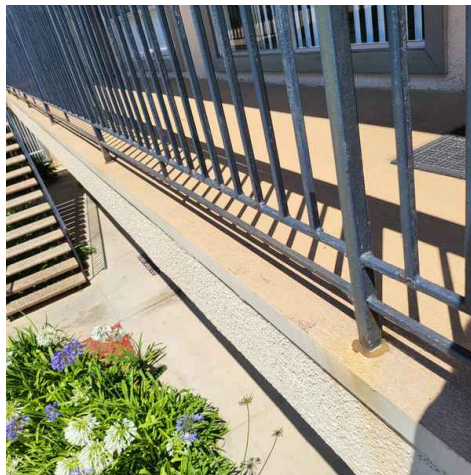
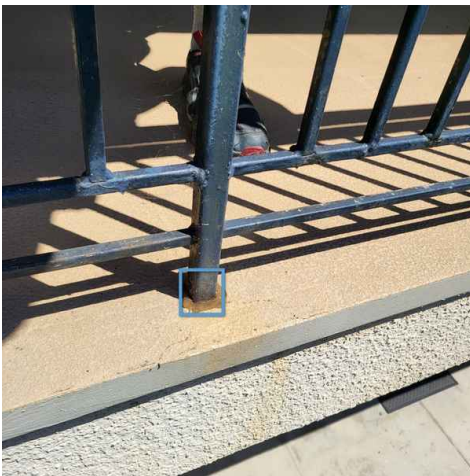
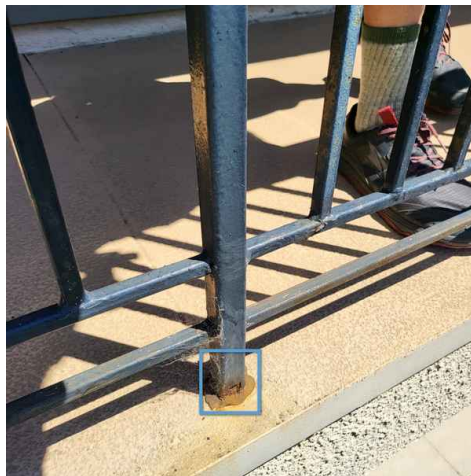
5.2.3 East Walkway

**DAMAGED STUCCO**

Minor - Stucco is cracking, stained, bulging, bubbling, blistering, efflorescing, soft, crumbling, discolored or showing signs of mold and mildew. These condition(s) are minor, and can be addressed as maintenance items.

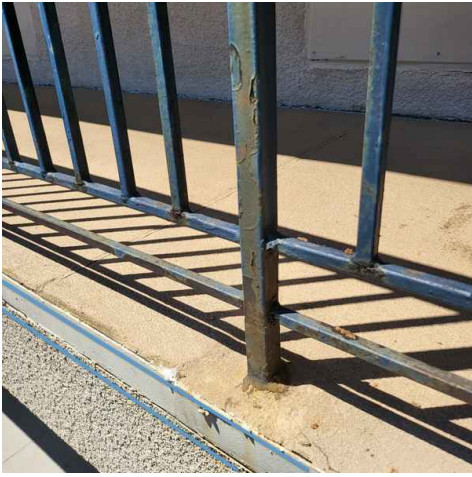
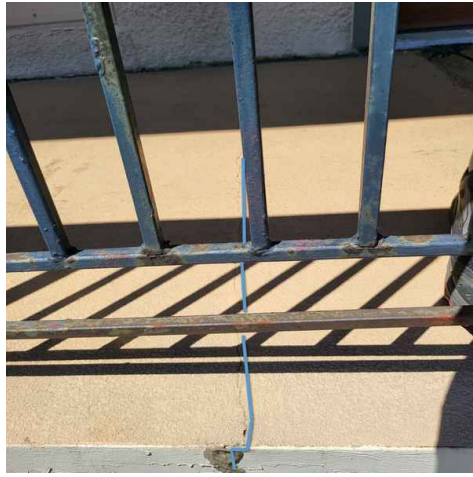
5.3.2 North Walkway

**CORROSION**

Minor - There is surface corrosion. The affected area(s) should be repaired.

Recommendation

Contact a qualified professional.

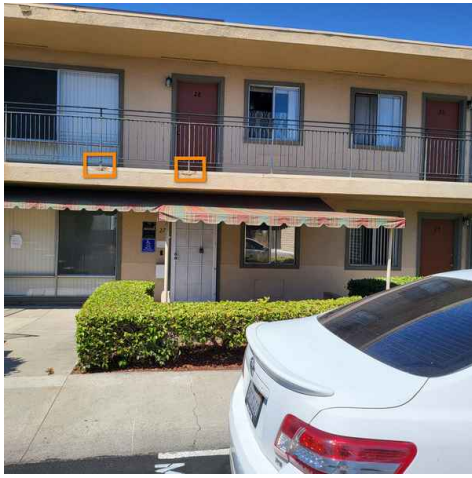
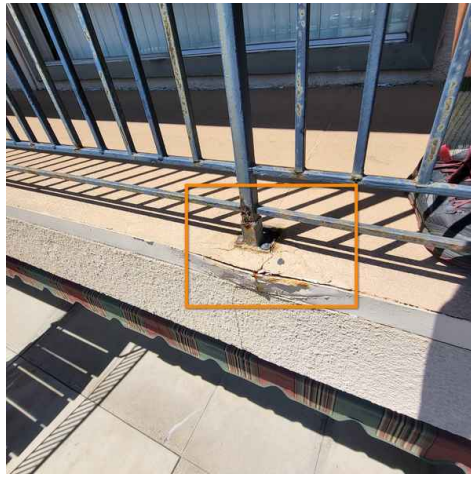
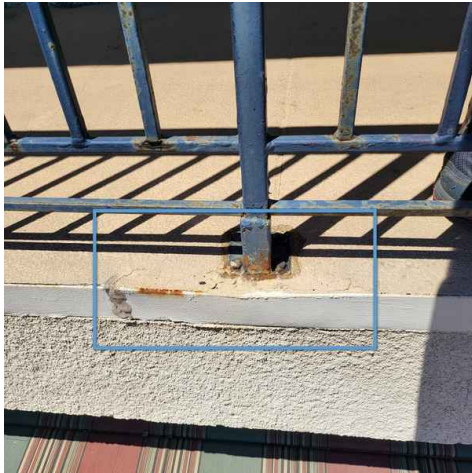
## 5.3.3 North Walkway

**CORROSION 2**

Minor - There is surface corrosion. The affected area(s) should be repaired.

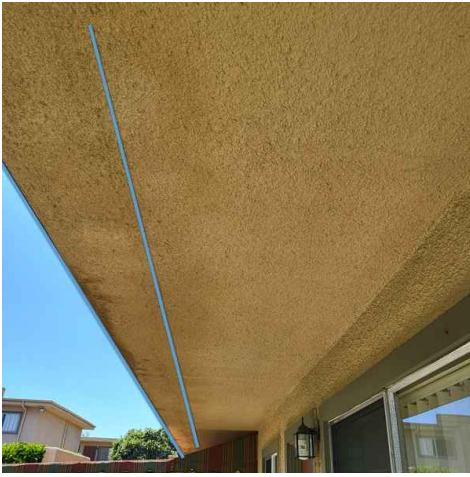
5.3.5 North Walkway

**UNSEALED CONNECTION(S)**

Recommendation

Contact a qualified professional.

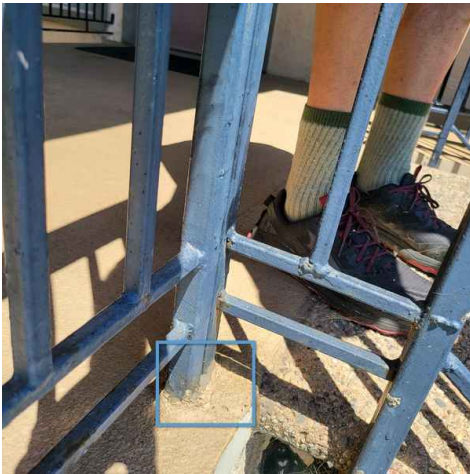
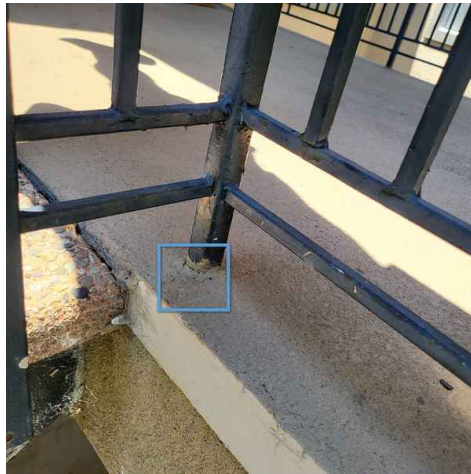
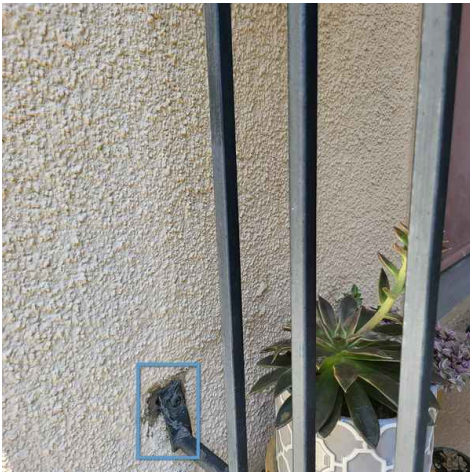
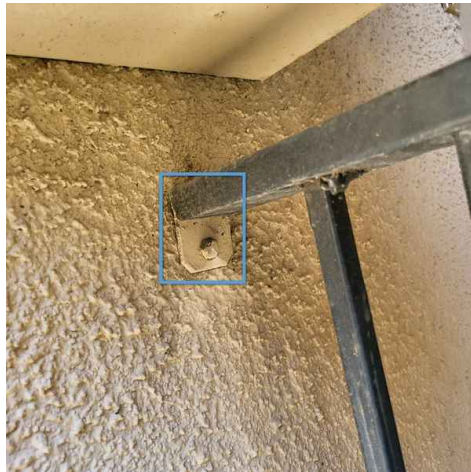
5.3.6 North Walkway

Marginal - The inspection revealed inadequate or improper construction, or evidence of instability in the support structure. This condition suggests that the support construction may not adhere to regulatory standards, potentially leading to long-term issues. A Phase 2 Pre-721 Evaluation (P2PE) is recommended to formulate a detailed repair plan. See Reference Information: Notification and Follow-Up - Marginal.

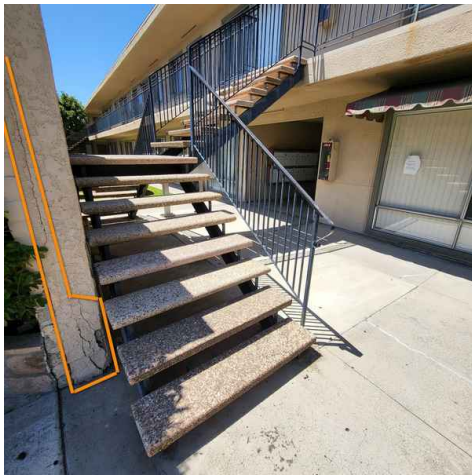
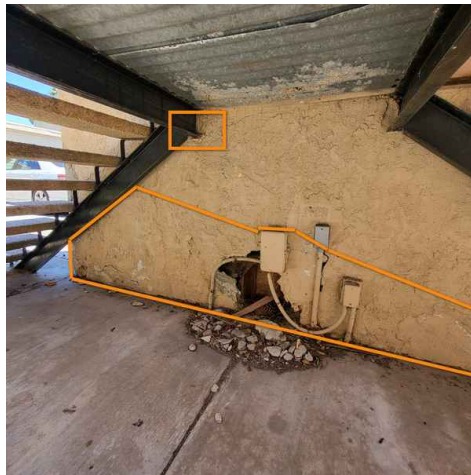
5.5.4 Middle Stairway

**TERMITE/WOOD ROT DAMAGE**

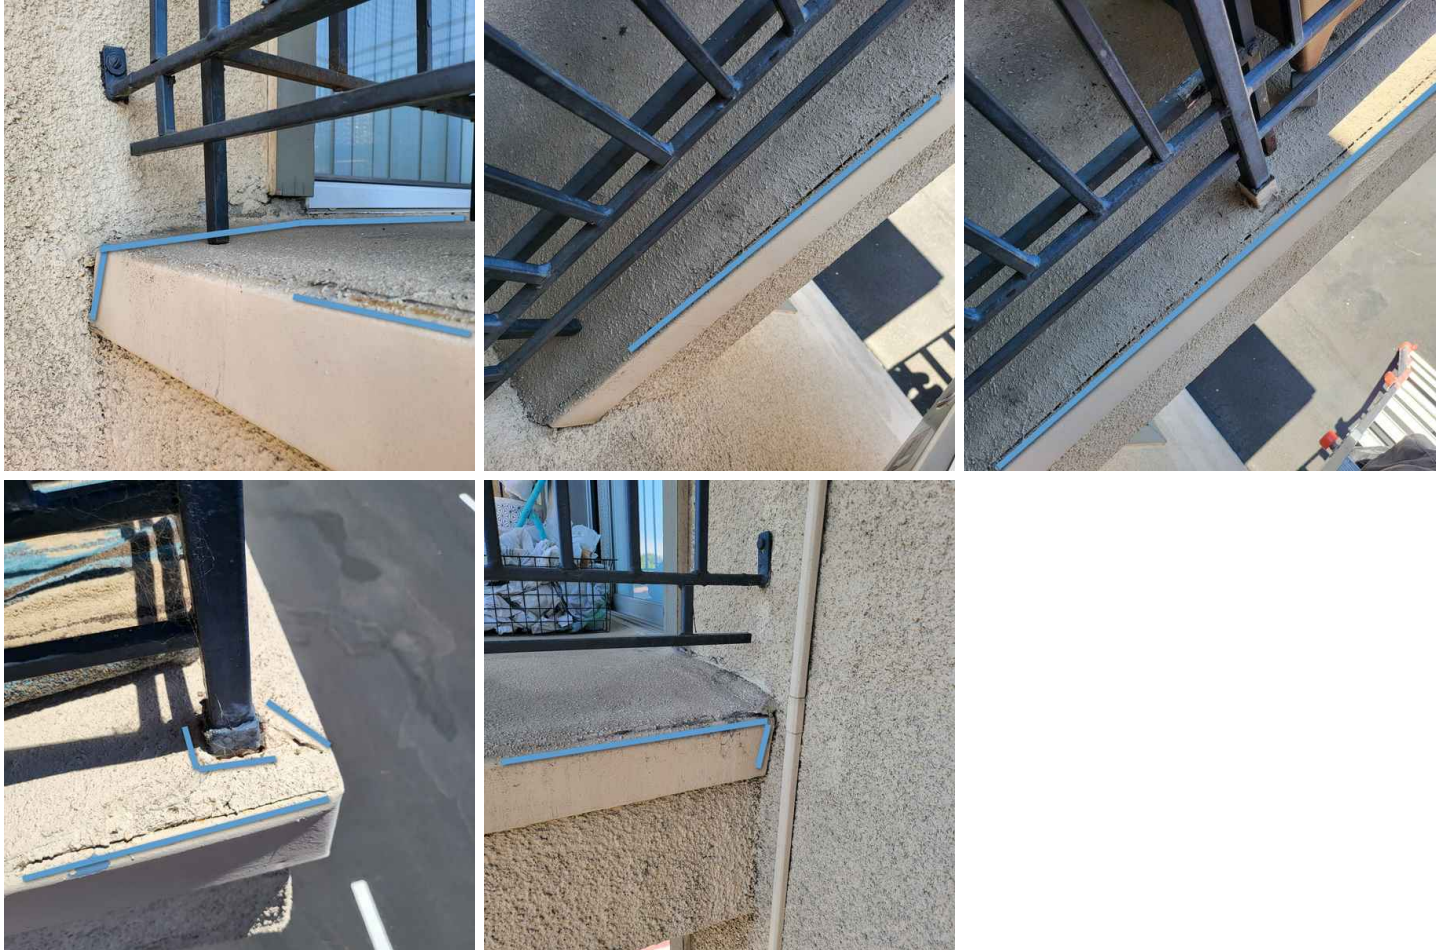
Minor - There are cracks, openings, or penetrations in the waterproofing. The affected areas should be sealed.

Contact a qualified professional.

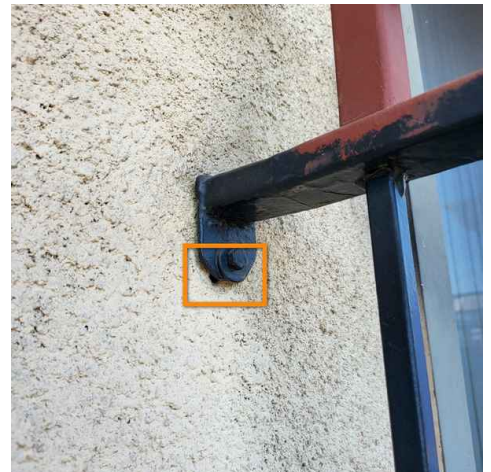
6.2.2 Apt. 8 Balcony

**MISSING OR LOOSE FASTENER(S)**

Hardware is loose or missing from railing connections. Appropriate hardware must be installed and loose hardware tightened prior to SB-721 Inspection.

Contact a qualified professional.

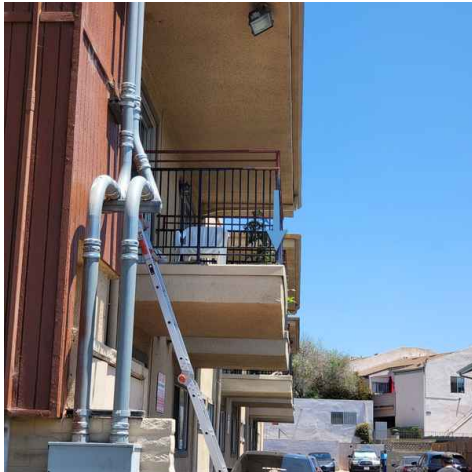
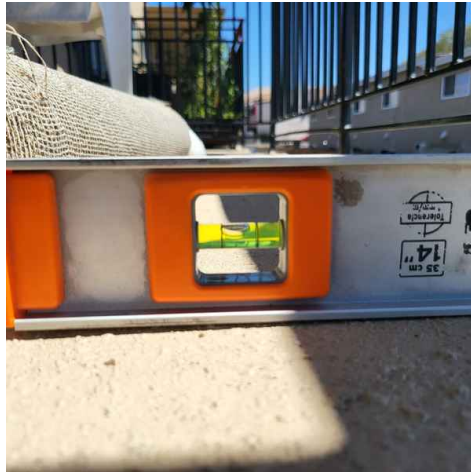
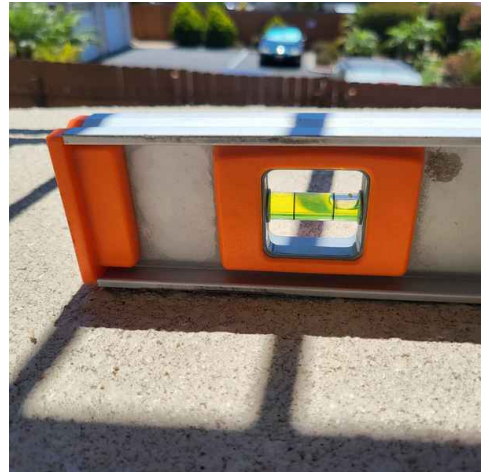
6.2.3 Apt. 8 Balcony

Minor - The inspection revealed inadequate or improper construction, or evidence of instability in the support structure. This condition suggests that the support construction may not adhere to regulatory standards.

Contact a qualified professional.

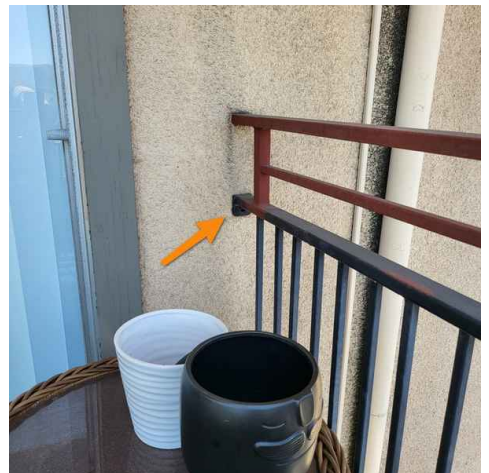
6.3.1 Apt. 10 Balcony

**MISSING OR LOOSE FASTENER(S)**

Hardware is loose or missing from railing connections. Appropriate hardware must be installed and loose hardware tightened prior to SB-721 Inspection.

Contact a qualified professional.

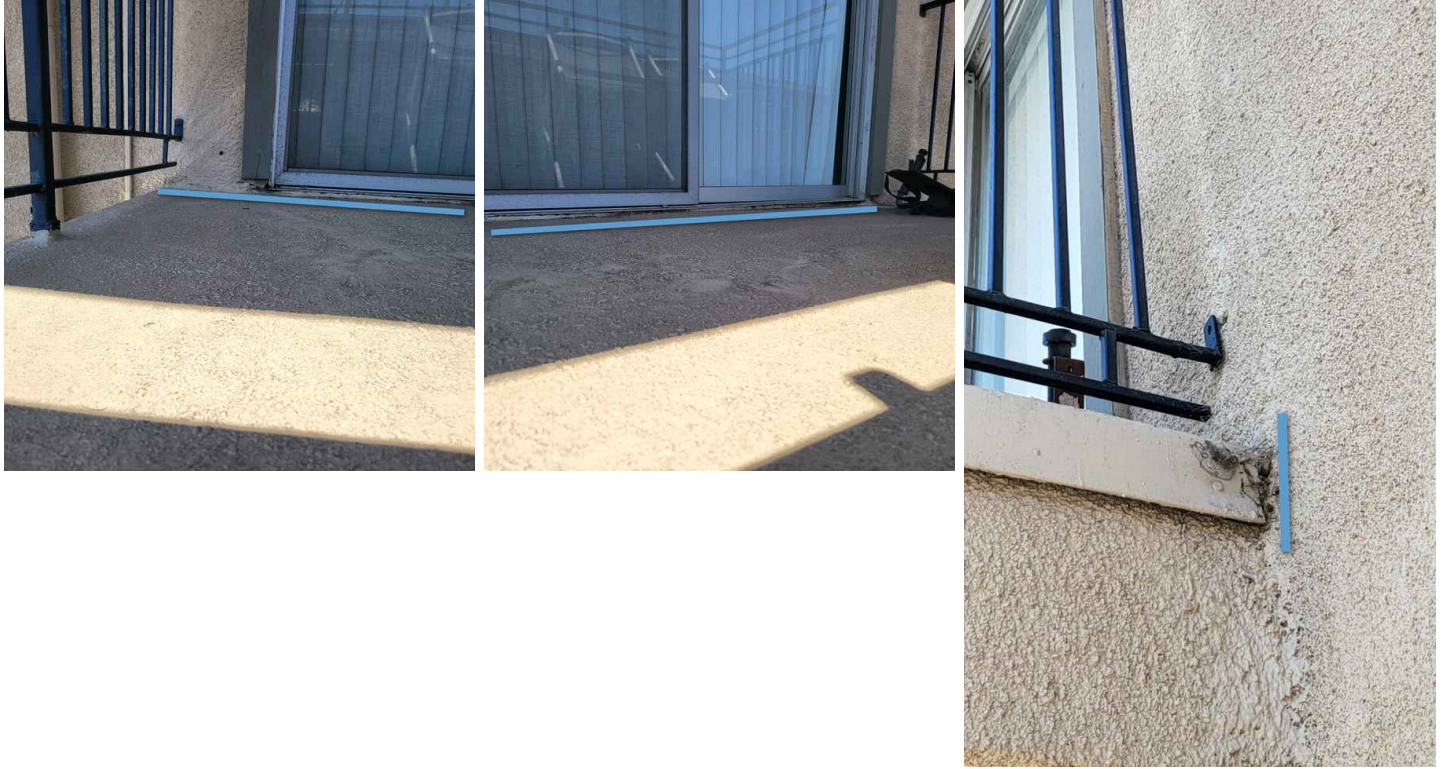
6.4.1 Apt. 12 Balcony

Minor - There are cracks, openings, or penetrations in the waterproofing. The affected areas should be sealed.

Contact a qualified professional.

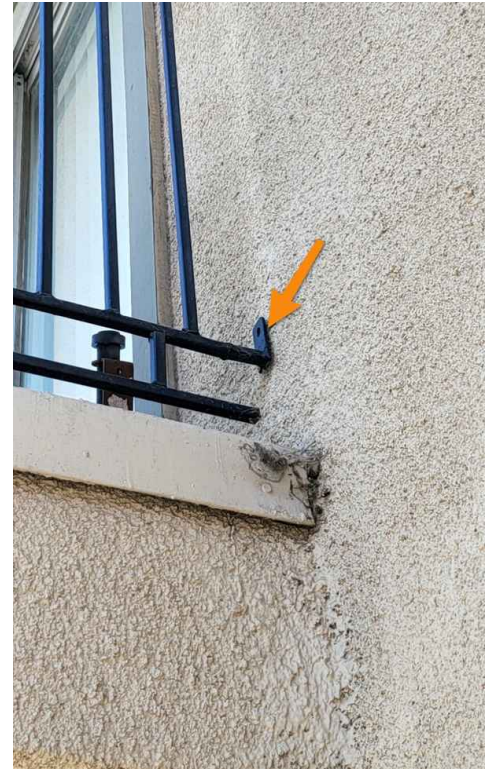
6.4.2 Apt. 12 Balcony

### MISSING OR LOOSE FASTENER(S)

Hardware is loose or missing from railing connections. Appropriate hardware must be installed and loose hardware tightened prior to SB-721 Inspection.

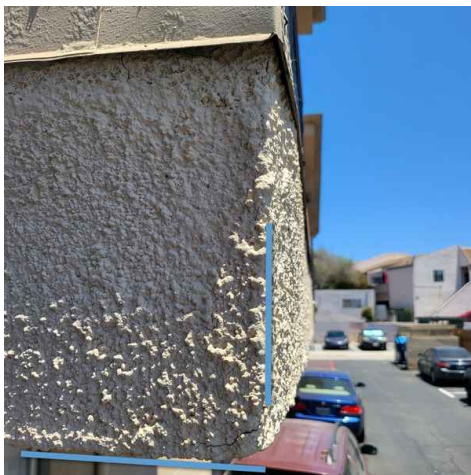
6.5.1 Apt. 14 Balcony

### DAMAGED STUCCO

Minor - Stucco is cracking, stained, bulging, bubbling, blistering, efflorescing, soft, crumbling, discolored or showing signs of mold and mildew. These condition(s) are minor, and can be addressed as maintenance items.

Cracking and puffing

Contact a qualified professional.

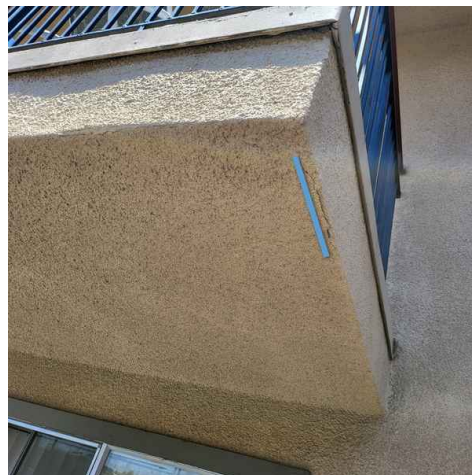
Cracking

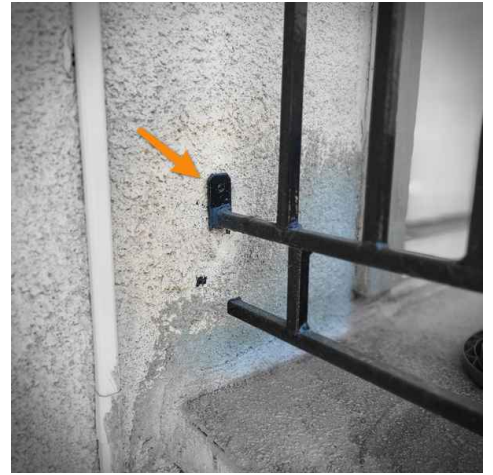
6.5.2 Apt. 14 Balcony

**MISSING OR LOOSE FASTENER(S)**

Hardware is loose or missing from railing connections. Appropriate hardware must be installed and loose hardware tightened prior to SB-721 Inspection.

Contact a qualified professional.

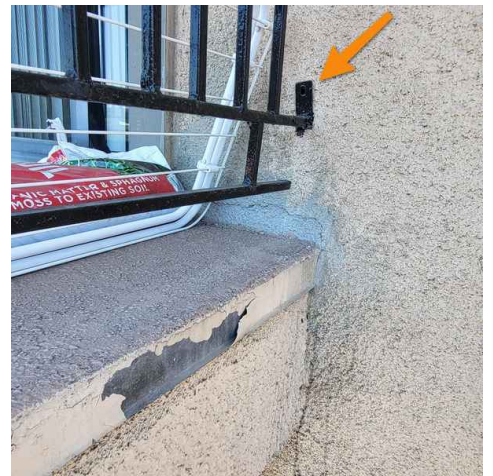
6.6.1 Apt. 16 Balcony

**MISSING OR LOOSE FASTENER(S)**

Hardware is loose or missing from railing connections. Appropriate hardware must be installed and loose hardware tightened prior to SB-721 Inspection.

Contact a qualified professional.

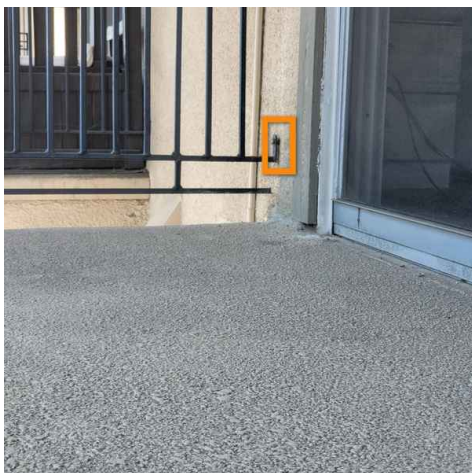
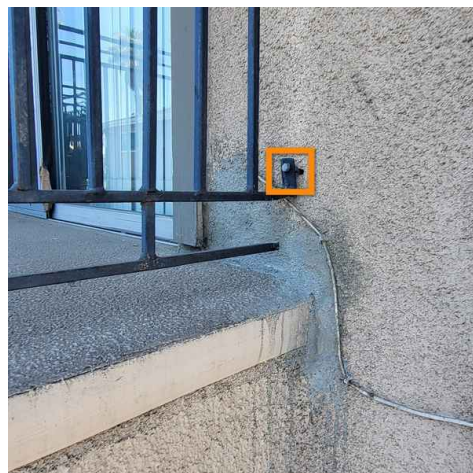
6.7.1 Apt. 18 Balcony

**MISSING OR LOOSE FASTENER(S)**

Hardware is loose or missing from railing connections. Appropriate hardware must be installed and loose hardware tightened prior to SB-721 Inspection.

Contact a qualified professional.

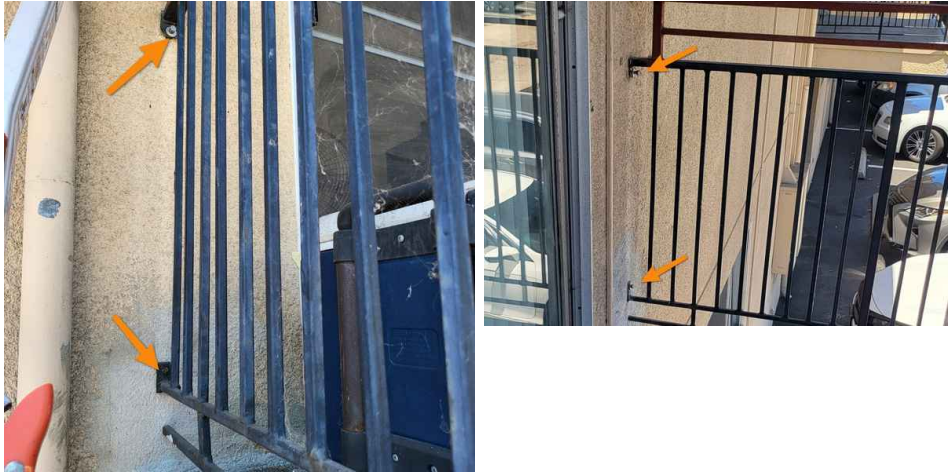
6.8.1 Apt. 20 Balcony 1

**MISSING OR LOOSE FASTENER(S)**

Hardware is loose or missing from railing connections. Appropriate hardware must be installed and loose hardware tightened prior to SB-721 Inspection.

Contact a qualified professional.

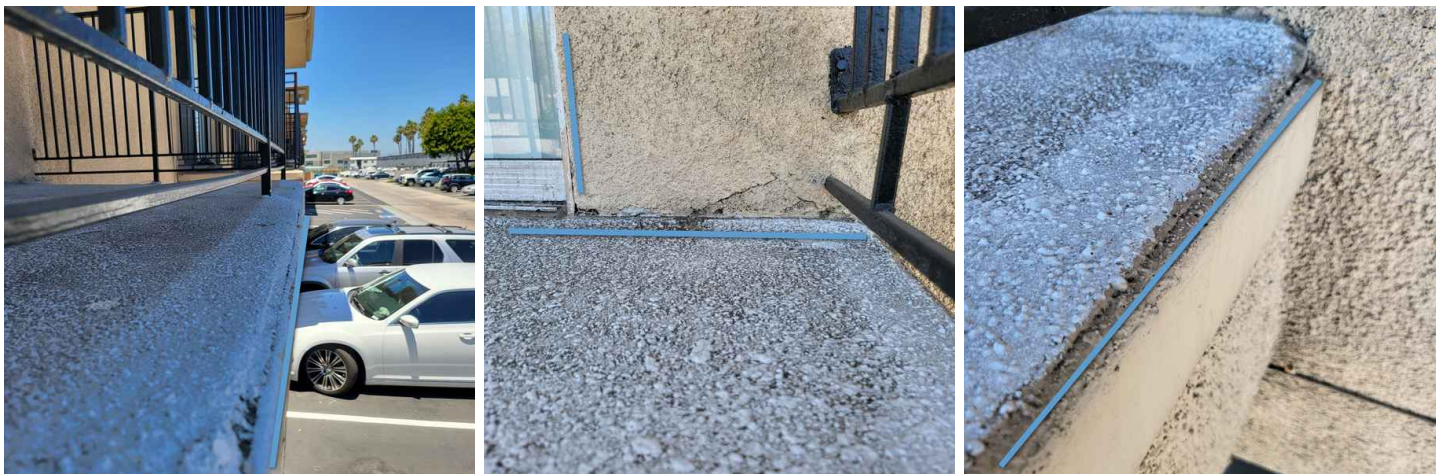
6.9.1 Apt. 20 Balcony 2

Minor - There are cracks, openings, or penetrations in the waterproofing. The affected areas should be sealed.

Contact a qualified professional.

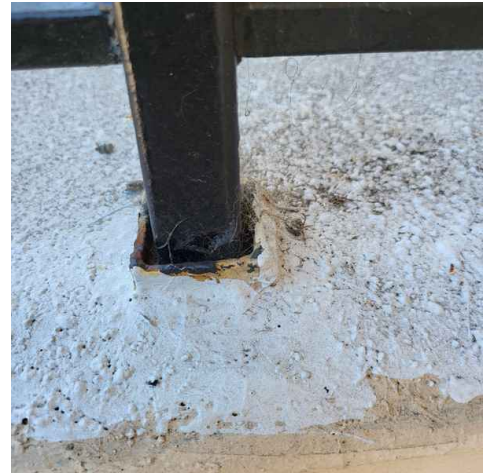
6.9.2 Apt. 20 Balcony 2

**UNSEALED CONNECTION(S)**

Contact a qualified professional.

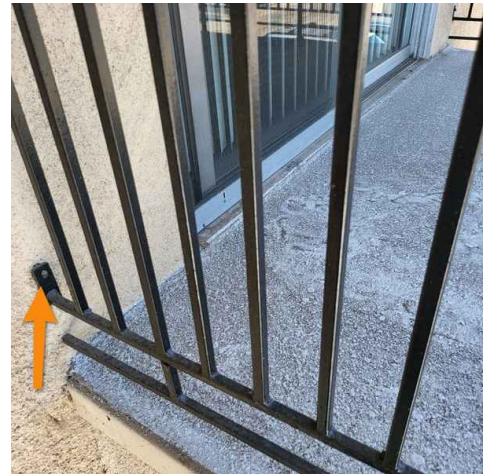
6.9.3 Apt. 20 Balcony 2

**MISSING OR LOOSE FASTENER(S)**

Hardware is loose or missing from railing connections. Appropriate hardware must be installed and loose hardware tightened prior to SB-721 Inspection.

Contact a qualified professional.

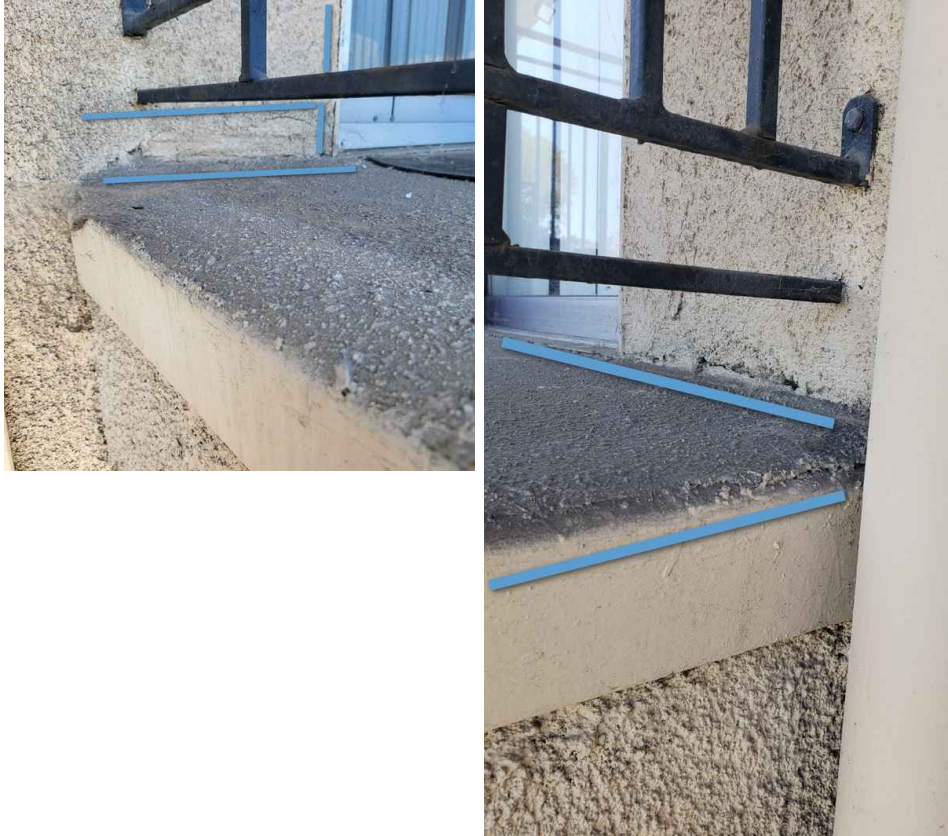
6.10.1 Apt. 22 Balcony

Minor - There are cracks, openings, or penetrations in the waterproofing. The affected areas should be sealed.

Contact a qualified professional.

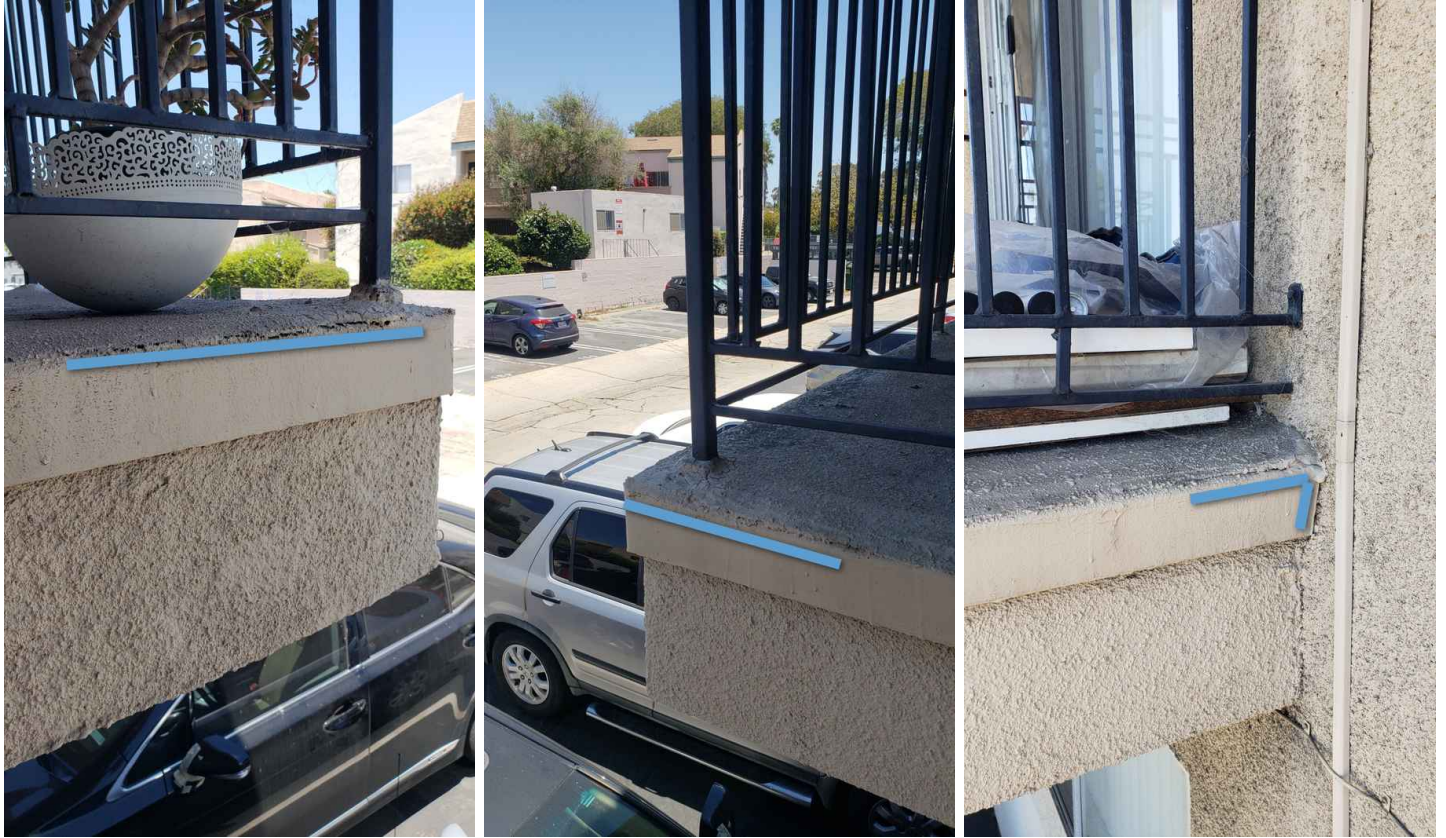
6.11.1 Apt. 24 Balcony

Minor - There are cracks, openings, or penetrations in the waterproofing. The affected areas should be sealed.

Contact a qualified professional.

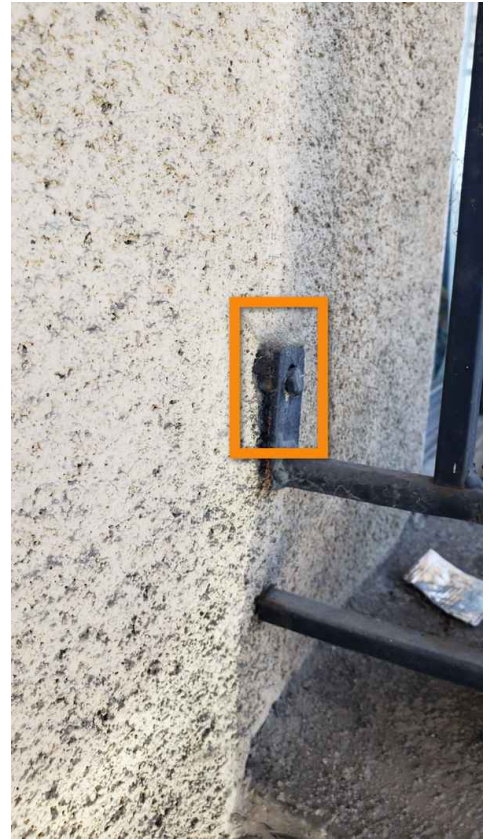
6.11.2 Apt. 24 Balcony

**MISSING OR LOOSE FASTENER(S)**

Hardware is loose or missing from railing connections. Appropriate hardware must be installed and loose hardware tightened prior to SB-721 Inspection.

Contact a qualified professional.

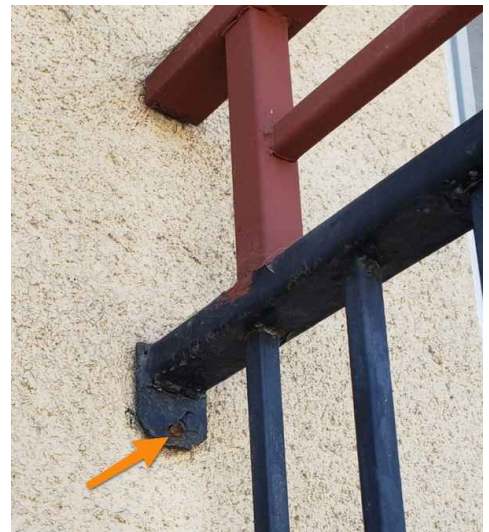
6.12.1 Apt. 26 Balcony

**MISSING OR LOOSE FASTENER(S)**

Hardware is loose or missing from railing connections. Appropriate hardware must be installed and loose hardware tightened prior to SB-721 Inspection.

Contact a qualified professional.

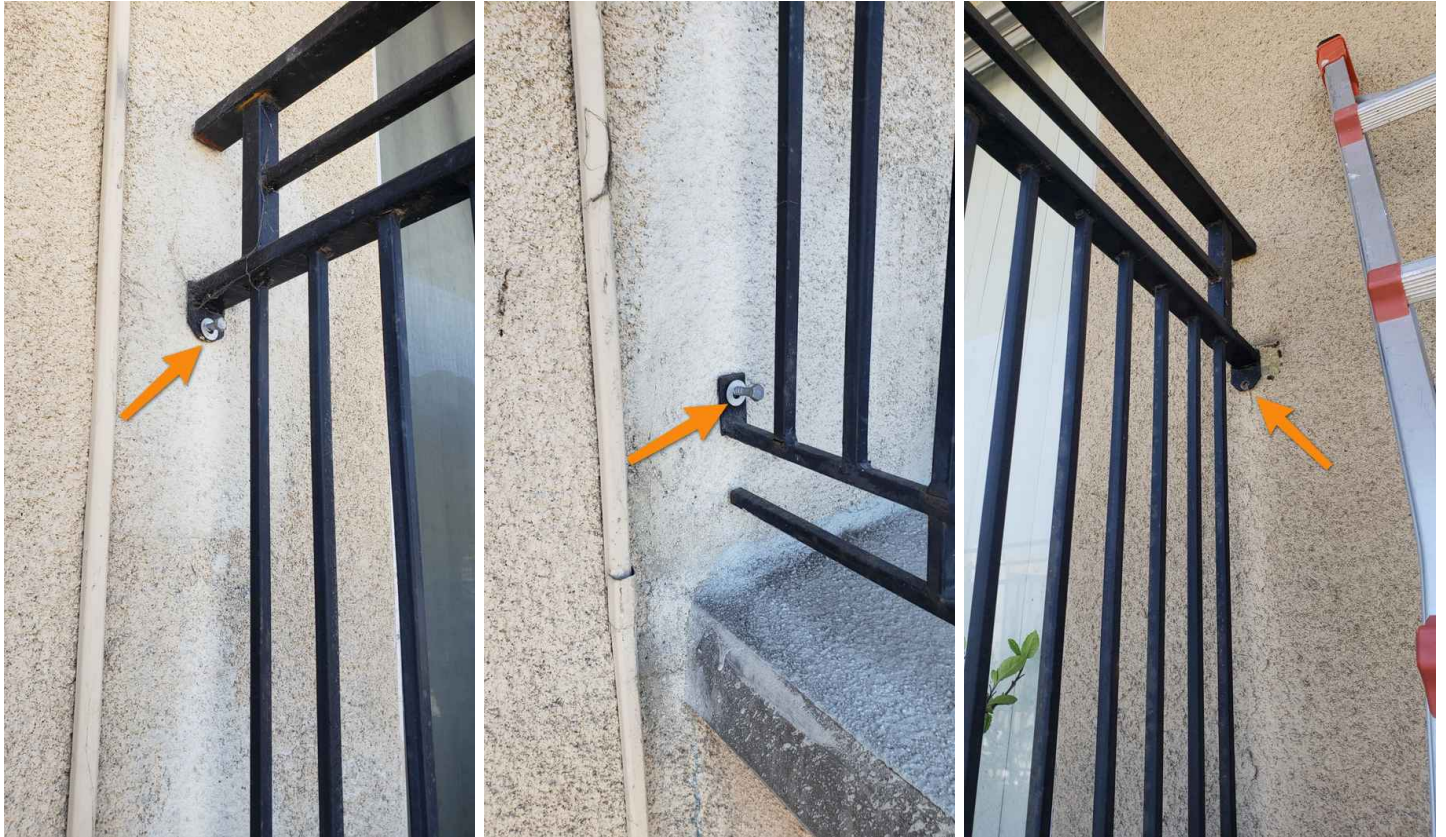
6.13.1 Apt. 28 Balcony

**MISSING OR LOOSE FASTENER(S)**

Hardware is loose or missing from railing connections. Appropriate hardware must be installed and loose hardware tightened prior to SB-721 Inspection.

Contact a qualified professional.

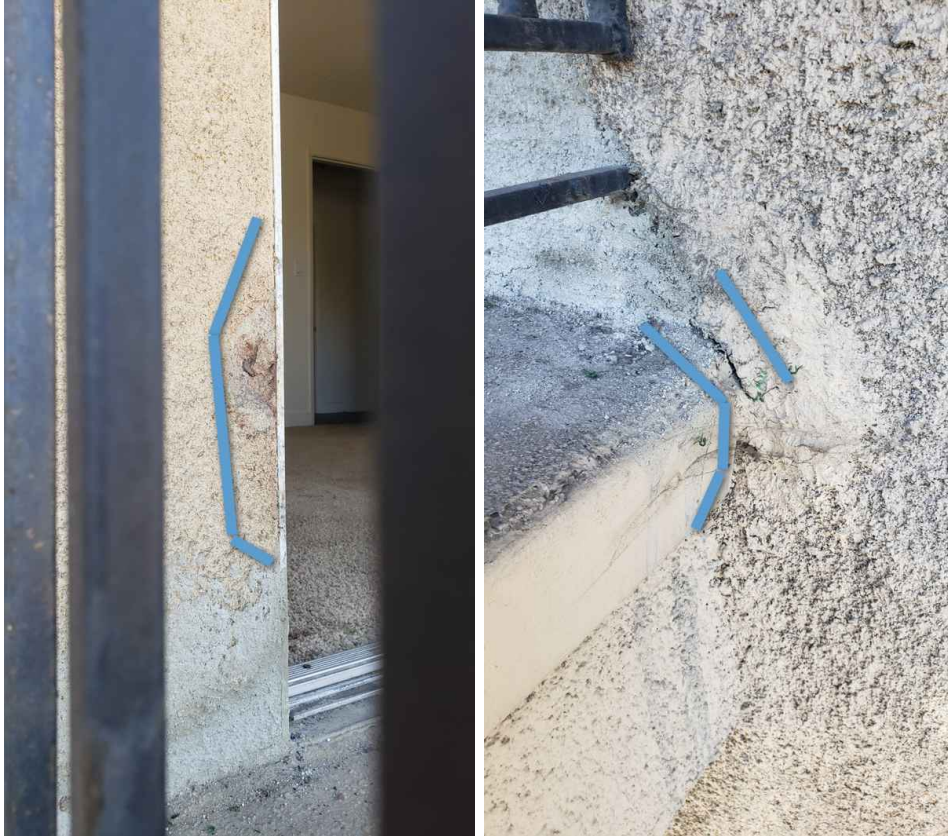
6.14.1 Apt. 30 Balcony

Minor - There are cracks, openings, or penetrations in the waterproofing. The affected areas should be sealed.

Contact a qualified professional.

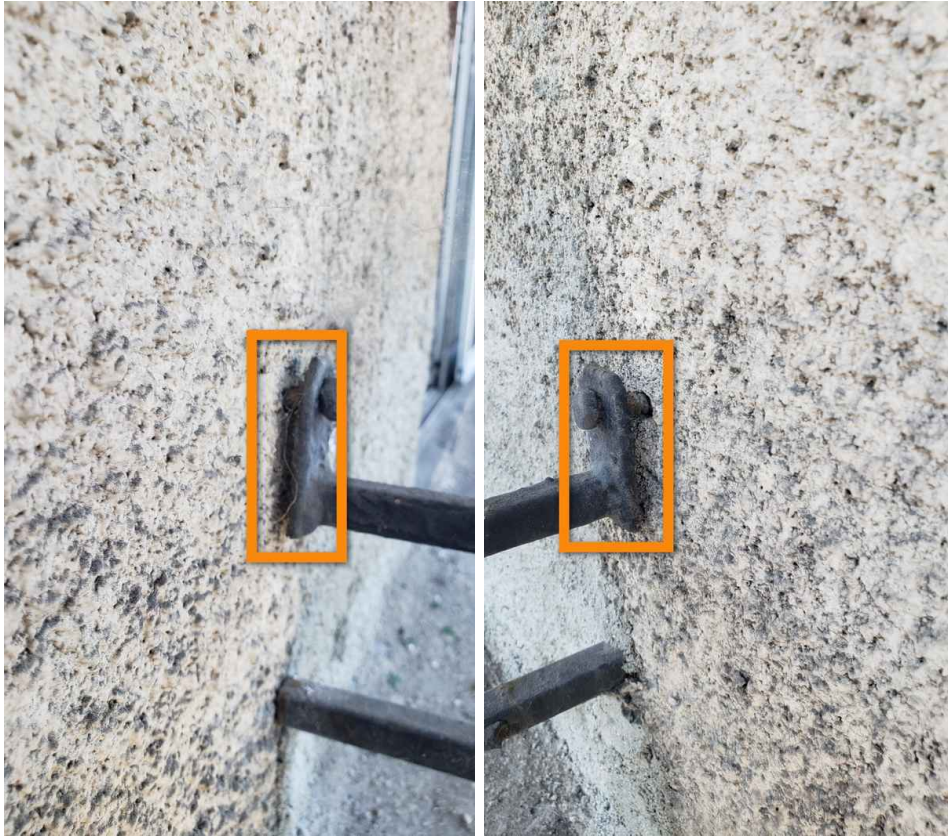
6.14.2 Apt. 30 Balcony

**MISSING OR LOOSE FASTENER(S)**

Hardware is loose or missing from railing connections. Appropriate hardware must be installed and loose hardware tightened prior to SB-721 Inspection.

Contact a qualified professional.

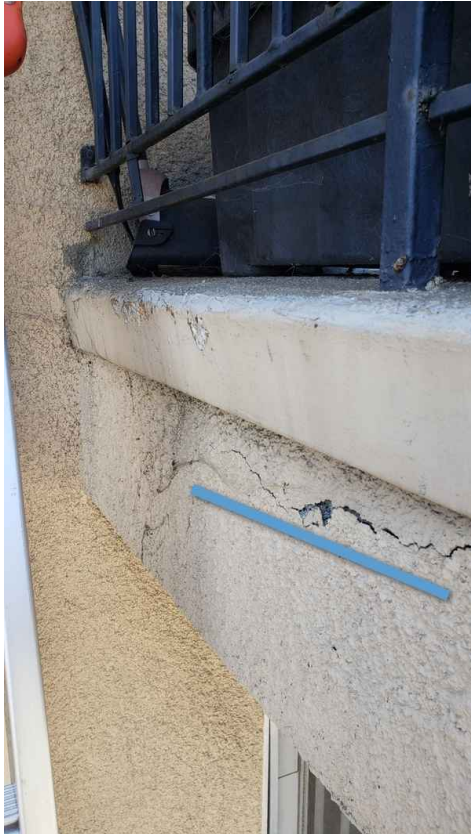
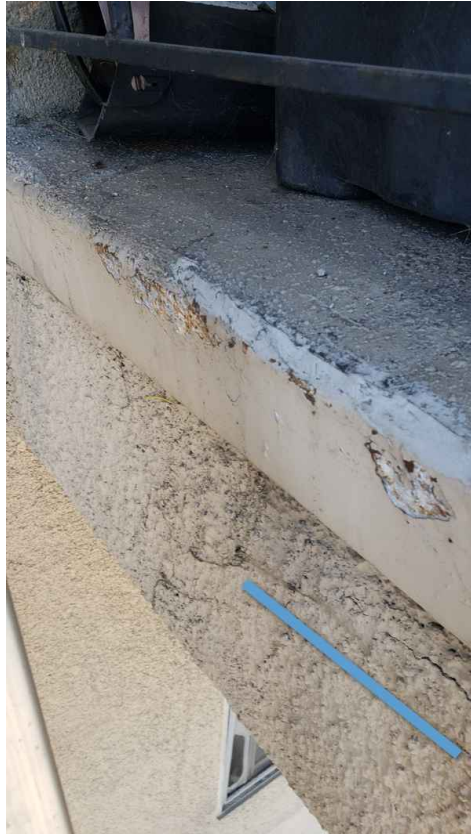
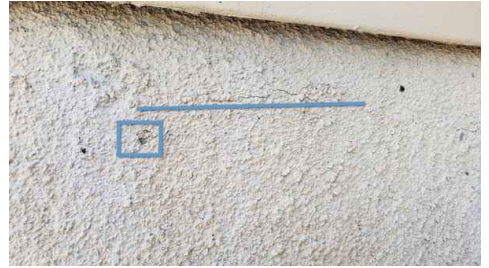
6.15.1 Apt. 32 Balcony

**DAMAGED STUCCO**

Minor - Stucco is cracking, stained, bulging, bubbling, blistering, efflorescing, soft, crumbling, discolored or showing signs of mold and mildew. These condition(s) are minor, and can be addressed as maintenance items.

Contact a qualified professional.

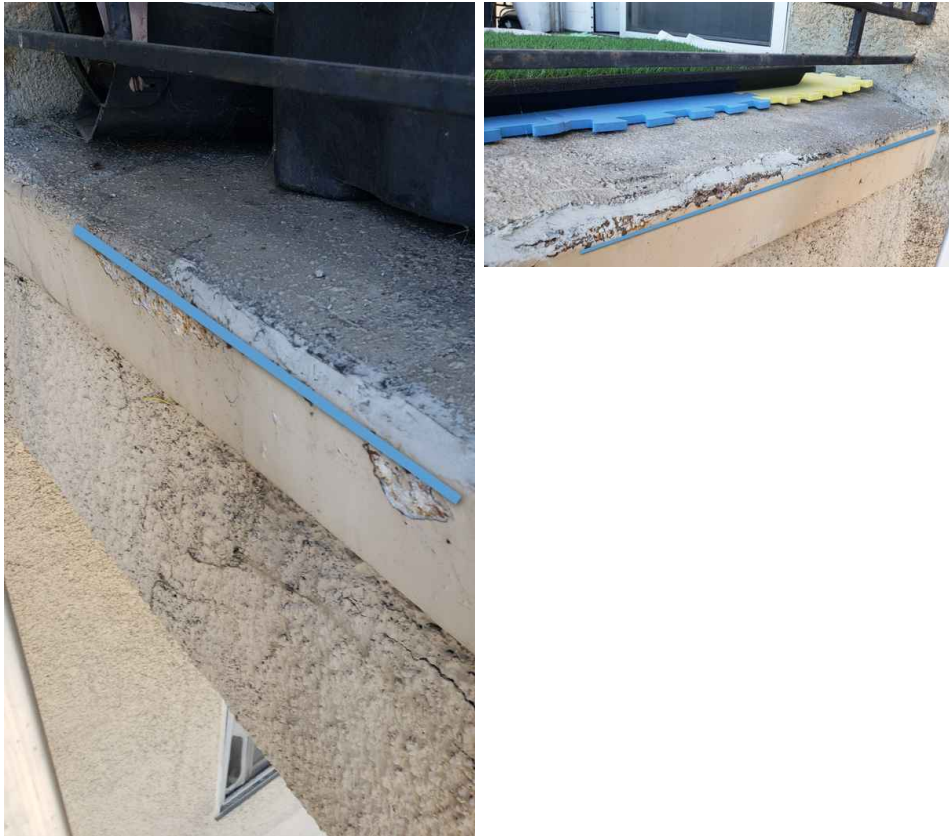
Minor - There are cracks, openings, or penetrations in the waterproofing. The affected areas should be sealed.

Contact a qualified professional.

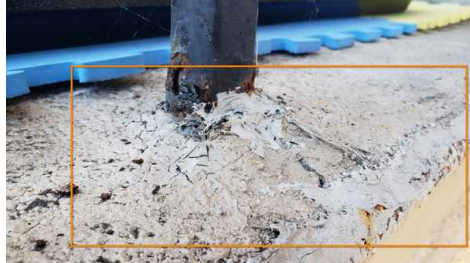
6.15.3 Apt. 32 Balcony

**CORROSION**

Marginal - There is significant corrosion that is affecting structural integrity. A Phase 2 Pre-721 Evaluation (P2PE) is recommended to formulate a detailed repair plan. See Reference Information: Notification and Follow Up - Marginal.

expansion from corrosion

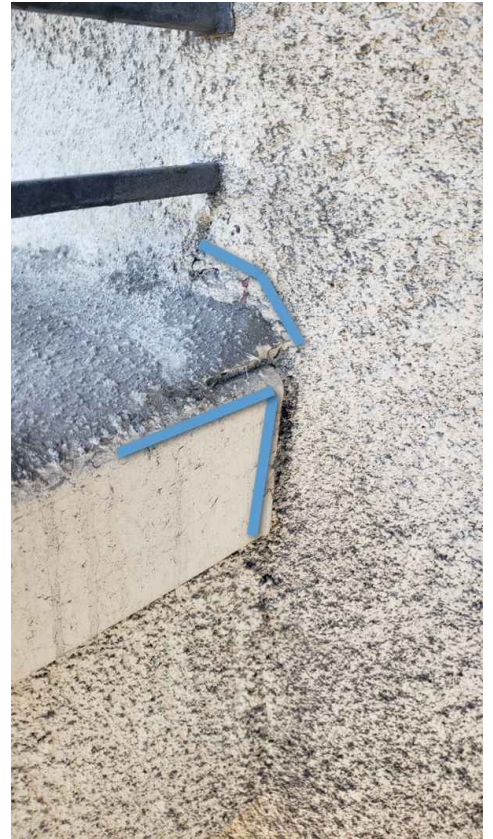
6.16.1 Apt. 34 Balcony

Minor - There are cracks, openings, or penetrations in the waterproofing. The affected areas should be sealed.

Contact a qualified professional.

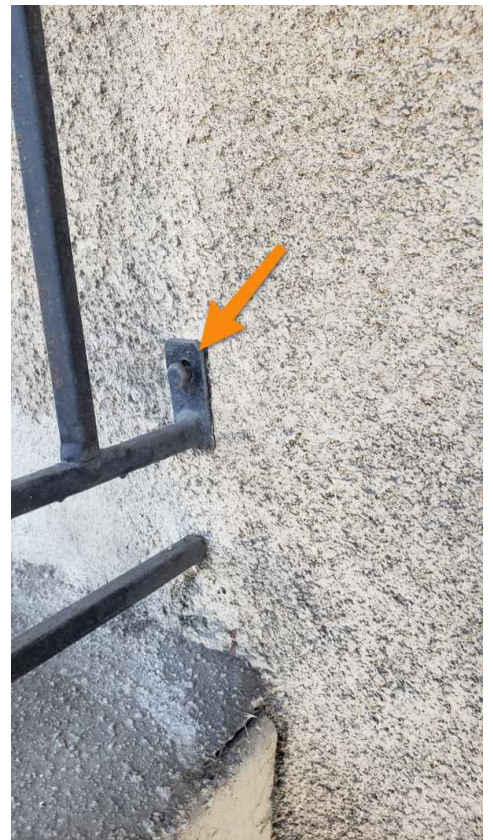
6.16.2 Apt. 34 Balcony

**MISSING OR LOOSE FASTENER(S)**

Hardware is loose or missing from railing connections. Appropriate hardware must be installed and loose hardware tightened prior to SB-721 Inspection.

Contact a qualified professional.

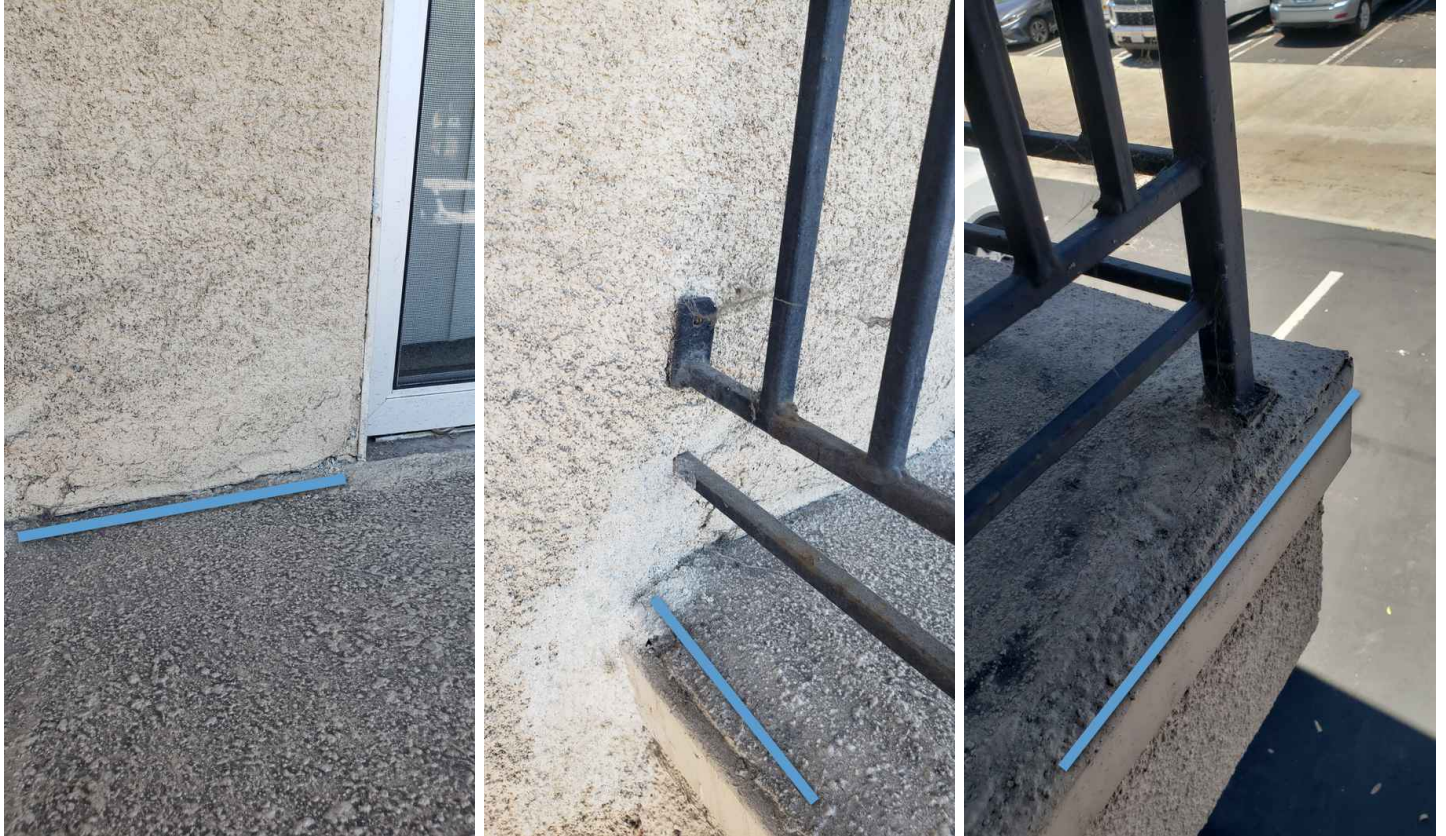
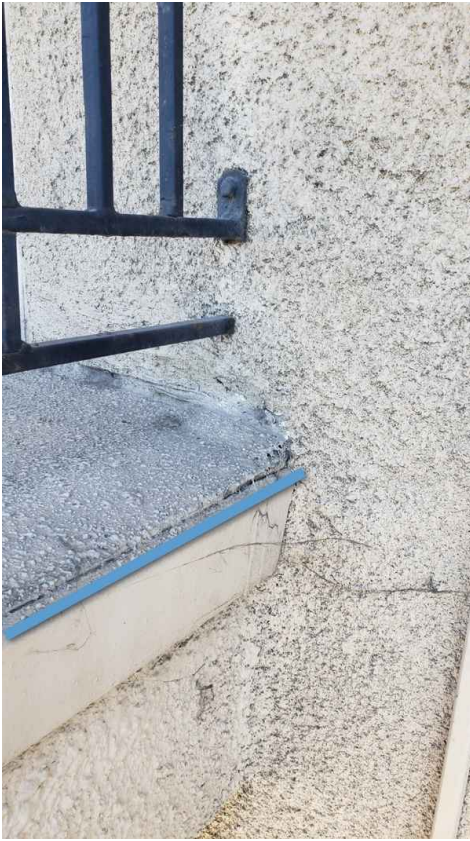
6.17.1 Apt. 36 Balcony

Minor - There are cracks, openings, or penetrations in the waterproofing. The affected areas should be sealed.

Contact a qualified professional.
