# PATRICK'S PROPERTY MAINTENANCE SERVICE

PHASE 1 PRE-721 EVALUATION BUILDING 2 UNITS 7-50

1234 Main Street  
Imperial Beach, CA 91932-1412

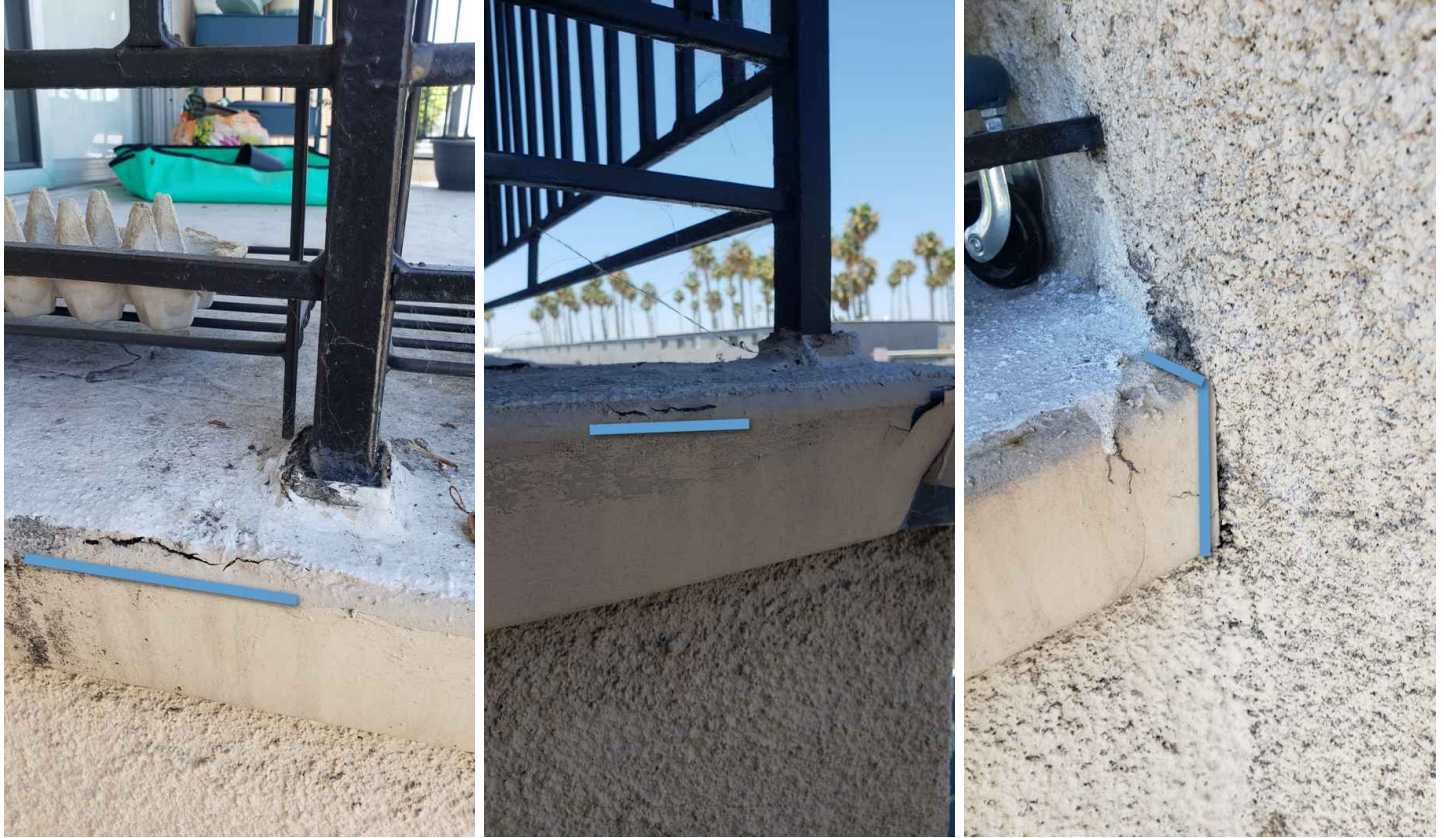
6.18.1 Apt. 38 Balcony 1

Minor - There are cracks, openings, or penetrations in the waterproofing. The affected areas should be sealed.

Contact a qualified professional.

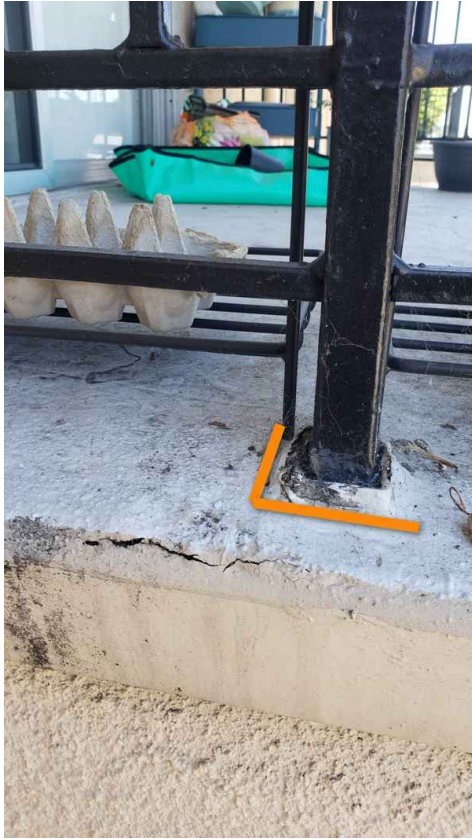
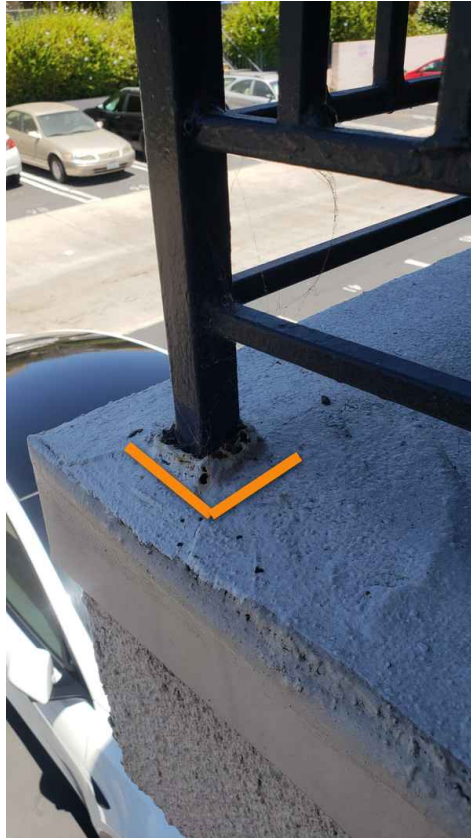
6.18.2 Apt. 38 Balcony 1

**CORROSION**

Marginal - There is significant corrosion that is affecting structural integrity. A Phase 2 Pre-721 Evaluation (P2PE) is recommended to formulate a detailed repair plan. See Reference Information: Notification and Follow Up - Marginal.

Contact a qualified professional.

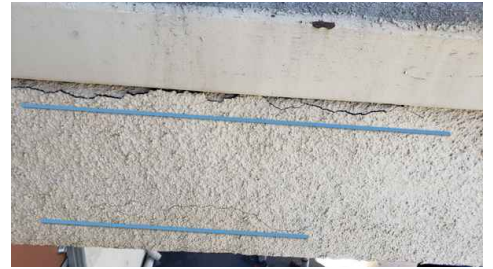
6.19.1 Apt. 38 Balcony 2

**DAMAGED STUCCO**

Minor - Stucco is cracking, stained, bulging, bubbling, blistering, efflorescing, soft, crumbling, discolored or showing signs of mold and mildew. These condition(s) are minor, and can be addressed as maintenance items.

Contact a qualified professional.

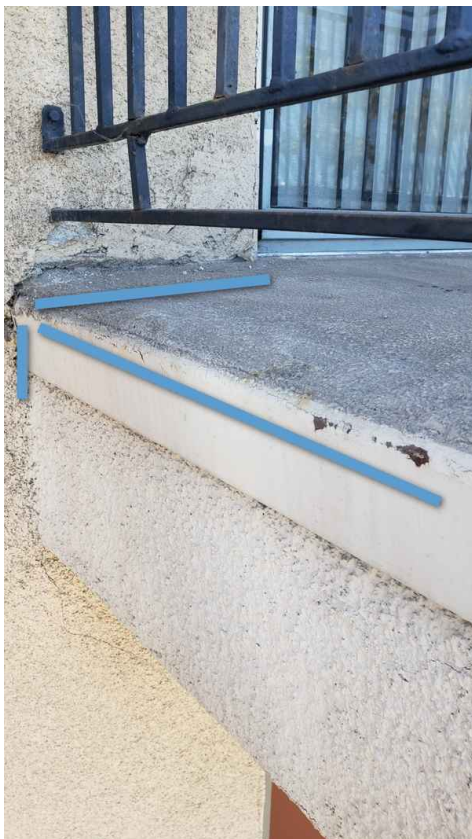
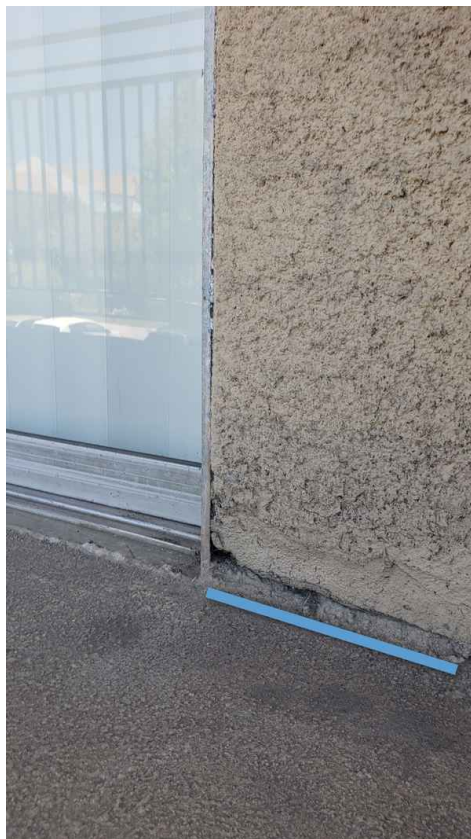
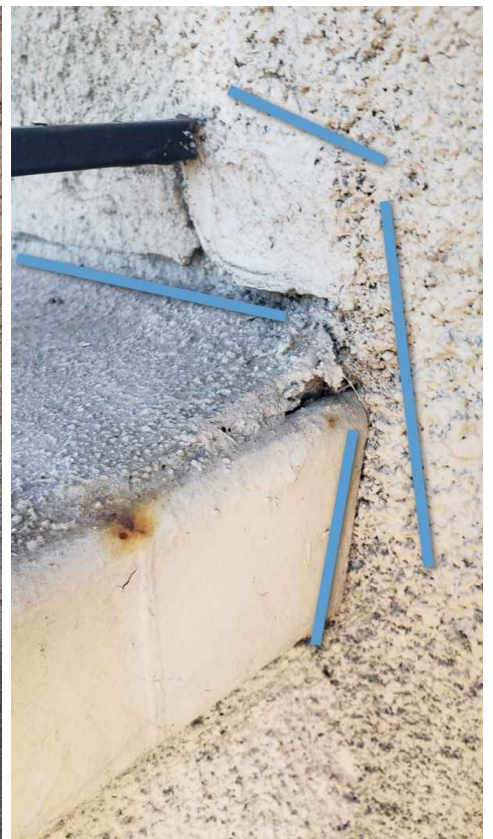
Minor - There are cracks, openings, or penetrations in the waterproofing. The affected areas should be sealed.

Contact a qualified professional.

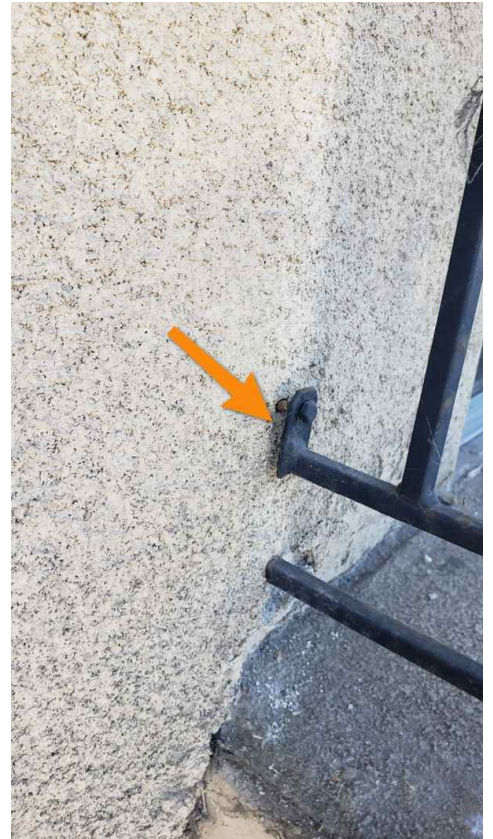
6.19.3 Apt. 38 Balcony 2

### **MISSING OR LOOSE FASTENER(S)**

Hardware is loose or missing from railing connections. Appropriate hardware must be installed and loose hardware tightened prior to SB-721 Inspection.
