PATRICK'S PROPERTY MAINTENANCE SERVICE

PHASE 1 PRE-721 EVALUATION BUILDING 3 UNITS 51 - 56

1234 Main Street
Imperial Beach, CA 91932-1412

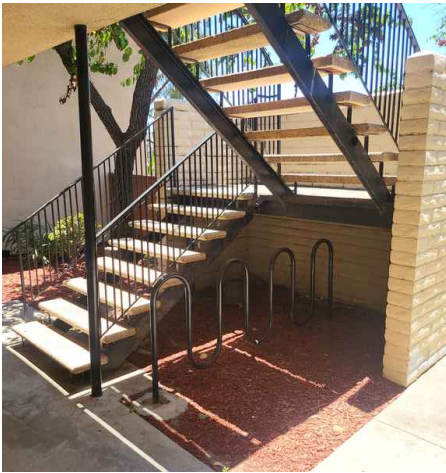
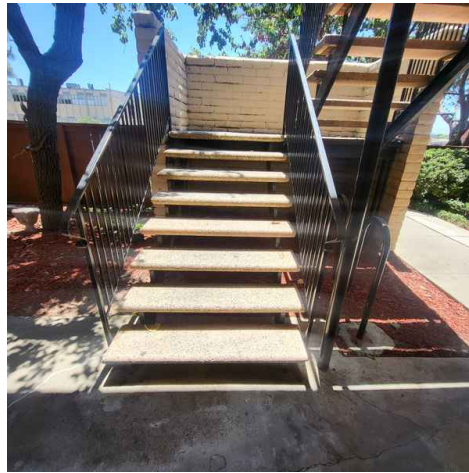
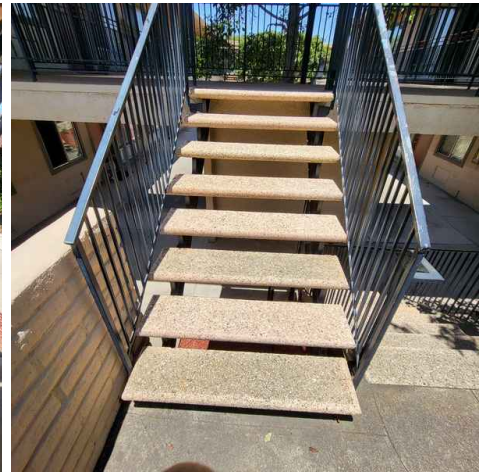
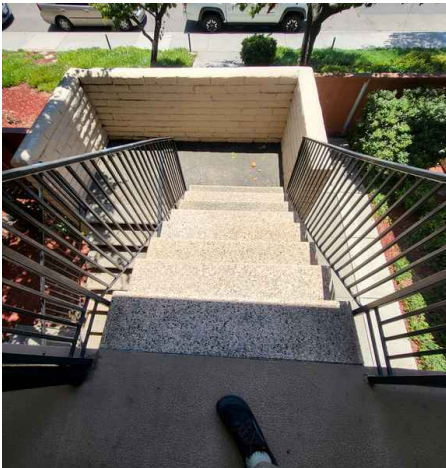
Main Stairway West: *Stairway Inspection Image(s)

Main Stairway West:
Approximate Height
10 ft

Main Stairway West: Number of Treads
15

Main Stairway West: Tread material
Precast Concrete

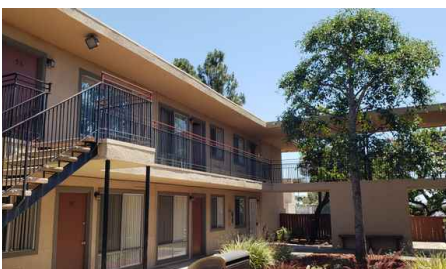
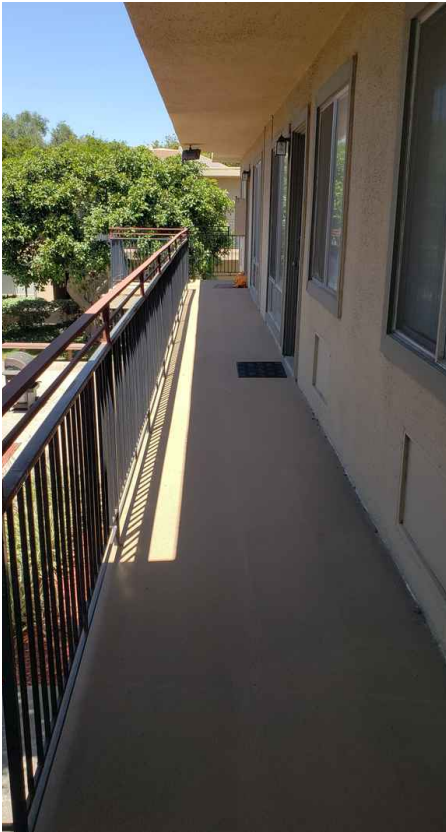
Walkway: *Walkway Inspection Image(s)

Walkway: Approximate Height
10 ft

Walkway: Walking Surface Material
Composite

Walkway: Support Material
Wood

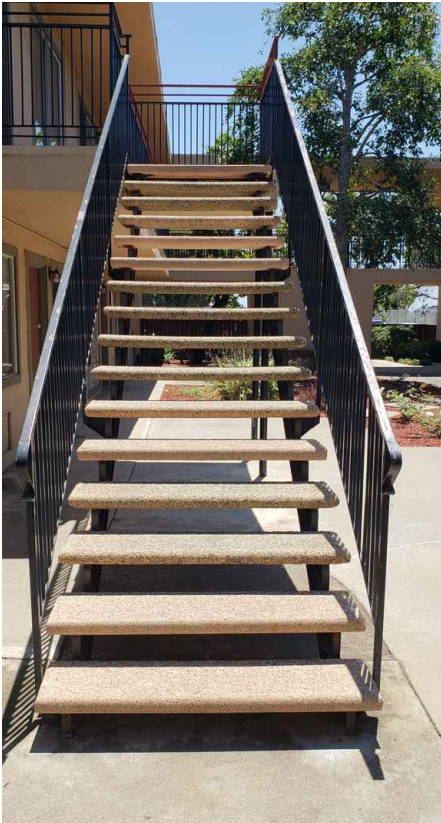
Stairway North: *Stairway Inspection Image(s)

Stairway North: Approximate Height
10 ft

Stairway North: Number of Treads
16

Stairway North: Tread material
Precast Concrete

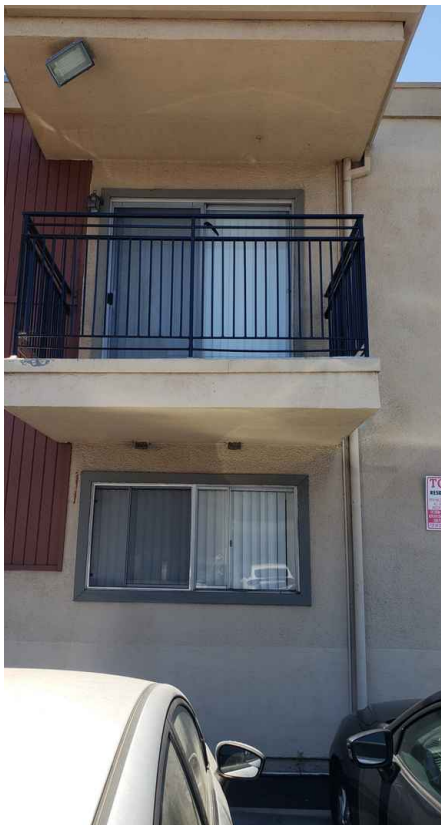
Apt. 52 Balcony: *Balcony Inspection Image(s)

Apt. 52 Balcony: Support Material
Wood

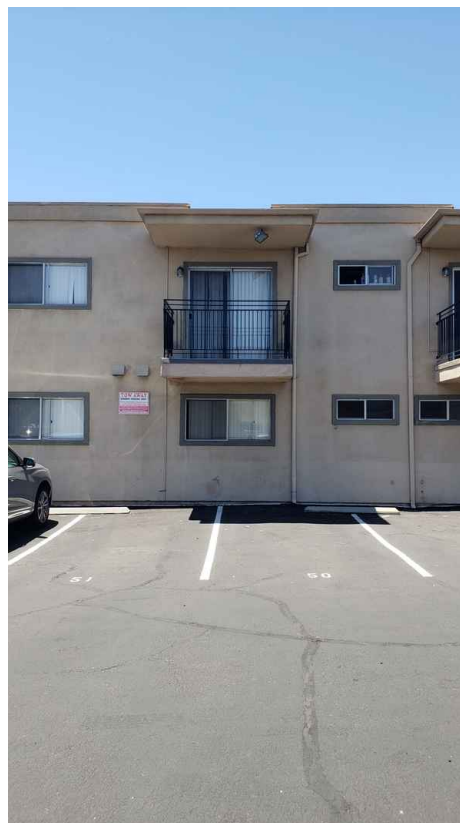
Apt. 54 Balcony : *Balcony Inspection Image(s)

Apt. 54 Balcony : Approximate Height
9 ft

Apt. 54 Balcony : Rail Material
Steel

Apt. 54 Balcony : Support Material
Wood

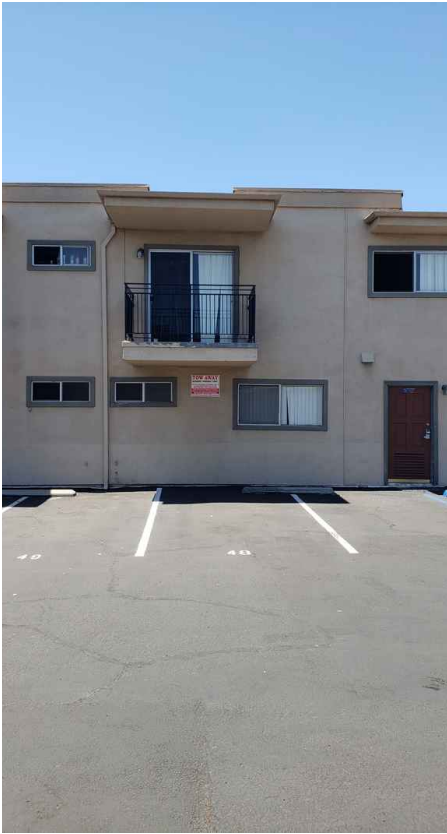
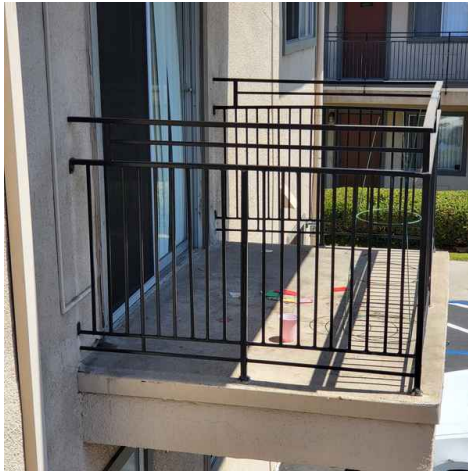
Apt. 56 Balcony : *Balcony Inspection Image(s)

Apt. 56 Balcony : Approximate Height
9 ft

Apt. 56 Balcony : Walking Surface Material
Composite

Apt. 56 Balcony : Support Material
Wood
