# PATRICK'S PROPERTY MAINTENANCE SERVICE

## PRE-721 EVALUATION PHASE 2

1234 Main Street  
Imperial Beach, CA 91932-1412

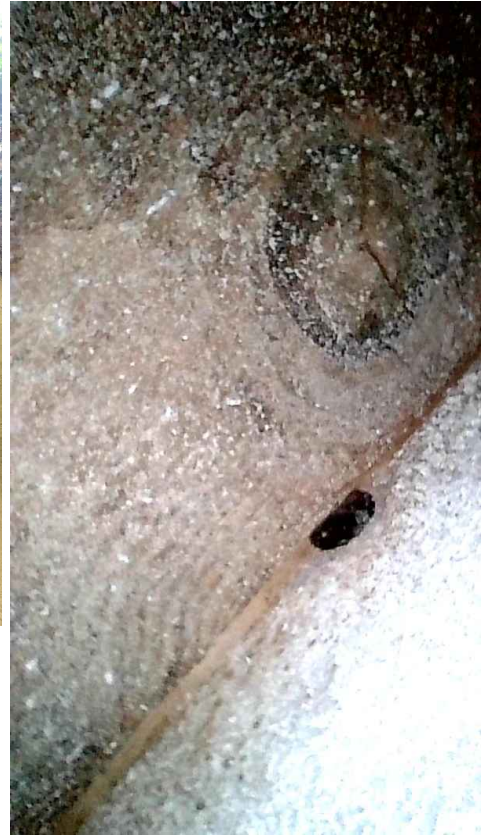
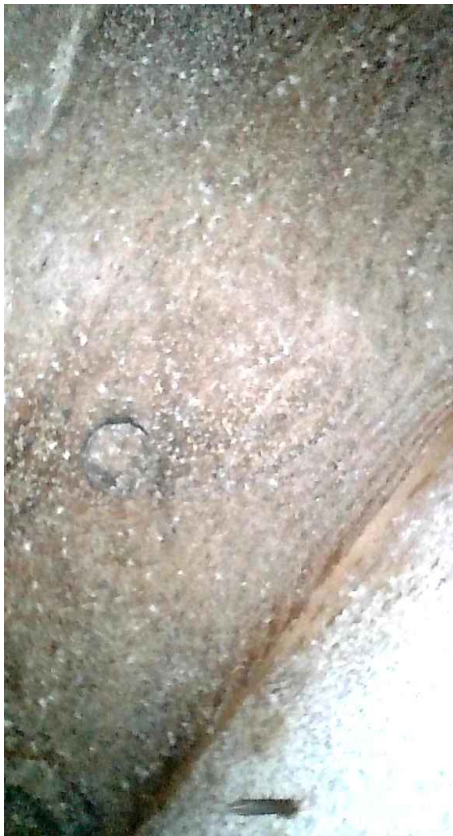
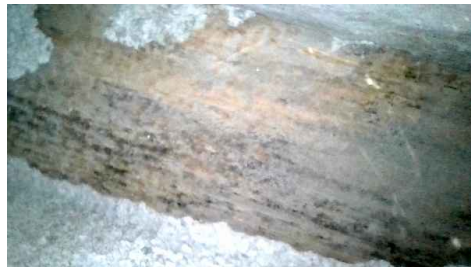
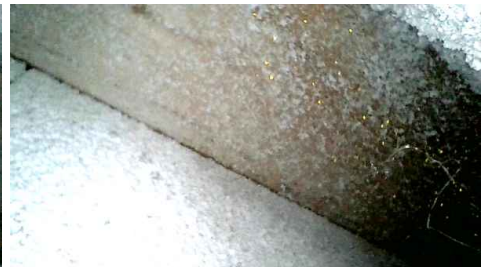
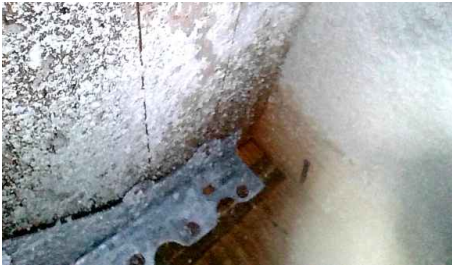
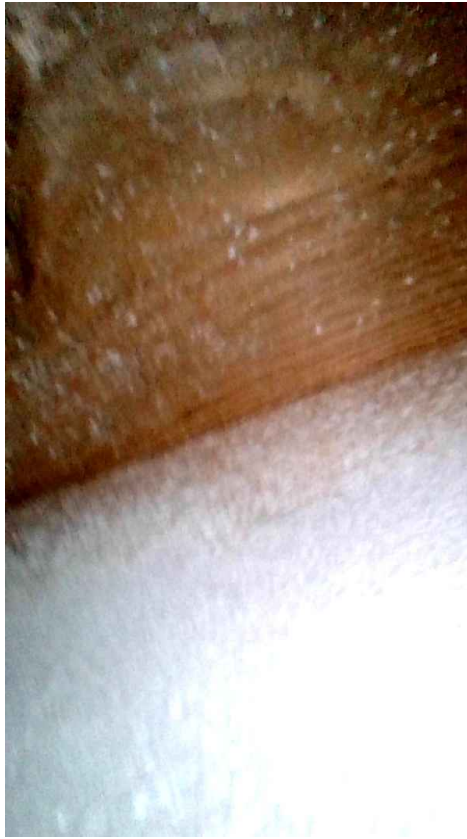
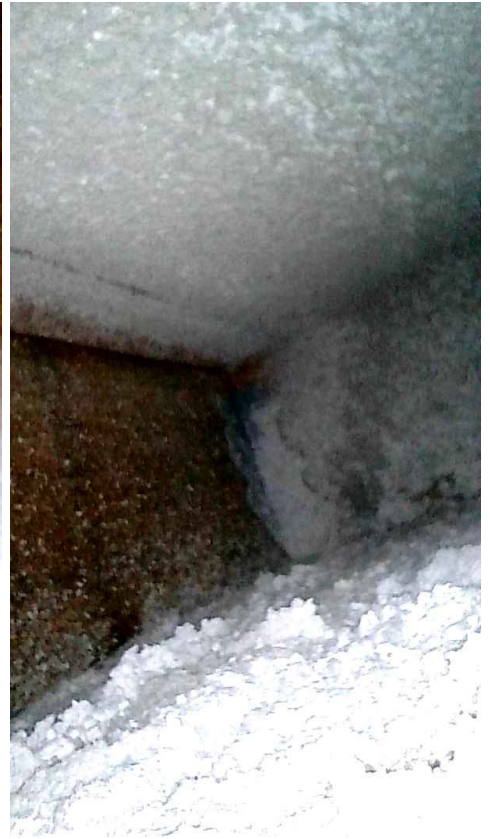
1st borescope inspection

The visual inspection in the P1PE noted cracks in the stucco running parallel to the walkway. See 1st photo.

At the time of the borescope inspection, no damage to the load-bearing components was observed

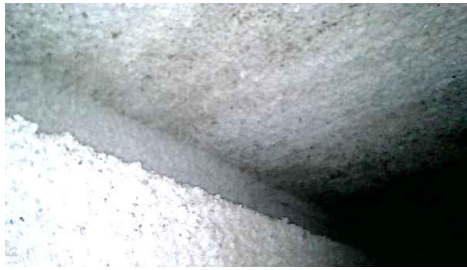
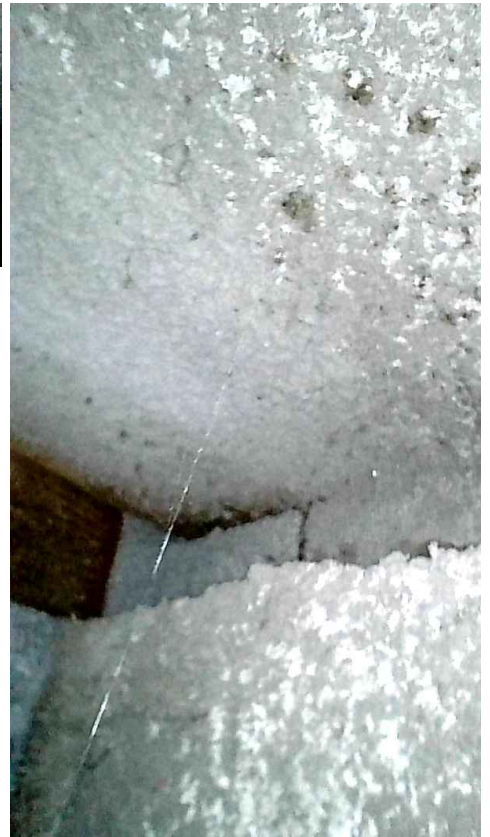
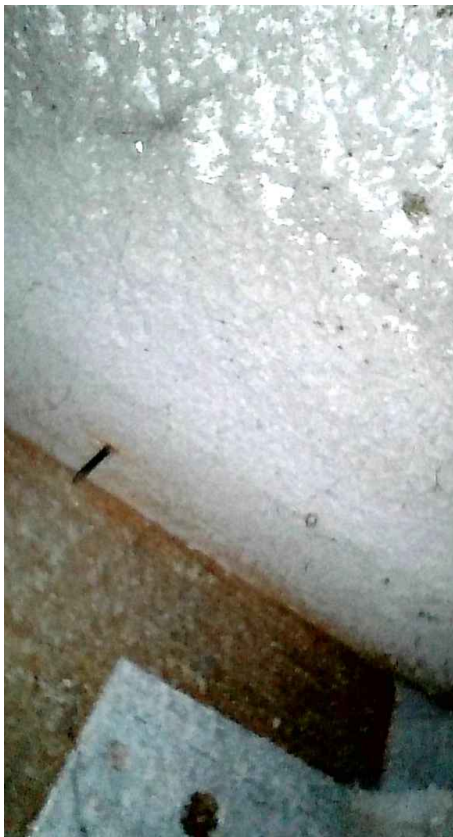
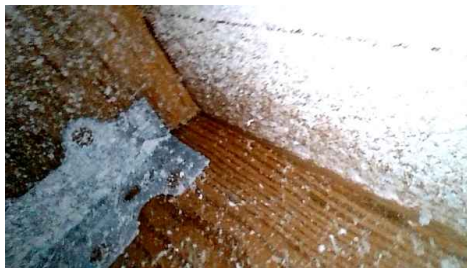
near right stringer attachment

The visual inspection in P1PE noted openings in the stucco around the right stair stringer. These are likely areas for water intrusion. Stucco soffit is discolored in this area.

At the time of the borescope inspection, no damage to the load-bearing components was observed.

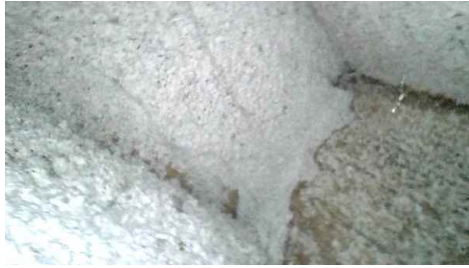
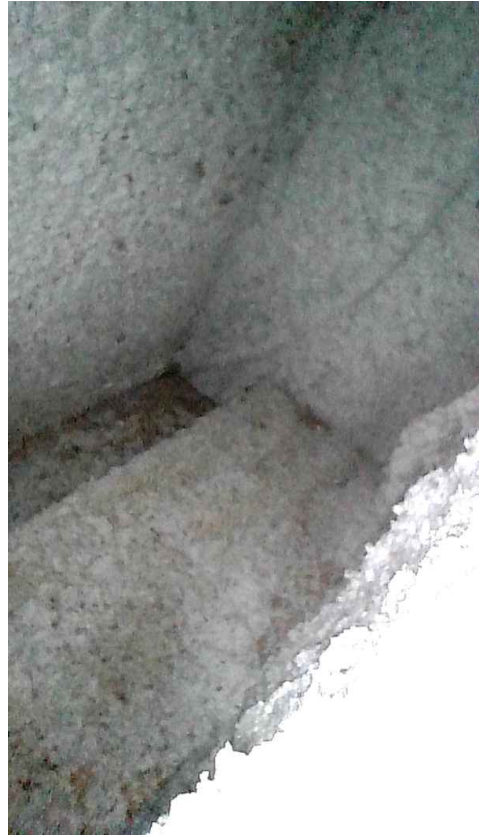
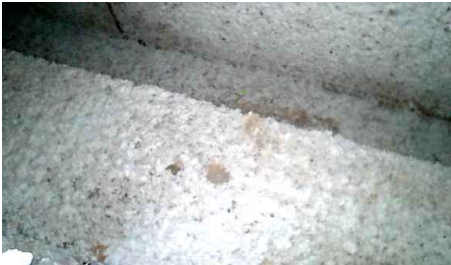
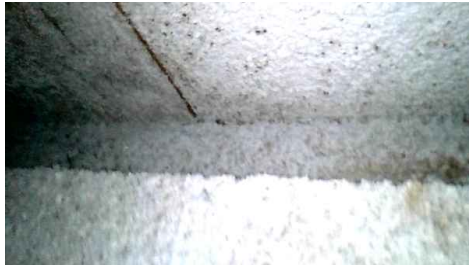
The visual inspection in P1PE noted openings in the stucco around the left stair stringer. These are likely areas for water intrusion. Stucco is discolored in this area.

The 3rd Borescope investigative opening revealed no issues

At the time of the borescope inspection no damage to the load-bearing components was observed

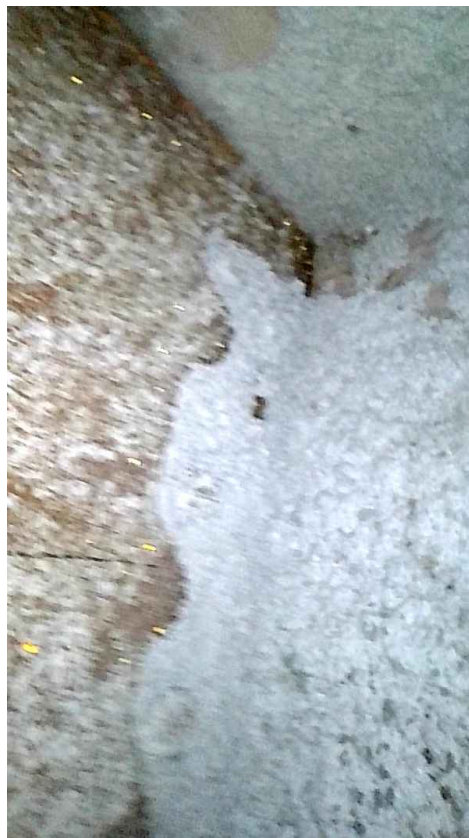
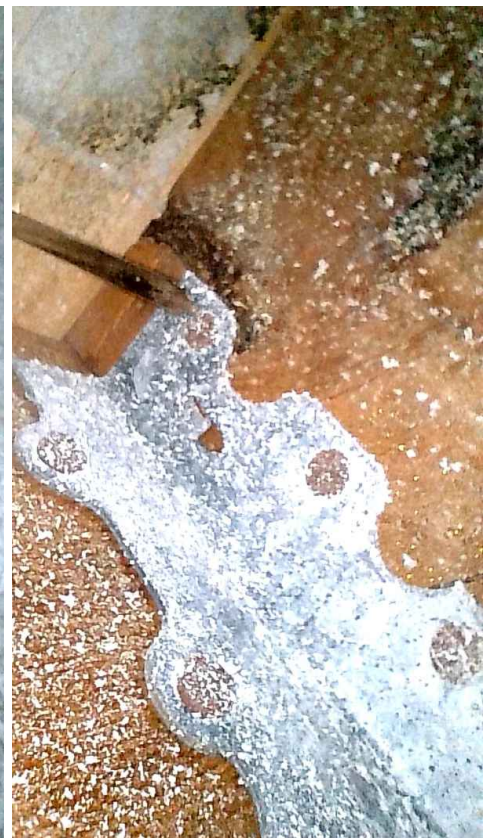
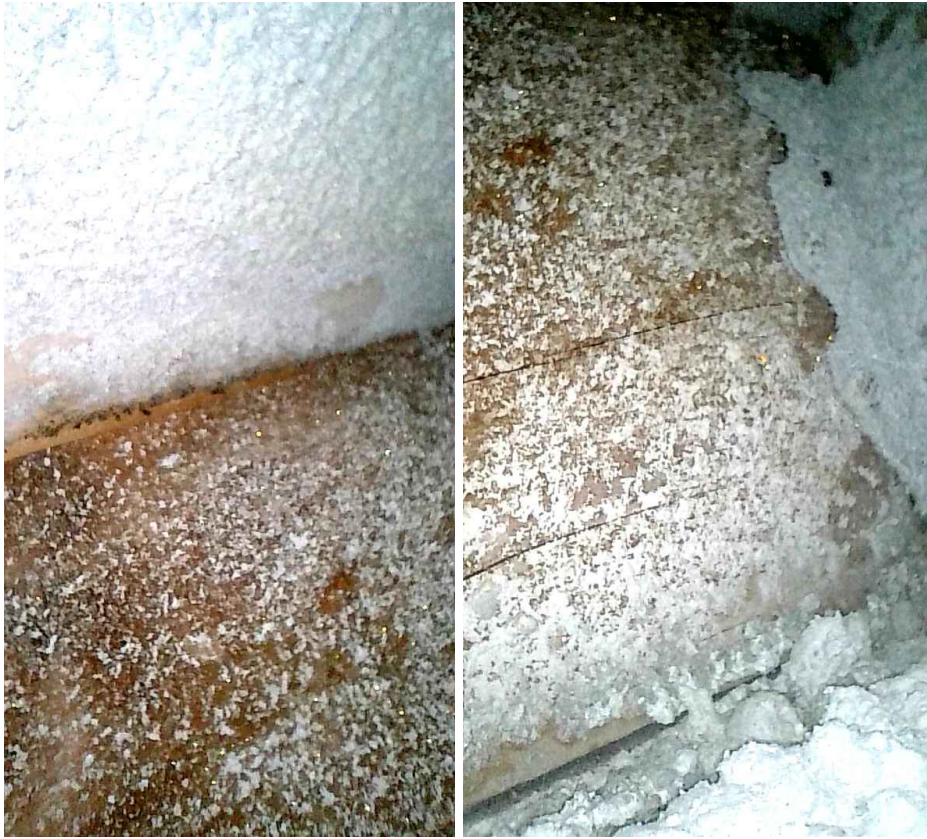
The visual inspection in P1PE noted opening along edge metal. Stucco is falling off the edge metal. See 2nd photo. This is a likely location for water intrusion.

At the time of the borescope inspection no damage to the load-bearing components was observed.

Moisture coming through

**The edge metal should be repaired or replaced and the waterproofing system above resealed.**

**Repair or replace the edge metal toward the south end of the walkway.**

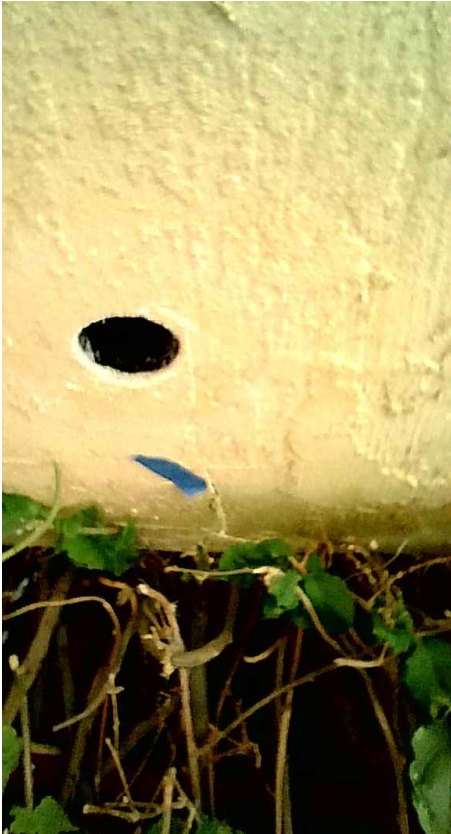
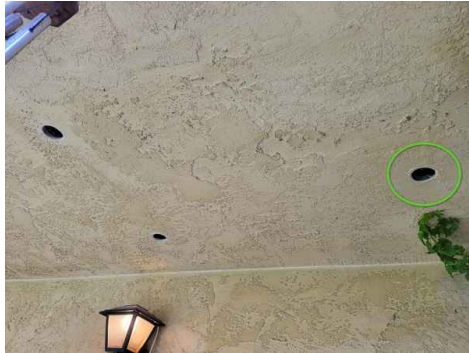
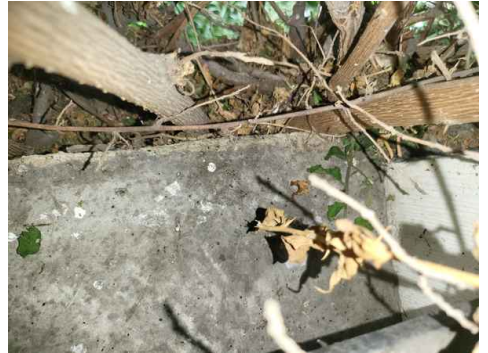
Deck above 5th hole

The visual inspection in P1PE at the south end of the walkway noted vine growth tight against the stucco. The stucco covering underneath is discolored.

**The 5th Borescope investigative opening revealed evidence of termite activity along the rim board.** Photos 8 and 10 show termite droppings. There are signs of minor water intrusion such as water stains along the rim board.

**Prior to the SB-721 Inspection an area of vine growth should be cleared and a section of stucco removed to investigate the extent of termite damage to the rim board or wood support components.**

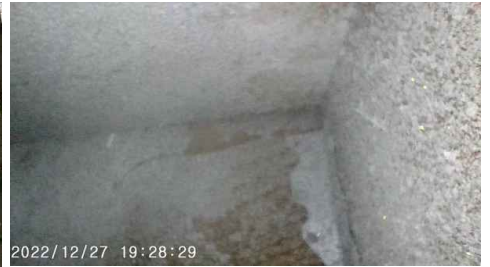
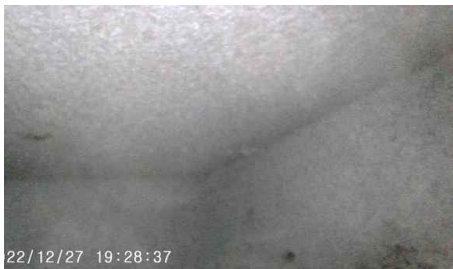
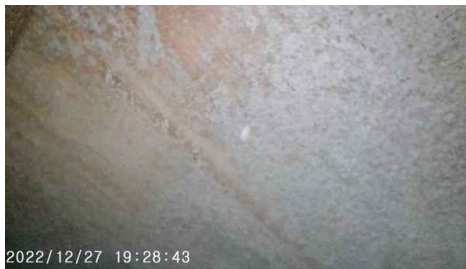
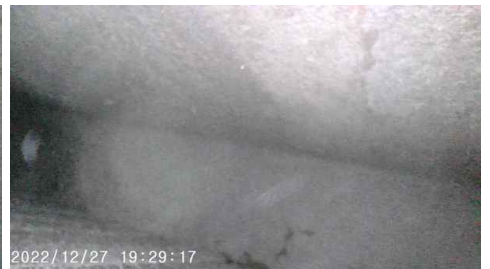
The visual inspection in P1PE noted a crack in the concrete deck. See 2nd photo. This is a potential location for water intrusion.

At the time of the borescope inspection no damage to the load-bearing components was observed.

Crack across concrete deck

**The deck crack should be sealed.**

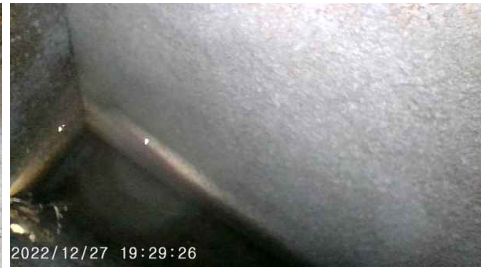
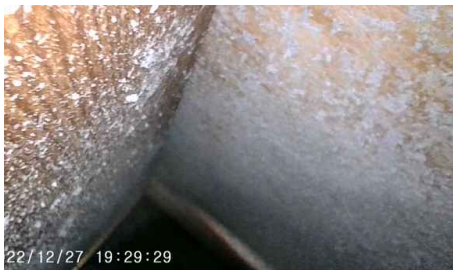
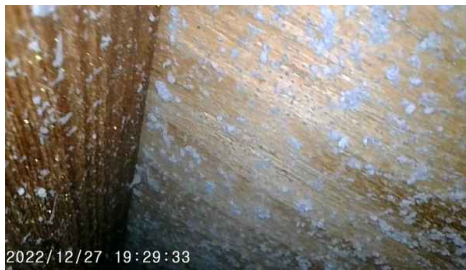
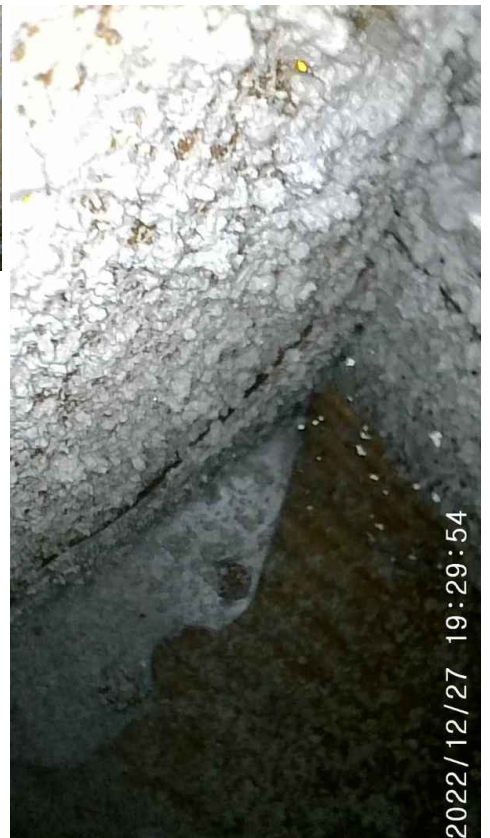
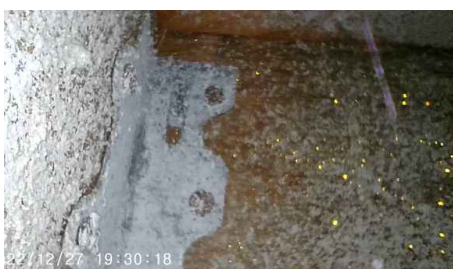
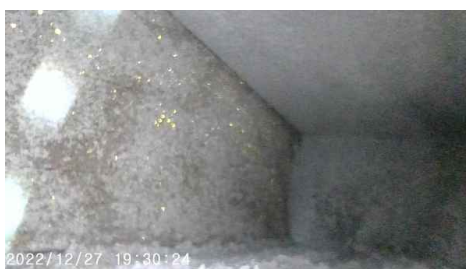
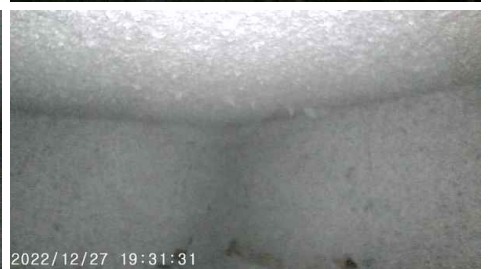
Crack across concrete deck

The visual inspection in P1PE noted a crack in the concrete deck. See 2nd photo. This is a potential location for water intrusion.

At the time of the borescope inspection no damage to the load-bearing components was observed.

**Reseal the walkway edge metal around the perimeter, the cracks in the concrete topping, where the concrete deck meets the stucco wall, at all railing connections and around the top stair tread and the stair stringer connections.**
