PATRICK'S PROPERTY MAINTENANCE SERVICE

SB-721 INSPECTION

1234 Main Street
Imperial Beach, CA 91932-1412

01/11/2025 9:00AM

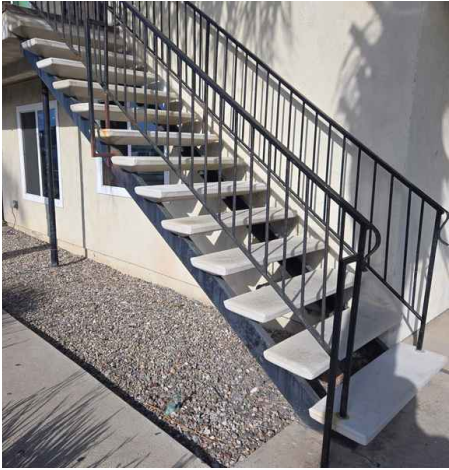
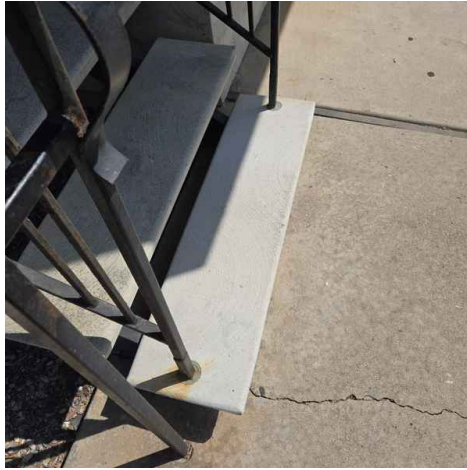
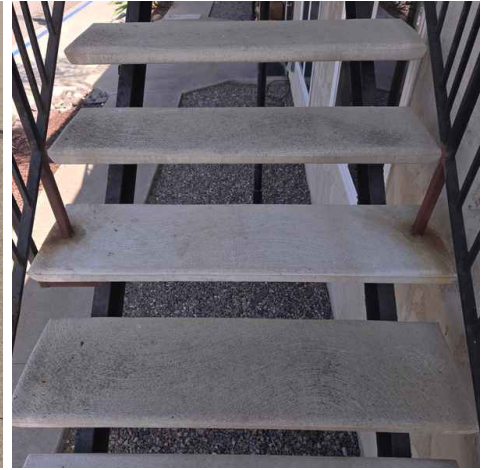
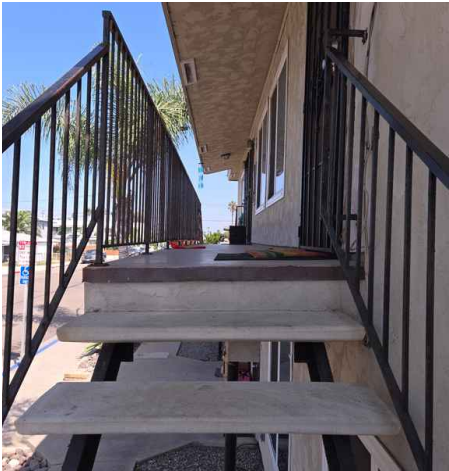
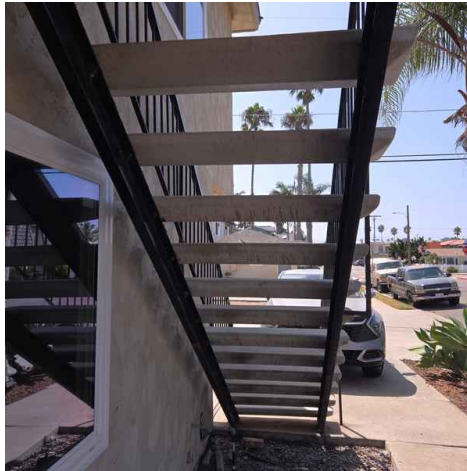
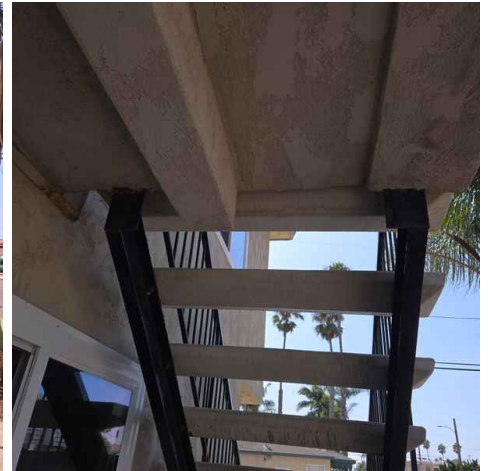
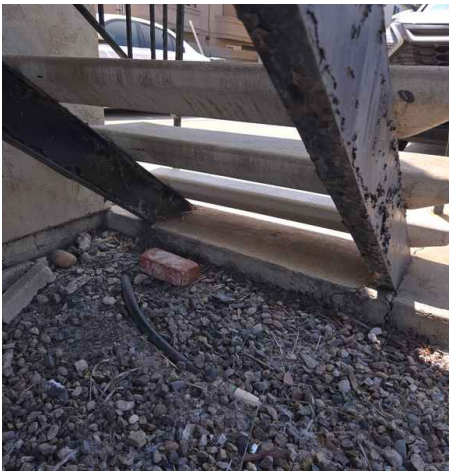
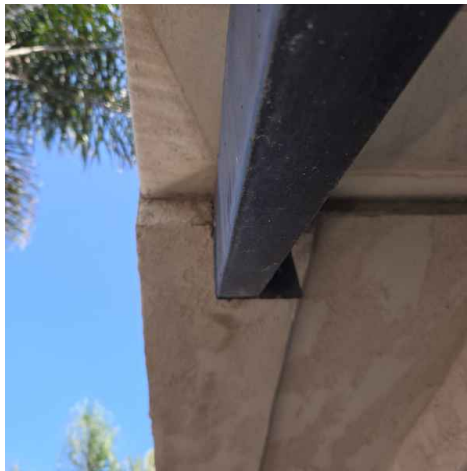
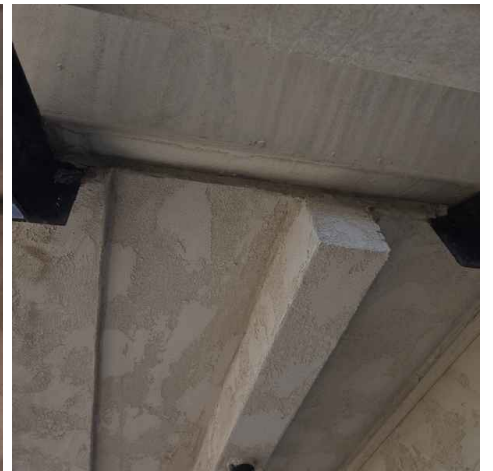
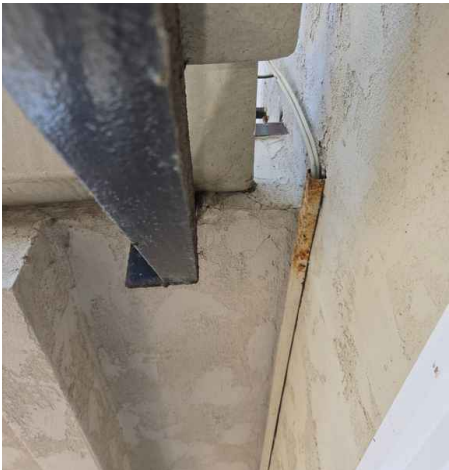
South Stairway: *Stairway Inspection Image(s)

South Stairway: Tread material
Precast Concrete

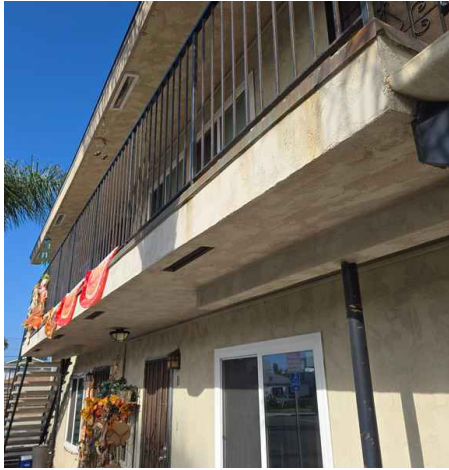
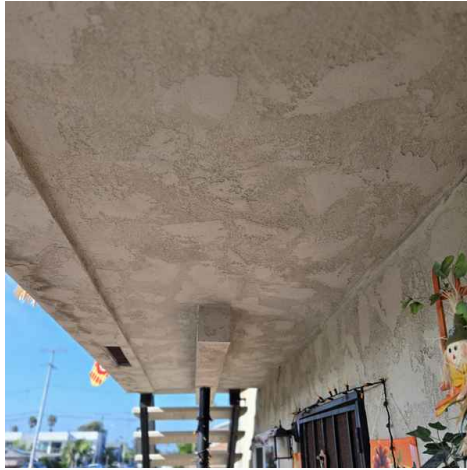
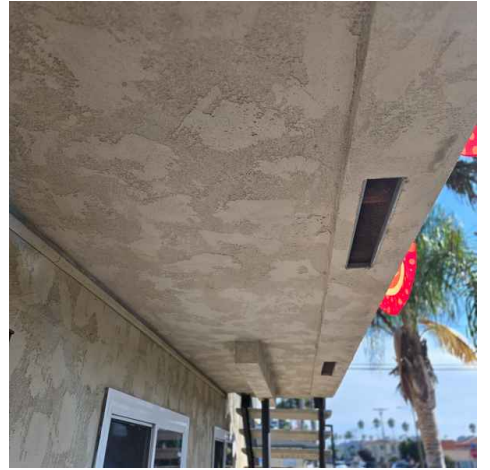
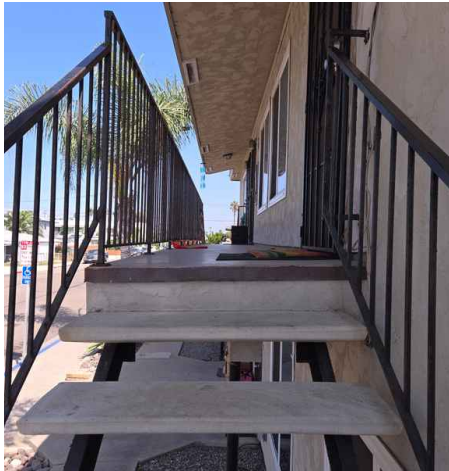
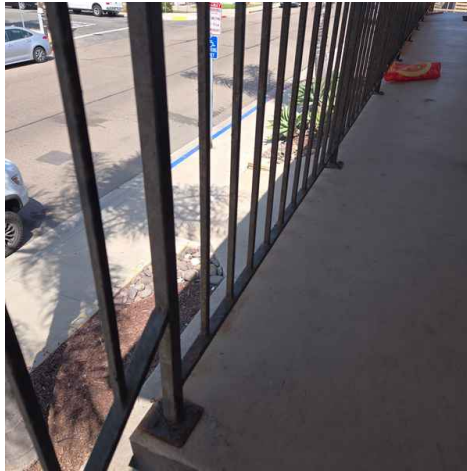
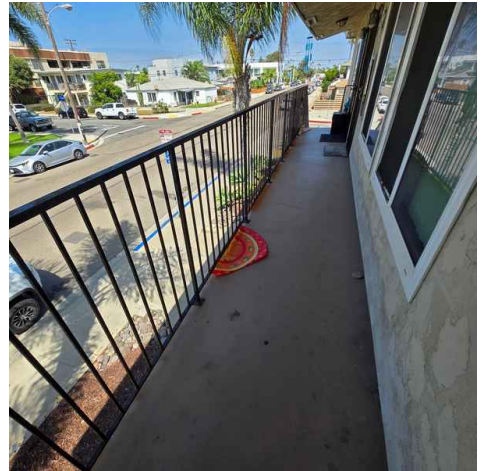
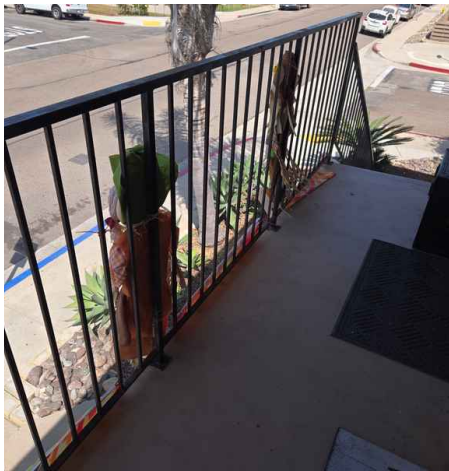
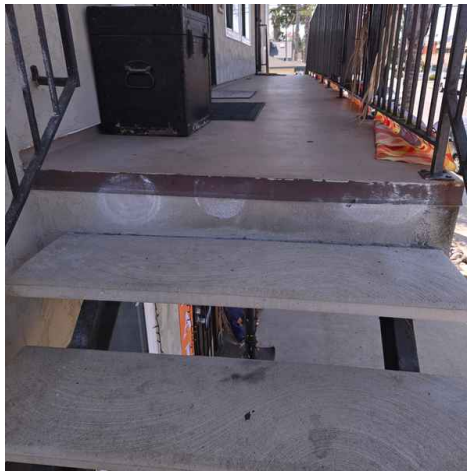
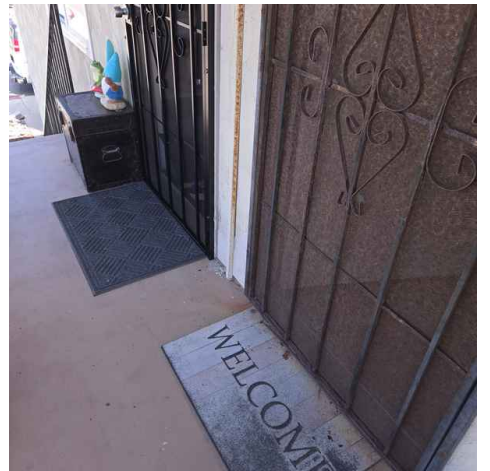
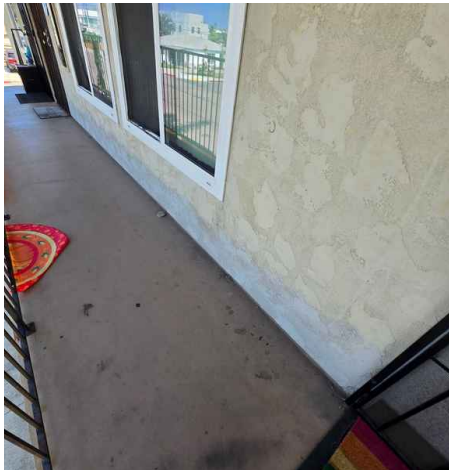
Walkway: *Walkway Inspection Image(s)

Walkway: Approximate Height
9 ft

Walkway: Walking Surface Material
Composite

Walkway: Support Material
Wood

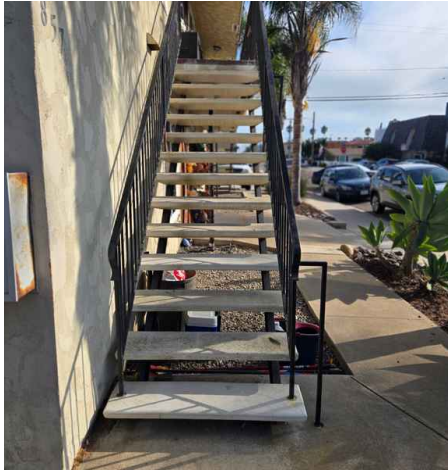
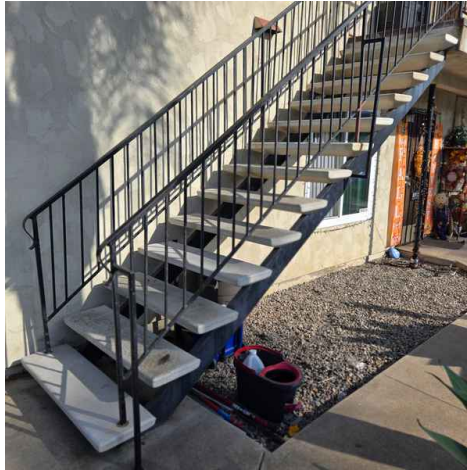
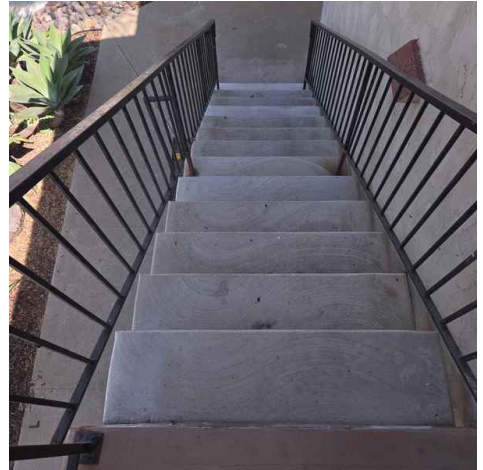
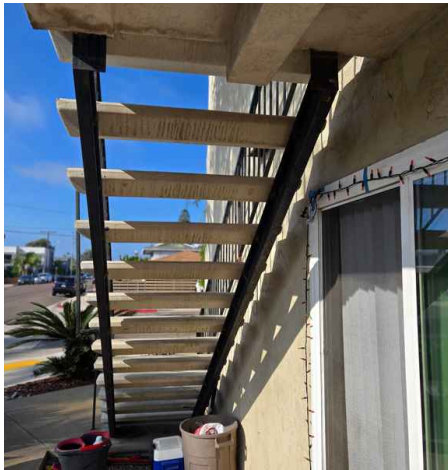
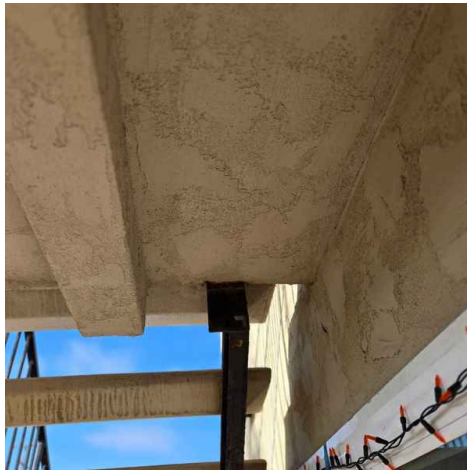
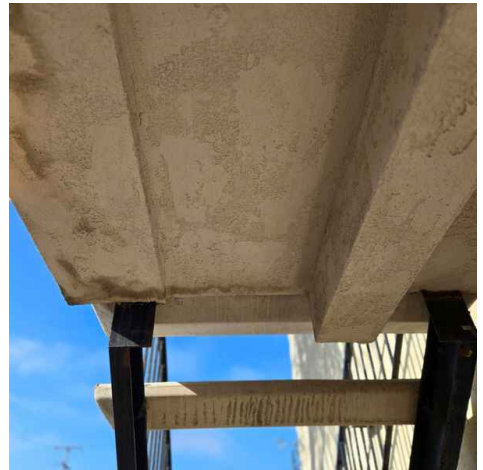
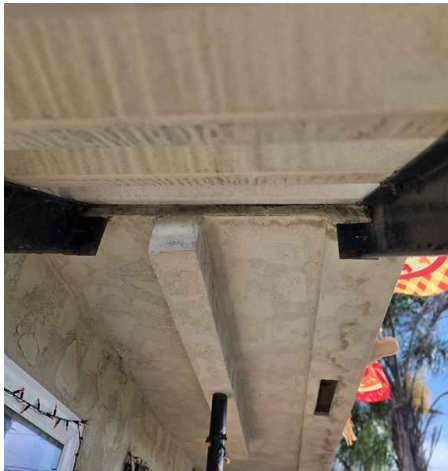
North Stairway: *Stairway Inspection Image(s)

North Stairway: Approximate Height
9 ft

North Stairway: Number of Treads
13

North Stairway: Tread material
Precast Concrete
