PATRICK'S PROPERTY MAINTENANCE SERVICE

PHASE 3 SB-721 INSPECTION

1234 Main Street
Imperial Beach, CA 91932-1412

01/11/2025 9:00AM

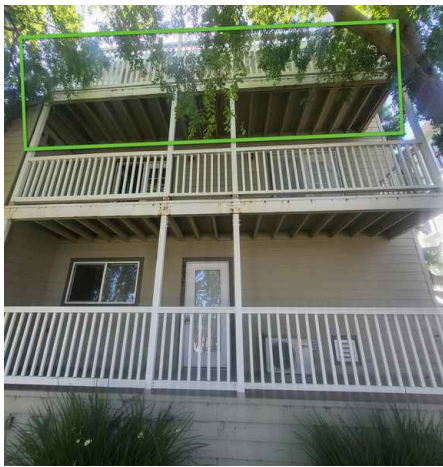
East Side
Balcony

Support structure(s) are functioning as intended, Waterproofing is in good condition

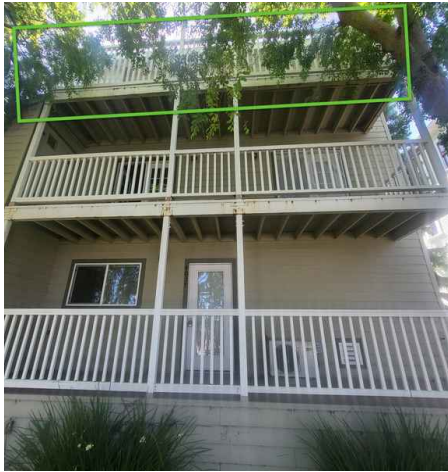
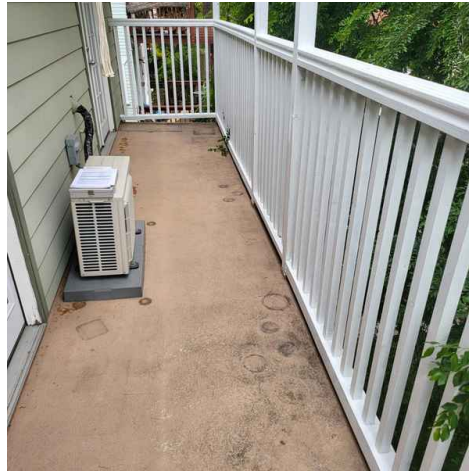
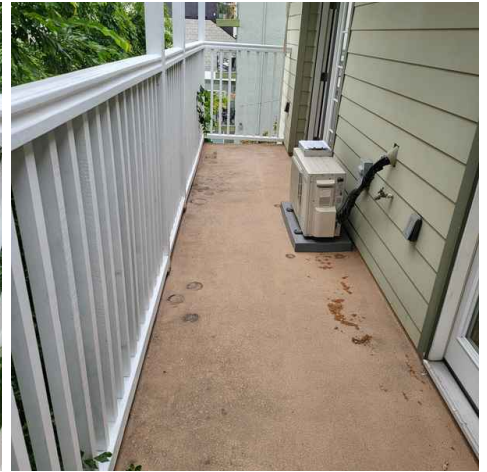
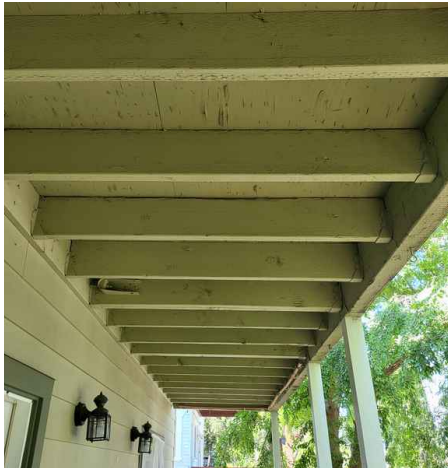
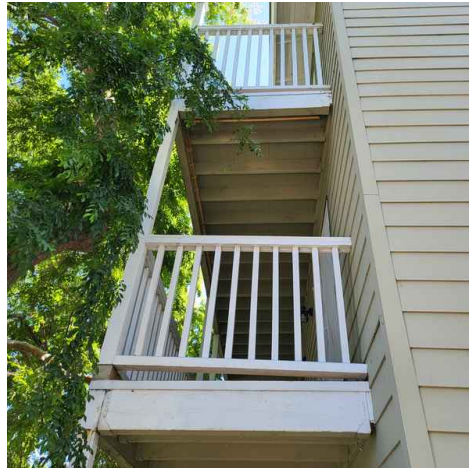
Balcony: *Balcony Inspection Image(s)

At the time of my inspection all elevated wood-framed and steel-framed decks / balconies / landings / stairway systems / walkways / terraces / guardrails / handrails / or any parts thereof in weather-exposed areas at the subject building did not exhibit signs of deterioration / decay / corrosion or similar damage that could pose a safety concern and there was no evidence of active water intrusion in concealed spaces of the inspected elements., No permit required.

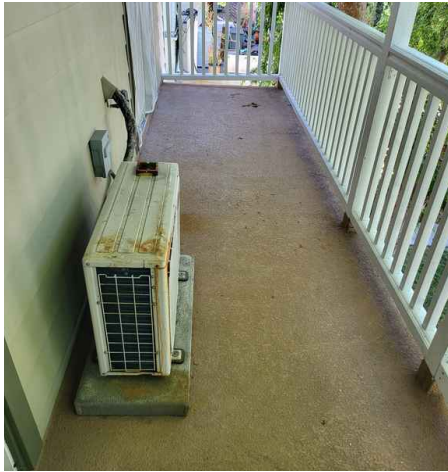
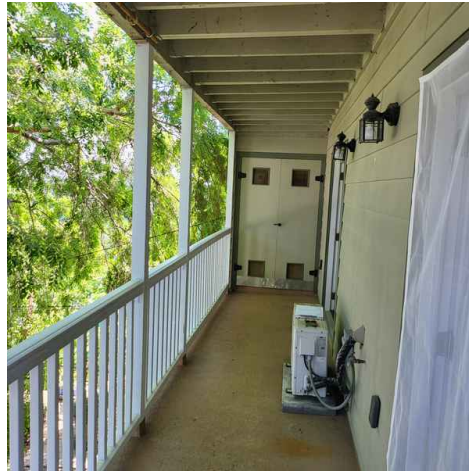
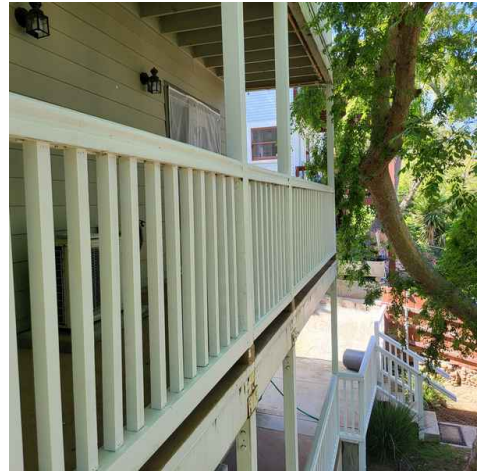
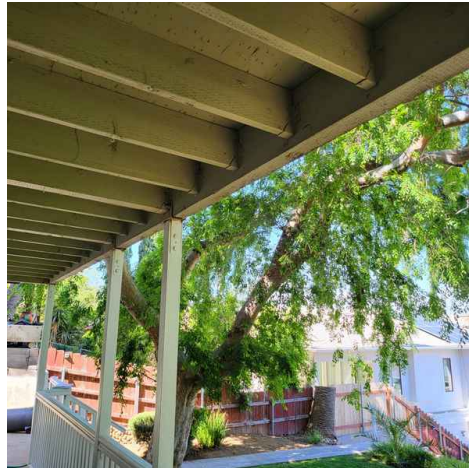
Balcony: *Balcony Inspection Image(s)

At the time of my inspection all elevated wood-framed and steel-framed decks / balconies / landings / stairway systems / walkways / terraces / guardrails / handrails / or any parts thereof in weather-exposed areas at the subject building did not exhibit signs of deterioration / decay / corrosion or similar damage that could pose a safety concern and there was no evidence of active water intrusion in concealed spaces of the inspected elements., No permit required.
