PATRICK'S PROPERTY MAINTENANCE SERVICE

PHASE 3 SB-721 INSPECTION

1234 Main Street
Imperial Beach, CA 91932-1412

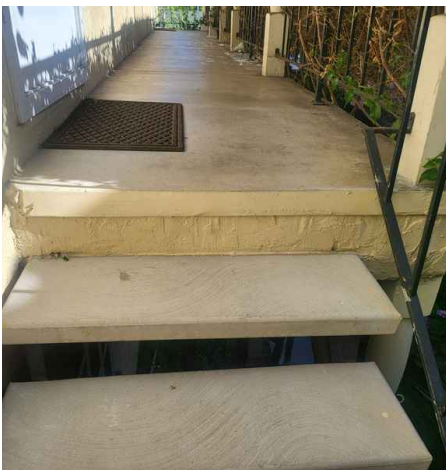
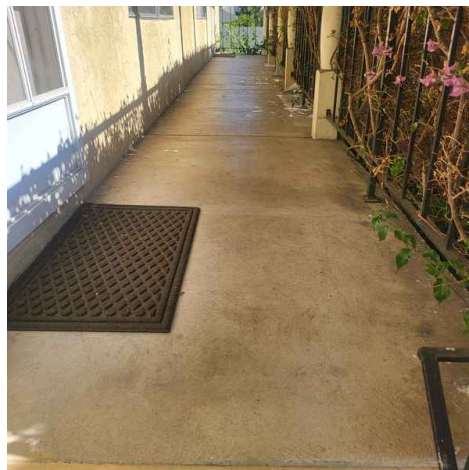
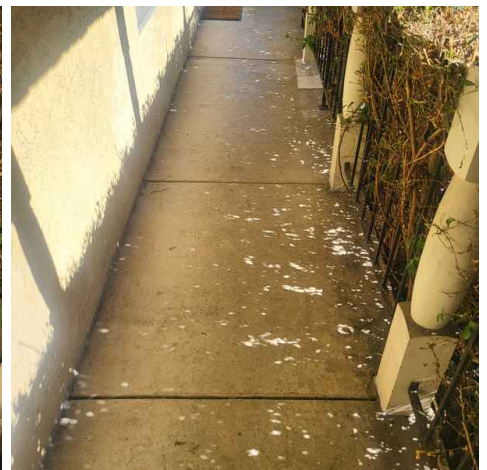
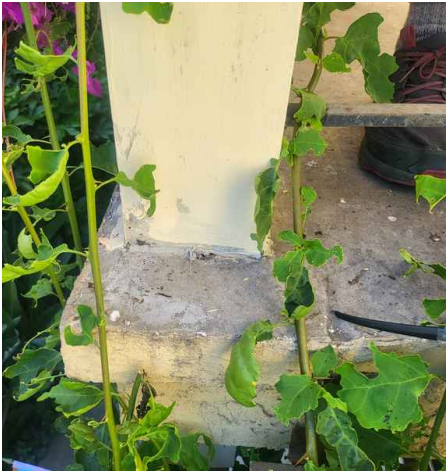
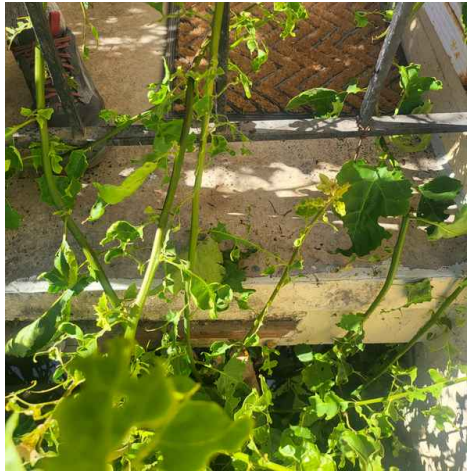
Walkway: *Walkway Inspection Image(s)

At the time of my inspection all elevated wood-framed and steel-framed decks / balconies / landings / stairway systems / walkways / terraces / guardrails / handrails / or any parts thereof in weather-exposed areas at the subject building did not exhibit signs of deterioration / decay / corrosion or similar damage that could pose a safety concern and there was no evidence of active water intrusion in concealed spaces of the inspected elements.
