PHASE 1 SB-721 EVALUATION

1234 Main Street
Imperial Beach, CA 91932-1412

Buyer Name
05/02/2024 9:00AM

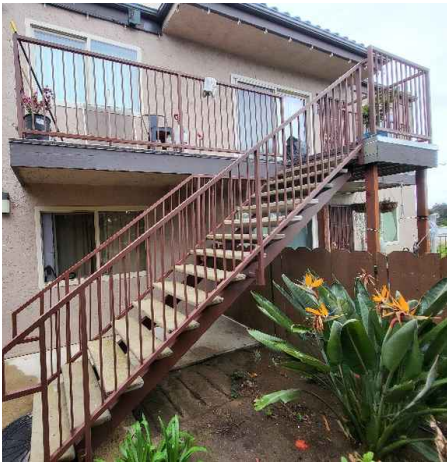
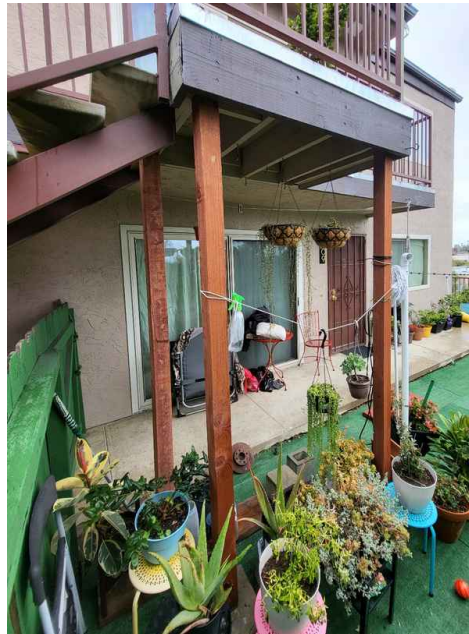
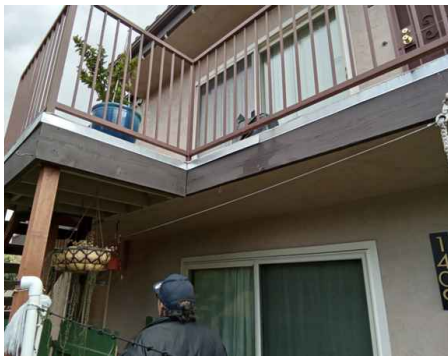
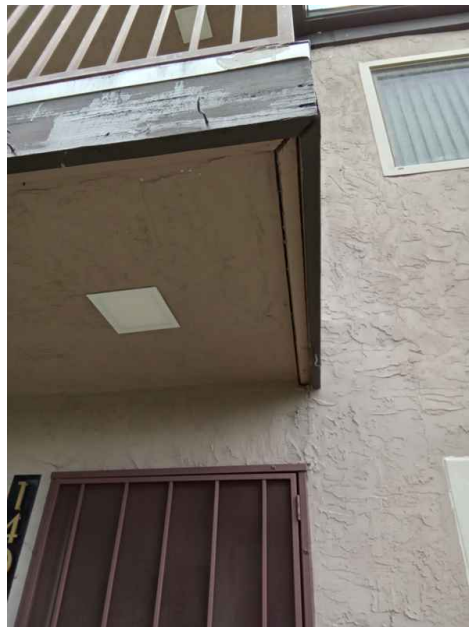
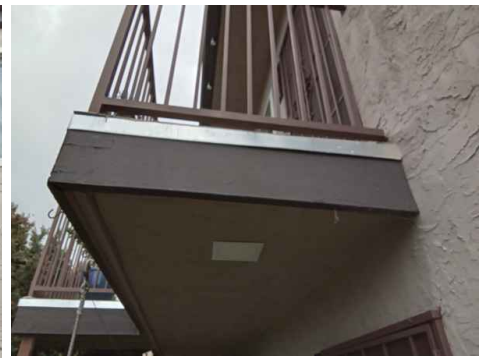
Walkway: Walkway Inspection Images

Walkway: Marginal Condition

Non-Emergency Repairs Required

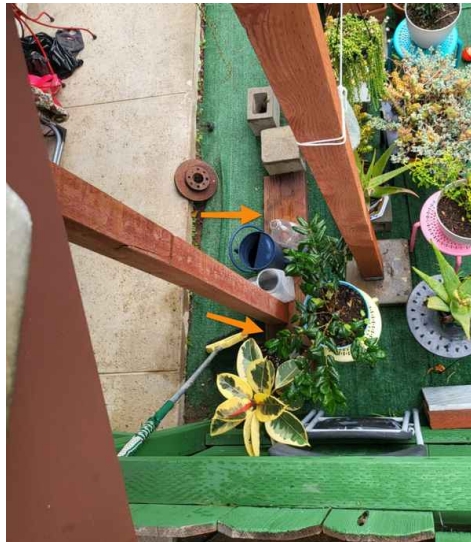
Temporary Support Beam

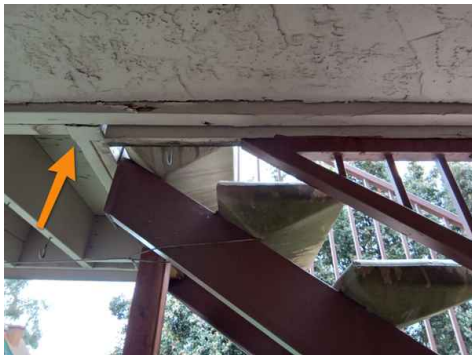
Landing Joist Hangers

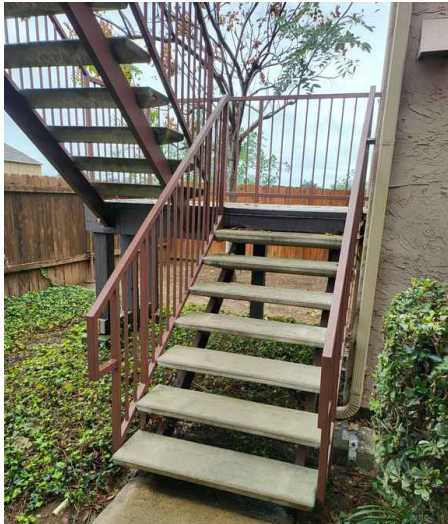
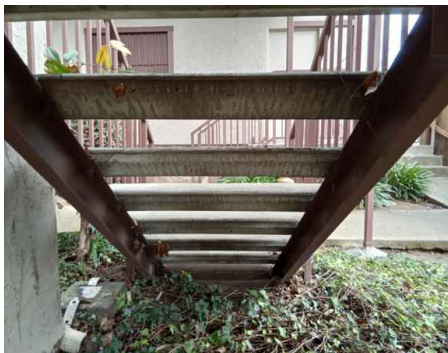
Stairway: Stairway Inspection Images

Stairway: Marginal Condition

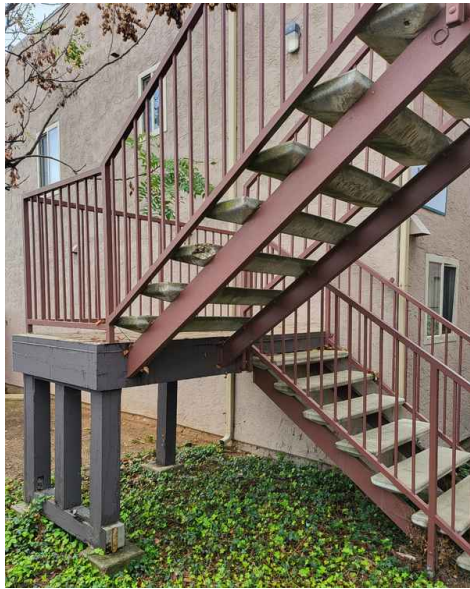
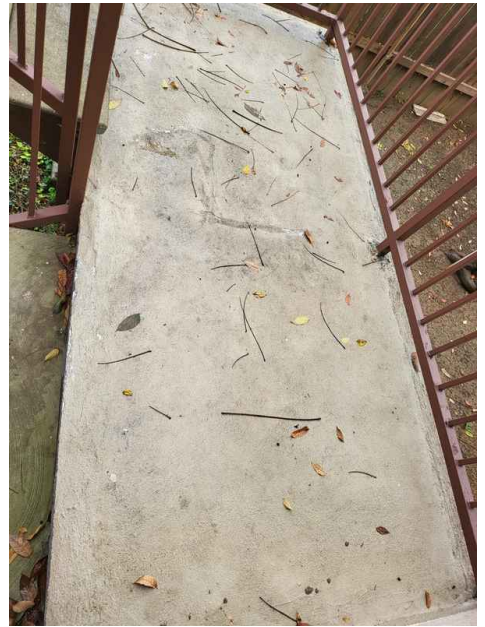
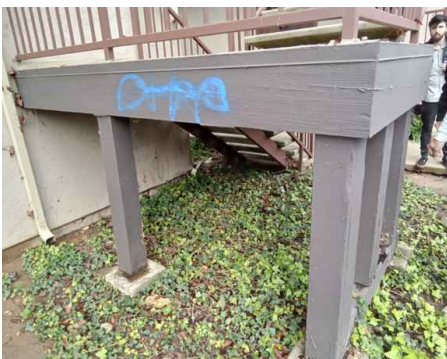
Landing: Landing Inspection Images

Landing: Marginal Condition

There are visible cracks in the decking surface and evidence of water intrusion. The decking material is lifted off the plywood in some areas. The plywood under the decking is likely damaged. The decking surface on the landing must be repaired or replaced prior to SB-721 Inspection.

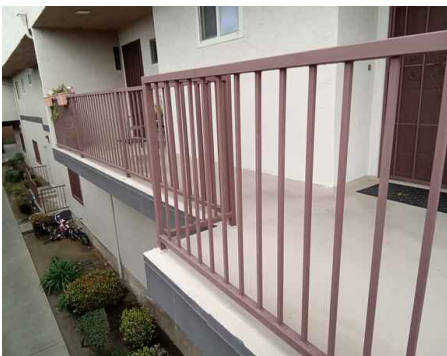
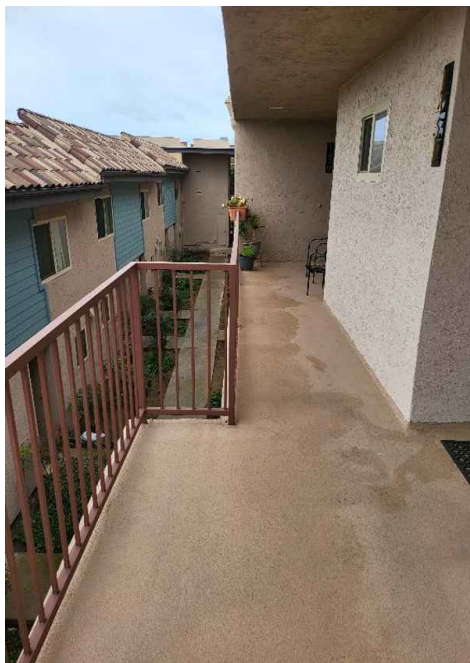
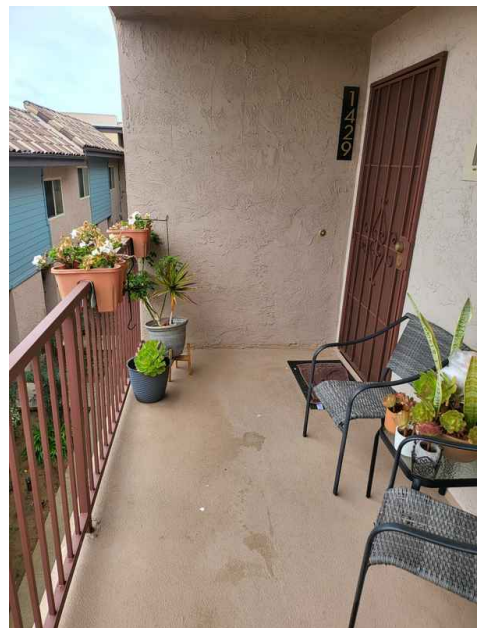
Walkway: Walkway Inspection Images

Walkway: Acceptable Condition

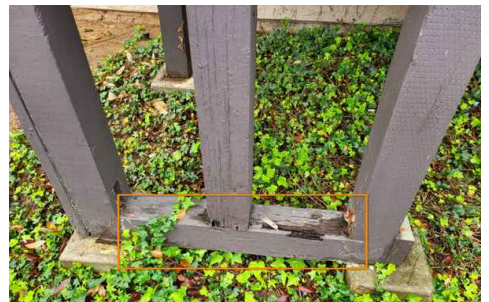
Rotted Cross Beam

Doubler supporting the stair stringers has moderate to severe termite damage/wood rot. The added 6x6 support beam rests on a 6x6 cross beam that has moderate to severe termite damage/wood rot. See the last photo.

One or more sections of the support framing have termite and/or dry rot damage. It is recommended that these sections be treated or replaced.

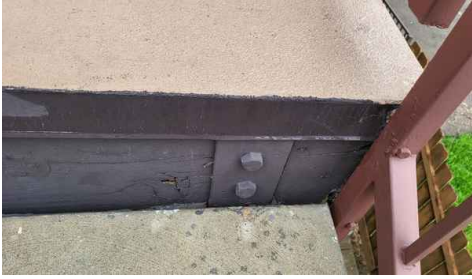
TERMITE/WOOD ROT DAMAGE

One or more sections of the rim joist and/or fascia have termite and/or dry rot damage. It is recommended that these sections be treated and sealed, or replaced.

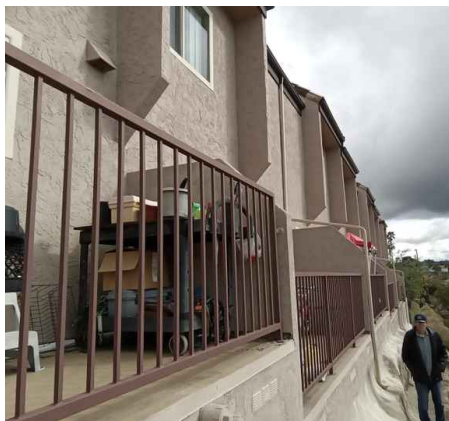
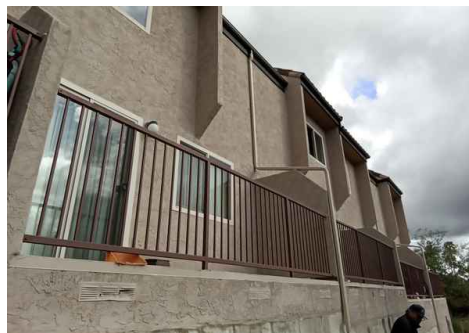
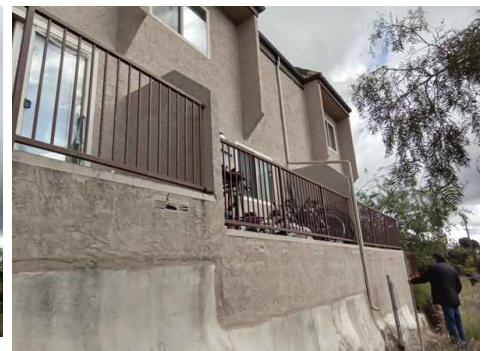
Porch: Porch Inspection Images

Porch: Acceptable Condition

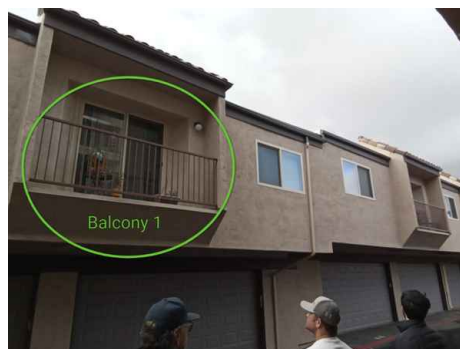
Balcony 1

Balcony 1: Acceptable Condition
