PATRICK'S PROPERTY MAINTENANCE SERVICE

PHASE 1 PRE-721 EVALUATION

1234 Main Street
Imperial Beach, CA 91932-1412

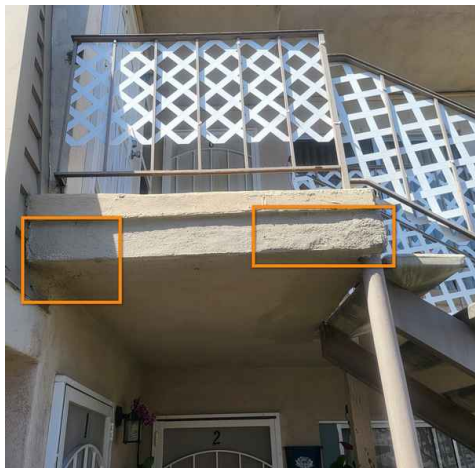
bubbling, efflorescence

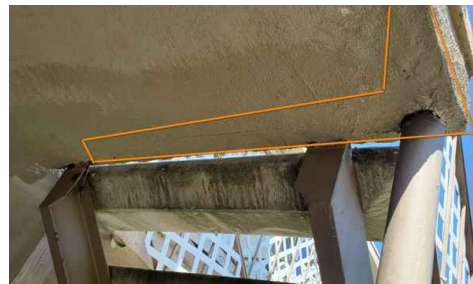
cracking

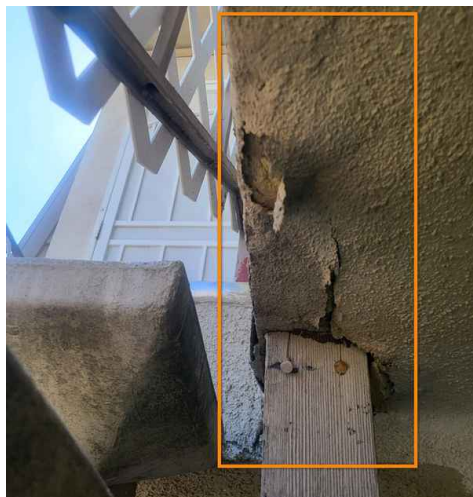
blistered

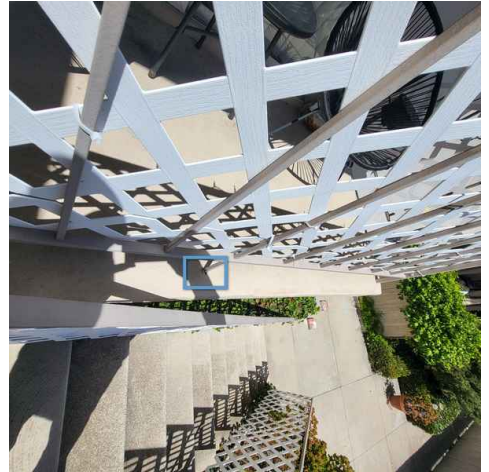
bottom rail to wall

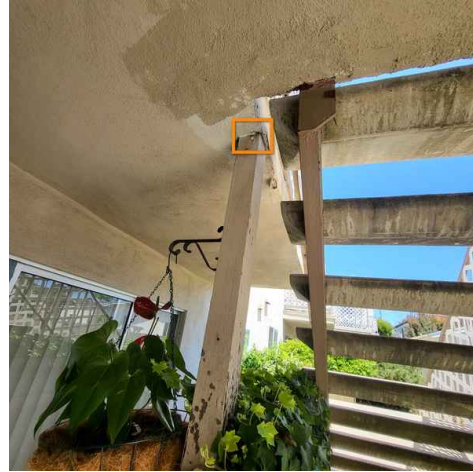
6.3.4 Walkway

Marginal - The inspection revealed evidence of minor instability in the support structure, possibly due to inadequate or improper construction methods. While currently stable, this condition suggests that the support construction may not adhere to regulatory standards, potentially leading to long-term issues. A Phase 2 Pre-721 Evaluation (P2PE) is recommended to formulate a detailed repair plan. See Reference Information: Notification and Follow Up - Marginal.

support beam or fence post

Recommendation

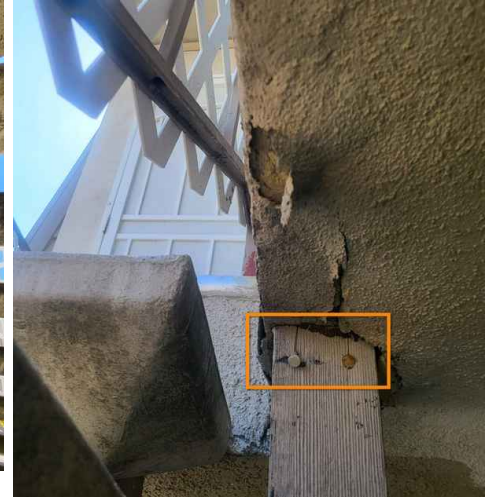
toenailed beam

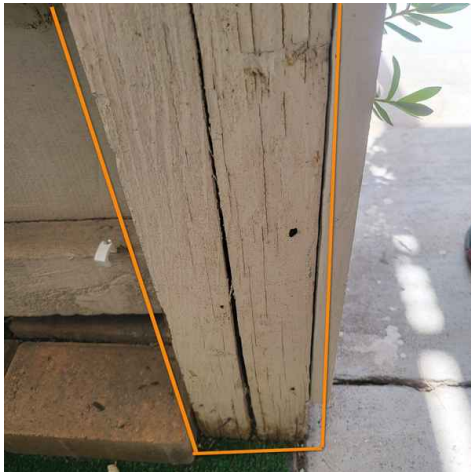
toenailed beam

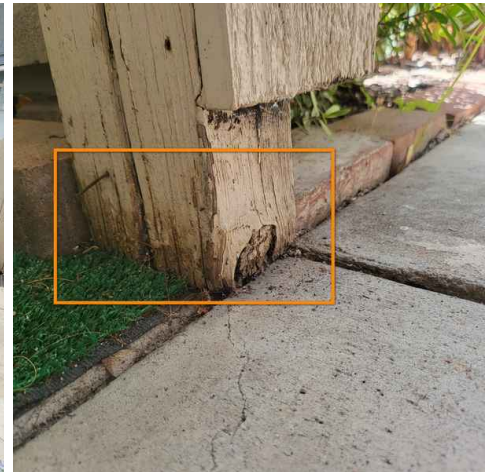
no standoff

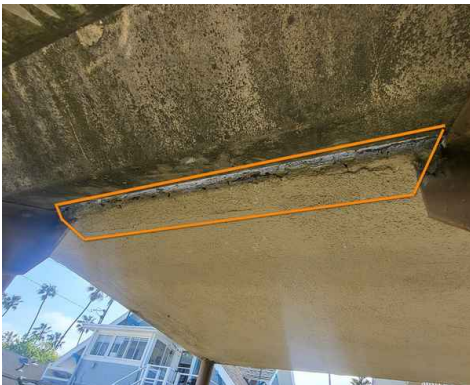
Marginal - Stucco is cracking, stained, bulging, bubbling, blistered, efflorescing, soft, crumbling, discolored or showing signs of mold and mildew. These conditions are marginal. A Phase 2 Pre-721 Evaluation (P2PE) is recommended to determine the extent of any water damage via borescope inspection or larger investigative openings, and to formulate a detailed repair plan. See Reference Information: Notification and Follow Up - Marginal.

cracking

Recommendation

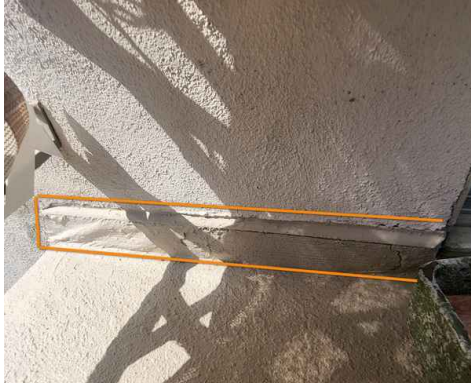
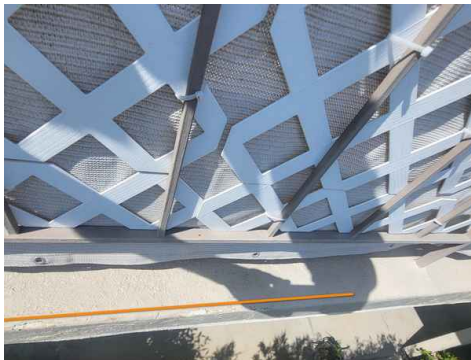
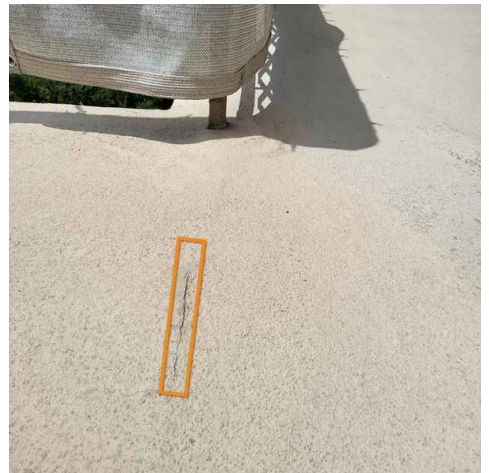
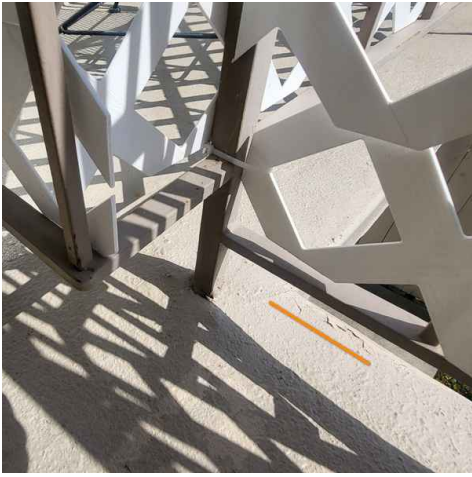
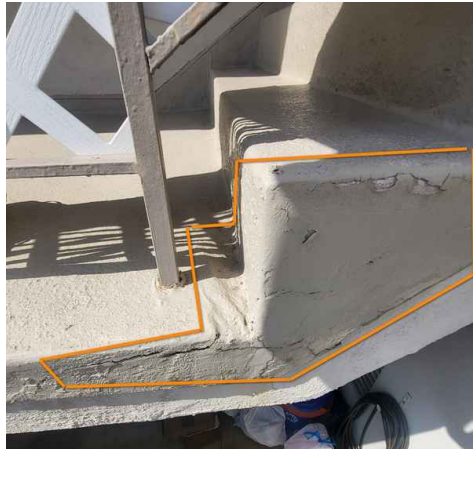
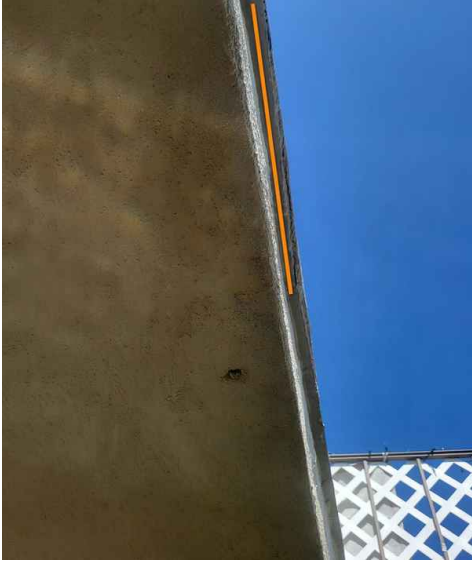
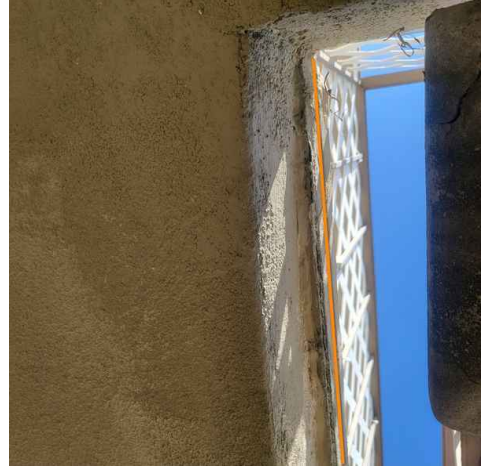
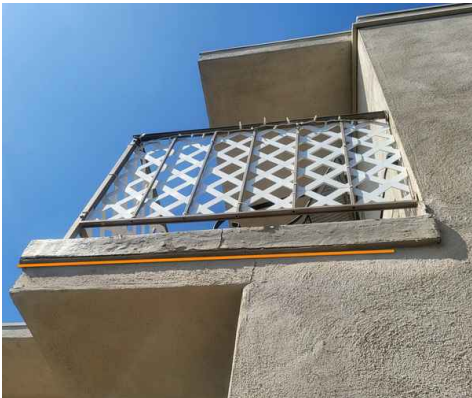
Marginal - There are cracks, openings, or penetrations in the waterproofing that allow significant water intrusion. A Phase 2 Pre-721 Evaluation (P2PE) is recommended to determine the extent of any water damage via borescope inspection or larger investigative openings, and to formulate a detailed repair plan. See Reference Information: Notification and Follow Up - Marginal.

Contact a qualified professional.
