PATRICK'S PROPERTY MAINTENANCE SERVICE

SB-721 INSPECTION

1234 Main Street
Imperial Beach, CA 91932-1412

01/11/2025 9:00AM

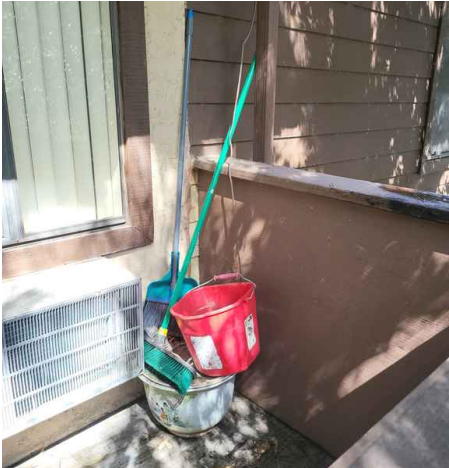
The balcony was repaired within the last 2 years.
